Southwest Metro Corridor and Bankstown Early Works Construction Monitoring Report 3 March 2022- August 2022

SMCSWSSJ-JHL-WEC-EM-REP-000027

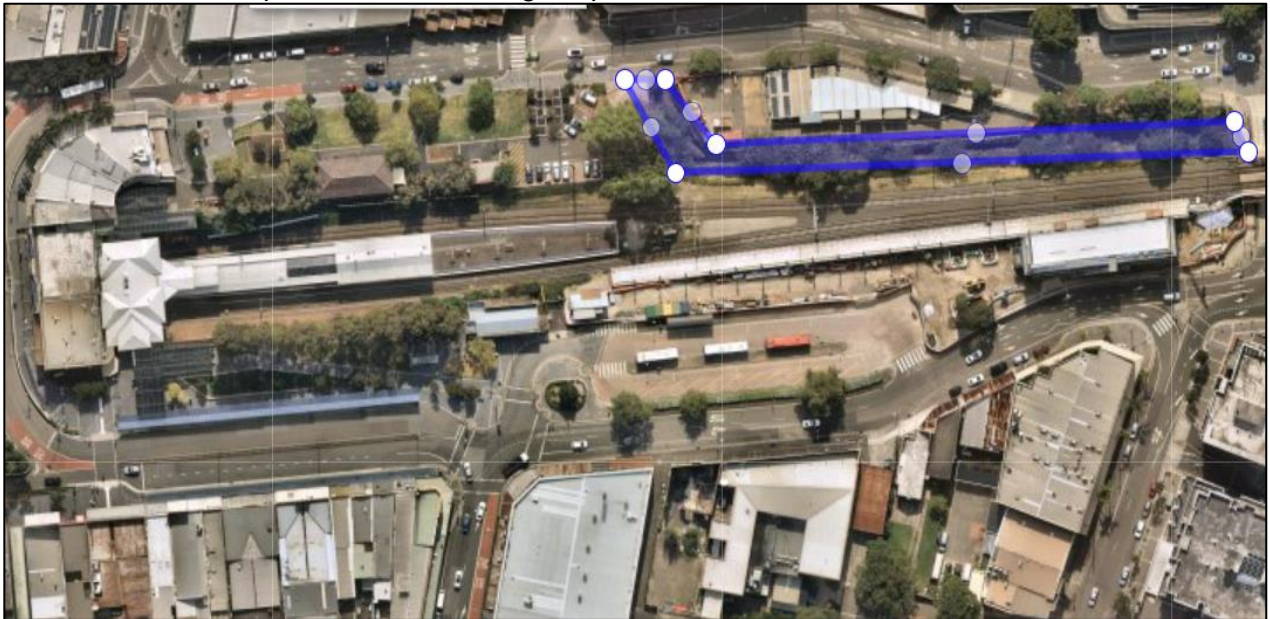
Figure 2. Bankstown early works (water quality location 9)

One baseline monitoring inspection was conducted in March 2021 (02/03/2021) and updated with 2 additional locations including BEW (10/09/2021 – see figure 2) and Canterbury compound (14/04/2021 – see figure 3). Refer to Table 2 for a summary.

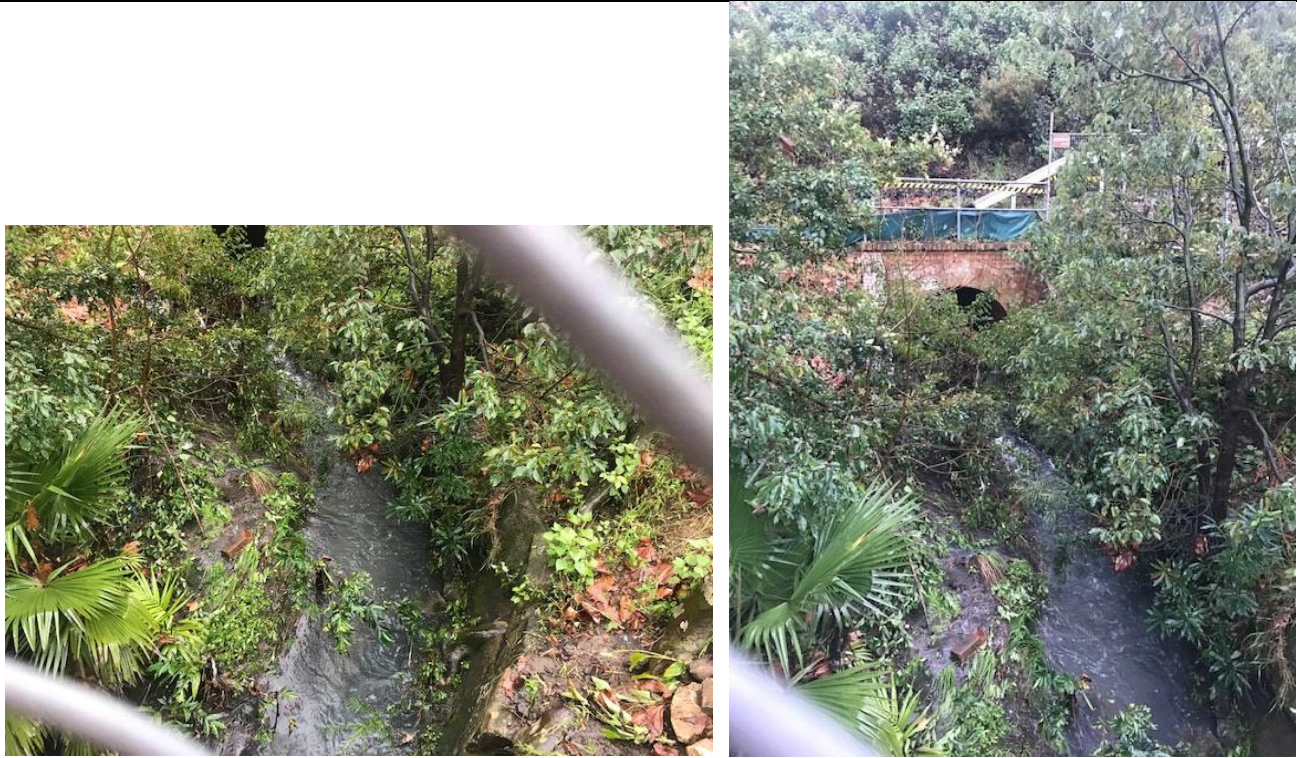
<p>ERSED Controls at Ewart St</p>

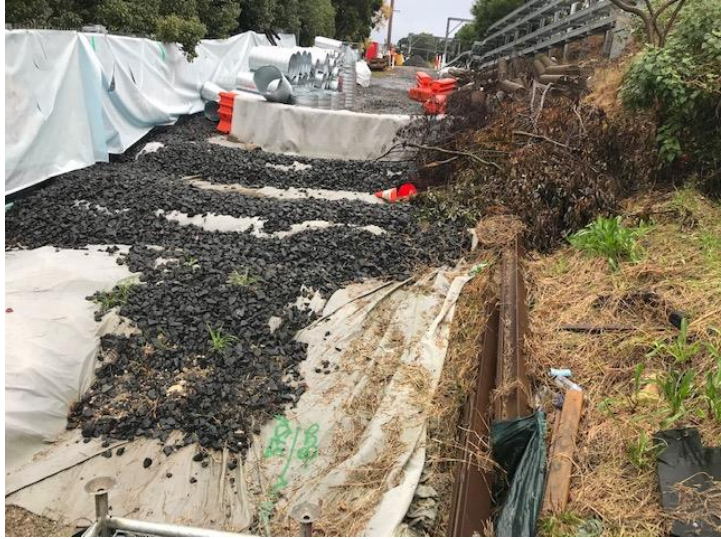
<p>No JHLOR works during WE01</p> <p>ERSED Controls in place at Ewart St</p> <p>No sign of dirty water from corridor</p>

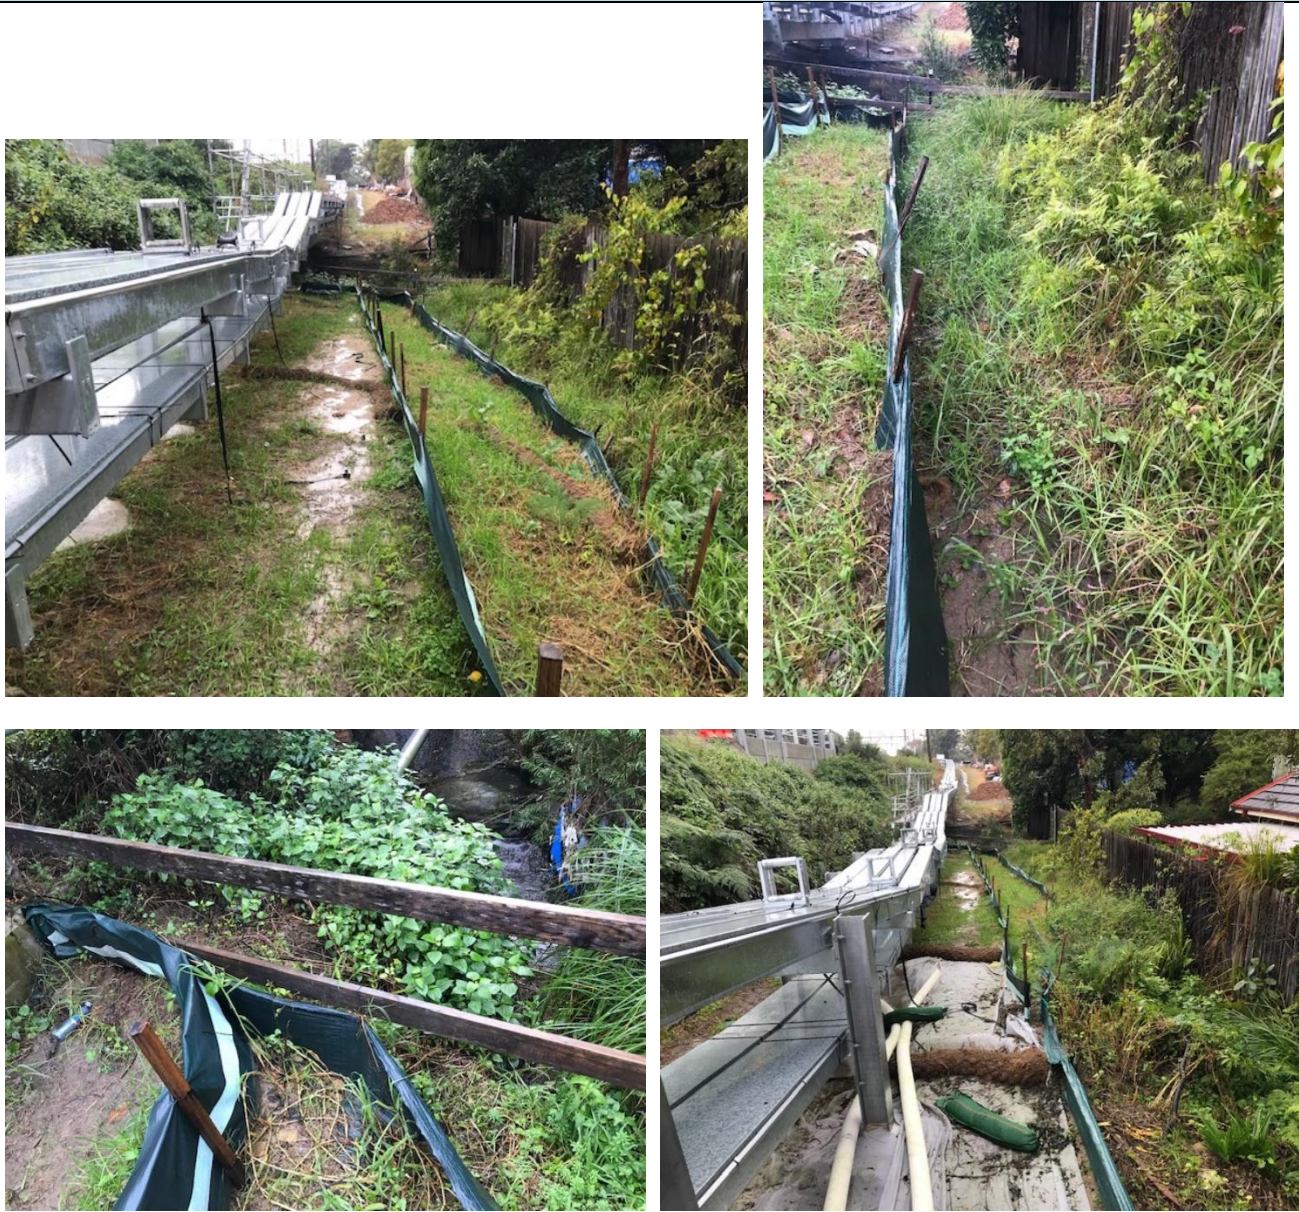
<p>No JHLOR work in area. No JHLOR works during WE01</p> <p>Erosion controls in place – surface below GST is covered with geofab. No signs of sediment flow into culvert.</p> <p>Heavy vegetation and stabilized surfaces on either side of culvert (inside corridor)</p>

No photos of the actual water in the culvert were taken at time of inspection (no PO available in afternoon) however photos from an earlier inspection in the morning show no sediment flow down slopes

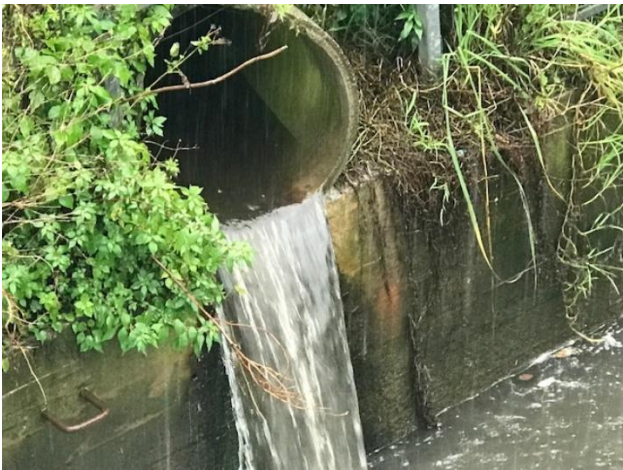
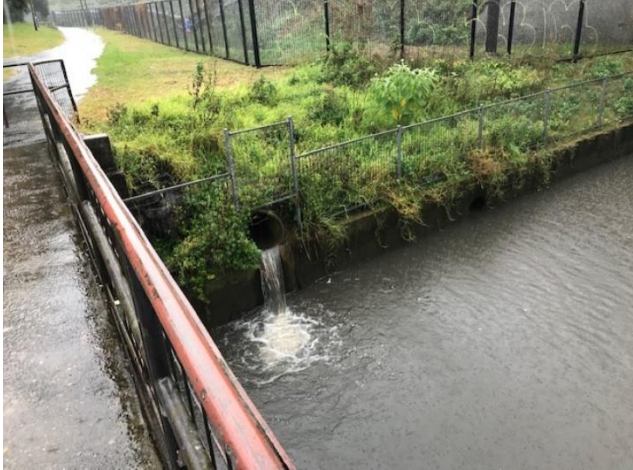
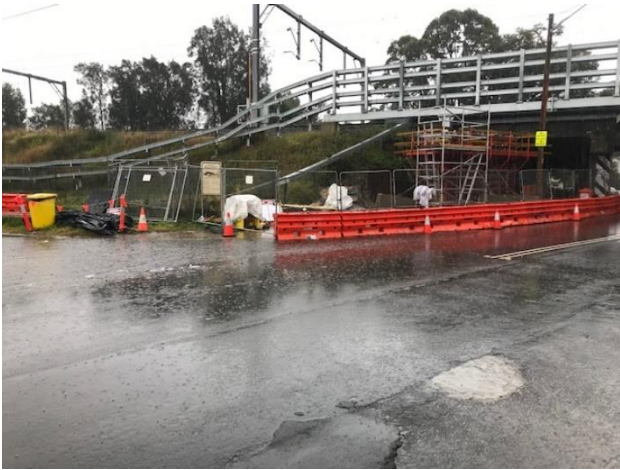
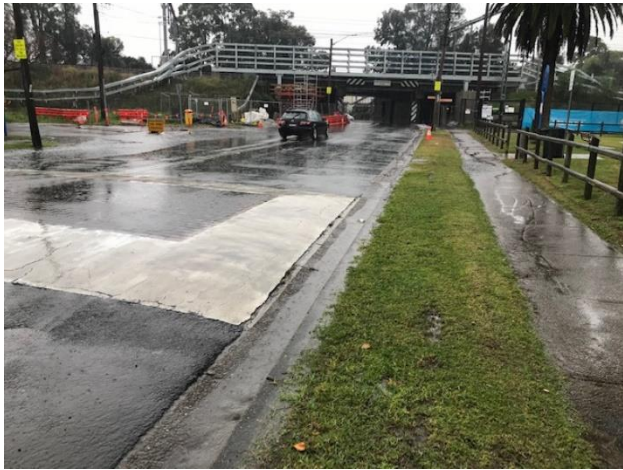
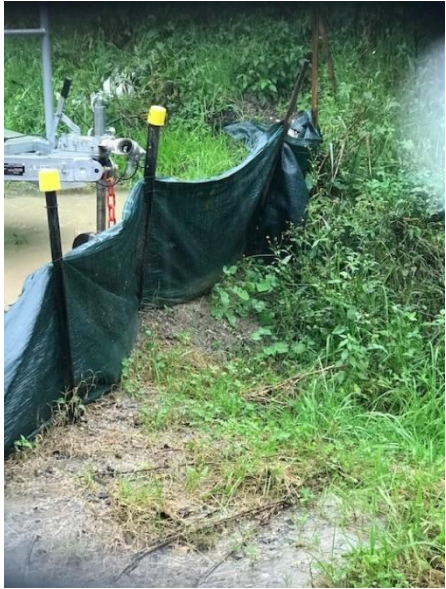
<p>Wairoa St. No construction activity in last week other than 2 concrete pours</p> <p>No JHLOR works during WE01</p> <p>ERSED controls in place with no dirty water leaving site.</p>

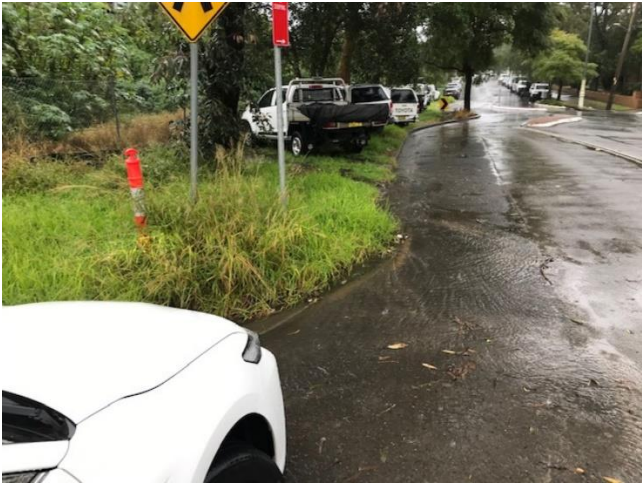
<p>Upstream (South side) Two open culverts</p>	<p>No JHLOR works in area during WE01</p>

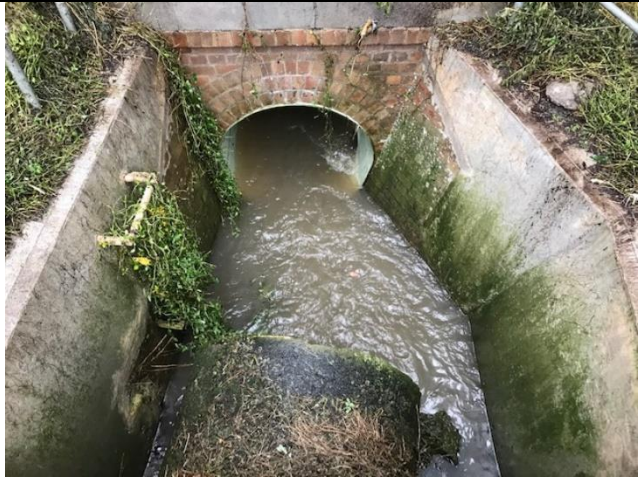
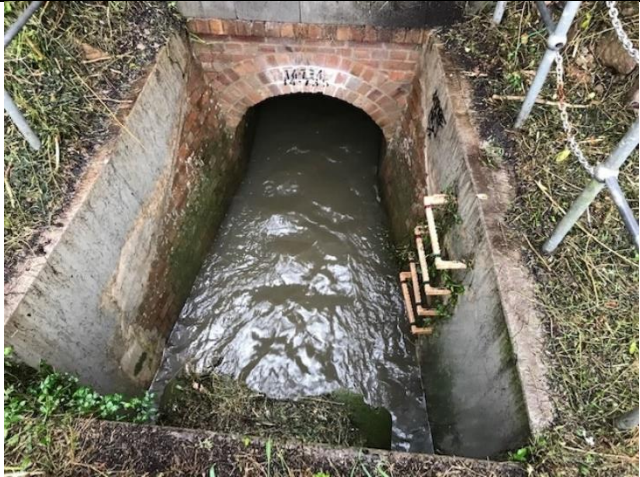
Eastern culvertWestern culvert			
Location 6 Wiley Park, countryside.	No JHLOR works in area	<p>Water clarity and colour: Downstream Western Culvert (Nth side) medium flow slightly turbid water. Small inlet from the RHS side is clear.</p> <p>NOTE: No dirty water discharge from upstream locations (gate WP3).</p> <p>Central culvert low flow with same colour water as the western culvert.</p> <p>Eastern culvert medium flow of clear water</p> <p>Upstream (Sth side) Not checked</p> <p>Odour: Nil</p> <p>Description of flow and quantity/ Visible runoff (into the water body): Medium flows. No debris in water</p> <p>Oil and Grease: None</p> <p>Details of any foreign objects within the water: None</p> <p>Other comments/description: Nil</p>	<p>Downstream (North Side) Upstream catchment – clean water through access gate (WP3) into channel. Batters above culverts are stabilized. No construction activities in area</p>

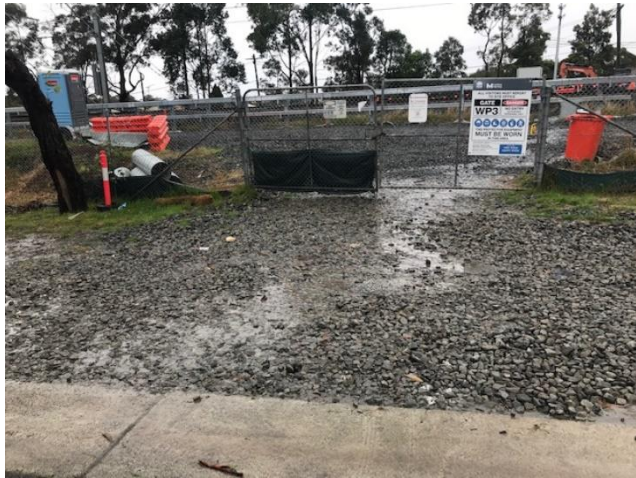
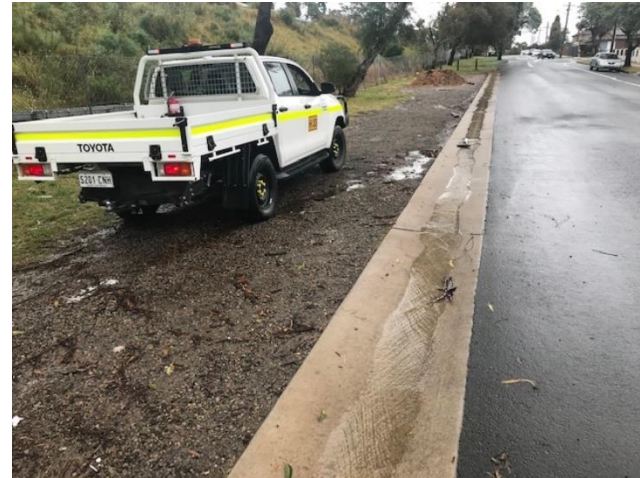
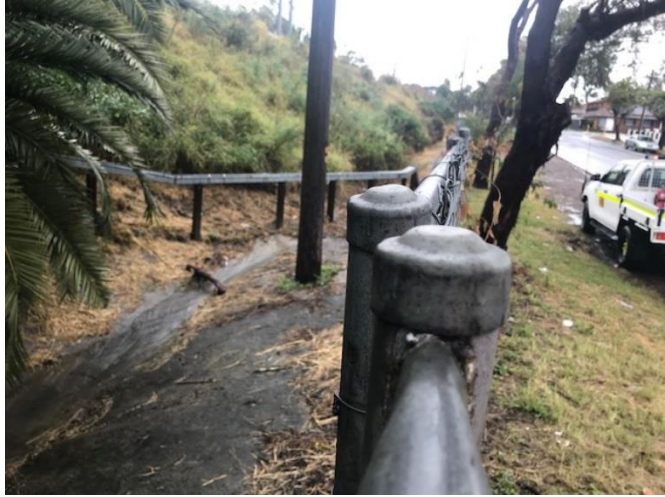
Western most culverts	<p>No JHLOR work in area - WP3. Access checked - no dirty water flowing from stabilised access down to culverts.</p> <p>Wiley Park Station Contractor alongside culverts – no construction activities observed.</p>

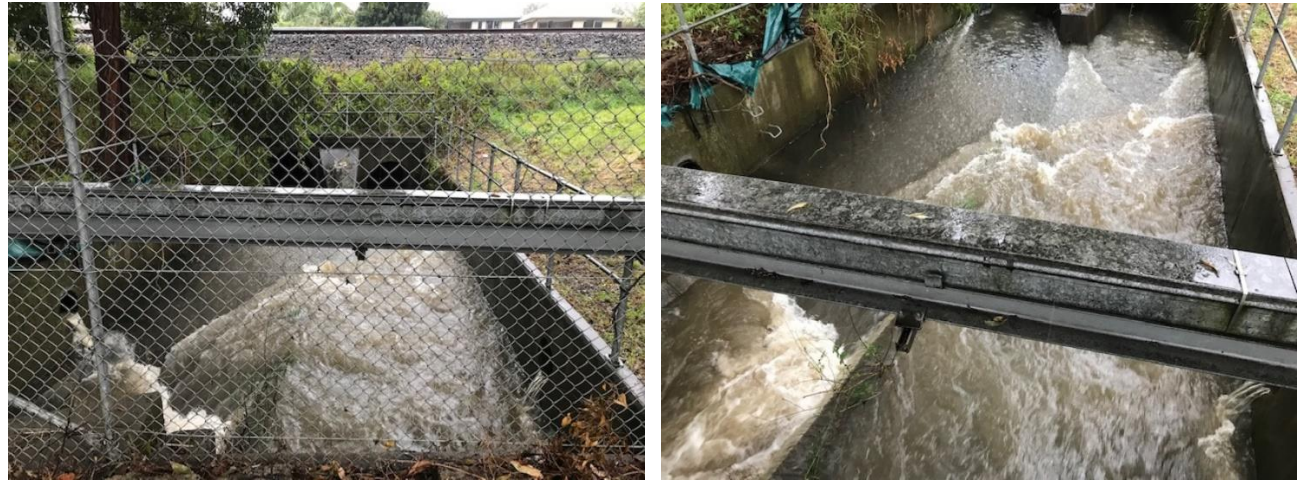
No JHLOR works within the catchment

Location 8 'NEW' Cant Compound	No JHLOR works within the	Water clarity and colour from Culvert Under Corridor. Medium flow, upstream water is clear.		No JHLOR works within the catchment
