# Southwest Metro Works Stage 3 Construction Monitoring Report 3 September 2025- February 2026

SMCSWSW8-JHL-WEC-EM-REP-000001

Document Details	
<b>Title</b>	Construction Monitoring Report
<b>Client</b>	Sydney Metro City & Southwest
<b>Client reference no.</b>	SMCSWSW8-JHL-WEC-EM-REP-000001
<b>JHLOR JV contract no.</b>	K44

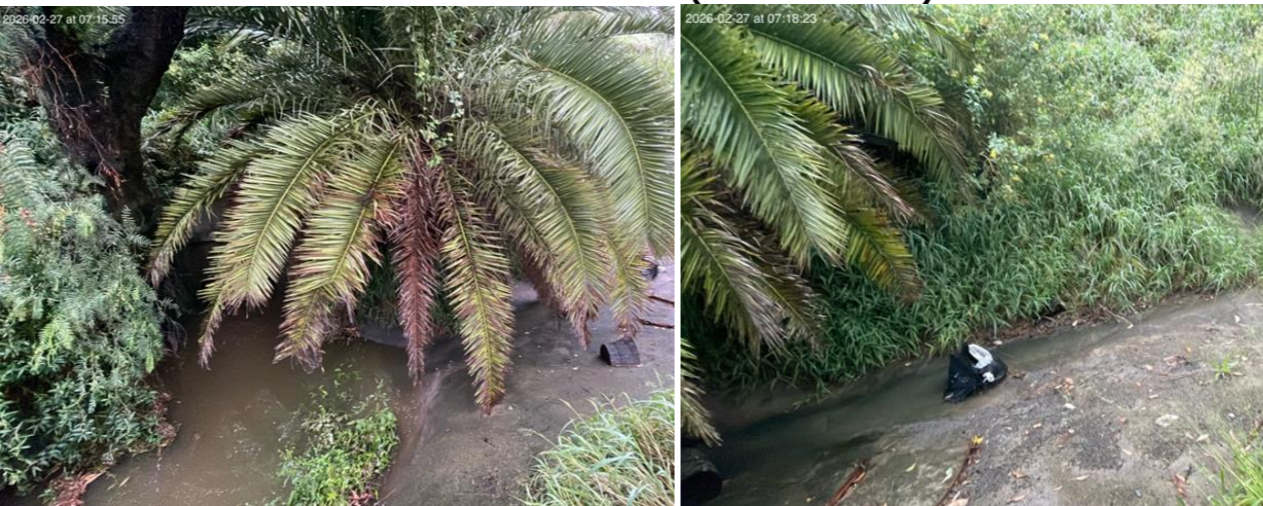
</div> <p style="text-align: center;"><b>Western most culvert</b></p> <p>Water at high level, looks like standing water without flow. Turbid water through main culvert with clean water flow from inlet on RHS.</p>

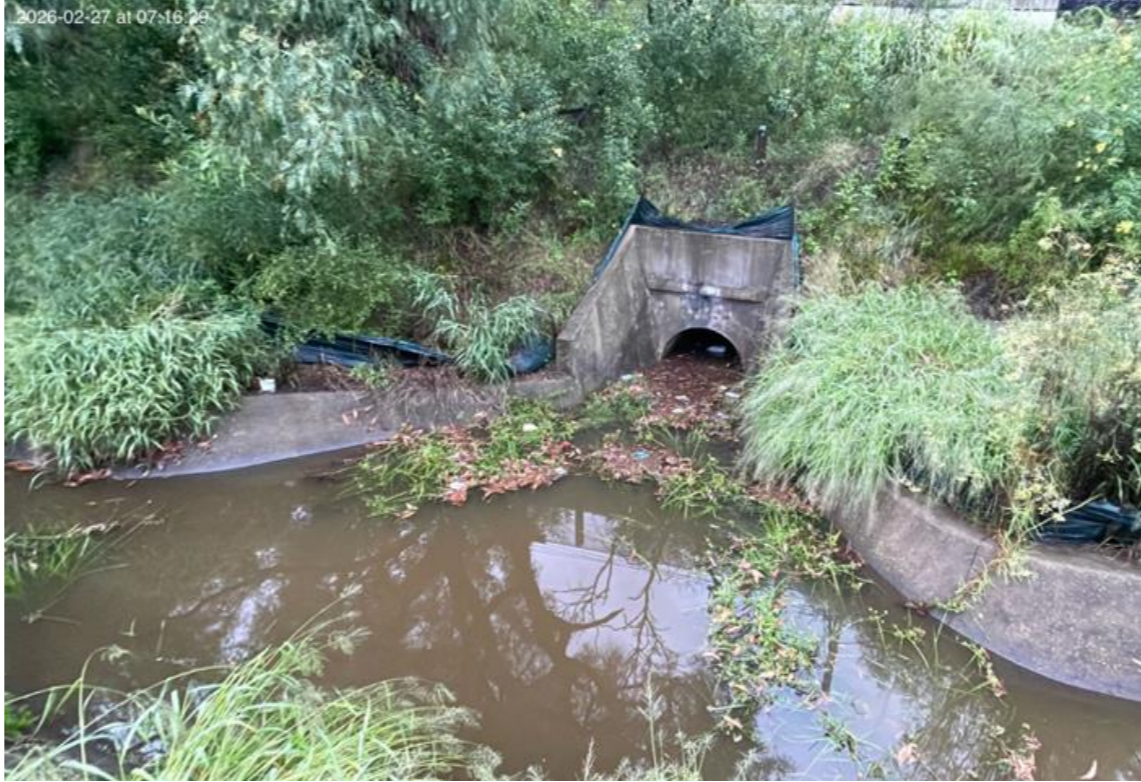
<p data-bbox="1448 982 1635 1010"><b>Middle culvert:</b></p> <p data-bbox="943 1014 2139 1041">Water at high level, looks like standing water without flow. Turbid water in middle section of culvert.</p>

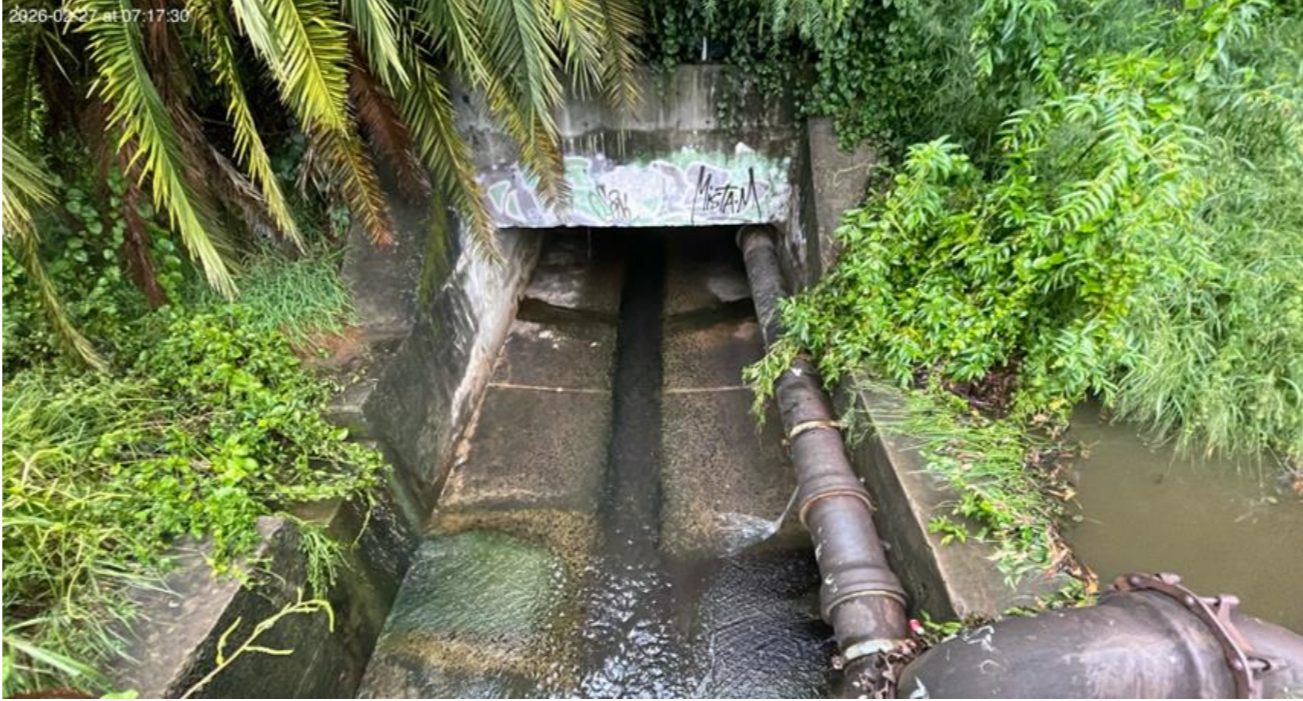
<p data-bbox="1418 1759 1665 1787"><b>Eastern most culvert</b></p> <p data-bbox="923 1791 2160 1850">Med flow, clear water through main culvert. No oil &amp; grease. No odour. Photos show culvert on corridor side of Urunga Pde.</p>			
			<b>DOWNSIDE OF CORRIDOR</b>

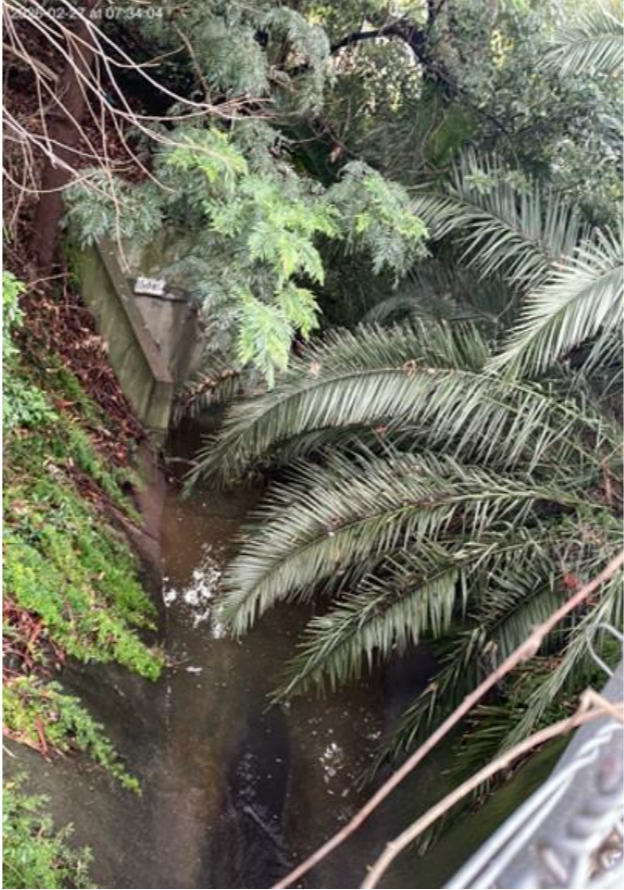
<p data-bbox="1080 1079 2000 1108"><b>Western most culvert</b> – low flow. Looks like clear water through main culvert.</p>

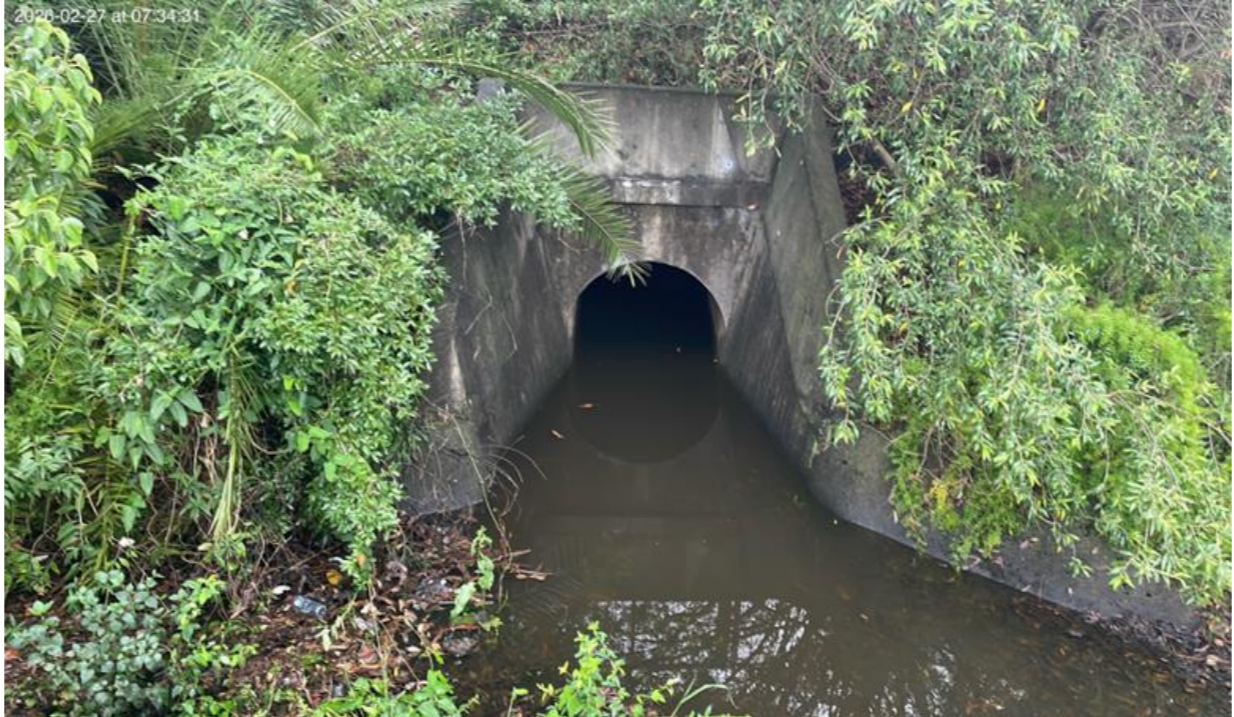
<p data-bbox="937 1839 2142 1902"><b>Middle culvert</b> – Standing water. This culvert picks up water flow off batters. It is not fed by incoming drains/culverts. Leaf litter on surface.</p>

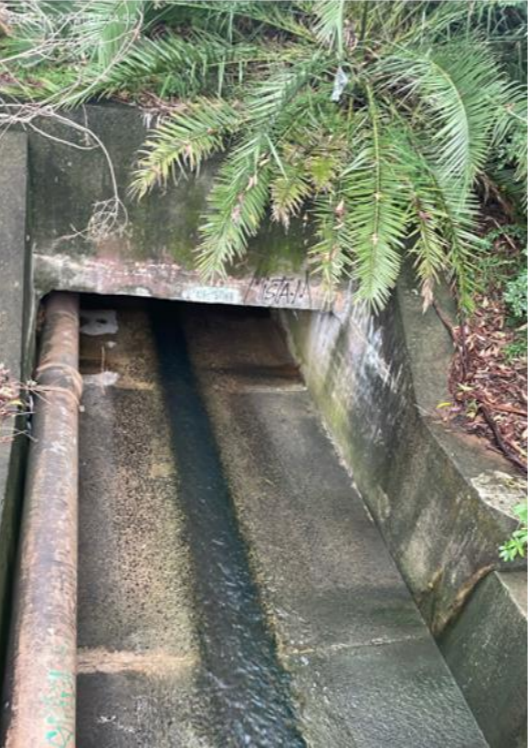
<p data-bbox="1142 951 1941 978">Eastern most Culvert – med flow, clear water through main culvert.</p>			
<p><b>Location 7</b> Bankstown</p>	<p>Nil activities in the area</p>		<p data-bbox="1151 1016 1932 1043"><b>No PO available – not inspected – no JHLOR works in catchment.</b></p> <p data-bbox="955 1047 2128 1108">NOTE: This flow line is below ground and runs across the corridor from Nth to Sth and can be seen through pits only. They are all inside corridor.</p>			
<p><b>Location 7ALT</b>  City side of Bankstown DOWN track (near Stacey St)</p>	<p data-bbox="276 1142 546 1289">No JHLOR excavation activities have been carried out alongside the corridor near this location.</p> <p data-bbox="276 1325 557 1444">Area stable with heavy vegetation growth in corridor CESS and alongside culvert</p>	<p data-bbox="602 1142 700 1169"><b>Sth Side</b></p> <p data-bbox="602 1173 884 1262"><b>Water clarity and colour:</b> med flow, clear water</p> <p data-bbox="602 1293 724 1320"><b>Odour:</b> Nil</p> <p data-bbox="602 1356 884 1476"><b>Description of flow and quantity/ Visible runoff (into the water body):</b> see above.</p> <p data-bbox="602 1507 834 1535"><b>Oil and Grease:</b> Nil</p> <p data-bbox="602 1570 863 1690"><b>Details of any foreign objects within the water:</b> No debris in water</p> <p data-bbox="602 1724 878 1812"><b>Other comments/description</b> Nil</p>

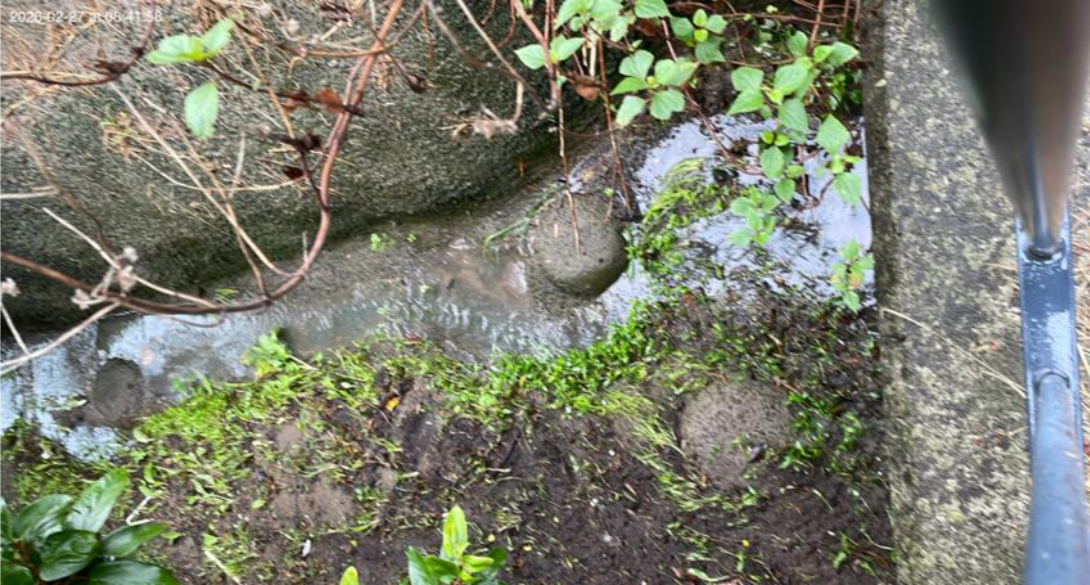
<p style="text-align: center;"><u>Upstream from JHLOR discharge point.</u> Low flow, slightly turbid water flowing in channel.</p>	<p>No excavation activities along the corridor near this location</p>

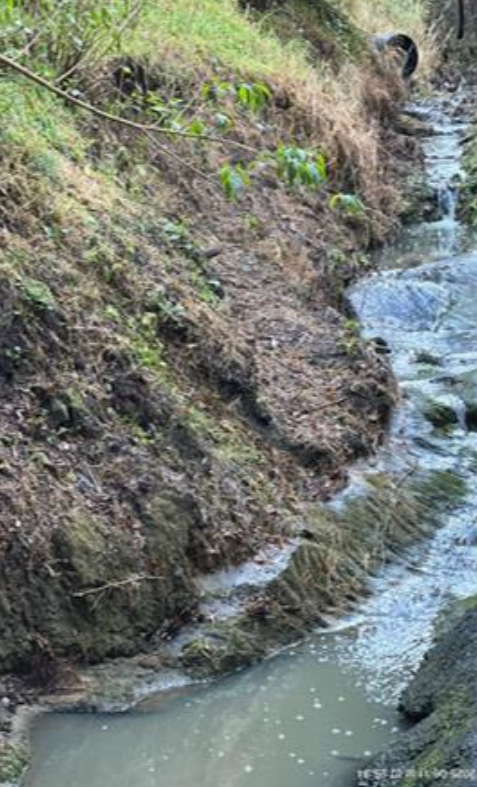
<p>This photo shows previous status of downstream batter slope during event dated 11/8/25. Batter showed signs of slip.</p>

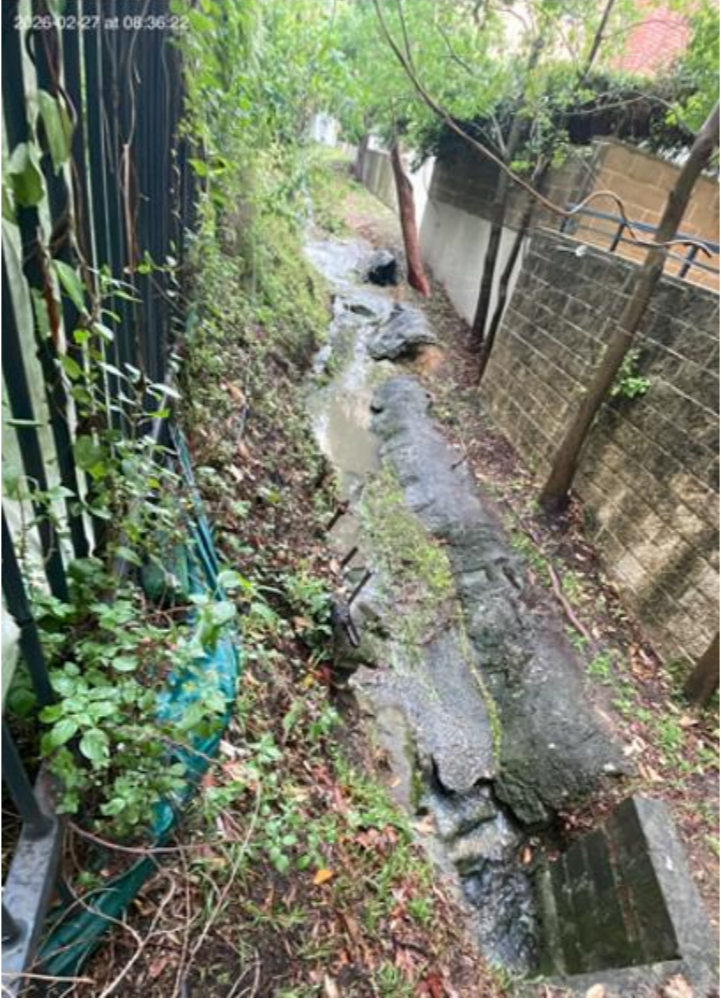
<p data-bbox="1264 1192 1819 1285"><u>Downstream from JHLOR discharge point:</u> Downstream water observed to be slightly turbid No photos of the batter scour/slip this period.</p>			
Location 9 Bankstown Platform works	Culvert backfilled.  No further inspections required for this waterway. Brick culvert filled in. No reporting & no photos required	<b>Water clarity and colour:</b>  <b>Odour:</b>  <b>Description of flow and quantity/ Visible runoff (into the water body):</b>  <b>Oil and Grease:</b>  <b>Details of any foreign objects within the water:</b>  <b>Other comments/description</b>	<p data-bbox="1154 1360 1923 1392"><b>JHLOR site.</b> Brick culvert filled in. No reporting &amp; no photos required</p>

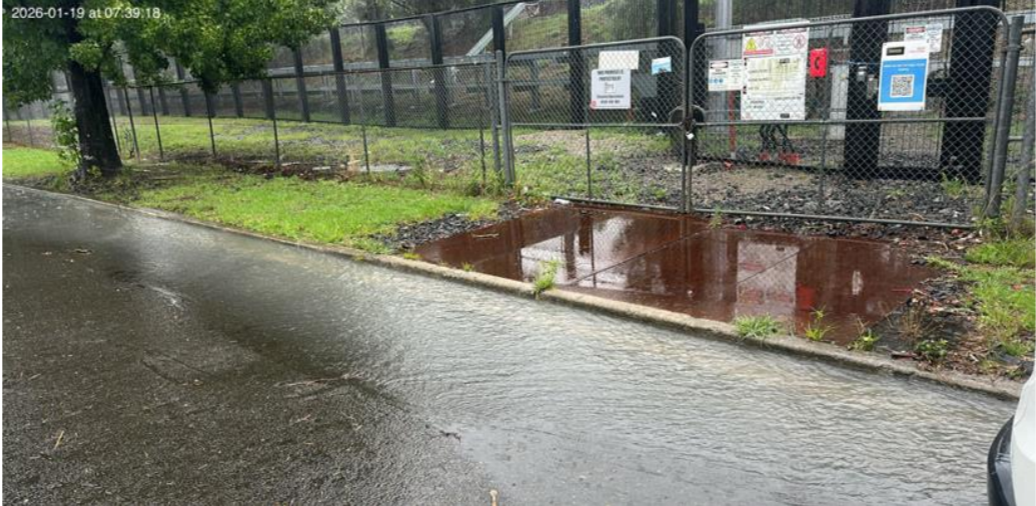
<p data-bbox="914 825 2163 888"><b>Area at Gould/Park St.</b> Turbid water drains from corridor (Legacy work from Sydney Trains old work behind concrete barrier where they excavated into the open channel to release water)</p>

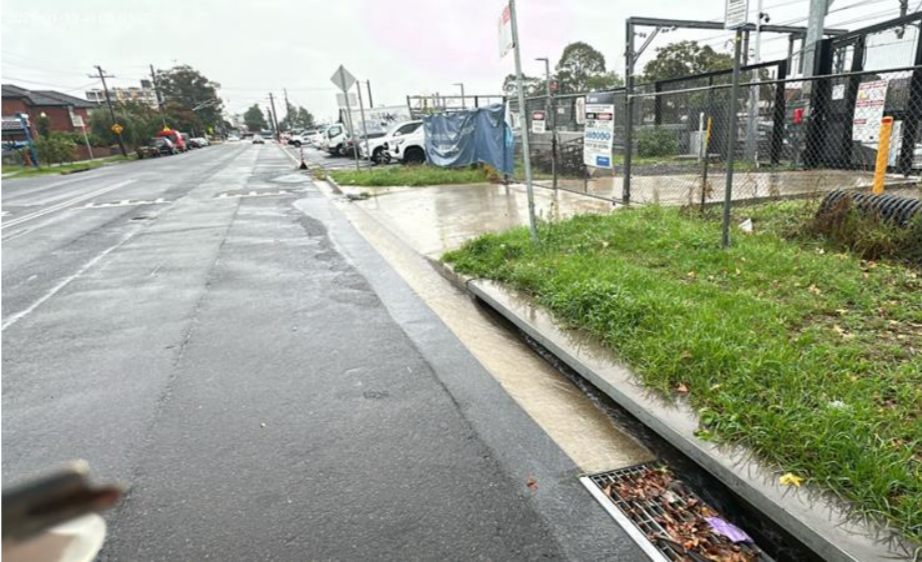
<p><b>Location 4</b> Belmore Triangle Access Road</p>	<p>BelmoreT – There is a ballast access road alongside this open channel, however the road doesn't drain to the culvert.</p> <p>Access track opens into BelmoreT transit space and also into Stockpile area at BelmoreT Wedge</p>	<p><b>Water clarity and colour:</b> Very Slightly turbid water through SW culvert.</p> <p><b>Odour:</b> Nil</p> <p><b>Description of flow and quantity/ Visible runoff (into the water body):</b> medium. No visible signs of sediment flow from ballast access road. Dirty water on track side of road is from truck wash along ballast road. None of this is draining into open culvert - It stays on this side and settles in vegetated pond.</p> <p><b>Oil and Grease:</b> Nil</p> <p><b>Details of any foreign objects within the water:</b> N/A</p> <p><b>Other comments/description:</b> N/A</p>	<p><b>SW outlet alongside access/ballast road.</b> Very Slightly turbid water flows from inside culvert pipe.</p>

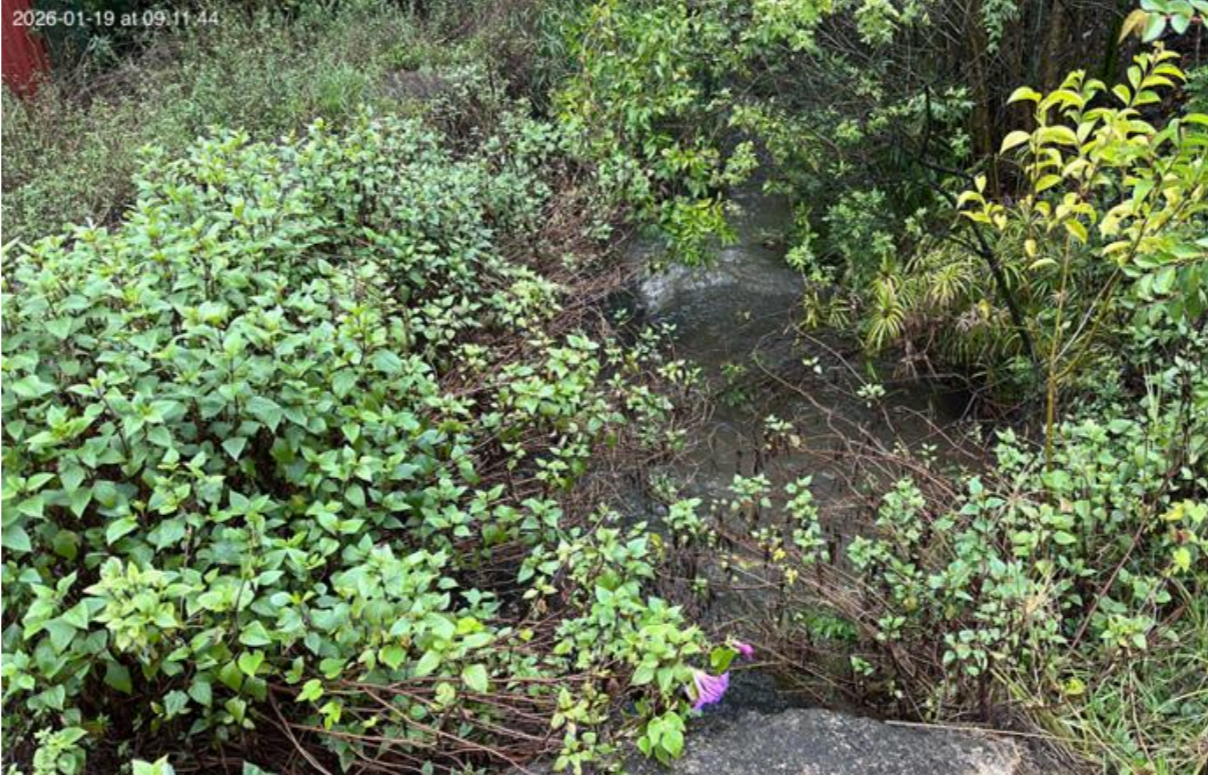
<p><b>Redman Pde – Upstream Status &amp; Controls.</b> Small volumes of clear water flowing into kerb/gutter</p>	<p>This water outlet location is alongside a stabilized ballast track that allows access into BelmoreT Area and BelmoreT Wedge Area</p> <p><b>Belmore Triangle Area:</b></p> <ol style="list-style-type: none"> <li>1.Is an open transit area for vehicles.</li> <li>2.Surface in the BelmoreT area is mostly covered by ballast.</li> <li>3.There is a mid batter berm (mulch) in place to divide catchment (concrete barrier divider placed).</li> <li>4.Thick vegetated area around lower sed fence at bottom of area. Second mulch berm added.</li> <li>5.No stockpiling of spoil in this area as it is only a transit point for plant and vehicles to hi-rail pad and BelmoreT wedge.</li> </ol> <p><b>Belmore Triangle Wedge Area:</b></p> <p>Stockpiles (spoil and Engineered fill) are located on top of batter above the access road. No sign of spoil movement down slope onto ballast access road – see ponded water on side of ballast access track Stockpile area is flat.</p> <p>Top of batter behind the spoil stockpiles is surrounded by double barrier and geofab curtain over barriers.</p>

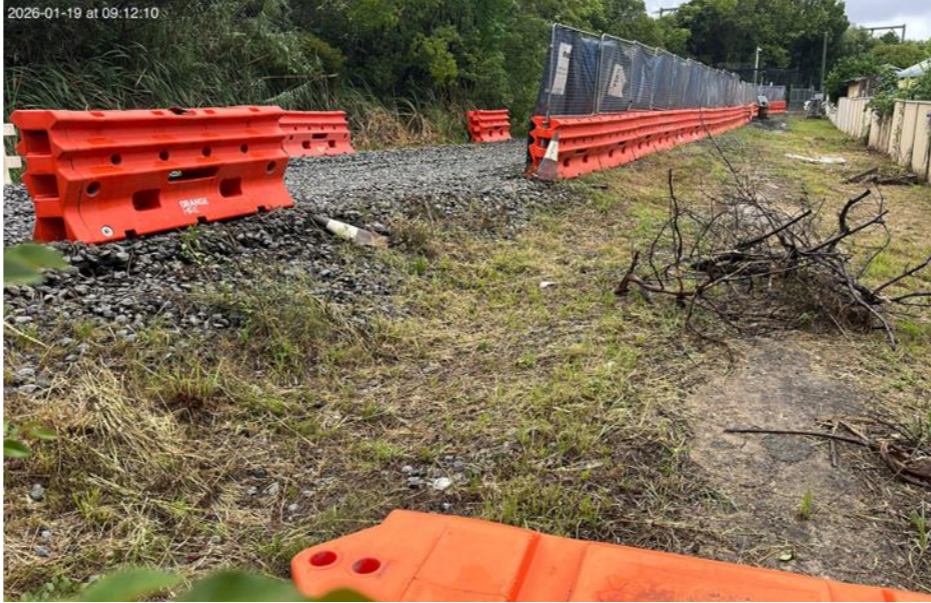
<p><b>BelmoreT Wedge Stockpile area.</b> Photos from top of batter above the ballast access road - Double concrete barrier &amp; geofab ERSED controls. Small volume of ponded water remains on top of platform (No dirty water seen along bottom of batter/ballast access track)</p>

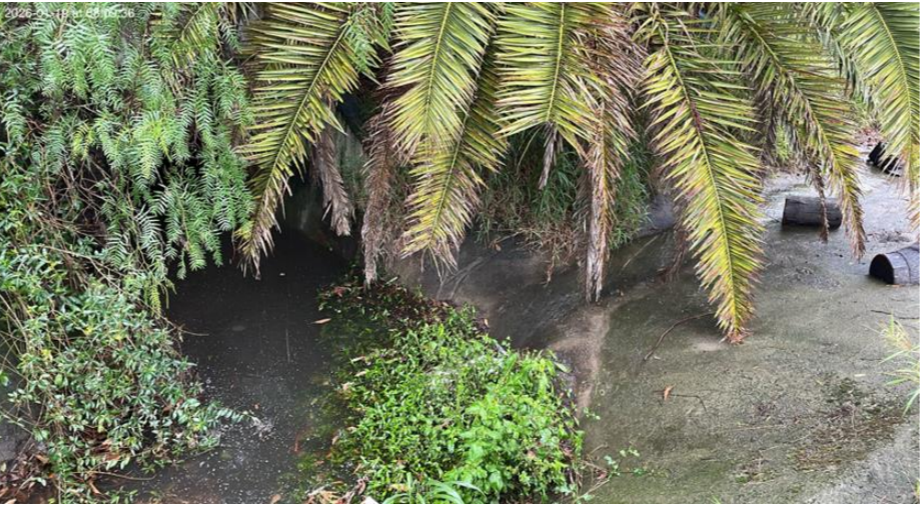
<p style="text-align: center;"><b>Western most culvert</b></p> <p>Water at high level, looks like standing water without flow. Clean water through main culvert with clean water flow from inlet on RHS.</p>

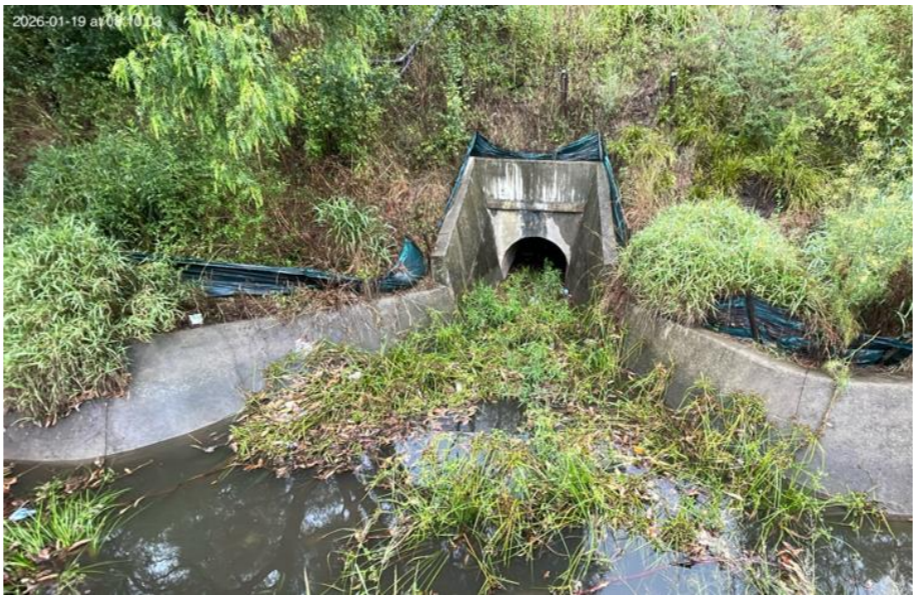
<p style="text-align: center;"><b>Middle culvert:</b></p> <p>Water at high level, looks like standing water without flow. Clear water in middle culvert.</p>

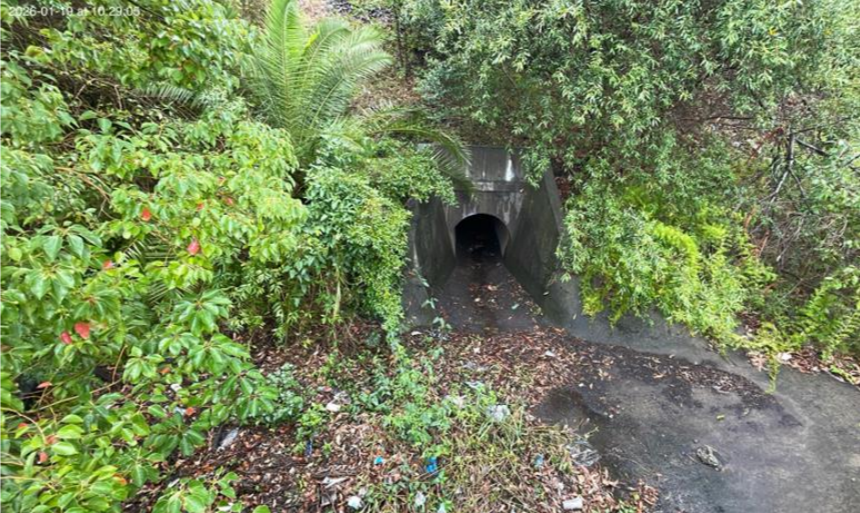
<p data-bbox="1003 730 2071 760"><b>Middle culvert</b> – None to very little, clear water draining off batters. Leaf litter on surface.</p>

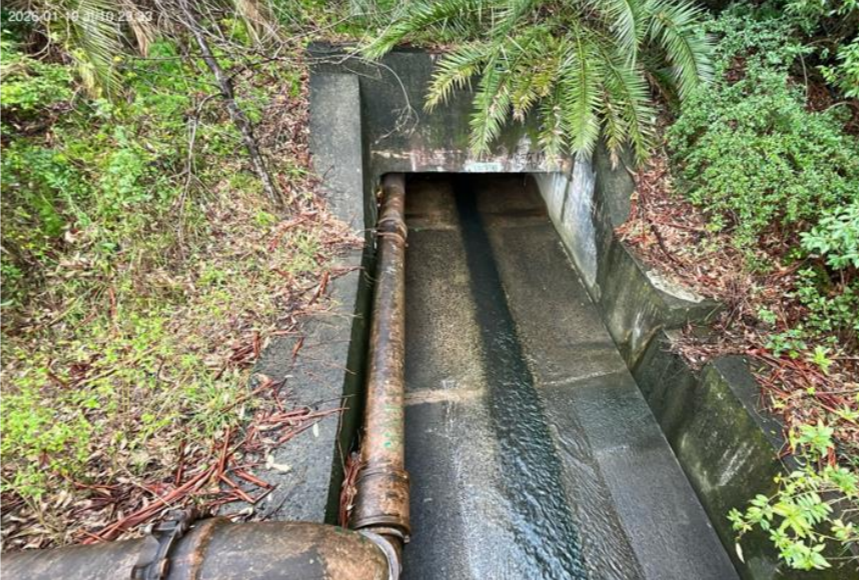
<p data-bbox="1139 1367 1941 1396"><b>Eastern most Culvert</b> – med flow, clear water through main culvert.</p>			
<p><b>Location 7</b> Bankstown</p>	<p>Nil activities in the area</p>		<p><b>No PO available – not inspected – no JHLOR works in catchment.</b> NOTE: This flow line is below ground and runs across the corridor from Nth to Sth and can be seen through pits only. They are all inside corridor.</p>			
<p><b>Location 7ALT</b>  City side of Bankstown DOWN track (near Stacey St)</p>	<p>No JHLOR excavation activities have been carried out alongside the corridor near this location in the last 6-8 months.  Area stable with heavy vegetation growth in corridor CESS and alongside culvert</p>	<p><b>Sth Side</b> <b>Water clarity and colour:</b> high flow, clear water  <b>Odour:</b> Nil  <b>Description of flow and quantity/ Visible runoff (into the water body):</b> see above.  <b>Oil and Grease:</b> Nil</p>

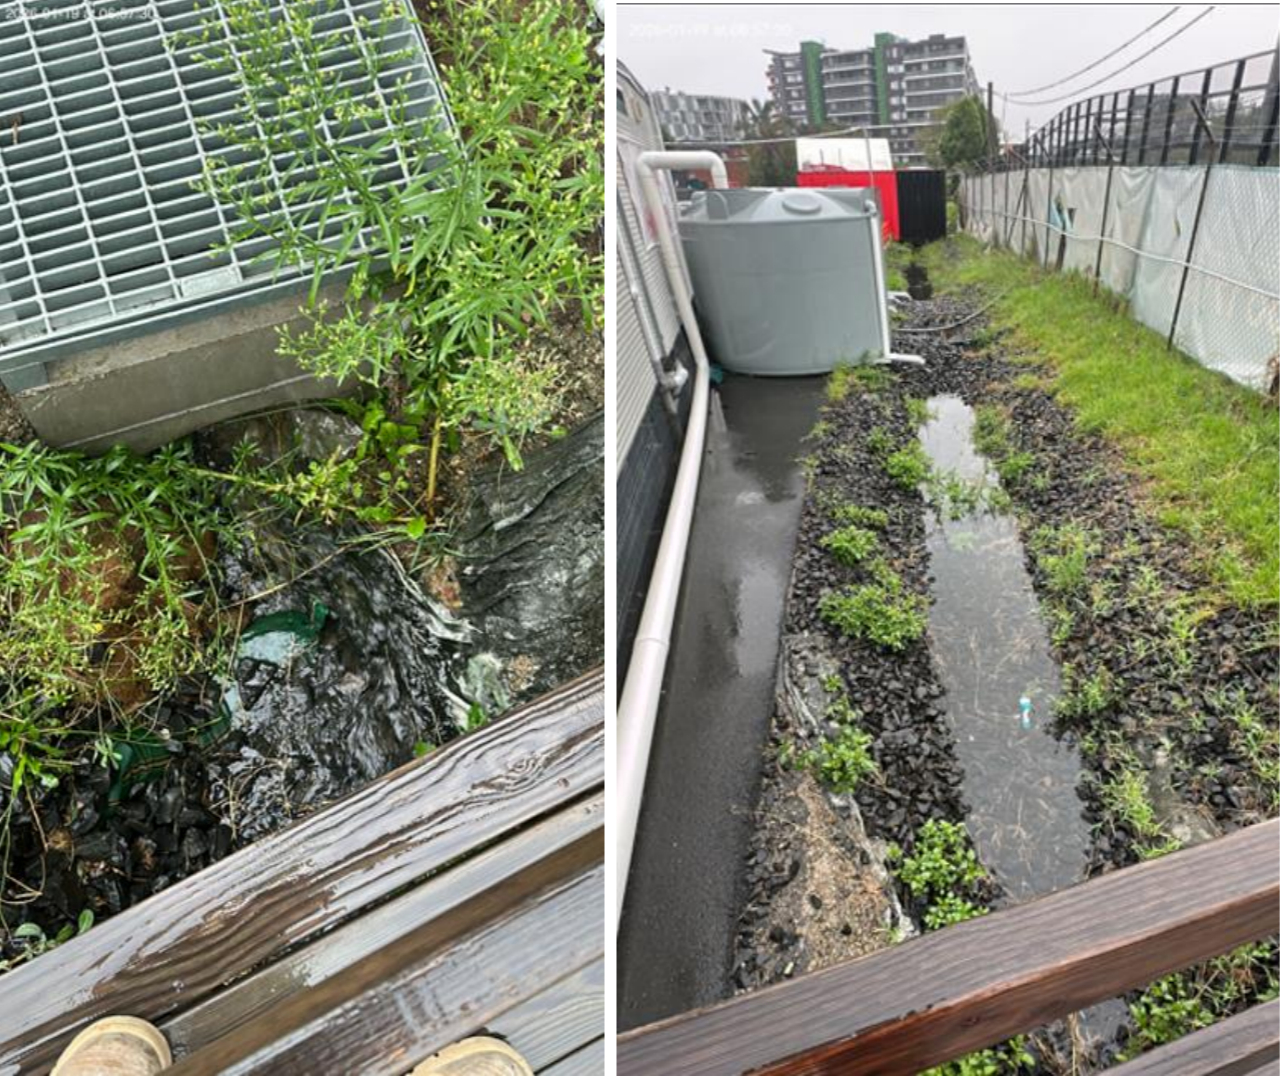
<p style="text-align: center;"><b>Med, clear water flow through ballast channel. No odour and no oil &amp; grease. Water is clear going into pit</b></p> <p style="text-align: center;"><b>Outside Canterbury Compound – Water Flow</b> Eastern Channel. Outside Canterbury Compound boundary alongside pedestrian footpath:</p>	No excavation activities along the corridor near this location

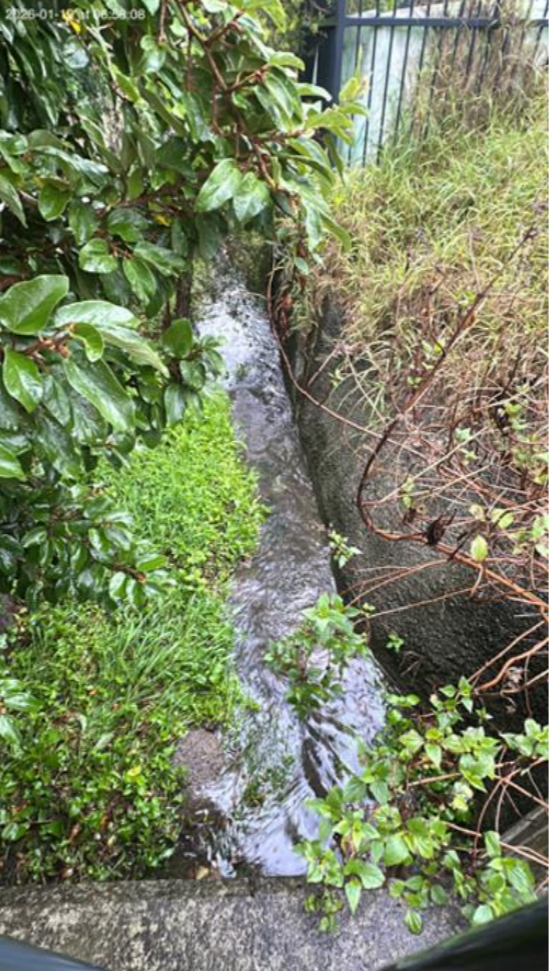
<p data-bbox="1323 1161 1760 1224"><u>Upstream from JHLOR discharge point.</u> Med, clear water flow in channel.</p>

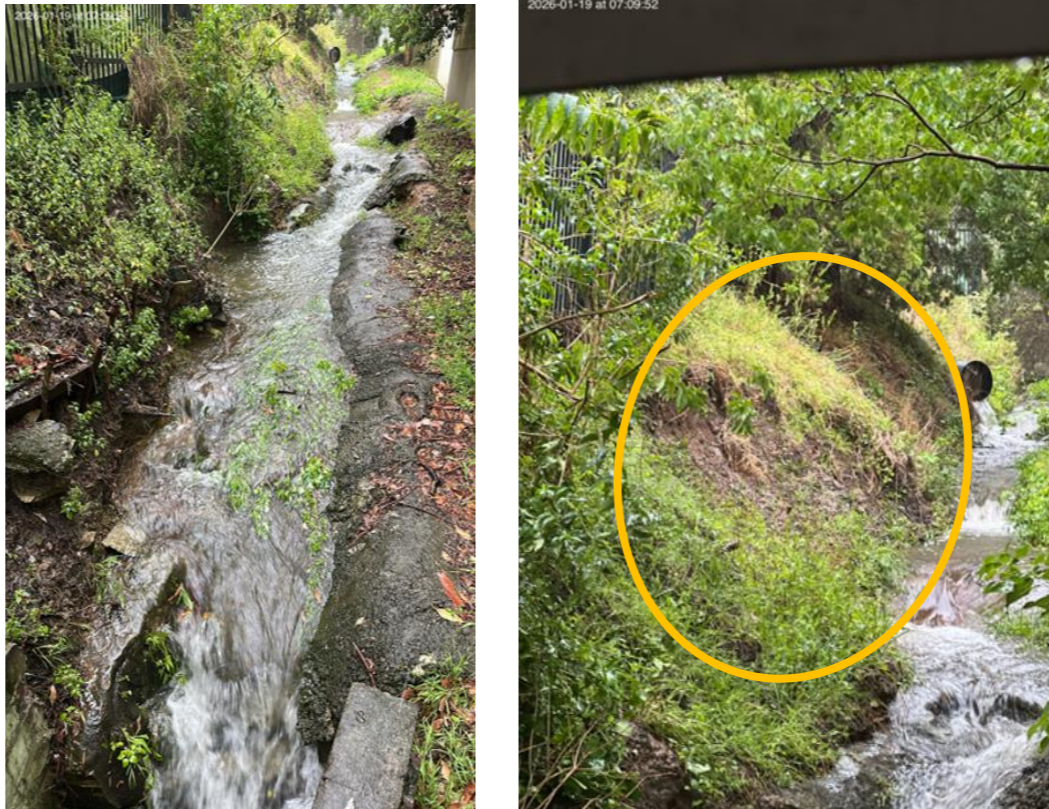
<p data-bbox="923 1045 2154 1108"><u>Downstream from JHLOR discharge point:</u> Downstream water observed to be clear – looks like no additional scour/collapse on downstream batter slope</p>

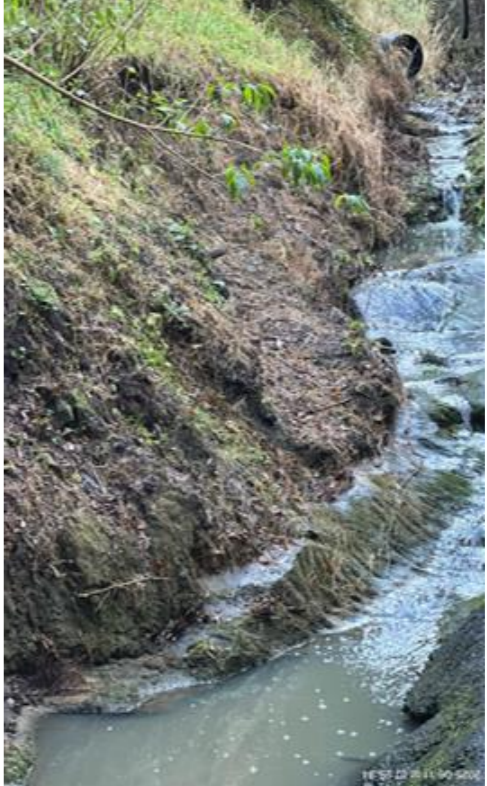
<p data-bbox="2193 989 2629 1115">This photo shows previous status of downstream batter slope during event dated 11/8/25. Batter showed signs of slip.</p>		
Location 9 Bankstown Platform works	Culvert backfilled. No further inspections required for this waterway. Brick culvert filled in. No reporting & no photos required	<b>Water clarity and colour:</b>  <b>Odour:</b>  <b>Description of flow and quantity/ Visible runoff (into the water body):</b>  <b>Oil and Grease:</b>  <b>Details of any foreign objects within the water:</b>  <b>Other comments/description</b>	<b>JHLOR site.</b> Brick culvert filled in. No reporting & no photos required

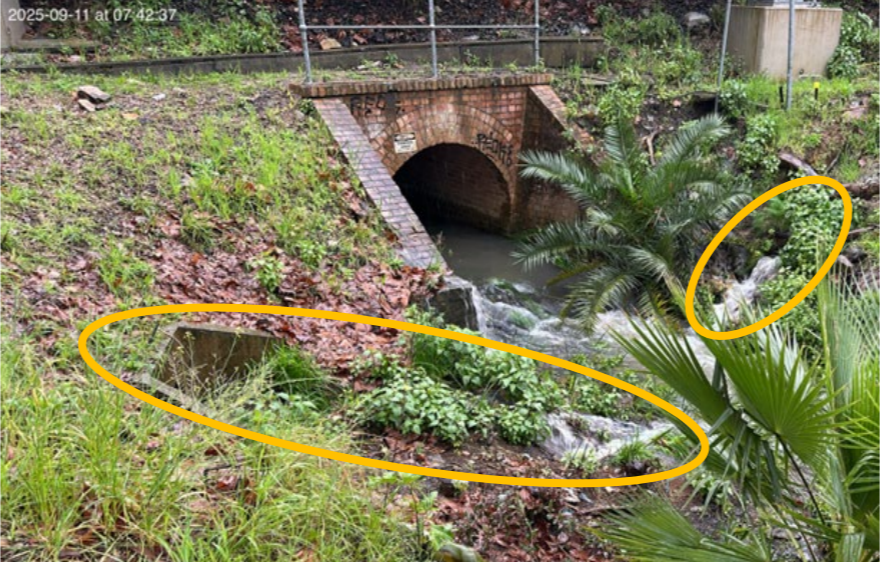
<p><b>LHS Inlet (Concrete Headwall)</b> Unknown upstream source. Unable to determine if turbid as too much white water. No cloud plume in main culvert from inlet</p> <p><b>RHS Inlet (Black pipe)</b> Unable to determine if turbid as too much white water. No cloud plume in main culvert from inlet on RHS.</p>			
<p><b>Location 2</b>  Hurlstone Park, countryside</p>	<p>No JHLOR construction/excavation activities along the corridor near this location</p>	<p><b>Water clarity and colour:</b> <b>Odour:</b> N/A</p> <p><b>Description of flow and quantity/ Visible runoff (into the water body):</b> N/A</p> <p><b>Oil and Grease:</b> N/A</p> <p><b>Details of any foreign objects within the water:</b> N/A</p> <p><b>Other comments/description:</b> N/A</p>	<p align="center"><b>NO PO AVAILABLE, AREA LOCKED – AREA NOT INSPECTED</b></p>	<p>Area alongside tracks and upstream from the this open culvert are very heavily vegetated.</p>

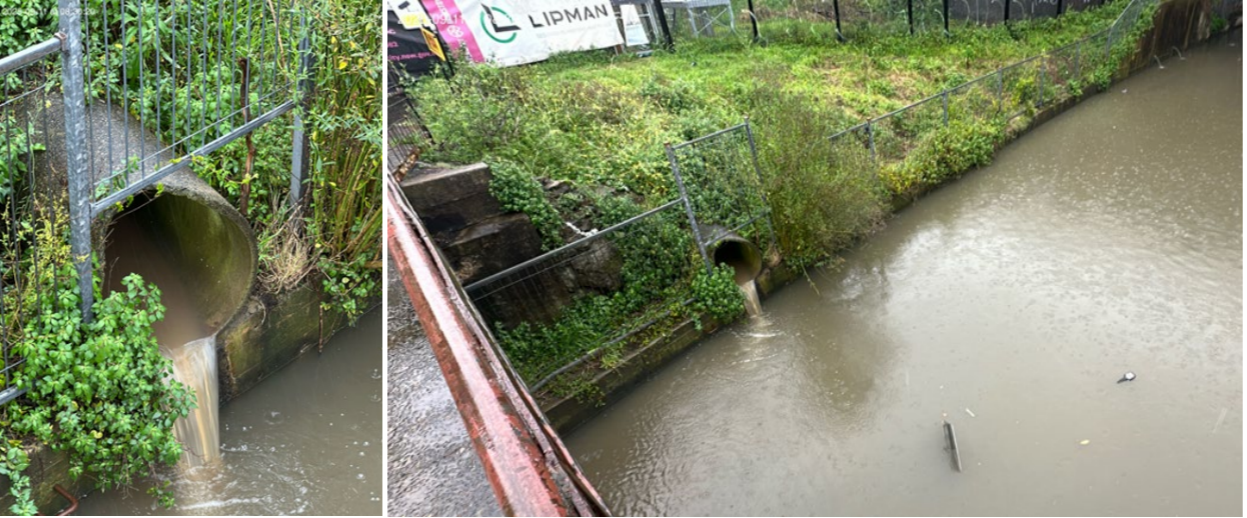
<p align="center"><b>SW outlet at River</b></p>	<p>Cooks River – tide is in.</p>

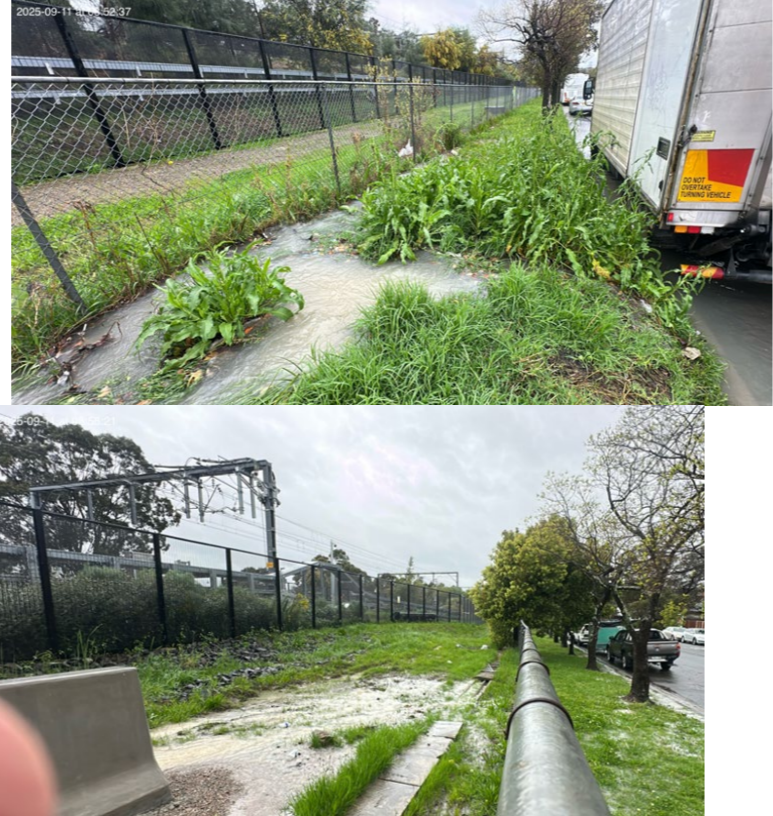
<p data-bbox="914 1014 2166 1077"><b>Area at Gould/Park St.</b> Slightly turbid water drains from corridor (ST old work behind concrete barrier where they excavated into the open channel to release water)</p>			
<p data-bbox="92 1108 264 1262"><b>Location 4</b> Belmore Triangle Access Road</p>	<p data-bbox="270 1108 587 1234">BelmoreT – There is a ballast access road alongside this open channel</p> <p data-bbox="270 1266 587 1419">Access track opens into BelmoreT transit space and also into Stockpile area at BelmoreT Wedge</p>	<p data-bbox="593 1108 899 1241"><b>Water clarity and colour:</b> Very Slightly turbid water through SW culvert.</p> <p data-bbox="593 1272 899 1297"><b>Odour:</b> Nil</p> <p data-bbox="593 1329 899 1759"><b>Description of flow and quantity/ Visible runoff (into the water body):</b> medium. No visible signs of sediment flow from ballast access road. Dirty water on track side of road is from truck wash along ballast road. None of this is draining into open culvert - It stays on this side and settles in vegetated pond.</p> <p data-bbox="593 1791 899 1816"><b>Oil and Grease:</b> Nil</p> <p data-bbox="593 1848 899 1942"><b>Details of any foreign objects within the water:</b> N/A</p>

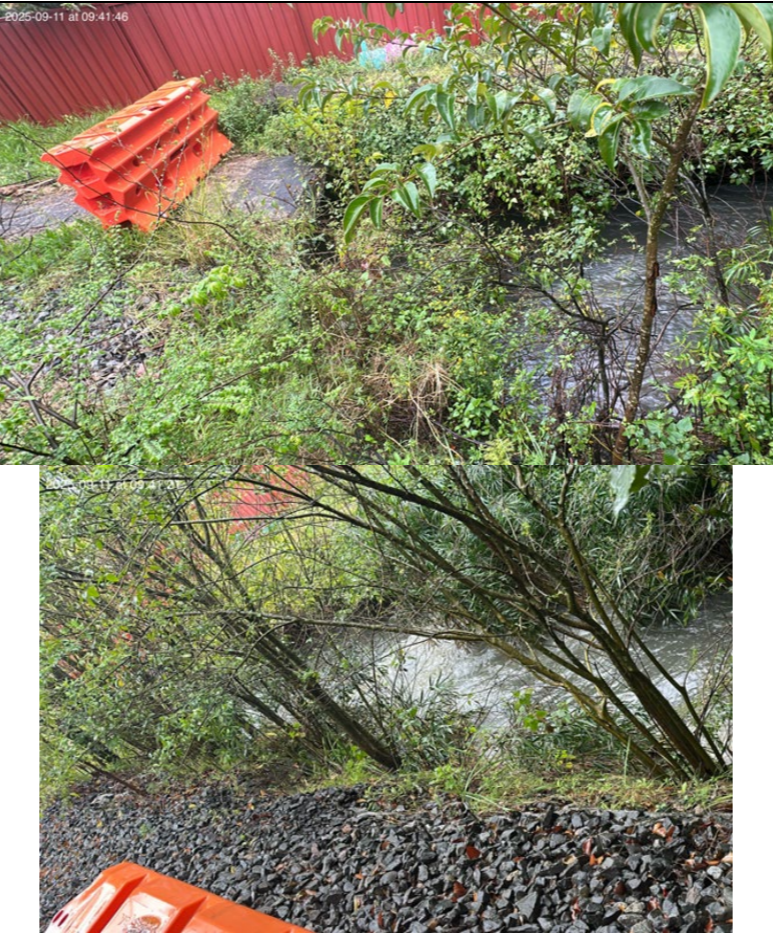
<p data-bbox="994 1984 2083 2009"><b>SW outlet alongside access/ballast road.</b> Very Slightly turbid water flows from inside culvert pipe.</p>	<p data-bbox="2181 1108 2653 1234">This water outlet location is alongside a stabilized ballast track that allows access into BelmoreT Area</p> <p data-bbox="2181 1266 2653 1291"><b>Belmore Triangle Area:</b></p> <ol data-bbox="2181 1302 2653 1696" style="list-style-type: none"> <li>1.Transit area.</li> <li>2.Surface in the BelmoreT area is mostly covered by ballast.</li> <li>3.There is a mid batter berm (mulch) in place to divide catchment (concrete barrier divider placed).</li> <li>4.Thick vegetated area around lower sed fence at bottom of area. Mulch berm added.</li> <li>5.No stockpiling of spoil in this area as it is only a transit point for plant and vehicles to hi-rail pad and BelmoreT wedge.</li> </ol> <p data-bbox="2181 1728 2653 1753"><b>Belmore Triangle Wedge Area:</b></p> <p data-bbox="2181 1764 2653 1969">Stockpiles (spoil and Engineered fill) are located on top of batter above the access road. No sign of spoil movement down slope onto ballast access road – see ponded water on side of ballast access track Stockpile area is flat.</p>

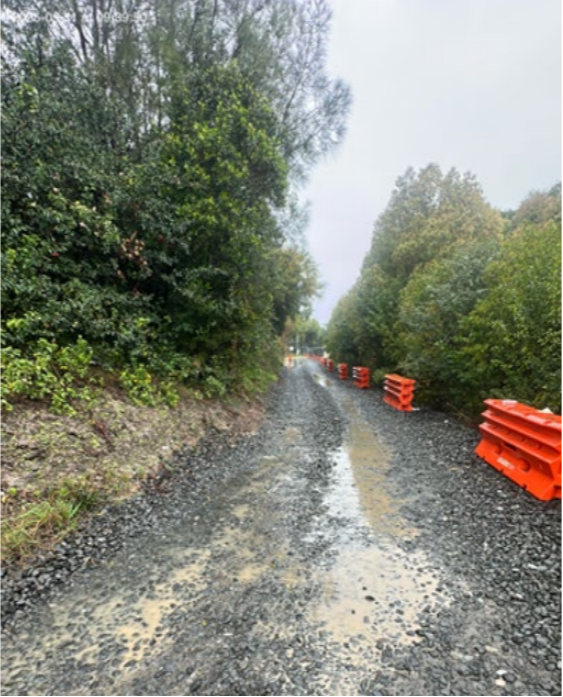
<p data-bbox="914 905 2145 1031"><b>Toe of batter on side of ballast Access road</b> – Water ponds in this location (the signs of turbidity is from truck wheels). NOTE: Dirty water does not drain to open culvert. Vegetated swale was checked alongside access – no signs of dirty water</p>

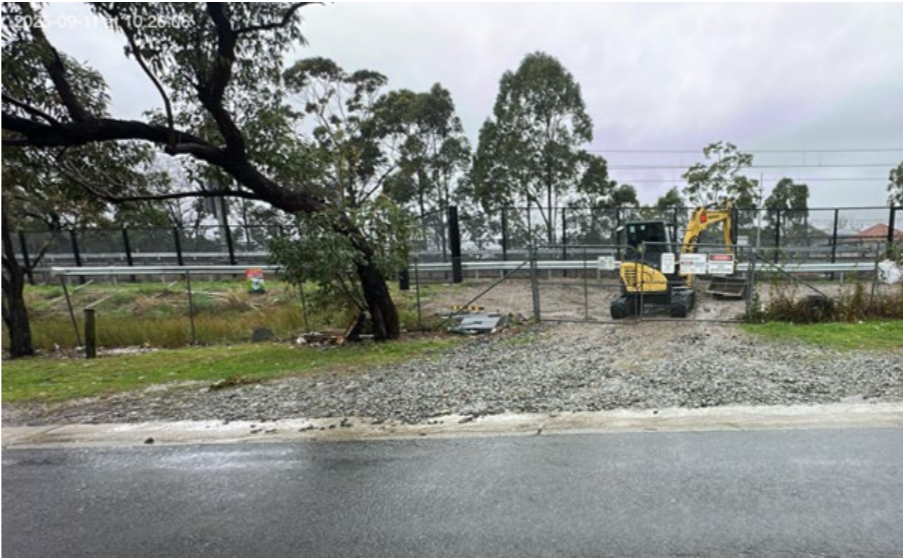
<p>Area upstream of Culvert. Inside corridor and Gate WP3 is well stabilised – however contractor (not JHGLOR) is using this access as laydown of plant, equipment &amp; Engineering fill (DGB). Very low flow of water in concrete channel down to western culvert. Water looks clear.</p>

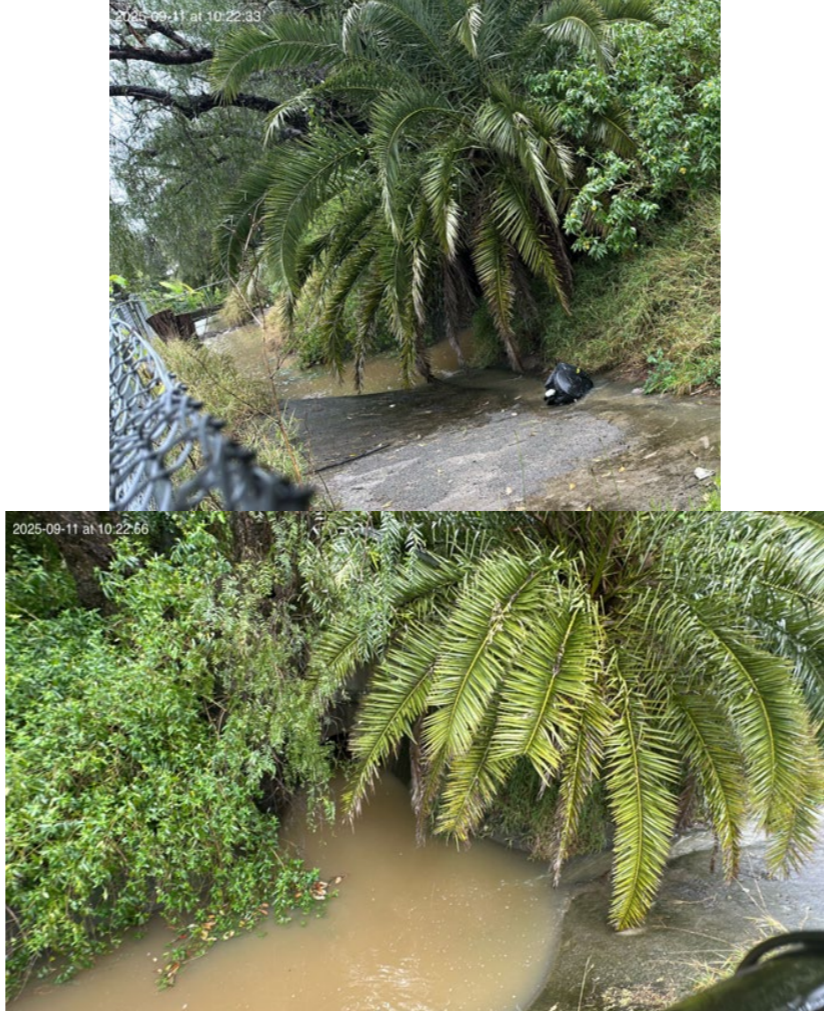
<p data-bbox="1409 1194 1668 1224"><b>Western most culvert</b></p> <p data-bbox="934 1226 2145 1285">High level, looks like standing water without flow. Turbid water through main culvert with very slightly turbid water flow from inlet on RHS.</p>

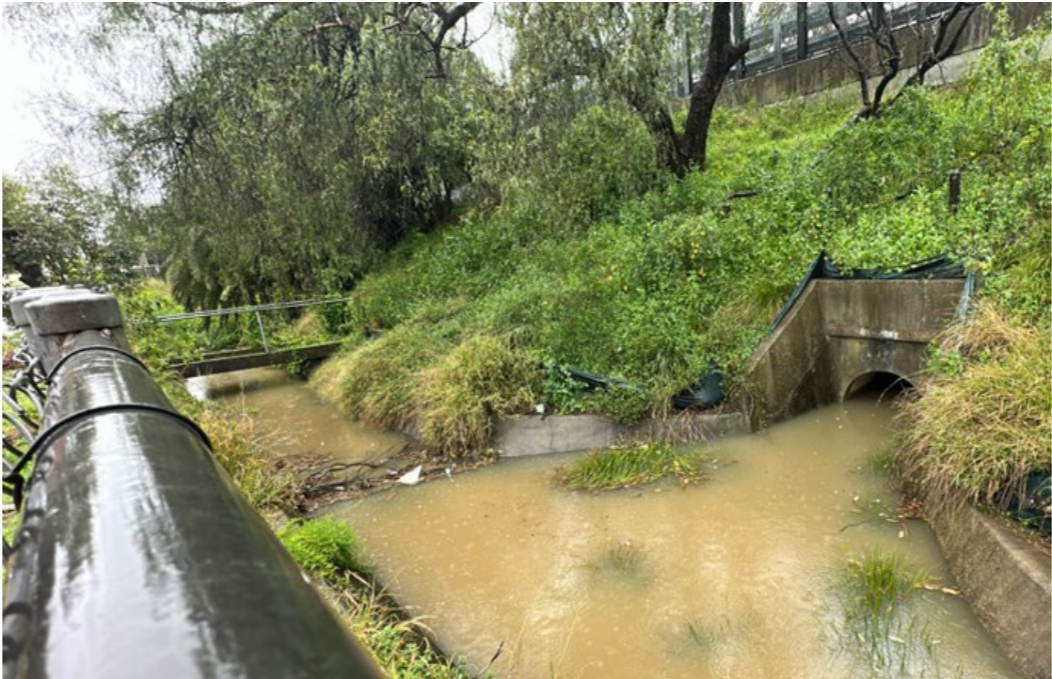
<p data-bbox="1448 1982 1635 2011"><b>Middle culvert:</b></p> <p data-bbox="1023 2013 2056 2043">High level, looks like standing water without flow. Turbid water through middle culvert</p>

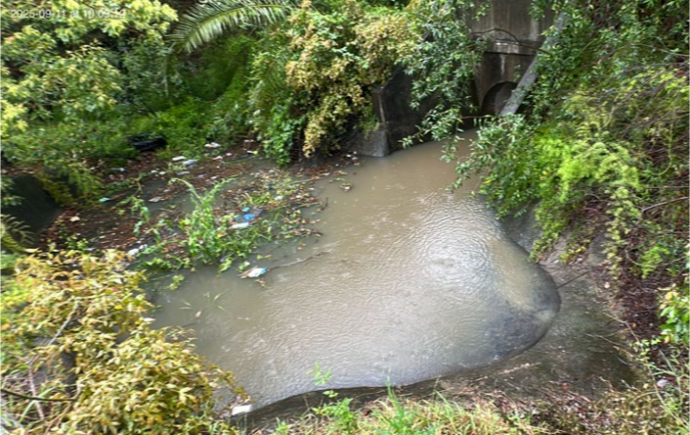
<p><b>Middle culvert</b> – Turbid water draining off batters. Leaf litter on surface.</p>
