# Southwest Metro Works Stage 3 Construction Monitoring Report 3 September 2025- February 2026

SMCSWSW8-JHL-WEC-EM-REP-000001

Document Details	
<b>Title</b>	Construction Monitoring Report
<b>Client</b>	Sydney Metro City & Southwest
<b>Client reference no.</b>	SMCSWSW8-JHL-WEC-EM-REP-000001
<b>JHLOR JV contract no.</b>	K44

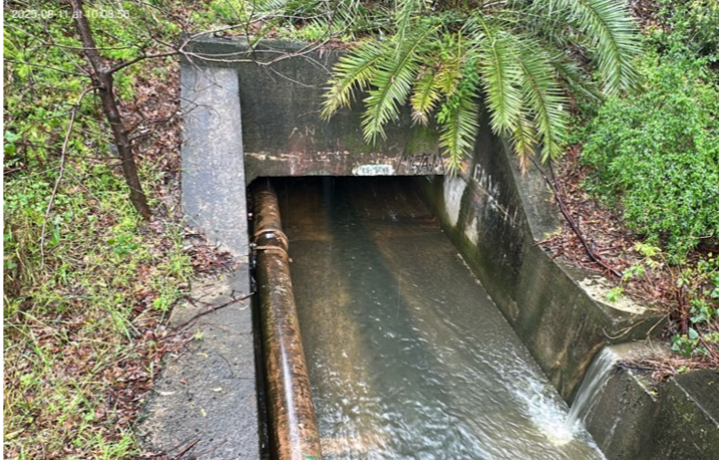
<p><b>Eastern most Culvert</b> – high flow, slightly turbid water through main culvert.</p>			
<p><b>Location 7</b> Bankstown</p>	<p>Nil activities in the area</p>		<p><b>No PO available – not inspected – no JHLOR works in catchment.</b> NOTE: This flow line is below ground and runs across the corridor from Nth to Sth and can be seen through pits only. They are all inside corridor.</p>			
<p><b>Location 7ALT</b>  City side of Bankstown DOWN track (near Stacey St)</p>	<p>No JHLOR excavation activities have been carried out alongside the corridor near this location in the last couple of months.  Area stable with heavy vegetation growth in corridor CESS and alongside culvert</p>	<p><b>Sth Side</b> <b>Water clarity and colour:</b> high flow, clear water  <b>Odour:</b> Nil  <b>Description of flow and quantity/ Visible runoff (into the water body):</b> see above.  <b>Oil and Grease:</b> Nil  <b>Details of any foreign objects within the water:</b> No debris in water  <b>Other comments/description</b> Nil</p>

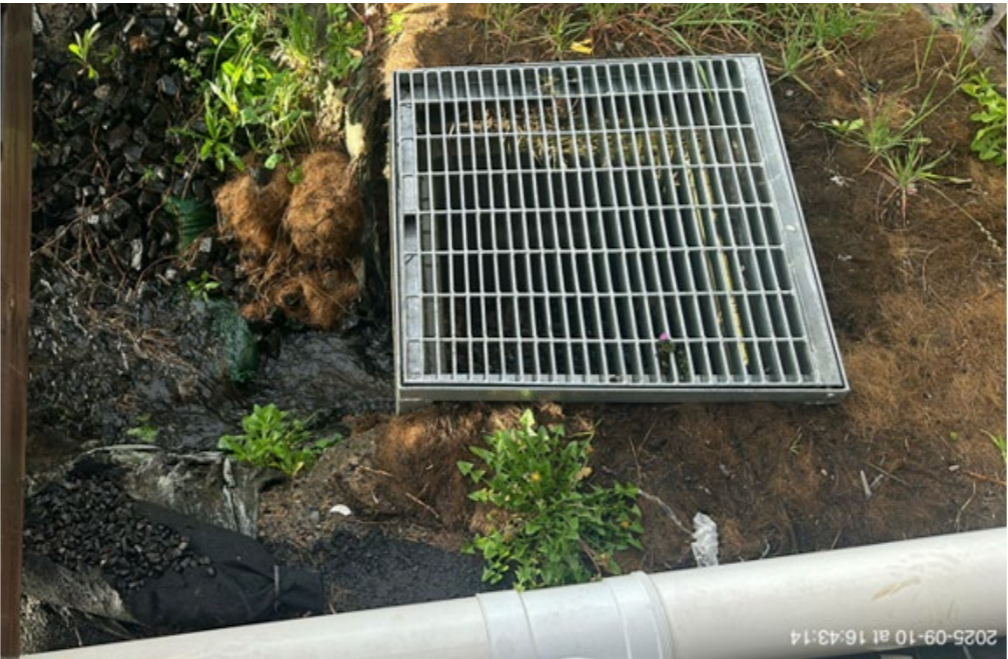
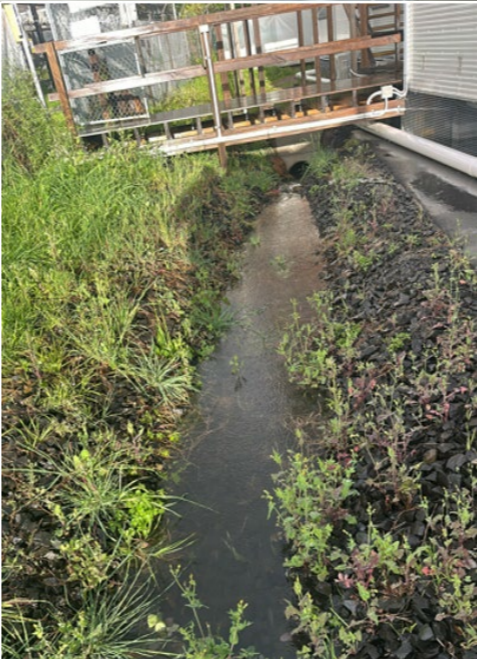
<p style="text-align: center;">Photos from rain period on 10/9/25 at +-16:45 (after 21.2mm)</p> <p style="text-align: center;">High water flow through ballast channel. No odour and no oil &amp; grease. Water is clear going into pit</p> <p style="text-align: center;"><b>Outside Canterbury Compound</b> Eastern Channel. Outside Canterbury Compound boundary alongside pedestrian footpath:</p>	No excavation activities along the corridor near this location

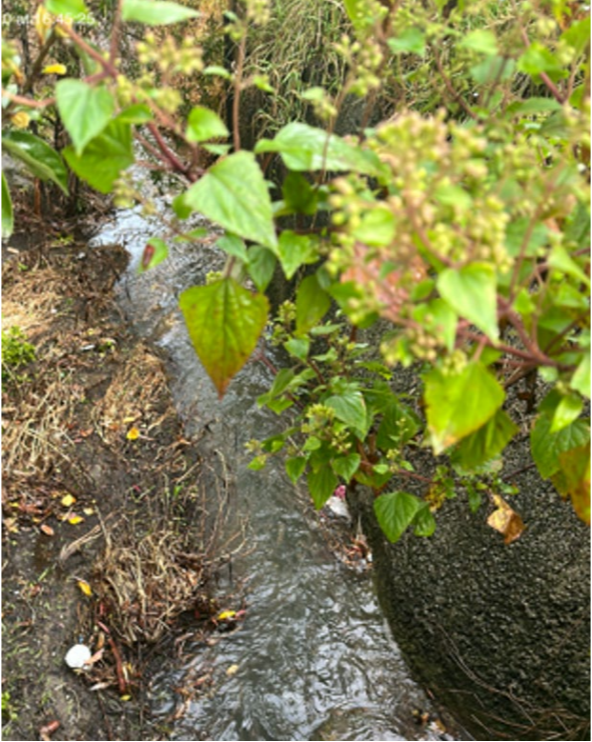
<p data-bbox="1308 951 1774 1014"><u>Upstream from JHLOR discharge point.</u> High water flow in channel appears clear.</p>

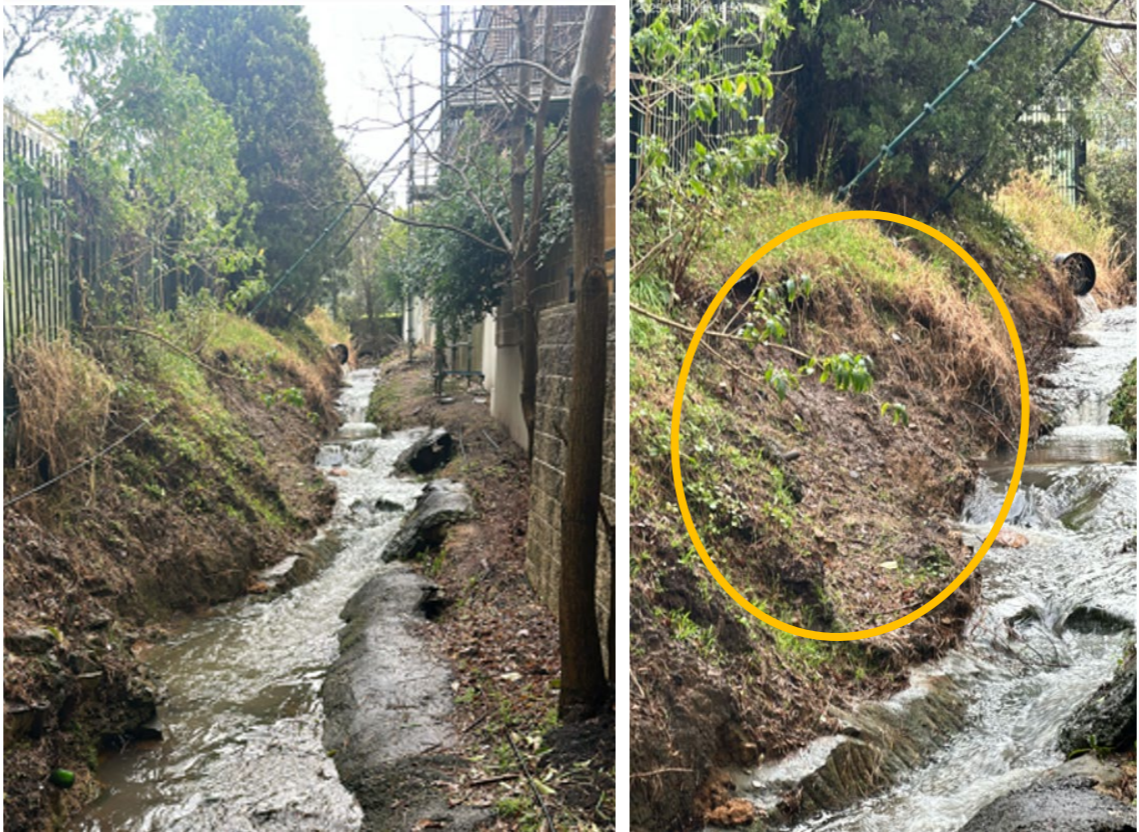
<p data-bbox="1041 1896 2041 1959"><u>Downstream from JHLOR discharge point:</u> Downstream water observed to be very slightly turbid - potentially from scour on batter.</p>
