# Southwest Metro Works Stage 3 Construction Monitoring Report 3 September 2025- February 2026

SMCSWSW8-JHL-WEC-EM-REP-000001

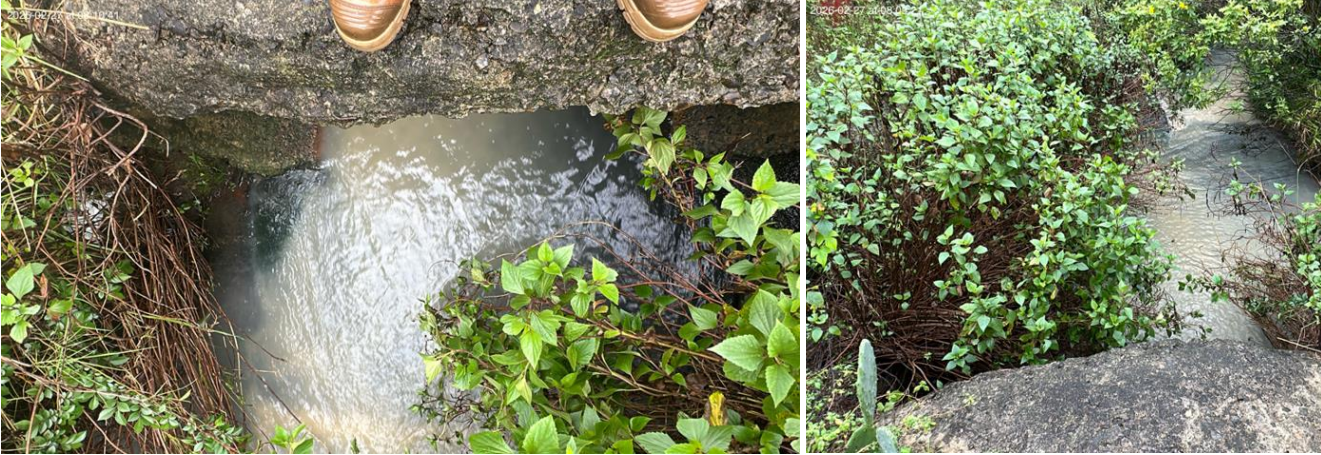
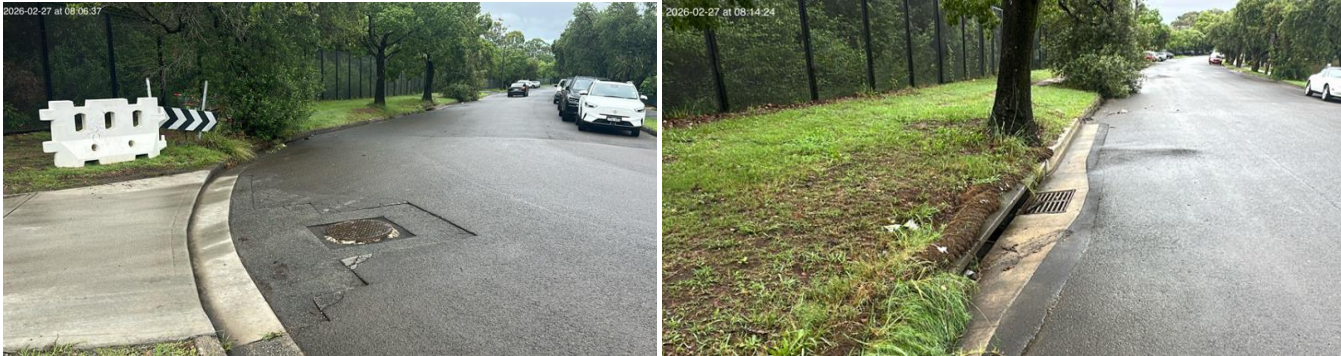
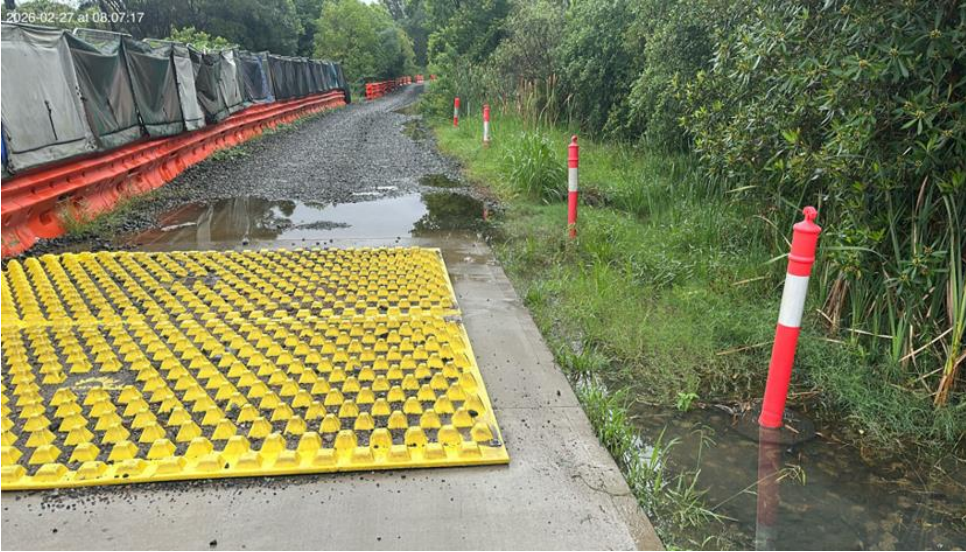
| Inspection Type: | JHLOR Construction Activities in area | Comments from Inspection of waterways | Photos | Additional Observations<br>Are there any impacts related to JHLOR construction works | Follow up action required | Outcome of follow up action |
|---|---|---|---|---|---|---|
| <b>Location 4</b><br>Belmore Triangle Access Road | <p>BelmoreT – There is a ballast access road alongside this open channel, however the road doesn't drain to the culvert.</p> <p>Access track opens into BelmoreT transit space and also into Stockpile area at BelmoreT Wedge</p> | <p><b>Water clarity and colour:</b> Turbid water through SW culvert.</p> <p><b>Odour:</b> Nil</p> <p><b>Description of flow and quantity/ Visible runoff (into the water body):</b> medium flow. No visible signs of sediment flow from ballast access road. Dirty water on track side of road is from truck wash along ballast road. None of this is draining into open culvert - It stays on this side and settles in vegetated pond.</p> <p><b>Oil and Grease:</b> Nil</p> <p><b>Details of any foreign objects within the water:</b> N/A</p> <p><b>Other comments/description:</b> N/A</p> | <p><b>SW outlet alongside access/ballast road.</b> Turbid water flows coming from inside culvert pipe. Unknown source</p> <p><b>Redman Pde – Upstream Status &amp; Controls.</b> No water flowing into kerb/gutter</p> <p><b>Ballast Access Road - Toe of batter on side of road.</b> Water ponds in this location (No signs of turbidity in the ponded water).<br/>NOTE: Dirty water does not drain to open culvert. Vegetated swale was checked alongside access – no signs of dirty water</p> | <p>This water outlet location is alongside a stabilized ballast track that allows access into BelmoreT Area and BelmoreT Wedge Area</p> <p><b>Belmore Triangle Area:</b><br/>1.Is an open transit area for vehicles.<br/>2.Surface in the BelmoreT area is mostly covered by ballast.<br/>3.There is a mid batter berm (mulch) in place to divide catchment (concrete barrier divider placed).<br/>4.Thick vegetated area around lower sed fence at bottom of area. Second mulch berm added.<br/>5.No stockpiling of spoil in this area as it is only a transit point for plant and vehicles to hi-rail pad and BelmoreT wedge.</p> <p><b>Belmore Triangle Wedge Area:</b><br/>Stockpiles (spoil and Engineered fill) are located on top of batter above the access road. No sign of dirty water movement down slope onto ballast access road – see ponded water on side of ballast access track<br/>Stockpile area is flat.</p> <p>Top of batter behind the spoil stockpiles is surrounded by double barrier and geofab curtain over barriers.</p> <p>Volumes of ponded water remains on top of platform retained in the stockpile bays. (No dirty water seen along bottom of batter/ballast access track)</p> | | |

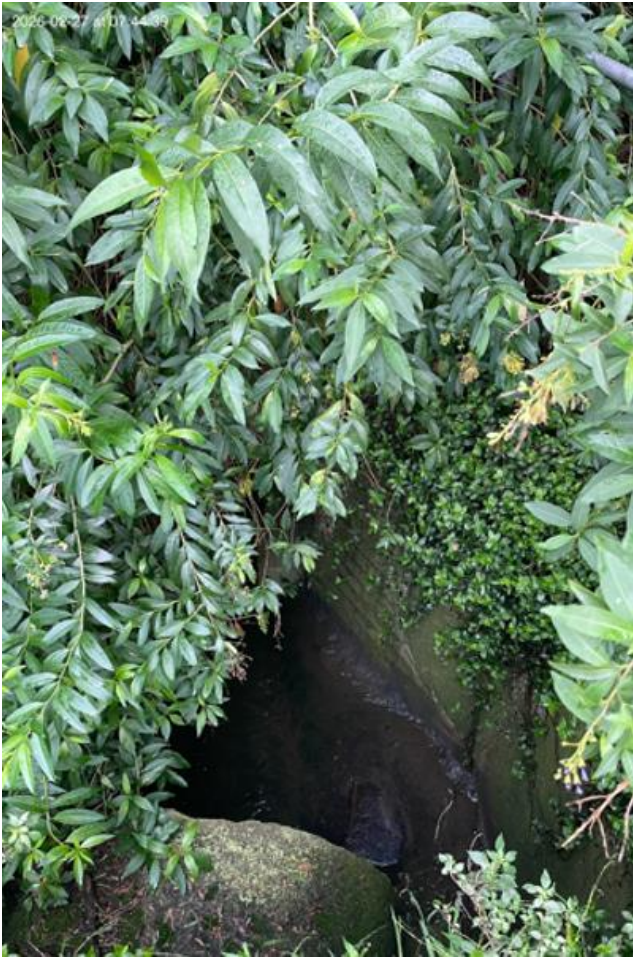
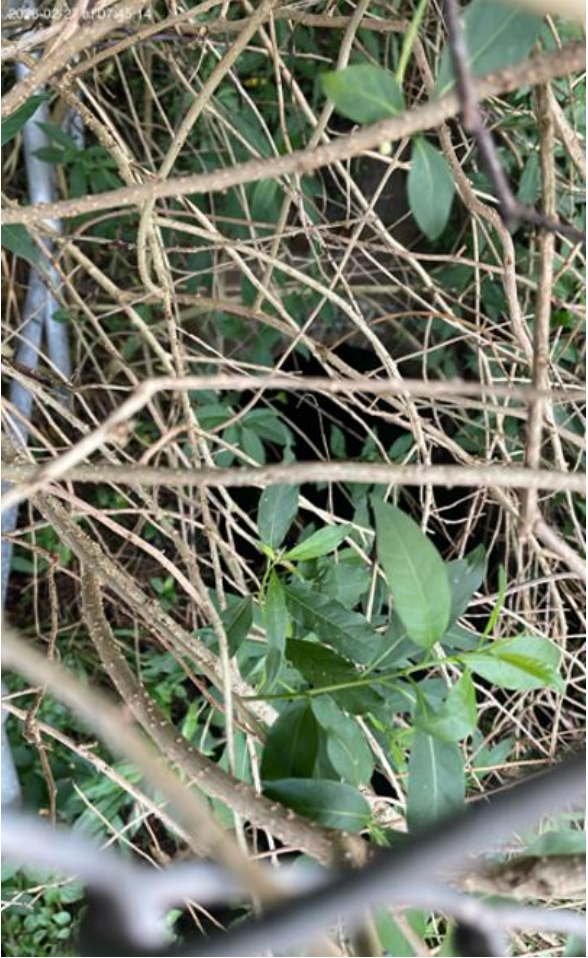
| Inspection Type: | JHLOR Construction Activities in area | Comments from Inspection of waterways | Photos | Additional Observations<br>Are there any impacts related to JHLOR construction works | Follow up action required | Outcome of follow up action |
|---|---|---|---|---|---|---|
| <b>Location 5</b><br>Lakemba, country side | <p>Only commisionig work on the platform buildings up at Station. Landscaping on the nature strip/outside of corridor (UP side) is completed and hardstand stabilised. ERSED in place. Exposed surfaces are covered.</p> <p>No excavation type work on the inside of corridor (Upside)</p> <p>No construction activities on the DWN side of corridor both inside/outside of corridor.</p> | <p><b>Water clarity and colour:</b><br/><b>Odour:</b> N/A</p> <p><b>Description of flow and quantity/ Visible runoff (into the water body):</b><br/>N/A</p> <p><b>Oil and Grease:</b> Nil</p> <p><b>Details of any foreign objects within the water:</b><br/>N/A</p> <p><b>Other comments/description:</b><br/>N/A</p> | <p><b>Nth side of corridor (UP side)</b><br/>No photos taken<br/>Drainage network below ground/road – water from road discharges into drop pit</p> <p><b>Sth side of corridor – Two culverts (Down Side)</b><br/>Vegetation obscures bottom of culverts. Looks clean.</p> <div></div> | | | |

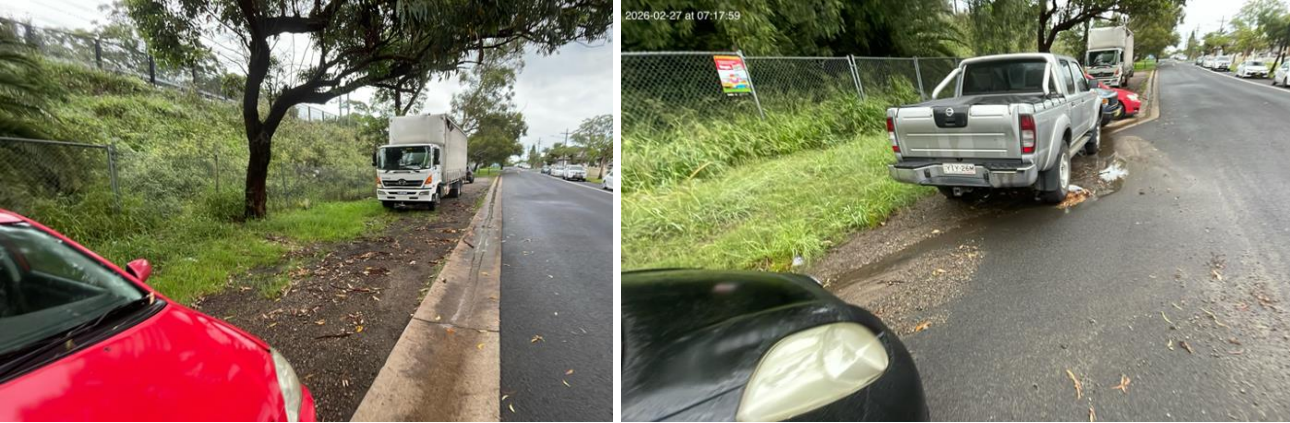
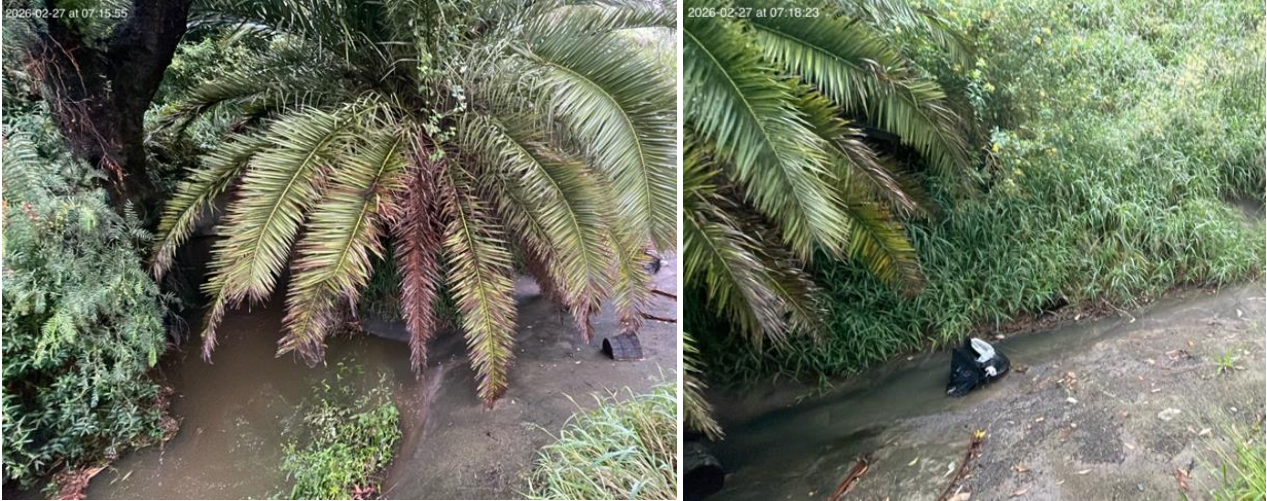
| Inspection Type: | JHLOR Construction Activities in area | Comments from Inspection of waterways | Photos | Additional Observations<br>Are there any impacts related to JHLOR construction works | Follow up action required | Outcome of follow up action |
|---|---|---|---|---|---|---|
| <b>Location 6</b><br><br>Wiley Park, countryside. | No JHLOR excavation works on the UP & DWN side of the tracks<br><br>Contractor (not JHGLOR) is using the WP3 access as laydown of plant, equipment & Engineering fill (DGB). | <b>Water clarity and colour:</b> See detail below photos<br><br><ul style="list-style-type: none"><li><b>Downstream (UP side):</b><br/>See notes in photo section.</li><li><b>Upstream (DWN side):</b><br/>See notes in photo section.</li></ul> <b>Odour:</b> Nil<br><br><b>Description of flow and quantity/ Visible runoff (into the water body):</b><br>See notes in photo section.<br><br><b>Oil and Grease:</b> Nil<br><br><b>Details of any foreign objects within the water:</b> Nil.<br><br><b>Other comments/description:</b><br>Nil | <div><div><div><b>CORRIDOR (UP SIDE)<br/>UPSTREAM AREA</b></div><div><i>Inside</i> of corridor - Area upstream of open Culverts at Gate WP3 is well stabilised.<br/><i>Outside</i> of corridor – very low flow of water in concrete channel down to western most culvert. Water looks clear.</div><div></div></div><div><div><b>ACTUAL CULVERT AREA (inside corridor)</b></div><div></div><div><b>Western most culvert</b><br/>Water at high level, looks like standing water without flow. Turbid water through main culvert with clean water flow from inlet on RHS.</div></div></div> | | | |

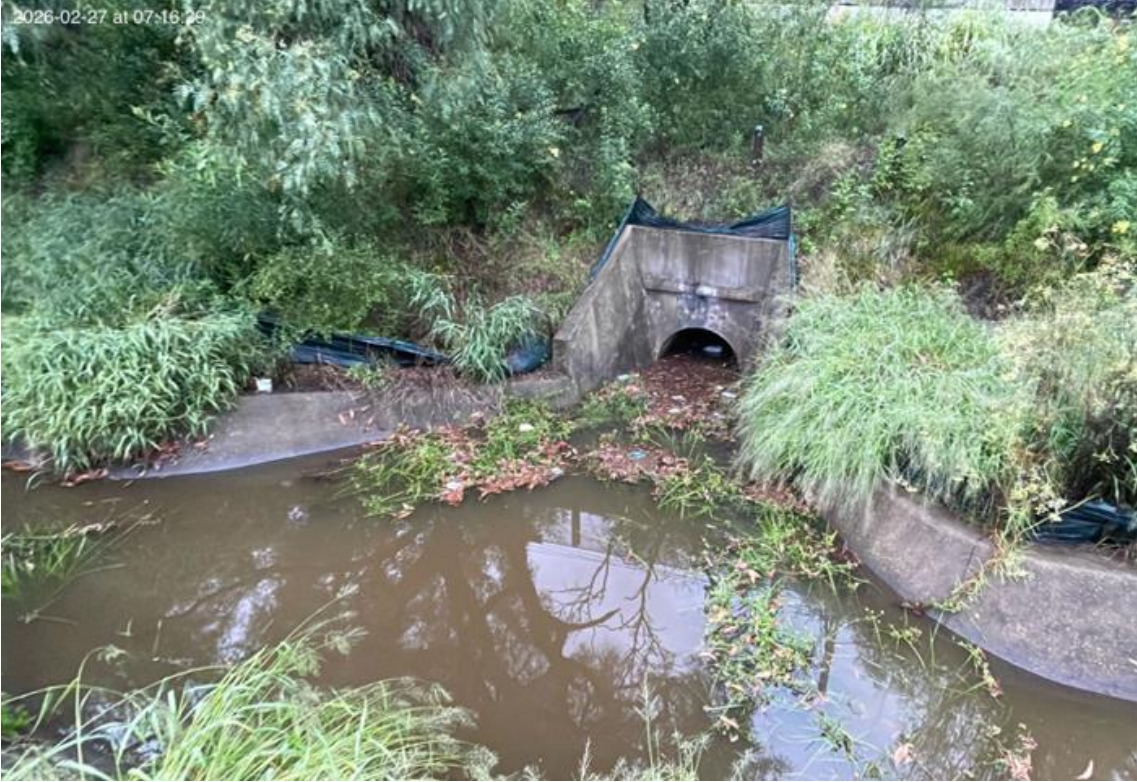
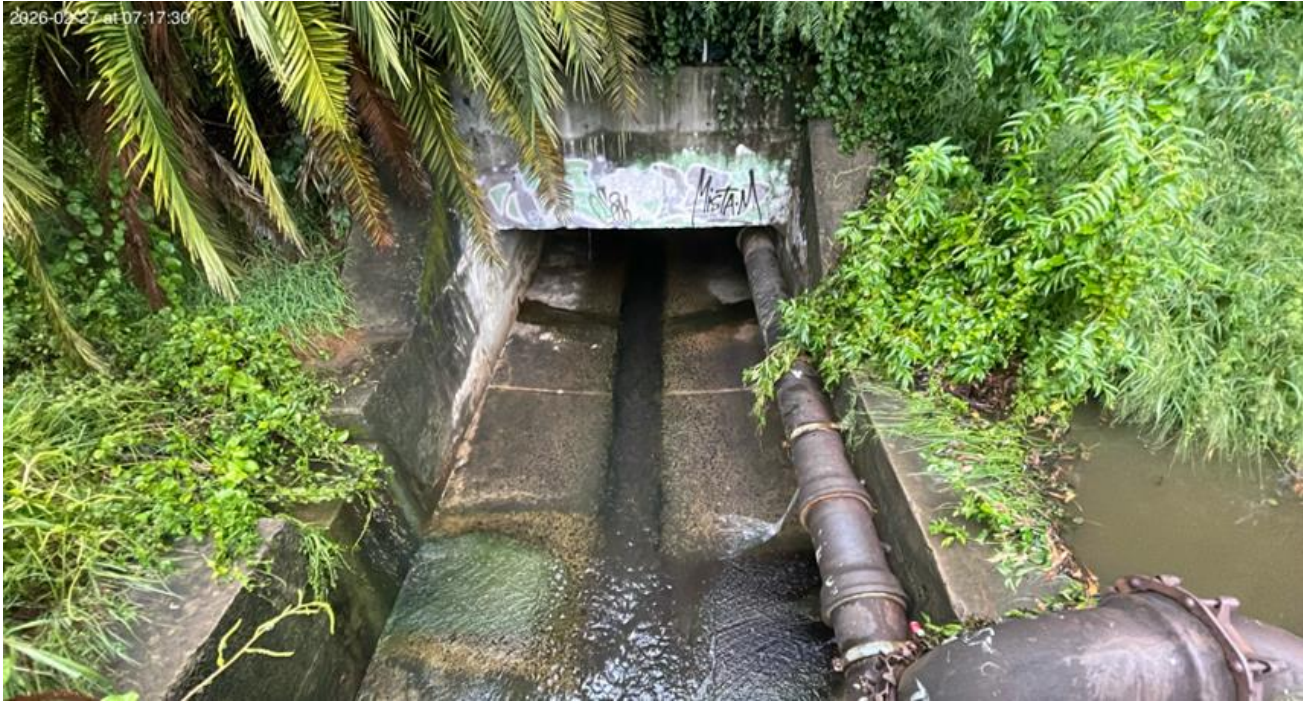
| Inspection Type: | JHLOR Construction Activities in area | Comments from Inspection of waterways | Photos | Additional Observations<br>Are there any impacts related to JHLOR construction works | Follow up action required | Outcome of follow up action |
|---|---|---|---|---|---|---|
| | | | <div><p><b>Middle culvert:</b><br/>Water at high level, looks like standing water without flow. Turbid water in middle section of culvert.</p></div> <div><p><b>Eastern most culvert</b><br/>Med flow, clear water through main culvert. No oil &amp; grease. No odour. Photos show culvert on corridor side of Urunga Pde.</p></div> <div><p><b>DOWNSIDE OF CORRIDOR</b></p></div> | | | |

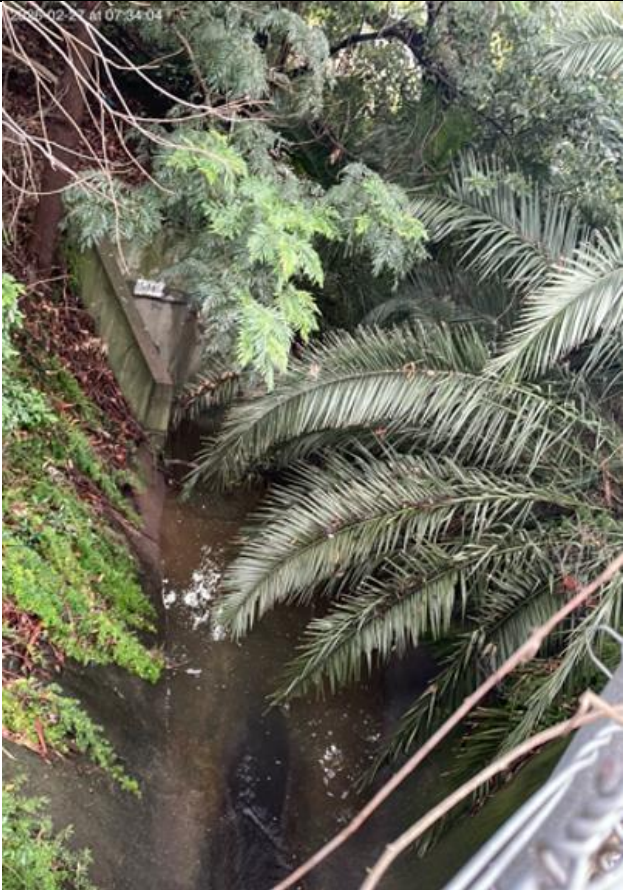
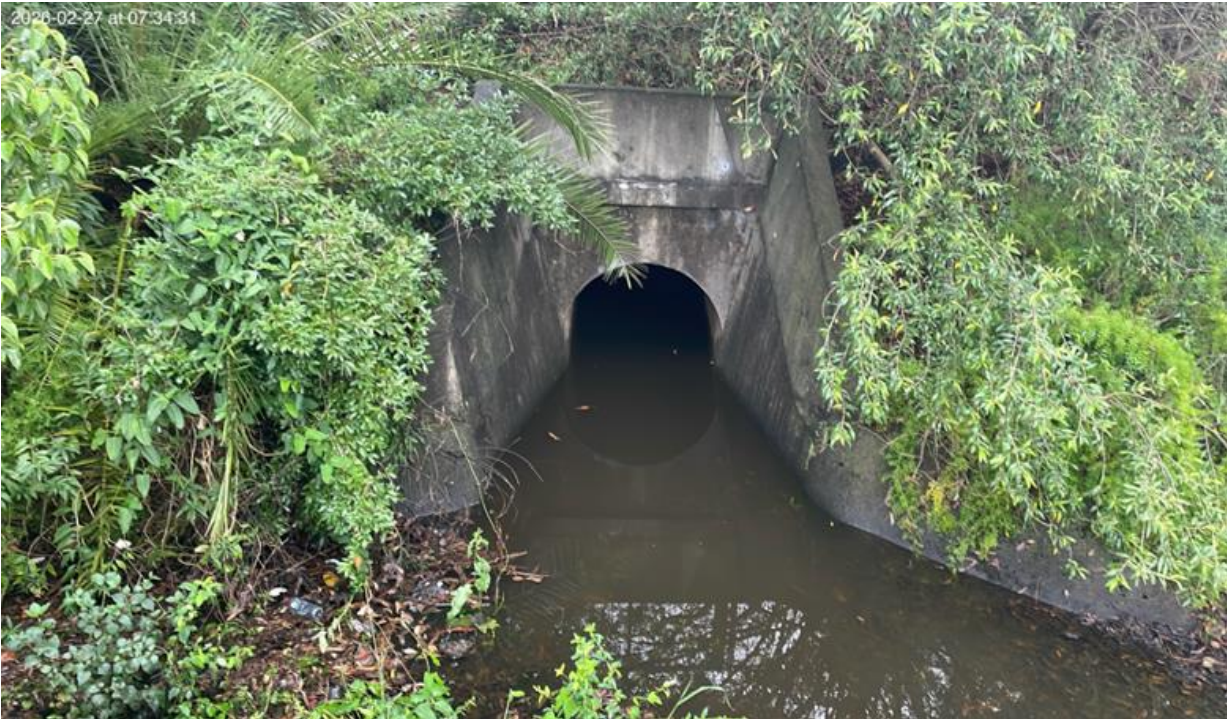
| Inspection Type: | JHLOR Construction Activities in area | Comments from Inspection of waterways | Photos | Additional Observations<br>Are there any impacts related to JHLOR construction works | Follow up action required | Outcome of follow up action |
|---|---|---|---|---|---|---|
| | | | <div><p><b>Western most culvert</b> – low flow. Looks like clear water through main culvert.</p></div> <div><p><b>Middle culvert</b> – Standing water. This culvert picks up water flow off batters. It is not fed by incoming drains/culverts. Leaf litter on surface.</p></div> | | | |

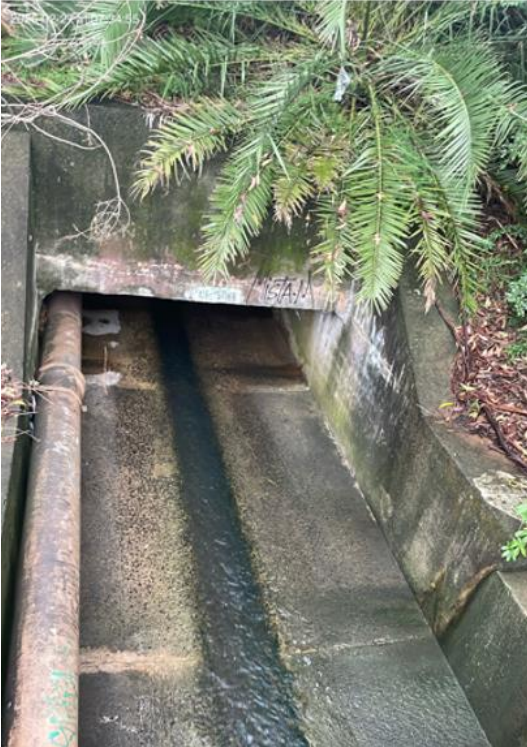
| Inspection Type: | JHLOR Construction Activities in area | Comments from Inspection of waterways | Photos | Additional Observations<br>Are there any impacts related to JHLOR construction works | Follow up action required | Outcome of follow up action |
|---|---|---|---|---|---|---|
| | | | <div></div> <div>Eastern most Culvert – med flow, clear water through main culvert.</div> | | | |

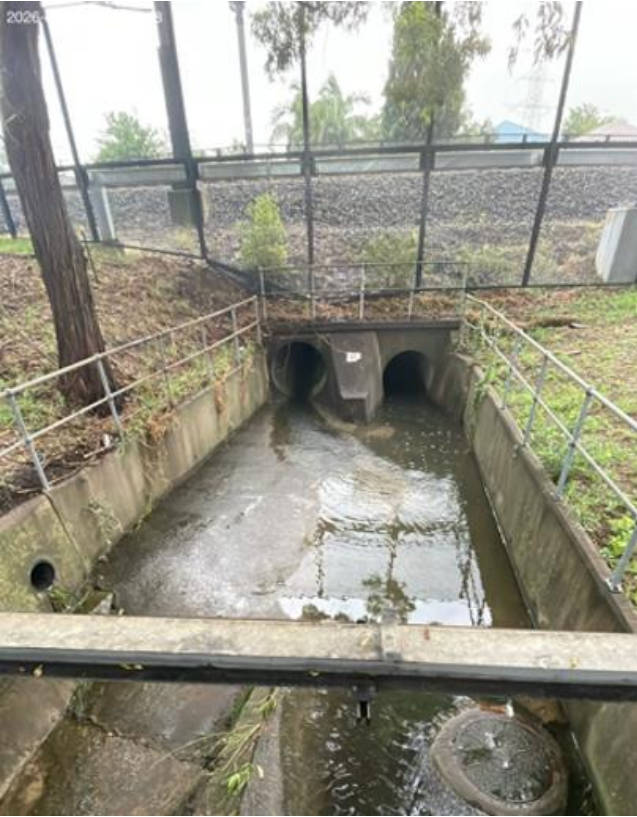
| Inspection Type: | JHLOR Construction Activities in area | Comments from Inspection of waterways | Photos | Additional Observations<br>Are there any impacts related to JHLOR construction works | Follow up action required | Outcome of follow up action |
|---|---|---|---|---|---|---|
| Location 7ALT<br><br>City side of Bankstown DOWN track (near Stacey St) | <p>No JHLOR excavation activities have been carried out alongside the corridor near this location.</p> <p>Area stable with heavy vegetation growth in corridor CESS and alongside culvert</p> | <p><b>Sth Side</b></p> <p><b>Water clarity and colour:</b> med flow, clear water</p> <p><b>Odour:</b> Nil</p> <p><b>Description of flow and quantity/ Visible runoff (into the water body):</b> see above.</p> <p><b>Oil and Grease:</b> Nil</p> <p><b>Details of any foreign objects within the water:</b> No debris in water</p> <p><b>Other comments/description</b><br/>Nil</p> | <div></div> | | | |

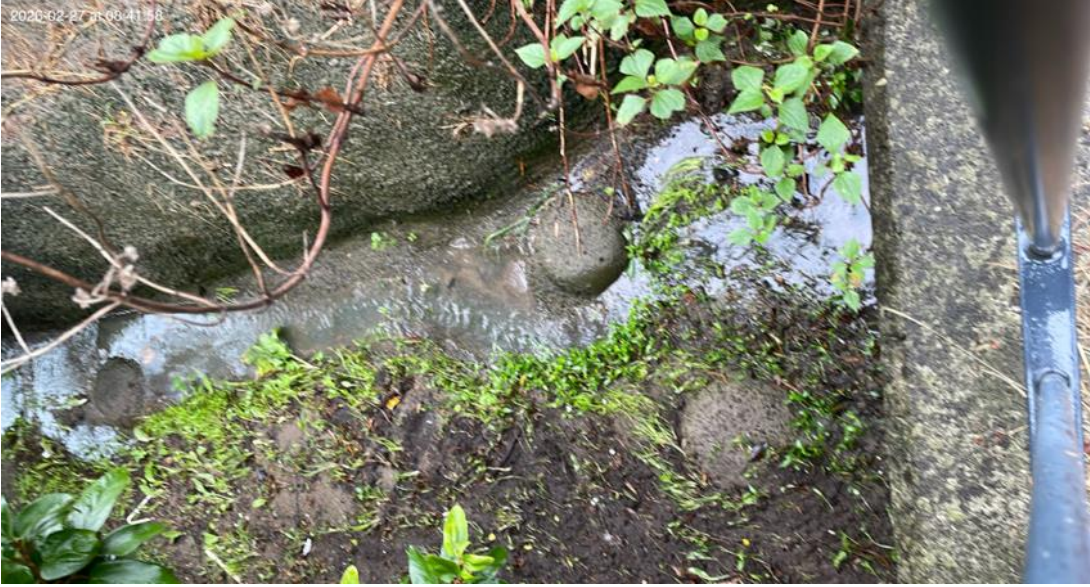
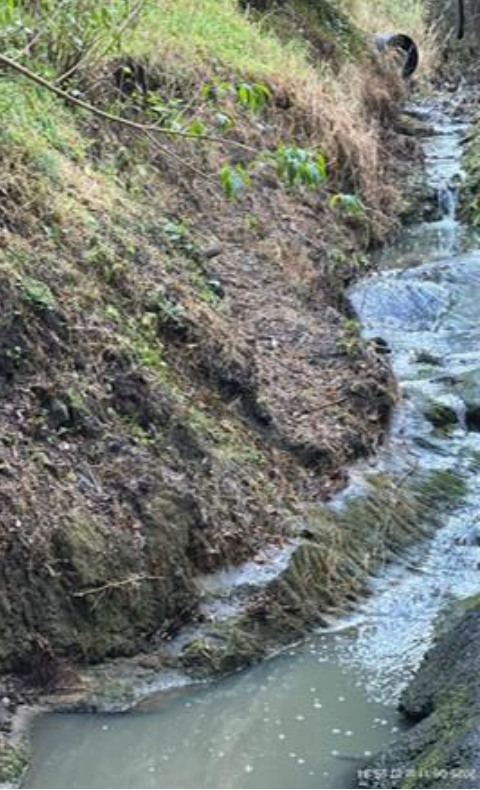
| Inspection Type: | JHLOR Construction Activities in area | Comments from Inspection of waterways | Photos | Additional Observations<br>Are there any impacts related to JHLOR construction works | Follow up action required | Outcome of follow up action |
|---|---|---|---|---|---|---|
| Location 8<br>Canterbury Compound | No JHLOR construction/excavation activities along the corridor near this location | <p><b>Water clarity and colour of water in main culvert (flowing Under Corridor).</b> low flow, slightly turbid water at downstream exit</p> <p>No photos taken of water flow from Canterbury Compound</p> <p><b>Odour:</b> Nil</p> <p><b>Description of flow and quantity/ Visible runoff (into the water body):</b><br/>Low, slightly turbid flow of water in open channel</p> <p><b>Oil and Grease:</b> Nil</p> <p><b>Details of any foreign objects within the water:</b> Nil</p> <p><b>Other comments/description:</b><br/>Nil</p> | <p><b>Inside Canterbury Compound – Water flow</b><br/>No photo taken of this area</p> <p><b>Outside Canterbury Compound – Water Flow</b><br/>Eastern Channel. Outside Canterbury Compound boundary alongside pedestrian footpath:</p> <div></div> <p><u>Upstream from JHLOR discharge point.</u><br/>Low flow, slightly turbid water flowing in channel.</p> | <p>No excavation activities along the corridor near this location</p> <div></div> <p>This photo shows previous status of downstream batter slope during event dated 11/8/25. Batter showed signs of slip.</p> | | |

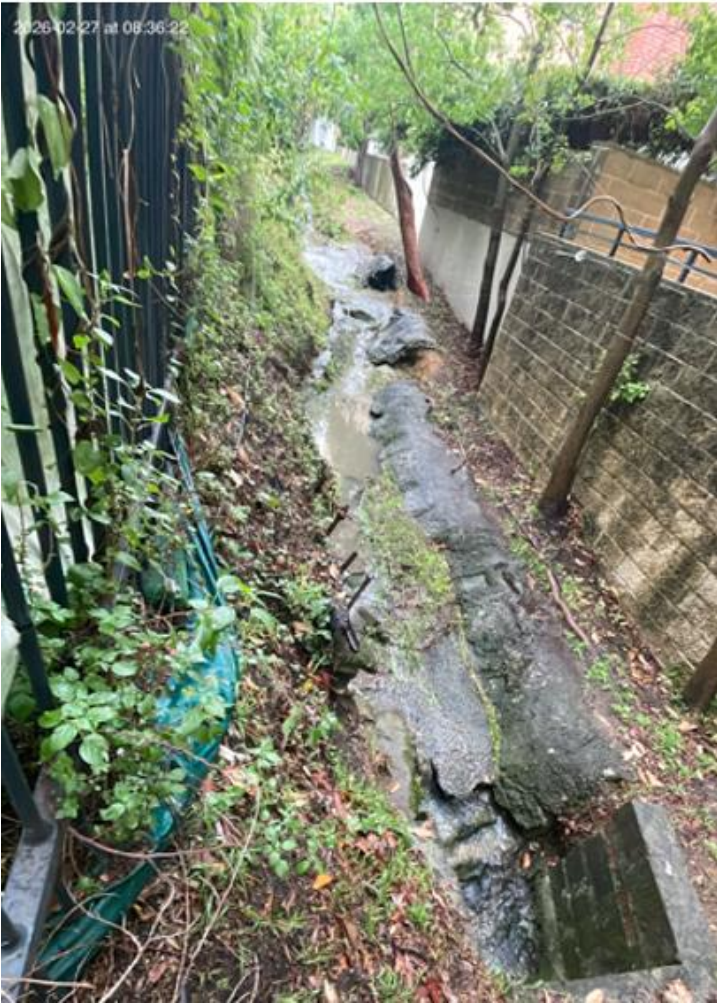
| Inspection Type: | JHLOR Construction Activities in area | Comments from Inspection of waterways | Photos | Additional Observations<br>Are there any impacts related to JHLOR construction works | Follow up action required | Outcome of follow up action |
|---|---|---|---|---|---|---|
| | | | <div></div> <p><u>Downstream from JHLOR discharge point:</u><br/>Downstream water observed to be slightly turbid<br/>No photos of the batter scour/slip this period.</p> | | | |

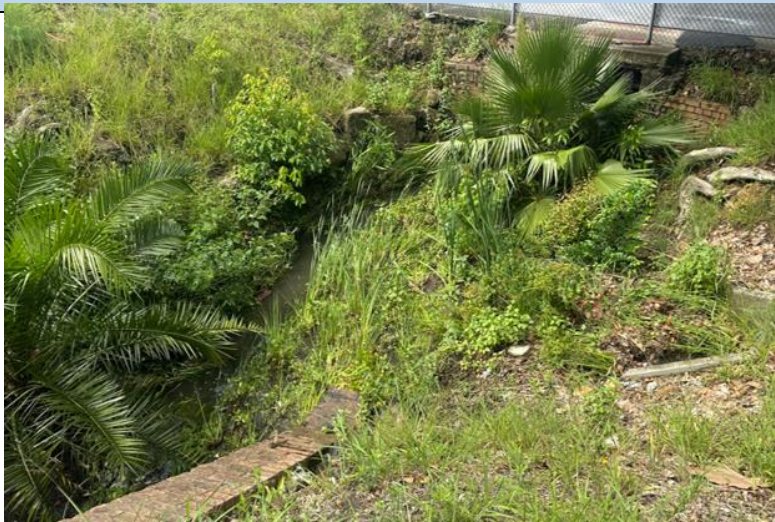
| Inspection Type: | JHLOR Construction Activities in area | Comments from waterways | Photos | | Additional Observations<br>Are there any impacts related to JHLOR construction works | Follow up action required | Outcome of follow up action |
|---|---|---|---|---|---|---|---|
| <b>Location 1</b><br><br>Dulwich Hill MSB (Ewart Culvert), country side of commuter car park | No work in this area in +- last 4 weeks<br><br>Surfaces alongside this culvert on the: <ul style="list-style-type: none"><li>west side around the culvert is stabilised – vegetation and heavy leaf litter.</li><li>East side (alongside MSB) stabilised with vegetation and geofab cover</li></ul> . | <b>Water clarity and colour:</b><br>Low flow water in main culvert looks slightly turbid.<br><br><i>Side inlet on LHS:</i> Unknown upstream source. No cloud plume in main culvert from inlet<br><br><i>Side inlet on RHS:</i> No cloud plume in main culvert from inlet on RHS.<br><br><b>Odour:</b> Nil<br><br><b>Description of flow and quantity/ Visible runoff (into the water body):</b> Currently low flow of water with signs of damage to vegetation.<br><br><b>Oil and Grease:</b> Nil<br><br><b>Details of any foreign objects within the water:</b> Nil<br><br><b>Other comments/description:</b> N/A | <br><br><b>LHS Inlet (Concrete Headwall)</b><br>Unknown upstream source. No cloud plume in main culvert from inlet<br><br><b>RHS Inlet (Black pipe)</b><br>No cloud plume in main culvert from inlet on RHS. | | JHLOR construction activites (for OHCB) at Ewart/Terrace Rd have been completed and surfaces have been stabilised since before the Xmas break. | | |

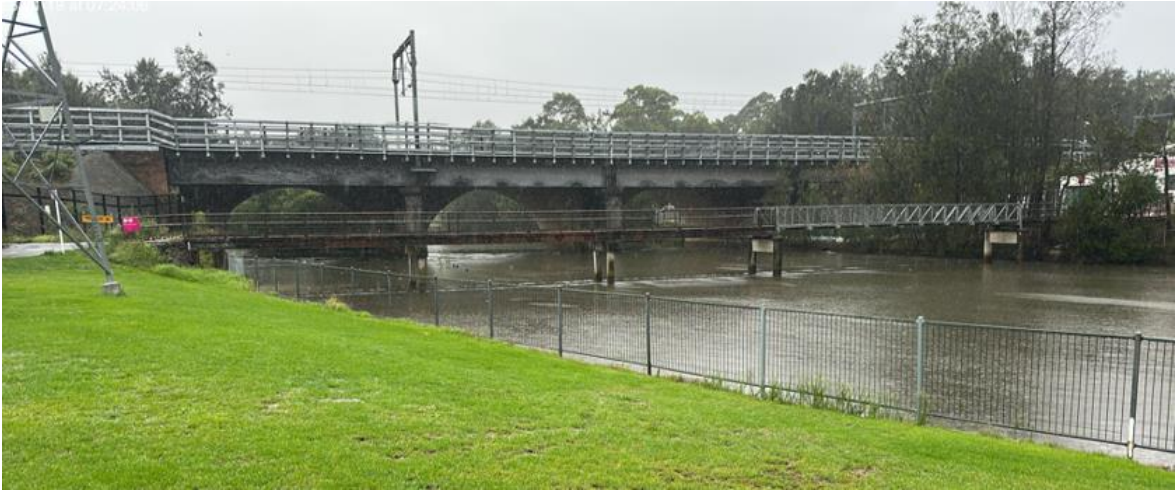
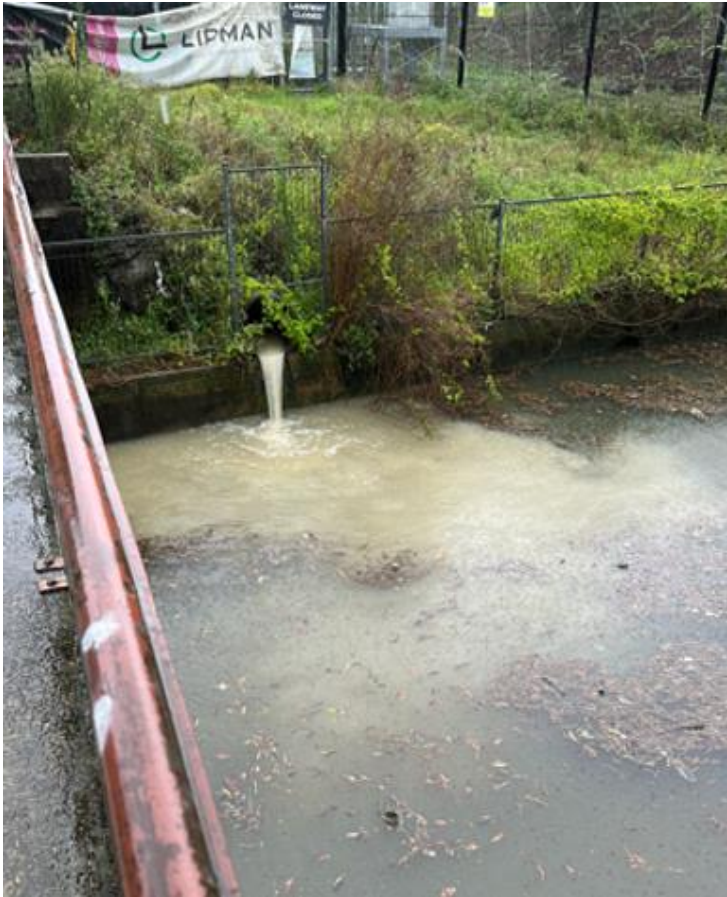
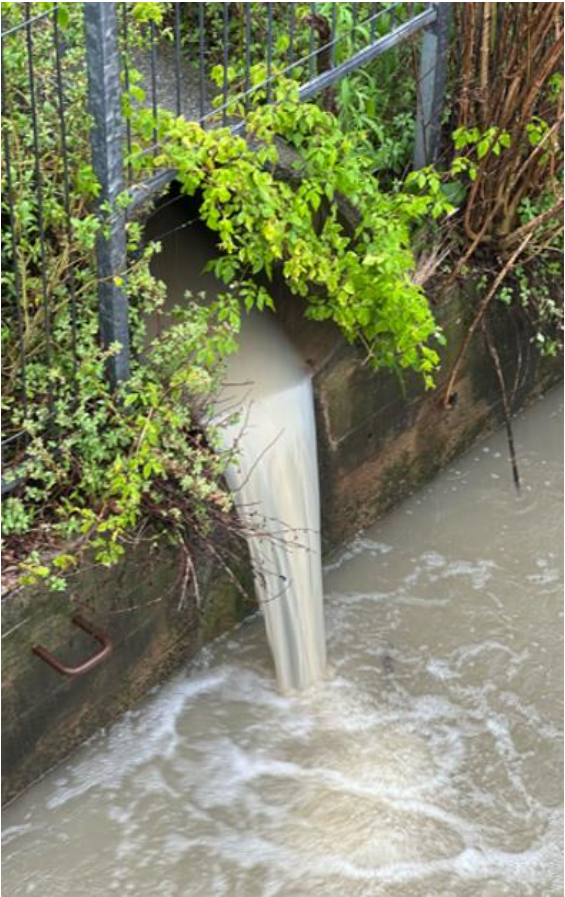
| Inspection Type: | JHLOR Construction Activities in area | Comments from Inspection of waterways | Photos | Additional Observations<br>Are there any impacts related to JHLOR construction works | Follow up action required | Outcome of follow up action |
|---|---|---|---|---|---|---|
| | <p>station. Corridor area is vegetated/stabilized all the way up to Campsie other than alongside the concrete crash barrier (Martinus).</p> <p>NOTE: Upstream photos taken along Wairoa, CB6 and locations near Gould St show turbid water flowing from corridor – unknown source but comes from under track culvert and is thought to be “legacy work” from Sydney Trains old work behind concrete barrier where they excavated into the open channel to release water from upstream</p> <p>Not from JHLOR works (no groundbreaking construction activities upstream).</p> | <p><b>Odour:</b> Nil</p> <p><b>Description of flow and quantity/ Visible runoff (into the water body):</b> High flow</p> <p><b>Oil and Grease:</b> Nil</p> <p><b>Details of any foreign objects within the water:</b> N/A</p> <p><b>Other comments/description:</b> N/A</p> | <p>Storm Water outlet at River</p> | <p>NOTE: Upstream photos taken along Wairoa, CB6 and locations near Gould St show turbid water flowing from corridor – unknown source but comes from under track culvert and is thought to be “legacy work” from Sydney Trains old work behind concrete barrier where they excavated into the open channel to release water from upstream</p> <p>Not from JHLOR works (no groundbreaking construction activities upstream).</p> | | |

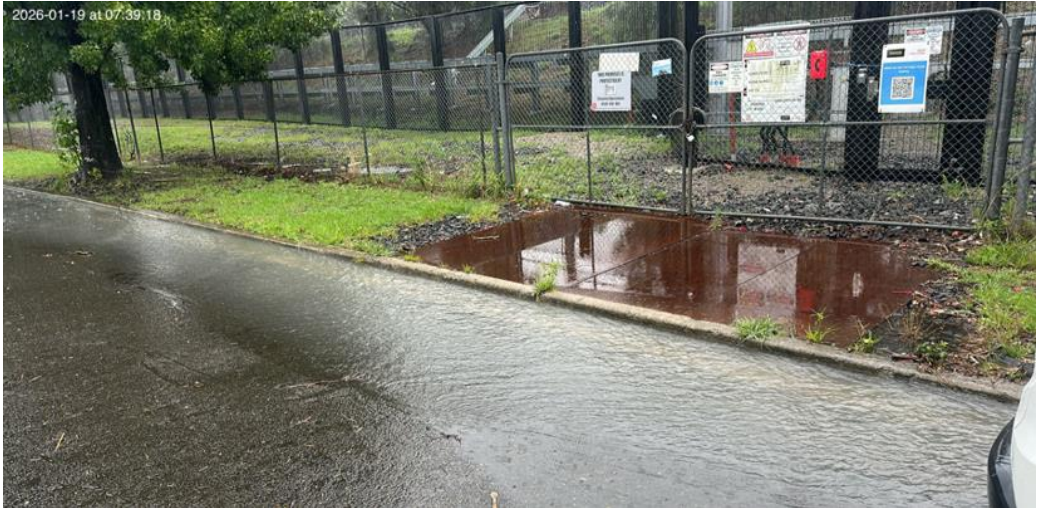
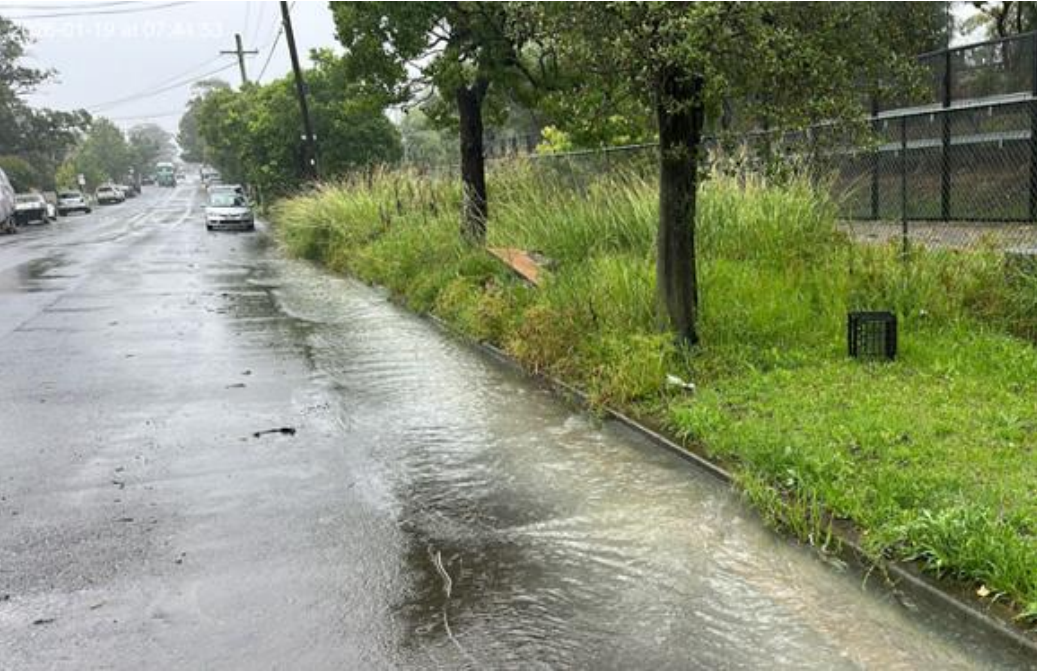
| Inspection Type: | JHLOR Construction Activities in area | Comments from Inspection of waterways | Photos | Additional Observations<br>Are there any impacts related to JHLOR construction works | Follow up action required | Outcome of follow up action |
|---|---|---|---|---|---|---|
| | | | <div><p><b>Area at Gould/Park St.</b> Turbid water drains from corridor (Legacy work from Sydney Trains old work behind concrete barrier where they excavated into the open channel to release water)</p></div> | | | |

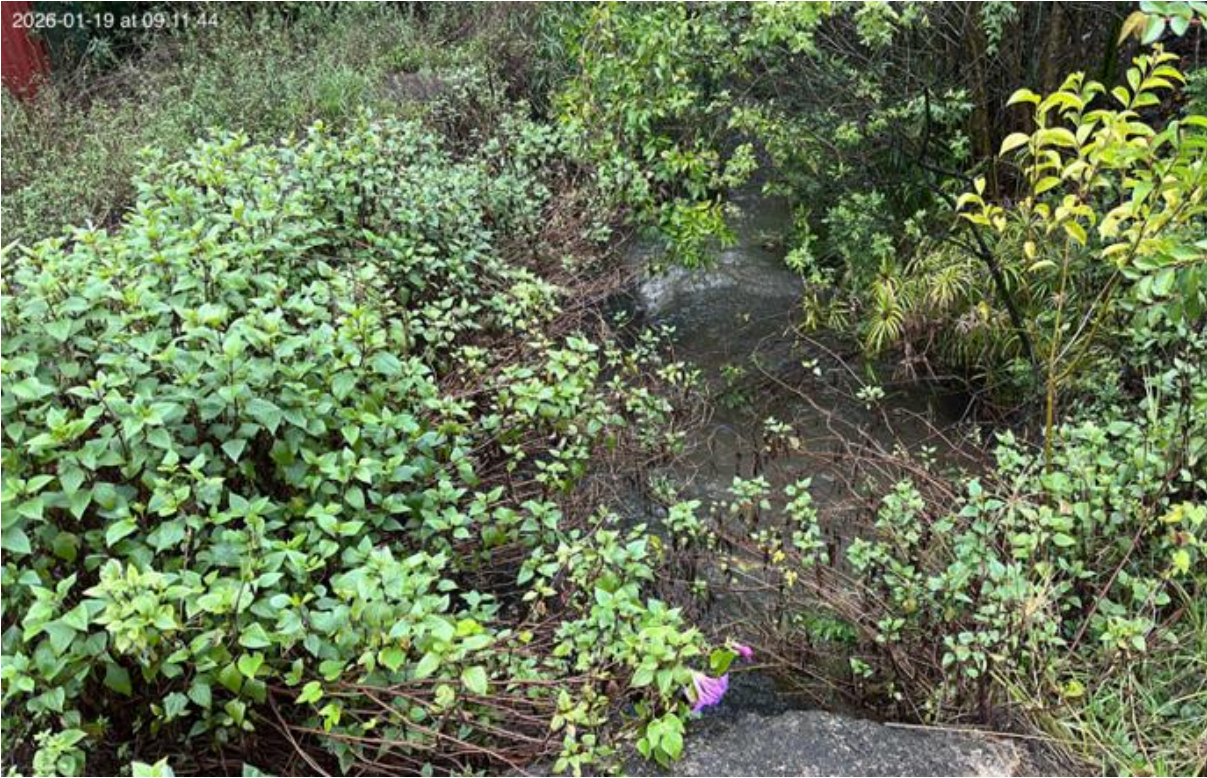
| Inspection Type: | JHLOR Construction Activities in area | Comments from Inspection of waterways | Photos | Additional Observations<br>Are there any impacts related to JHLOR construction works | Follow up action required | Outcome of follow up action |
|---|---|---|---|---|---|---|
| <b>Location 4</b><br>Belmore Triangle Access Road | <p>BelmoreT – There is a ballast access road alongside this open channel, however the road doesn’t drain to the culvert.</p> <p>Access track opens into BelmoreT transit space and also into Stockpile area at BelmoreT Wedge</p> | <p><b>Water clarity and colour:</b> Very Slightly turbid water through SW culvert.</p> <p><b>Odour:</b> Nil</p> <p><b>Description of flow and quantity/ Visible runoff (into the water body):</b> medium. No visible signs of sediment flow from ballast access road. Dirty water on track side of road is from truck wash along ballast road. None of this is draining into open culvert - It stays on this side and settles in vegetated pond.</p> <p><b>Oil and Grease:</b> Nil</p> <p><b>Details of any foreign objects within the water:</b> N/A</p> <p><b>Other comments/description:</b> N/A</p> | <p><b>SW outlet alongside access/ballast road.</b> Very Slightly turbid water flows from inside culvert pipe.</p> <p><b>Redman Pde – Upstream Status &amp; Controls.</b> Small volumes of clear water flowing into kerb/gutter</p> | <p>This water outlet location is alongside a stabilized ballast track that allows access into BelmoreT Area and BelmoreT Wedge Area</p> <p><b>Belmore Triangle Area:</b><br/>1.Is an open transit area for vehicles.<br/>2.Surface in the BelmoreT area is mostly covered by ballast.<br/>3.There is a mid batter berm (mulch) in place to divide catchment (concrete barrier divider placed).<br/>4.Thick vegetated area around lower sed fence at bottom of area. Second mulch berm added.<br/>5.No stockpiling of spoil in this area as it is only a transit point for plant and vehicles to hi-rail pad and BelmoreT wedge.</p> <p><b>Belmore Triangle Wedge Area:</b><br/>Stockpiles (spoil and Engineered fill) are located on top of batter above the access road. No sign of spoil movement down slope onto ballast access road – see ponded water on side of ballast access track<br/>Stockpile area is flat.</p> <p>Top of batter behind the spoil stockpiles is surrounded by double barrier and geofab curtain over barriers.</p> | | |

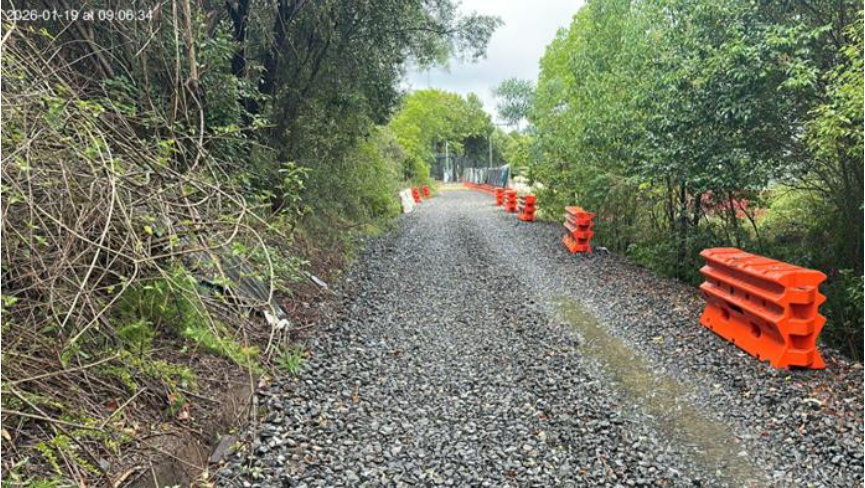
| Inspection Type: | JHLOR Construction Activities in area | Comments from Inspection of waterways | Photos | Additional Observations<br>Are there any impacts related to JHLOR construction works | Follow up action required | Outcome of follow up action |
|---|---|---|---|---|---|---|
| | | | <div></div> <p><b>Ballast Access Road - Toe of batter on side.</b> Water ponds in this location (No signs of turbidity in the ponded water).<br/>NOTE: Dirty water does not drain to open culvert. Vegetated swale was checked alongside access – no signs of dirty water</p> <div></div> <div></div> | | | |

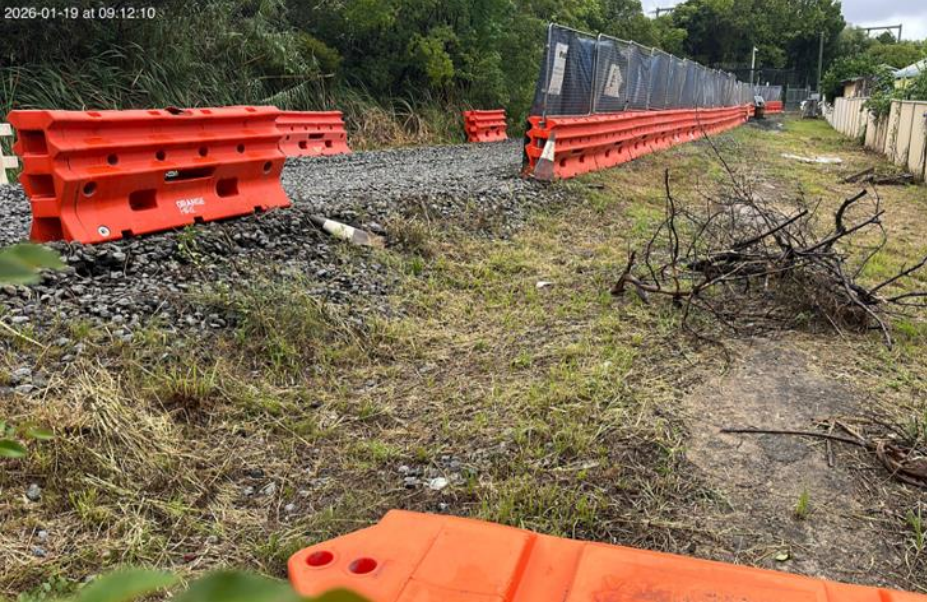
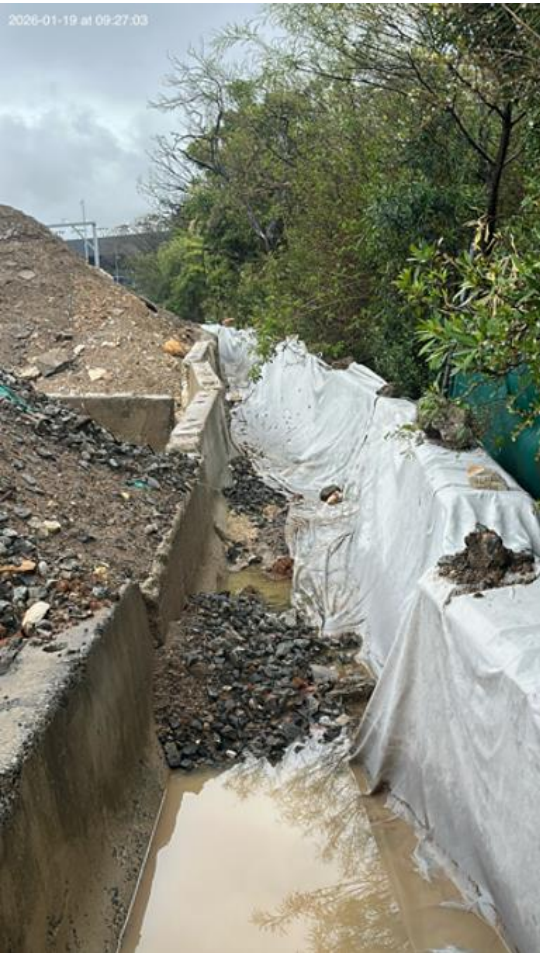
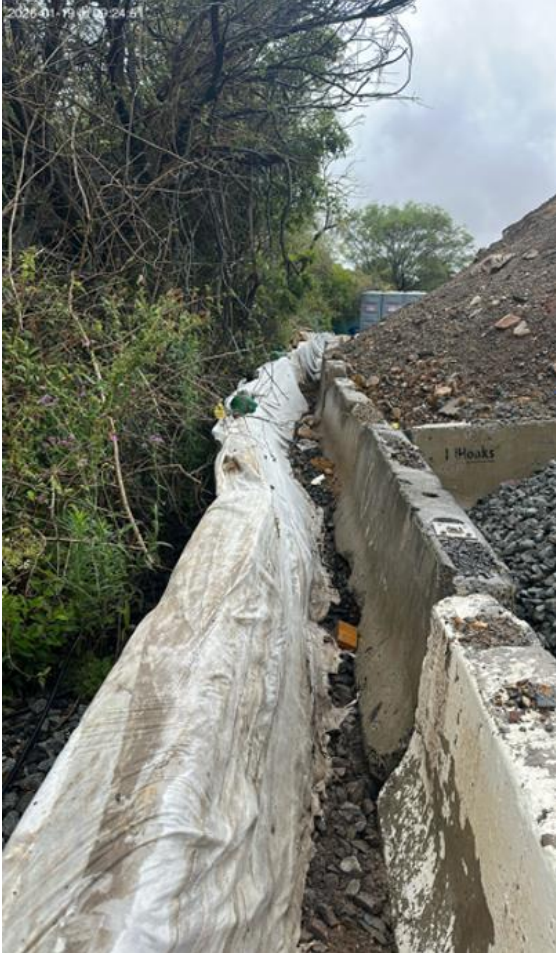
| Inspection Type: | JHLOR Construction Activities in area | Comments from Inspection of waterways | Photos | Additional Observations<br>Are there any impacts related to JHLOR construction works | Follow up action required | Outcome of follow up action |
|---|---|---|---|---|---|---|
| | | | <div></div> <p><b>BelmoreT Wedge Stockpile area.</b> Photos from top of batter above the ballast accesss road - Double concrete barrier &amp; geofab ERSED controls. Small volume of ponded water remains on top of platform (No dirty water seen along bottom of batter/ballast acess track)</p> <div></div> | | | |

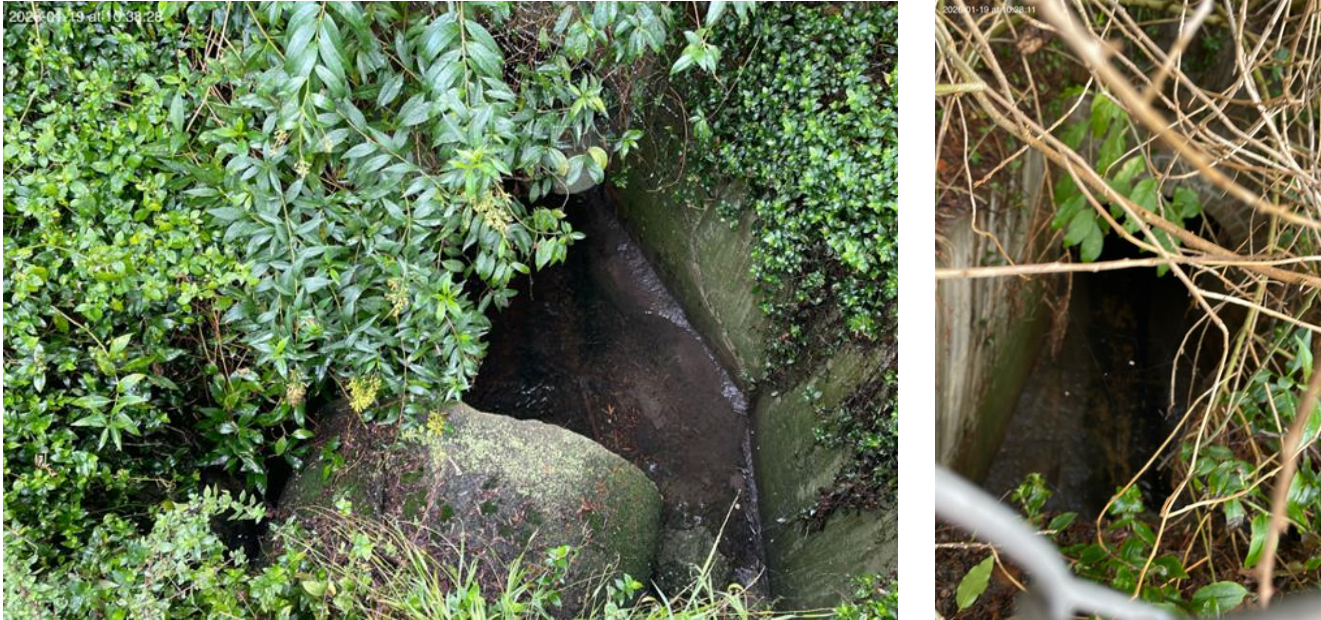
| Inspection Type: | JHLOR Construction Activities in area | Comments from Inspection of waterways | Photos | Additional Observations<br>Are there any impacts related to JHLOR construction works | Follow up action required | Outcome of follow up action |
|---|---|---|---|---|---|---|
| | <p>corridor (UP side) is completed and hardstand stabilised. ERSED in place. Exposed surfaces are covered.</p> <p>No excavation type work on the inside of corridor (Upside)</p> <p>No construction activities on the DWN side of corridor both inside/outside of corridor.</p> | <p>N/A</p> <p><b>Oil and Grease:</b> Nil</p> <p><b>Details of any foreign objects within the water:</b> N/A</p> <p><b>Other comments/description:</b> N/A</p> | <p>Vegetation obscures bottom of culverts but looks like water is clear.</p> | | | |
