# Southwest Metro Works Stage 3 Construction Monitoring Report 3 September 2025- February 2026

SMCSWSW8-JHL-WEC-EM-REP-000001

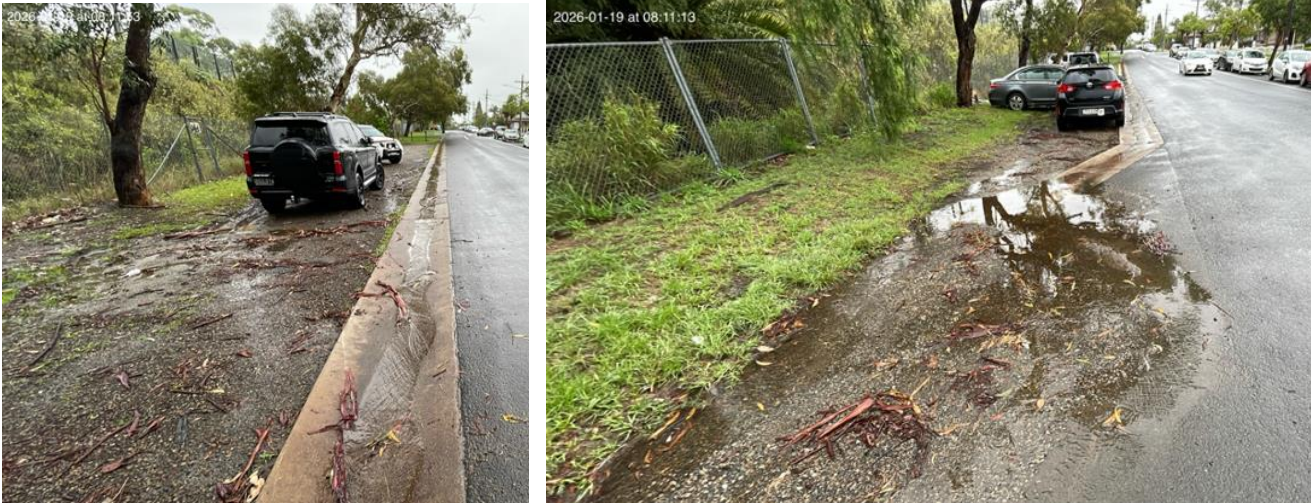
| Inspection Type: | JHLOR Construction Activities in area | Comments from Inspection of waterways | Photos | Additional Observations<br>Are there any impacts related to JHLOR construction works | Follow up action required | Outcome of follow up action |
|---|---|---|---|---|---|---|
| <p>Location 6</p> <p>Wiley Park, countryside.</p> | <p>No JHLOR excavation works on the UP &amp; DWN side of the tracks</p> <p>Contractor (not JHGLOR) is using the WP3 access as laydown of plant, equipment &amp; Engineering fill (DGB).</p> | <p><b>Water clarity and colour:</b> See detail below photos</p> <ul style="list-style-type: none"><li><b>Downstream (UP side):</b><br/>See notes in photo section.</li><li><b>Upstream (DWN side):</b><br/>See notes in photo section.</li></ul> <p><b>Odour:</b> Nil</p> <p><b>Description of flow and quantity/ Visible runoff (into the water body):</b><br/>See notes in photo section.</p> <p><b>Oil and Grease:</b> Nil</p> <p><b>Details of any foreign objects within the water:</b> Nil.</p> <p><b>Other comments/description:</b> Nil</p> | <p><b>UPSIDE OF CORRIDOR<br/>UPSTREAM AREA</b></p> <p>On inside of corridor - Area upstream of open Culverts at Gate WP3 () is well stabilised.<br/>On outside of corridor - Med flow of water in concrete channel (due to earlier down por) down to western most culvert. Water looks clear.</p> | | | |

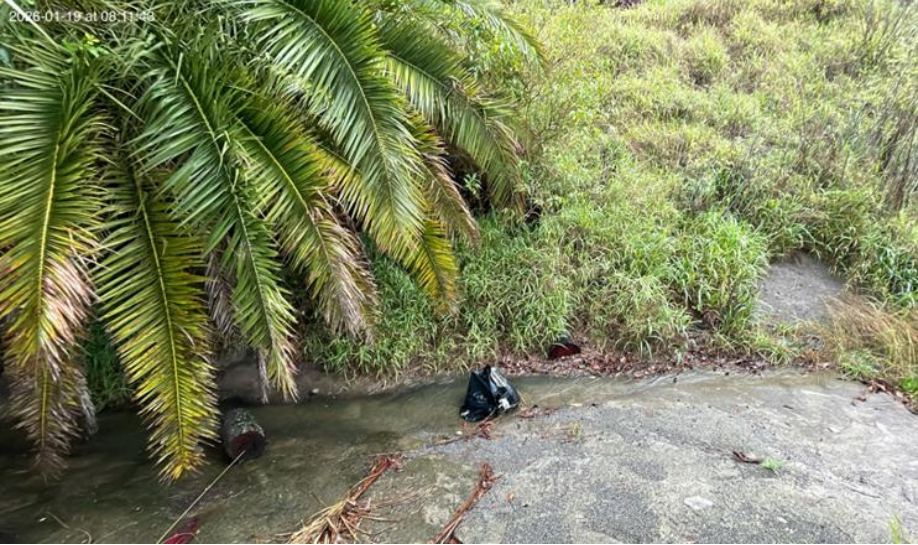
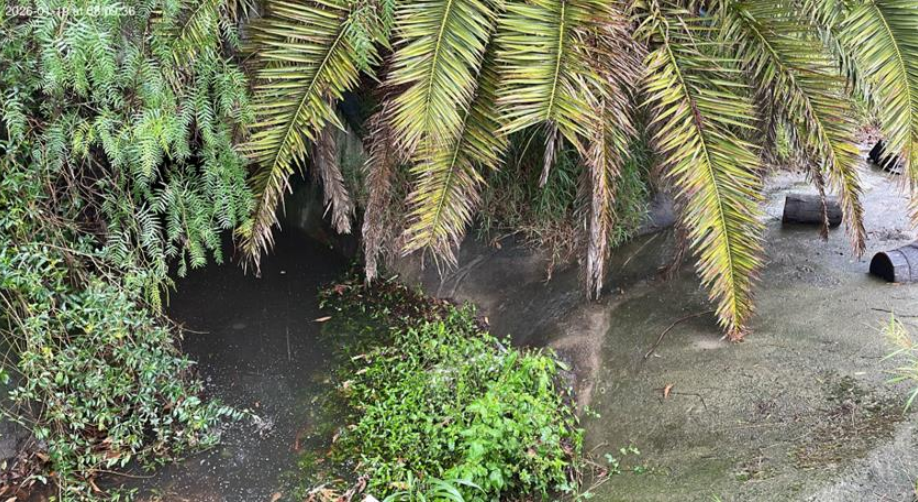
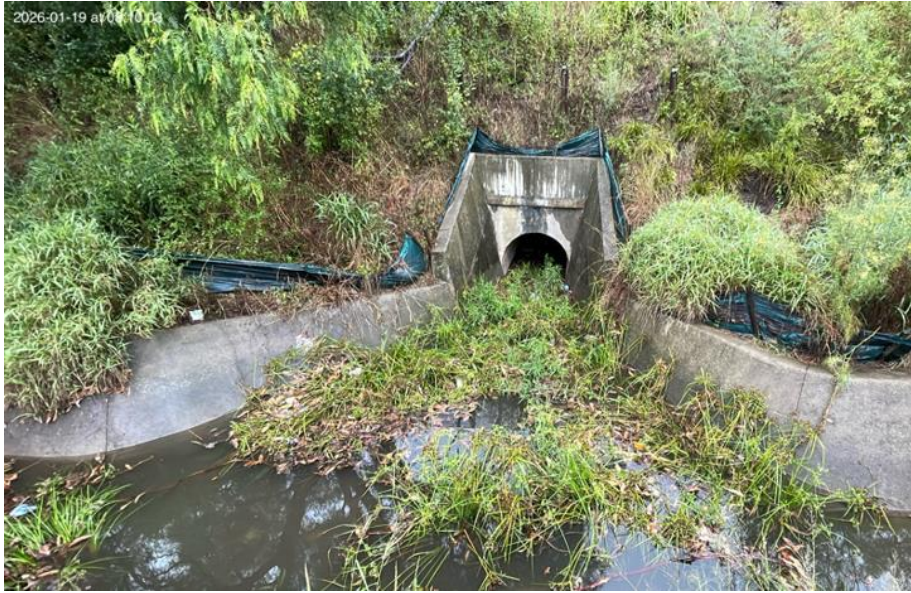
| Inspection Type: | JHLOR Construction Activities in area | Comments from Inspection of waterways | Photos | Additional Observations<br>Are there any impacts related to JHLOR construction works | Follow up action required | Outcome of follow up action |
|---|---|---|---|---|---|---|
| | | | <div><p><b>Western most culvert</b></p><p>Water at high level, looks like standing water without flow. Clean water through main culvert with clean water flow from inlet on RHS.</p><p><b>Middle culvert:</b></p><p>Water at high level, looks like standing water without flow. Clear water in middle culvert.</p></div> | | | |

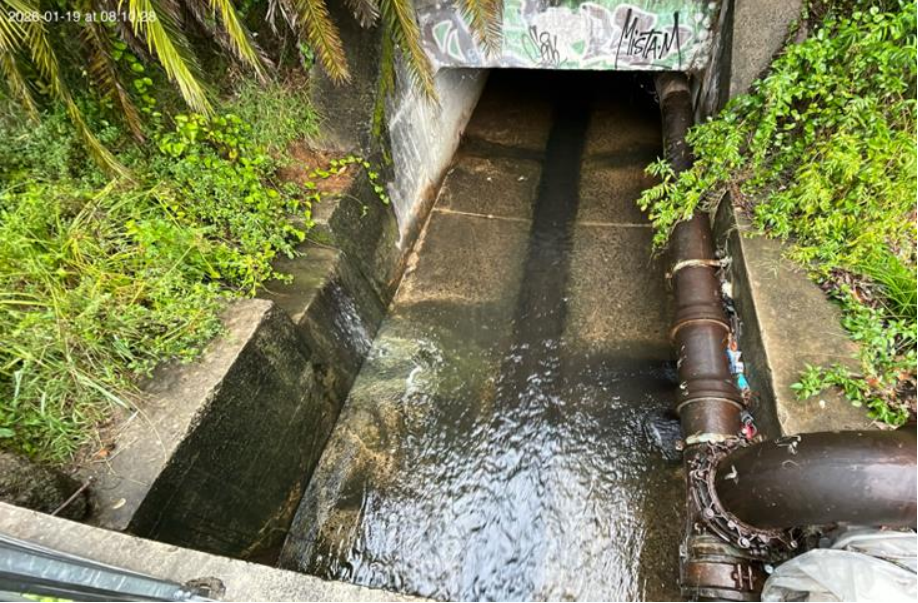
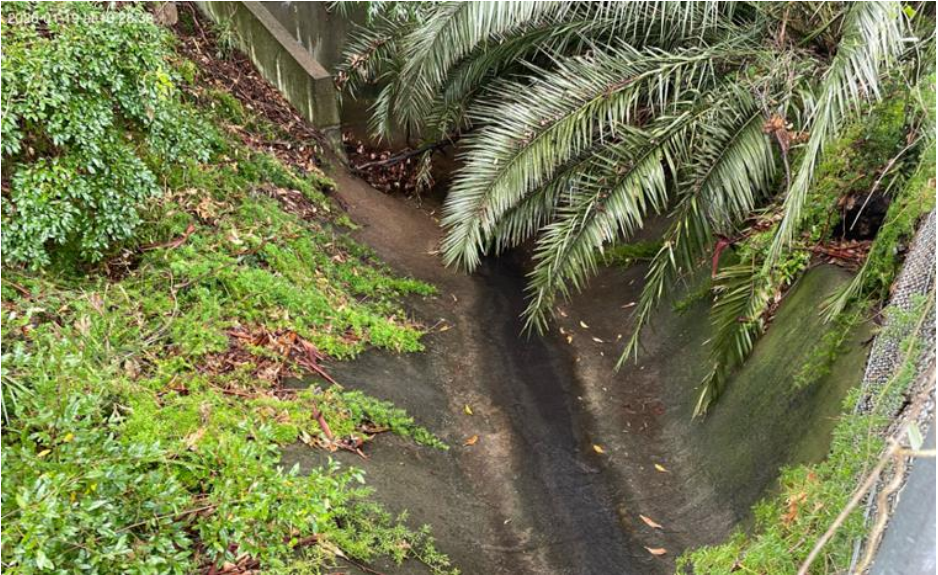
| Inspection Type: | JHLOR Construction Activities in area | Comments from Inspection of waterways | Photos | Additional Observations<br>Are there any impacts related to JHLOR construction works | Follow up action required | Outcome of follow up action |
|---|---|---|---|---|---|---|
| | | | <div><p><b>Eastern most culvert</b></p><p>Med flow, clear water through main culvert. No oil &amp; grease. No odour. Photos show culvert on corridor side of Urunga Pde.</p><p><b>DOWNSIDE OF CORRIDOR</b></p><p><b>Western most culvert</b> – low flow. Clear water through main culvert.</p></div> | | | |

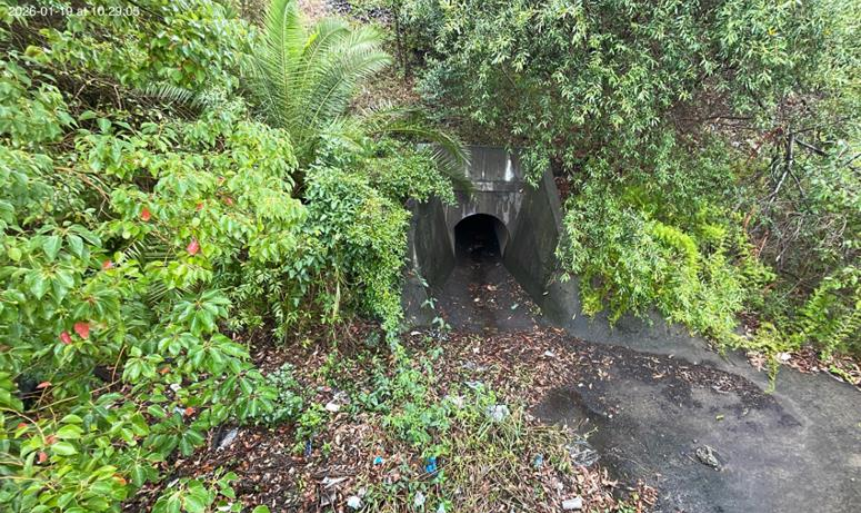
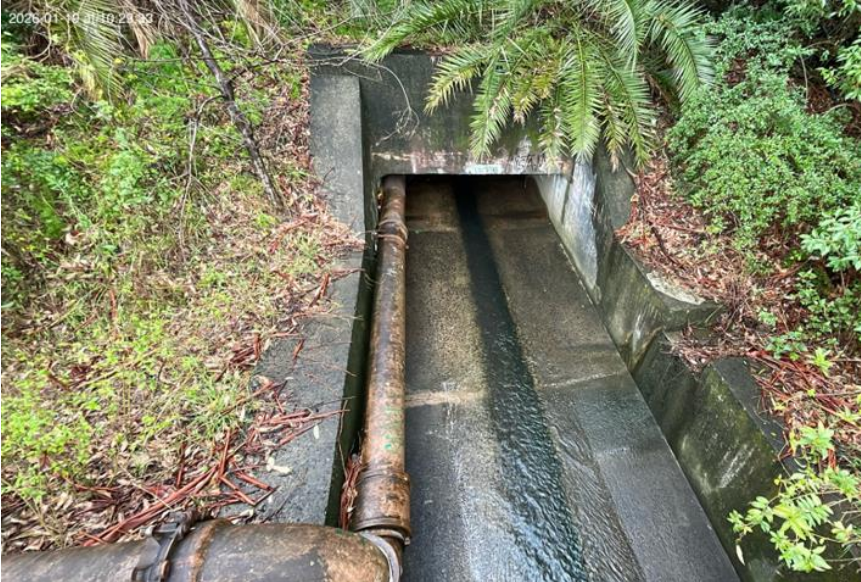
| Inspection Type: | JHLOR Construction Activities in area | Comments from Inspection of waterways | Photos | Additional Observations<br>Are there any impacts related to JHLOR construction works | Follow up action required | Outcome of follow up action |
|---|---|---|---|---|---|---|
| | | | <div><p><b>Middle culvert</b> – None to very little, clear water draining off batters. Leaf litter on surface.</p><p><b>Eastern most Culvert</b> – med flow, clear water through main culvert.</p></div> | | | |

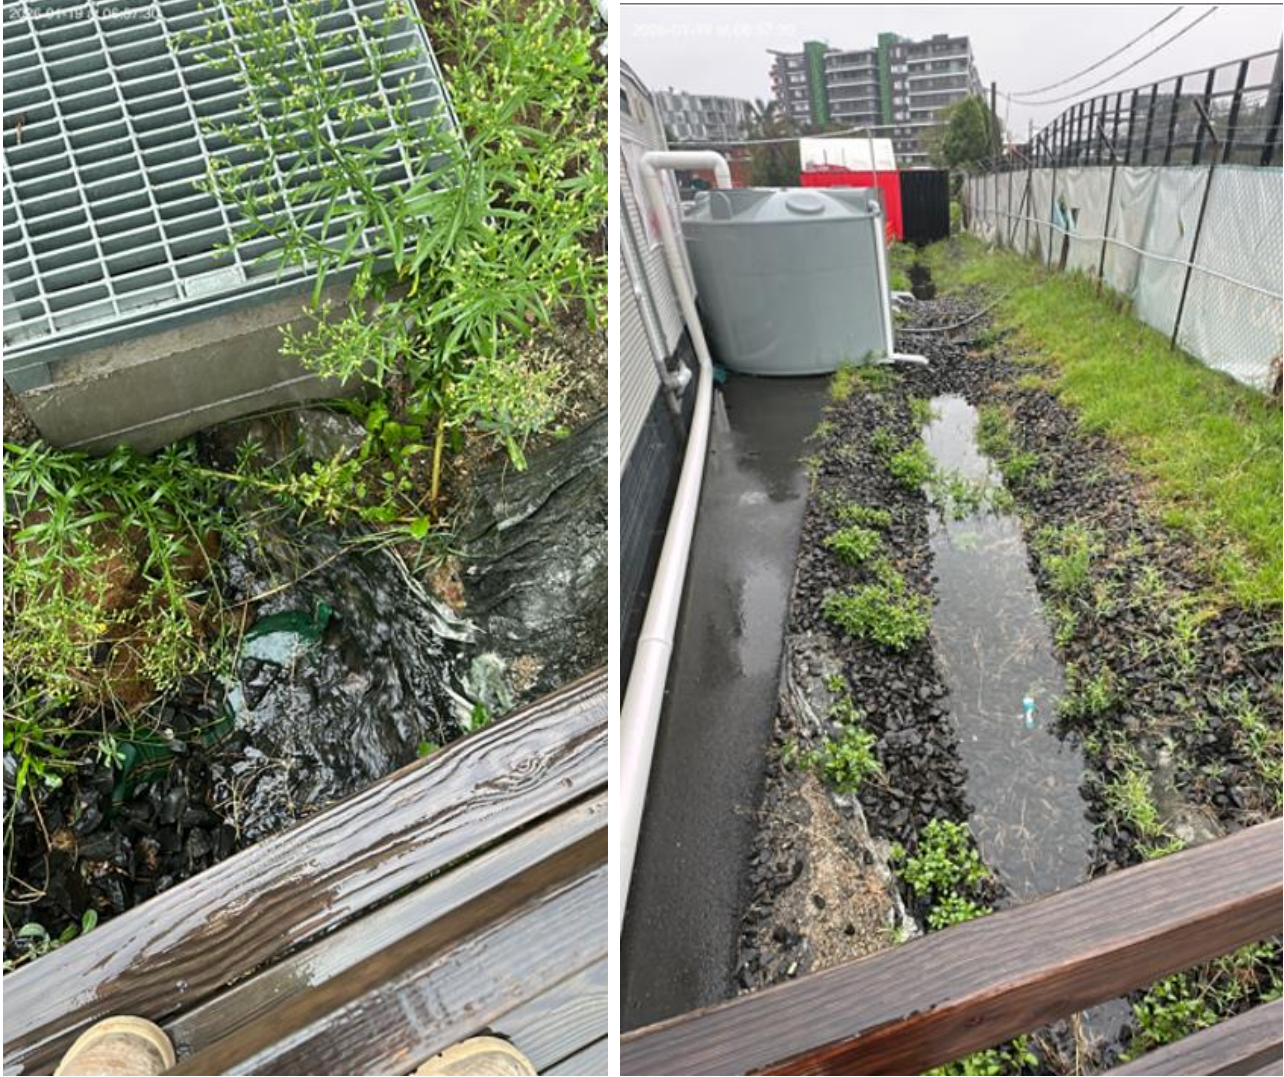
| Inspection Type: | JHLOR Construction Activities in area | Comments from Inspection of waterways | Photos | Additional Observations<br>Are there any impacts related to JHLOR construction works | Follow up action required | Outcome of follow up action |
|---|---|---|---|---|---|---|
| Location 8<br>Canterbury Compound | No JHLOR construction/excavation activities along the corridor near this location | <b>Water clarity and colour of water in main culvert (flowing Under Corridor).</b> Med flow, clear water at downstream exit<br><br>NOTE: There is clear water flow from compound hard stand/asphalt carpark into ballast drain at pit.<br><br><b>Odour:</b> Nil<br><br><b>Description of flow and quantity/ Visible runoff (into the water body):</b><br>Med, clear flow of water in open channel<br><br><b>Oil and Grease:</b> Nil<br><br><b>Details of any foreign objects within the water:</b> Nil<br><br><b>Other comments/description:</b><br>Nil | <div>Inside Canterbury Compound – Water flow</div> <div></div> <div>Med, clear water flow through ballast channel. No odour and no oil &amp; grease. Water is clear going into pit</div> <div>Outside Canterbury Compound – Water Flow</div> <div>Eastern Channel. Outside Canterbury Compound boundary alongside pedestrian footpath:</div> | No excavation activities along the corridor near this location | | |

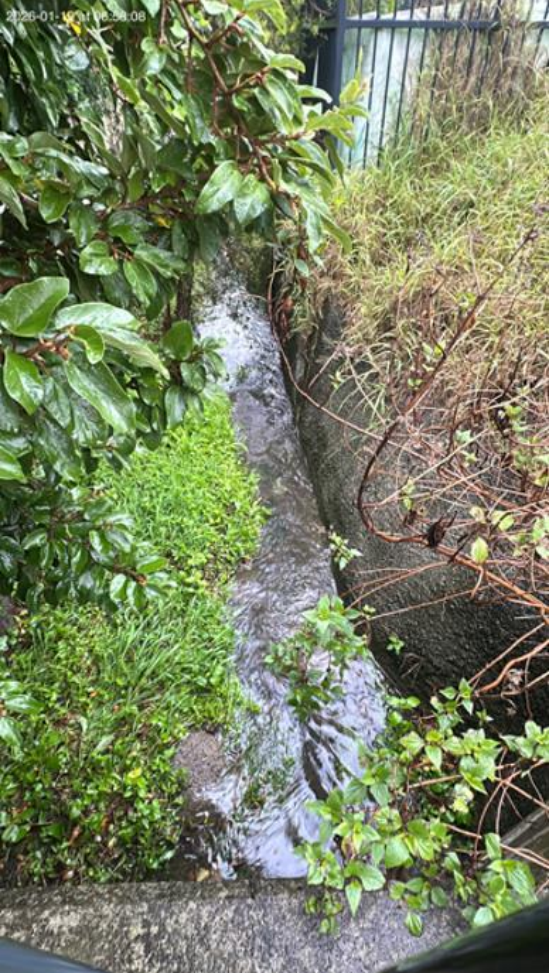
| Inspection Type: | JHLOR Construction Activities in area | Comments from Inspection of waterways | Photos | Additional Observations<br>Are there any impacts related to JHLOR construction works | Follow up action required | Outcome of follow up action |
|---|---|---|---|---|---|---|
| | | | <div><p><u>Upstream from JHLOR discharge point.</u><br/>Med, clear water flow in channel.</p></div> | | | |

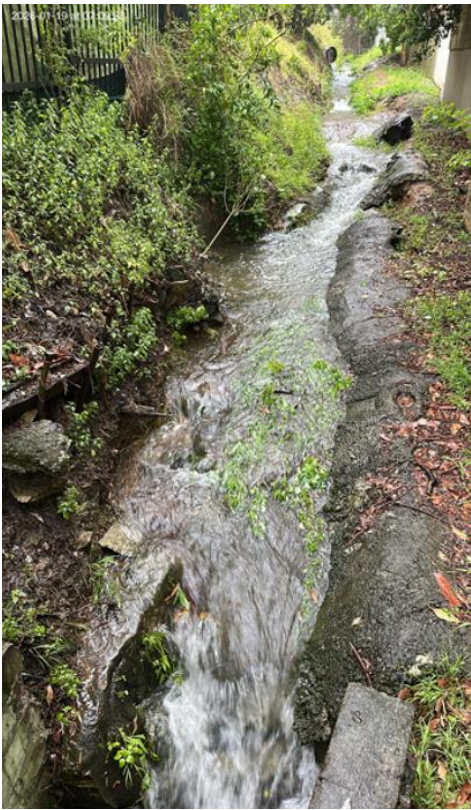
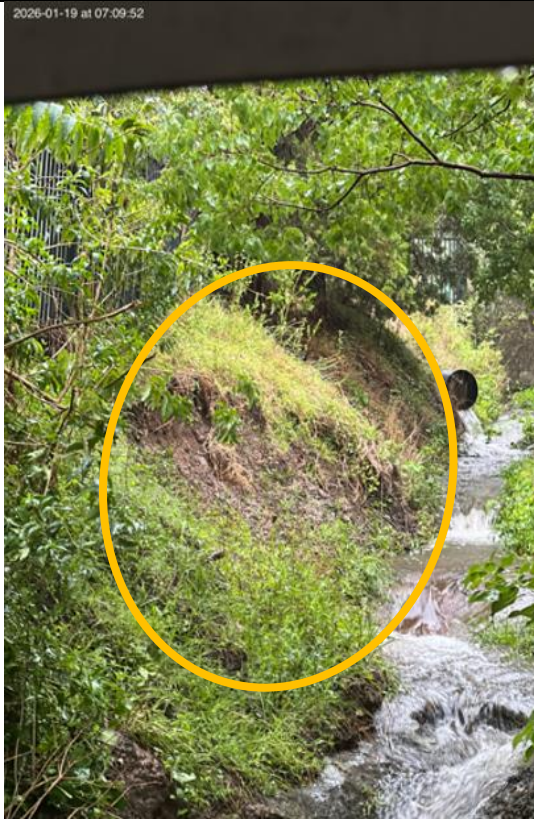
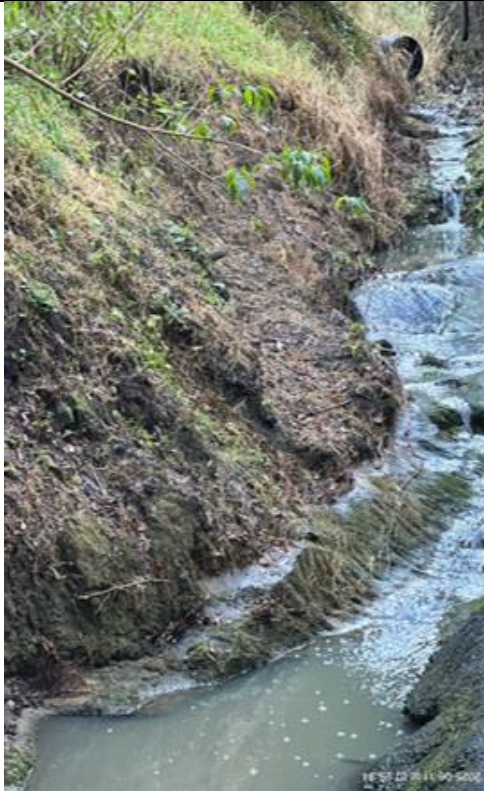
| Inspection Type: | JHLOR Construction Activities in area | Comments from Inspection of waterways | Photos | Additional Observations<br>Are there any impacts related to JHLOR construction works | Follow up action required | Outcome of follow up action |
|---|---|---|---|---|---|---|
| | | | <div></div> <p><u>Downstream from JHLOR discharge point:</u><br/>Downstream water observed to be clear – looks like no additional scour/collapse on downstream batter slope</p> | <div></div> <p>This photo shows previous status of downstream batter slope during event dated 11/8/25. Batter showed signs of slip.</p> | | |

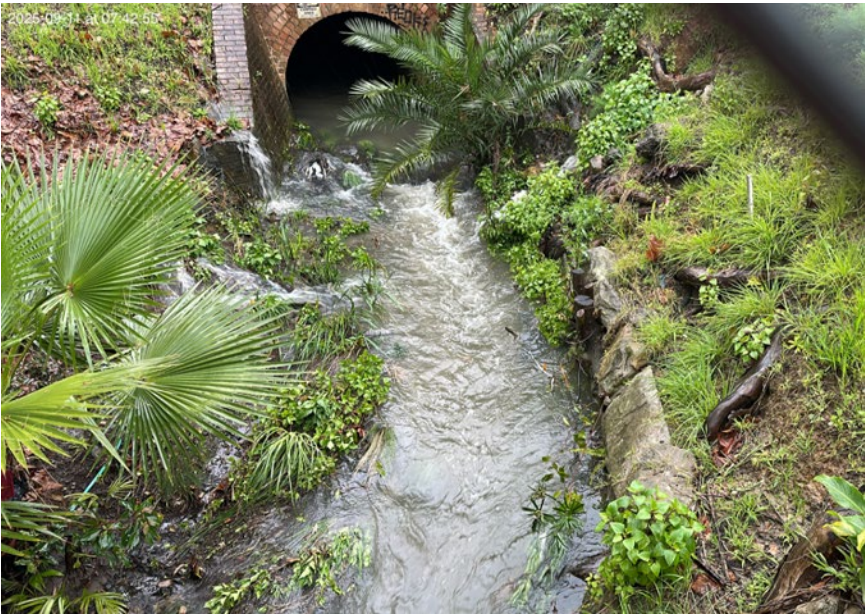
| Inspection Type: | JHLOR Construction Activities in area | Comments from Inspection of waterways | Photos | Additional Observations<br>Are there any impacts related to JHLOR construction works | Follow up action required | Outcome of follow up action |
|---|---|---|---|---|---|---|
| <div>Location 1</div> <div>Dulwich Hill MSB (Ewart Culvert), country side of commuter car park</div> | <div>No work in this area in +- last 3 weeks</div> <div>Surfaces alongside this culvert on the:</div> <ul style="list-style-type: none"><li>west side around the culvert is stabilised – vegetation and heavy leaf litter.</li><li>East side (alongside MSB) stabilised with vegetation and geofab cover</li></ul> | <div><b>Water clarity and colour:</b></div> <div>High flow water in main culvert looks slightly turbid.</div> <div>Side inlet on LHS: Unknown upstream source. Unable to determine if turbid as too much white water. No cloud plume in main culvert from inlet</div> <div>Side inlet on RHS: Unable to determine if turbid as too much white water. No cloud plume in main culvert from inlet on RHS.</div> <div><b>Odour:</b> Nil</div> | | | | |

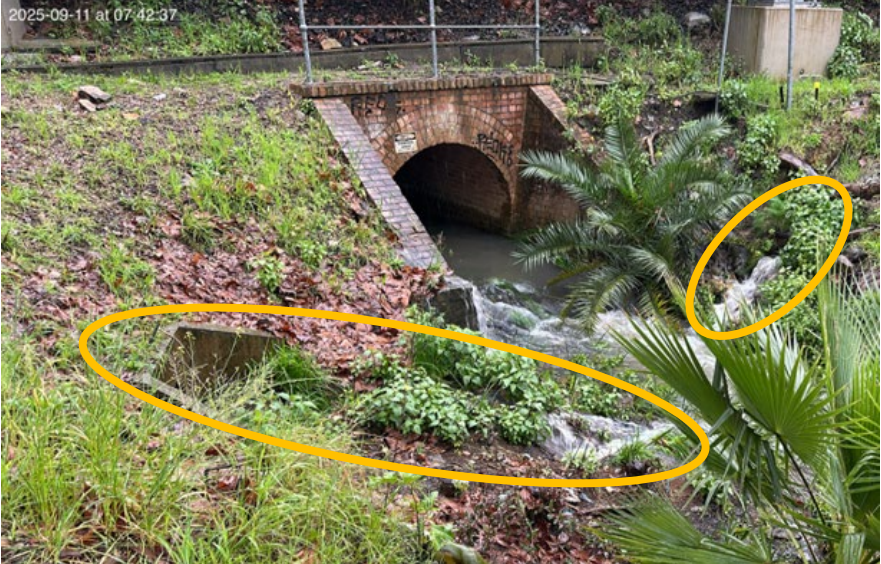
| Inspection Type: | JHLOR Construction Activities in area | Comments from Inspection of waterways | Photos | Additional Observations<br>Are there any impacts related to JHLOR construction works | Follow up action required | Outcome of follow up action |
|---|---|---|---|---|---|---|
| | | <p><b>Description of flow and quantity/ Visible runoff (into the water body):</b><br/>Currently high flow of water with signs of damage to vegetation.</p> <p><b>Oil and Grease:</b> Nil</p> <p><b>Details of any foreign objects within the water:</b> Nil</p> <p><b>Other comments/description:</b><br/>N/A</p> | <div></div> <p><b>LHS Inlet (Concrete Headwall)</b><br/>Unknown upstream source. Unable to determine if turbid as too much white water. No cloud plume in main culvert from inlet</p> <p><b>RHS Inlet (Black pipe)</b><br/>Unable to determine if turbid as too much white water. No cloud plume in main culvert from inlet on RHS.</p> | | | |

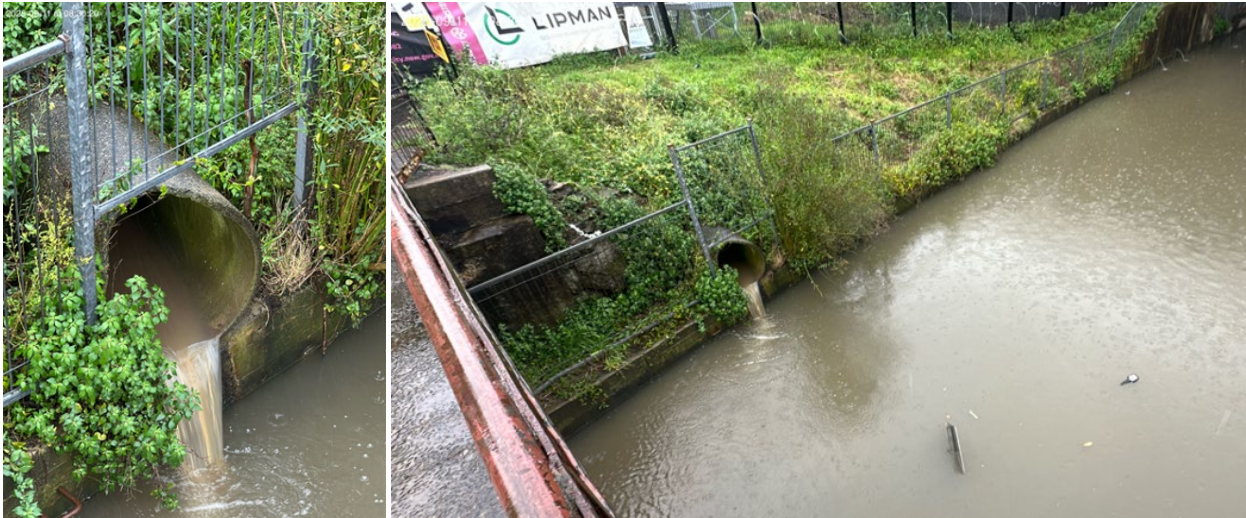
| Inspection Type: | JHLOR Construction Activities in area | Comments from Inspection of waterways | Photos | Additional Observations<br>Are there any impacts related to JHLOR construction works | Follow up action required | Outcome of follow up action |
|---|---|---|---|---|---|---|
| <p><b>Location 3</b></p> <p>West bank of Cook's River</p> | <p>No JHLOR construction/excavation activities along the corridor near this location or any work back to Campsie station. Corridor area is vegetated/stabilized all the way up to Campsie other than alongside the concrete crash barrier (Martinus).</p> <p>Upstream photos taken at Wairoa, CB6 and location near Gould St (ST old work behind concrete barrier)</p> | <p><b>Water clarity and colour:</b> Slightly turbid water at outlet of SW pipe. Water in pond and river is dirty.</p> <p><b>Odour:</b> Nil</p> <p><b>Description of flow and quantity/ Visible runoff (into the water body):</b><br/>Low flow</p> <p><b>Oil and Grease:</b> Nil</p> <p><b>Details of any foreign objects within the water:</b> N/A</p> | <div></div> <p><b>SW outlet at River</b></p> | Cooks River – tide is in. | | |

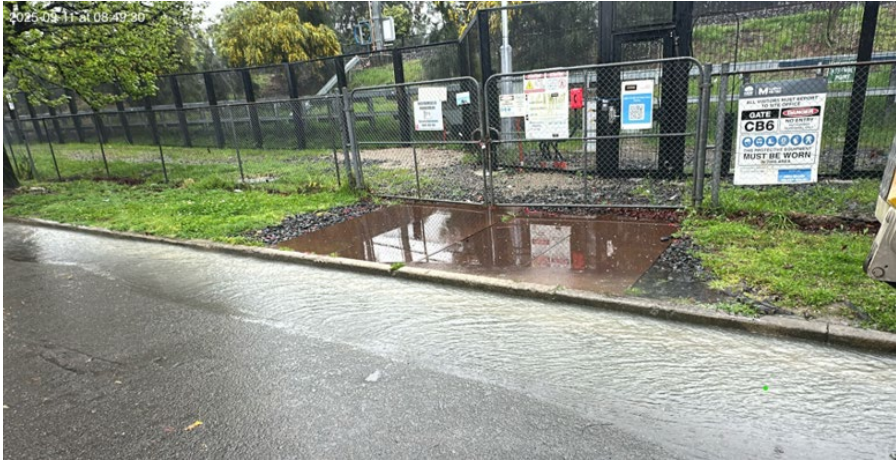
| Inspection Type: | JHLOR Construction Activities in area | Comments from Inspection of waterways | Photos | Additional Observations<br>Are there any impacts related to JHLOR construction works | Follow up action required | Outcome of follow up action |
|---|---|---|---|---|---|---|
| | | Other comments/description:<br>N/A | <div></div> <div></div> <div></div> <div>Upstream at Wairoa. No flow from acess gate CB6.</div> | | | |

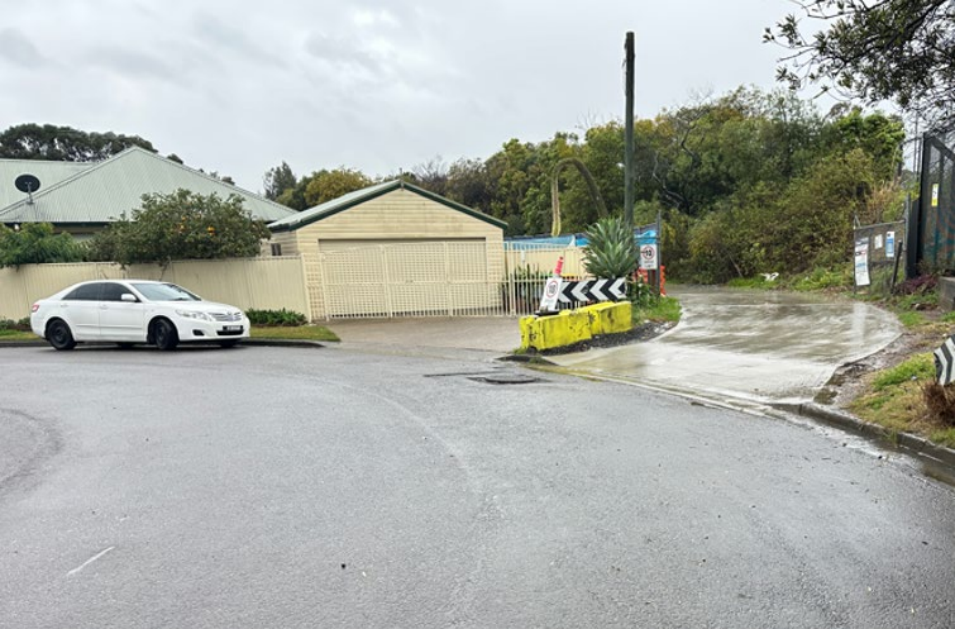
| Inspection Type: | JHLOR Construction Activities in area | Comments from Inspection of waterways | Photos | Additional Observations<br>Are there any impacts related to JHLOR construction works | Follow up action required | Outcome of follow up action |
|---|---|---|---|---|---|---|
| | | <b>Other comments/description:</b><br>N/A | <div></div> <div></div> <p><b>Redman Pde – Upstream Status &amp; Controls.</b> Lifted ERSED controls at drainage pit on Redman Pde. No access along Redman Pde for JHLOR trucks .... blocked by Council Work Site. Clear water flowing in kerb</p> | Top of batter at the spoil stockpiles is surrounded by double barrier and geofab curtain over barriers. | | |

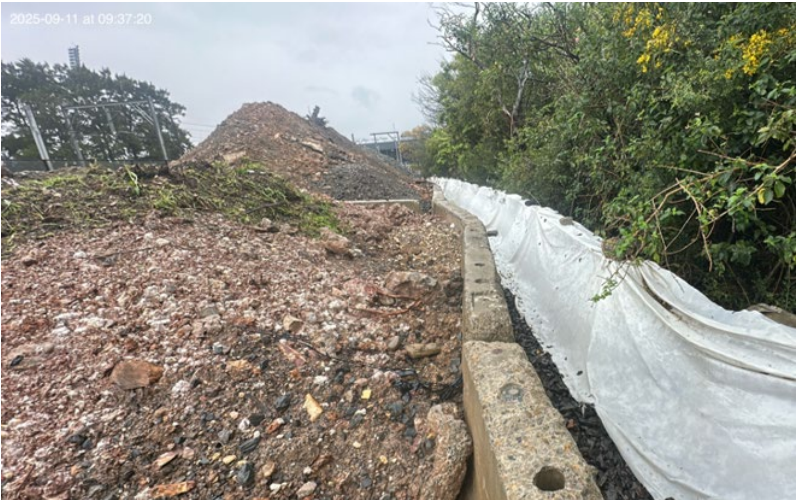
| Inspection Type: | JHLOR Construction Activities in area | Comments from Inspection of waterways | Photos | Additional Observations<br>Are there any impacts related to JHLOR construction works | Follow up action required | Outcome of follow up action |
|---|---|---|---|---|---|---|
| | | | <div><p><b>Toe of batter on side of ballast Access road</b> – Water ponds in this location (the signs of turbidity is from truck wheels).</p><p>NOTE: Dirty water does not drain to open culvert. Vegetated swale was checked alongside access – no signs of dirty water</p><div></div></div> | | | |

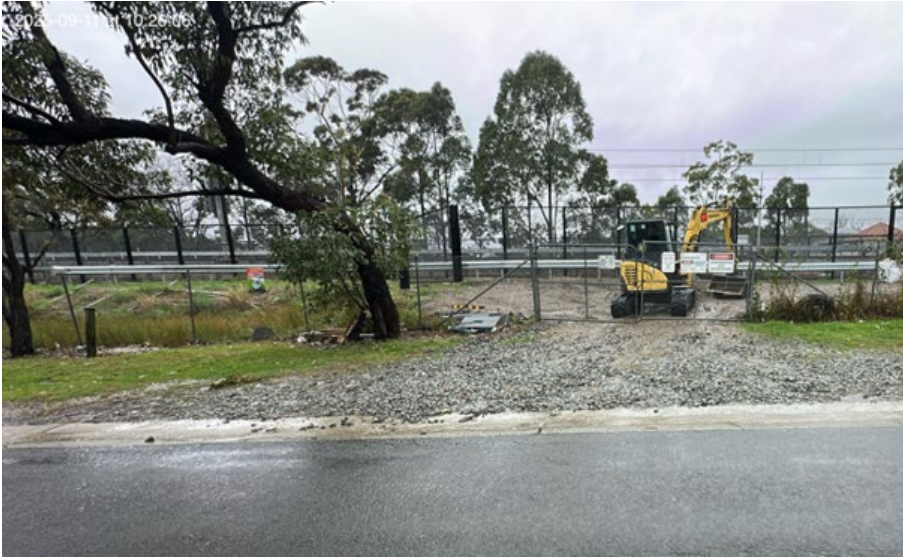
| Inspection Type: | JHLOR Construction Activities in area | Comments from Inspection of waterways | Photos | Additional Observations<br>Are there any impacts related to JHLOR construction works | Follow up action required | Outcome of follow up action |
|---|---|---|---|---|---|---|
| Location 6<br><br>Wiley Park, countryside. | <p>No JHLOR excavation works on the UP &amp; DWN side of the tracks</p> <p>Contractor (not JHGLOR) is using the WP3 access as laydown of plant, equipment &amp; Engineering fill (DGB).</p> | <p><b>Water clarity and colour:</b> Eastern culvert has slightly turbid water flowing.</p> <ul style="list-style-type: none"><li><b>Downstream (Nth side):</b><br/>See notes in photo section.</li><li><b>Upstream (Sth side):</b><br/>See notes in photo section.</li></ul> <p><b>Odour:</b> Nil</p> <p><b>Description of flow and quantity/ Visible runoff (into the water body):</b><br/>See notes in photo section.</p> <p><b>Oil and Grease:</b> Nil</p> <p><b>Details of any foreign objects within the water:</b> Nil.</p> <p><b>Other comments/description:</b><br/>Nil</p> | <p><b>NORTH SIDE OF CORRIDOR</b></p> <p>Area upstream of Culvert. Inside corridor and Gate WP3 is well stabilised – however contractor (not JHGLOR) is using this access as laydown of plant, equipment &amp; Engineering fill (DGB). Very low flow of water in concrete channel down to western culvert. Water looks clear.</p> | | | |

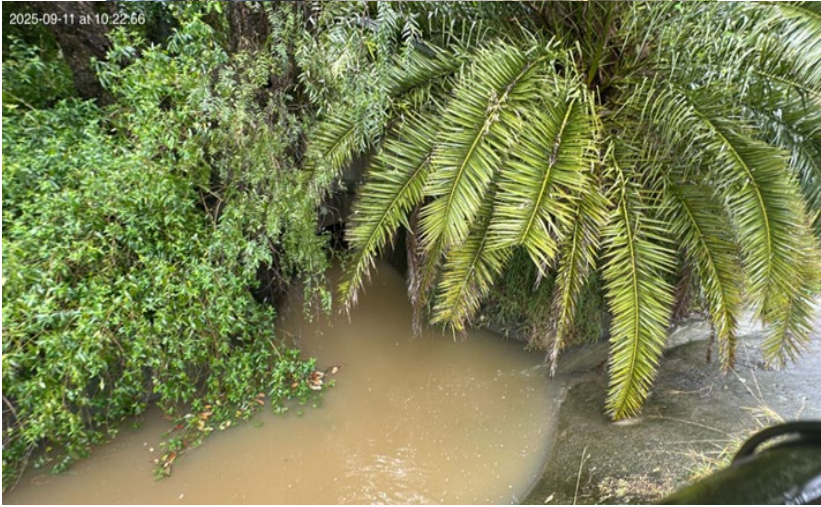
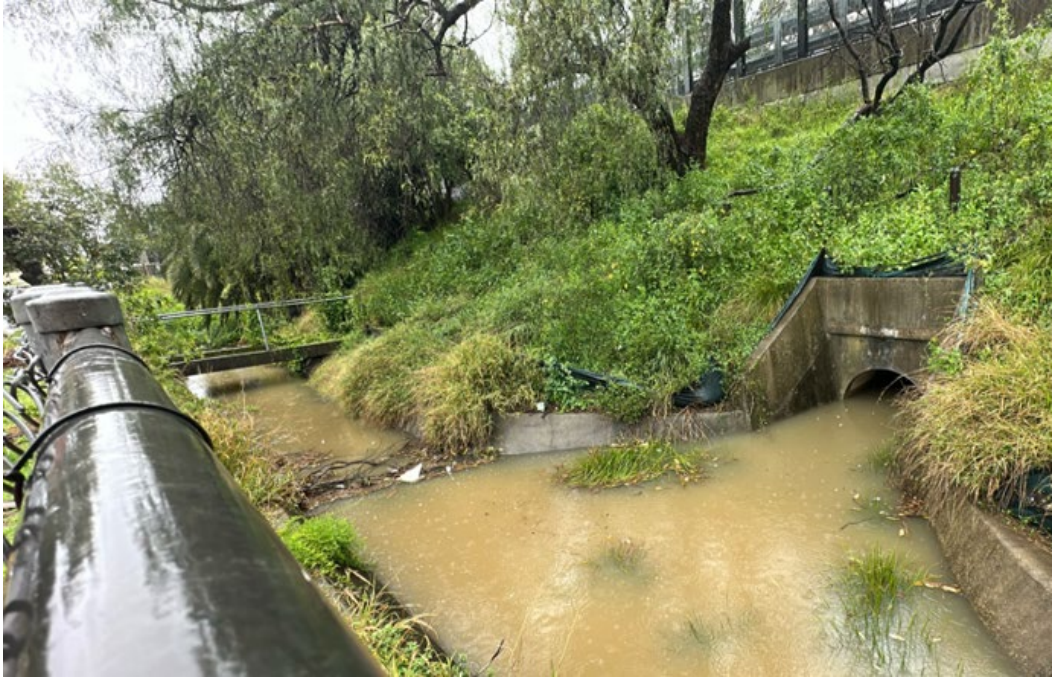
| Inspection Type: | JHLOR Construction Activities in area | Comments from Inspection of waterways | Photos | Additional Observations<br>Are there any impacts related to JHLOR construction works | Follow up action required | Outcome of follow up action |
|---|---|---|---|---|---|---|
| | | | <div><p><b>Western most culvert</b></p><p>High level, looks like standing water without flow. Turbid water through main culvert with very slightly turbid water flow from inlet on RHS.</p><p><b>Middle culvert:</b></p><p>High level, looks like standing water without flow. Turbid water through middle culvert</p></div> | | | |

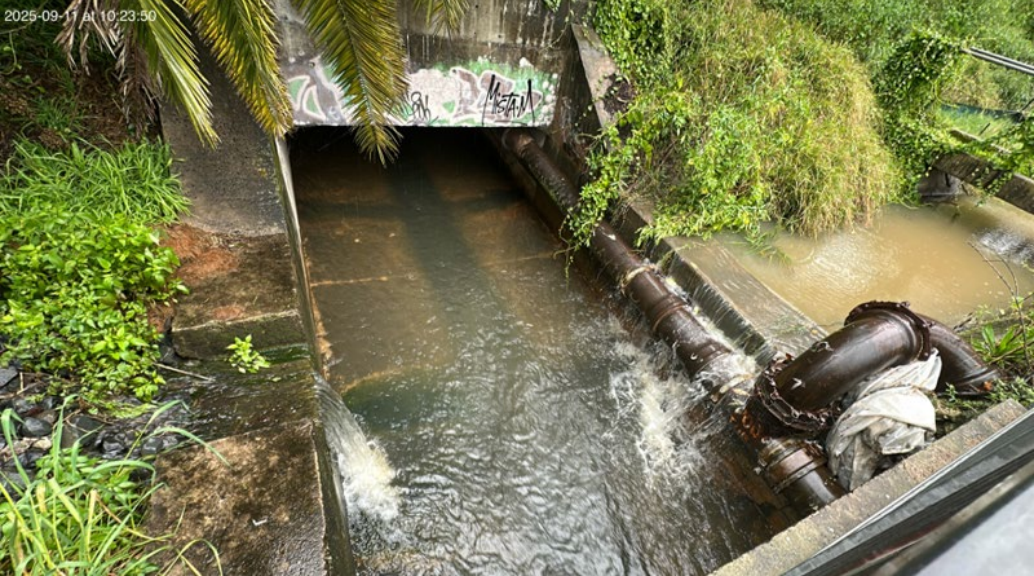
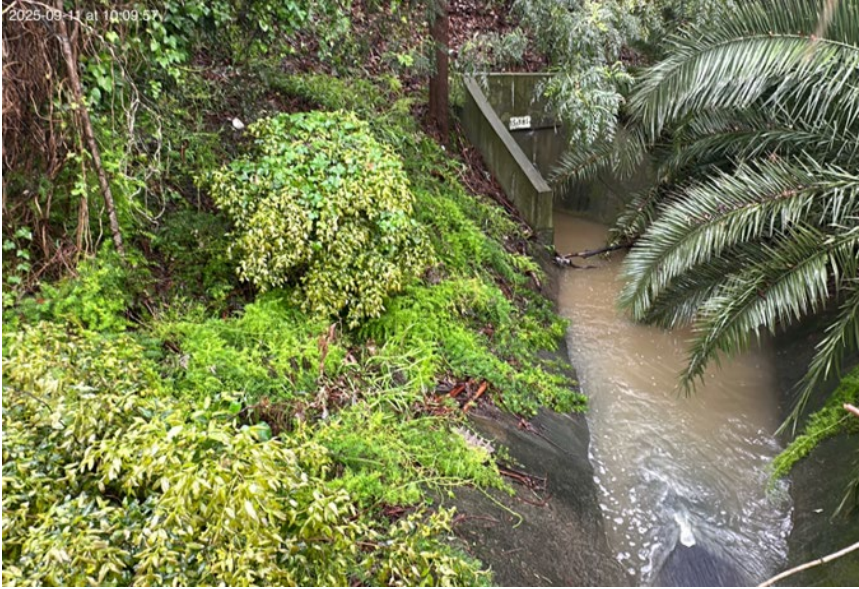
| Inspection Type: | JHLOR Construction Activities in area | Comments from Inspection of waterways | Photos | Additional Observations<br>Are there any impacts related to JHLOR construction works | Follow up action required | Outcome of follow up action |
|---|---|---|---|---|---|---|
| | | | <div><div><div>2025-09-11 at 10:23:50</div></div><div><div>Eastern most culvert</div><div>High flow, slightly turbid water through main culvert. No oil &amp; grease. No odour. Photos show culvert on corridor side of Urunga Pde.</div></div><div><div>SOUTH SIDE OF CORRIDOR</div><div><div>2025-09-11 at 10:09:57</div></div><div><div>Western most culvert</div><div>– High flow. Turbid water through main culvert.</div></div></div></div> | | | |

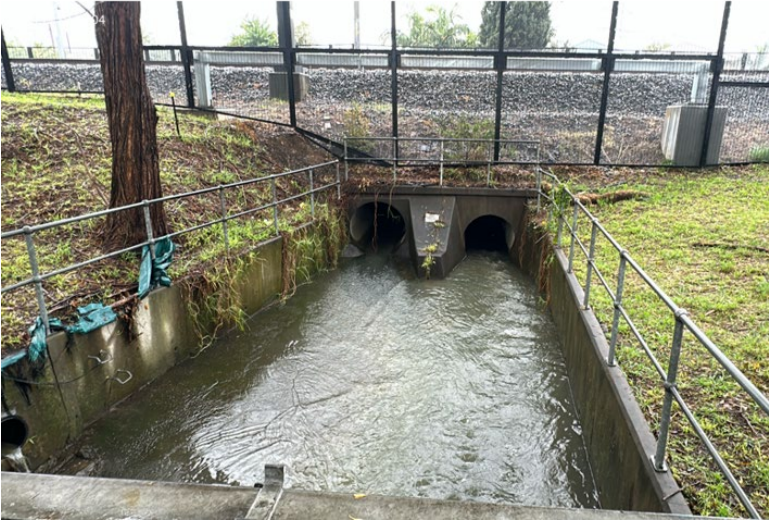
| Inspection Type: | JHLOR Construction Activities in area | Comments from Inspection of waterways | Photos | Additional Observations<br>Are there any impacts related to JHLOR construction works | Follow up action required | Outcome of follow up action |
|---|---|---|---|---|---|---|
| <b>Location 7ALT</b><br><br>City side of Bankstown DOWN track (near Stacey St) | <p>No JHLOR excavation activities have been carried out alongside the corridor near this location in the last couple of months.</p> <p>Area stable with heavy vegetation growth in corridor CESS and alongside culvert</p> | <p><b><u>Sth Side</u></b></p> <p><b>Water clarity and colour:</b> high flow, clear water</p> <p><b>Odour:</b> Nil</p> <p><b>Description of flow and quantity/ Visible runoff (into the water body):</b> see above.</p> <p><b>Oil and Grease:</b> Nil</p> <p><b>Details of any foreign objects within the water:</b> No debris in water</p> <p><b>Other comments/description</b><br/>Nil</p> | | | | |

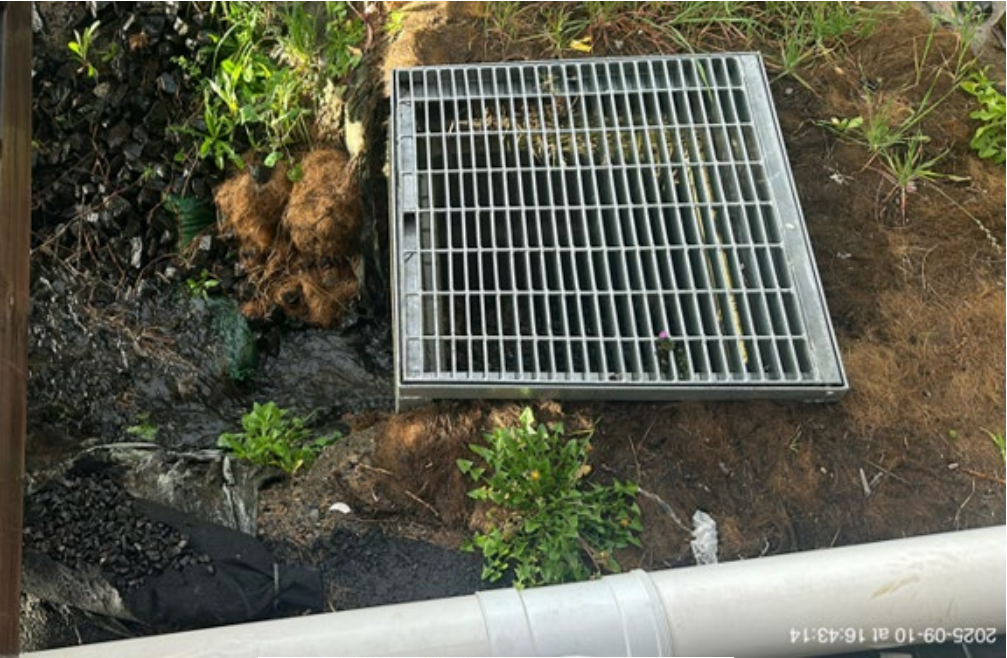
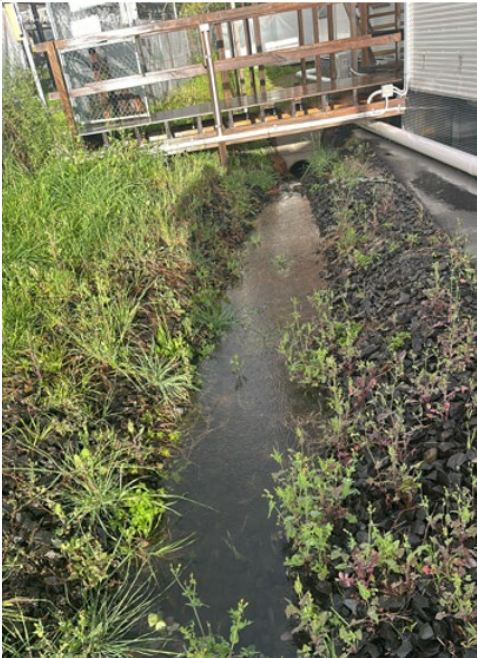
| Inspection Type: | JHLOR Construction Activities in area | Comments from Inspection of waterways | Photos | Additional Observations<br>Are there any impacts related to JHLOR construction works | Follow up action required | Outcome of follow up action |
|---|---|---|---|---|---|---|
| Location 8<br>Canterbury Compound | No JHLOR construction/excavation activities along the corridor near this location | <p><b>Water clarity and colour from Culvert Under Corridor.</b> High flow, slightly turbid water at downstream exit (potentially from batter scour).</p> <p>NOTE: There is clear water flow from compound hard stand/asphalt carpark into ballast drain at pit.</p> <p><b>Odour:</b> Nil</p> <p><b>Description of flow and quantity/ Visible runoff (into the water body):</b> turbid water, high flow of water in eastern channel</p> <p><b>Oil and Grease:</b> Nil</p> <p><b>Details of any foreign objects within the water:</b> Nil</p> <p><b>Other comments/description:</b> Nil</p> | <p>Inside Canterbury Compound</p> <p>Photos from rain period on 10/9/25 at +-16:45 (after 21.2mm)</p> <p>High water flow through ballast channel. No odour and no oil &amp; grease. Water is clear going into pit</p> <p>Outside Canterbury Compound</p> <p>Eastern Channel. Outside Canterbury Compound boundary alongside pedestrian footpath:</p> | No excavation activities along the corridor near this location | | |

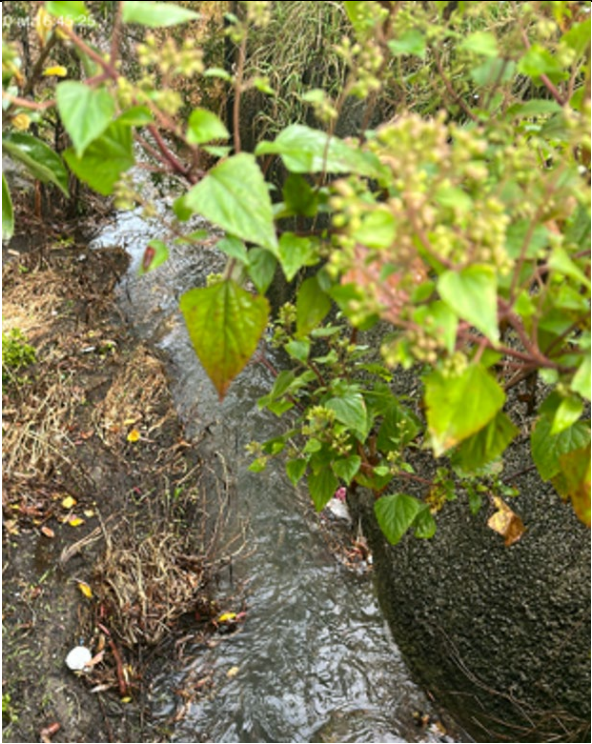
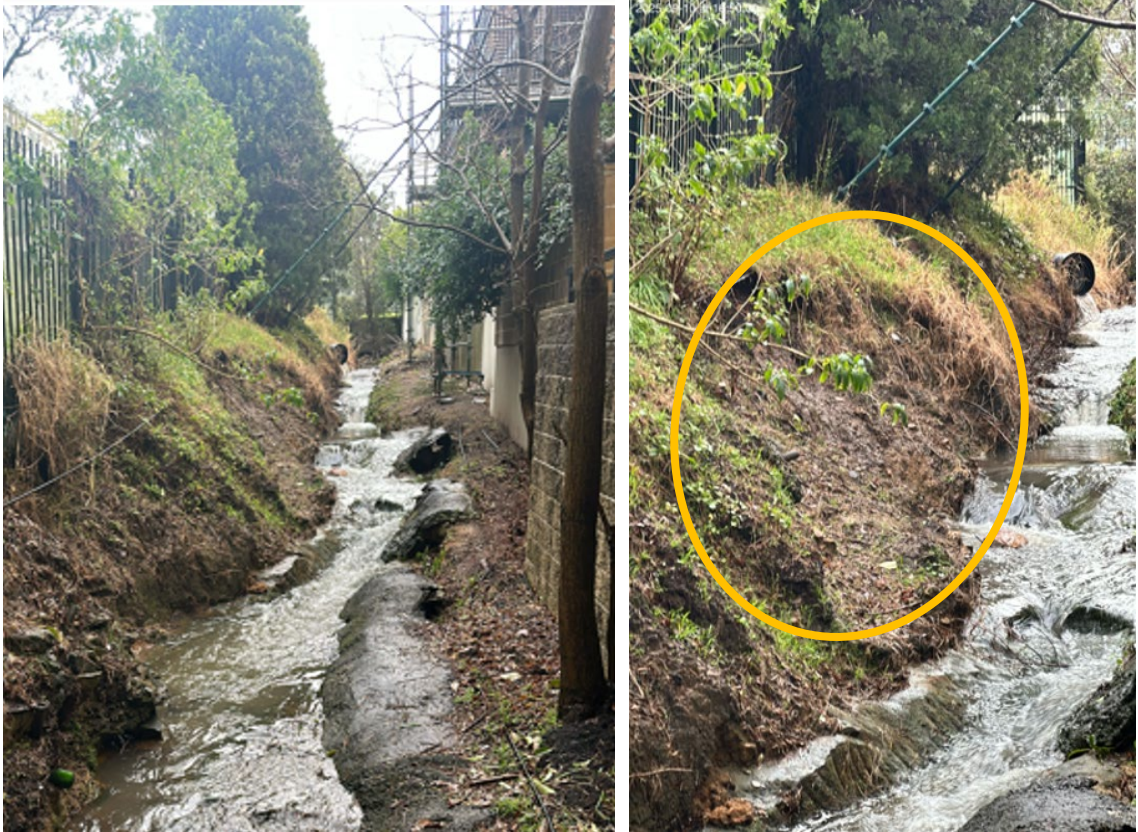
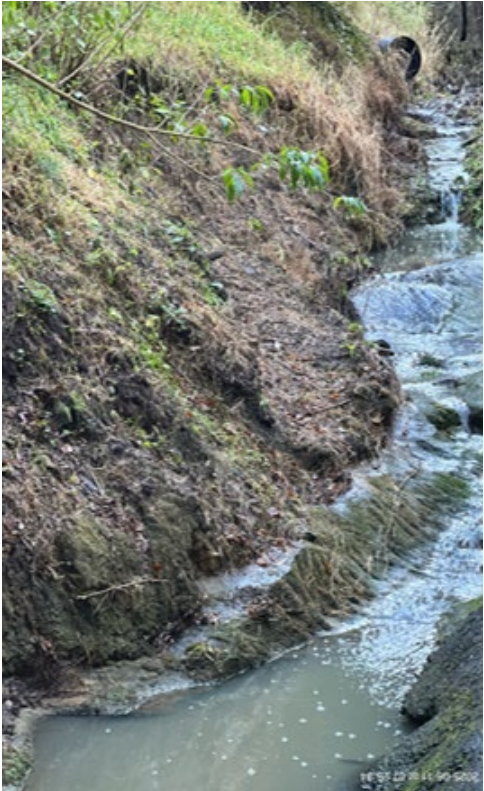
| Inspection Type: | JHLOR Construction Activities in area | Comments from Inspection of waterways | Photos | Additional Observations<br>Are there any impacts related to JHLOR construction works | Follow up action required | Outcome of follow up action |
|---|---|---|---|---|---|---|
| | | | <div><p><u>Upstream from JHLOR discharge point.</u><br/>High water flow in channel appears clear.</p></div> <div><p><u>Downstream from JHLOR discharge point:</u><br/>Downstream water observed to be very slightly turbid - potentially from scour on batter.</p></div> | <div><p>This photo shows previous status of downstream batter during event dated 11/8/25. Batter showed signs of slip.</p></div> | | |
