# CIDS & ODS Tree Impact Assessment Report

## SWM3- Tree and Vegetation Management Work Part 2 Instruction

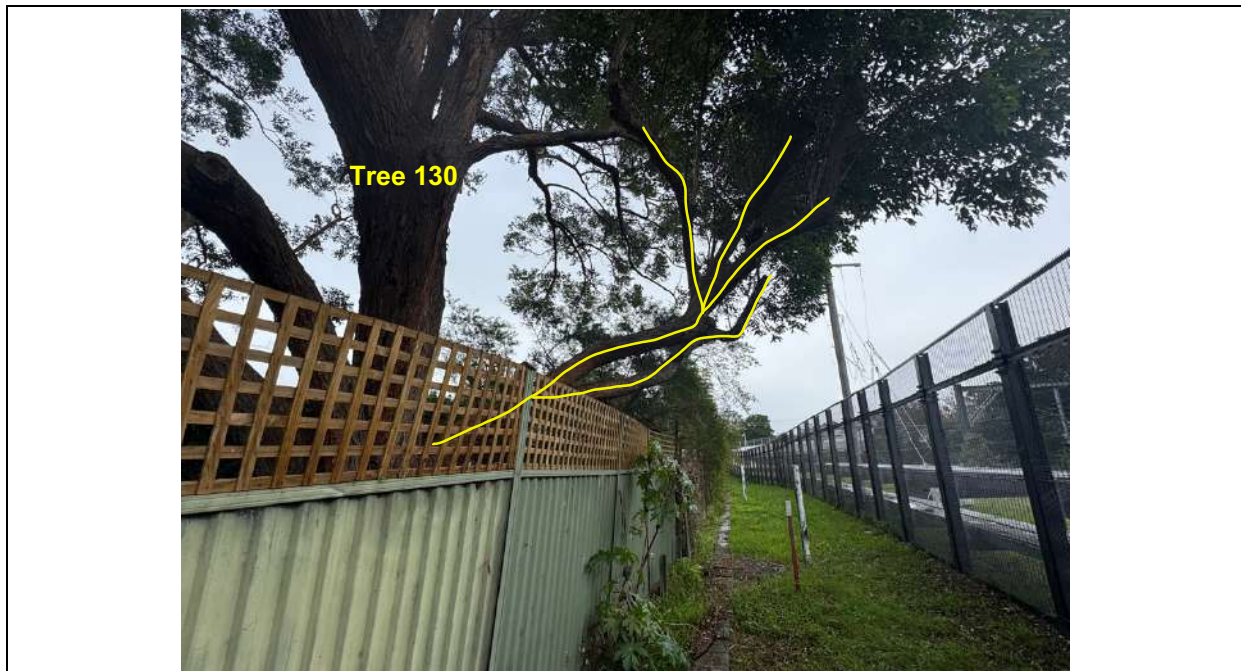
**Image 3:** Looking towards tree 130, showing the first order branch to the North recommended for pruning. The final pruning cut is estimated to be 230mm in diameter and at approximately 1.5m above ground level. Approximately 5% of the live foliage area will be removed.

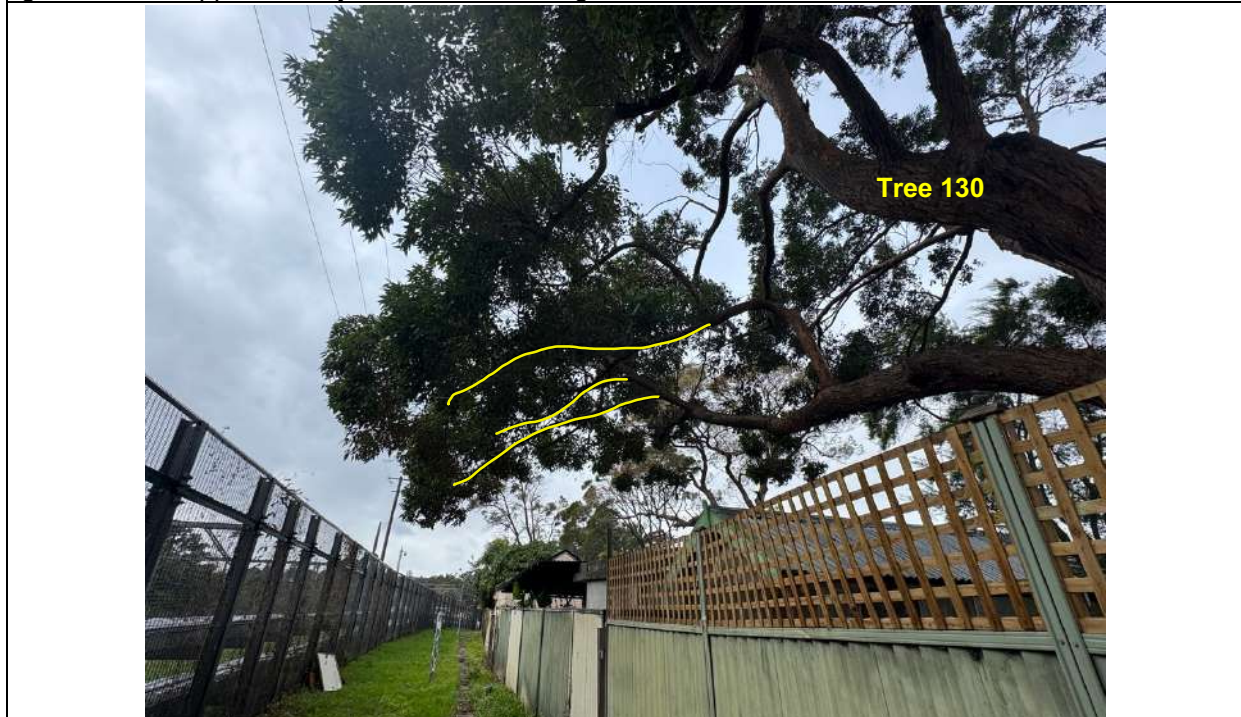
**Image 4:** Looking towards tree 130, showing the three third order branches to the East recommended for pruning. The final pruning cuts are estimated to be 50-70mm in diameter and at approximately 3m above ground level. Less than 5% of the live foliage area will be removed.

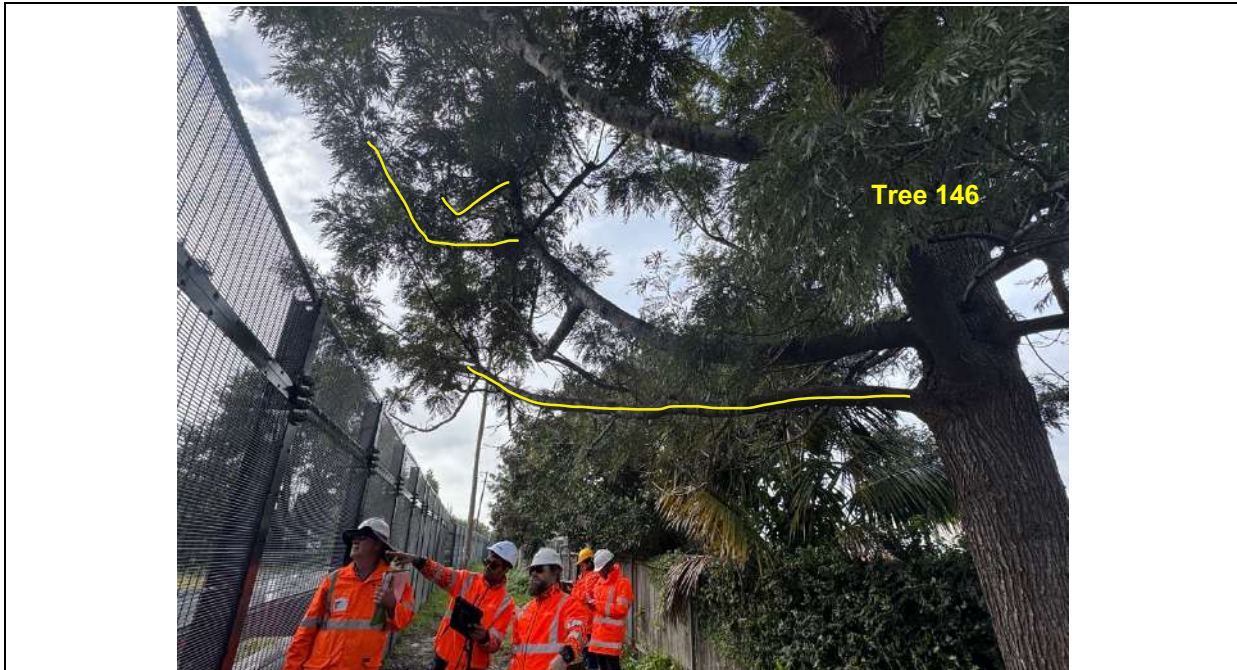
**Image 5:** Looking towards tree 146, showing the three branches to the Northeast, North and Northwest recommended for pruning. The final pruning cuts are estimated to be 130mm, 70mm and 40mm in diameter. Approximately 10% of the live foliage area will be removed.

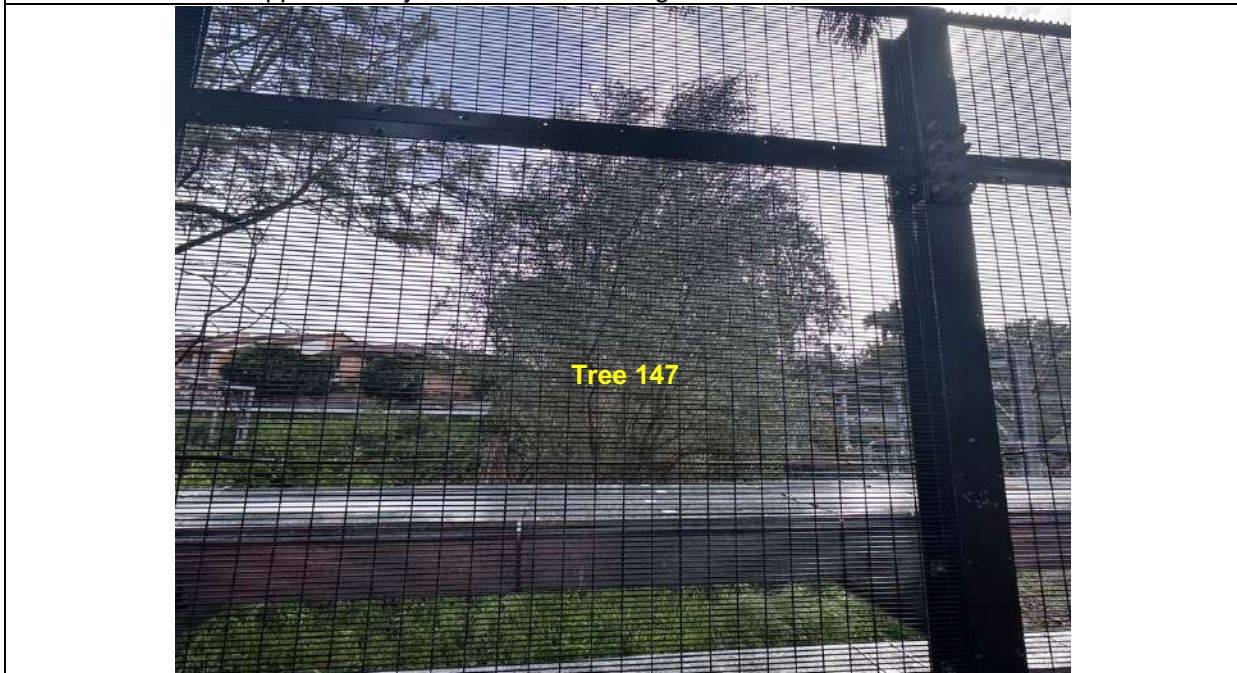
**Image 6:** Looking towards tree 147. The tree is recommended for removal.

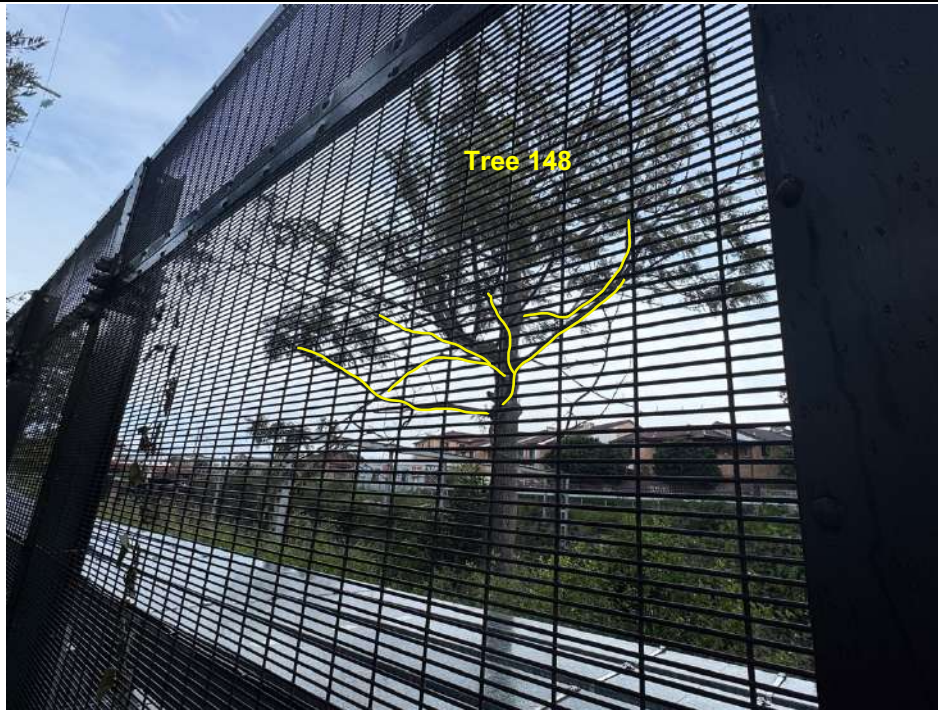
**Image 7:** Looking towards tree 148, showing the four first order branches to the South and Southeast recommended for pruning. The final pruning cuts are estimated to range from 100-130mm in diameter. Approximately 15% of the live foliage area will be removed.

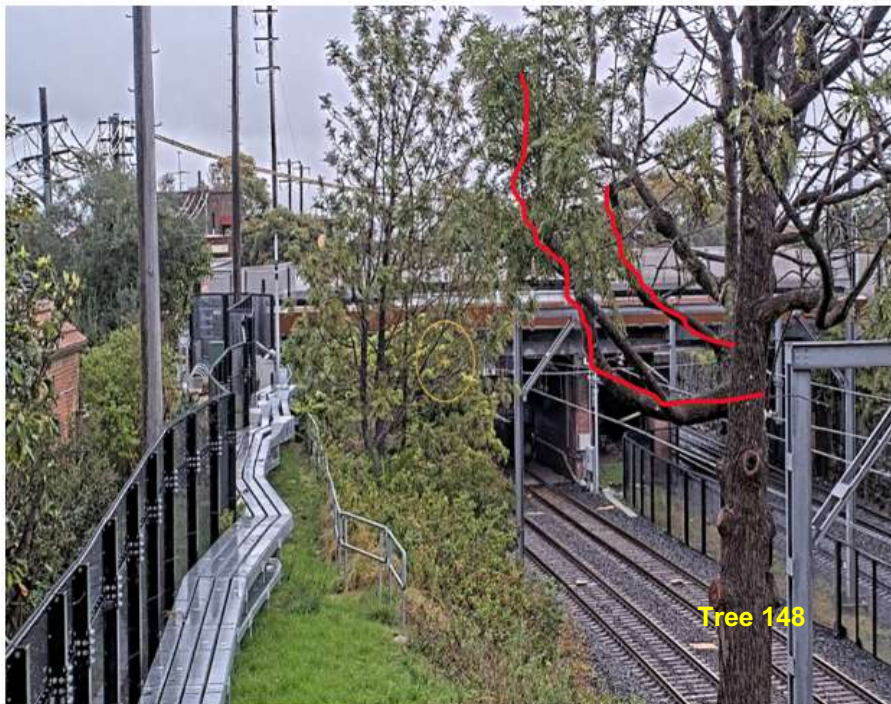
**Image 8:** Looking towards tree 148, showing two additional first order branches to the South to be removed. The final pruning cuts are estimated to range from 80-120mm in diameter. An additional 5% of the live foliage area will be removed. The branches to be removed have been marked red.

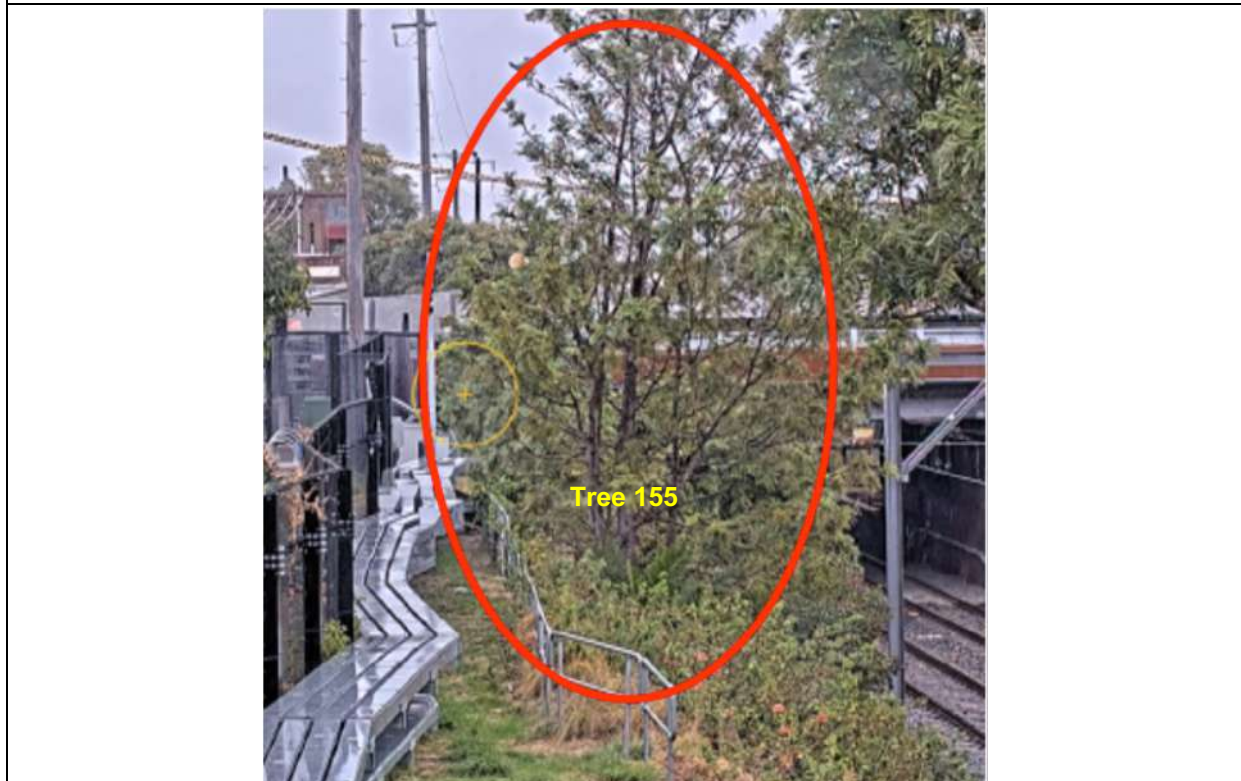
**Image 10:** Looking towards tree 155. The tree is recommended for removal.

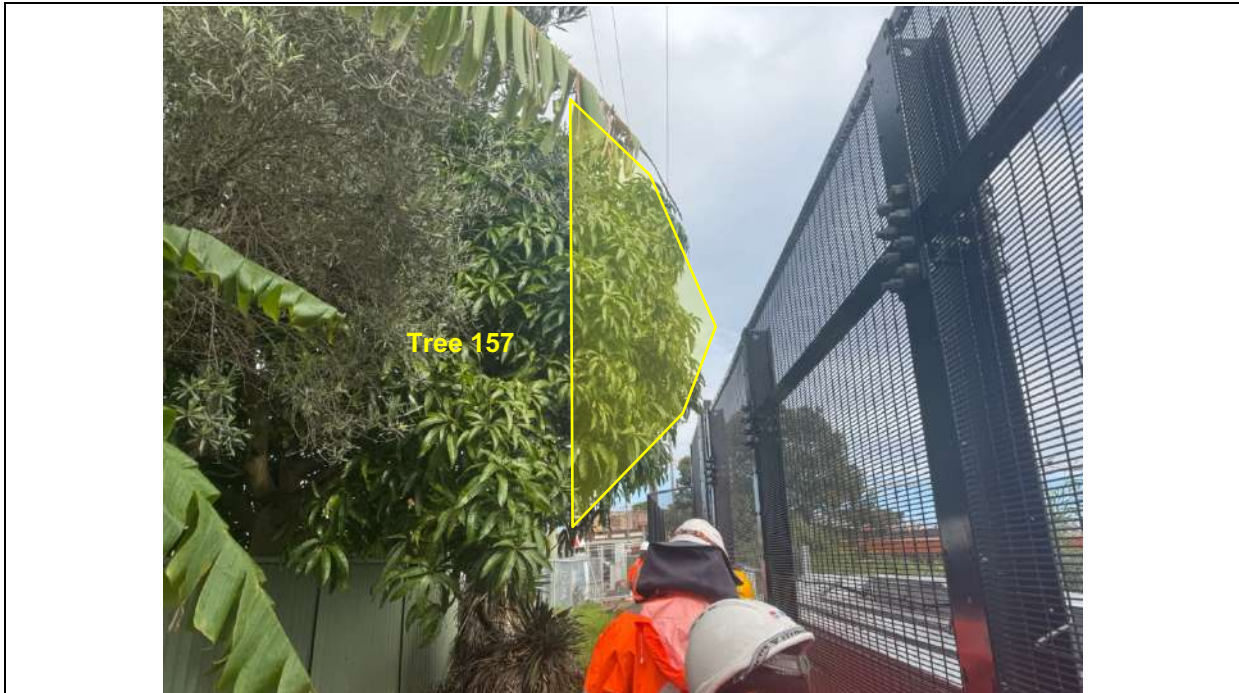
**Image 11:** Looking towards tree 157, showing the area of foliage requiring pruning. Pruning of branches up to 50mm in diameter is to provide a minimum of 2 meter clearance to all areas of the fence. Approximately 10% of the live foliage area will be removed from the tree.

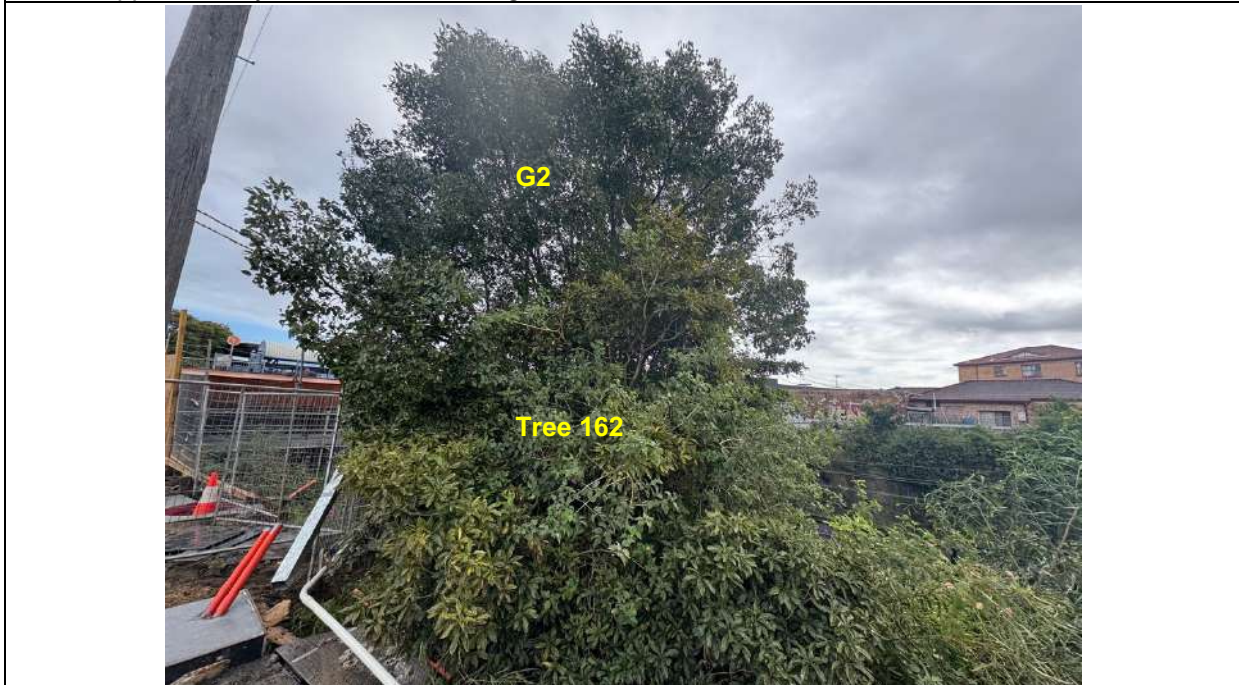
**Image 12:** Looking towards tree 162 and G2. The trees are recommended for removal.

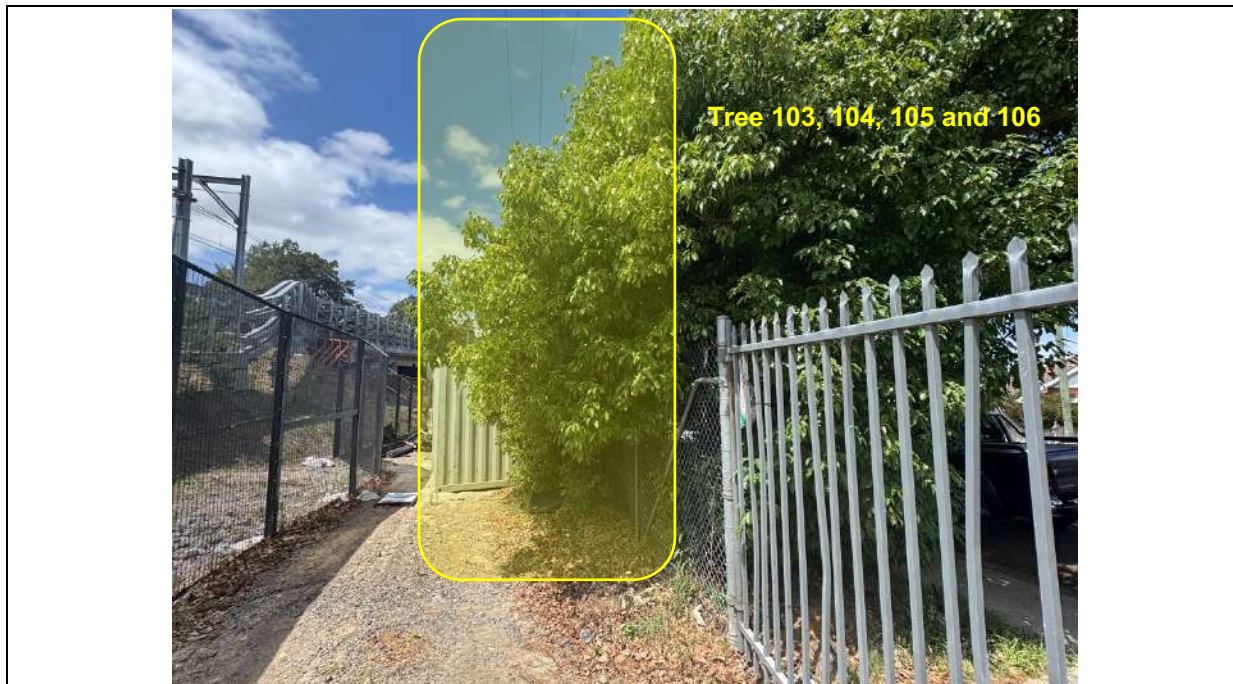
**Image 13:** Looking towards tree 103, 104, 105 and 106. Canopy pruning is required. The smaller suckering regrowth measuring less than 50mm in diameter is to be pruned back to the chainwire boundary fence. Approximately 5-10% of the live foliage area of each tree will be removed. **Note – there is a bees nest in this location which should be treated prior to pruning works to ensure a safe working environment.**

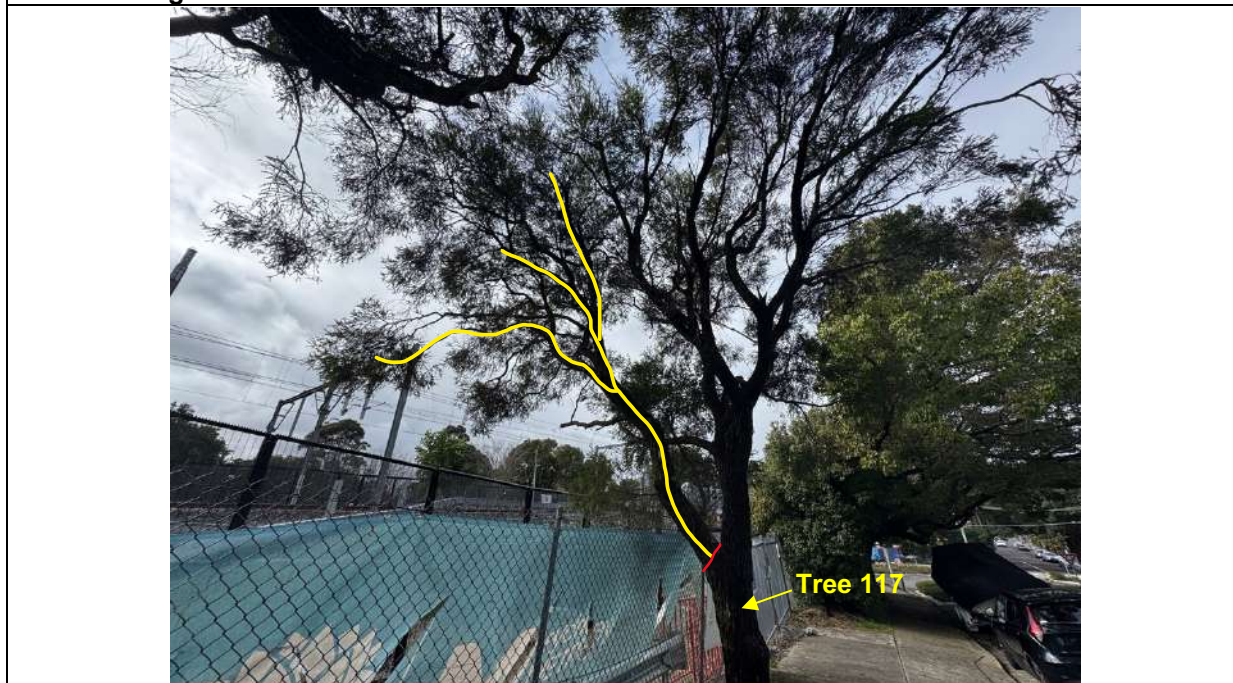
**Image 14:** Looking towards tree 117. Canopy pruning is required to provide fence clearance. The primary stem to the Northwest is to be pruned at 1.5m above ground level. The final pruning cut will be 200mm in diameter. Approximately 30% of the live foliage area will be removed. This is considered significant canopy pruning, indicating the condition and useful life expectancy of the tree could be impacted, however, the pruning is a preferred option to whole tree removal.

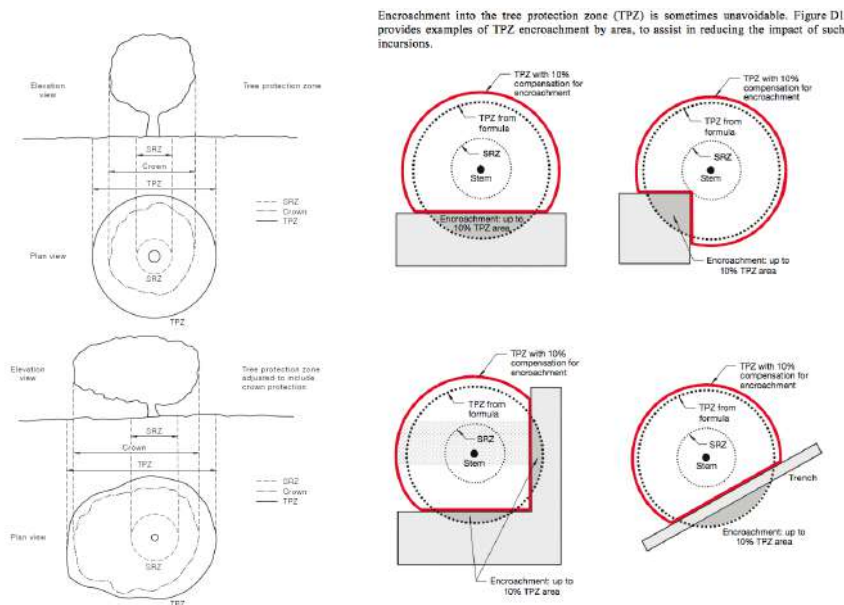
2. **Structural Root Zone:** This is the area around the base of a tree required for the trees stability in the ground. An area larger than the SRZ always need to be maintained to preserve a viable tree as it will only have a minor effect on the trees vigour and health. There are several factors that determine the SRZ which include height, crown area, soil type and soil moisture. It can also be influenced by other factors such as natural or built structures. Generally work within the SRZ should be avoided.

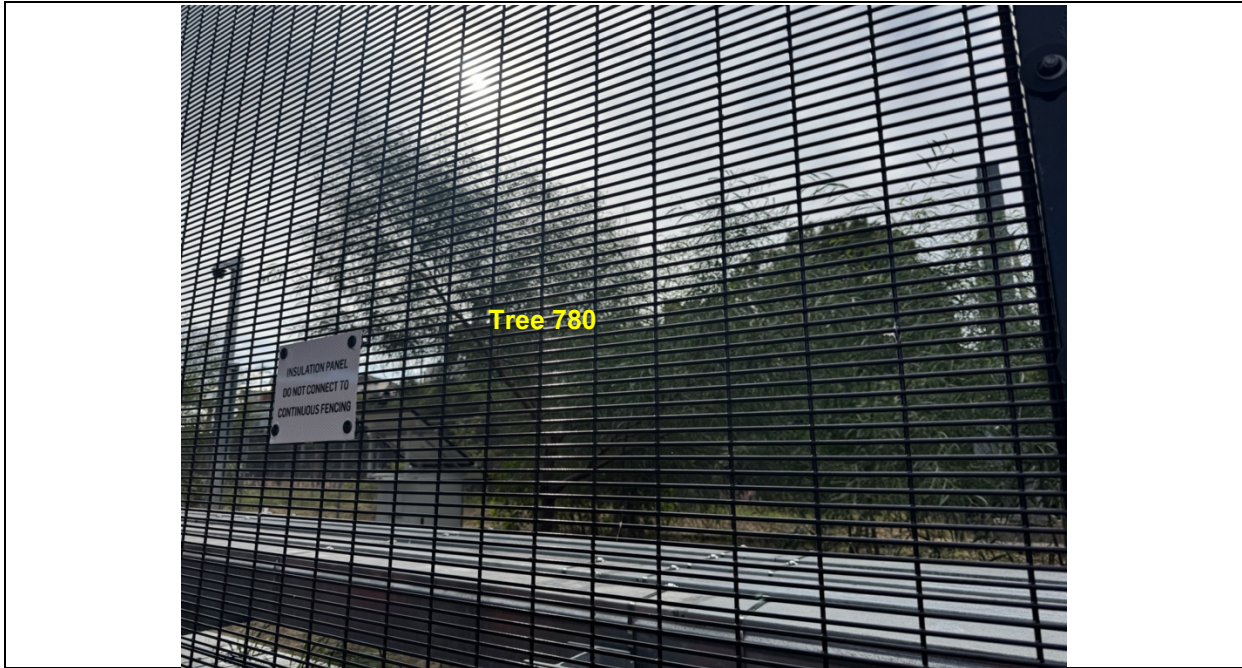
**Image 1:** Looking towards tree 780. The tree is recommended for removal.

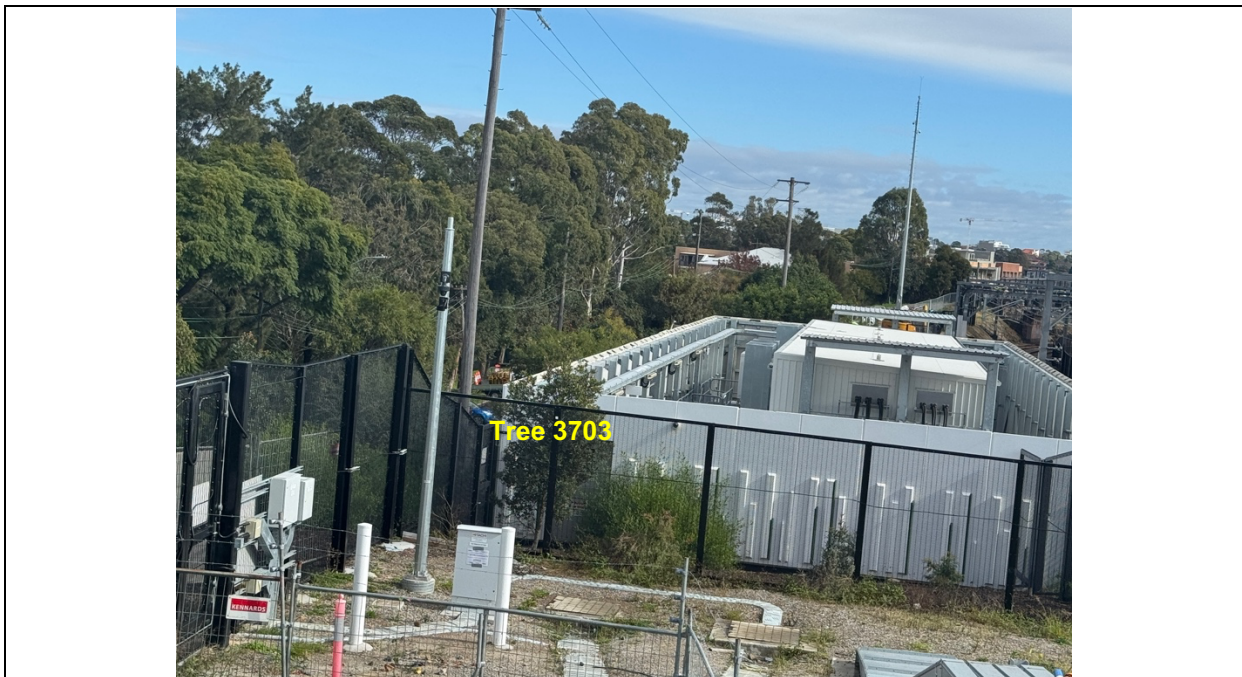
**Image 2:** Looking towards tree 3703. The tree is recommended for removal.

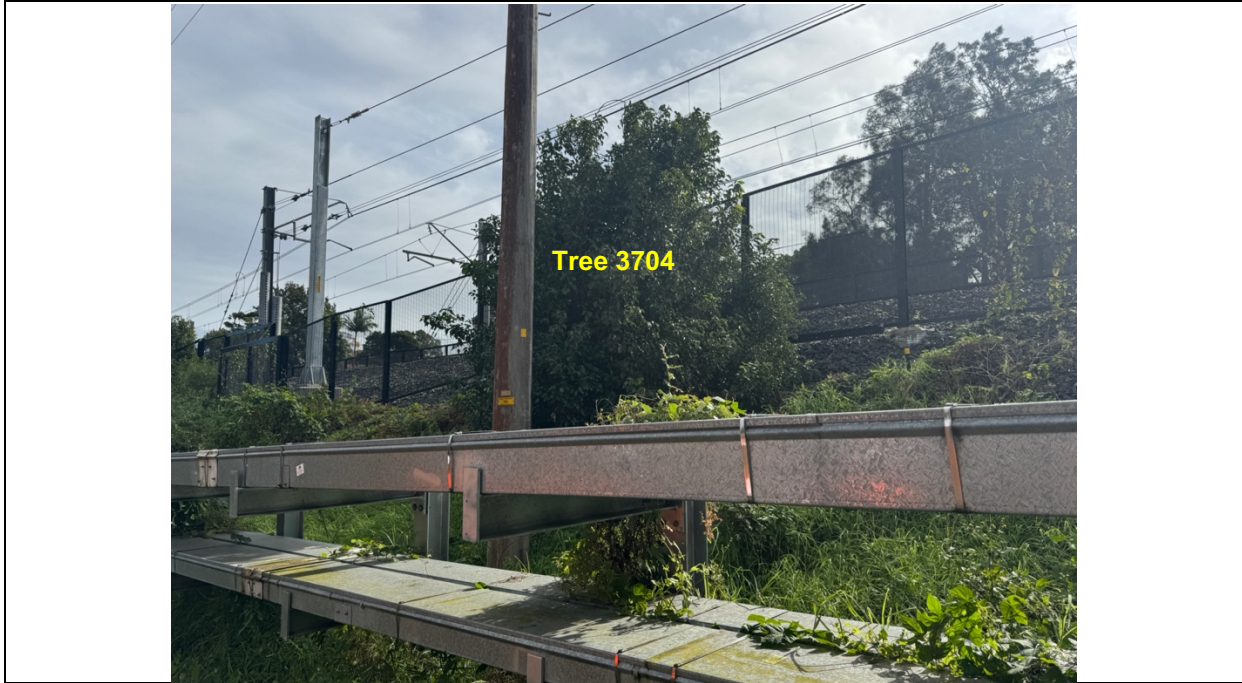
**Image 3:** Looking towards tree 3704. The tree is recommended for removal.

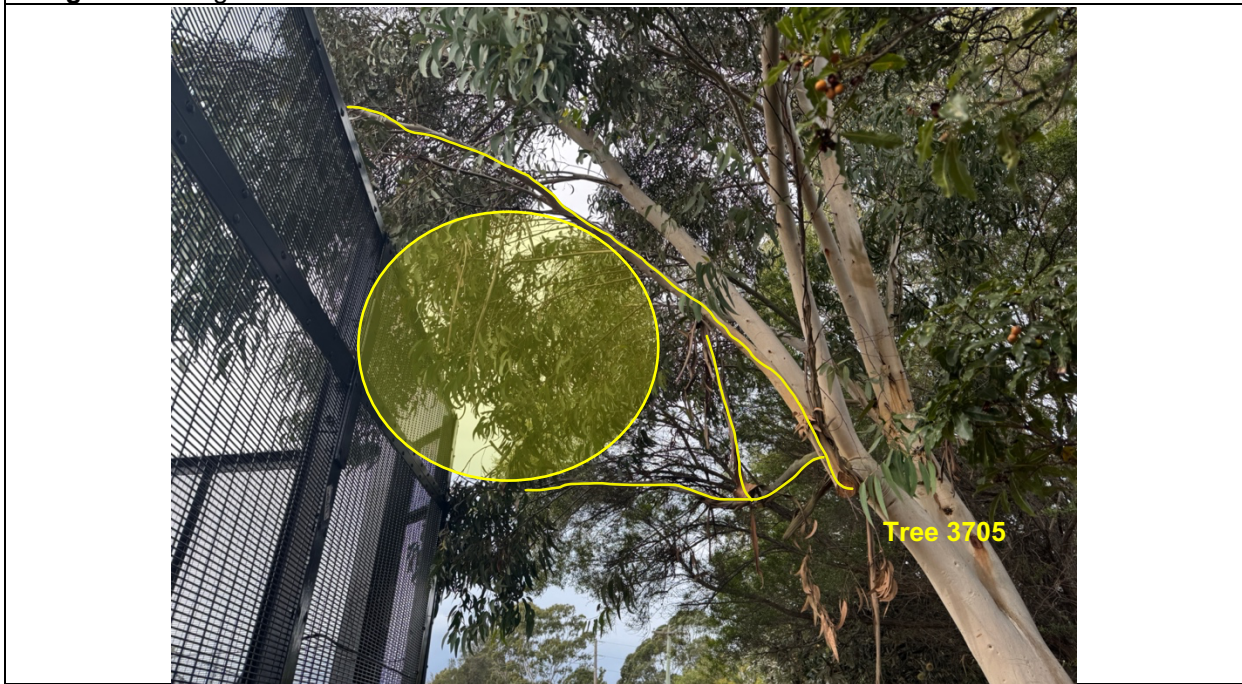
**Image 4:** Looking towards tree 3705, showing the 130mm diameter second order branch to the North at 2.5m above ground level recommended for pruning. The removal of smaller branches measuring less than 50mm in diameter will also be required to provide 2m clearance from the fence. Approximately 10% of the live foliage area will be removed.

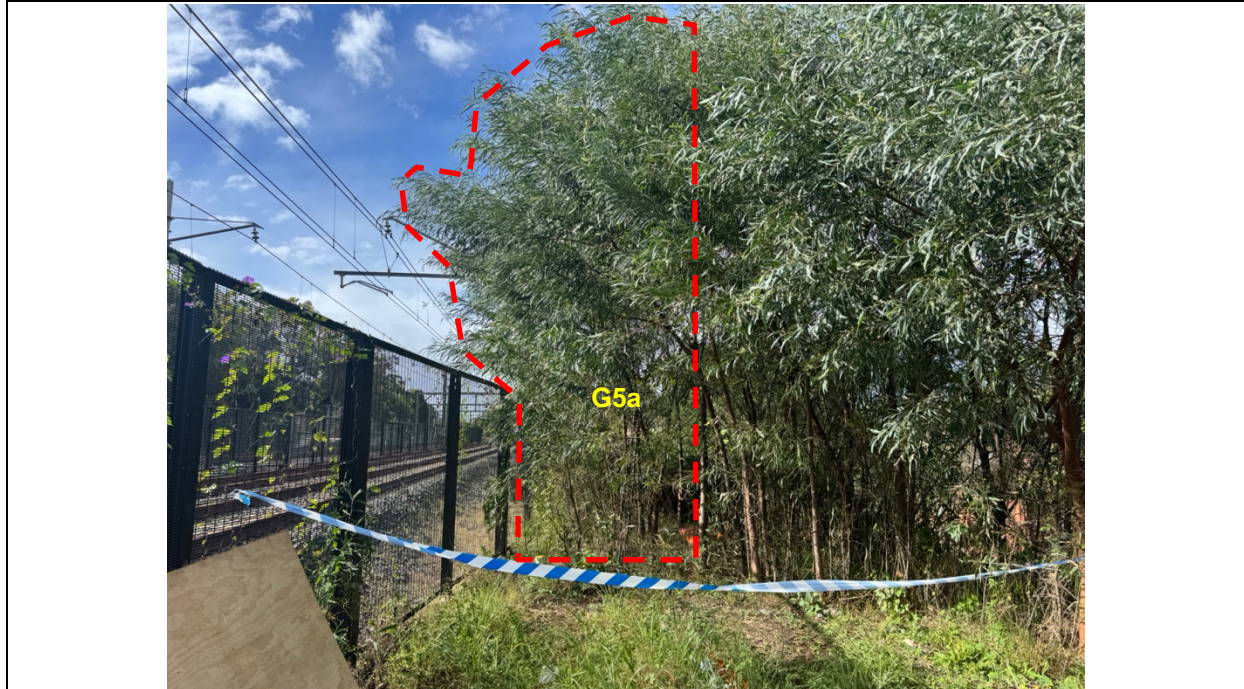
**Image 5:** Looking towards G5a. Trees that are located within 2m of the fence are recommended for removal.

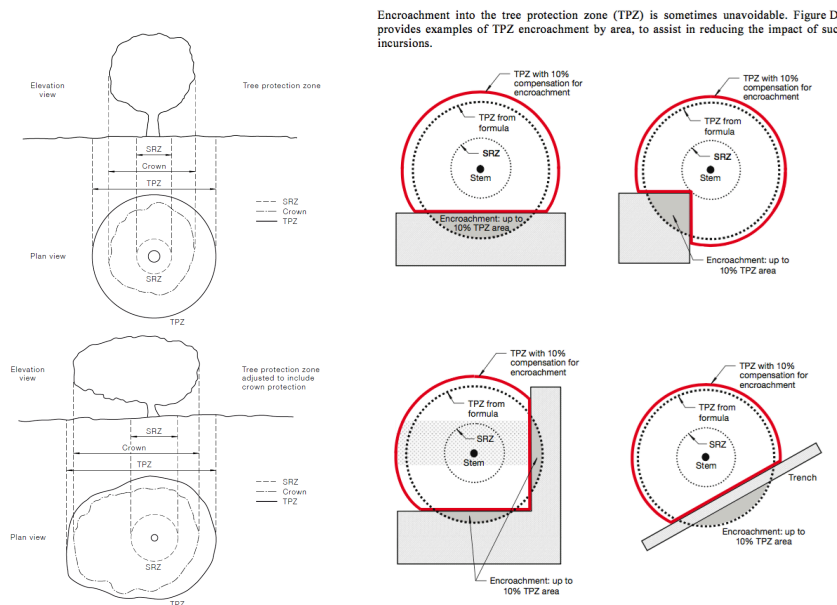
2. **Structural Root Zone:** This is the area around the base of a tree required for the trees stability in the ground. An area larger than the SRZ always need to be maintained to preserve a viable tree as it will only have a minor effect on the trees vigour and health. There are several factors that determine the SRZ which include height, crown area, soil type and soil moisture. It can also be influenced by other factors such as natural or built structures. Generally work within the SRZ should be avoided.

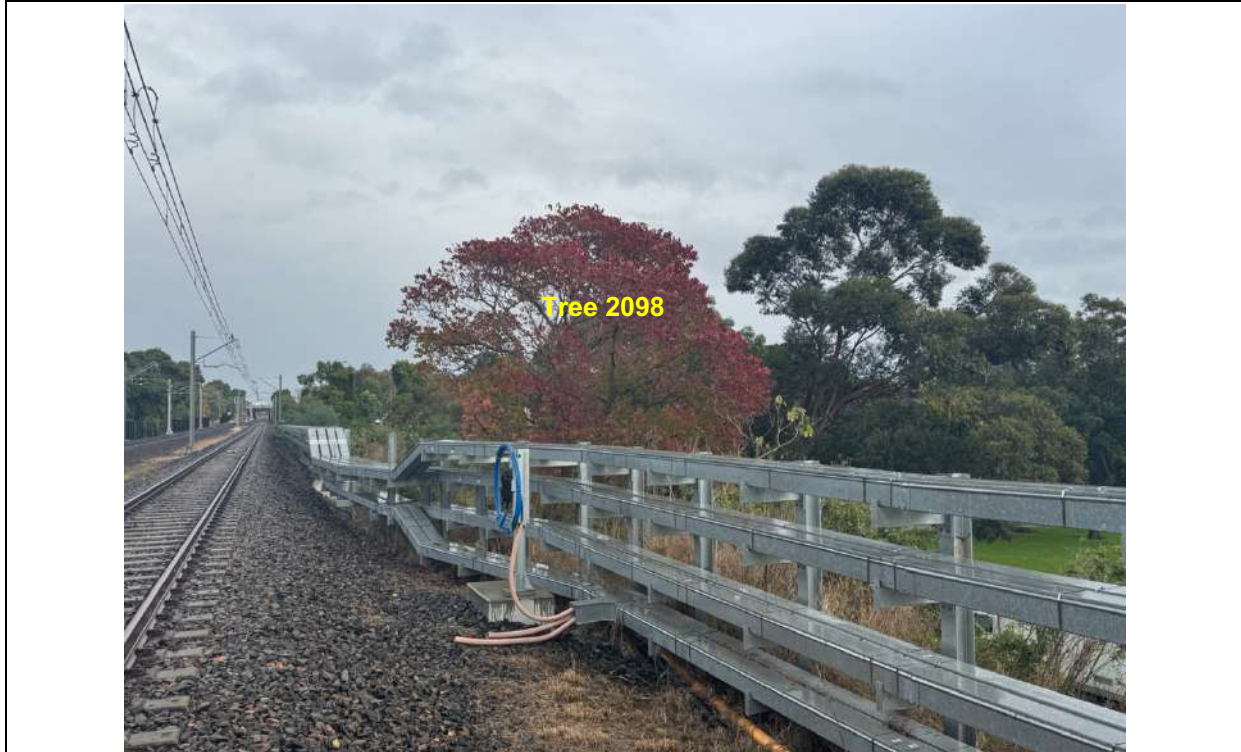
**Image 3:** Looking towards tree 2098. The tree is recommended for removal due to extent of required canopy pruning, which would result in the removal of more than 30% of the live foliage area and impact the form of the tree.

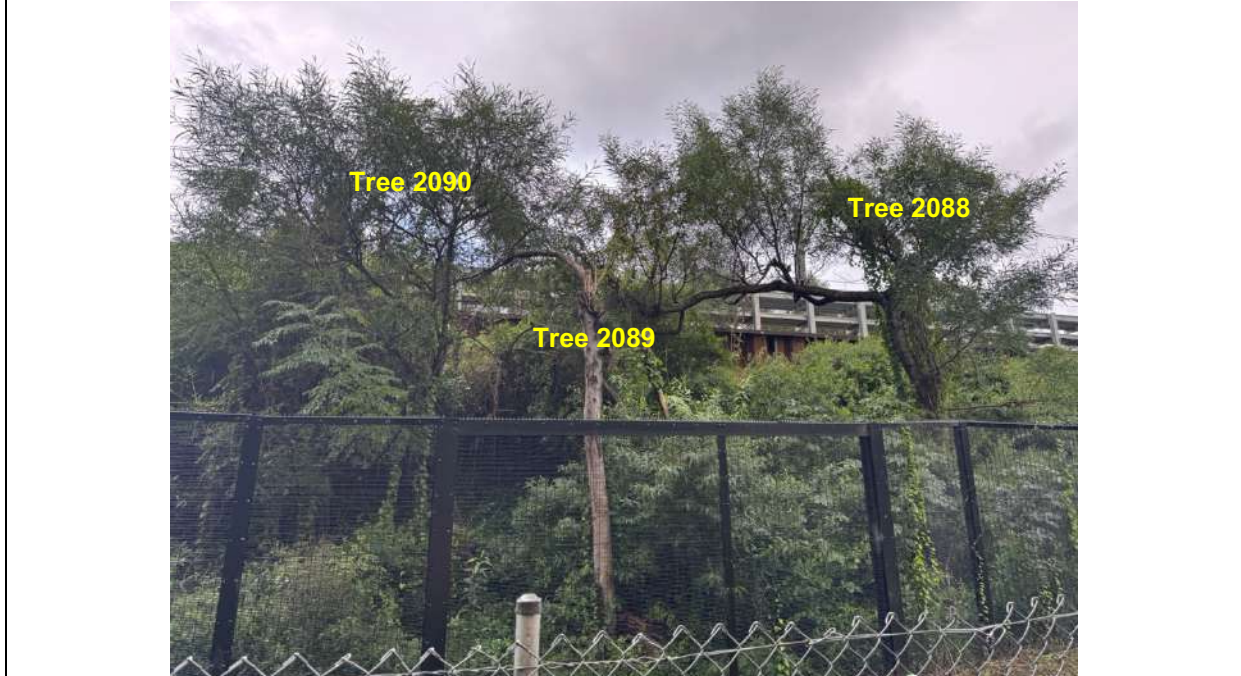
**Image 4:** Looking towards tree 2088, 2089 and 2090. The trees have been recommended for removal.

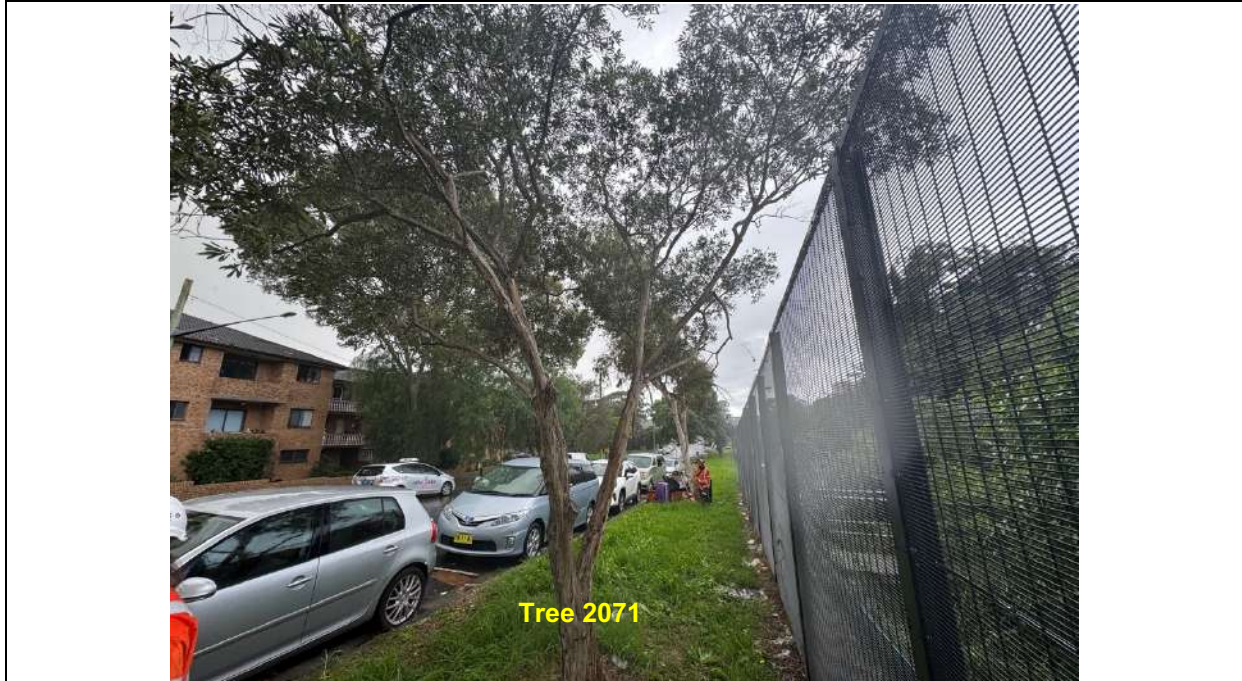
**Image 5:** Looking towards Tree 2071. The tree is recommended for removal due to extent of required canopy pruning, which would result in the removal of more than 30% of the live foliage area and impact the form of the tree.

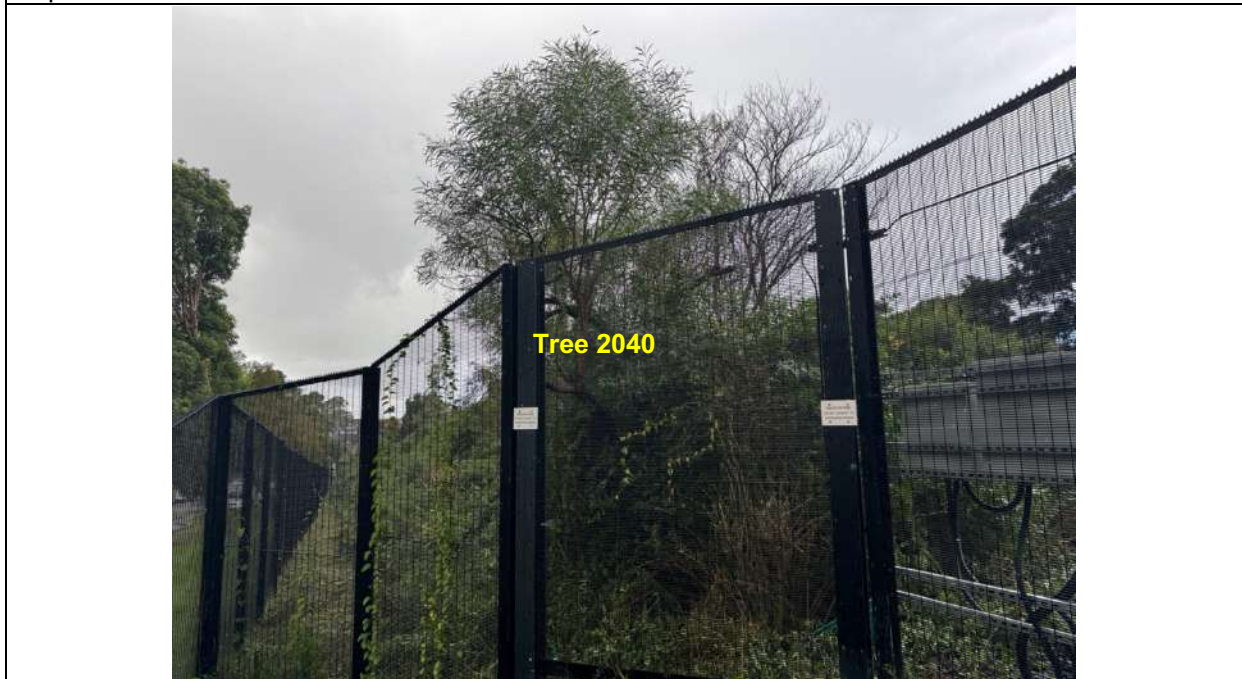
**Image 6:** Looking towards tree 2040. The tree is recommended for removal.

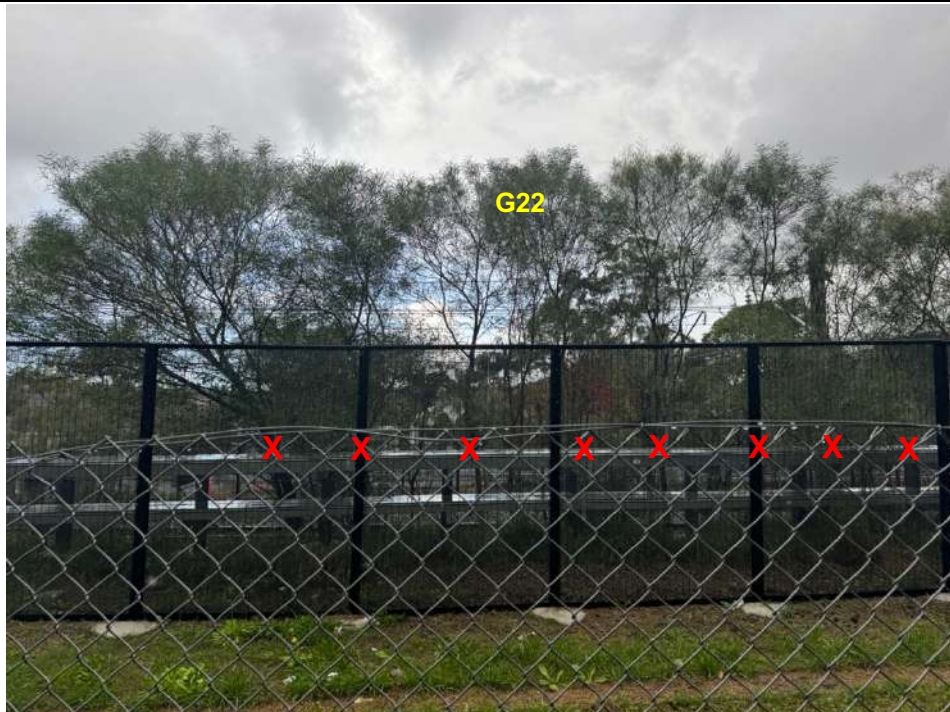
**Image 7:** Looking towards G22. Eight trees (marked with a red X) within the Eastern section of the group are recommended for removal. The remaining trees within the Western section of the group will require minor canopy pruning.

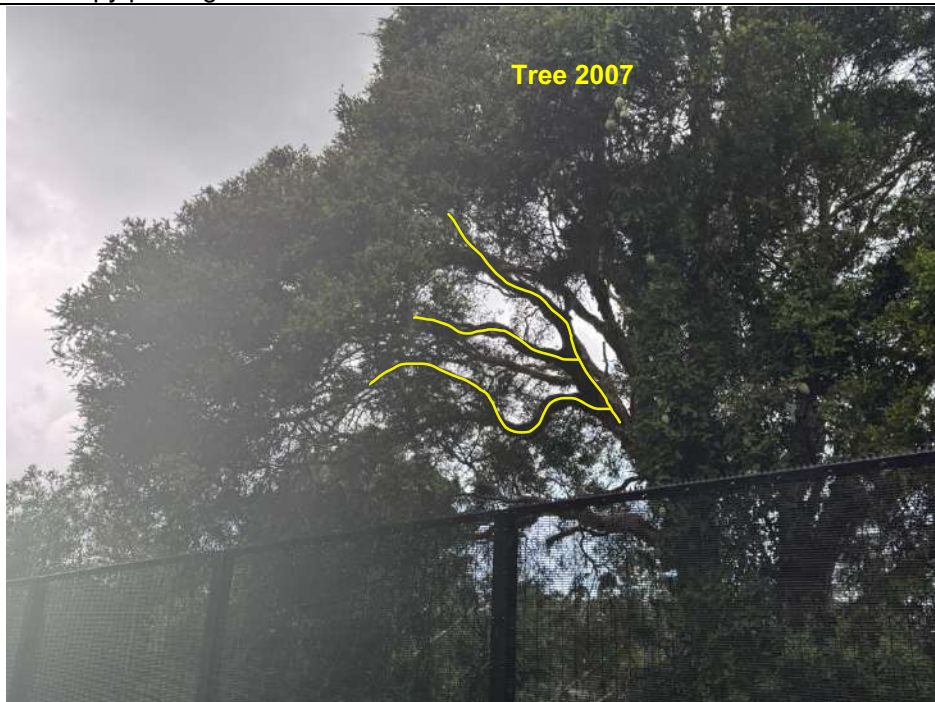
**Image 8:** Looking towards tree 2007, showing the primary branch to the North recommended for removal. The final pruning cut is estimated to be 200mm in diameter and at approximately 6m above ground level. Approximately 15% of the live foliage area will be removed.

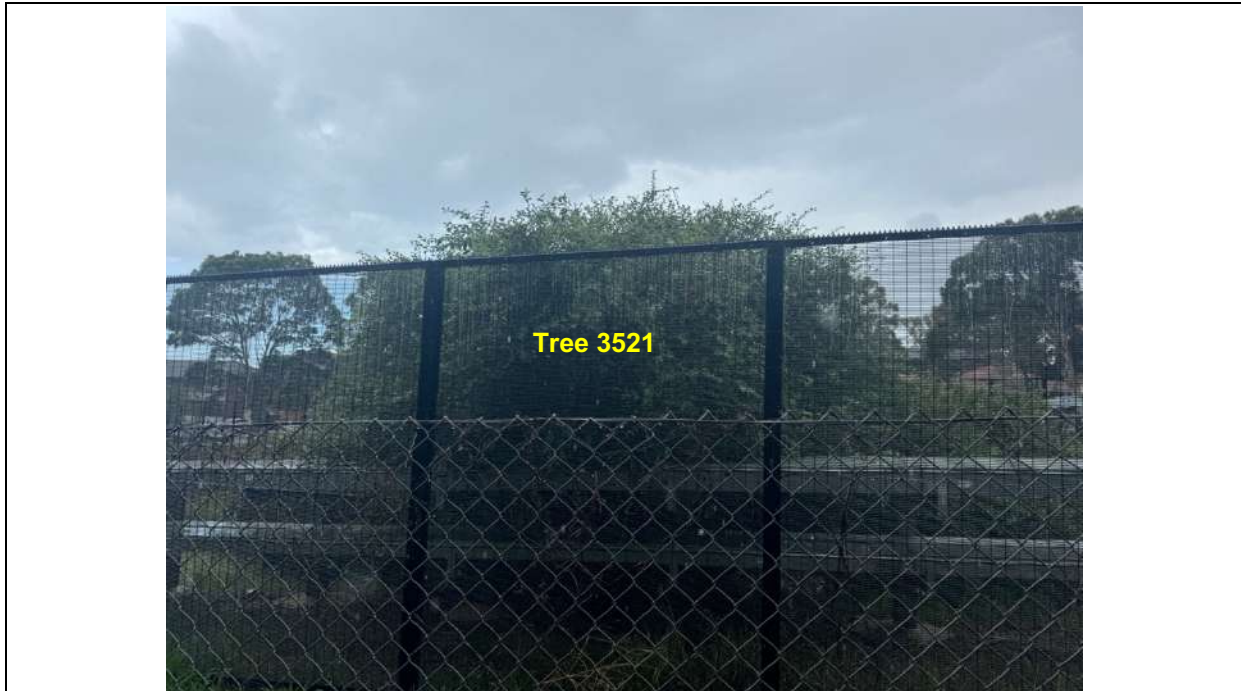
**Image 9:** Looking towards tree 3521. The tree is recommended for removal.

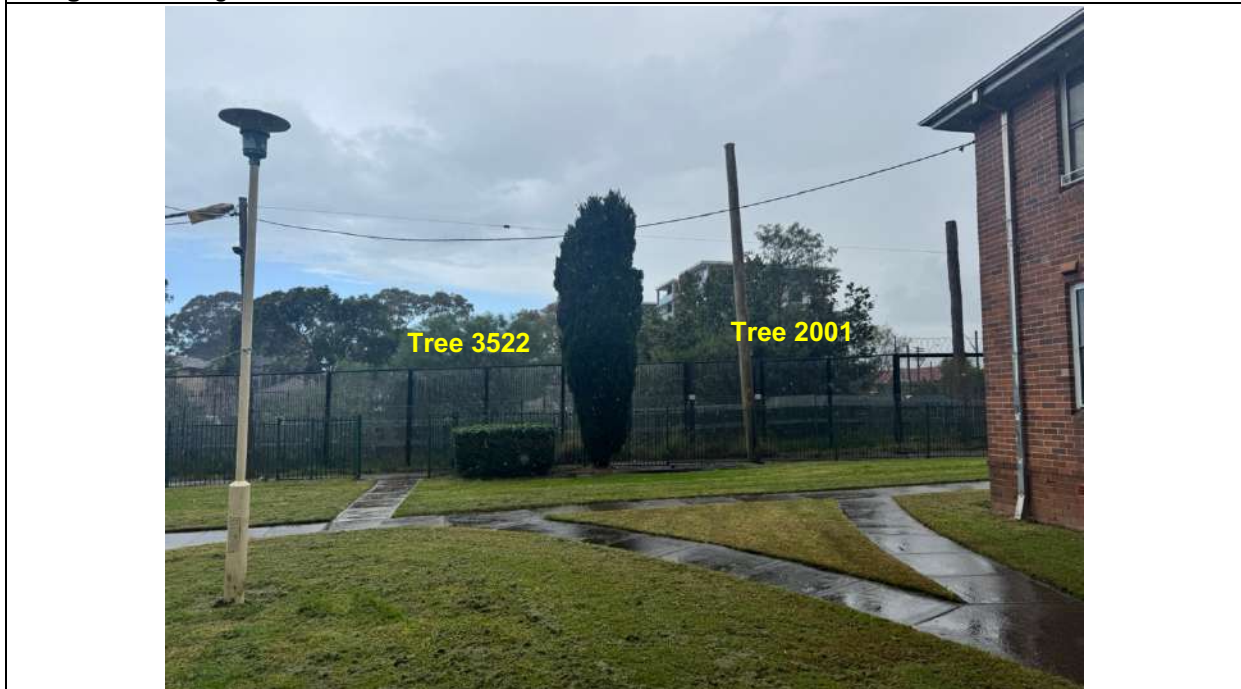
**Image 10:** Looking towards tree 3522 and 2001. The trees are recommended for removal.
