# CIDS & ODS Tree Impact Assessment Report

## SWM3- Tree and Vegetation Management Work Part 2 Instruction

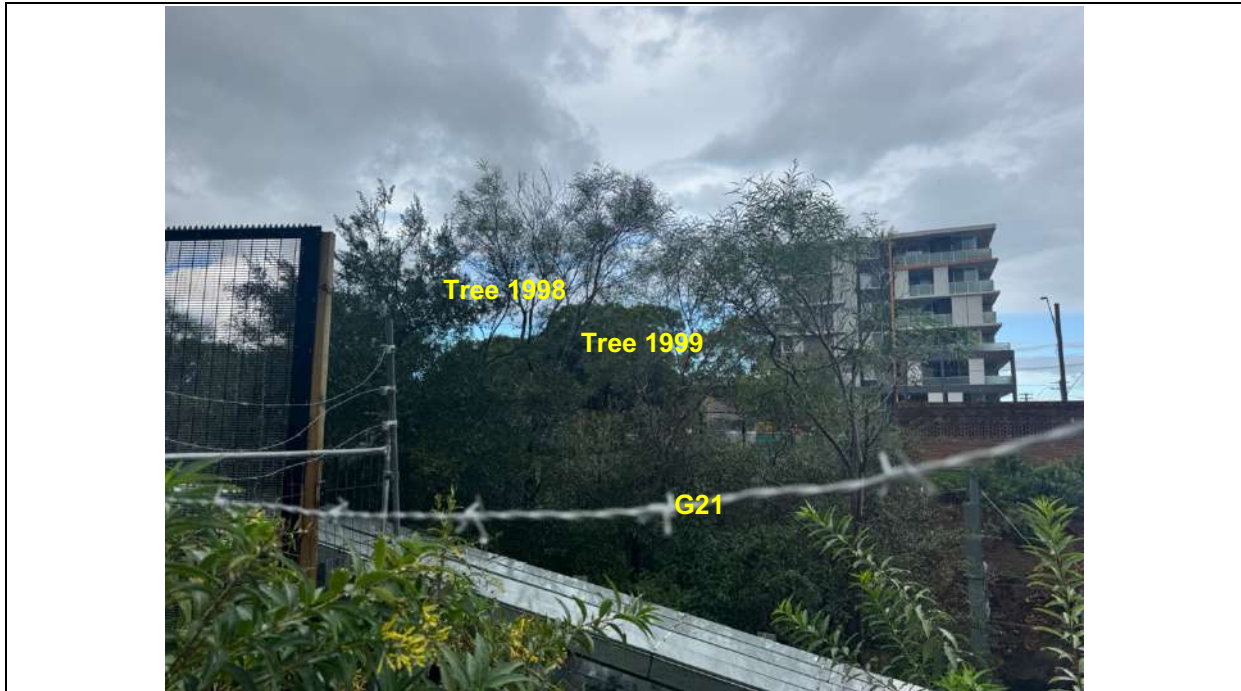
**Image 11:** Looking towards tree 1998,1999 and G21. The trees are recommended for removal.

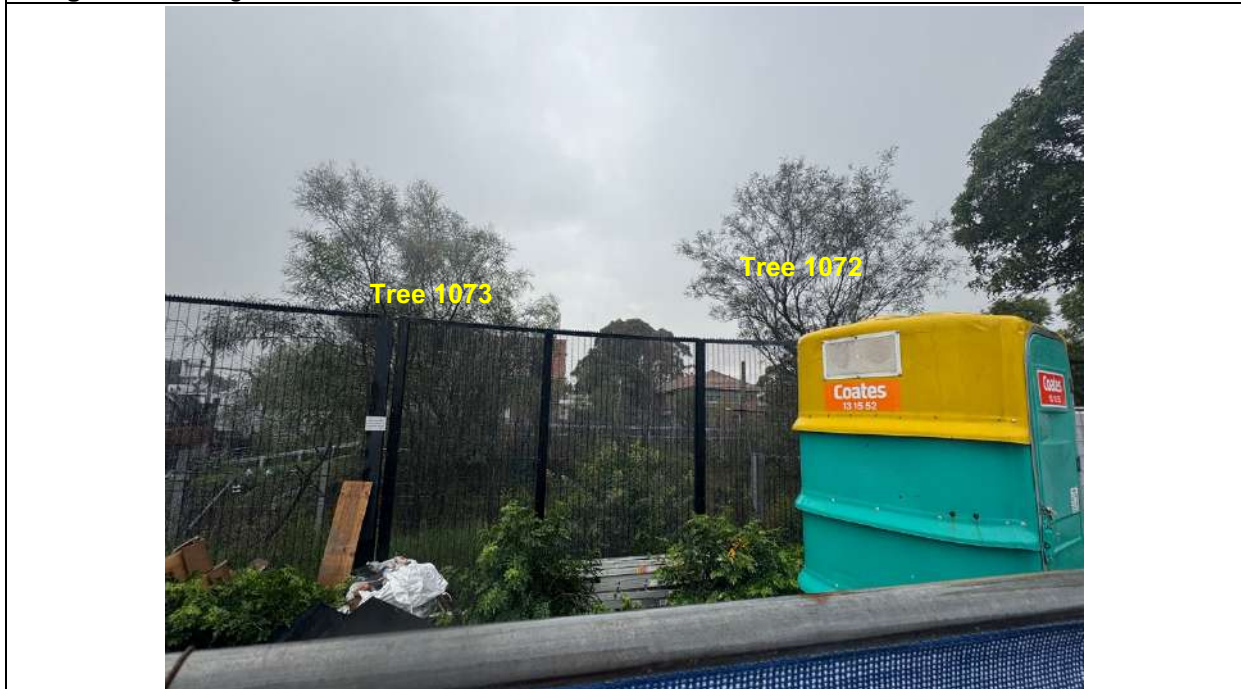
**Image 12:** Looking towards tree 1073 and 1072. The trees are recommended for removal.

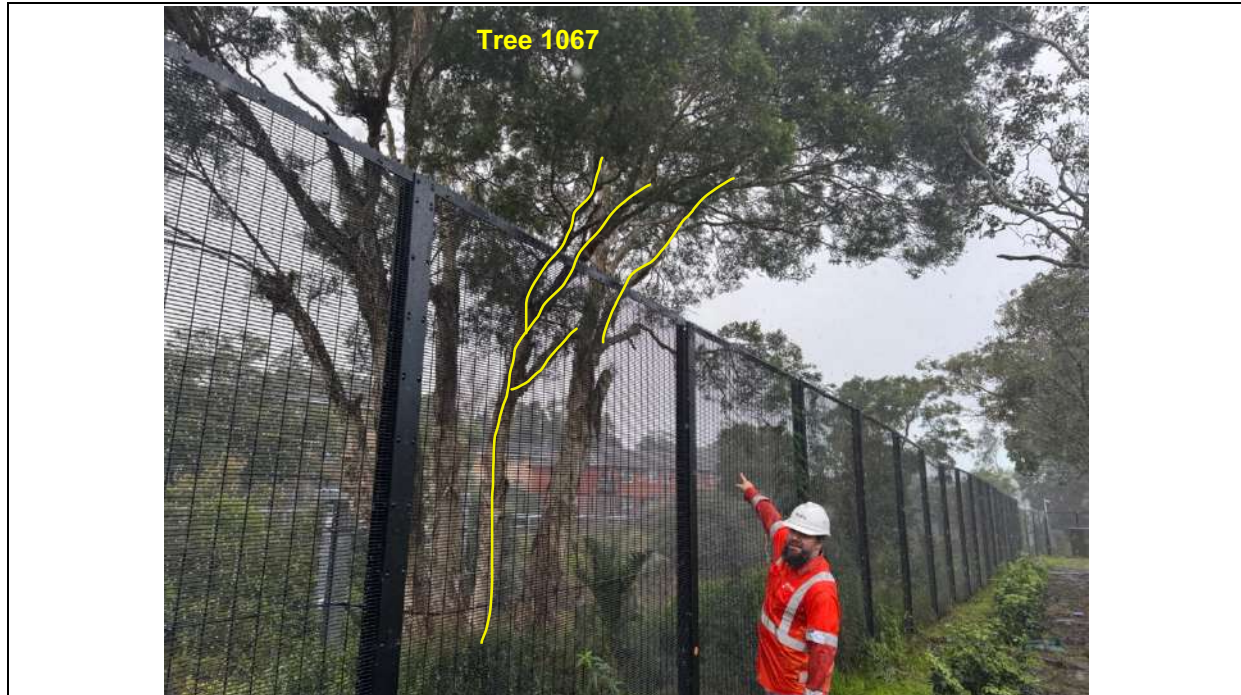
**Image 13:** Looking towards tree 1067, showing the primary stem (180mm) to the Southeast recommended for pruning, and the first order branch (120mm) to the Southeast recommended for pruning. Approximately 15-20% of the live foliage area will be removed.

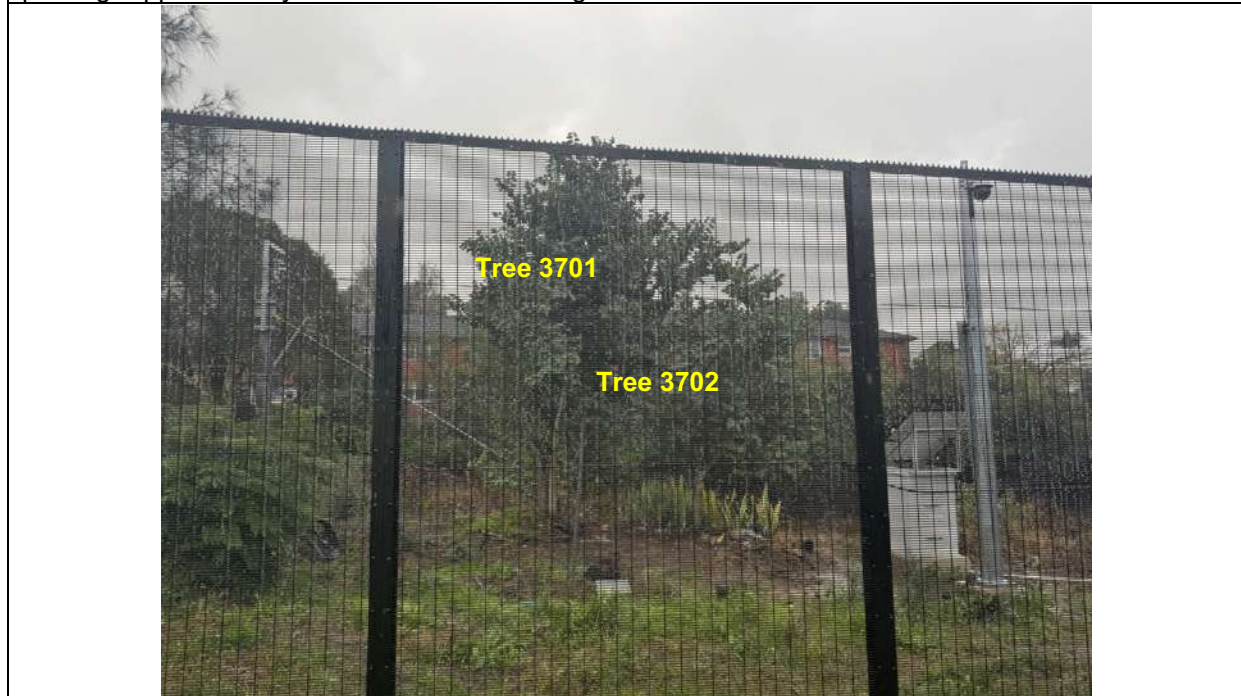
**Image 14:** Looking towards tree 3701 and 3702. The trees are recommended for removal.

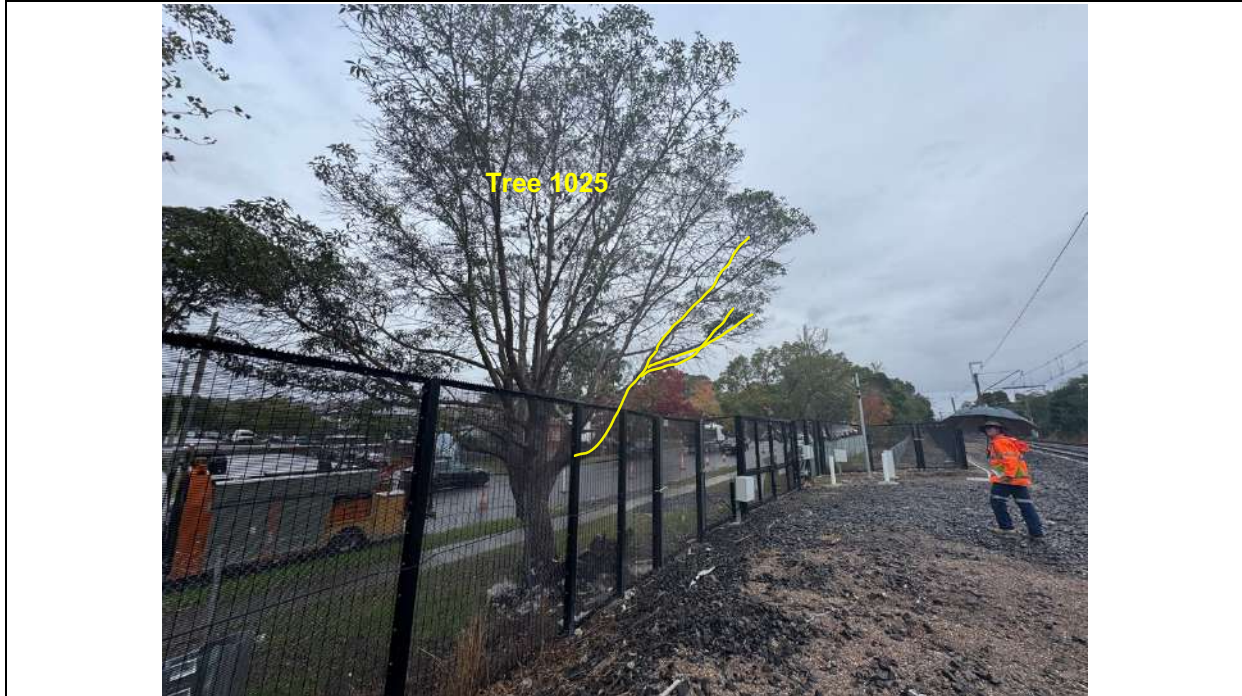
**Image 15:** Looking towards tree 1025, showing the first order branch (180mm) to the West recommended for pruning. Approximately 10% of the live foliage area will be removed.

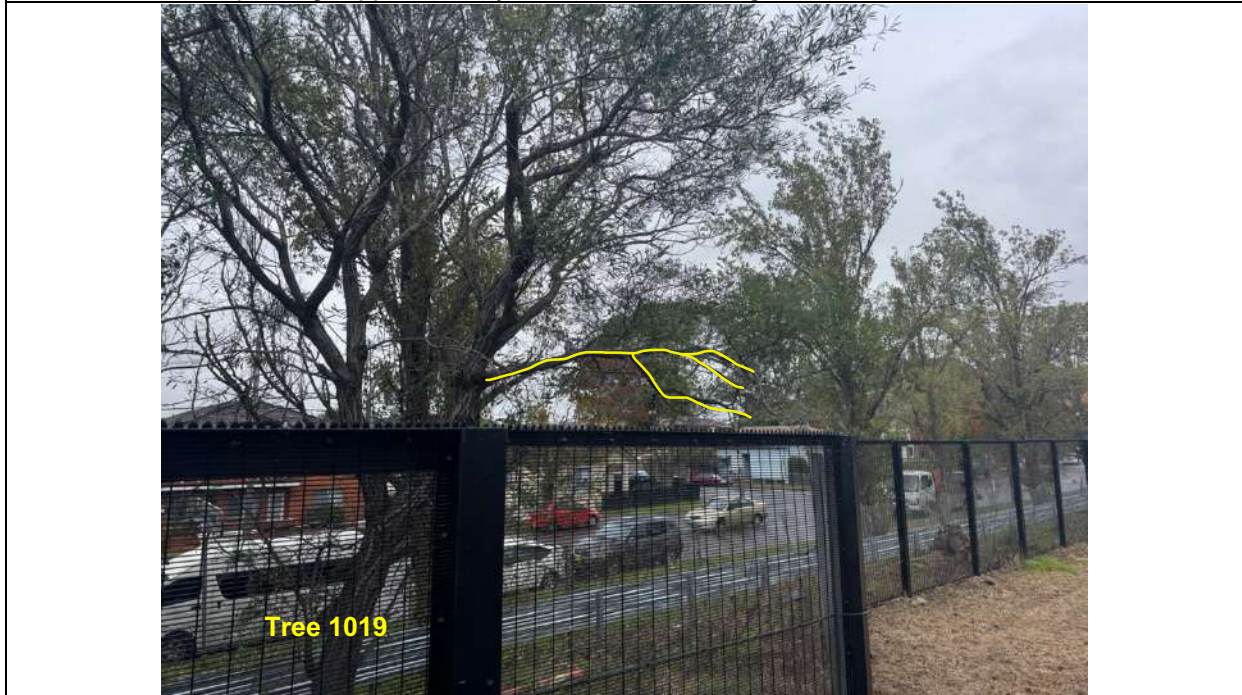
**Image 16:** Looking towards tree 1019, showing the first order branch (120mm) to the West recommended for pruning. Approximately 5% of the live foliage area will be removed.

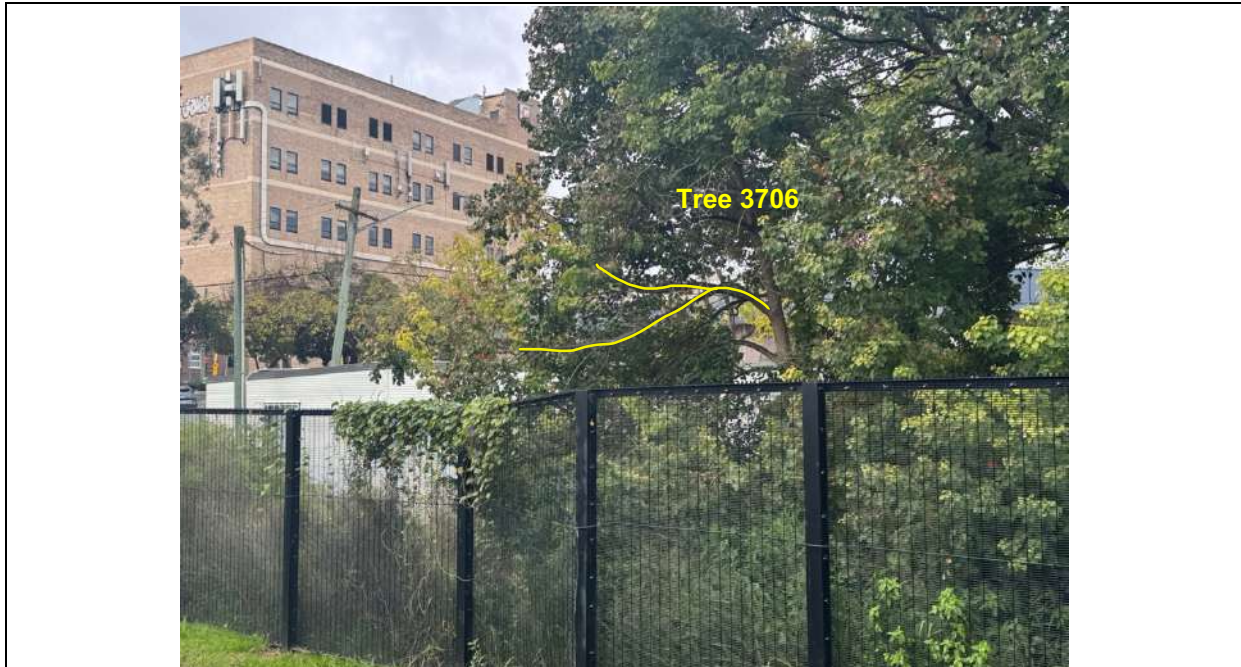
**Image 17:** Looking towards tree 3706, showing the first order branch (100mm) to the West recommended for pruning. Less than 10% of the live foliage area will be removed.

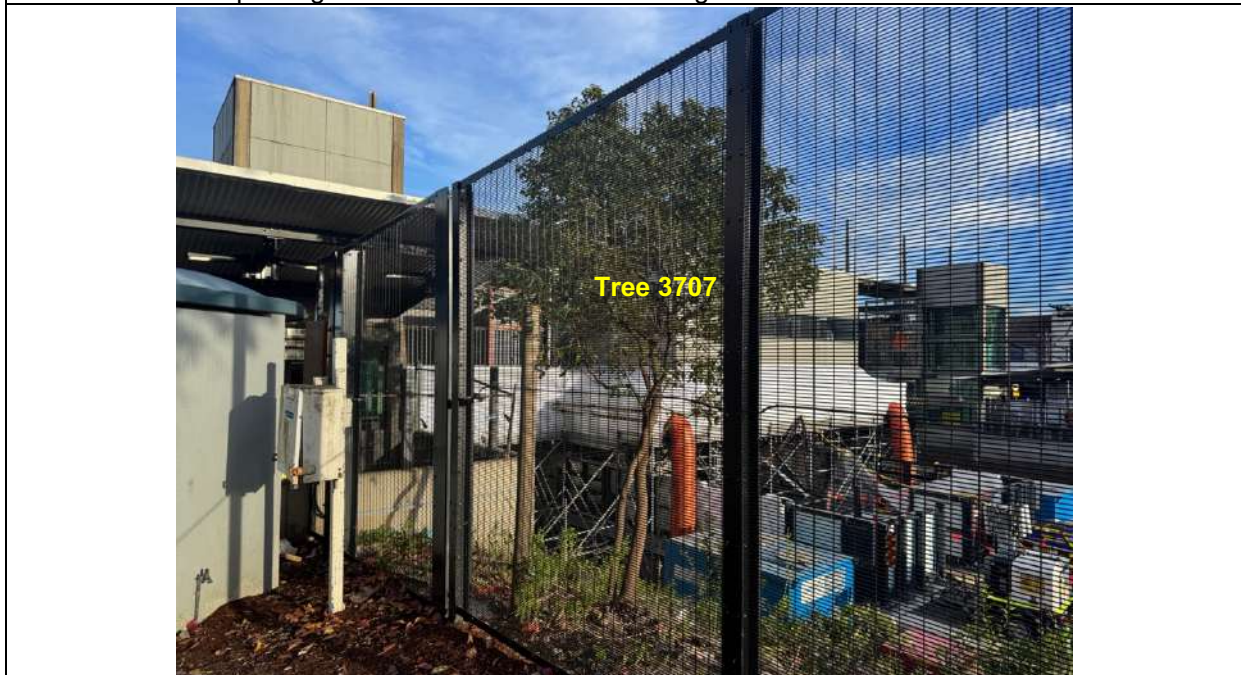
**Image 18:** Looking towards tree 3707. The tree is recommended for removal.

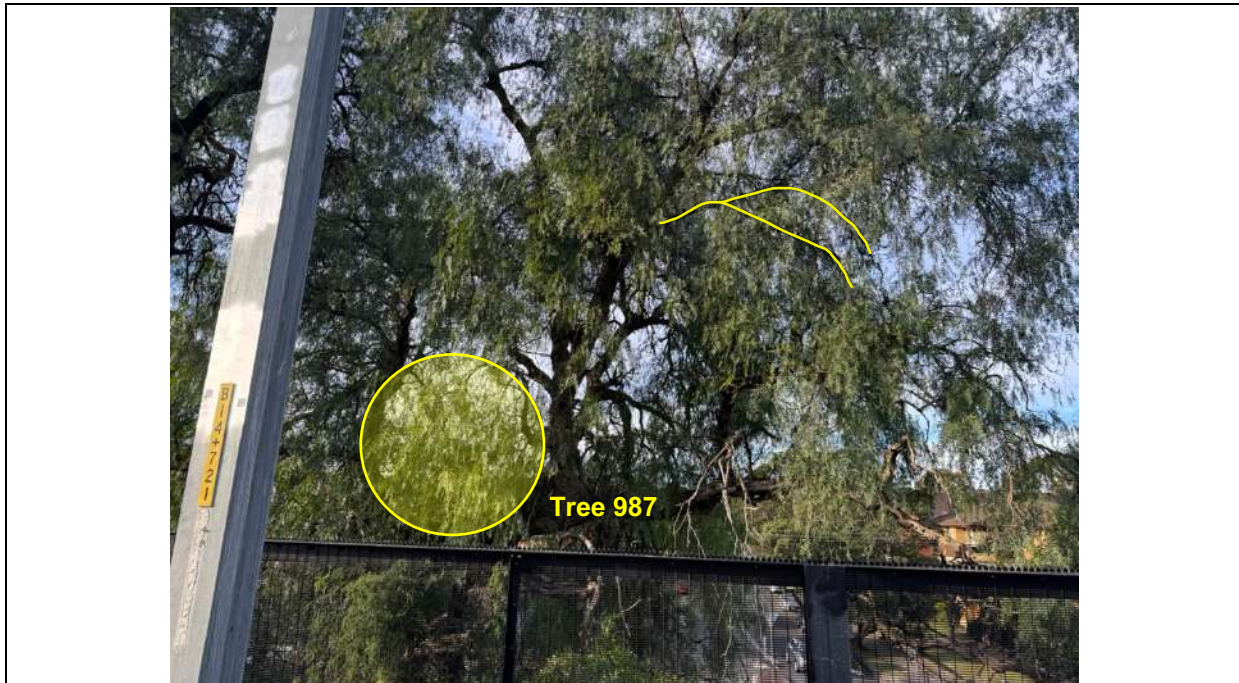
**Image 19:** Looking towards tree 987, showing the recommended pruning for fence clearance. The 60mm diameter 4<sup>th</sup> order branch to the West at 6m is to be pruned. The 70mm 2<sup>nd</sup> order branches to the West at 3m are to be pruned. Less than 5% of the live foliage area will be removed.

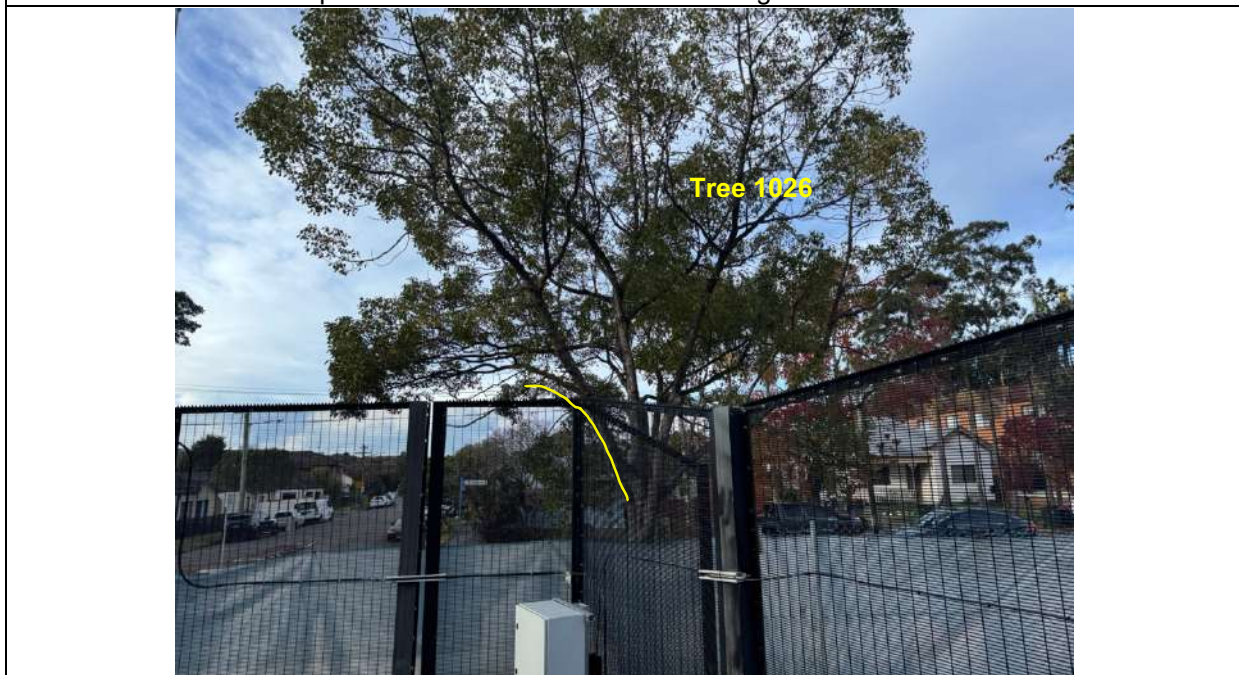
**Image 20:** Looking towards tree 1026, showing the recommended pruning for fence clearance. The 70mm diameter 2<sup>nd</sup> order branch to the Northeast at 2.5m is to be pruned. Less than 5% of the live foliage area will be removed.

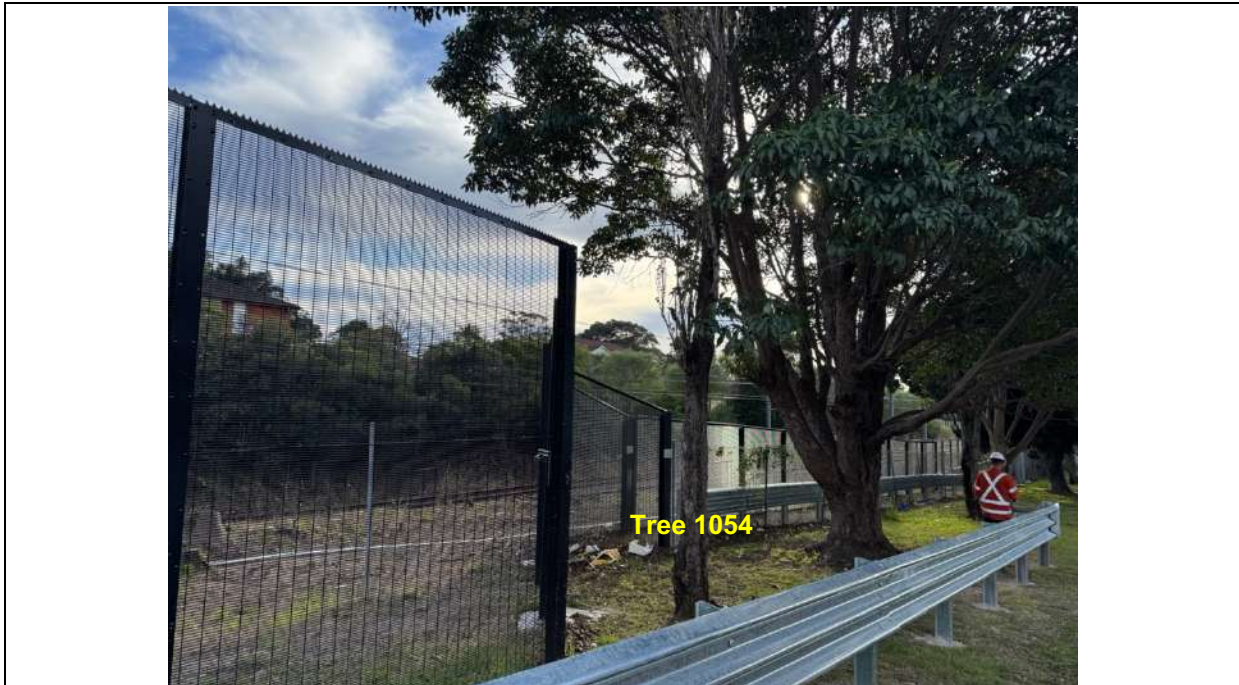
**Image 21:** Looking towards tree 1054. The tree is recommended for removal for fence clearance requirements.

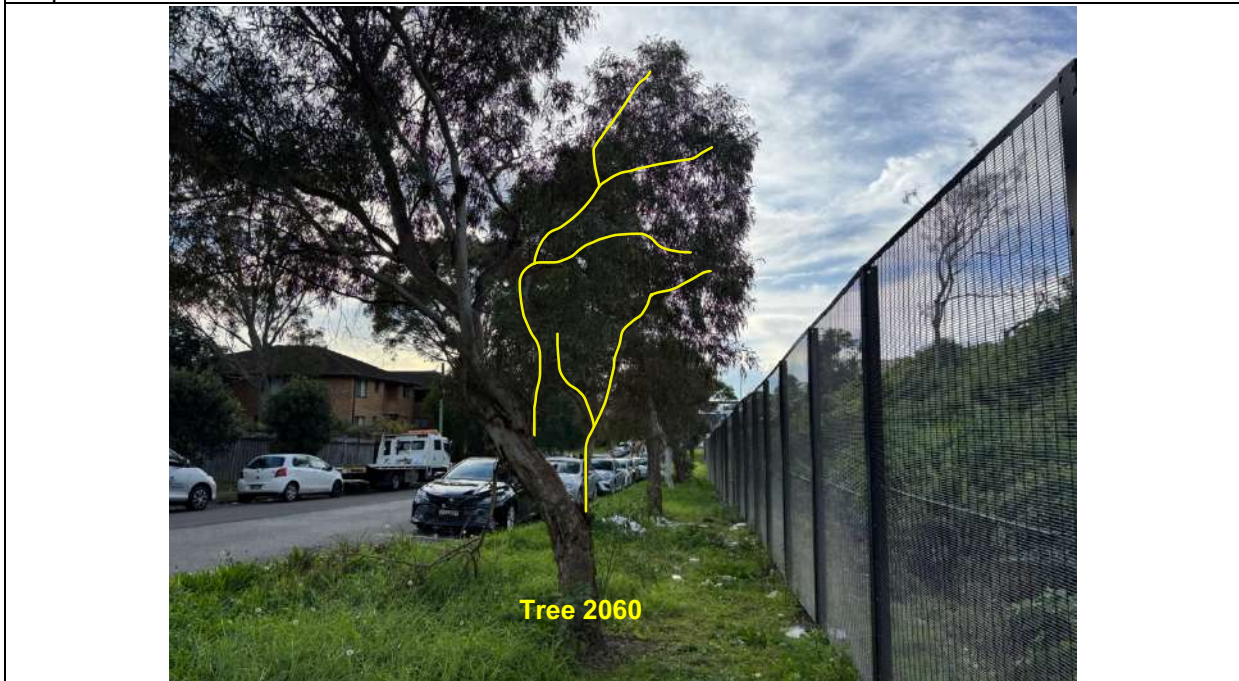
**Image 22:** Looking towards tree 2060, showing the recommended pruning for fence clearance. The 60mm diameter epicormic branches on the lower trunk growing towards the fence are to be pruned. Less than 10% of the live foliage area will be removed.

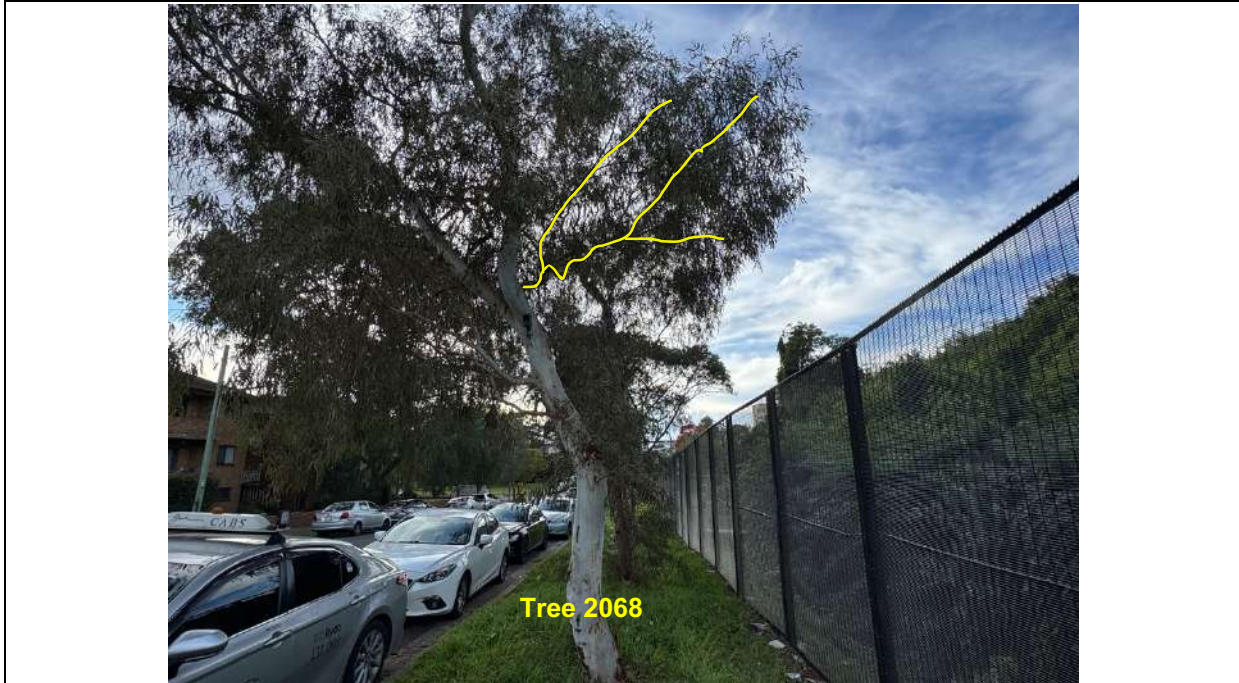
**Image 23:** Looking towards tree 2068, showing the recommended pruning for fence clearance. The 80mm diameter 2<sup>nd</sup> order branch to the South at 4m is to be pruned. Less than 5% of the live foliage area will be removed.

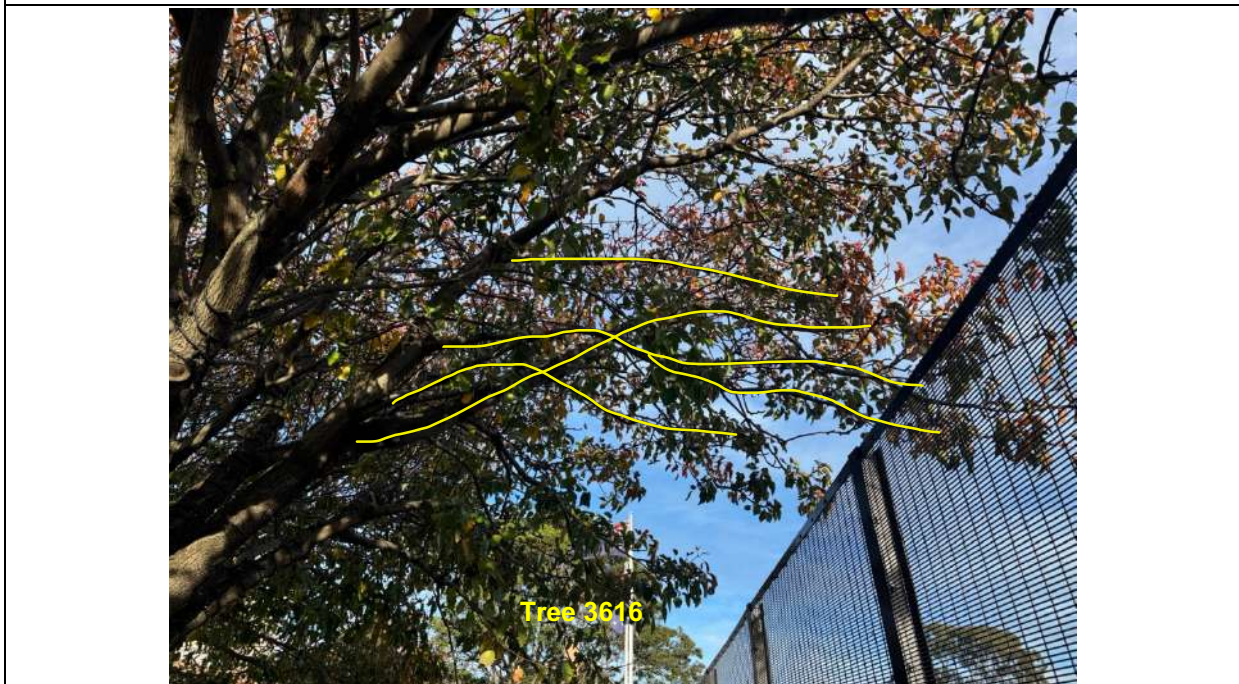
**Image 24:** Looking towards tree 3616, showing the recommended pruning for fence clearance. The 2<sup>nd</sup> and 3<sup>rd</sup> order branches to the North-Northeast at 3-5m are to be pruned. Approximately 5% of the live foliage area will be removed. Final pruning cuts must not exceed 140mm in diameter. See Image 25 below for additional pruning for tree 3616.

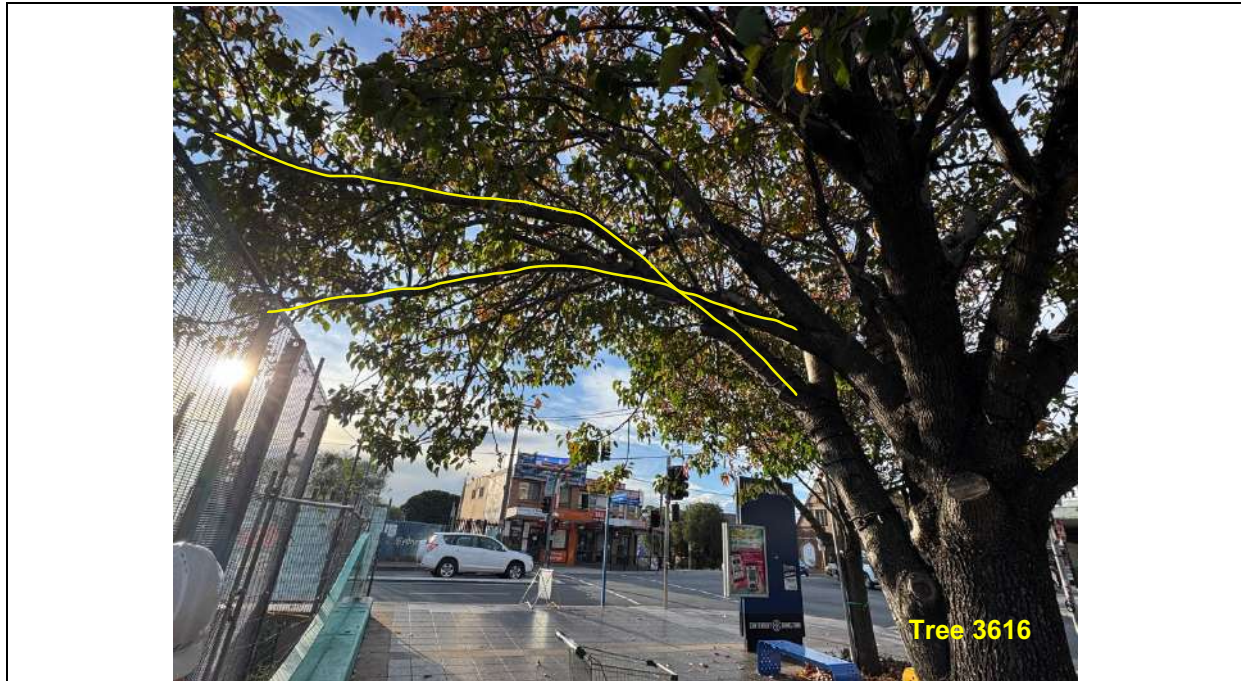
**Image 25:** Looking towards tree 3616, showing the additional recommended pruning for fence clearance. The 2<sup>nd</sup> order branches to the Northeast at 3m are to be pruned. Approximately 5% of the live foliage area will be removed. Final pruning cuts must not exceed 140mm in diameter.

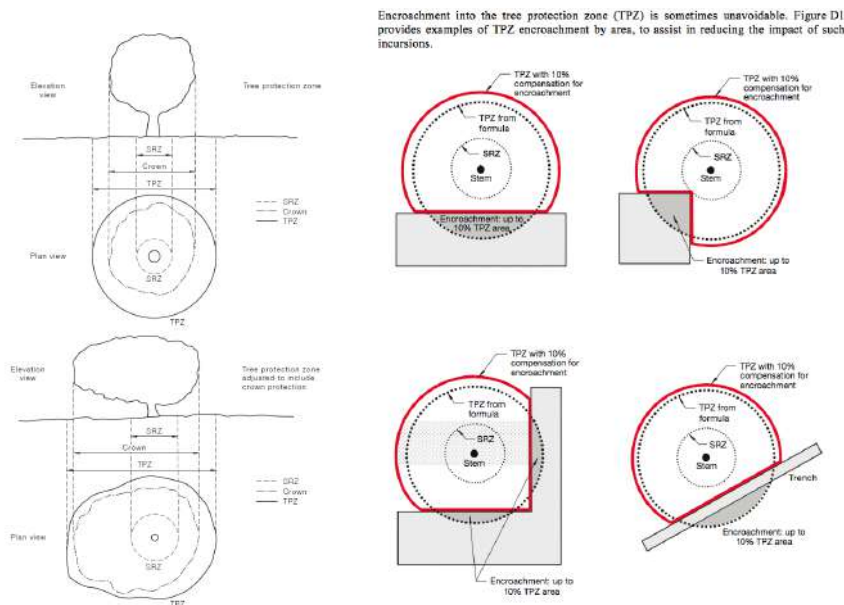
2. **Structural Root Zone:** This is the area around the base of a tree required for the trees stability in the ground. An area larger than the SRZ always need to be maintained to preserve a viable tree as it will only have a minor effect on the trees vigour and health. There are several factors that determine the SRZ which include height, crown area, soil type and soil moisture. It can also be influenced by other factors such as natural or built structures. Generally work within the SRZ should be avoided.

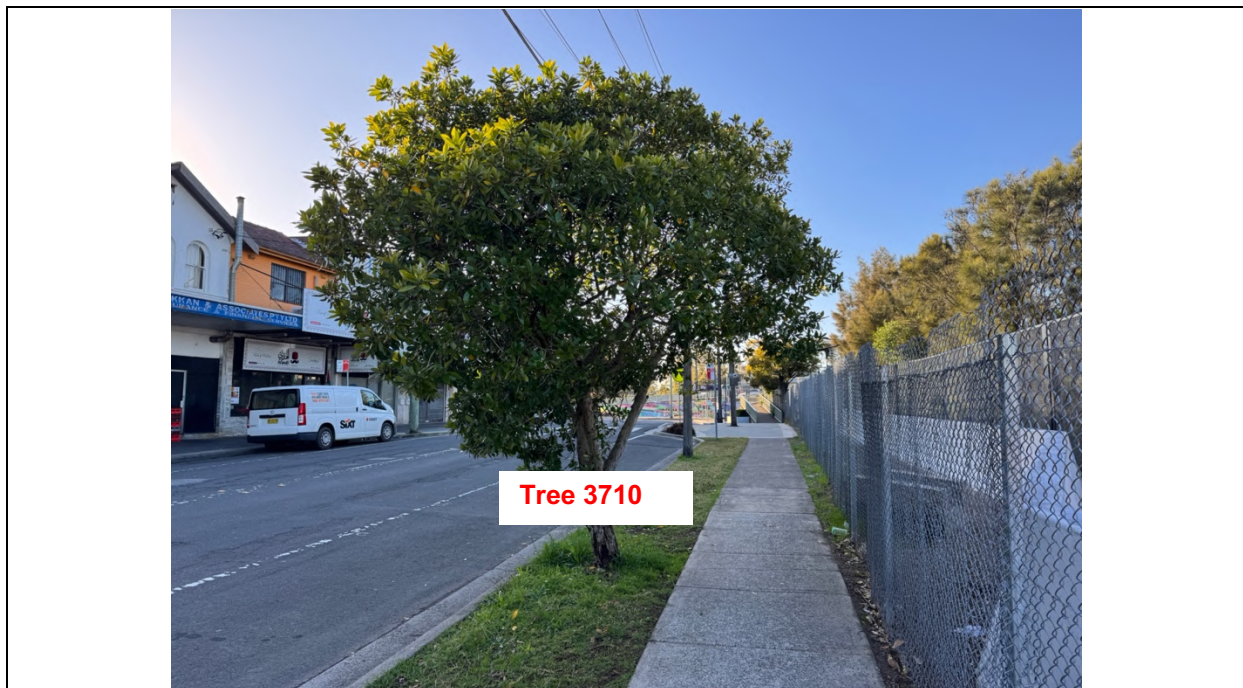
**Image 2:** Looking towards tree 3710. The tree is recommended for removal.

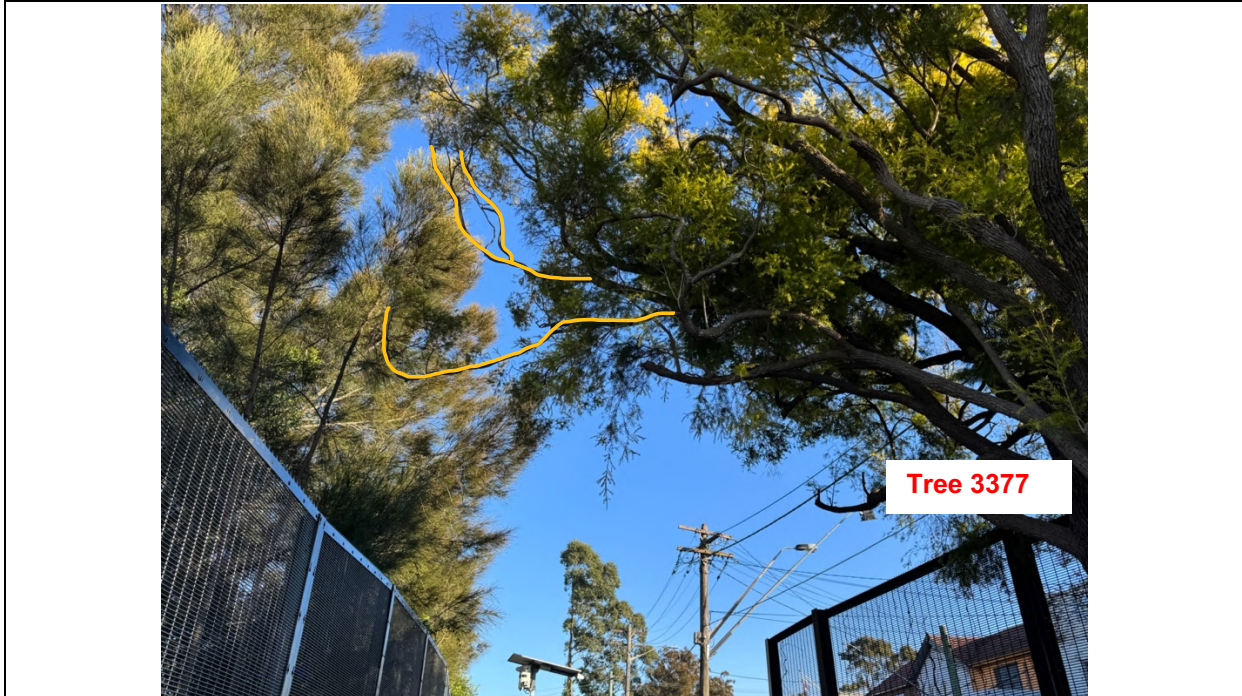
**Image 3:** Looking towards tree 3377. Canopy pruning is required to provide 2m clearance from the fence. Maximum finished cut diameters must not exceed 50mm. The pruning will result in the removal of less than 10% of the live foliage area of the tree. The branches to be removed have been marked yellow.

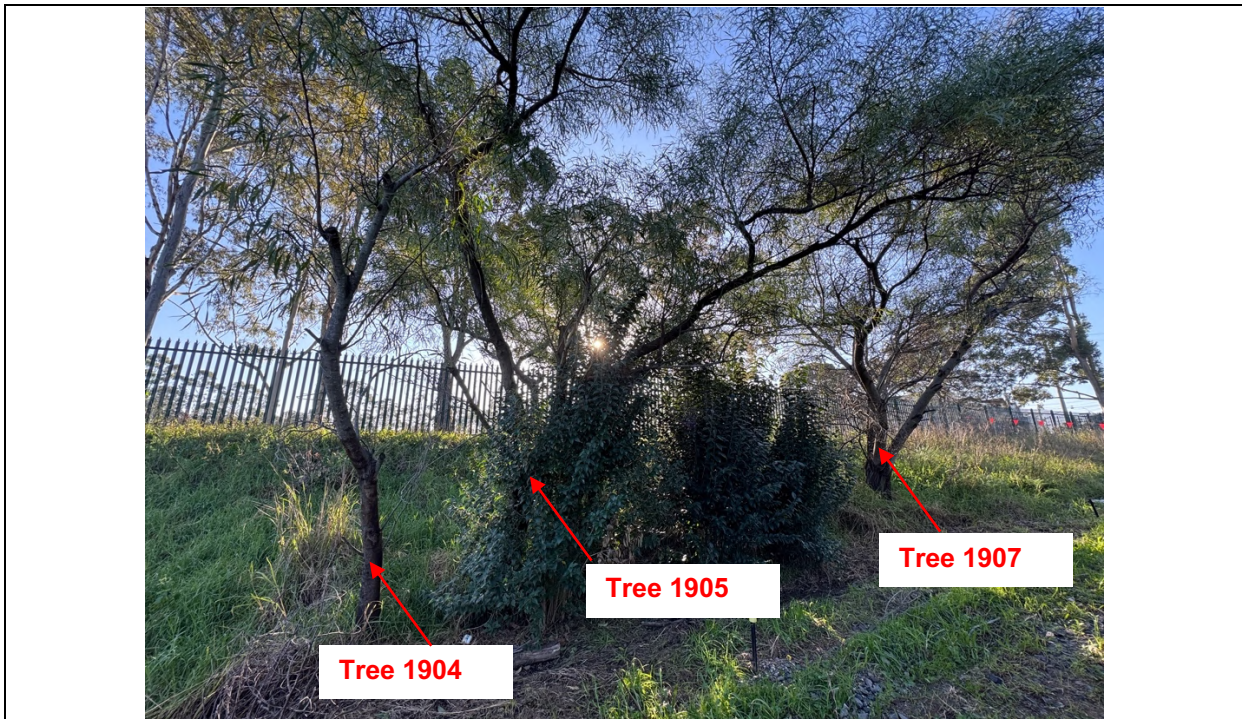
**Image 4:** Looking towards tree 1904, 1905 and 1907. The trees are recommended for removal.

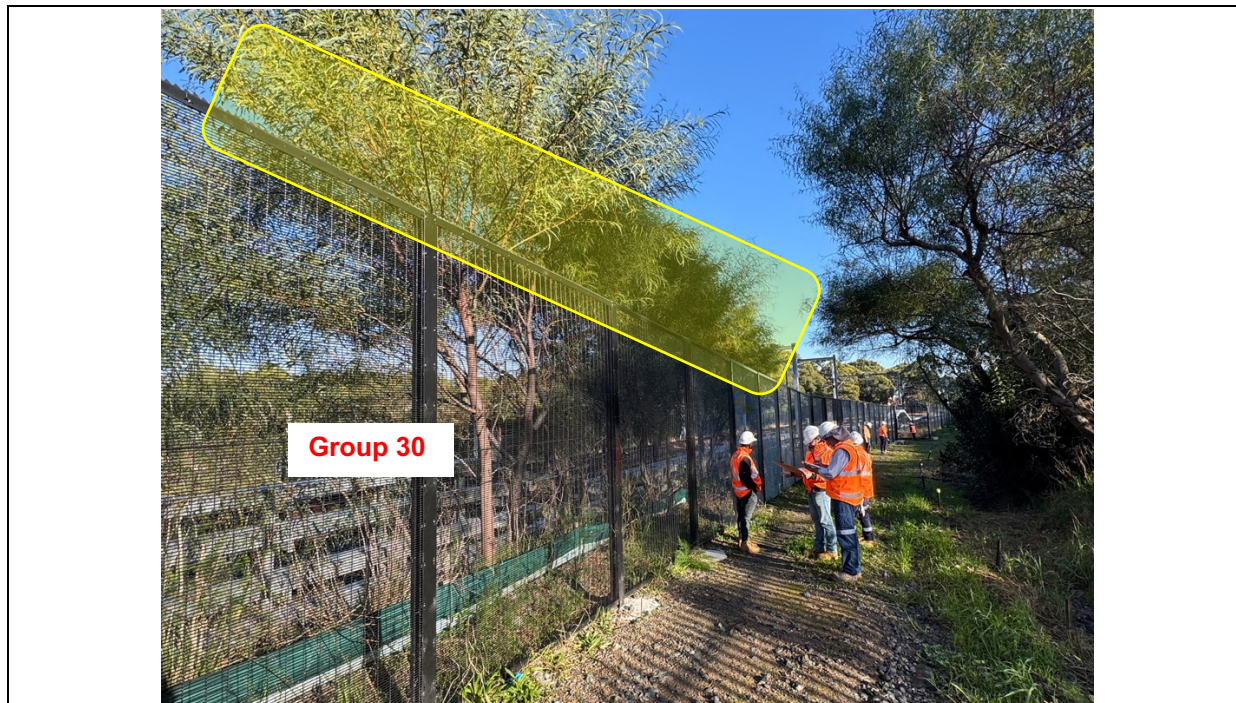
**Image 5:** Looking towards G30. Canopy pruning is required to provide 2m clearance from the fence. Maximum finished cut diameters must not exceed 50mm. The pruning will result in the removal of approximately 20% of the live foliage area of each tree, which is considered significant, but a preferred option to whole tree removal. An approximate area of the pruning has been shaded yellow.

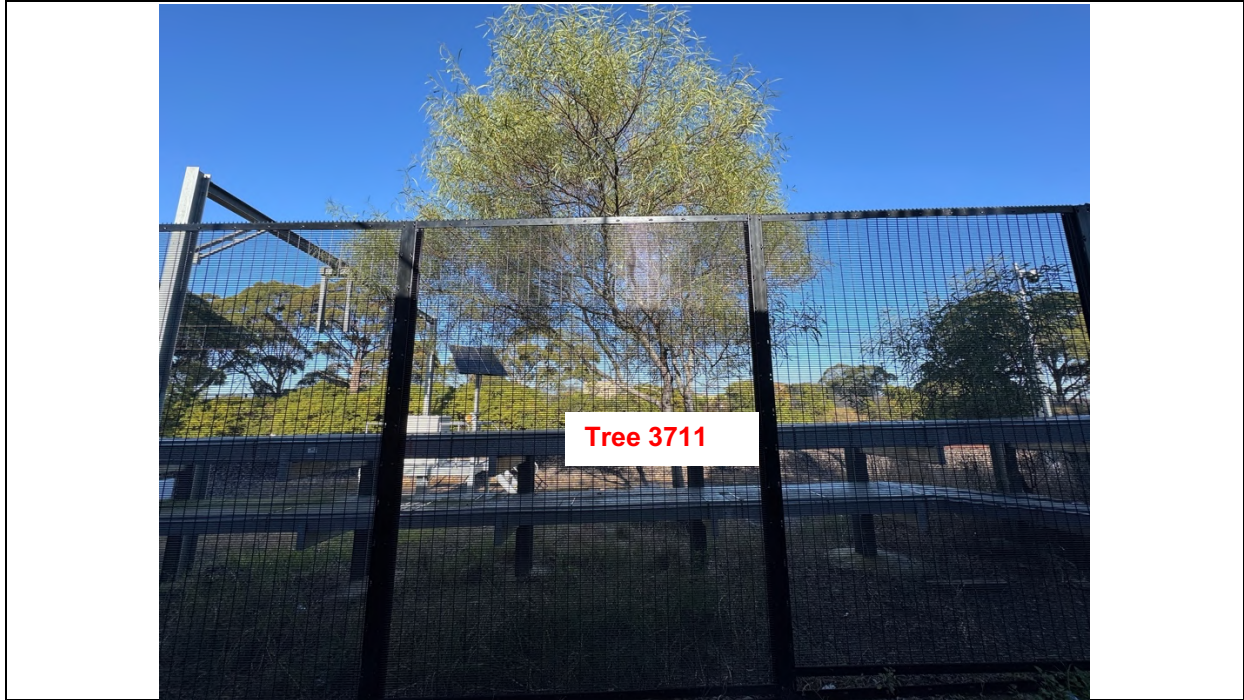
**Image 7:** Looking towards tree 3711. The tree is recommended for removal.

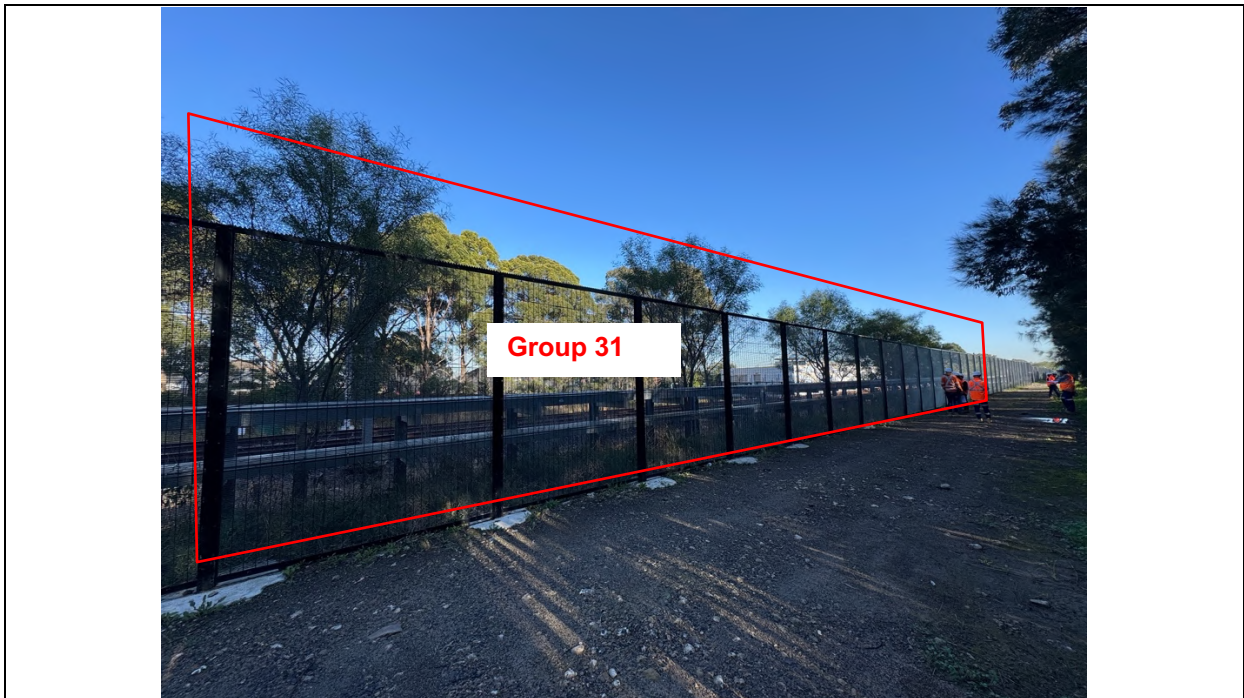
**Image 8:** Looking towards G31. The trees are recommended for removal.

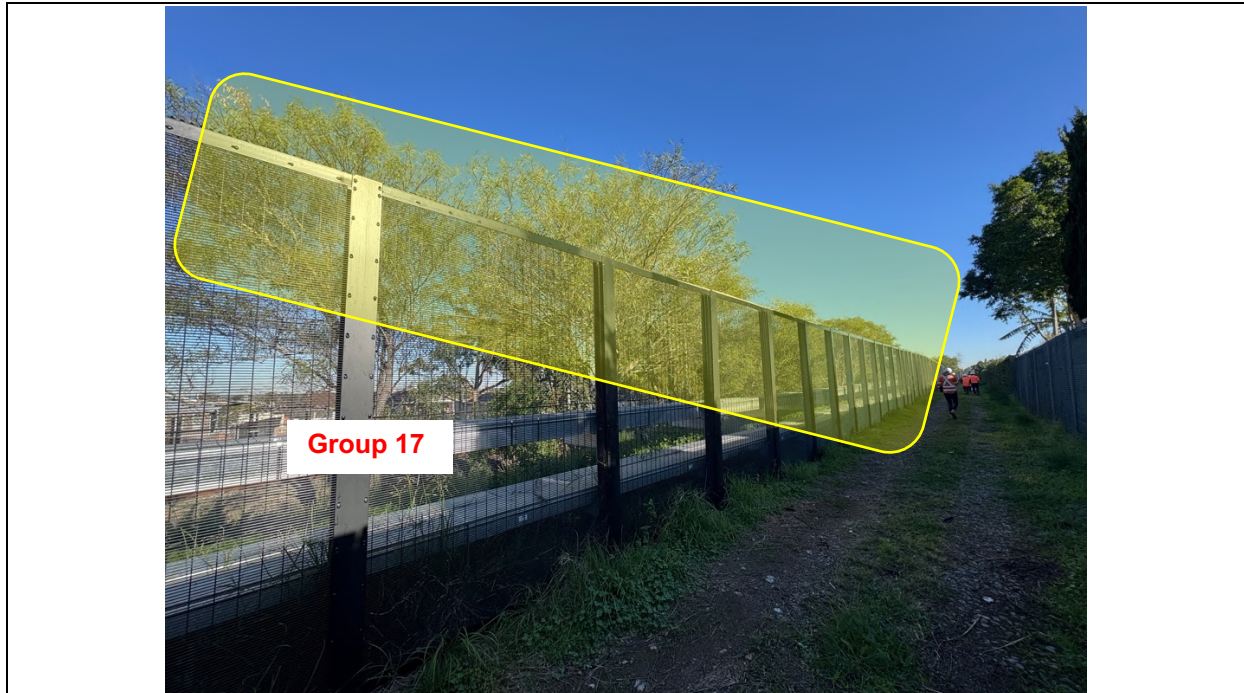
**Image 9:** Looking towards G17. Canopy pruning is required to provide 3m clearance from the fence, and up to sky clearance. Maximum finished cut diameters must not exceed 50mm. The pruning will result in the removal of approximately 20% of the live foliage area of each tree, which is considered significant, but a preferred option to whole tree removal. An approximate area of the pruning has been shaded yellow.

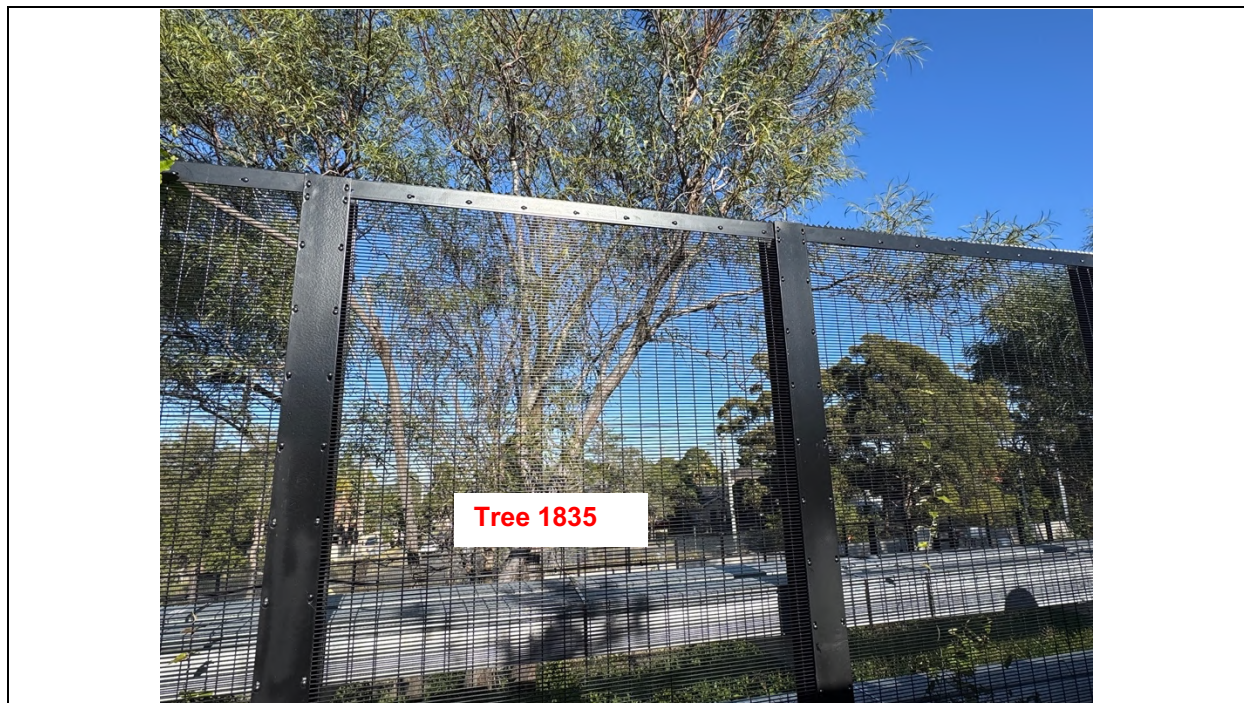
**Image 10:** Looking towards tree 1835. The tree is recommended for removal.

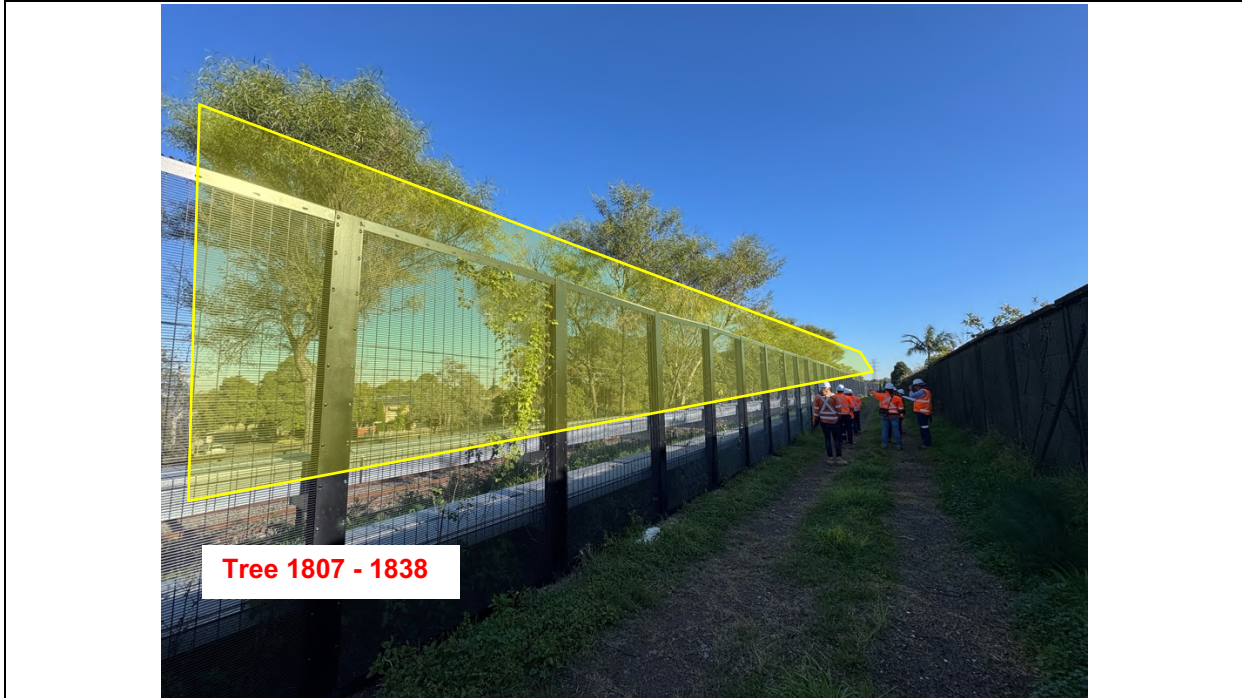
**Tree 1807 - 1838**
