# CIDS & ODS Tree Impact Assessment Report

## SWM3- Tree and Vegetation Management Work Part 2 Instruction

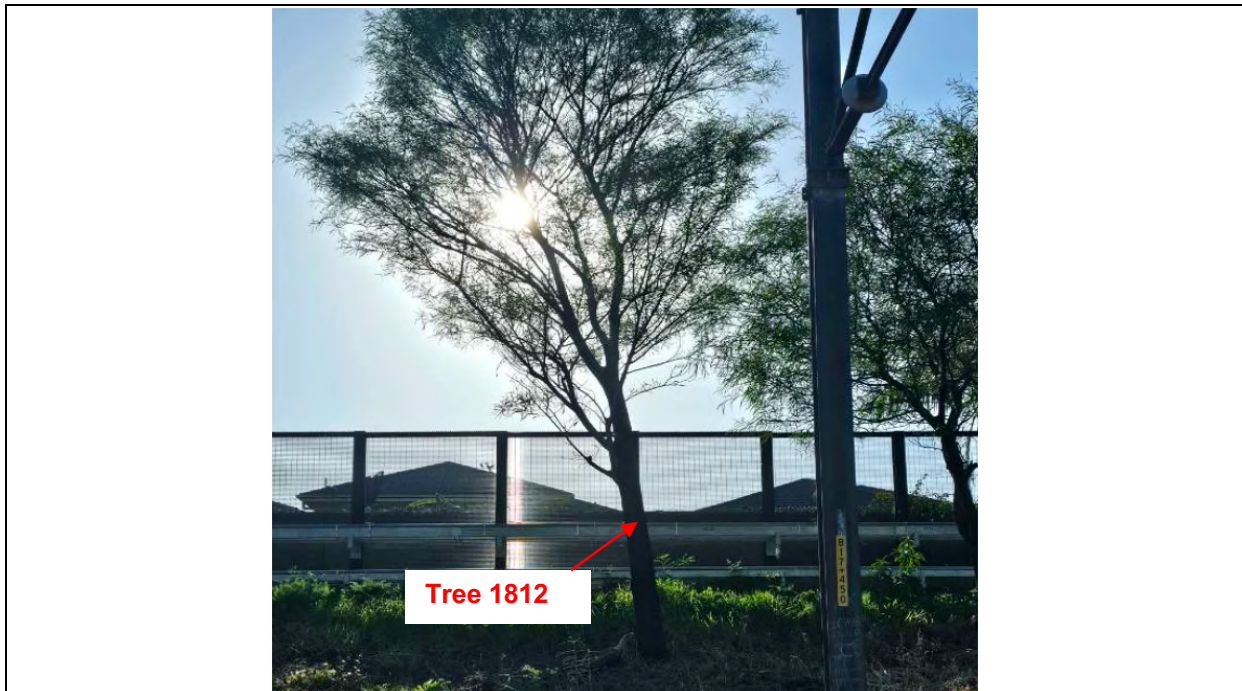
**Image 11:** Looking towards tree 1807 - 1838. Canopy pruning is required to provide 3m clearance from the fence, and up to sky clearance. Maximum finished cut diameters must not exceed 50mm. The pruning will result in the removal of approximately 20% of the live foliage area of each tree, which is considered significant, but a preferred option to whole tree removal. An approximate area of the pruning has been shaded yellow.

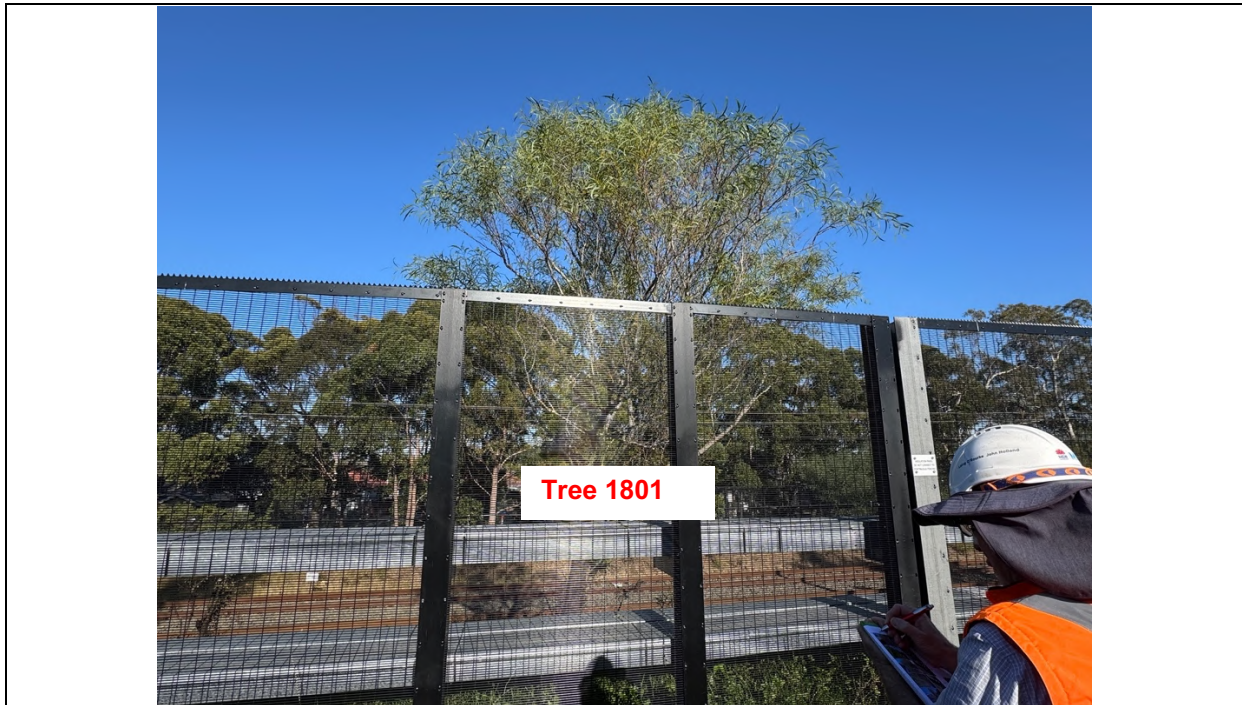
**Image 13:** Looking towards tree 1801. The tree is recommended for removal.

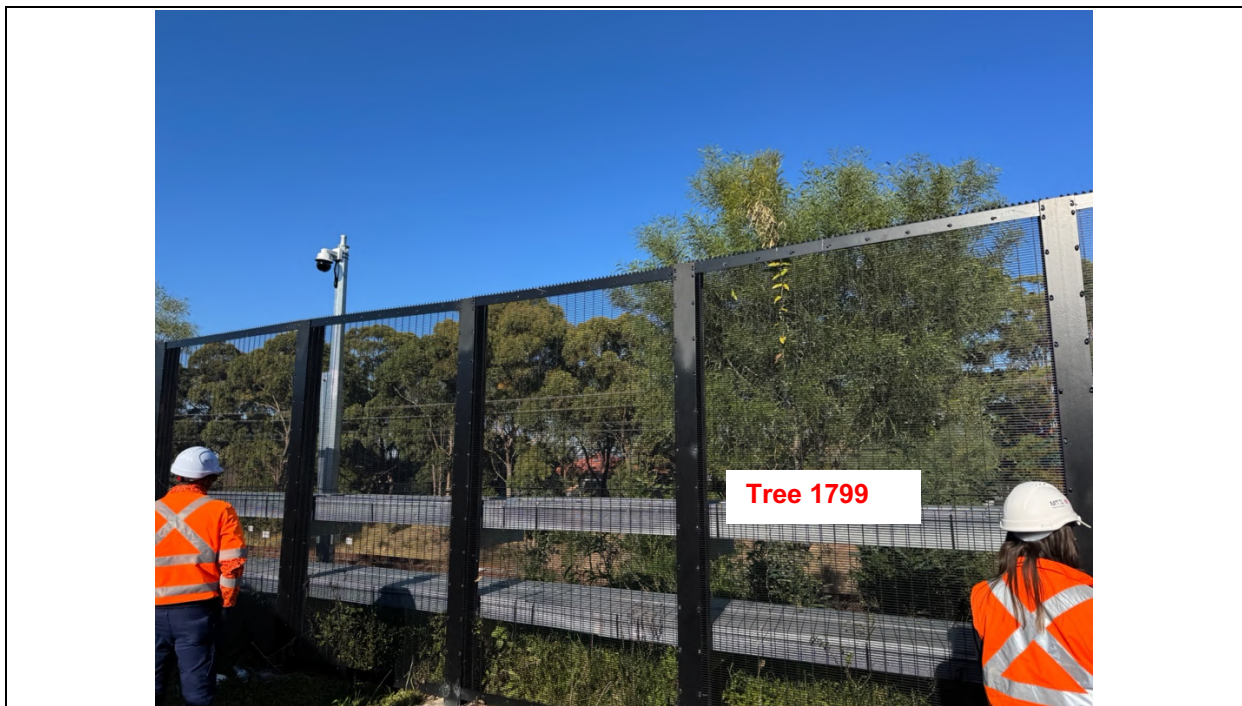
**Image 14:** Looking towards tree 1799. The tree is recommended for removal.

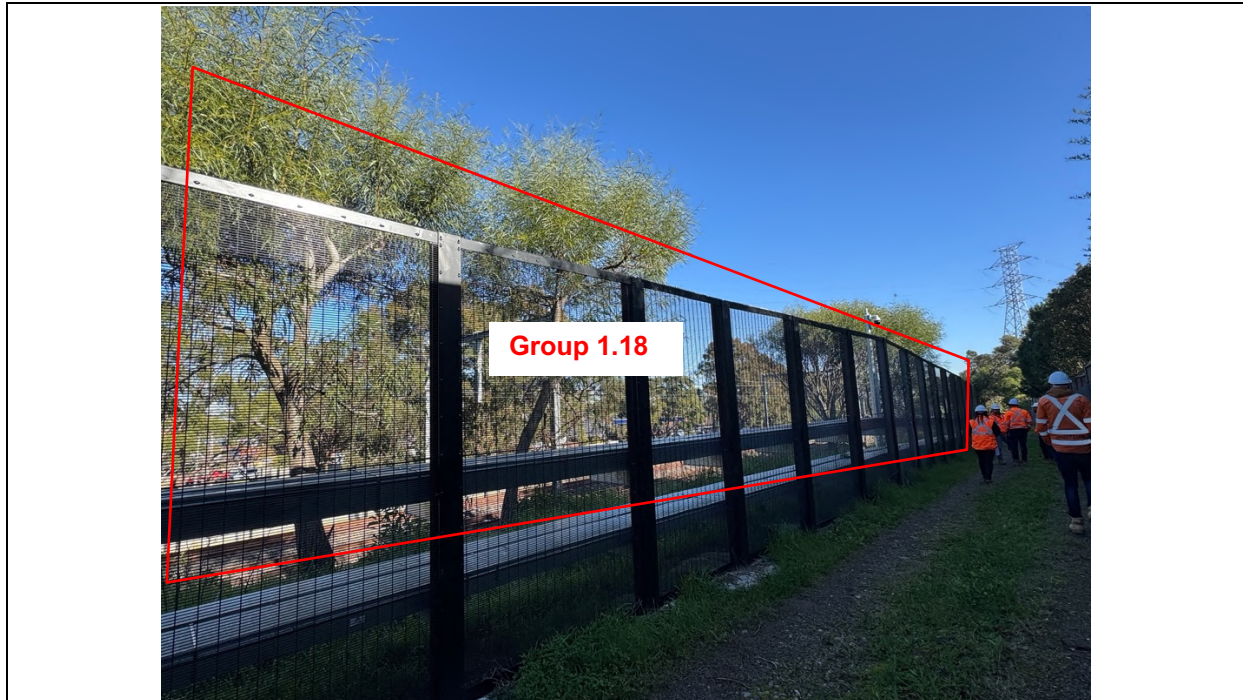
**Image 15:** Looking towards G1.18. The trees are recommended for removal.

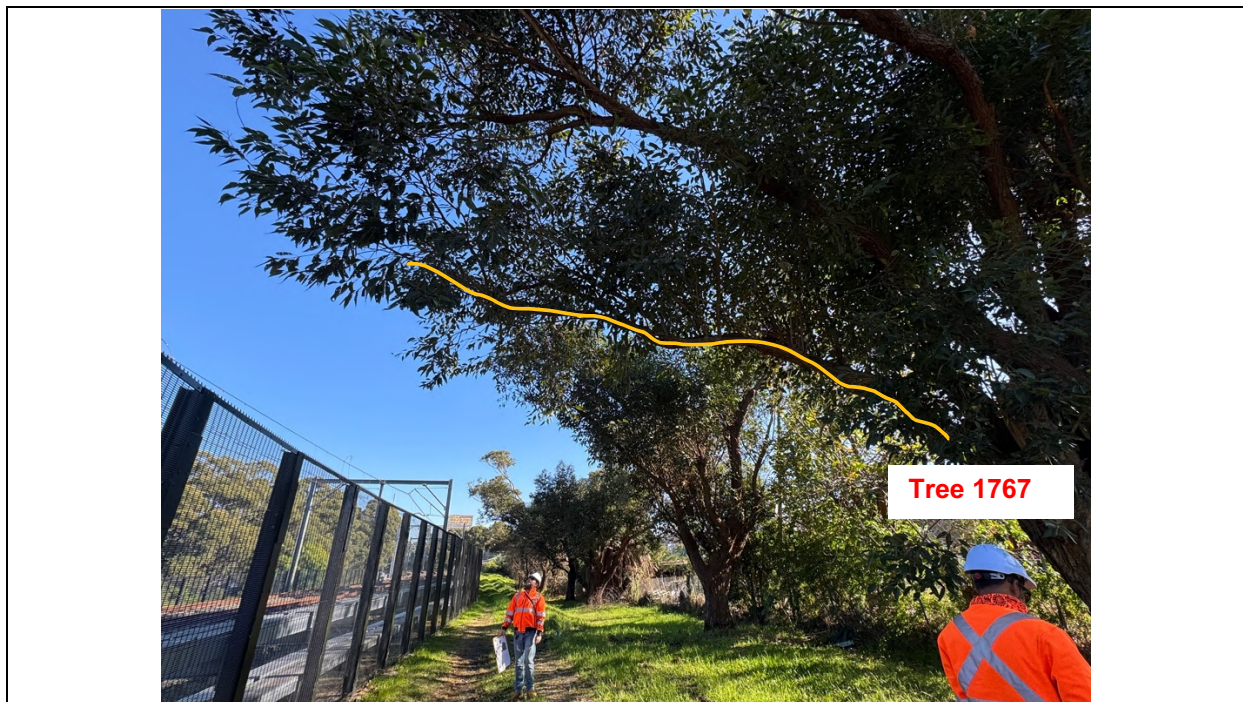
**Image 16:** Looking towards tree 1767. Canopy pruning is required to provide 2m clearance from the fence. The lowest primary branch to the South at 3m is to be removed. The finished cut diameter is estimated to be 160mm. The pruning will result in the removal of less than 10% of the live foliage area of the tree. The branch to be removed has been marked yellow.

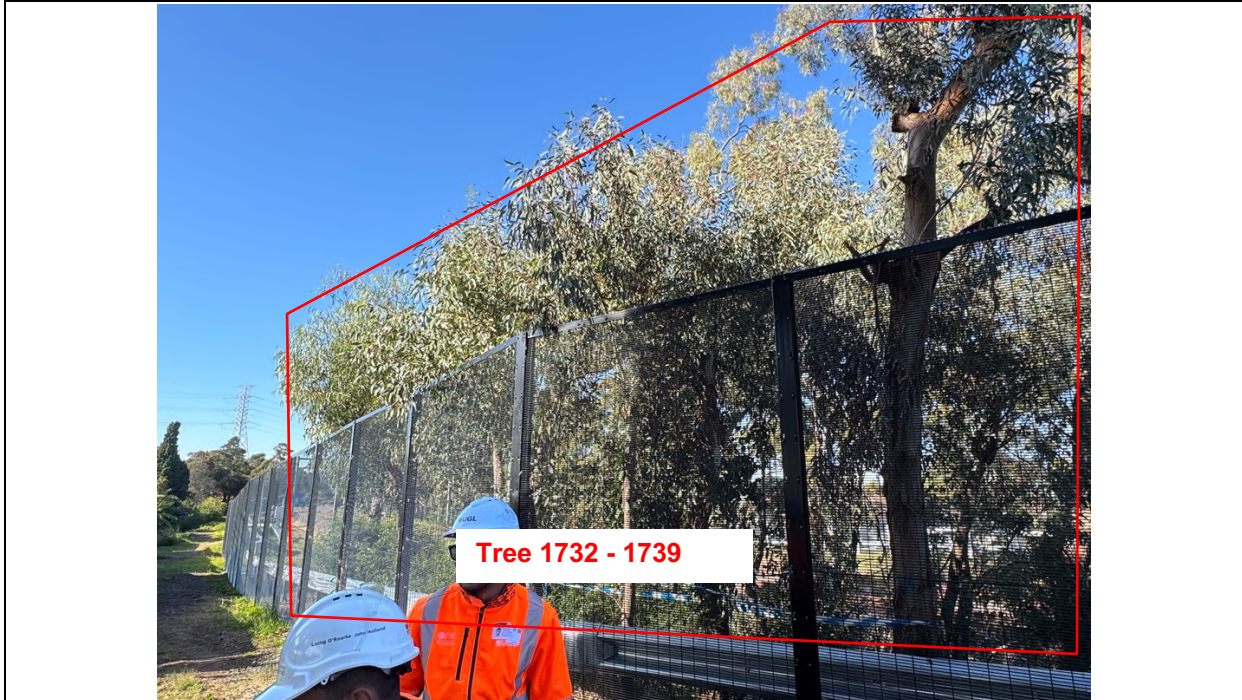
**Image 17:** Looking towards tree 1732, 1736, 1737, 1738 and 1739. The trees are recommended for removal.

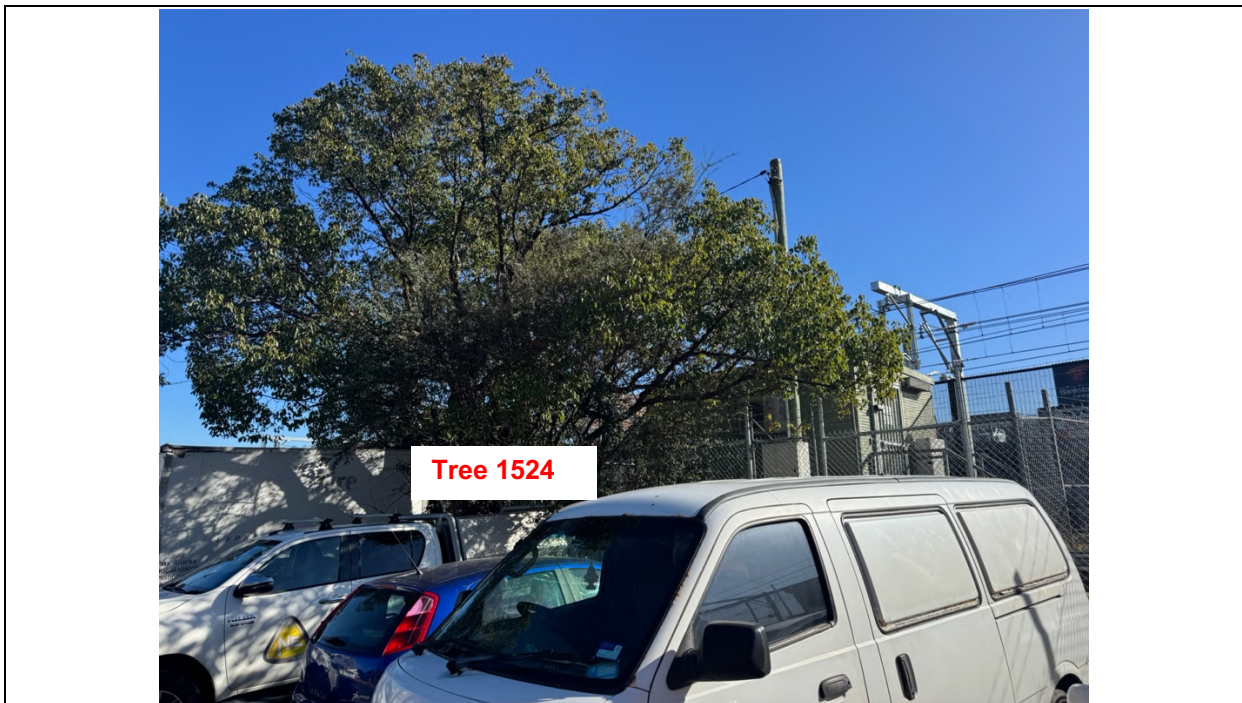
**Image 18:** Looking towards tree 1524. The tree is recommended for removal.

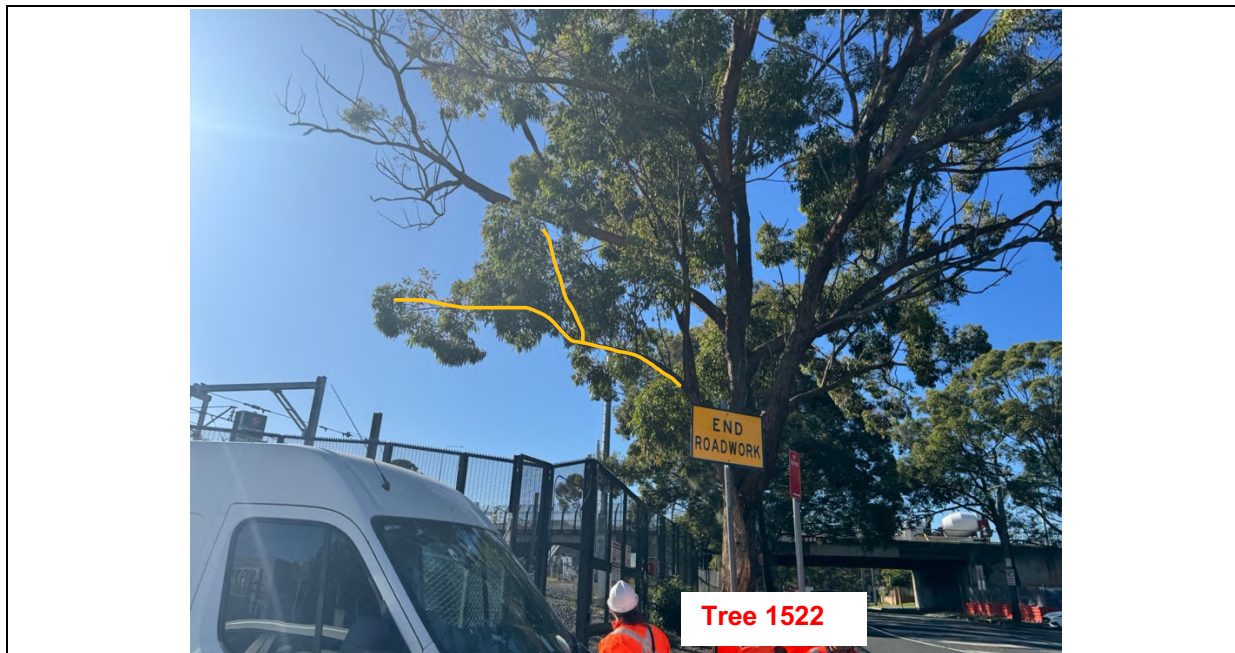
**Image 19:** Looking towards tree 1522. Canopy pruning is required to provide 2m clearance from the fence. The second order branch to the North at 4m is to be removed. The finished cut diameter is estimated to be 70mm. The pruning will result in the removal of less than 5% of the live foliage area of the tree. The branch to be removed has been marked yellow.

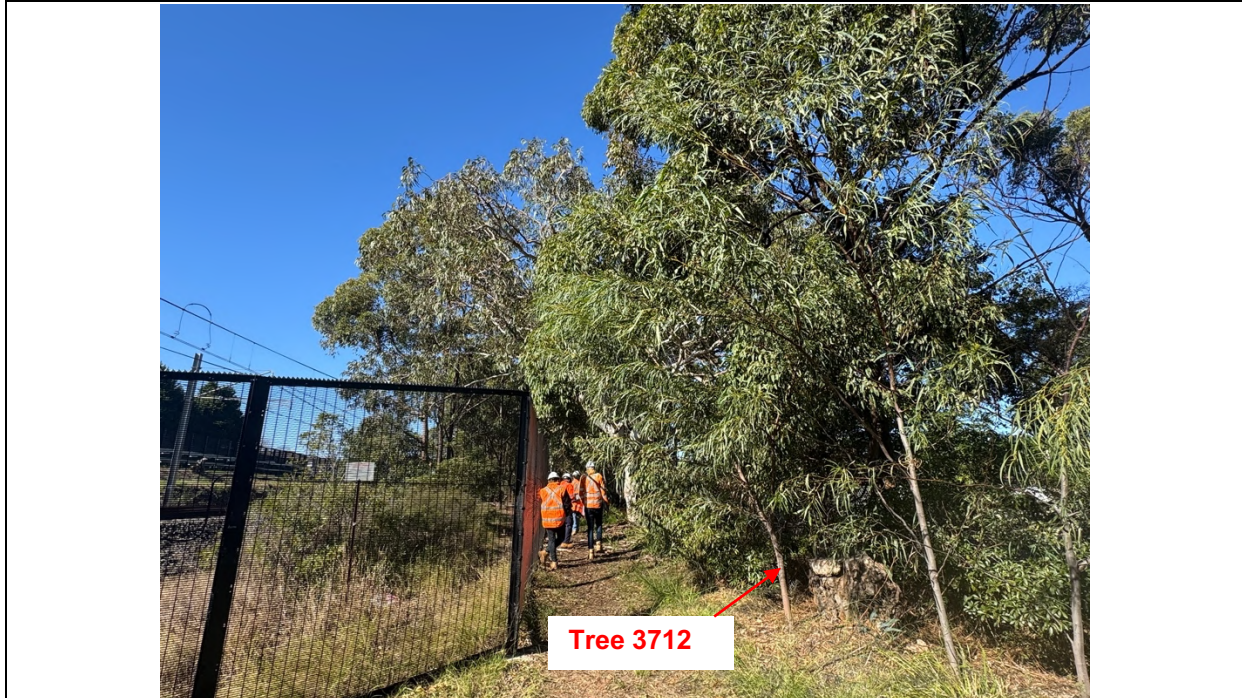
**Image 31:** Looking towards tree 3712. The tree is recommended for removal.

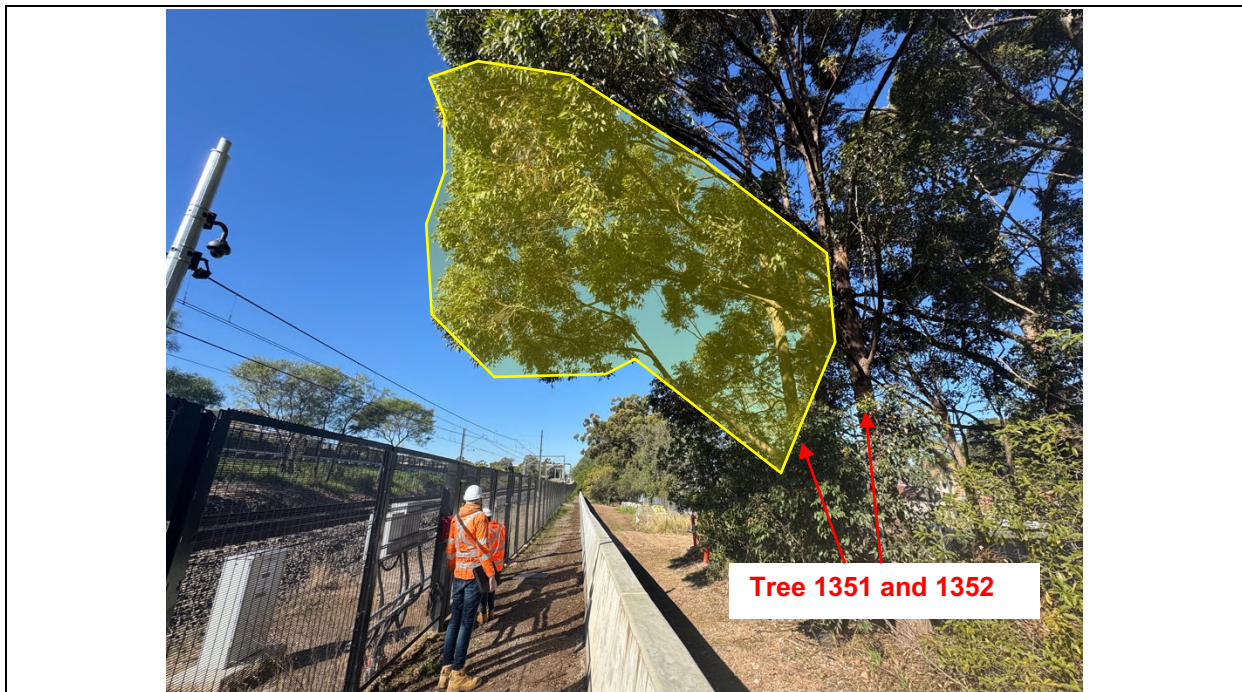
**Image 32:** Looking towards tree 1351 and 1352. Canopy pruning is required to provide unobstructed visibility of the fence. The first order branches up to 4m above ground height and extending to the North are to be removed. Finished cut diameters must not exceed 100mm. The pruning will result in the removal of approximately 10-15% of the live foliage area of each tree. An approximate area of branches to be removed has been shaded yellow.

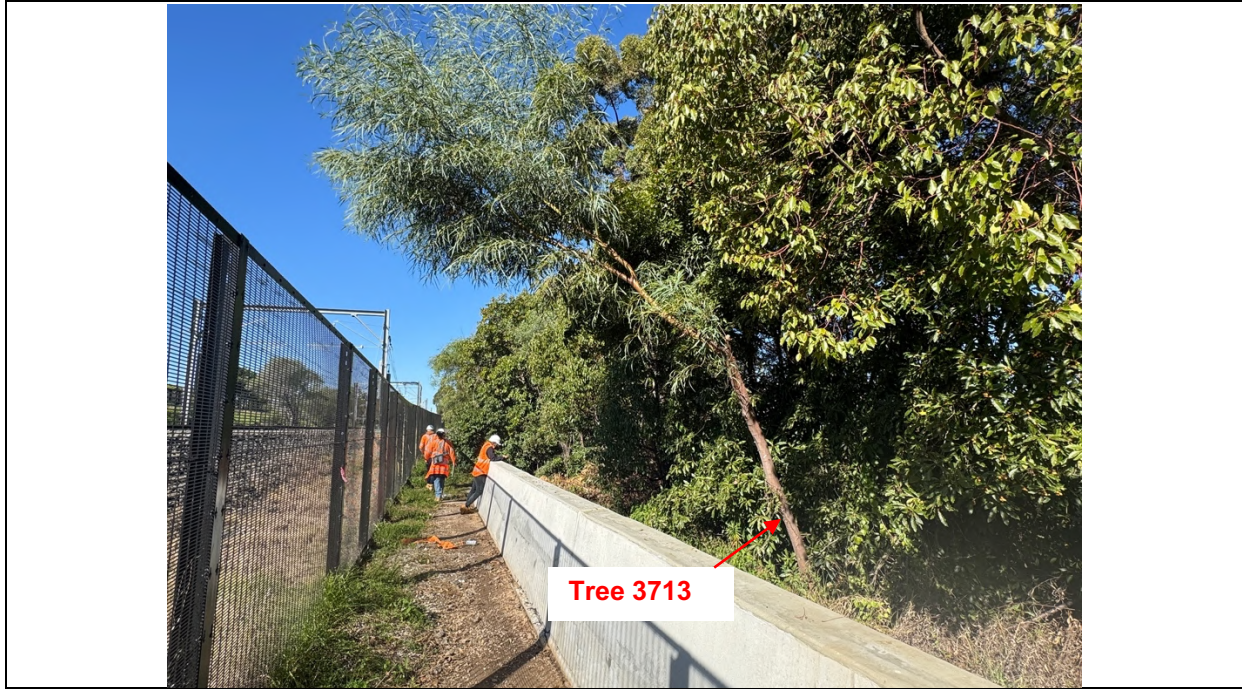
**Image 33:** Looking towards tree 3713. The tree is recommended for removal.

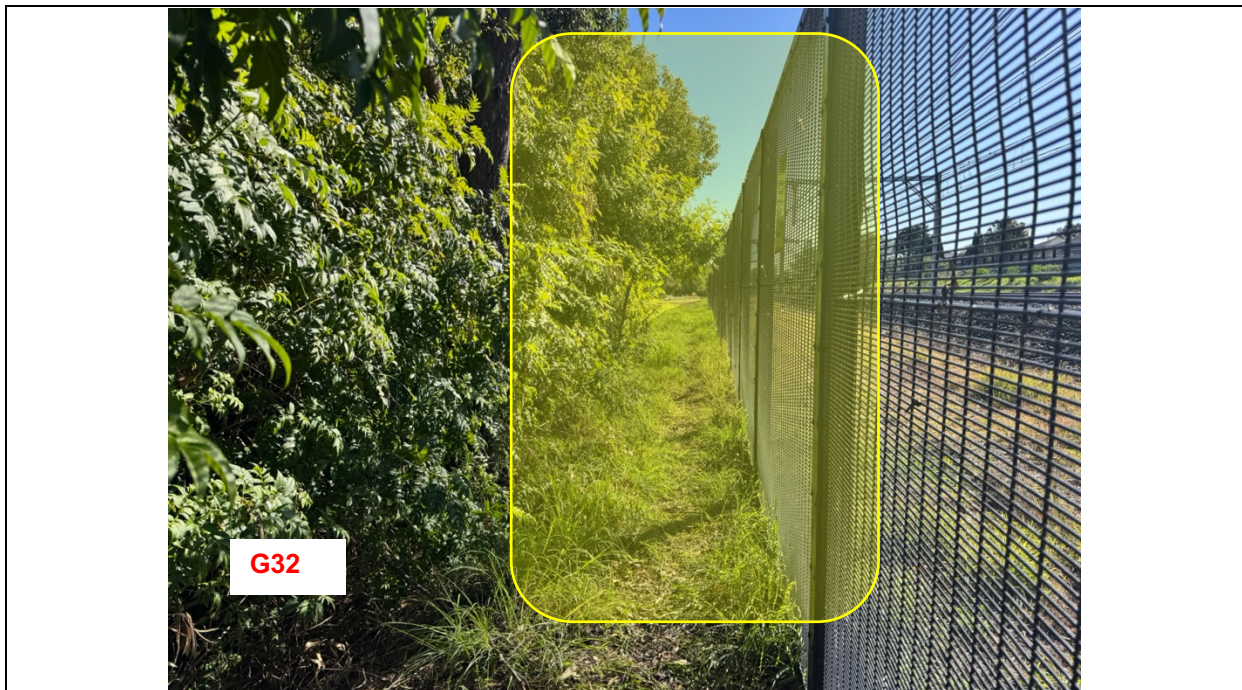
**Image 34:** Looking towards tree G32. Canopy pruning is required to provide 2m clearance from the fence. Maximum finished cut diameters must not exceed 50mm. The pruning will result in the removal of up to 20% of the live foliage area of each tree within the group, which is considered significant, but a preferred option to whole tree removal. An approximate area of the pruning has been shaded yellow.

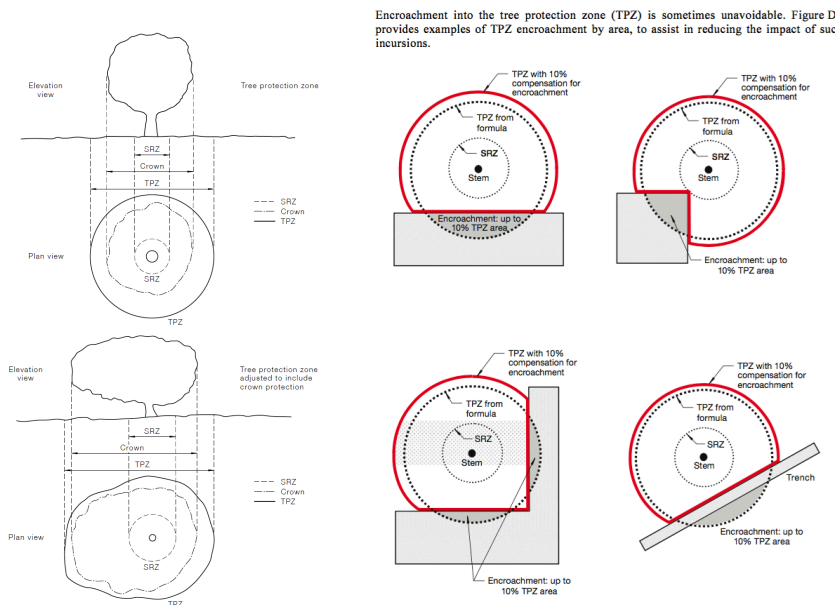
- Structural Root Zone:** This is the area around the base of a tree required for the trees stability in the ground. An area larger than the SRZ always need to be maintained to preserve a viable tree as it will only have a minor effect on the trees vigour and health. There are several factors that determine the SRZ which include height, crown area, soil type and soil moisture. It can also be influenced by other factors such as natural or built structures. Generally work within the SRZ should be avoided.

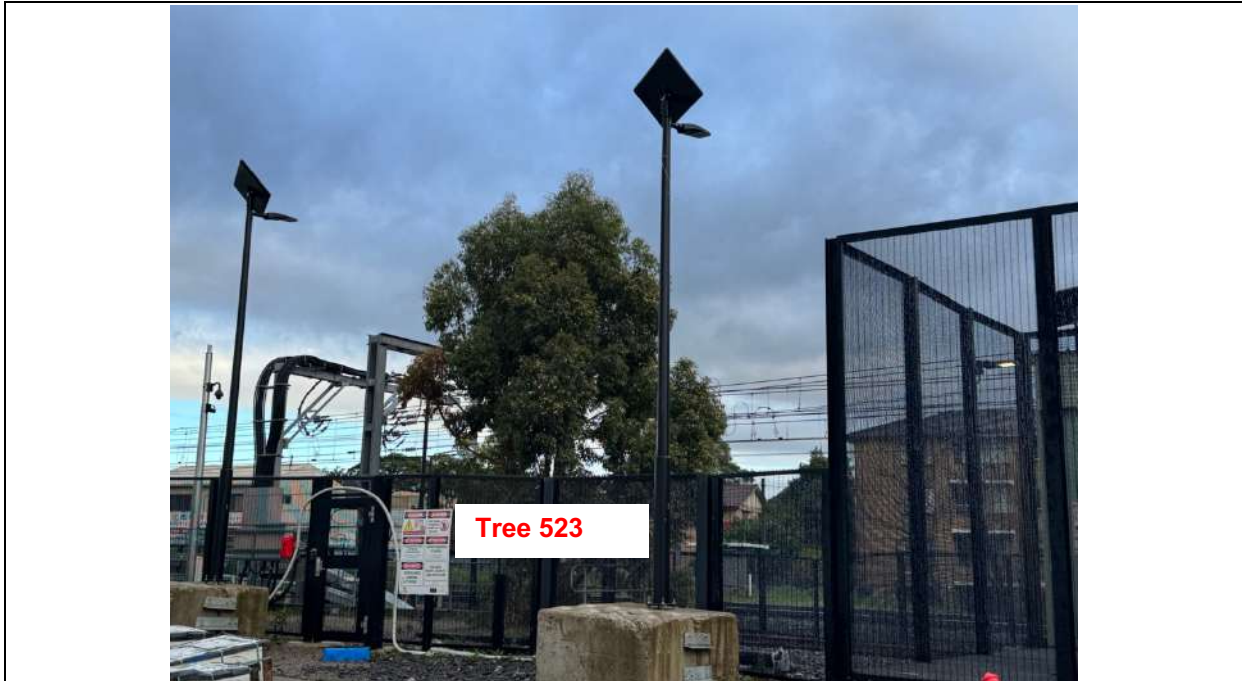
**Image 1:** Looking towards tree 523. The tree is recommended for removal.

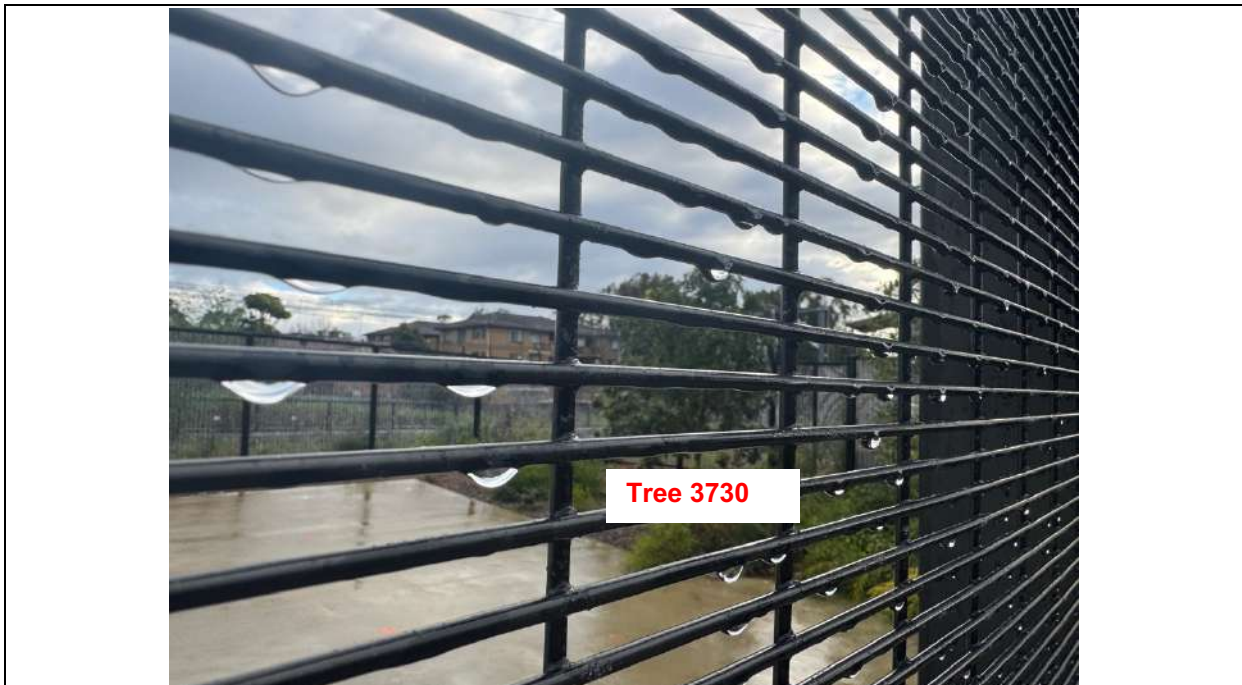
**Image 2:** Looking towards tree 3730. The tree is recommended for removal.

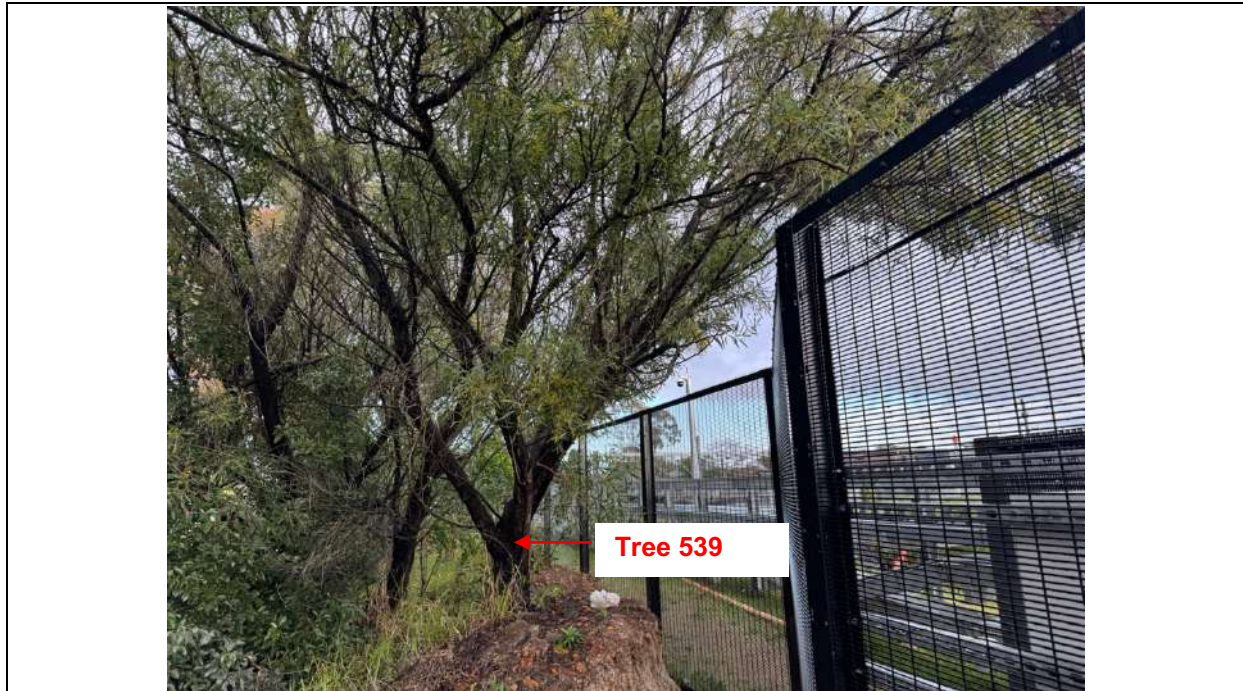
**Image 3:** Looking towards tree 539. The tree is recommended for removal.

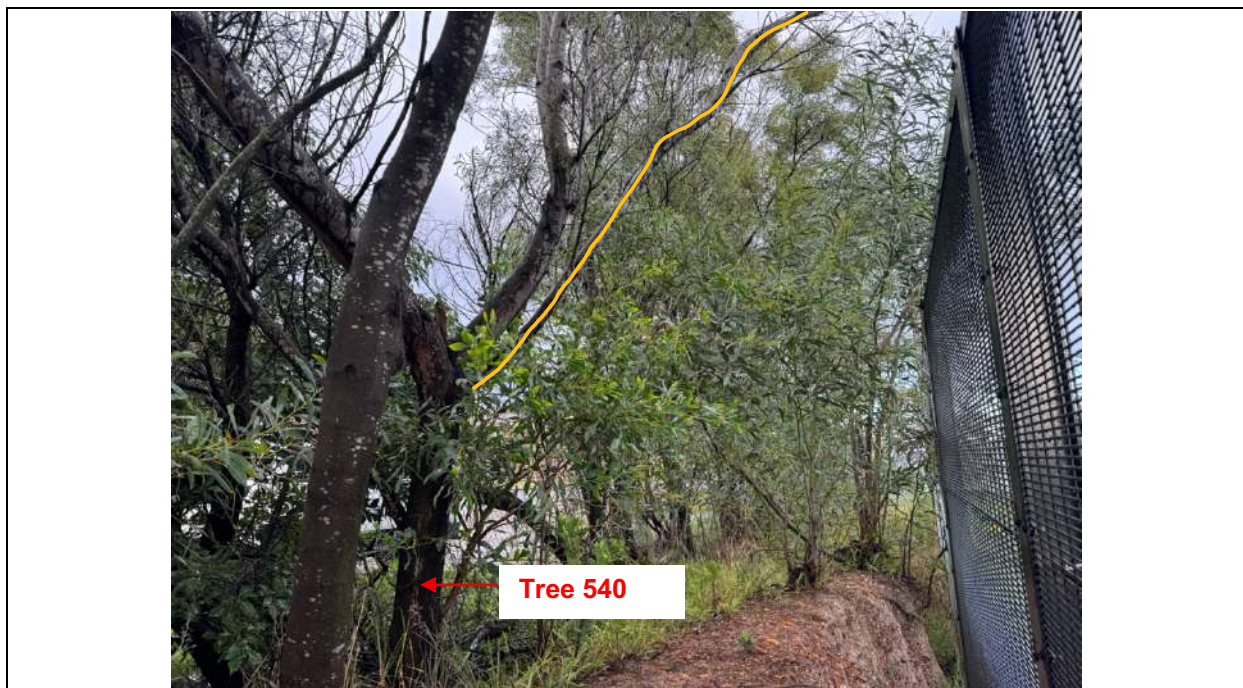
**Image 4:** Looking towards tree 540. Canopy pruning is required to provide 2m clearance from the fence. The 60mm diameter first order branch over the fence is to be pruned at approximately 1m above ground level. The pruning will result in the removal of 5% of the live foliage area of the tree. The branch to be removed has been marked yellow.

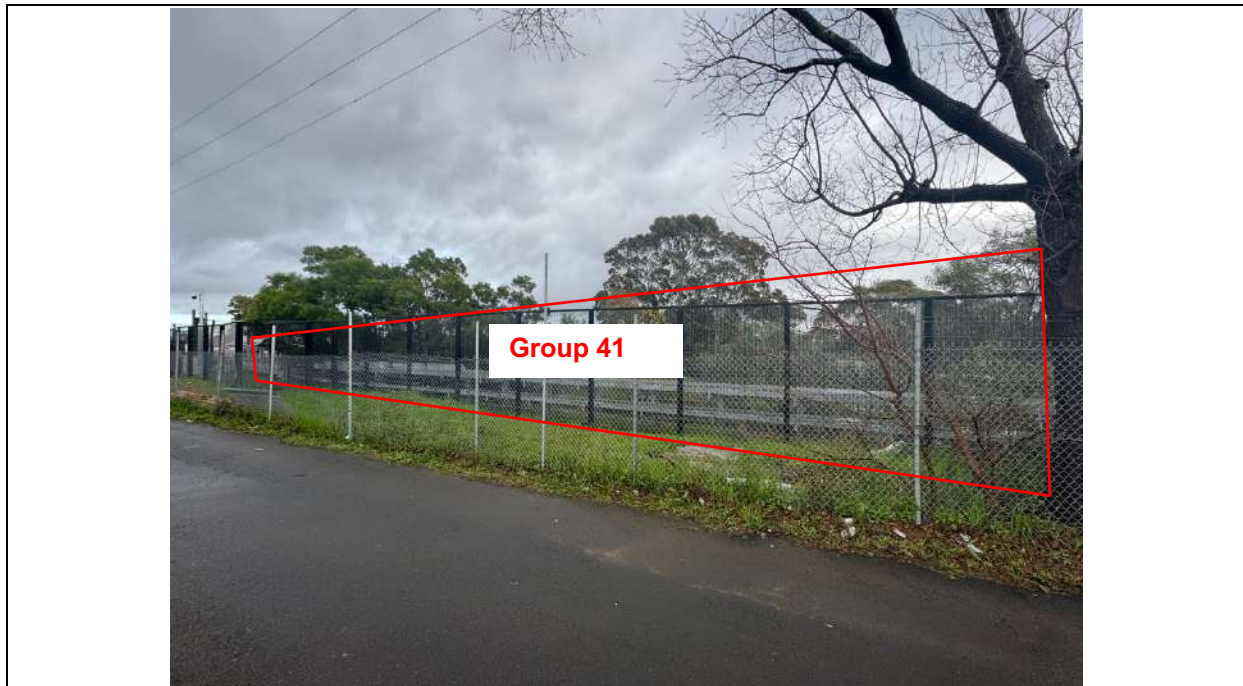
**Image 6:** Looking towards G41. Group of approximately 20 trees recommended for removal. See Image 7 below for a close up of 5 trees at the Western end of the group.

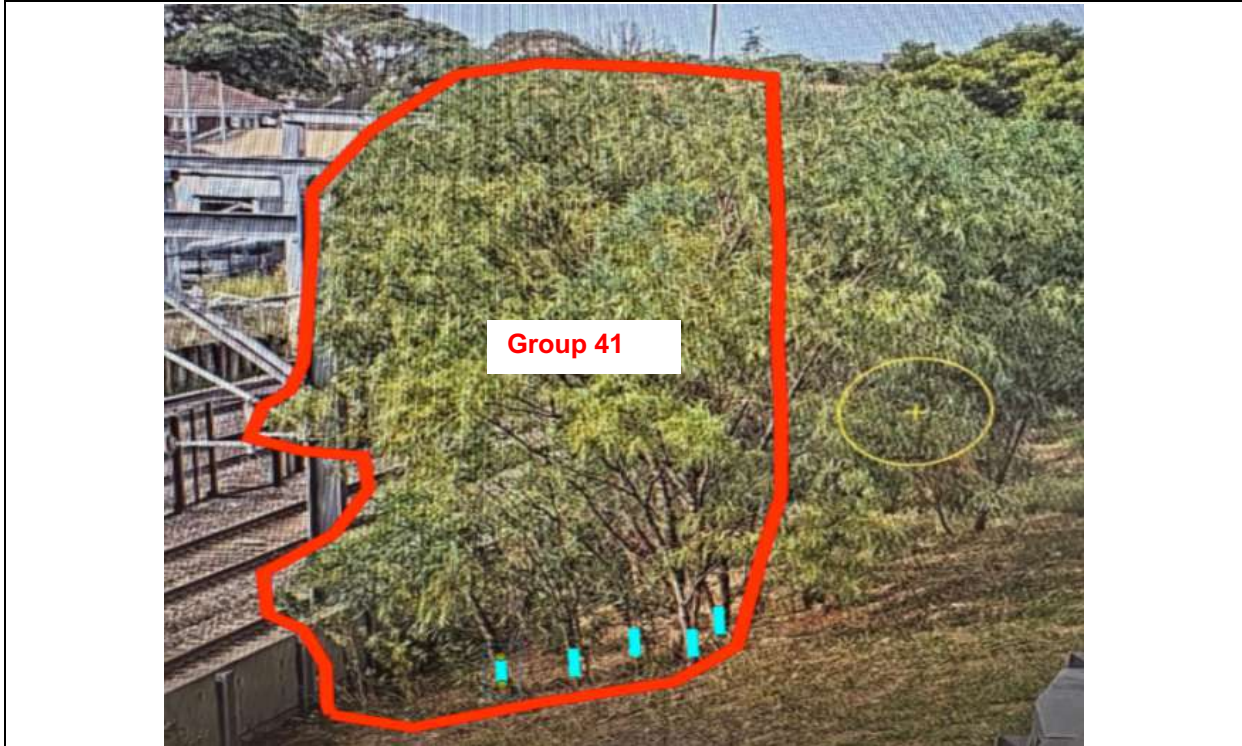
**Image 7:** Looking towards G41. Showing a close up of 5 small trees at the Western end of the G41 on Lilian Lane near Moreton St Bridge..

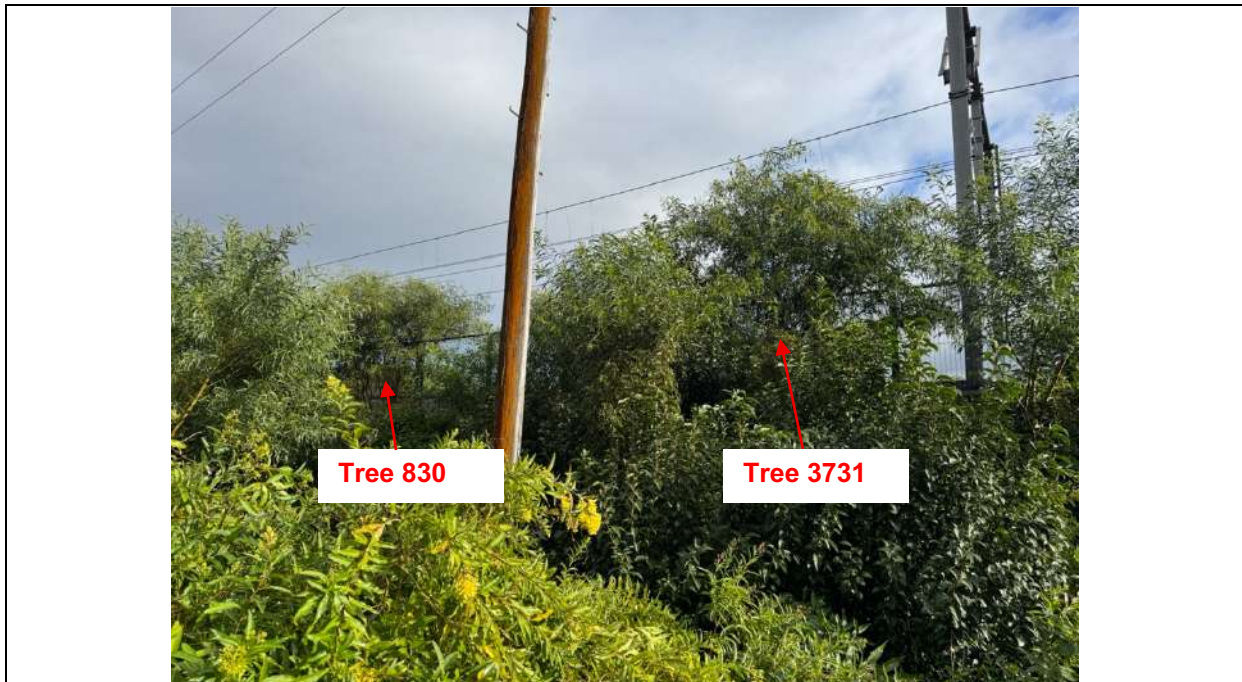
**Image 8:** Looking towards tree 830 and 3731. The trees are recommended for removal.

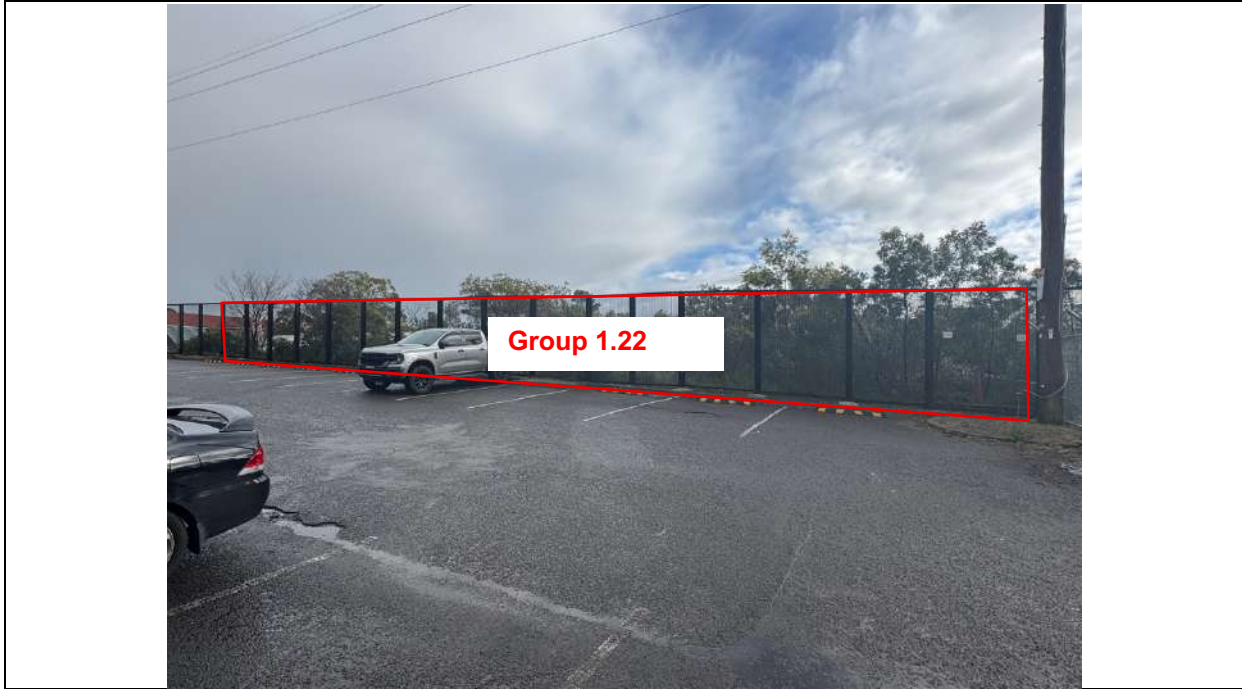
**Image 9:** Looking towards G1.22. Group of approximately 15 trees recommended for removal.

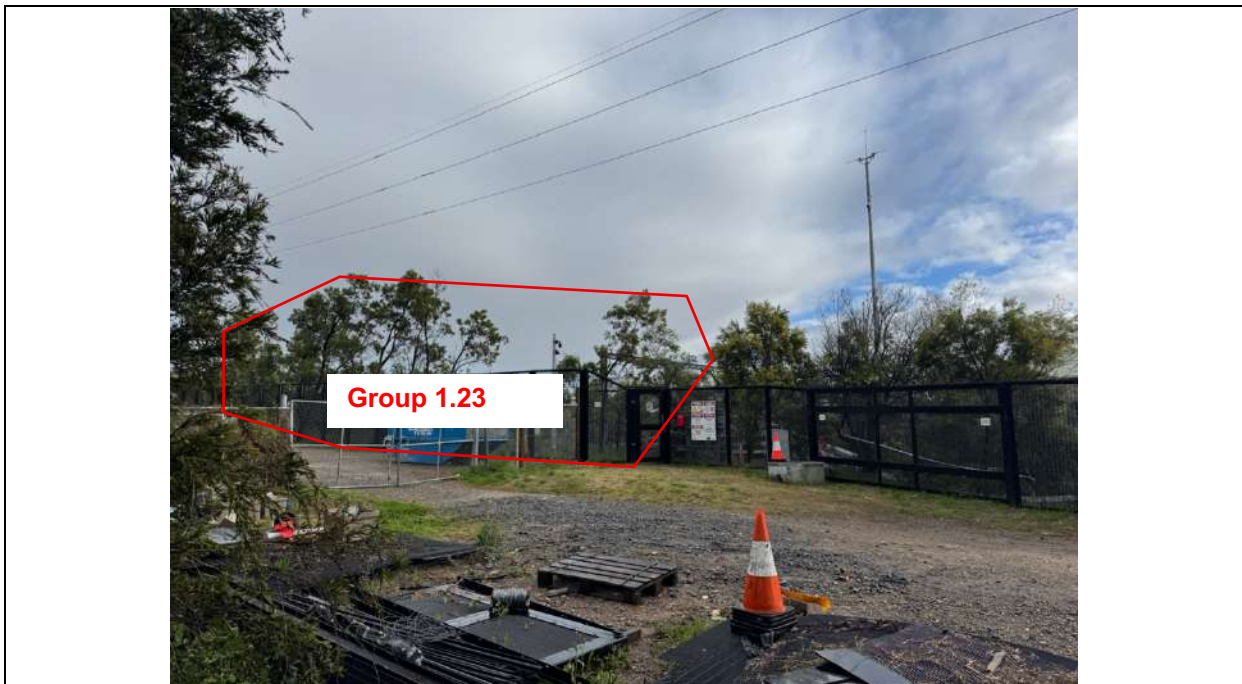
**Image 10:** Looking towards G1.23. Group of approximately 25 trees recommended for removal.

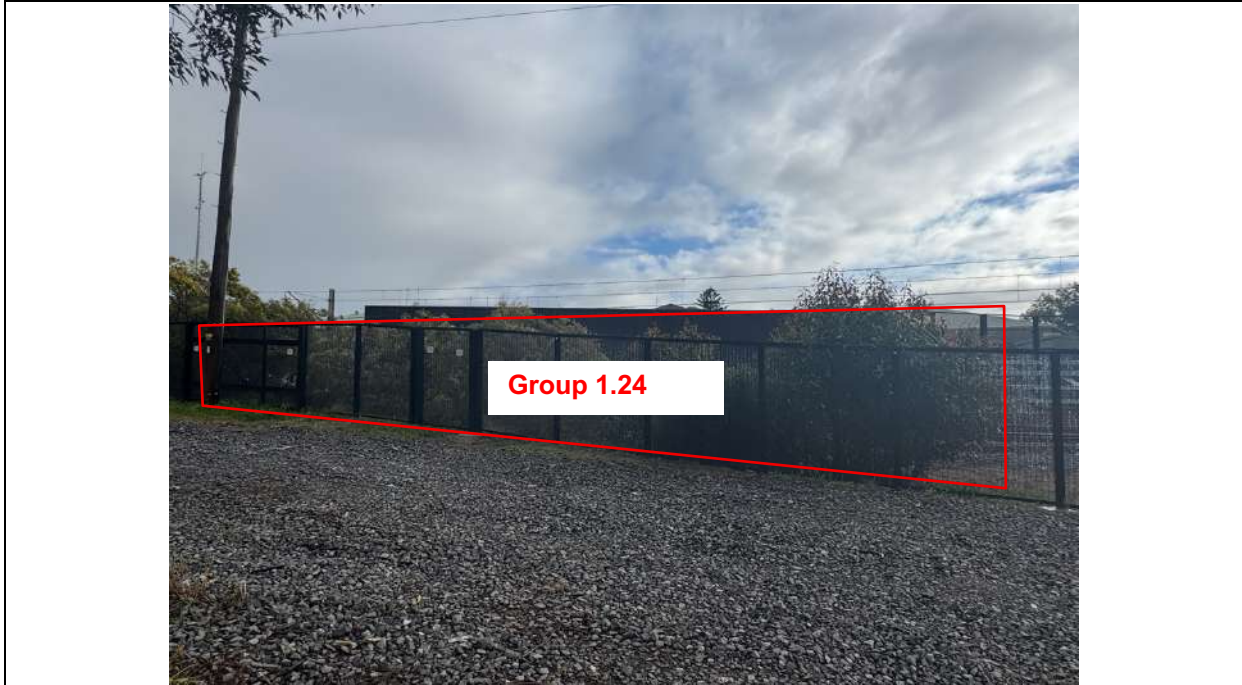
**Image 11:** Looking towards G1.24. Group of approximately 20 trees recommended for removal.

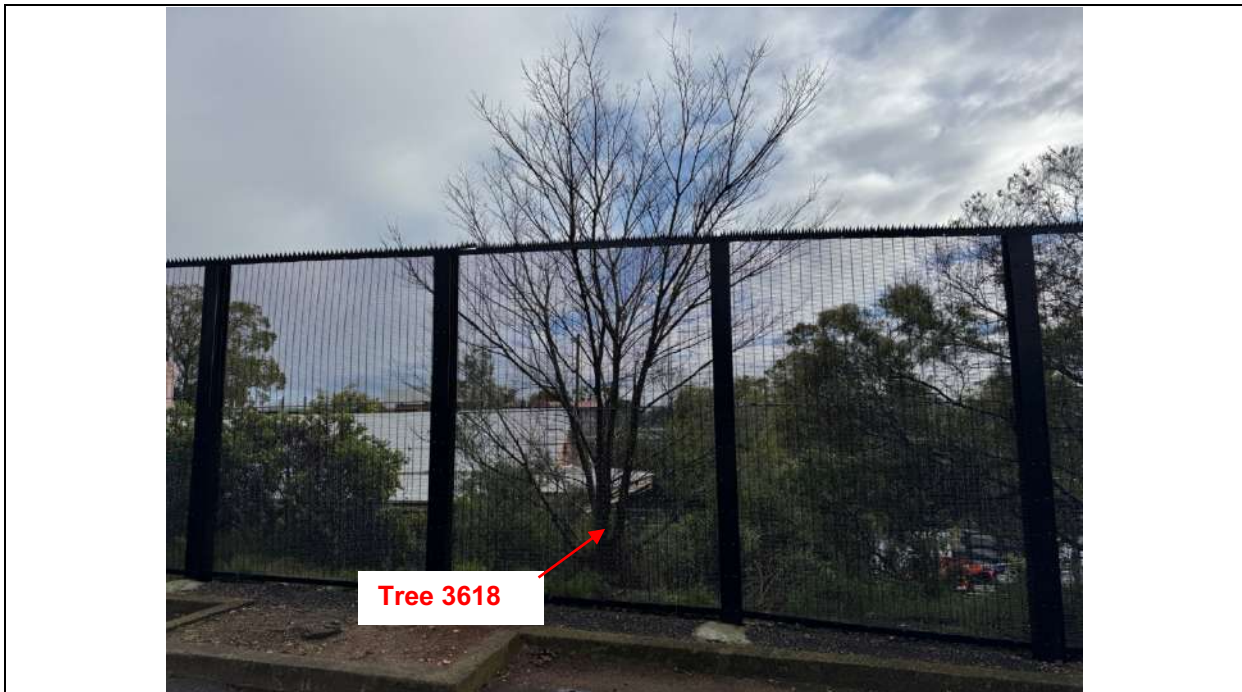
**Image 12:** Looking towards tree 3618. The tree is recommended for removal

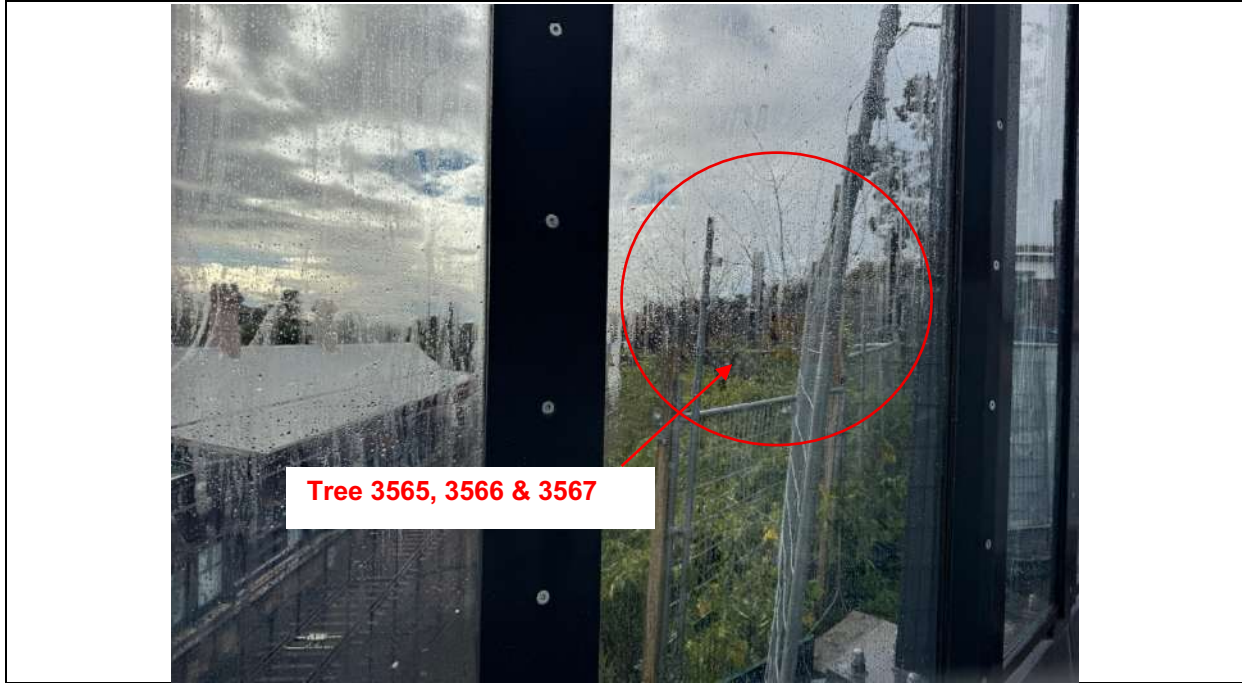
**Image 13:** Looking towards tree 3565, 3566 and 3567. The trees are recommended for removal.

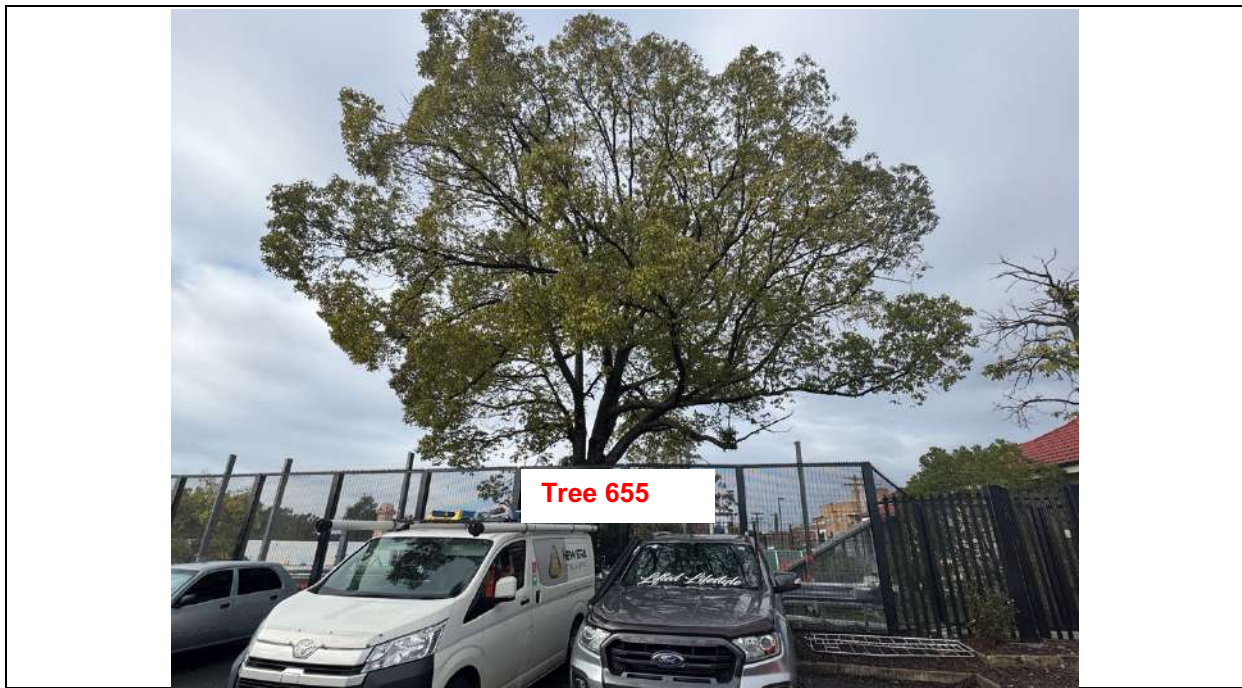
**Image 14:** Looking towards tree 655. The tree is recommended for removal.
