# CIDS & ODS Tree Impact Assessment Report

## SWM3- Tree and Vegetation Management Work Part 2 Instruction

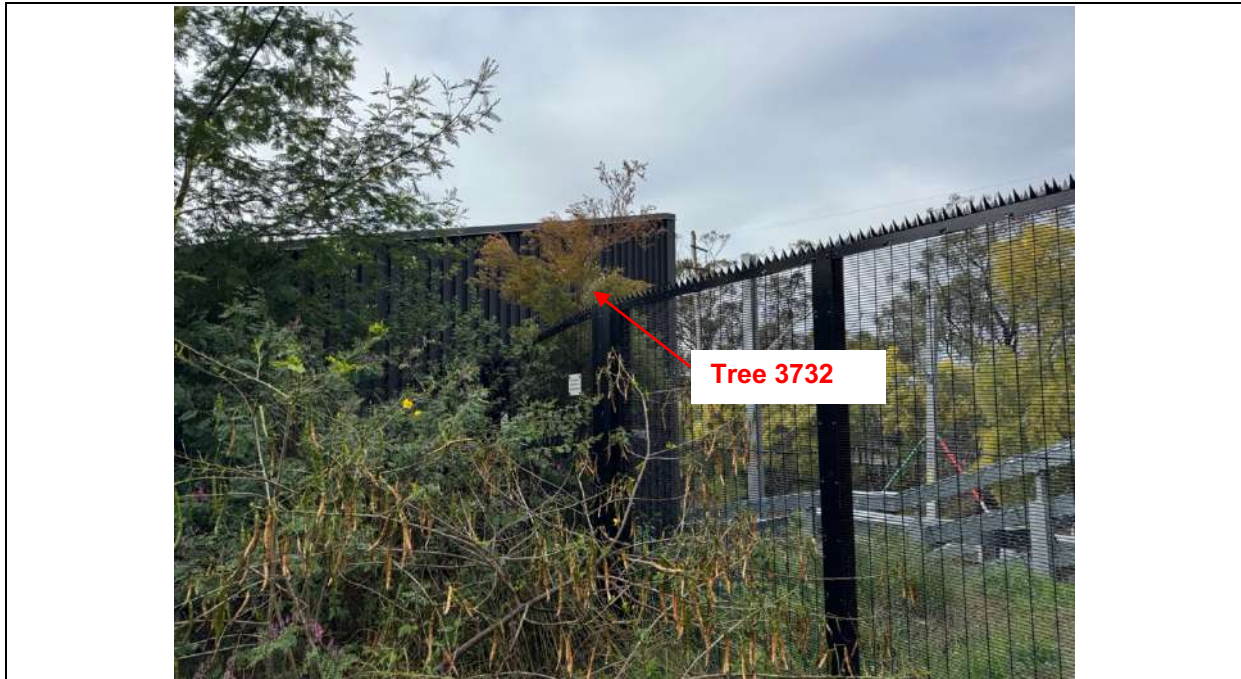
**Image 15:** Looking towards tree 3732. The tree is recommended for removal.

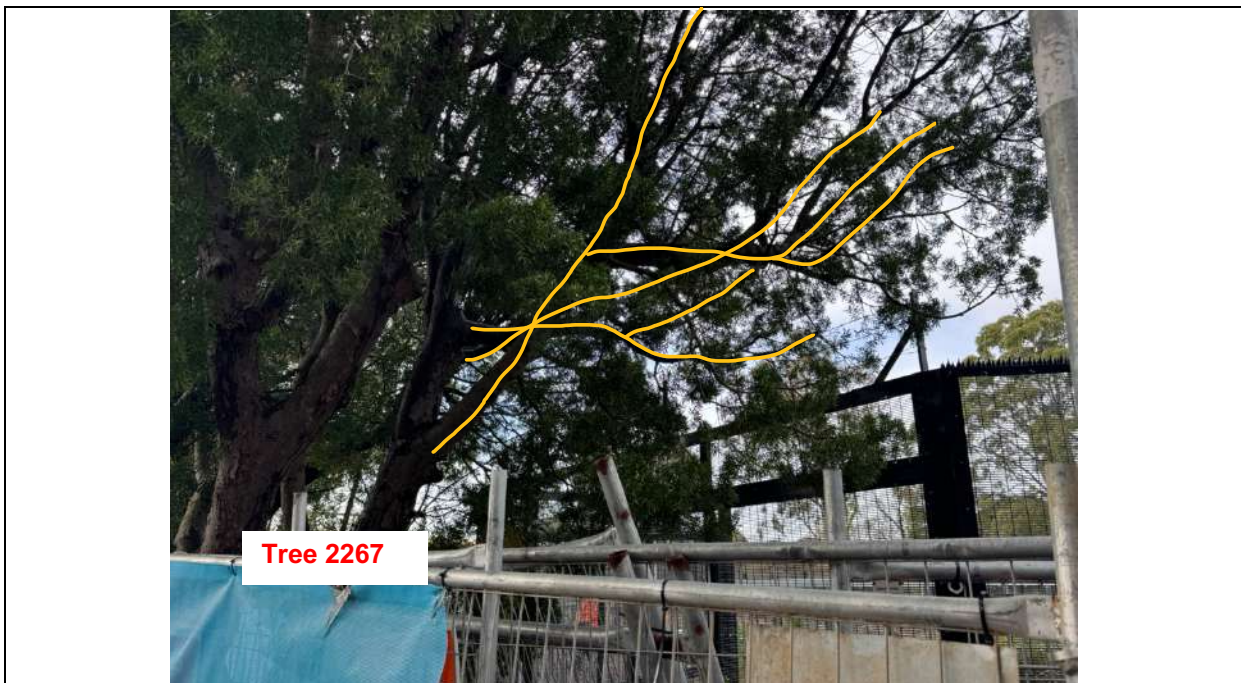
**Image 16:** Looking towards tree 2267. Canopy pruning is required to provide 2m clearance from the fence. The three first order branches to the South (max finished cut diameter of 140mm) and the smaller branches measuring less than 50mm in diameter to the South are to be pruned. The pruning will result in the removal of approximately 10% of the live foliage area of the tree. The branches to be removed have been marked yellow.

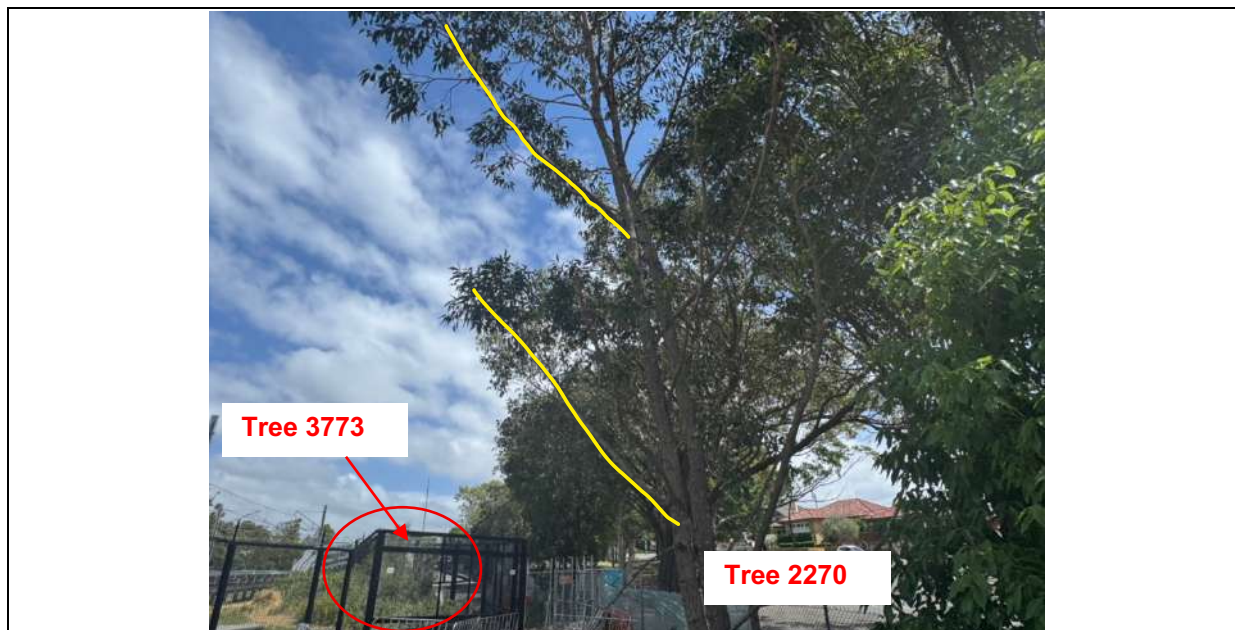
**Image 17:** Looking towards tree 2270. Canopy pruning is required to provide 2m clearance from the fence. The two first order branches to the Southwest (max finished cut diameter of 60mm) are to be pruned. The pruning will result in the removal of approximately 5% of the live foliage area of the tree. The branches to be removed have been marked yellow. Also showing tree 3773 which is recommended for removal.

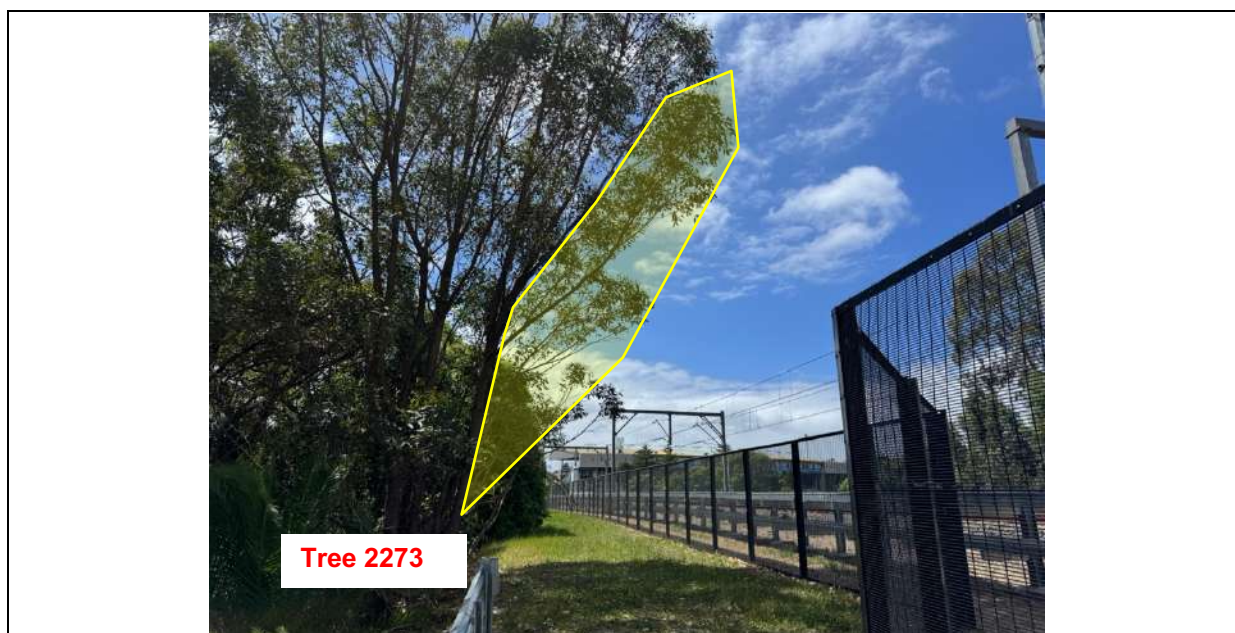
**Image 18:** Looking towards tree 2273. Canopy pruning is required to provide 2m clearance from the fence. The smaller branches to the Southwest (max finished cut diameter of 70mm) are to be pruned. The pruning will result in the removal of approximately 5% of the live foliage area of the tree. The approximate area of pruning has been marked yellow.

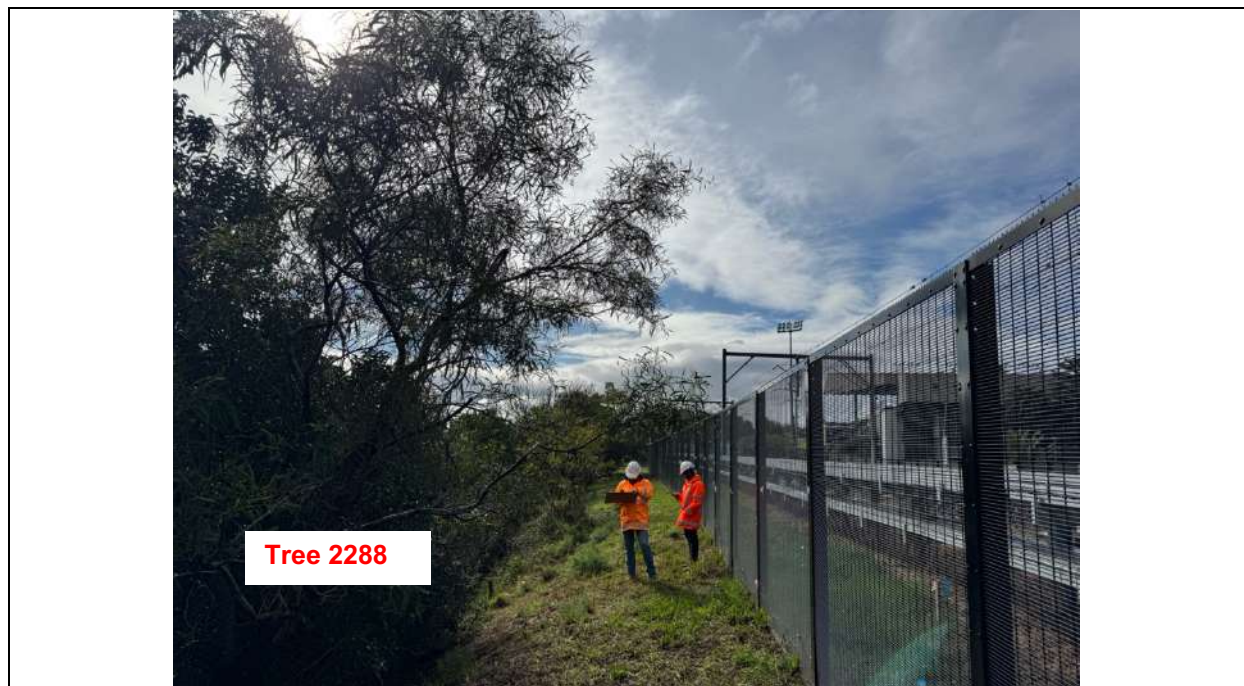
**Image 20:** Looking towards tree 2288. The tree is recommended for removal.

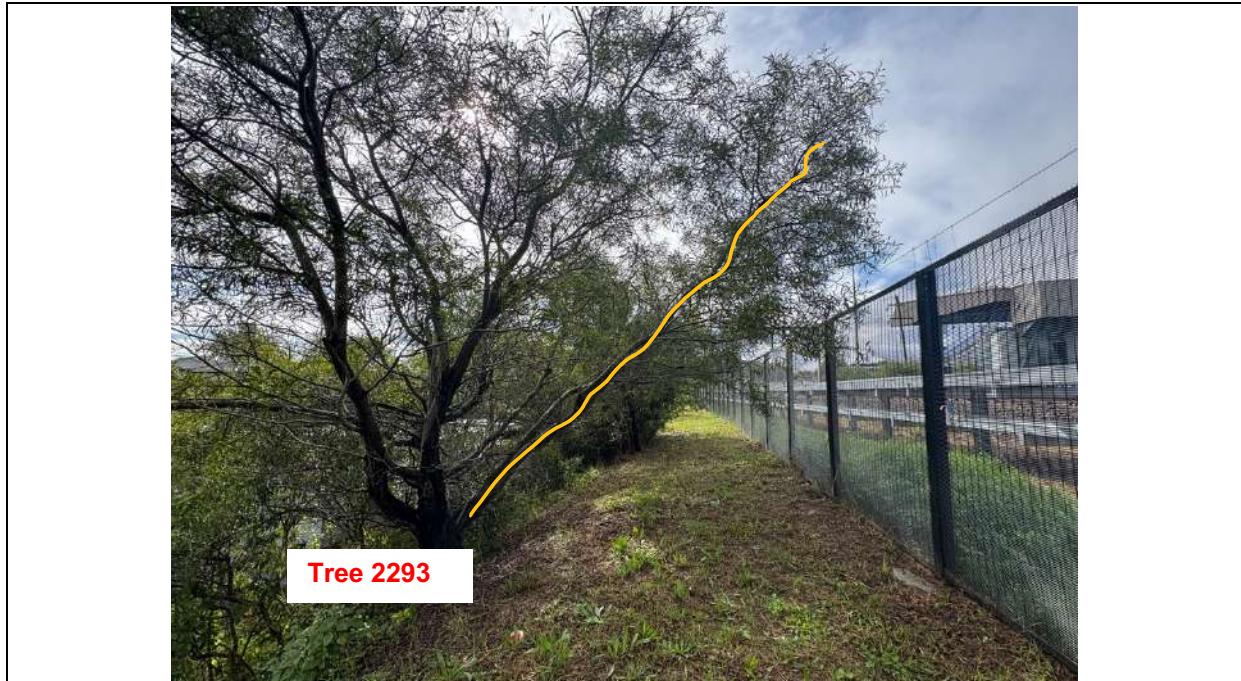
**Image 21:** Looking towards tree 2293. Canopy pruning is required to provide 2m clearance from the fence. The first order branch to the South (finished cut diameter of 180mm) is to be removed. The pruning will result in the removal of approximately 15% of the live foliage area of the tree. The branch to be removed has been marked yellow.

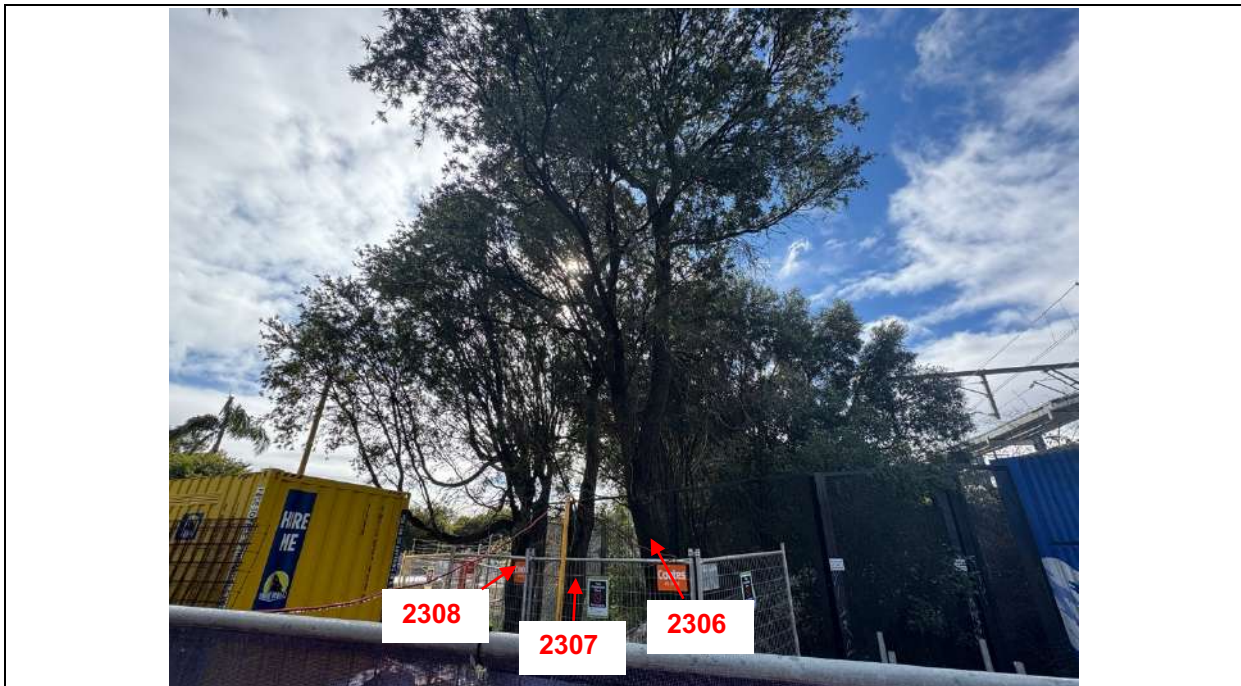
**Image 24:** Looking towards tree 2306, 2307 and 2308. The trees are recommended for removal.

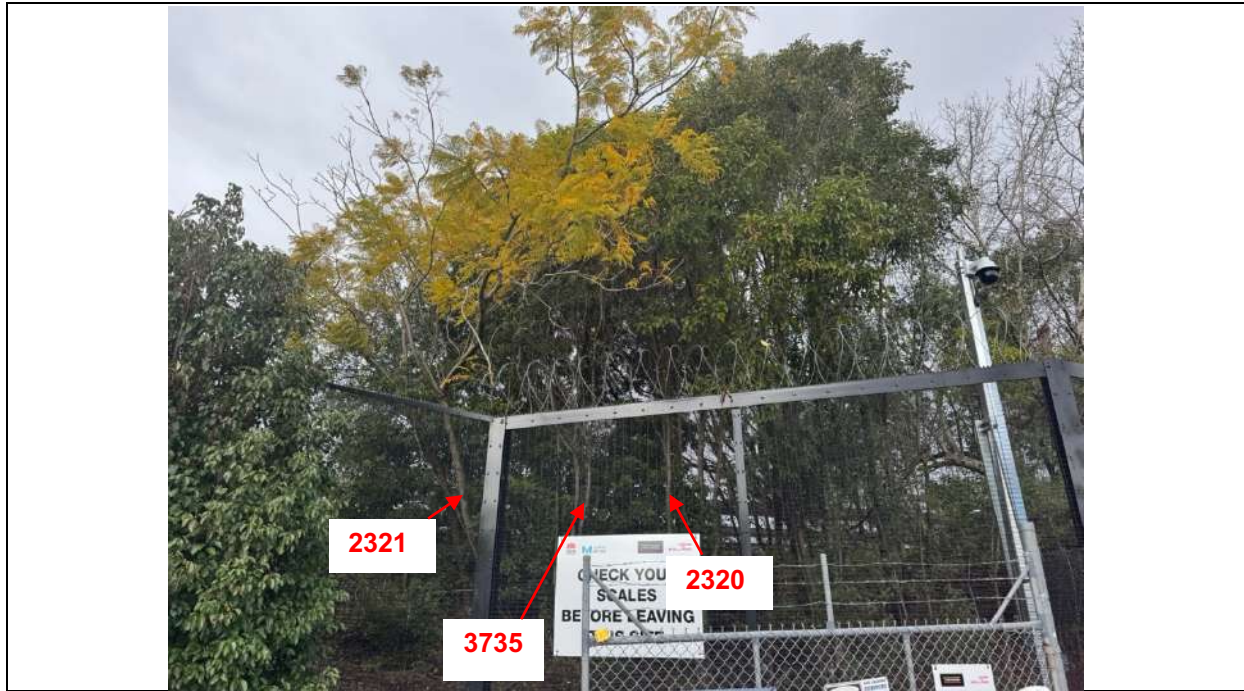
**Image 25:** Looking towards tree 2320, 2321 and 3735. The trees are recommended for removal.

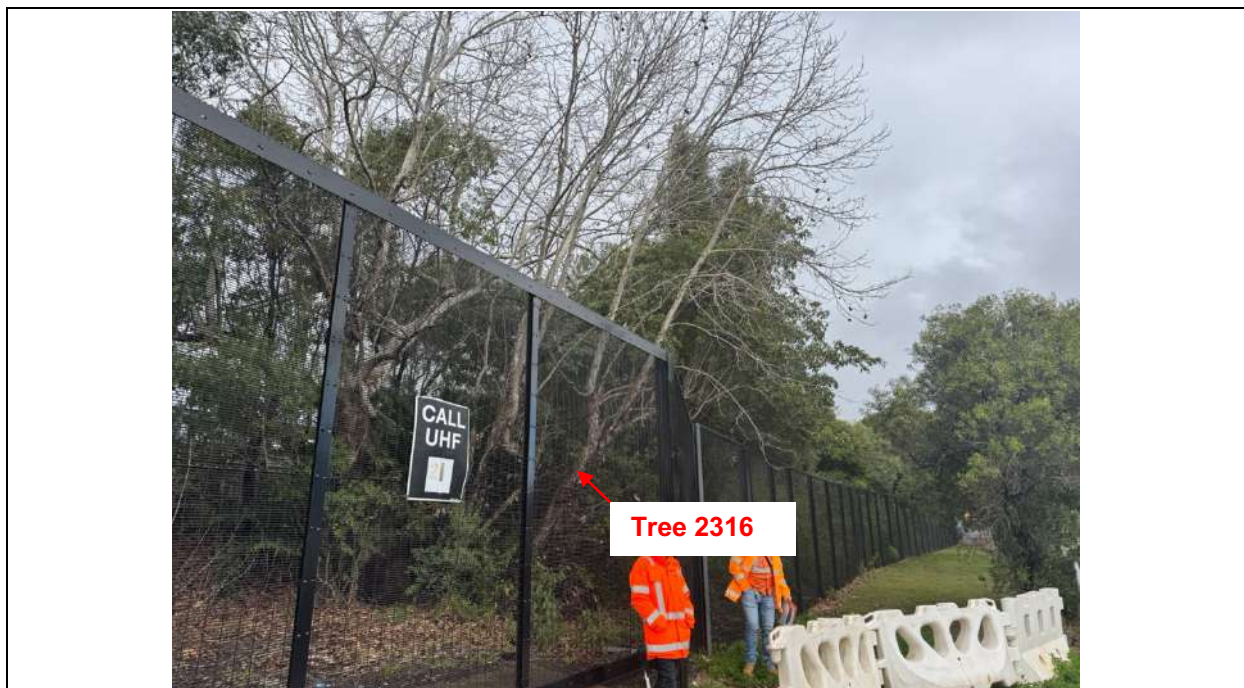
**Image 26:** Looking towards tree 2316. The tree is recommended for removal.

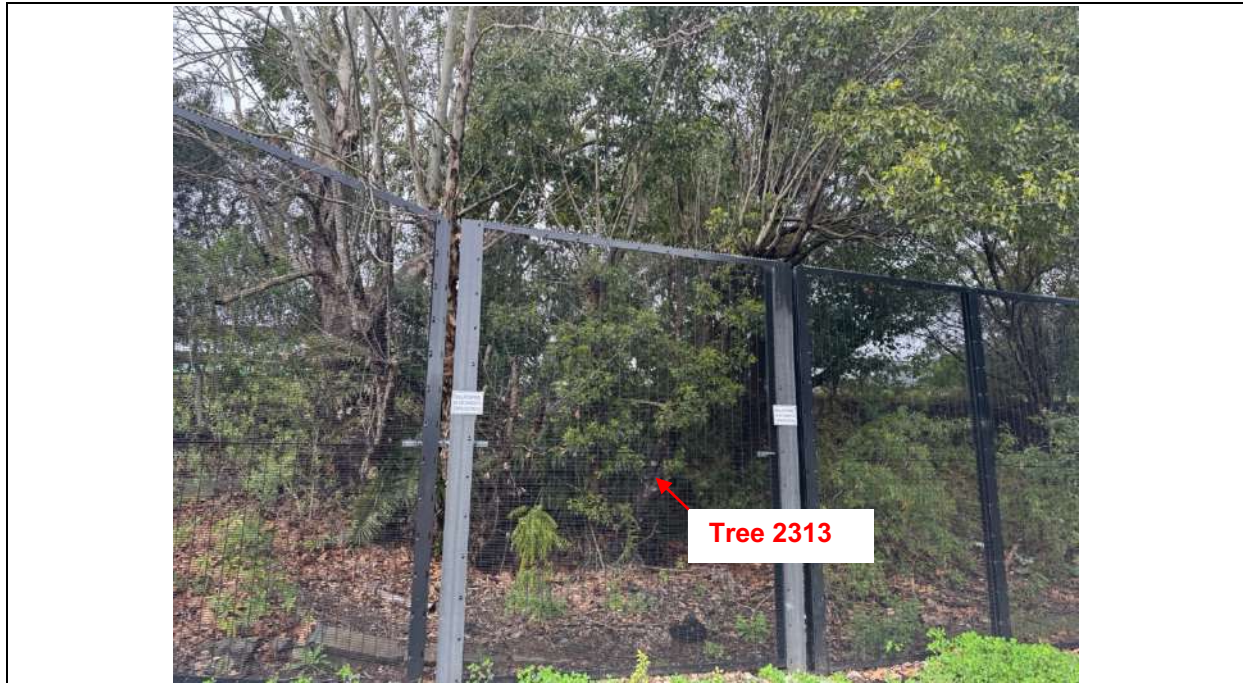
**Image 27:** Looking towards tree 2313. The tree is recommended for removal.

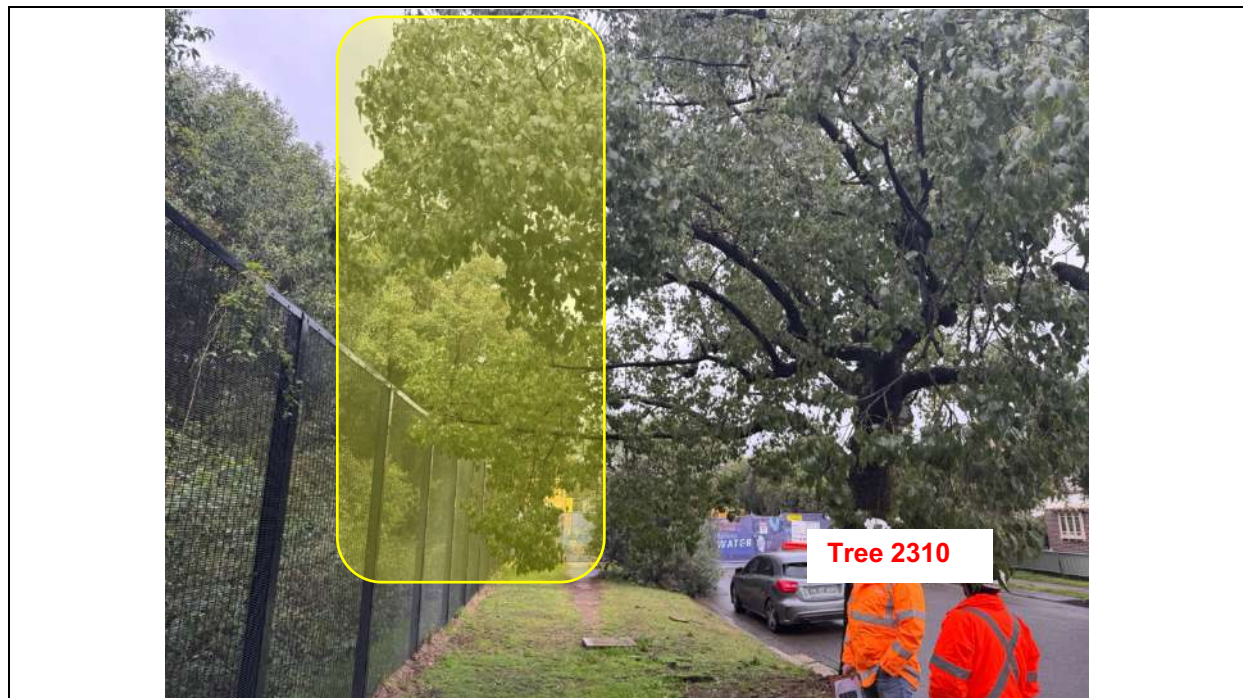
**Image 28:** Looking towards tree 2310. Canopy pruning is required to provide 2m clearance from the fence. Smaller branches measuring less than 80mm in diameter are to be pruned. The pruning will result in the removal of approximately 10% of the live foliage area of the tree. The approximate area of the pruning has been marked yellow.

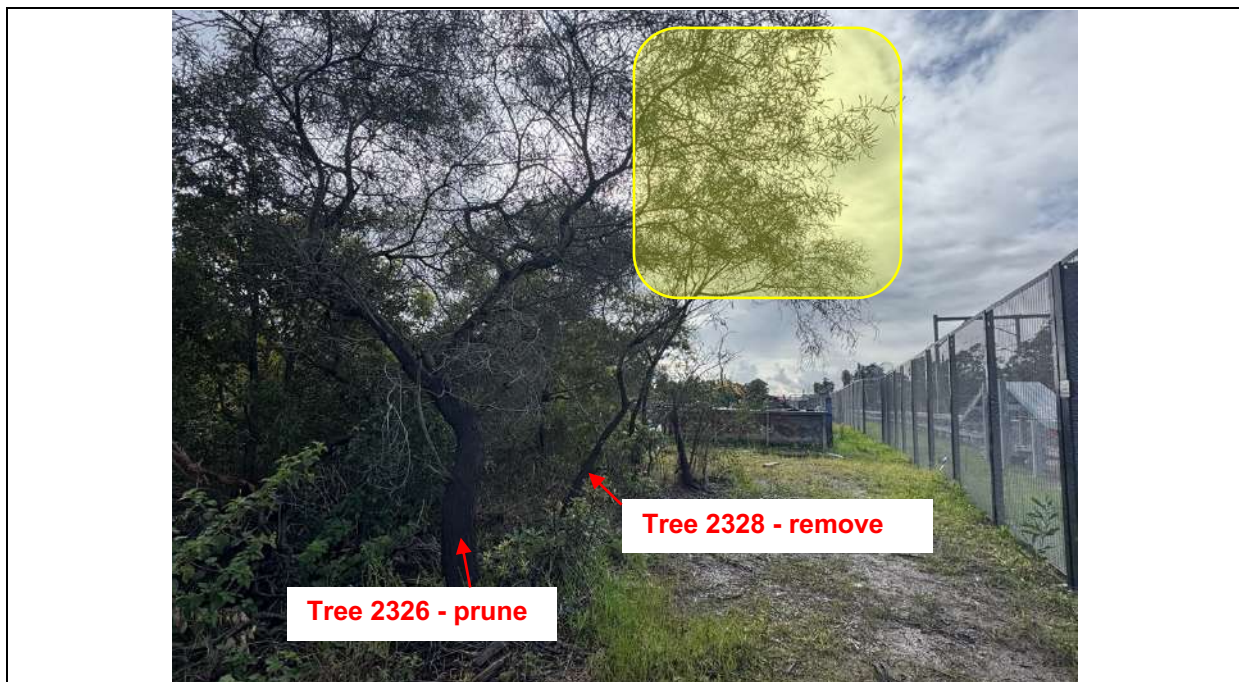
**Image 30:** Looking towards tree 2326 and 2328. Canopy pruning is required for tree 2326 to provide 3m clearance from the fence. The smaller branches measuring less than 50mm are to be pruned. The pruning will result in the removal of approximately 5% of the live foliage area of tree 2326. The approximate area of the pruning has been marked yellow. Tree 2328 is recommended for removal.

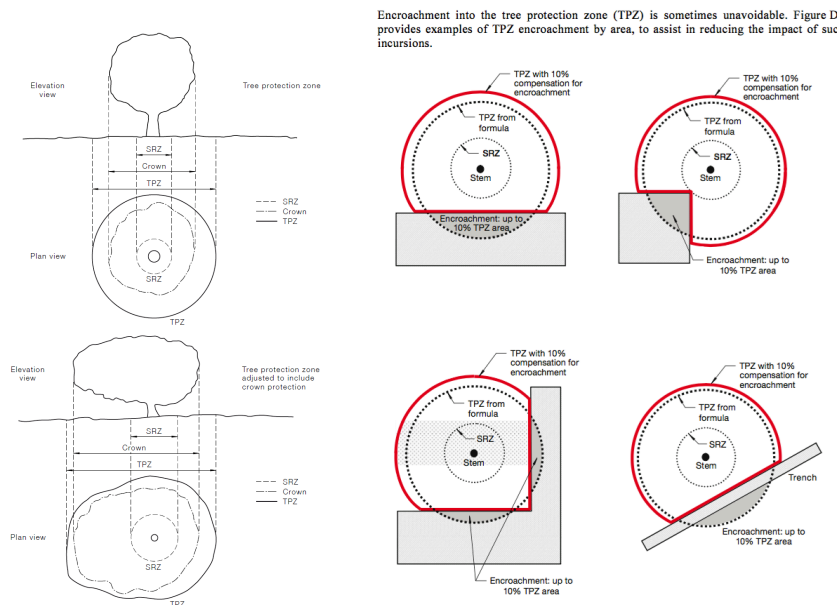
2. **Structural Root Zone:** This is the area around the base of a tree required for the trees stability in the ground. An area larger than the SRZ always need to be maintained to preserve a viable tree as it will only have a minor effect on the trees vigour and health. There are several factors that determine the SRZ which include height, crown area, soil type and soil moisture. It can also be influenced by other factors such as natural or built structures. Generally work within the SRZ should be avoided.

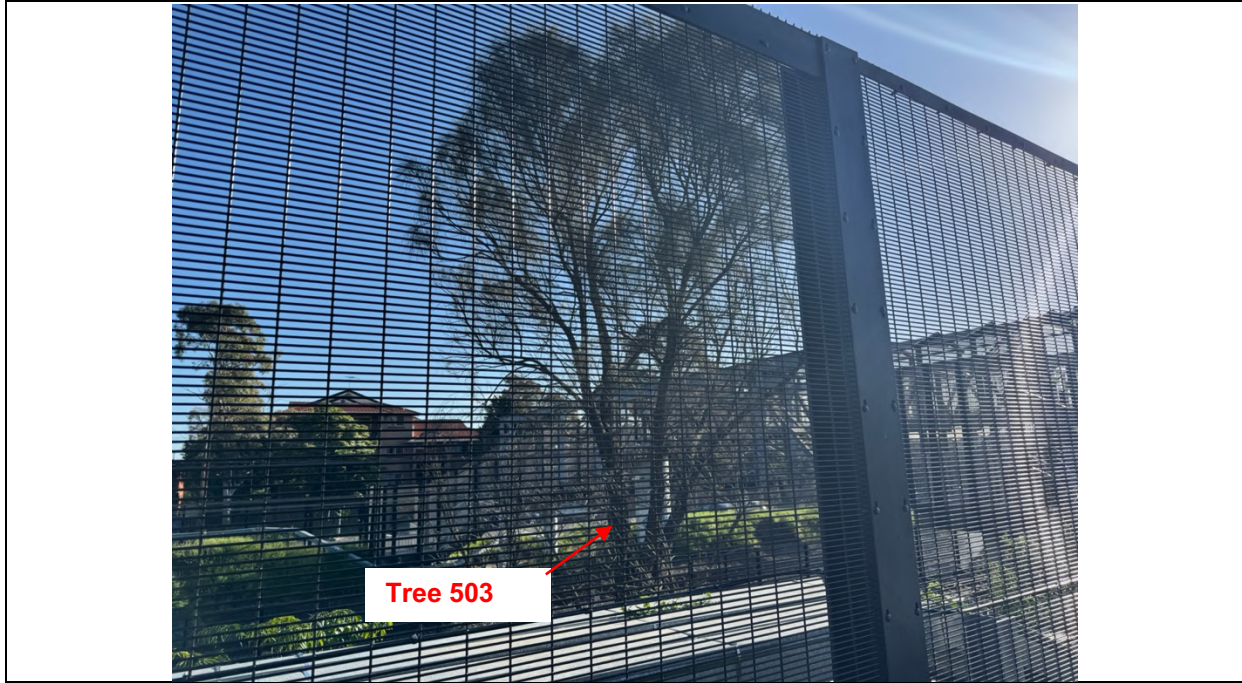
**Image 3:** Looking towards tree 503. The tree is recommended for removal

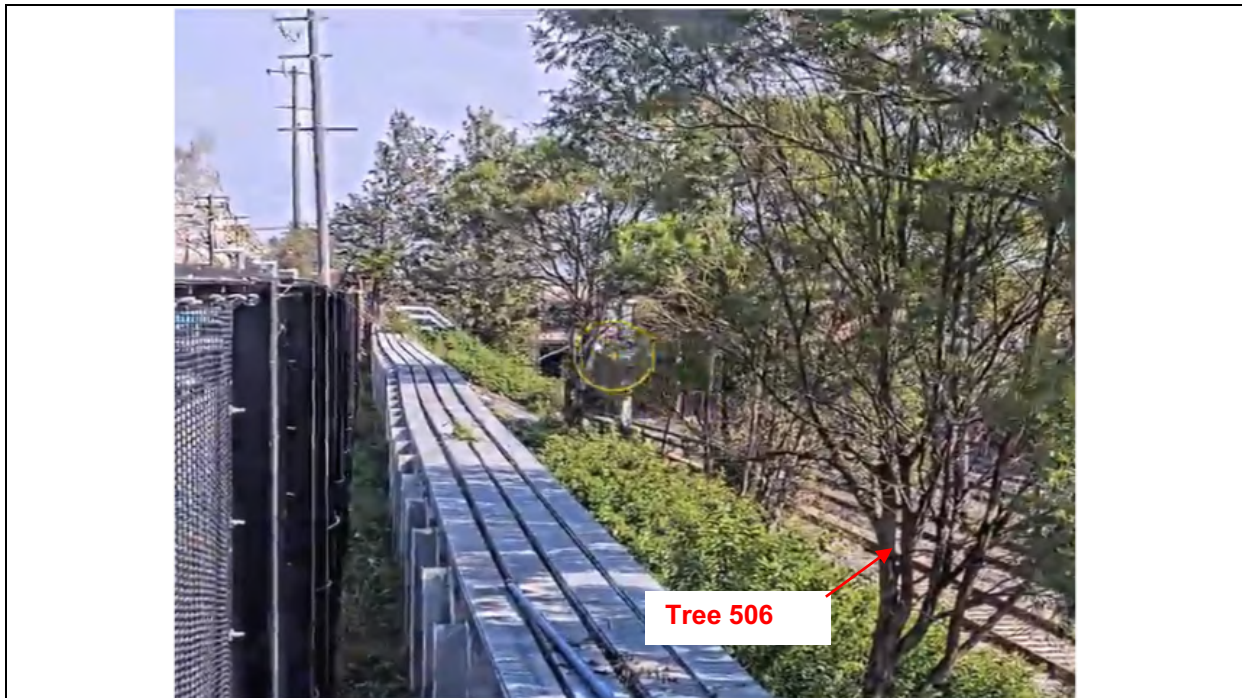
**Image 4:** Looking towards tree 506. The tree is recommended for removal

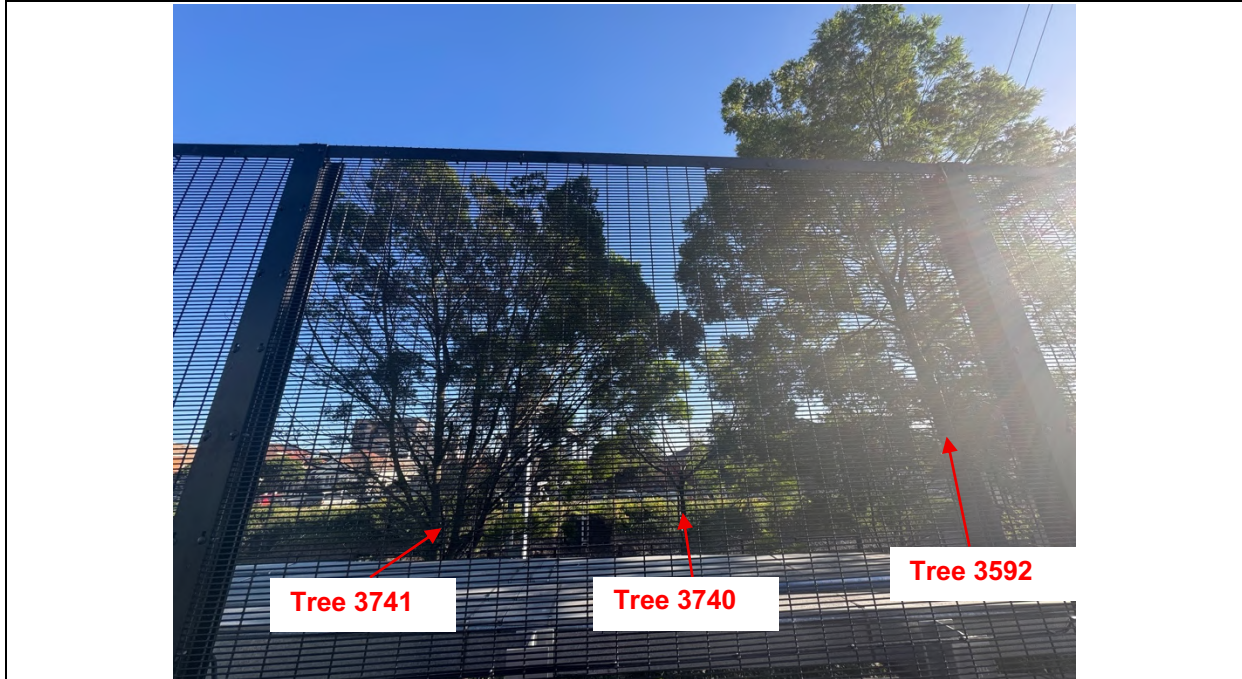
**Image 5:** Looking towards tree 3592, 3740 and 3741. The trees are recommended for removal.

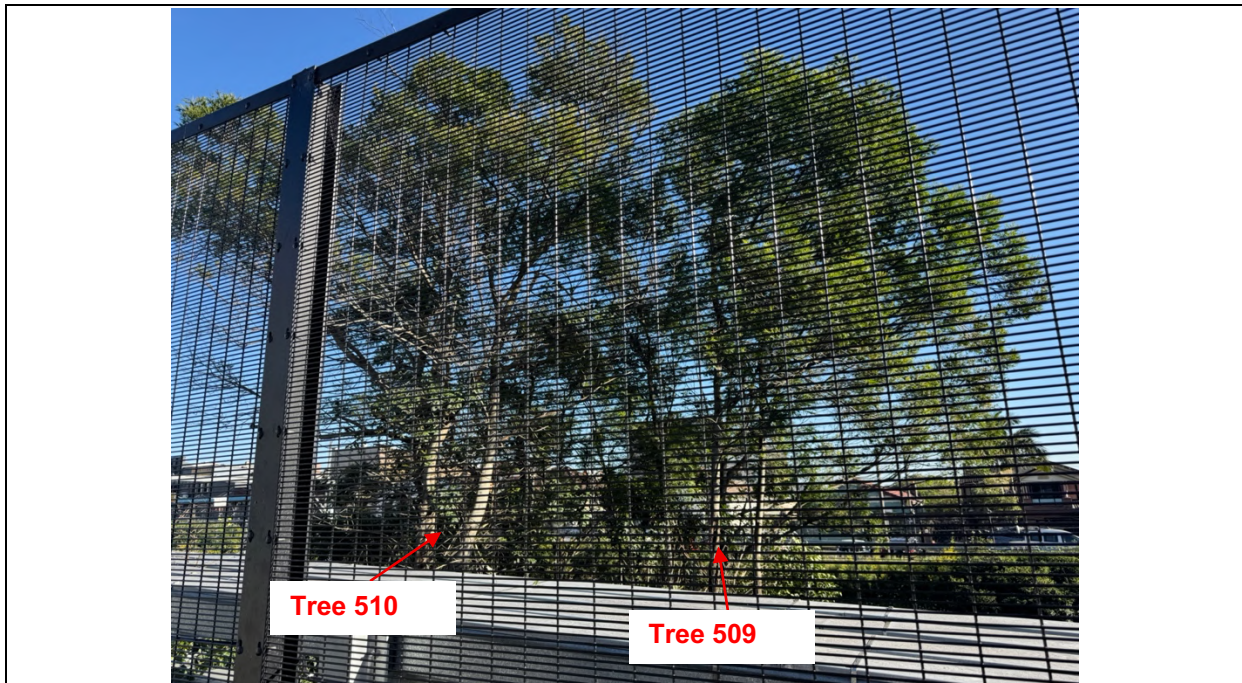
**Image 6:** Looking towards tree 509 and 510. The trees are recommended for removal.

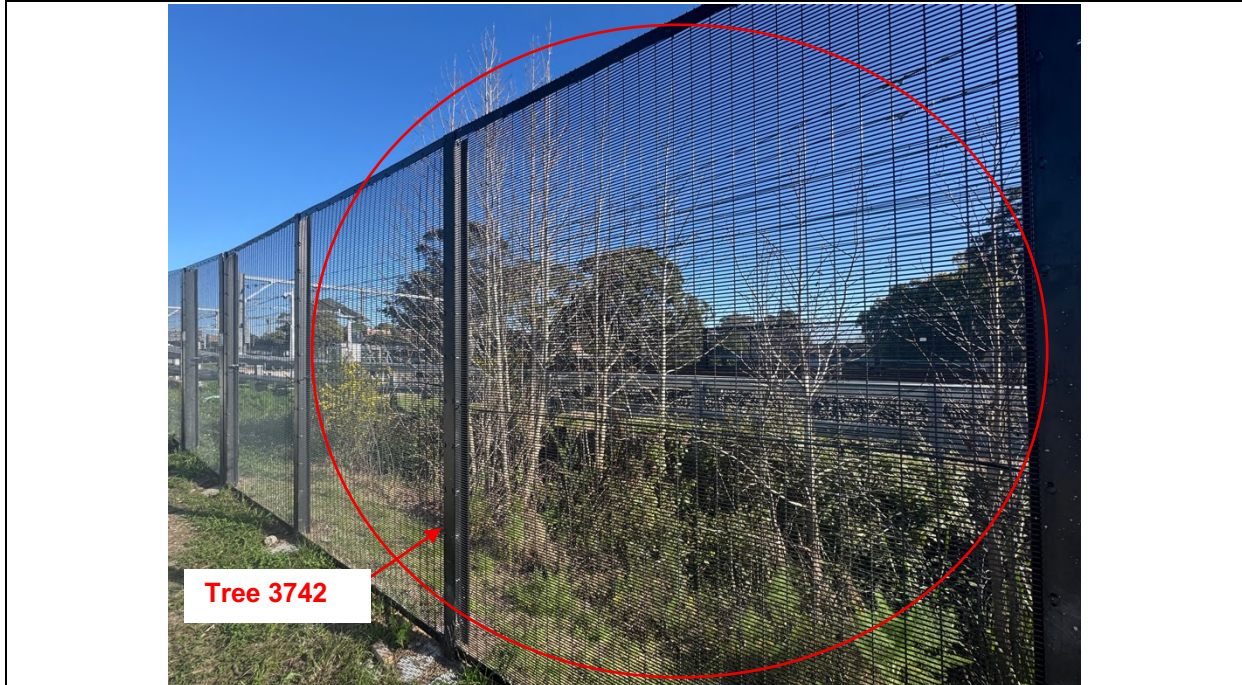
**Image 7:** Looking towards tree 3742. Tree 3742 is suckering regrowth from an old stump. The regrowth is recommended for removal.

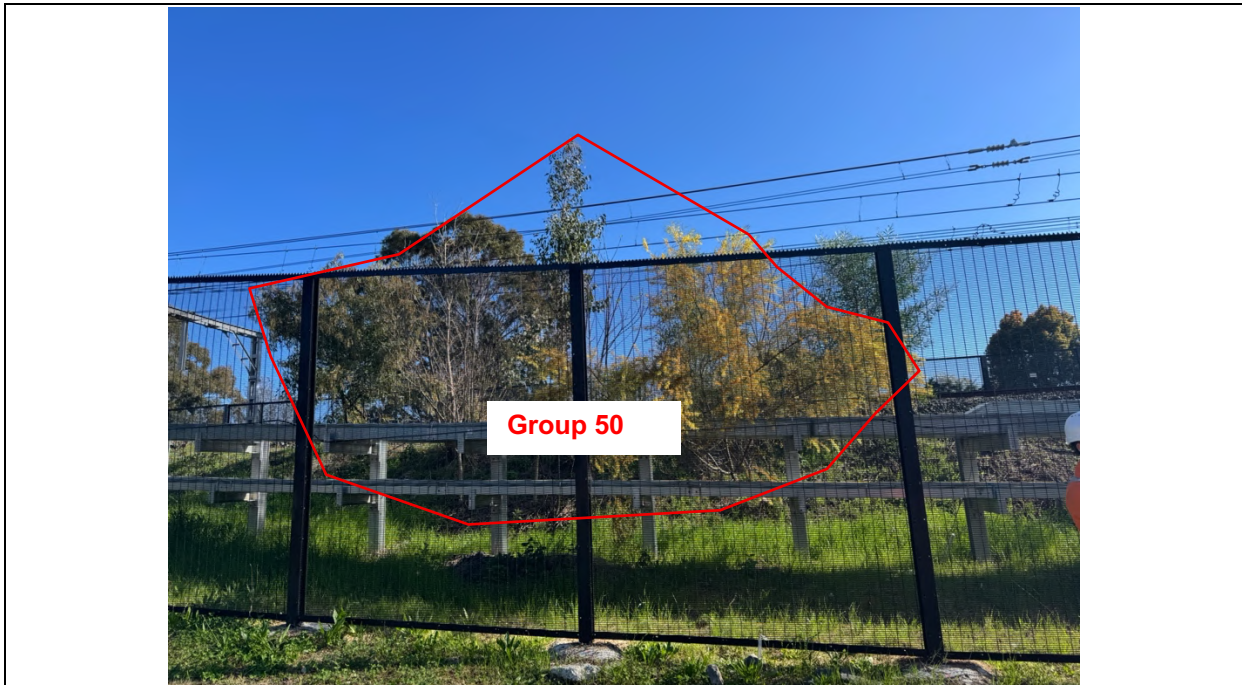
**Image 8:** Looking towards G50. Group of approximately 6 trees recommended for removal.

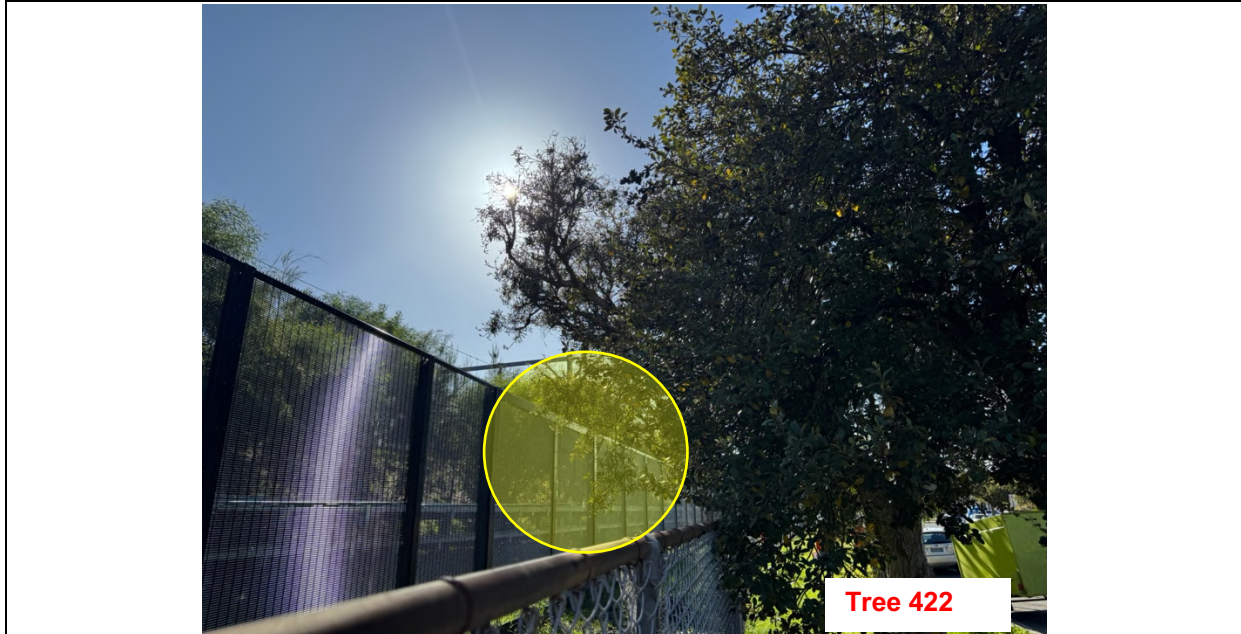
**Image 9:** Looking towards tree 422. Canopy pruning is required to provide 2m clearance from the fence. Smaller branches measuring less than 50mm in diameter are to be pruned. The pruning will result in the removal of approximately 5-10% of the live foliage area of the tree. The approximate area of the pruning has been marked yellow.

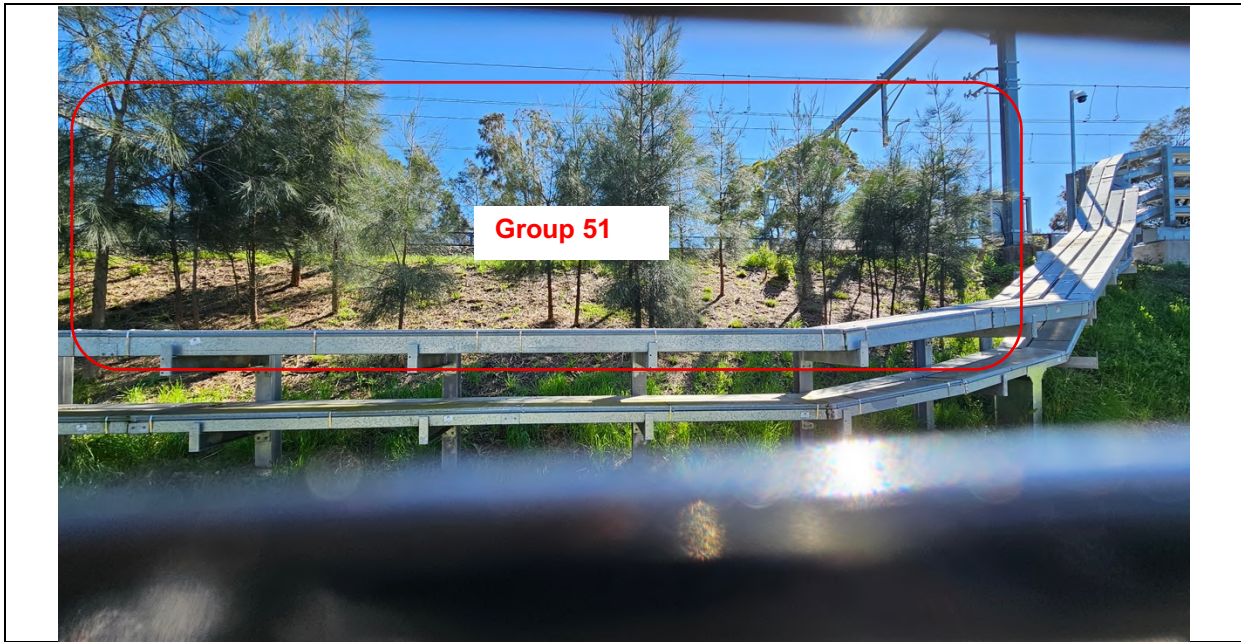
**Image 11:** Looking the Eastern most trees within G51. Approximately 13 trees are recommended for removal in total. Smaller shrubs that do not meet the definition of trees are also to be removed.

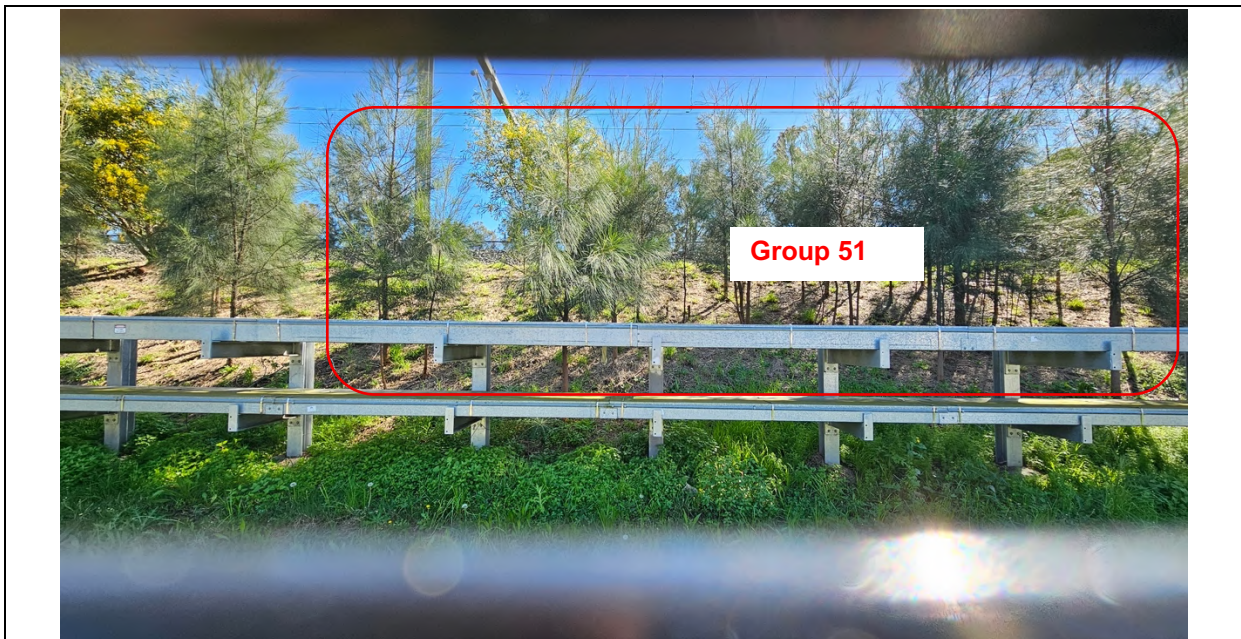
**Image 12:** Looking the Western most trees within G51. Approximately 13 trees are recommended for removal in total. Smaller shrubs that do not meet the definition of trees are also to be removed.

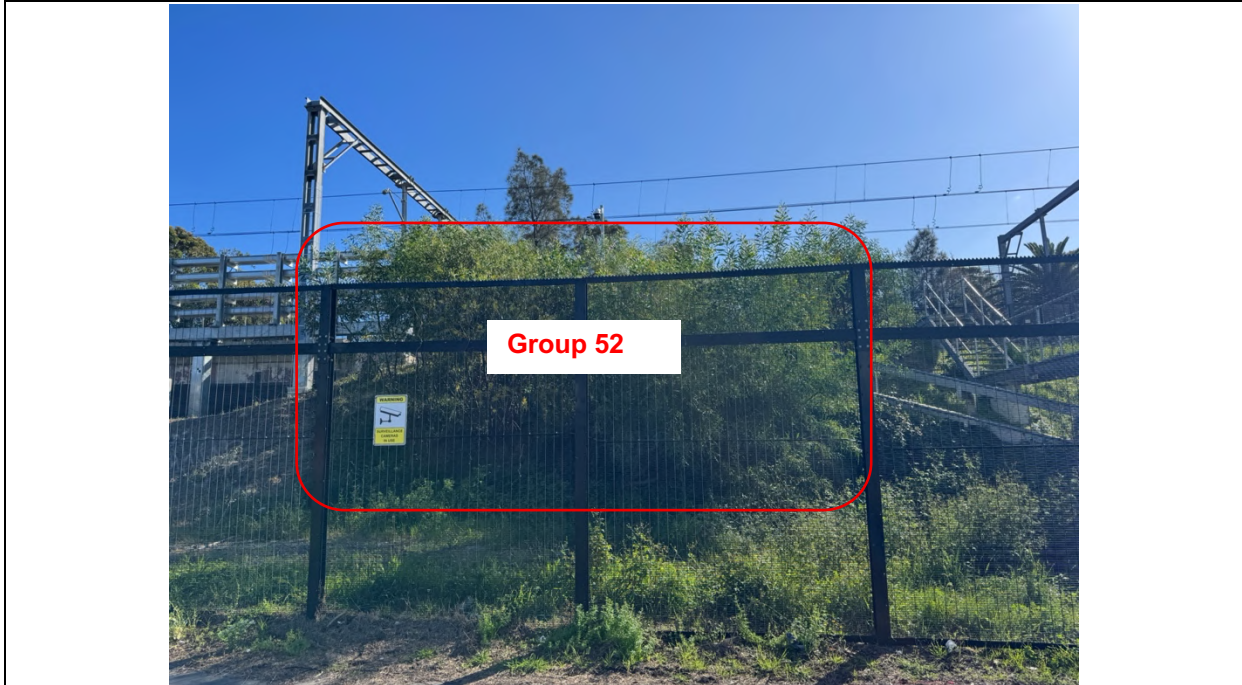
**Image 13:** Looking towards G52. Group of approximately 5 trees recommended for removal.

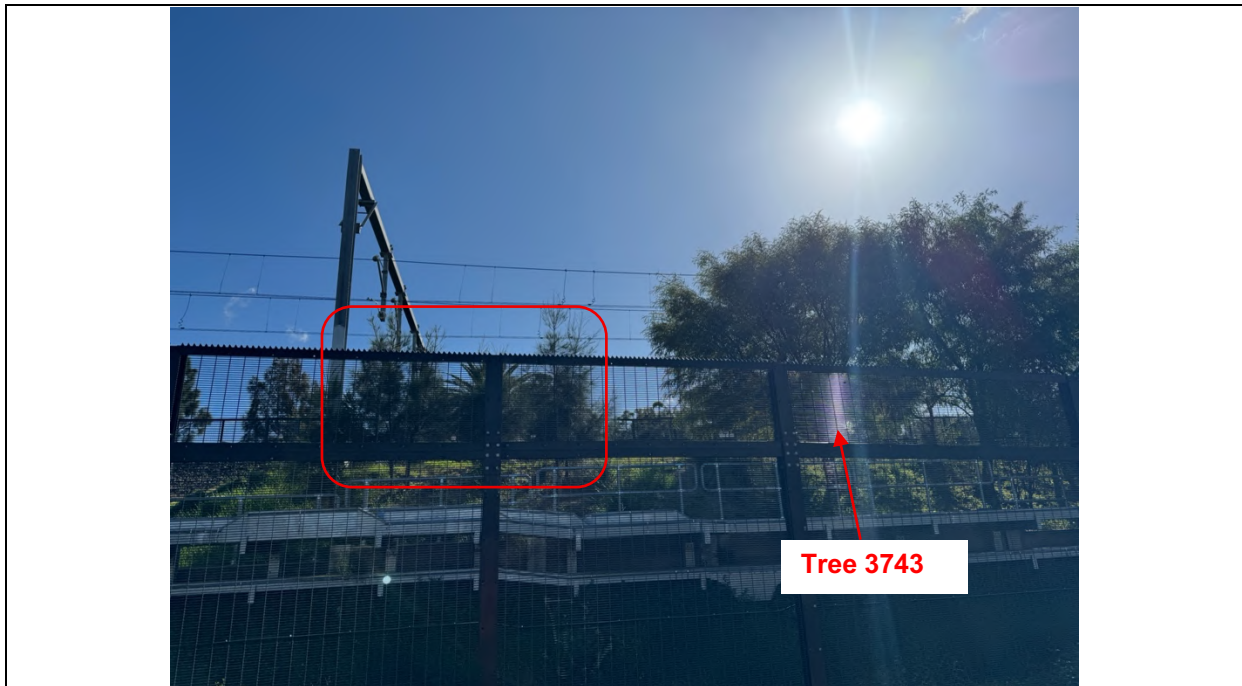
**Image 14:** Looking towards tree 3743. The tree is recommended for removal. The smaller shrubs to the West (outlined red) that do not meet the definition of a tree are also to be removed.

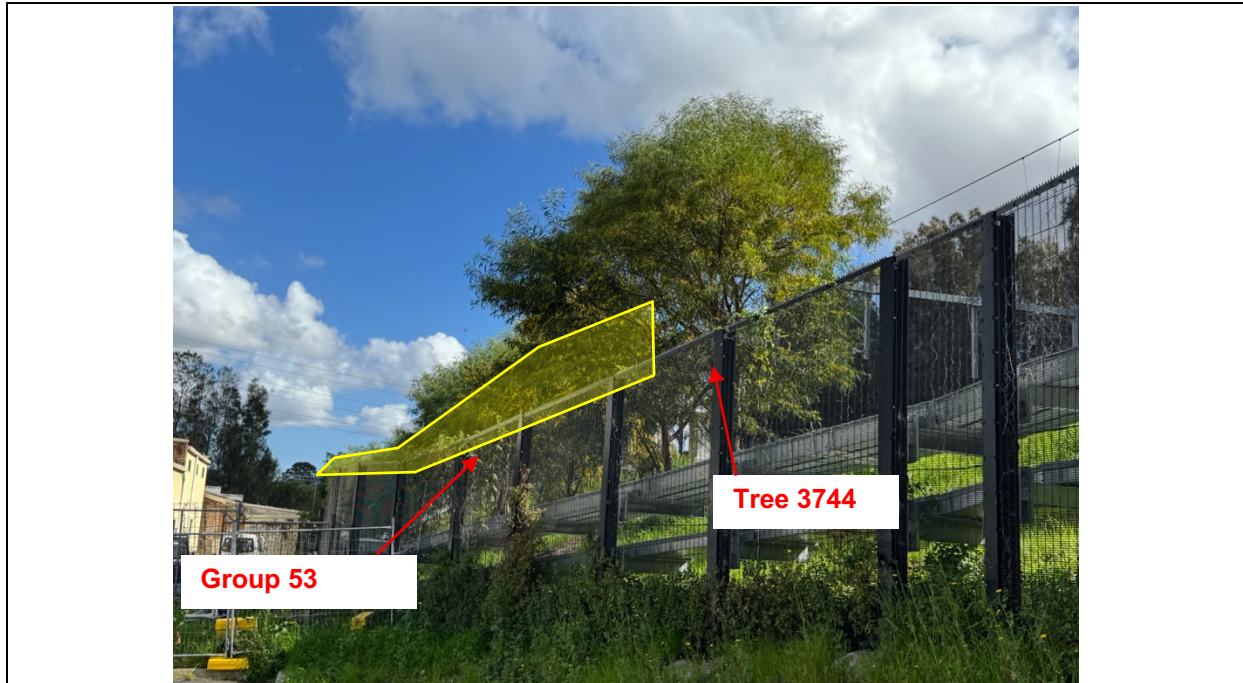
**Image 15:** Looking towards tree 3743. The tree is recommended for removal. Also showing G53 Looking towards Group 53, which is a group of approximately 20 trees recommended for pruning. Smaller branches measuring less than 50mm in diameter are to be pruned. The pruning will result in the removal of less than 10% of the live foliage area of each tree within the group. The approximate area of the pruning for G53 has been marked yellow.

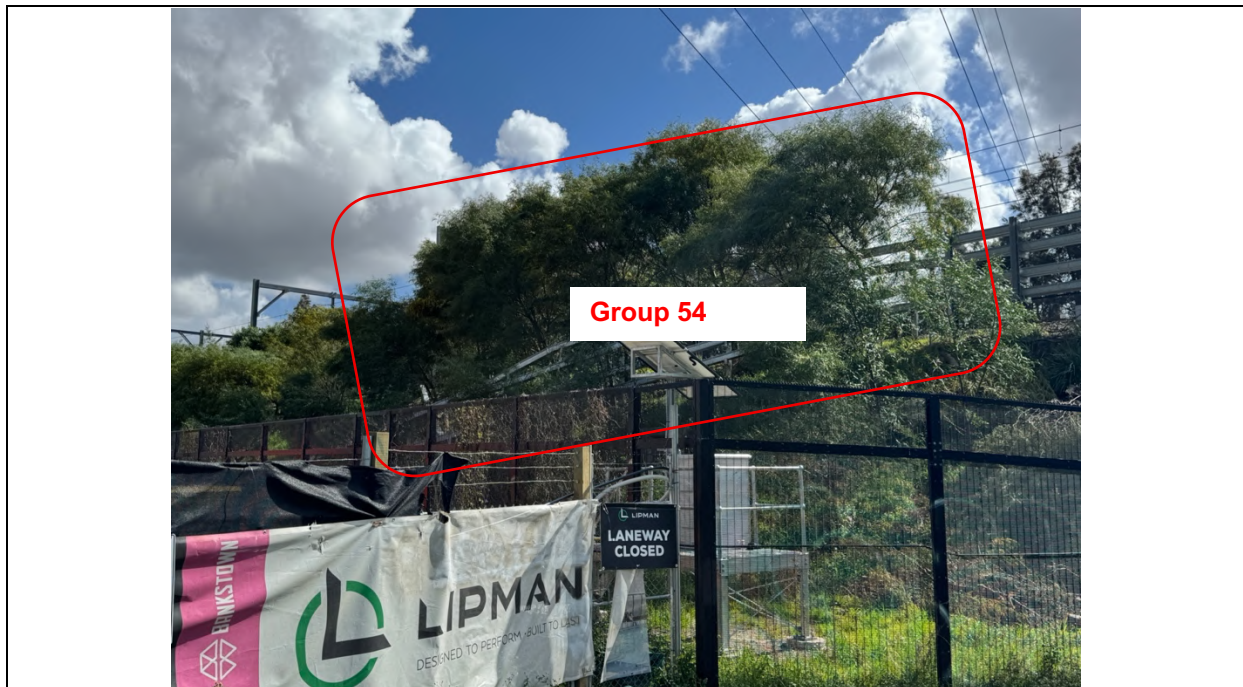
**Image 16:** Looking towards G54. Group of approximately 12 trees recommended for removal.
