# CIDS & ODS Tree Impact Assessment Report

## SWM3- Tree and Vegetation Management Work Part 2 Instruction

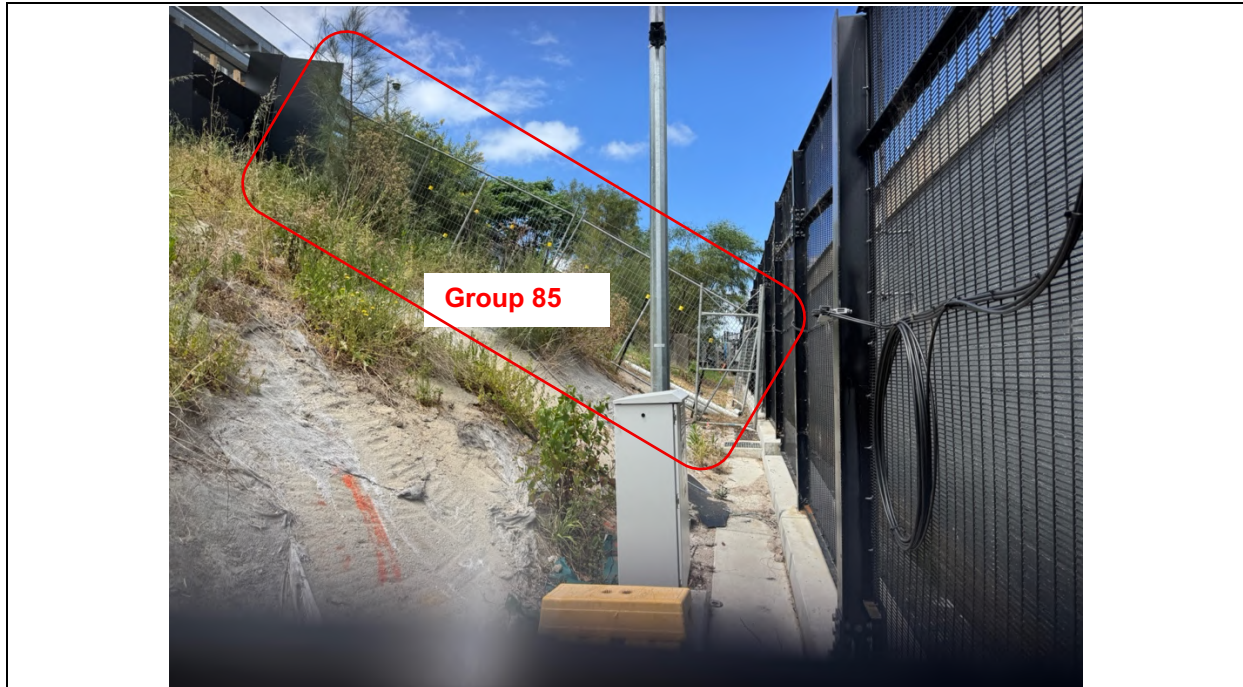
**Image 17:** Looking towards G85. Group of approximately 4 trees recommended for removal.

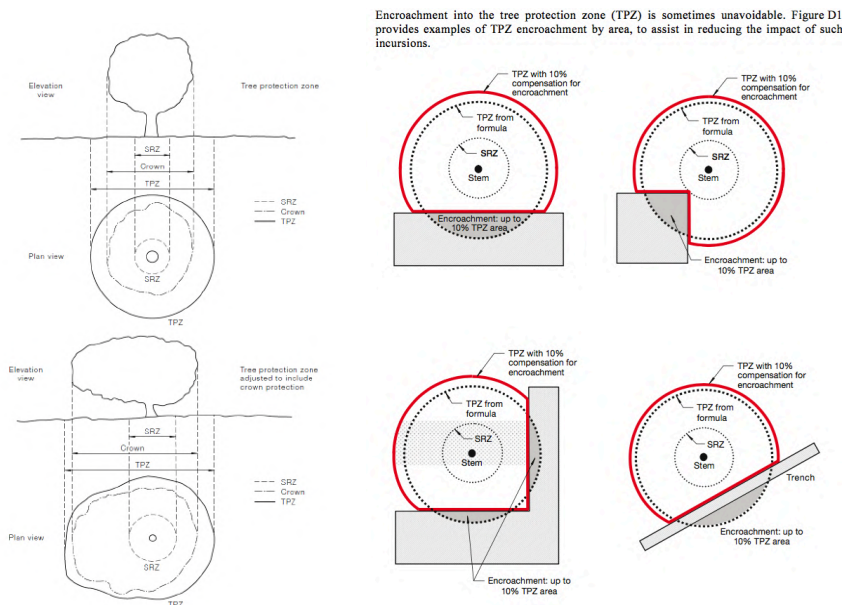
2. **Structural Root Zone:** This is the area around the base of a tree required for the trees stability in the ground. An area larger than the SRZ always need to be maintained to preserve a viable tree as it will only have a minor effect on the trees vigour and health. There are several factors that determine the SRZ which include height, crown area, soil type and soil moisture. It can also be influenced by other factors such as natural or built structures. Generally work within the SRZ should be avoided.

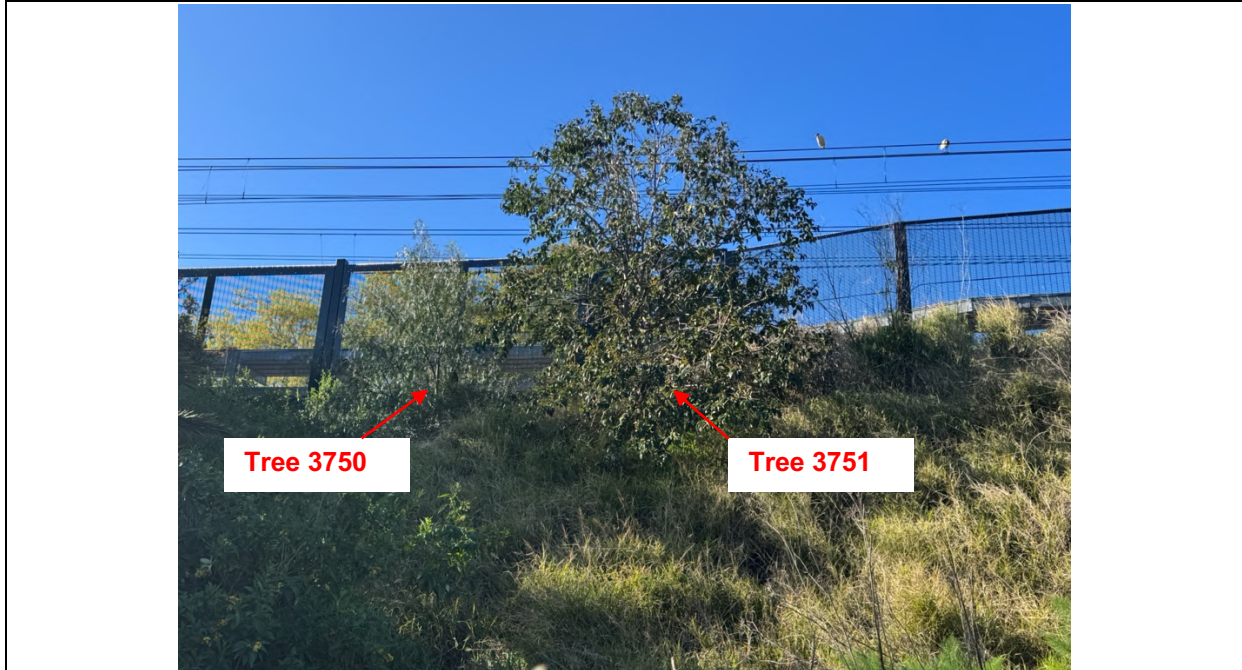
**Image 3:** Looking towards tree 3750 and 3751. The trees are recommended for removal

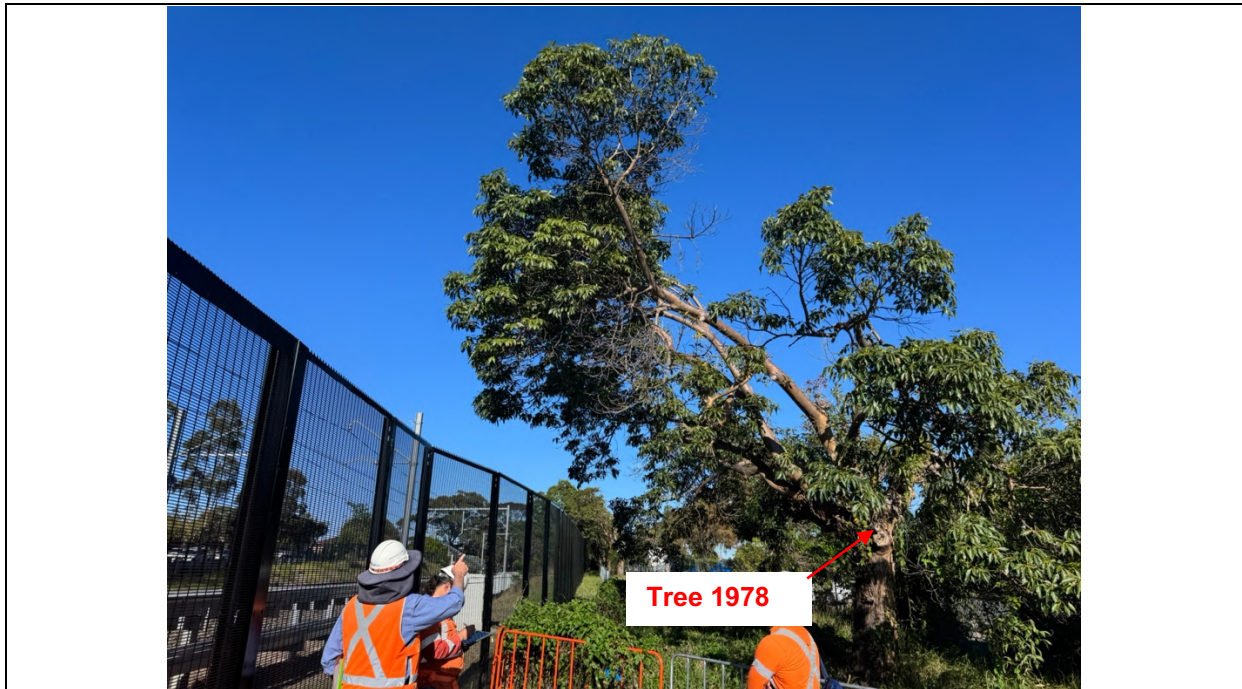
**Image 4:** Looking towards tree 1978. The tree is recommended for removal due to excessive canopy pruning required for fence clearance.

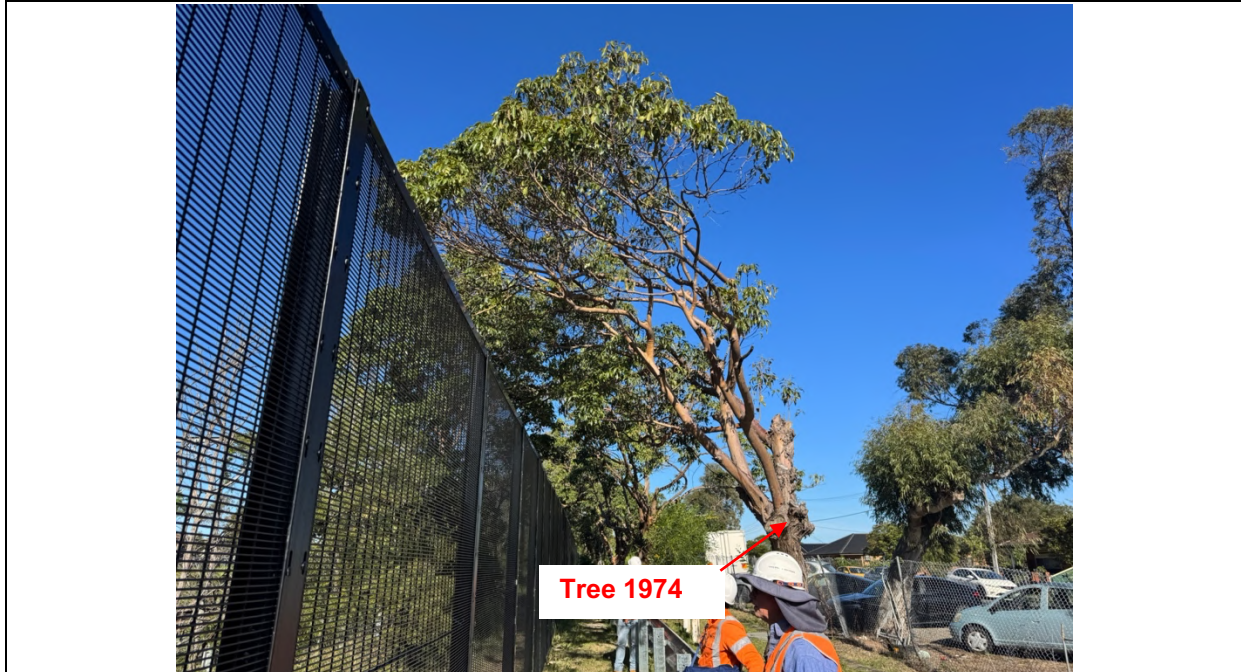
**Image 5:** Looking towards tree 1974. The tree is recommended for removal due to excessive canopy pruning required for fence clearance.

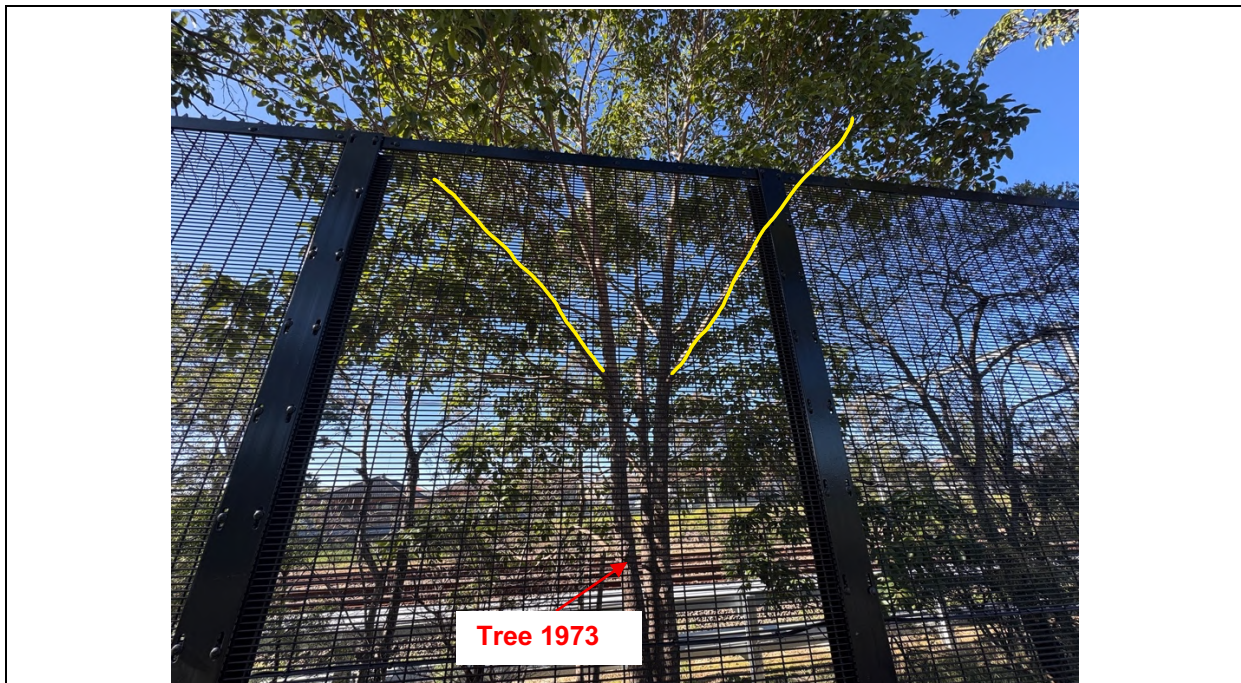
**Image 6:** Looking towards tree 1973. Canopy pruning is required to provide clearance from the fence. The two first order branches require pruning to provide fence clearance. The finished cut diameters measure approximately 50mm and 60mm. The pruning will result in the removal of approximately 10% of the live foliage area of the tree. The branches to be pruned have been marked yellow.

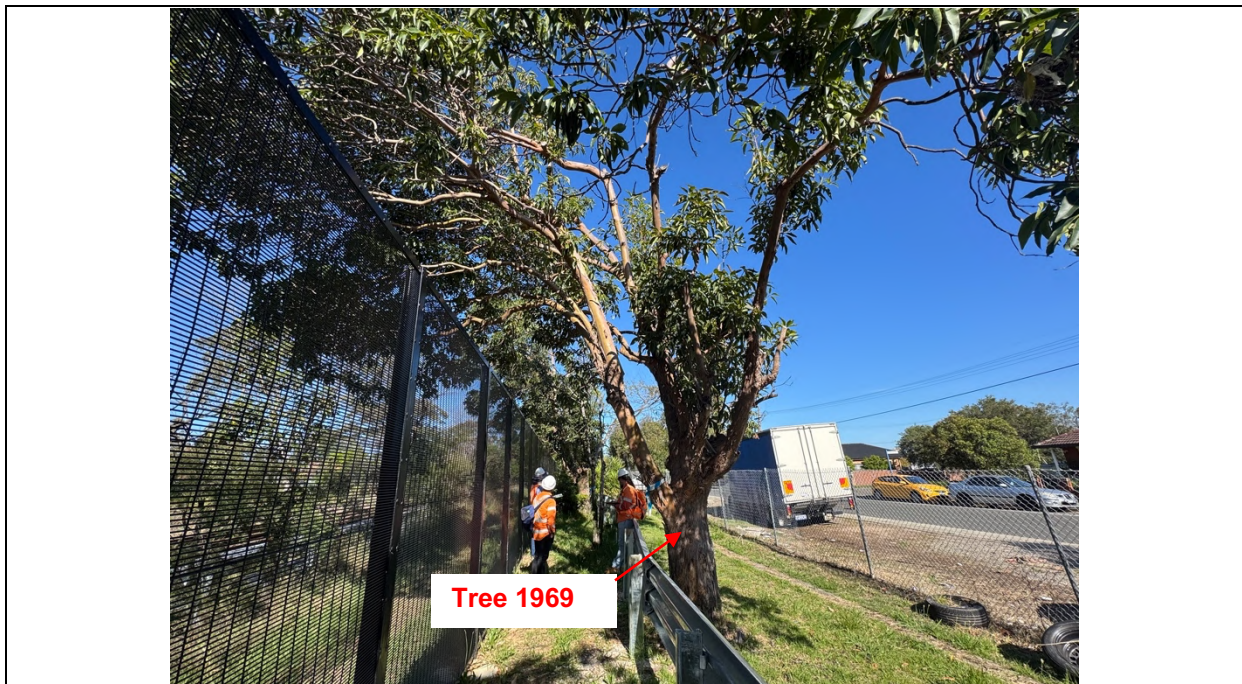
**Image 8:** Looking towards tree 1969. The tree is recommended for removal due to excessive canopy pruning required for fence clearance.

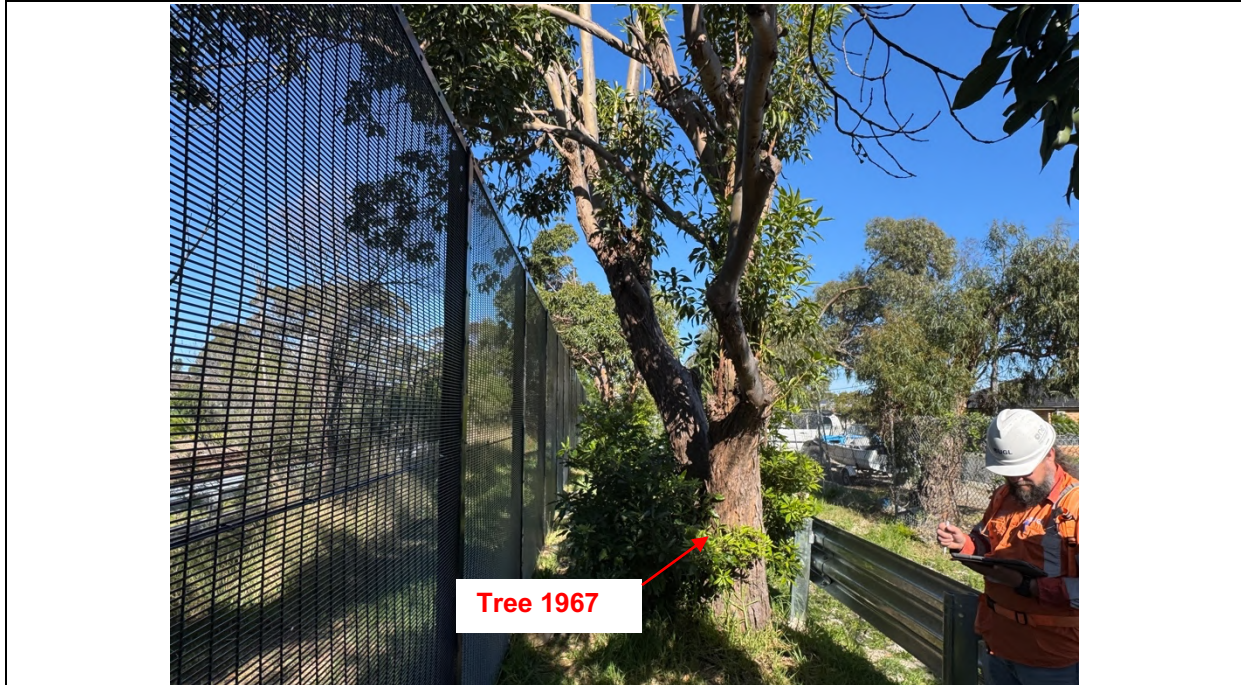
**Image 9:** Looking towards tree 1967. The tree is recommended for removal due to excessive canopy pruning required for fence clearance.

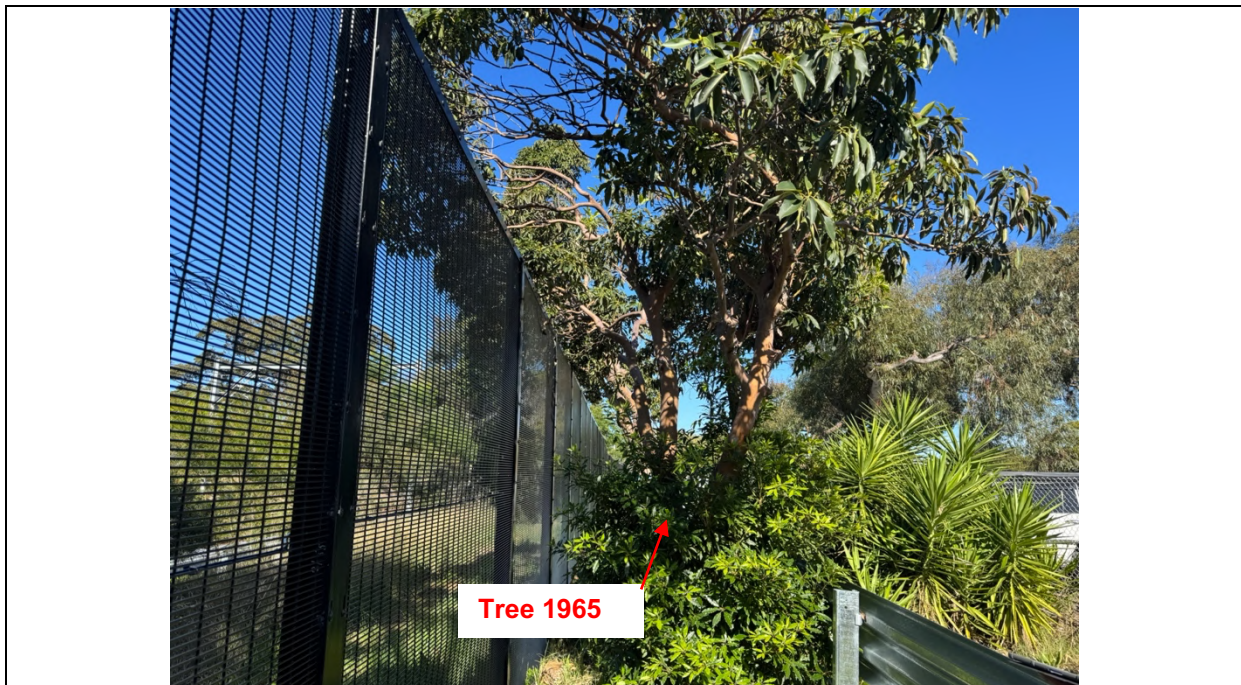
**Image 10:** Looking towards tree 1965. The tree is recommended for removal due to excessive canopy pruning required for fence clearance.

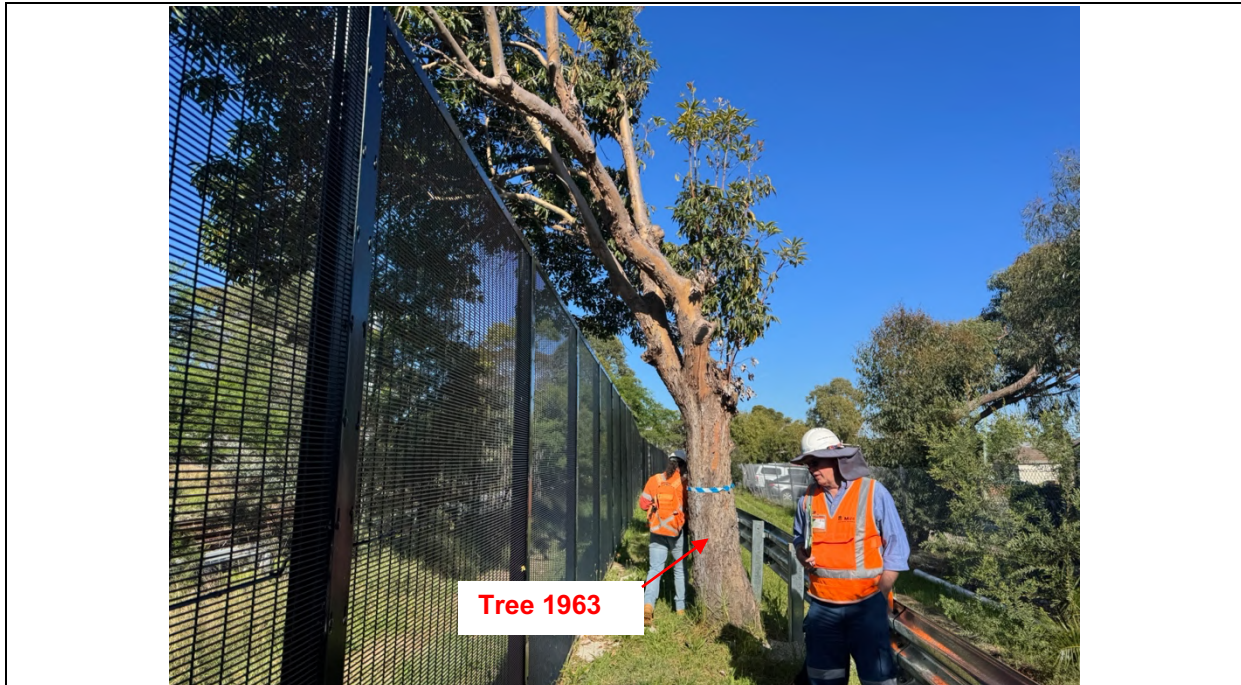
**Image 11:** Looking towards tree 1963. The tree is recommended for removal due to excessive canopy pruning required for fence clearance.

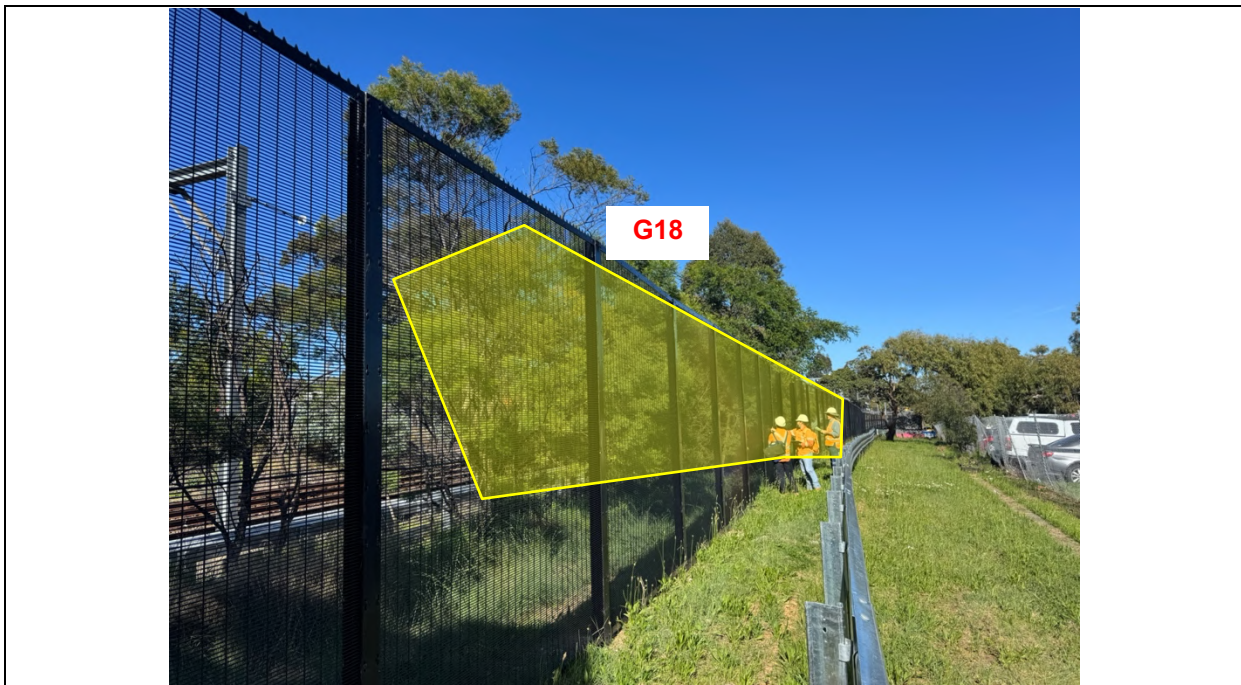
**Image 12:** Looking towards G18, which is a group of approximately 46 trees recommended for pruning. Smaller branches measuring less than 50mm in diameter are to be pruned. The pruning will result in the removal of less than 10% of the live foliage area of each tree within the group. The approximate area of the pruning has been marked yellow.

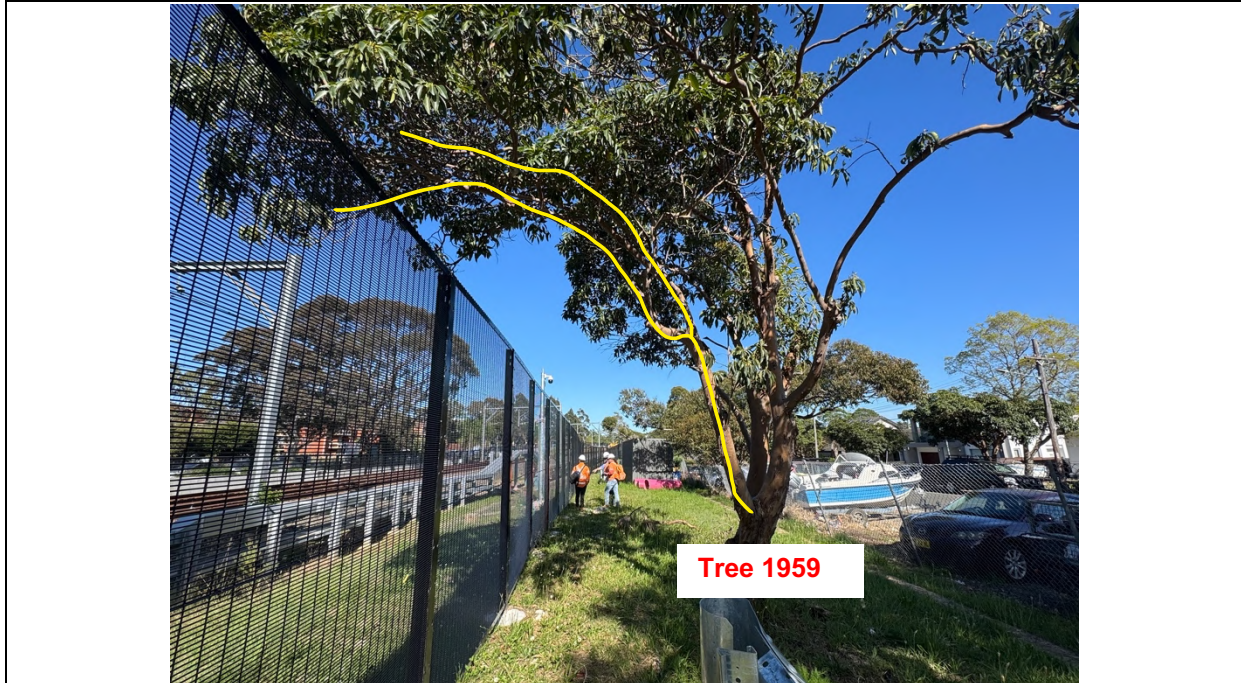
**Image 13:** Looking towards tree 1959. Canopy pruning is required to provide 2m clearance from the fence. The 180mm diameter first order branch to the South at 1m is to be pruned (yellow line). Smaller branches measuring less than 50mm in diameter also require pruning. The pruning will result in the removal of approximately 20-30% of the live foliage area of the tree, which is significant pruning, but a preferred option to whole tree removal.

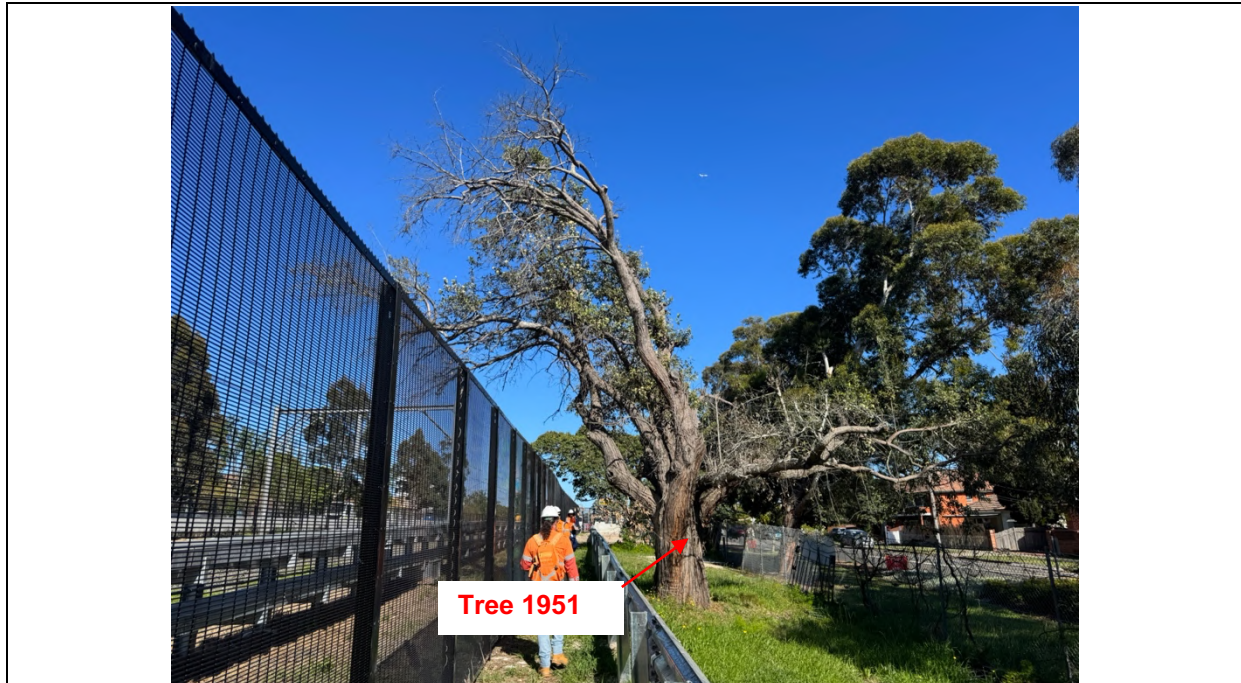
**Image 15:** Looking towards tree 1951. The tree is recommended for removal due to excessive canopy pruning required for fence clearance and due to the condition of the tree (health in advanced decline).

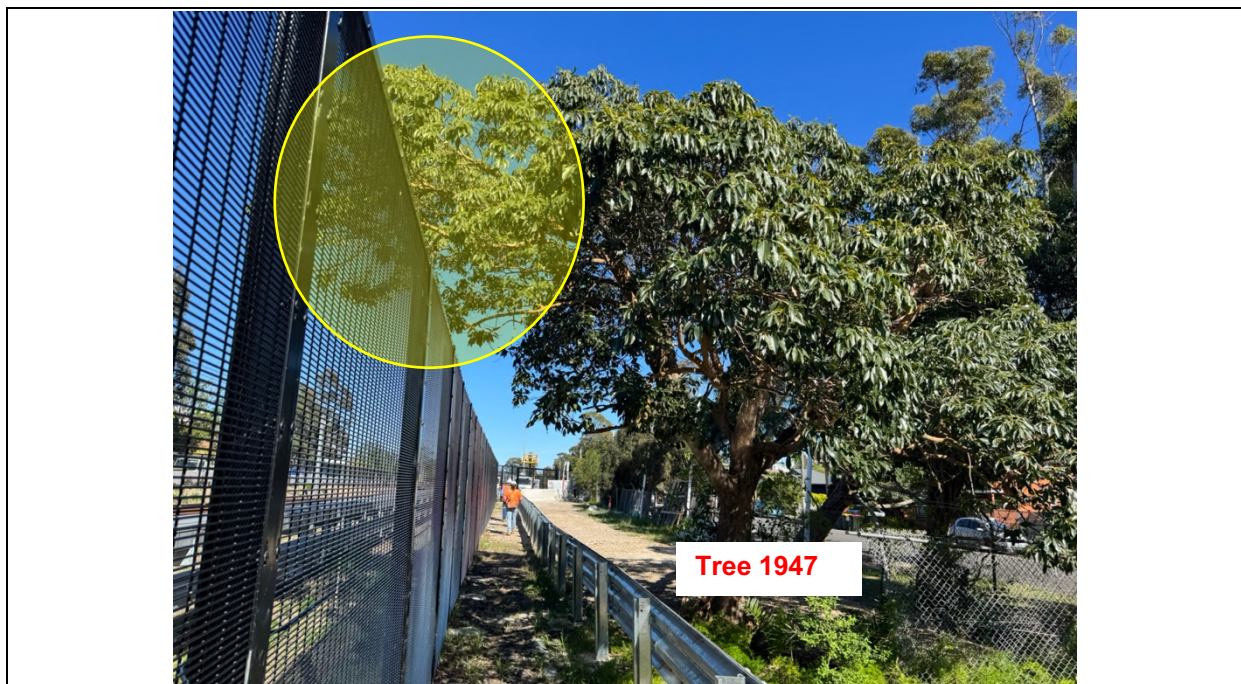
**Image 16:** Looking towards tree 1947. Canopy pruning is required to provide 2m clearance from the fence. The finished cut diameters must not exceed 100mm. The pruning will result in the removal of approximately 20% of the live foliage area of the tree. The area of canopy to be pruned has been marked yellow.

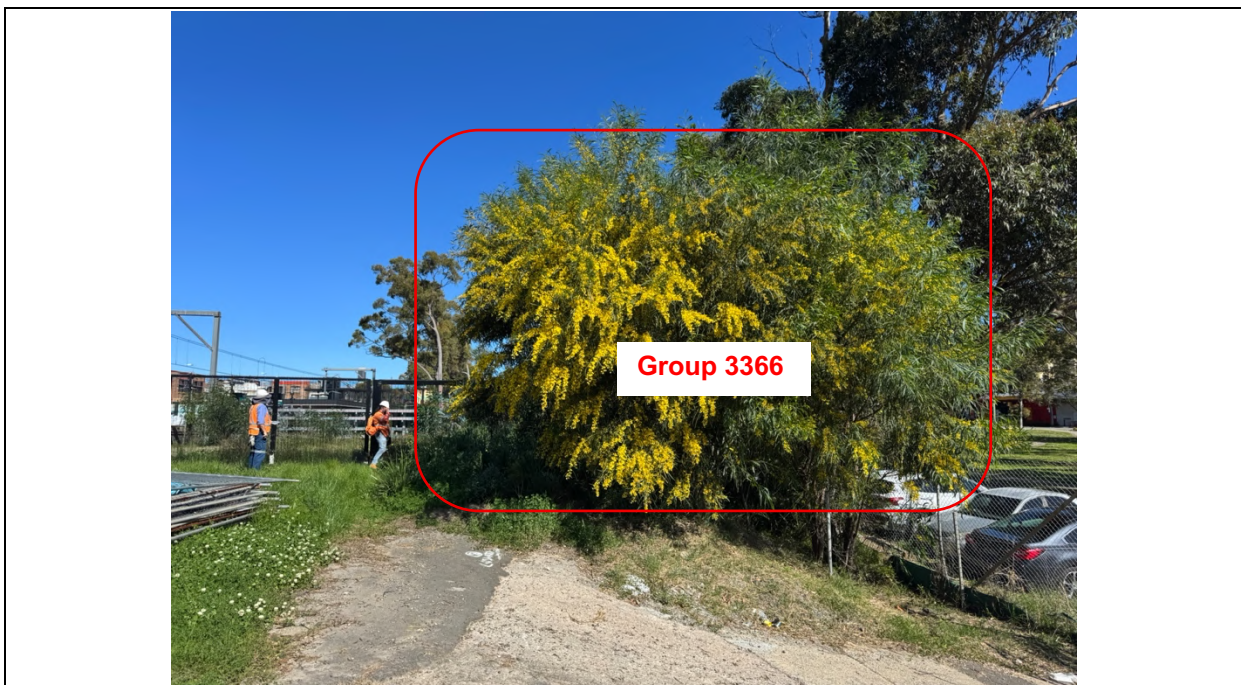
**Image 18:** Looking group G3366, which is a group of approximately 10. The group of trees is recommended for removal.

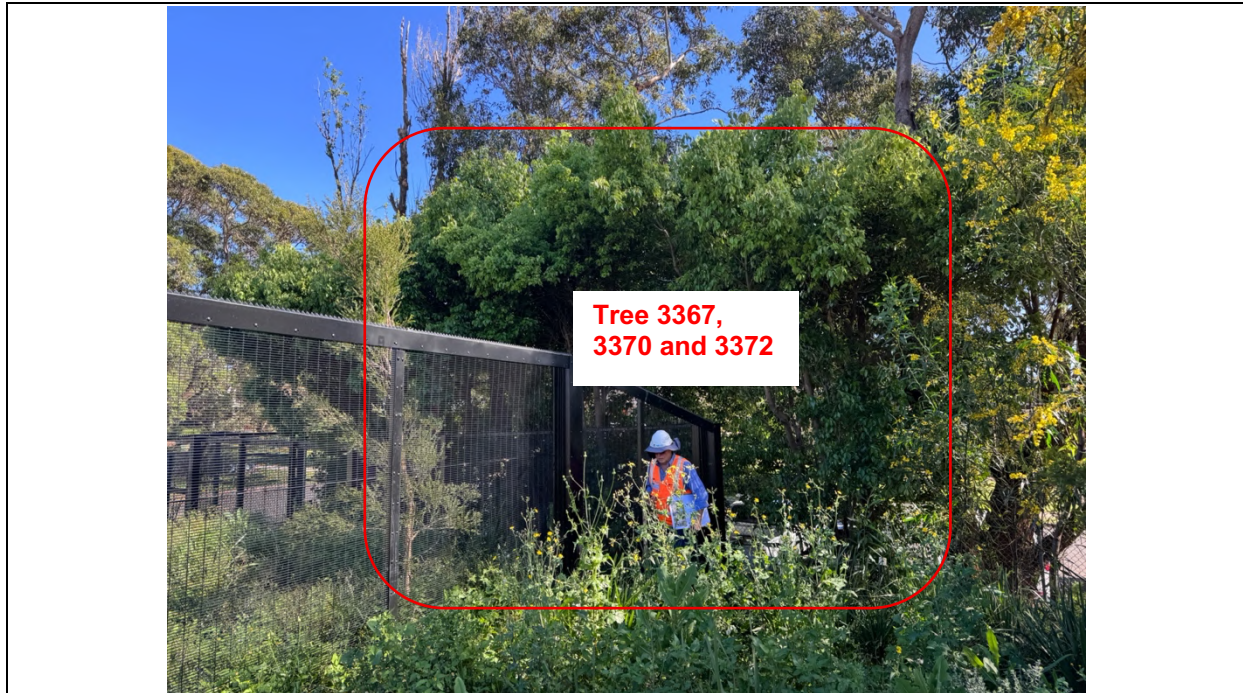
**Image 19:** Looking towards tree 3367, 3370 and 3372. The trees are recommended for removal.

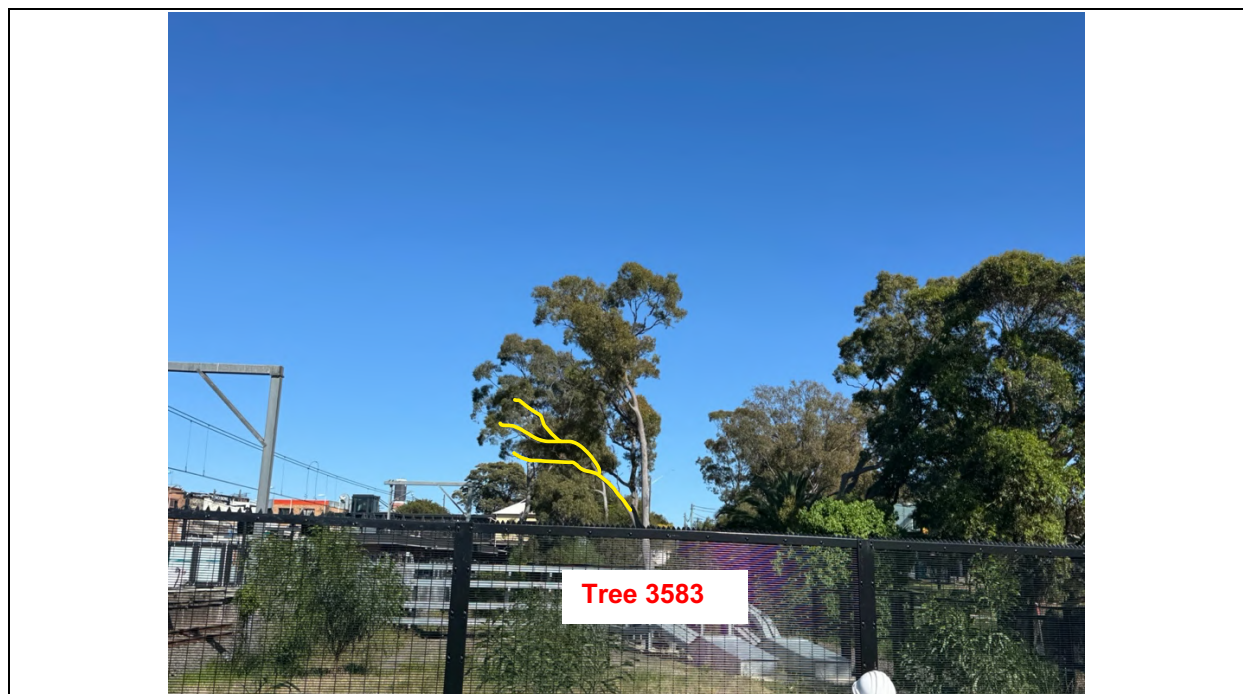
**Image 20:** Looking towards tree 3583. Canopy pruning is required to provide 2m clearance from the fence. The 200mm diameter second order branch to the Southwest at 5m is to be pruned (yellow line). The pruning will result in the removal of approximately 10% of the live foliage area of the tree.

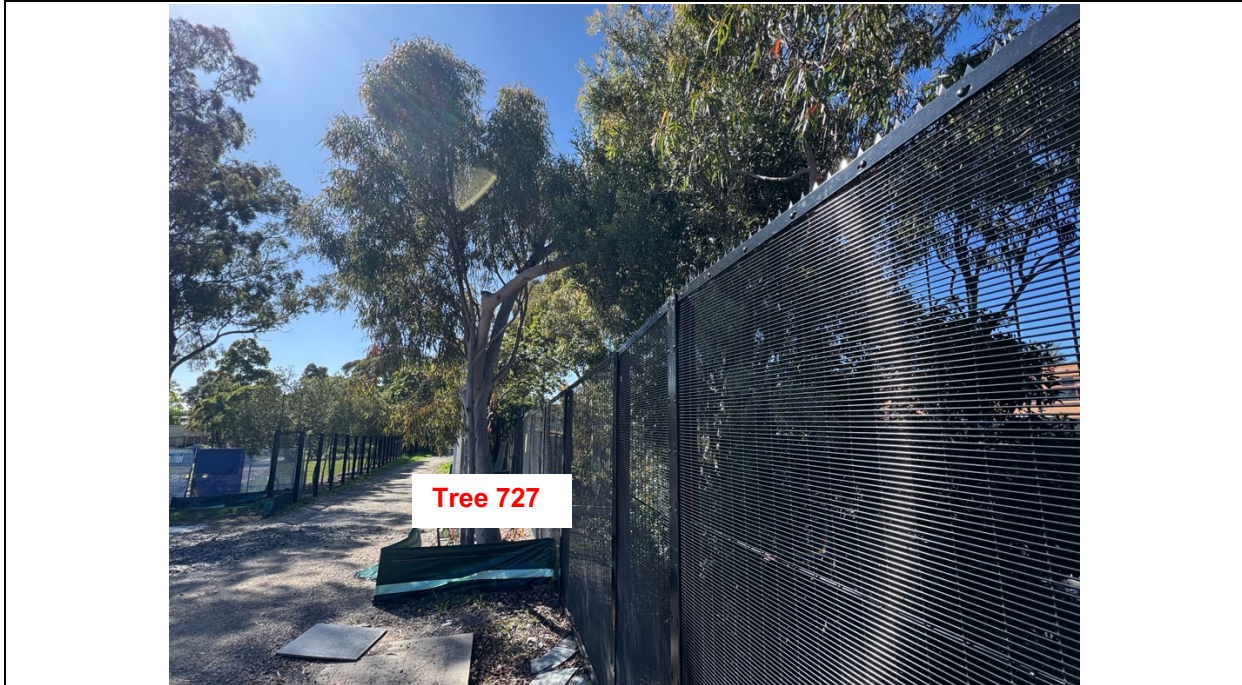
**Image 23:** Looking towards tree 727. The tree is recommended for removal.

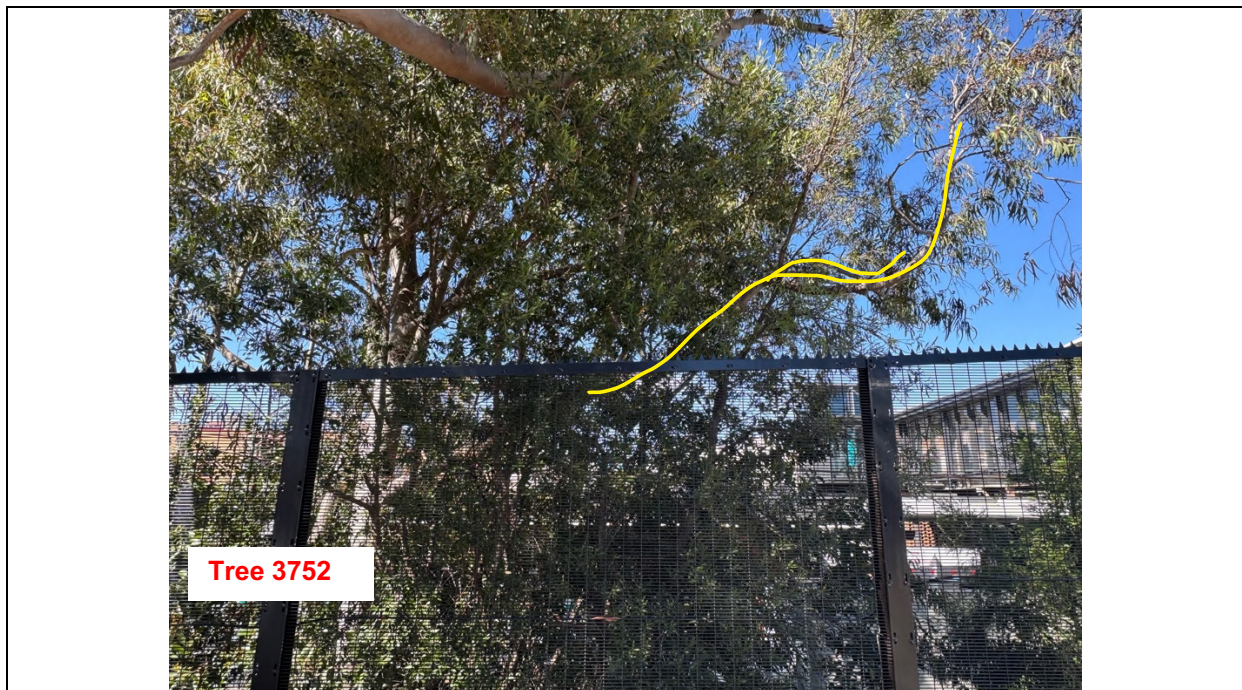
**Image 24:** Looking towards tree 3752. Canopy pruning is required to provide 2m clearance from the fence. The 80mm diameter second order branch to the West at 3m is to be pruned (yellow line). The pruning will result in the removal of approximately 5% of the live foliage area of the tree.

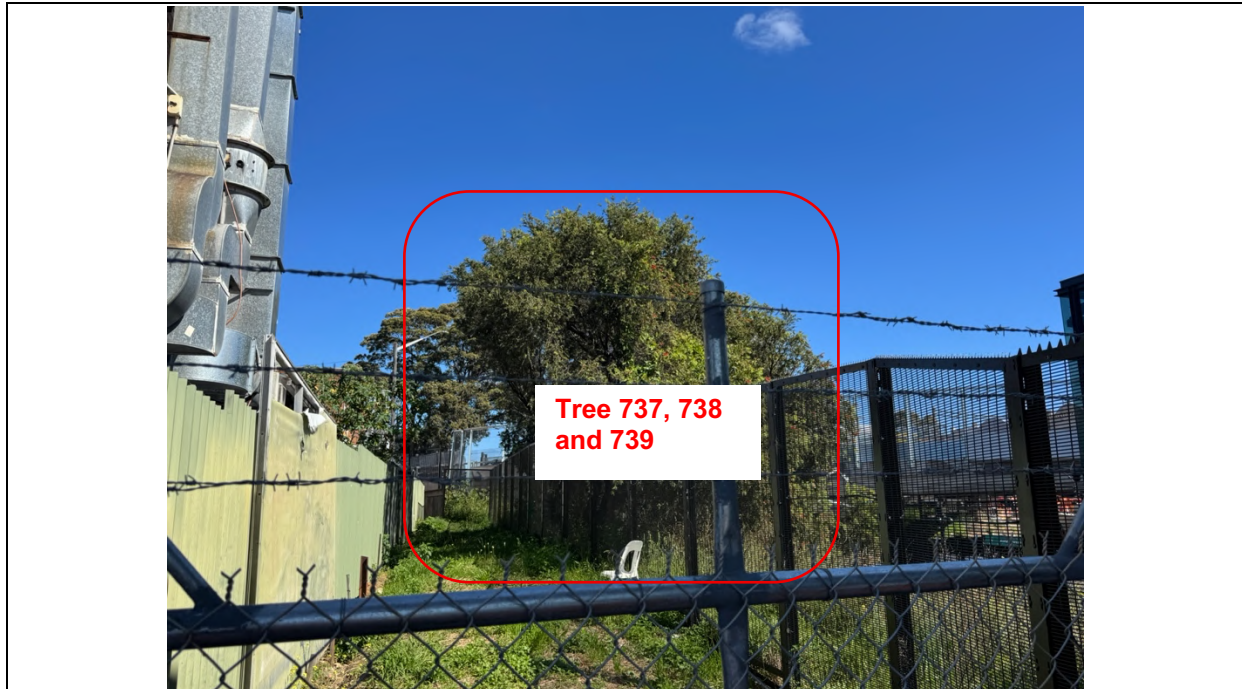
**Image 25:** Looking towards tree 737, 738 and 739. The trees are recommended for removal.

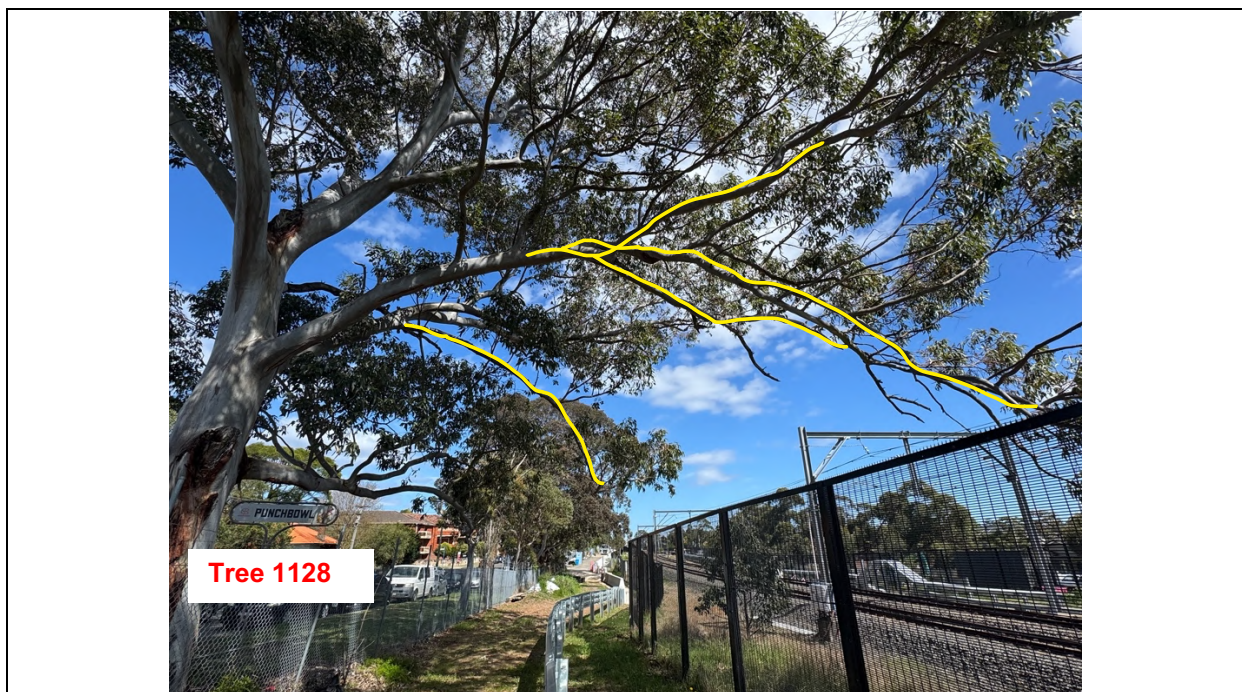
**Image 26:** Looking towards tree 1128. Canopy pruning is required to provide 2m clearance from the fence. The 200mm diameter first order branch to the North at 6m is to be reduced in length to the third upright branch, and the 120mm diameter second order branch to the Northwest at 5m is to be pruned (yellow lines). The pruning will result in the removal of approximately 5% of the live foliage area of the tree.

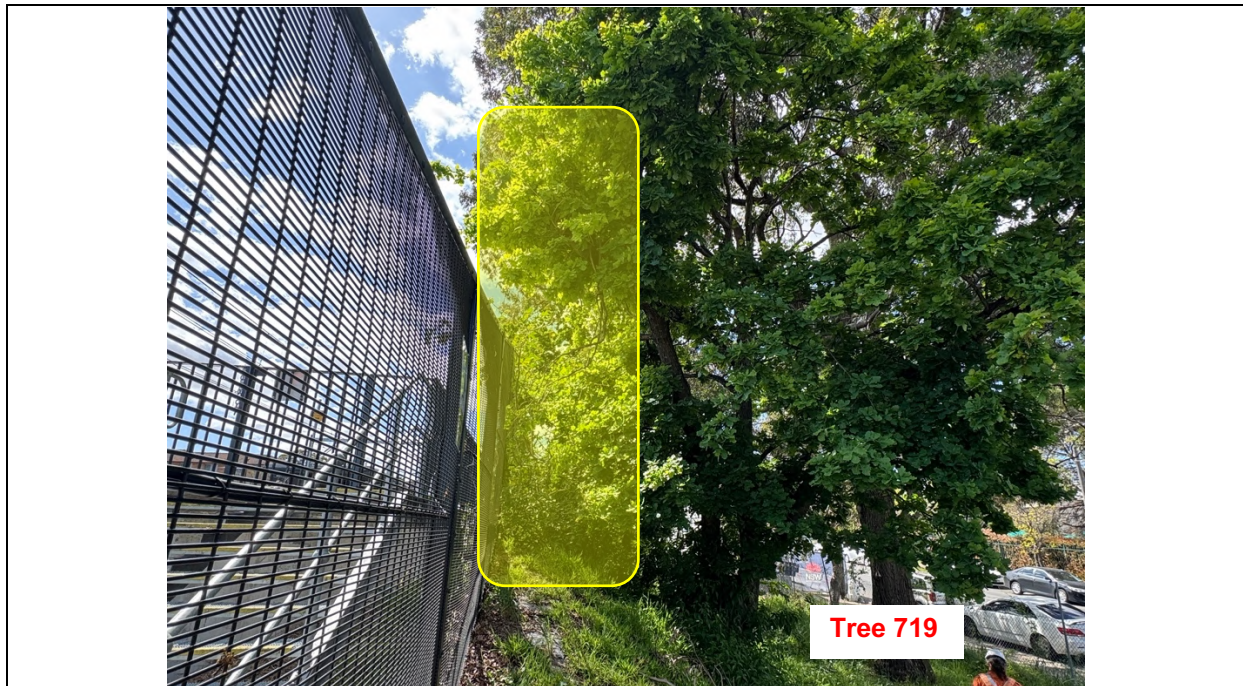
**Image 27:** Looking towards Group 60, which is a group of trees recommended for pruning. Smaller branches measuring less than 50mm in diameter are to be pruned. The pruning will result in the removal of less than 10% of the live foliage area of each tree within the group. The approximate area of the pruning for G60 has been marked yellow.

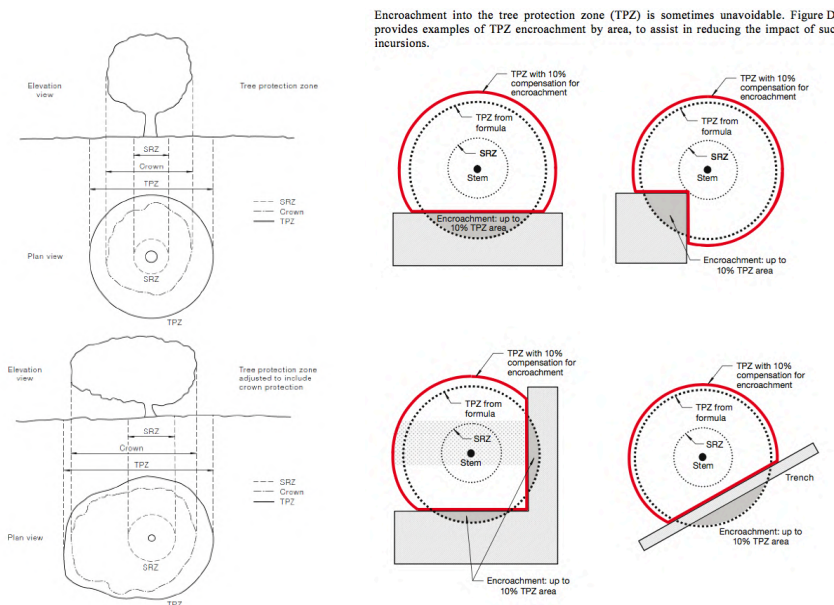
- Structural Root Zone:** This is the area around the base of a tree required for the trees stability in the ground. An area larger than the SRZ always need to be maintained to preserve a viable tree as it will only have a minor effect on the trees vigour and health. There are several factors that determine the SRZ which include height, crown area, soil type and soil moisture. It can also be influenced by other factors such as natural or built structures. Generally work within the SRZ should be avoided.

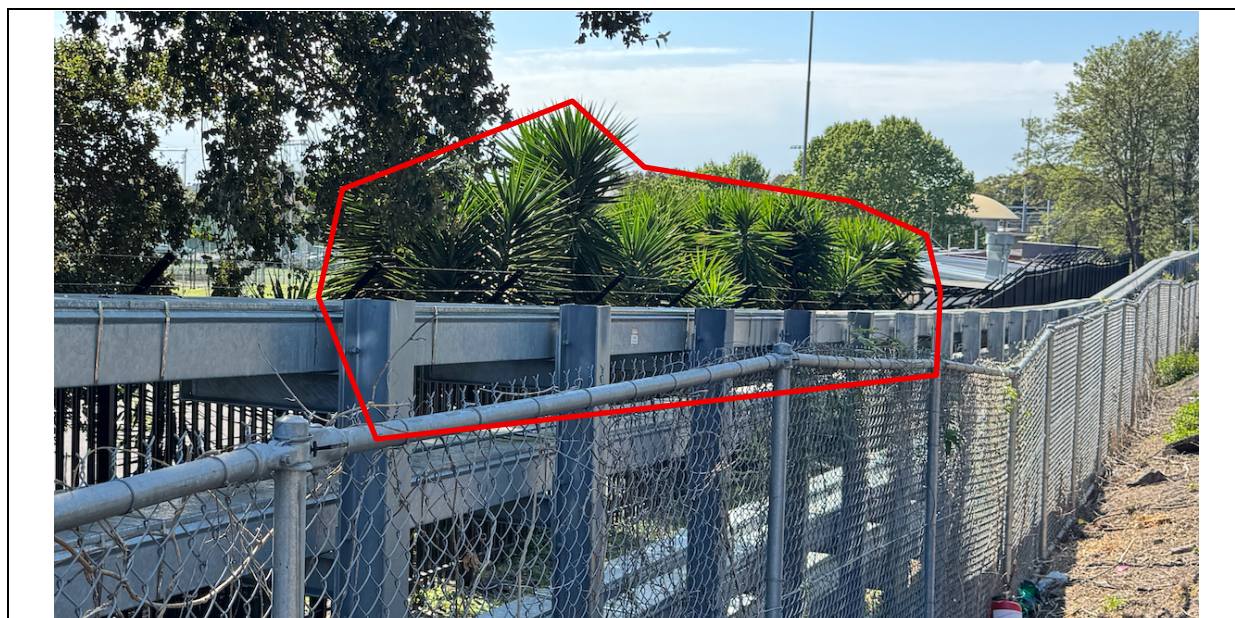
**Image 2:** Looking towards a group of *Yucca aloifolia* (Spanish Bayonet) located in the Portuguese Community Club. The plants are multi-stemmed and do not meet the criteria of significant trees as per section 2.1.2. The plants are recommended for removal to provide 2m clearance from the fence.

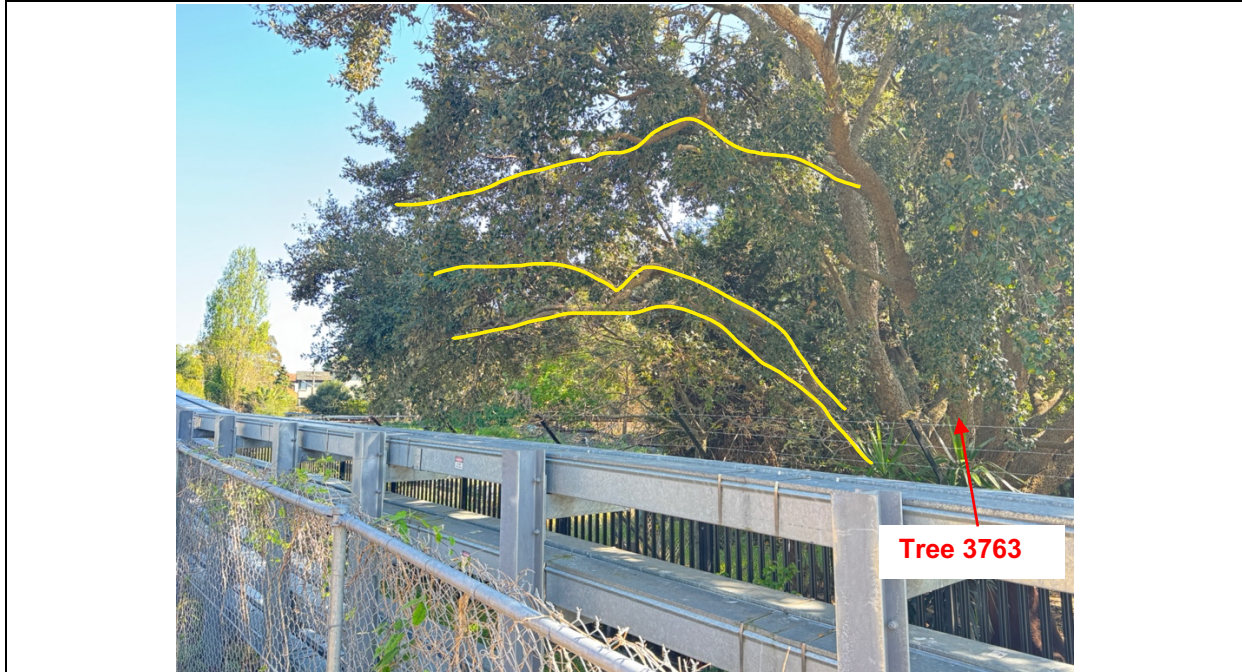
**Image 3:** Looking towards tree 3763, located in the Portuguese Community Club. Canopy pruning is required to provide clearance from the fence. The second and third order branches to the South require pruning to provide fence clearance. The maximum finished cut diameter measures approximately 160mm. The pruning will result in the removal of approximately 5% of the live foliage area of the tree. The branches to be pruned have been marked yellow.

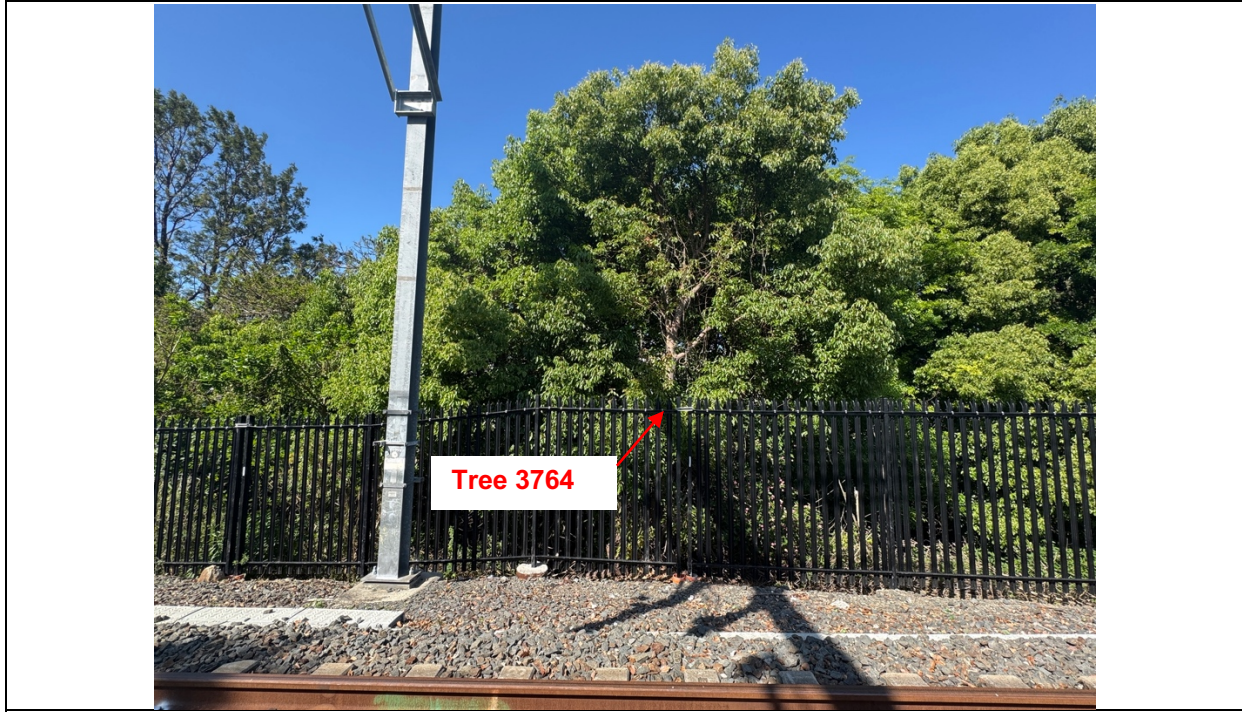
**Image 5:** Looking towards tree 3764. The tree is recommended for removal.
