# CIDS & ODS Tree Impact Assessment Report

## SWM3- Tree and Vegetation Management Work Part 2 Instruction

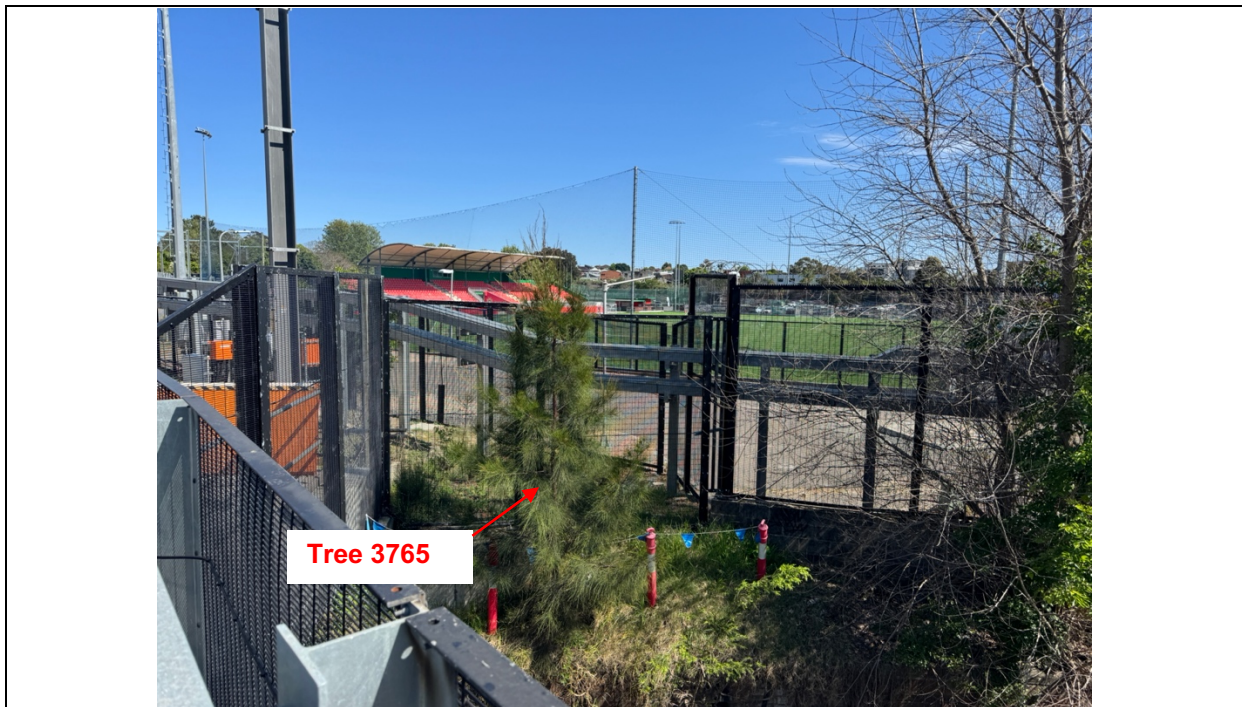
**Image 6:** Looking towards tree 3765. The tree is recommended for removal.

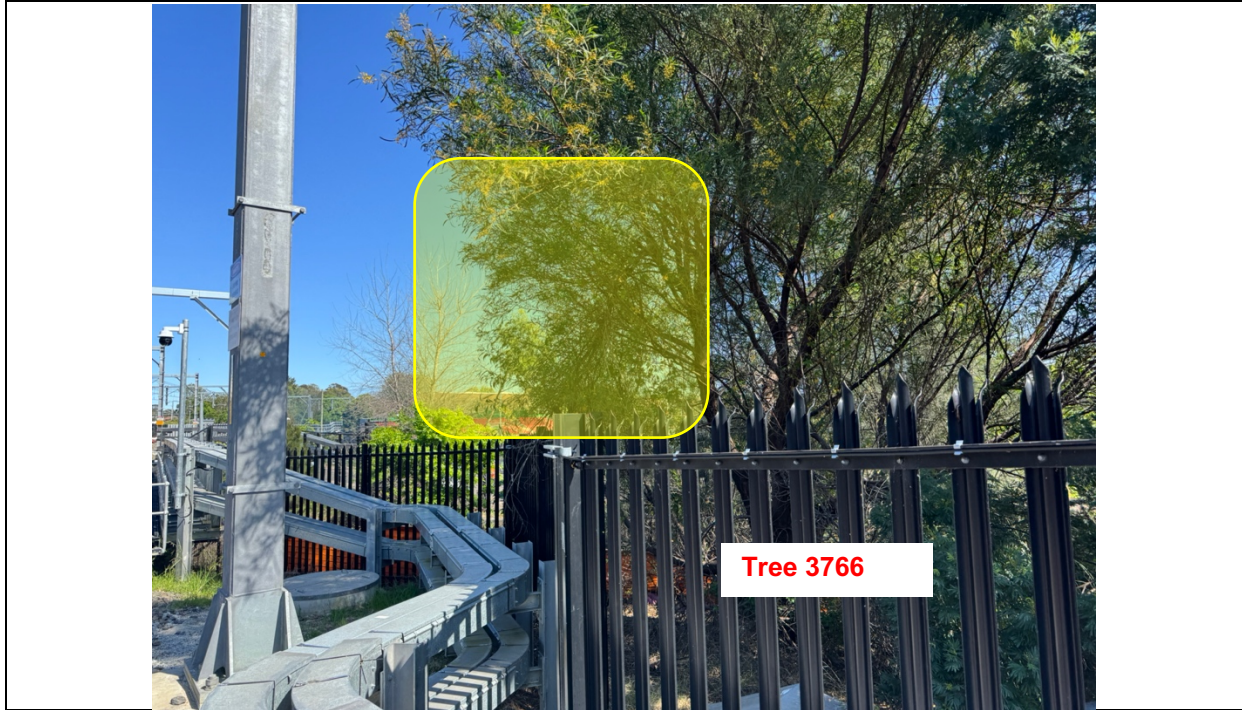
**Image 7:** Looking towards tree 3766. Canopy pruning is required to provide 2m clearance from the fence. Smaller branches measuring less than 100mm in diameter are to be pruned. The pruning will result in the removal of 5% of the live foliage area of the tree.

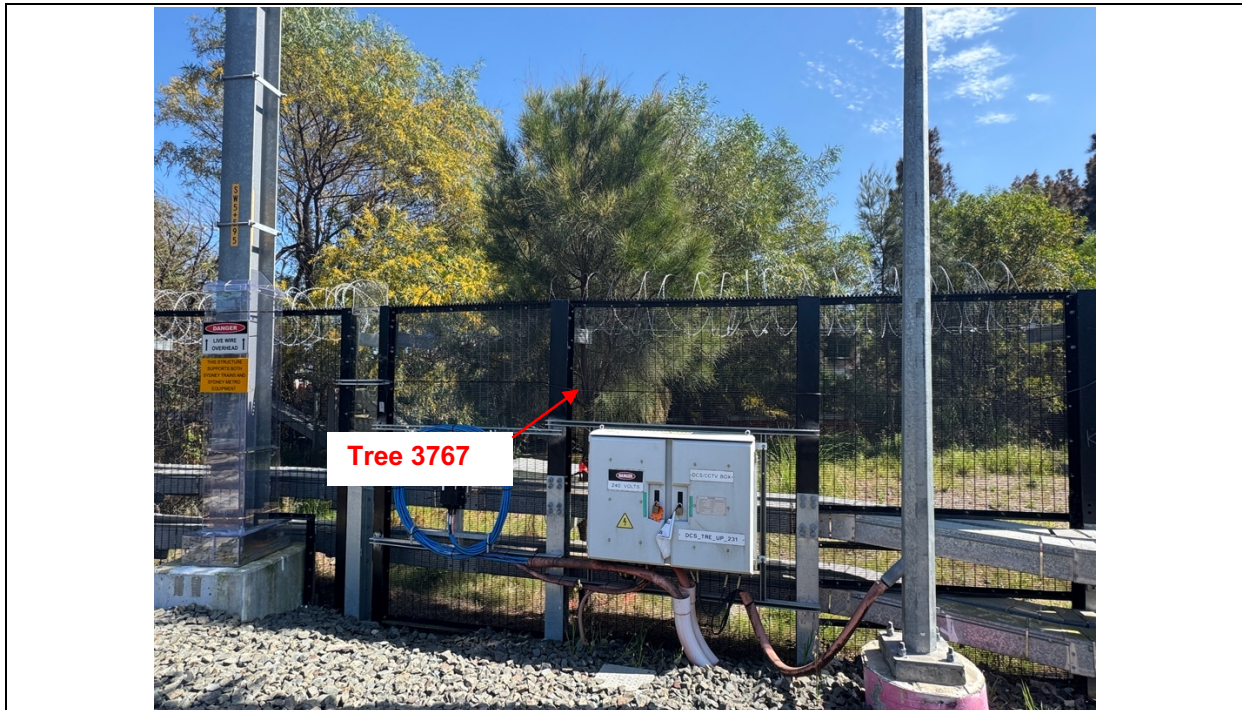
**Image 8:** Looking towards tree 3767. The tree is recommended for removal.

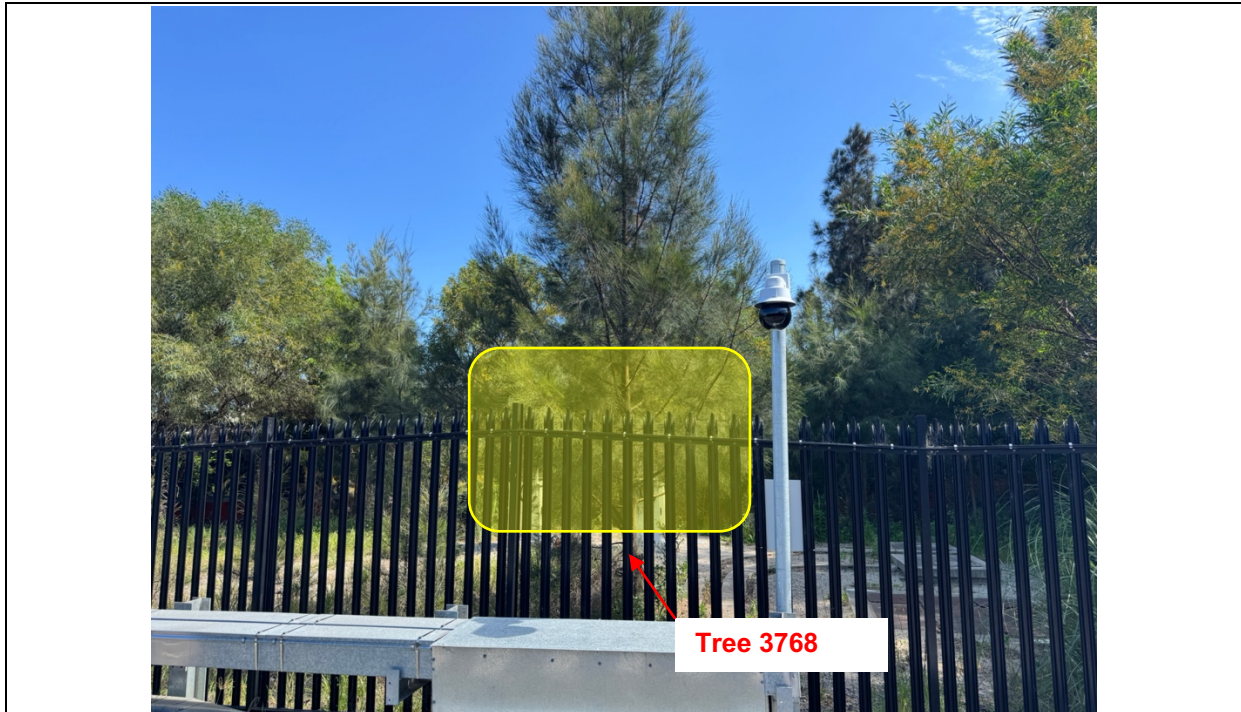
**Image 9:** Looking towards tree 3768. Canopy pruning is required to provide 2m clearance from the fence. Smaller branches measuring less than 100mm in diameter are to be pruned. The pruning will result in the removal of less than 10% of the live foliage area of the tree.

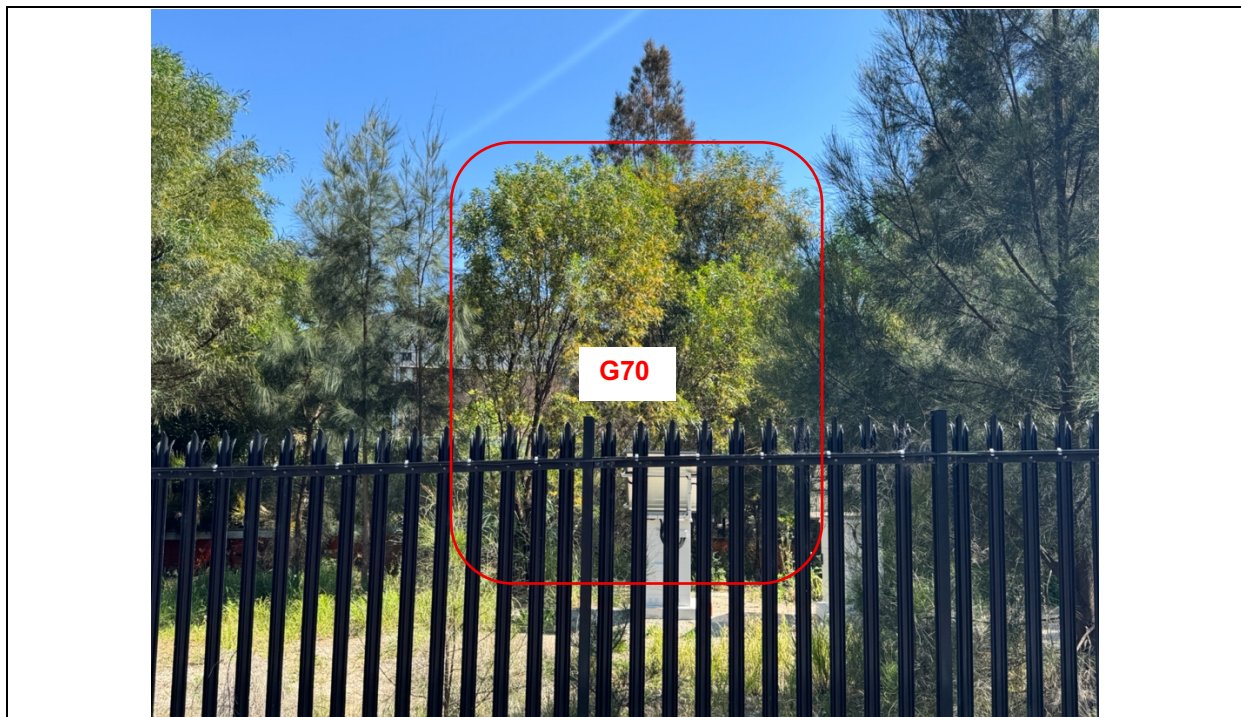
**Image 10:** Looking towards G70, which is a group of approximately 4 small trees. The trees are recommended for removal.

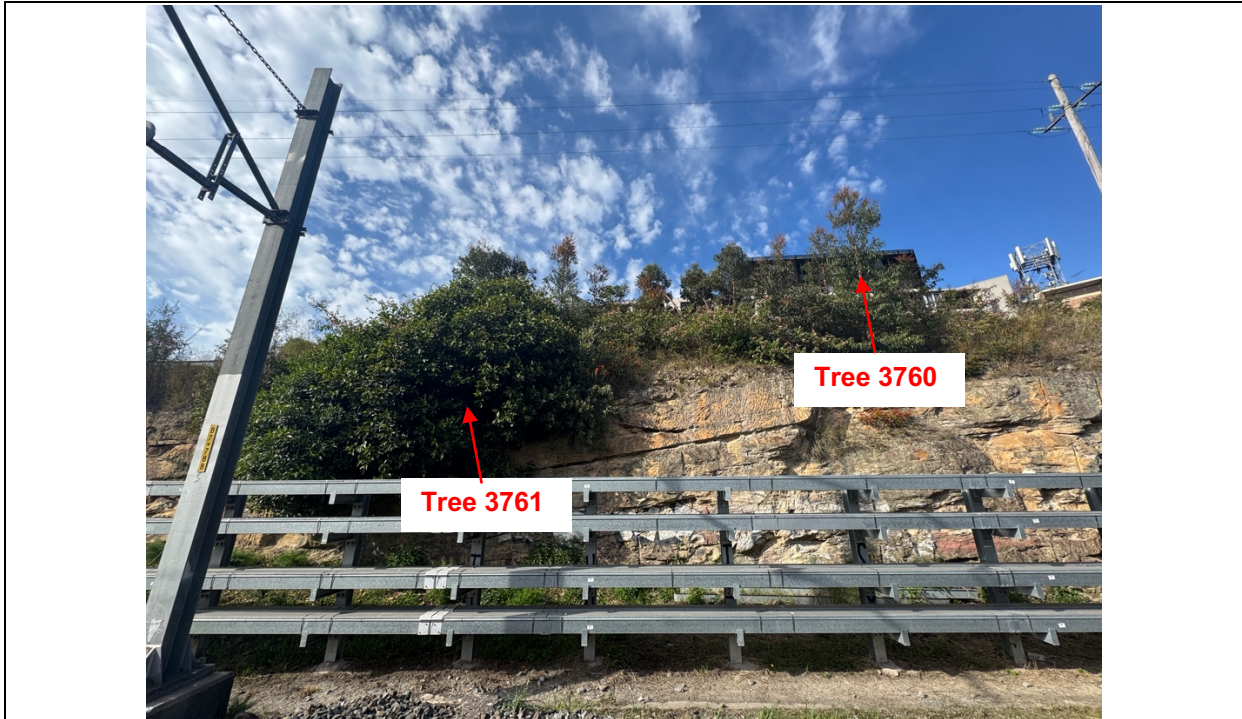
**Image 11:** Looking towards tree 3760 and 3761. The trees are recommended for removal.

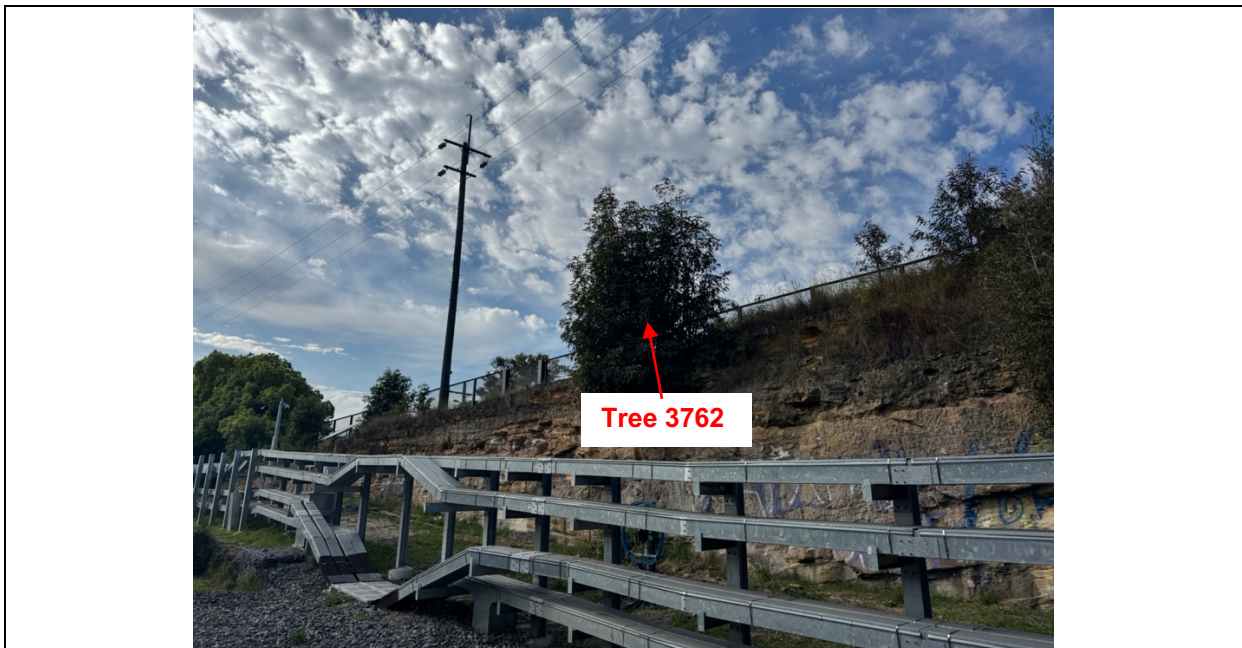
**Image 12:** Looking towards tree 3762. The tree is recommended for removal.

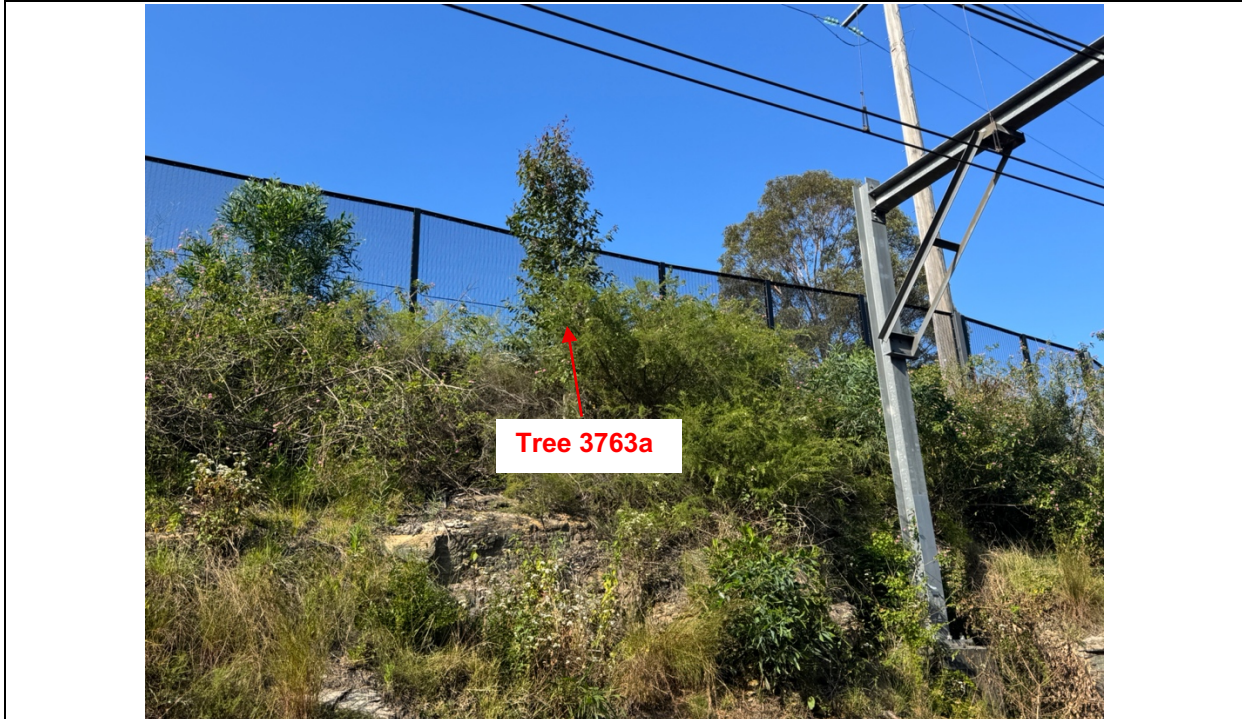
**Image 13:** Looking towards tree 3763a. The tree is recommended for removal.

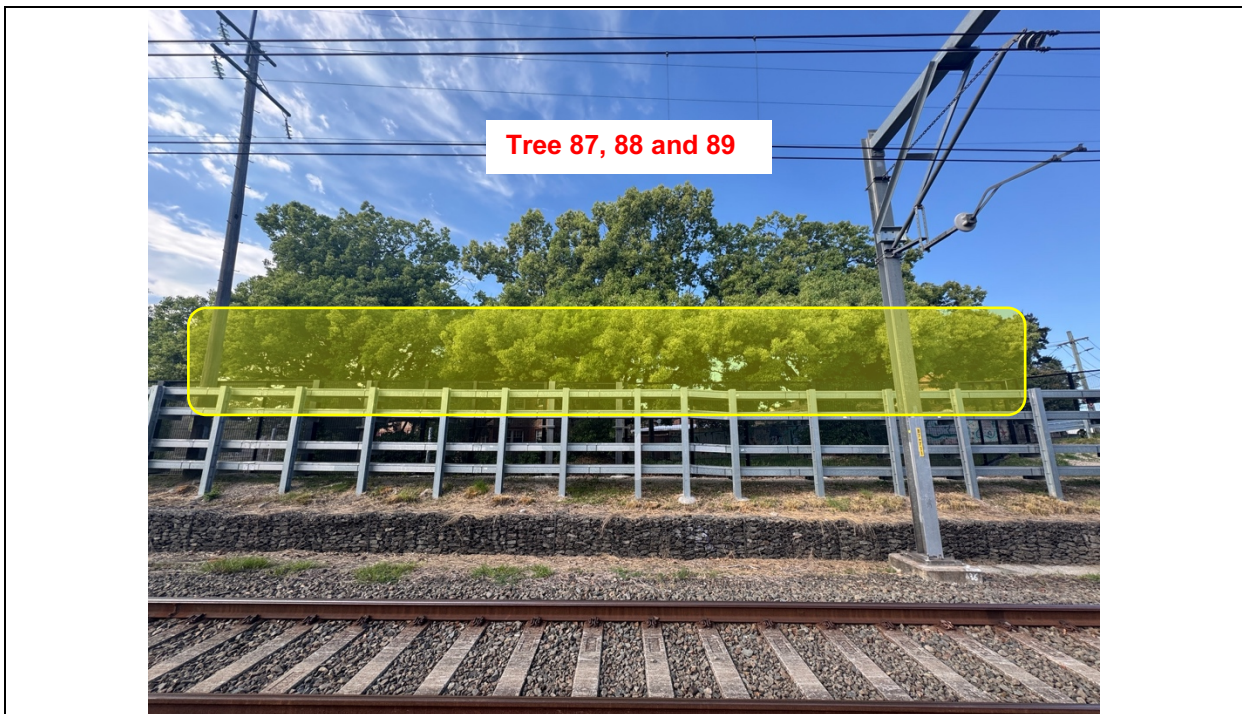
**Image 14:** Looking towards tree 87, 88 and 89. Canopy pruning is required to provide 2m clearance from the fence. Smaller branches measuring less than 80mm in diameter are to be pruned. The pruning will result in the removal of less than 10% of the live foliage area of each tree.

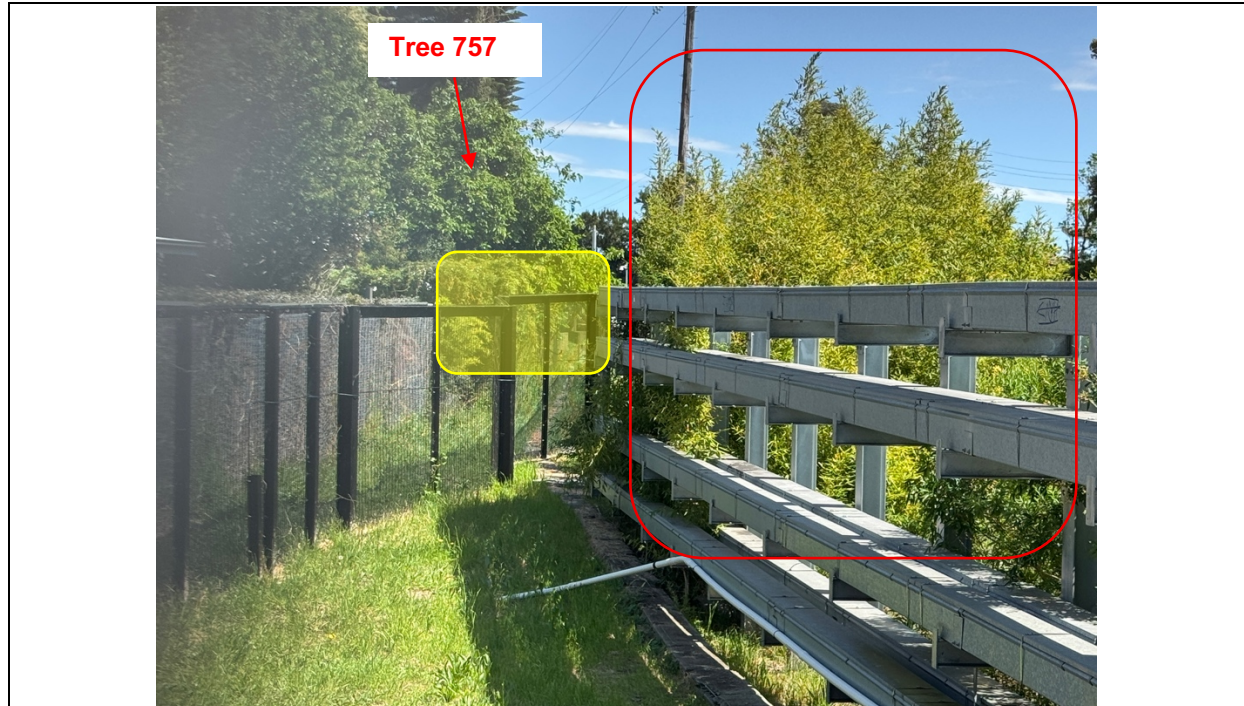
**Image 15:** Looking towards tree 757. Canopy pruning is required to provide 2m clearance from the fence. Smaller branches measuring less than 50mm in diameter are to be pruned. The pruning will result in the removal of less than 10% of the live foliage area of the tree (yellow hatched area). Also showing the bamboo (red outline) that is recommended for removal. The bamboo are multi-stemmed monocotyledons and do not meet the criteria of significant trees as per section 2.1.2.

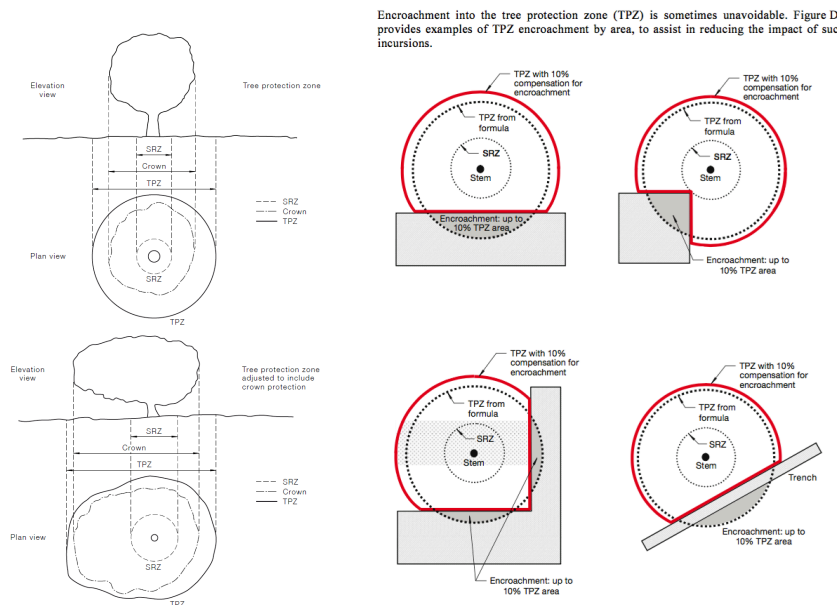
2. **Structural Root Zone:** This is the area around the base of a tree required for the trees stability in the ground. An area larger than the SRZ always need to be maintained to preserve a viable tree as it will only have a minor effect on the trees vigour and health. There are several factors that determine the SRZ which include height, crown area, soil type and soil moisture. It can also be influenced by other factors such as natural or built structures. Generally work within the SRZ should be avoided.

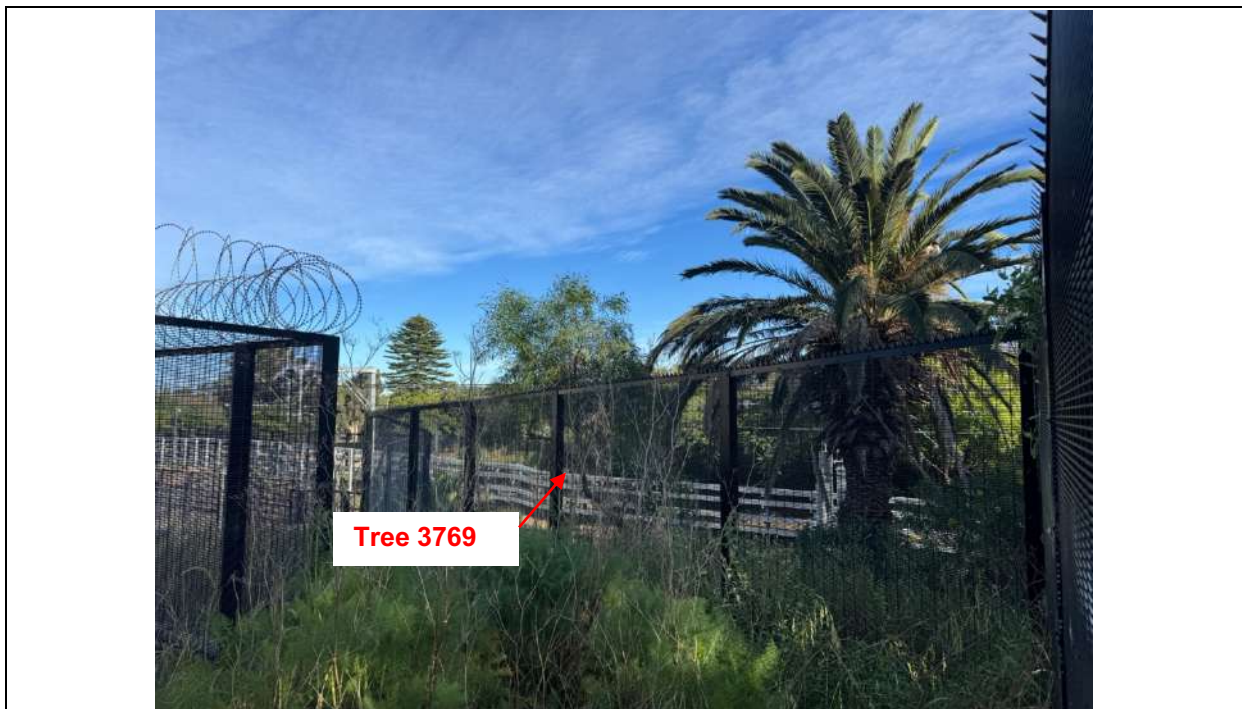
**Image 2:** Looking towards tree 3769. The tree is recommended for removal.

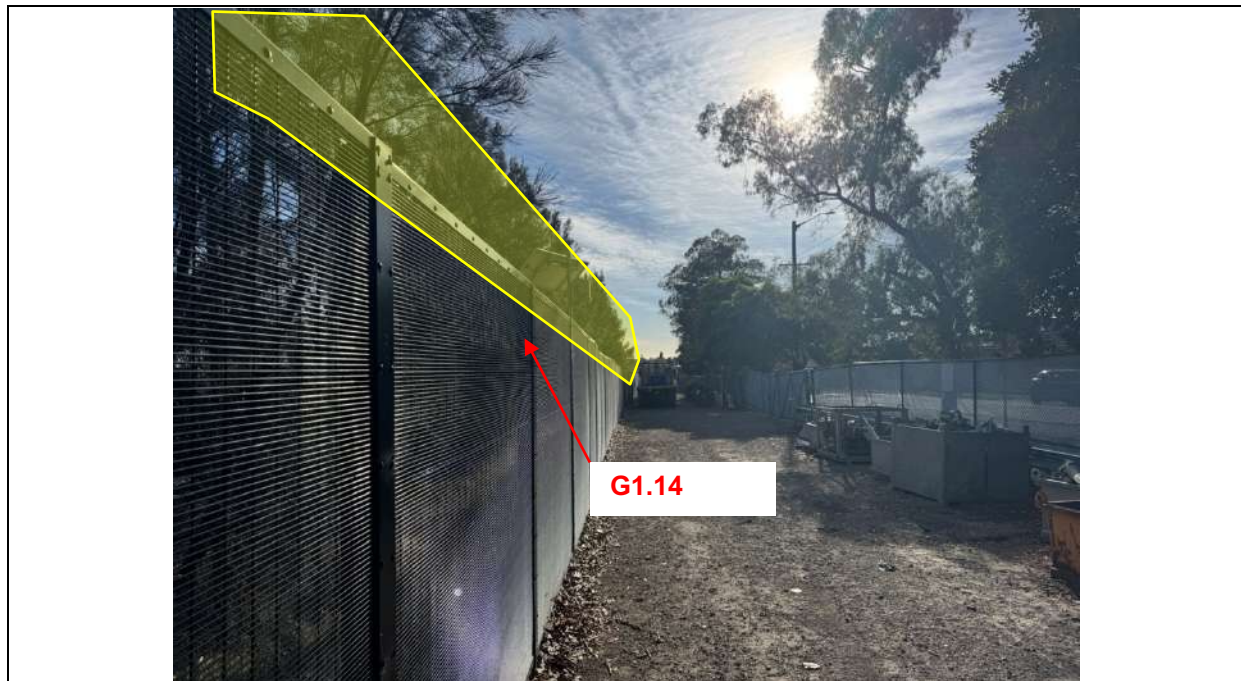
**Image 3:** Looking towards tree G1.14. Canopy pruning is required to provide 2m clearance from the fence. The maximum finished cut diameter must not exceed 100mm. The pruning will result in the removal of approximately 5% of the live foliage area of each tree in the group. The approximate area of pruning has been marked yellow.

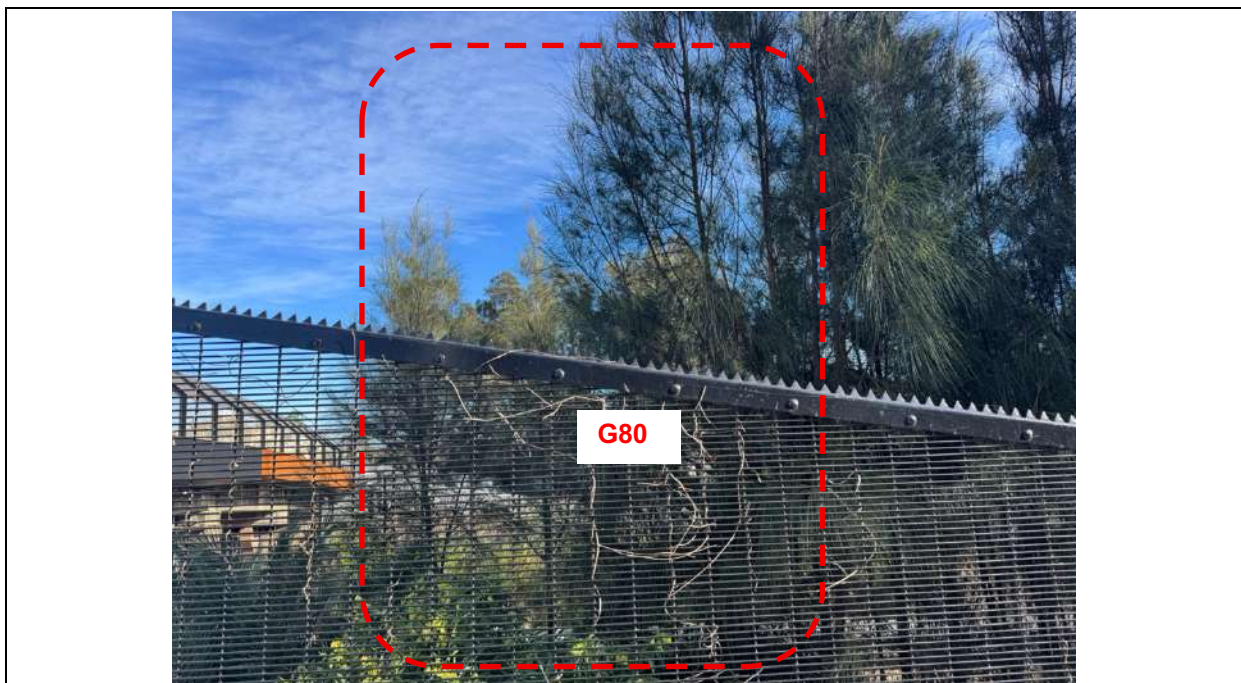
**Image 6:** Looking towards tree G80, which is a group of four trees. The trees are recommended for removal.

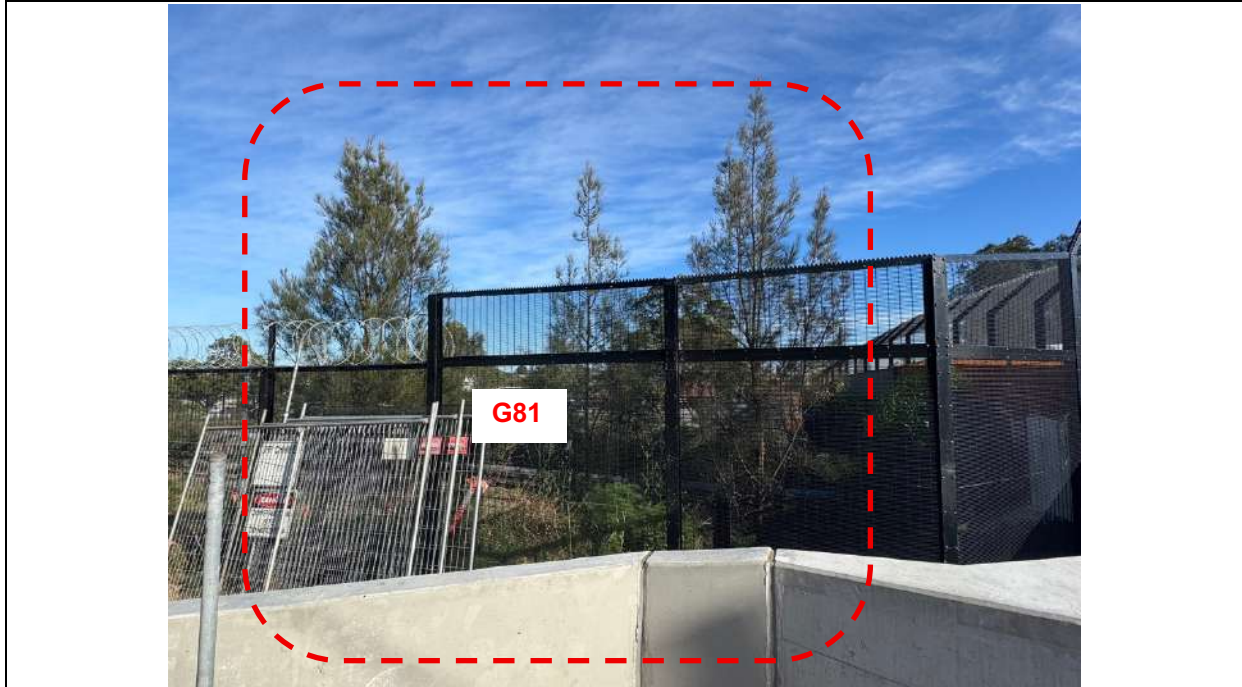
**Image 7:** Looking towards tree G81, which is a group of three trees. The trees are recommended for removal.

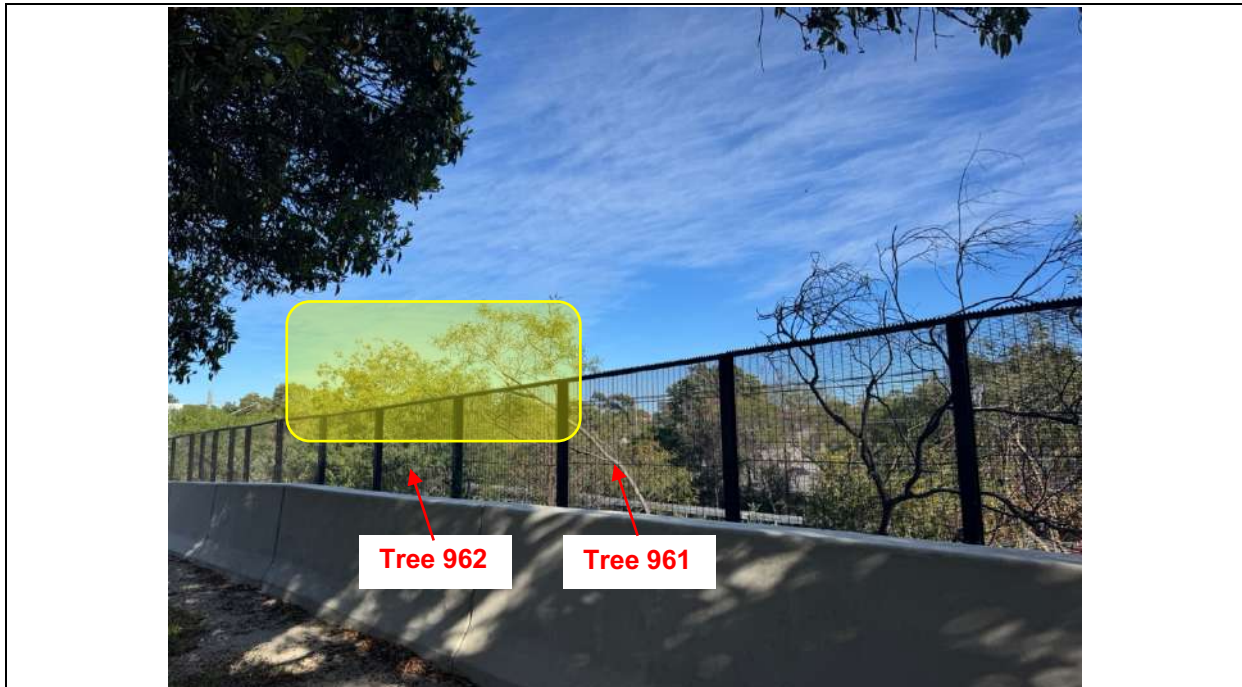
**Image 8:** Looking towards trees 961 and 962. Canopy pruning is required to provide 2m clearance from the fence. Smaller branches measuring less than 50mm in diameter are to be pruned. The pruning will result in the removal of 10% of the live foliage area of each tree.

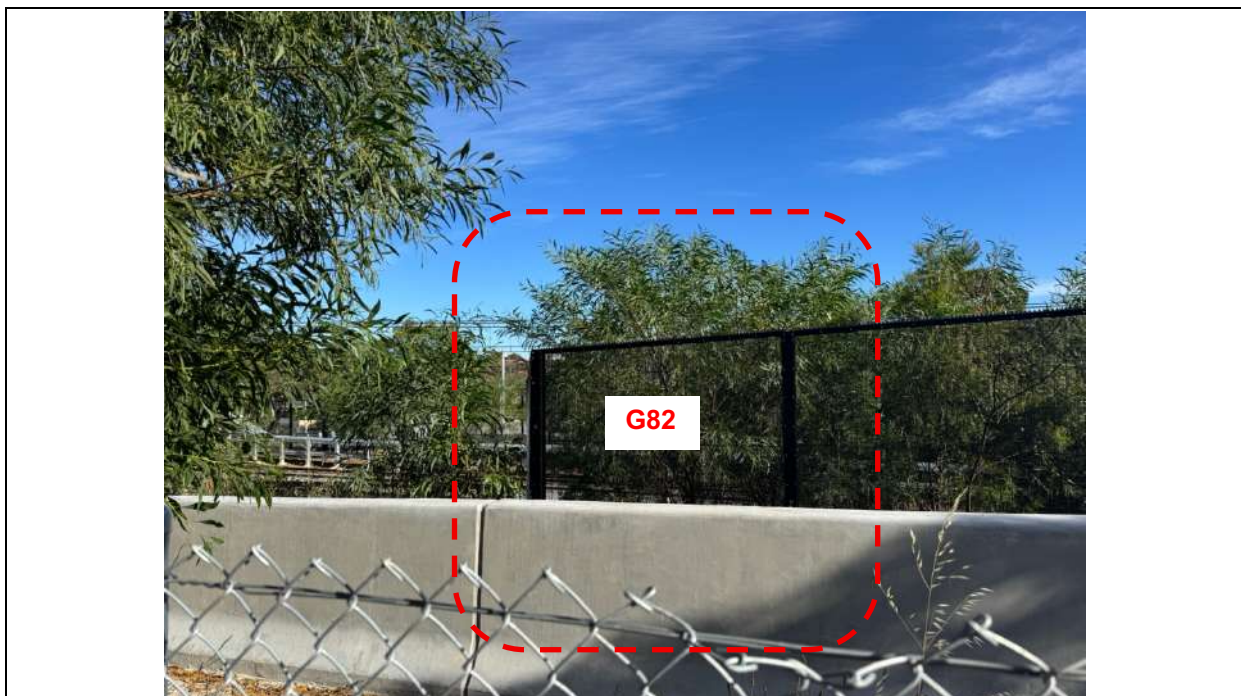
**Image 10:** Looking towards tree G82, which is a group of four trees. The trees are recommended for removal.

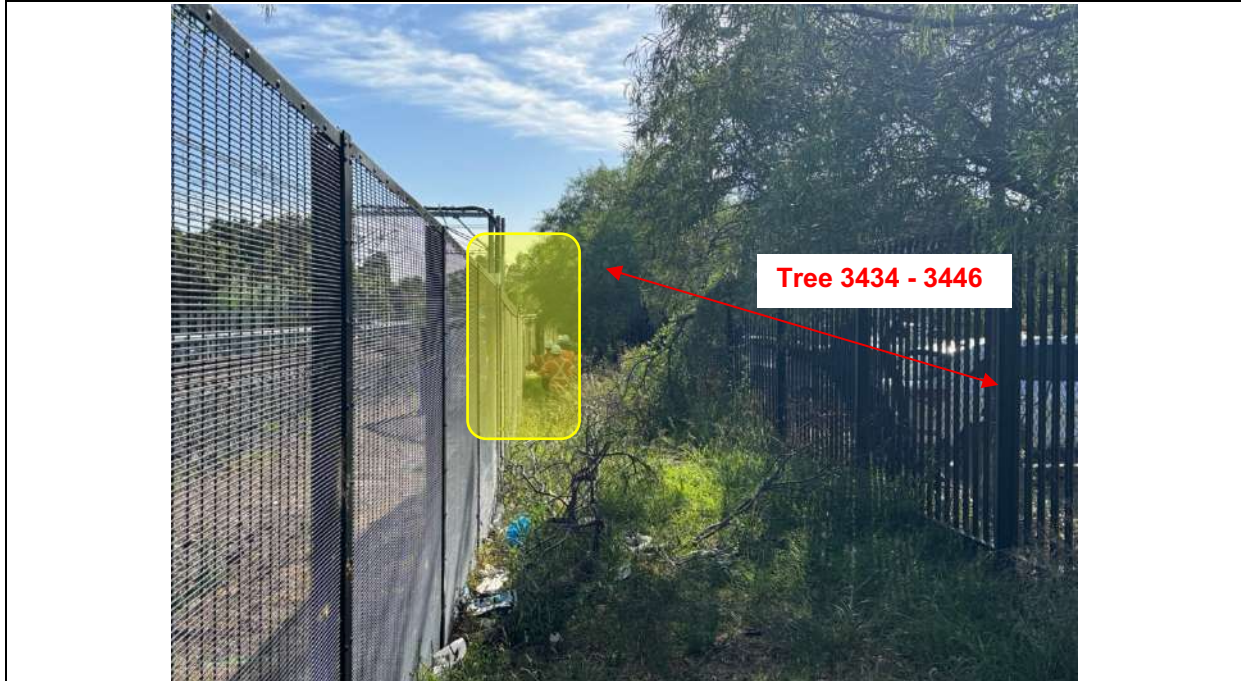
**Image 11:** Looking along the fence line adjacent to tree 3434 – 3446 (thirteen trees). Canopy pruning is required to provide 2m clearance from the fence. Smaller branches measuring less than 100mm in diameter are to be pruned. The pruning will result in the removal of less than 10% of the live foliage area of each tree. The approximate area requiring pruning has been marked yellow.

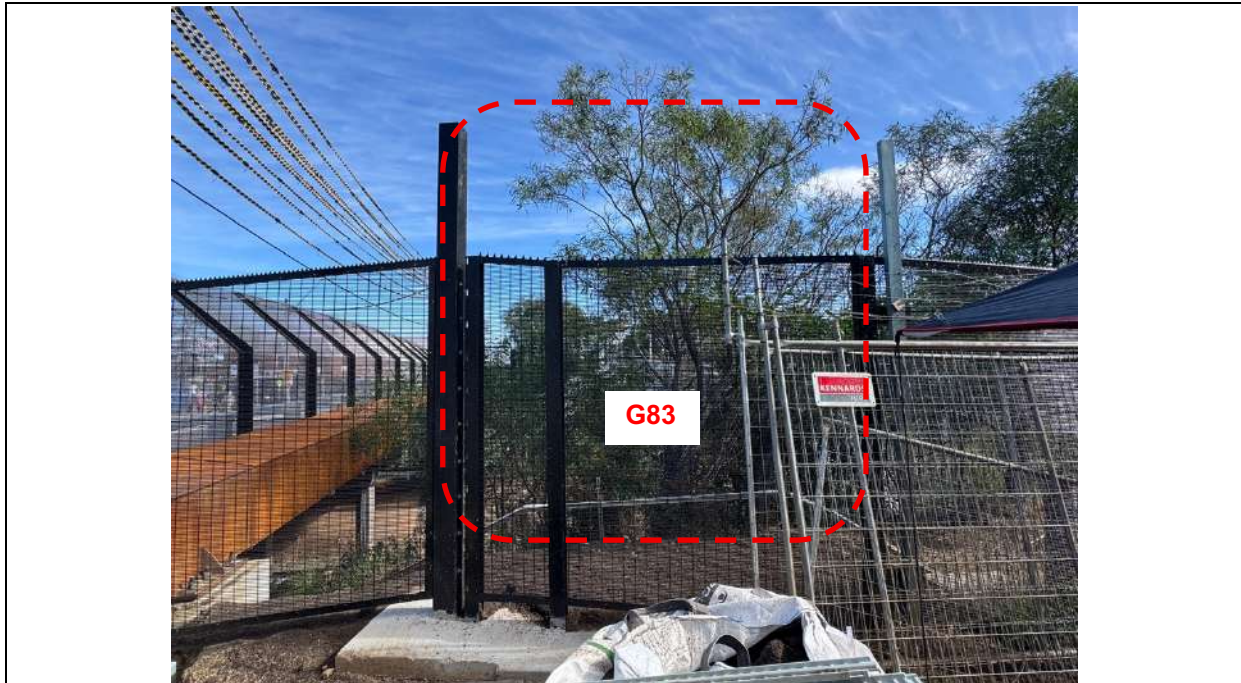
**Image 15:** Looking towards tree G83, which is a group of five trees. The trees are recommended for removal.

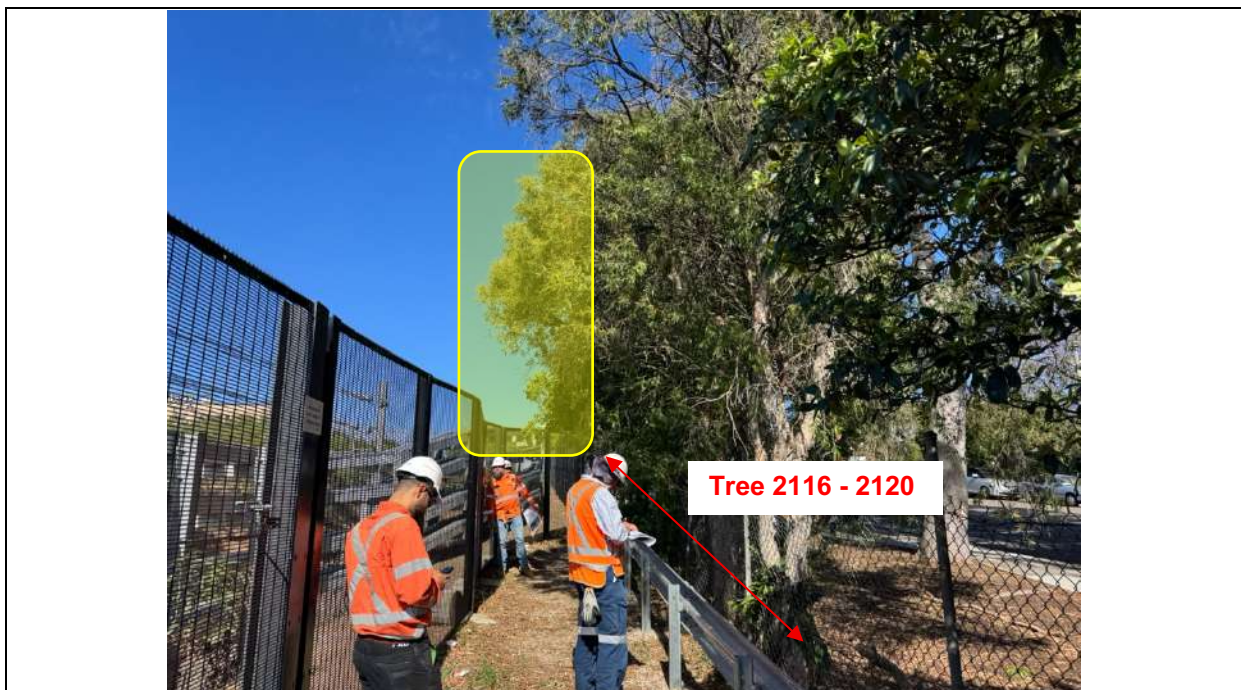
**Image 16:** Looking along the fence line adjacent to tree 2116, 2117, 2119, 2120 (four trees). Canopy pruning is required to provide 2m clearance from the fence. Smaller branches measuring less than 100mm in diameter are to be pruned. The pruning will result in the removal of less than 10% of the live foliage area of each tree. The approximate area requiring pruning has been marked yellow.

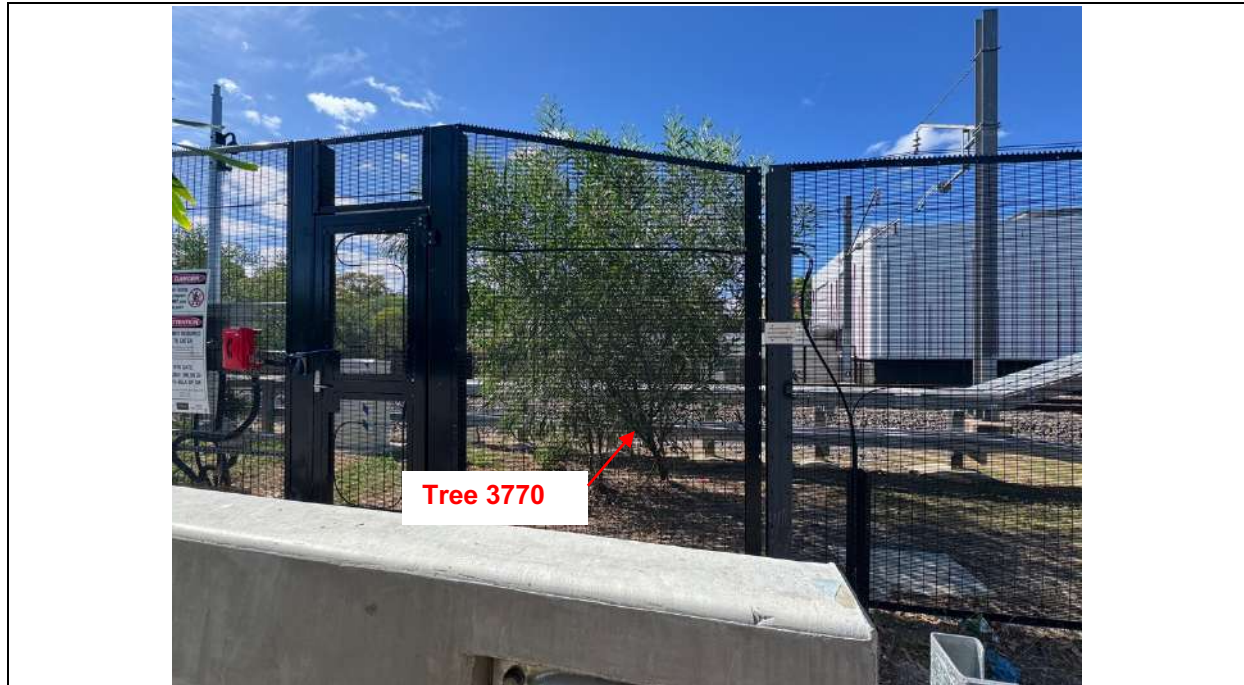
**Image 17:** Looking towards tree 3770. The tree is recommended for removal.

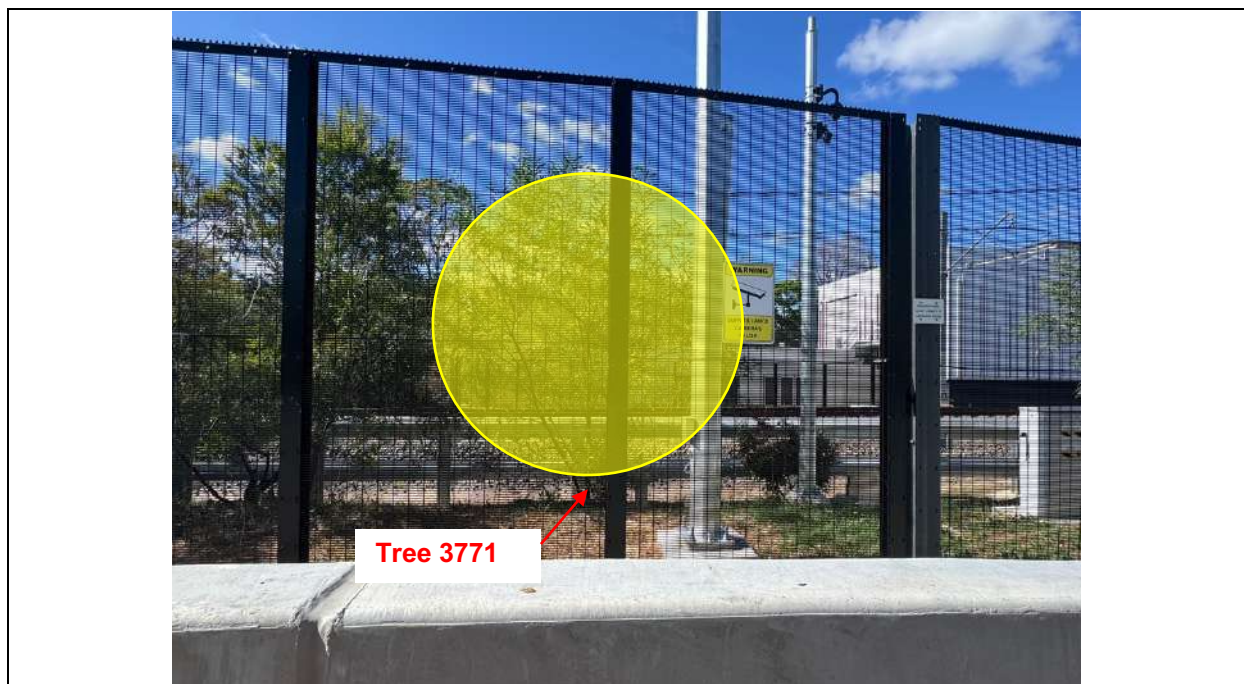
**Image 18:** Looking towards tree 3771. Canopy pruning is required to provide line of sight to the UTO fence. Smaller branches measuring less than 50mm in diameter are to be pruned that extend towards the fence. The pruning will result in the removal of approximately 20% of the live foliage area and is considered significant, however it is a preferred option to whole tree removal. The approximate area requiring pruning has been marked yellow.

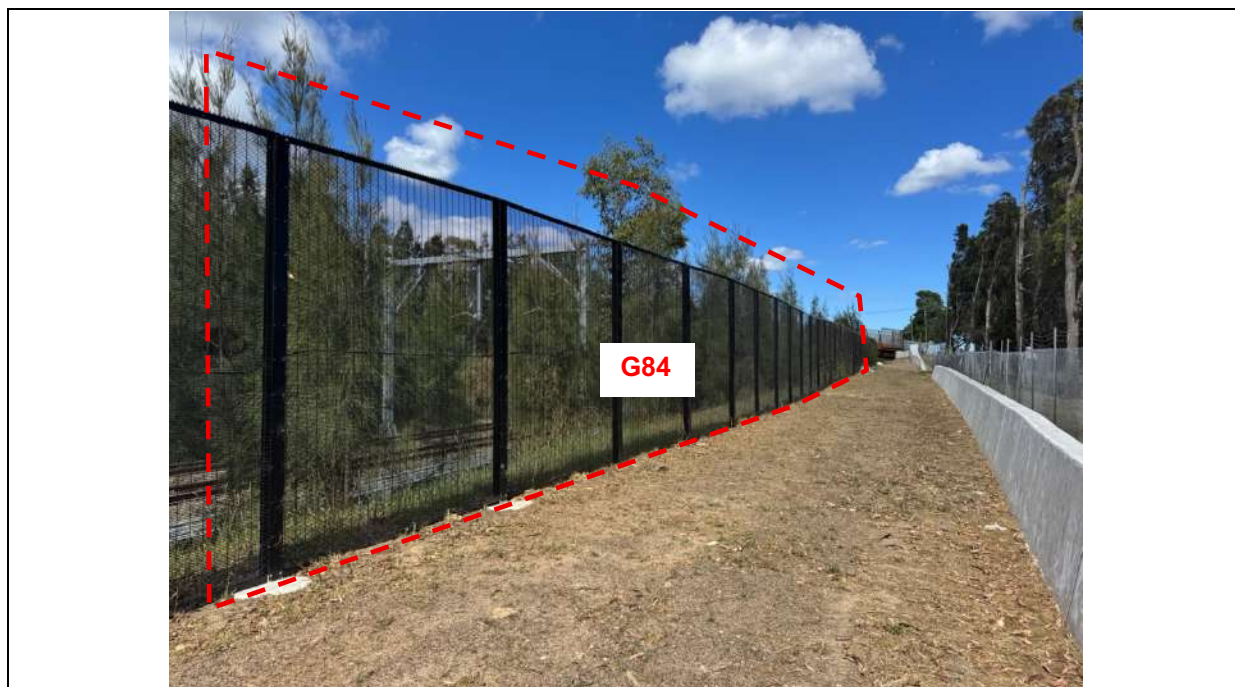
**Image 19:** Looking along the fence line adjacent to tree 2156, 2157, and tree 3476 - 3491 (sixteen trees). Canopy pruning is required to provide 2m clearance from the fence. Smaller branches measuring less than 100mm in diameter are to be pruned. The pruning will result in the removal of less than 10% of the live foliage area of each tree. The approximate area requiring pruning has been marked yellow.

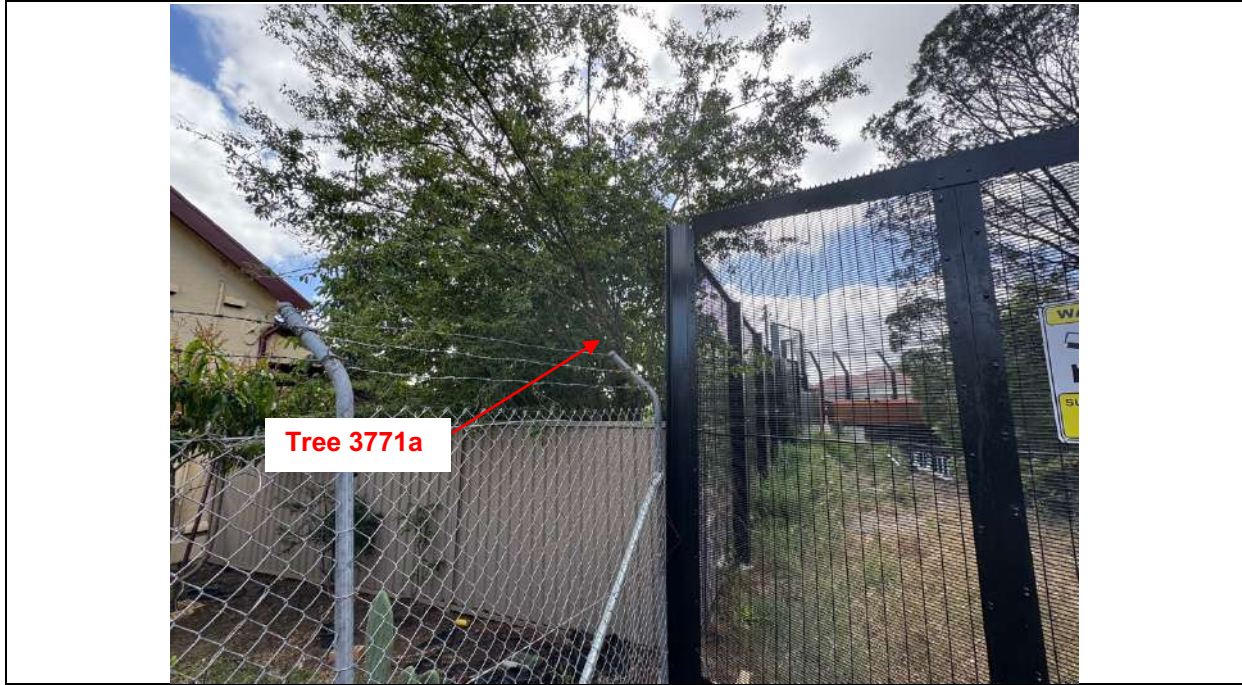
**Image 21:** Looking towards tree 3771a. The tree is recommended for removal.

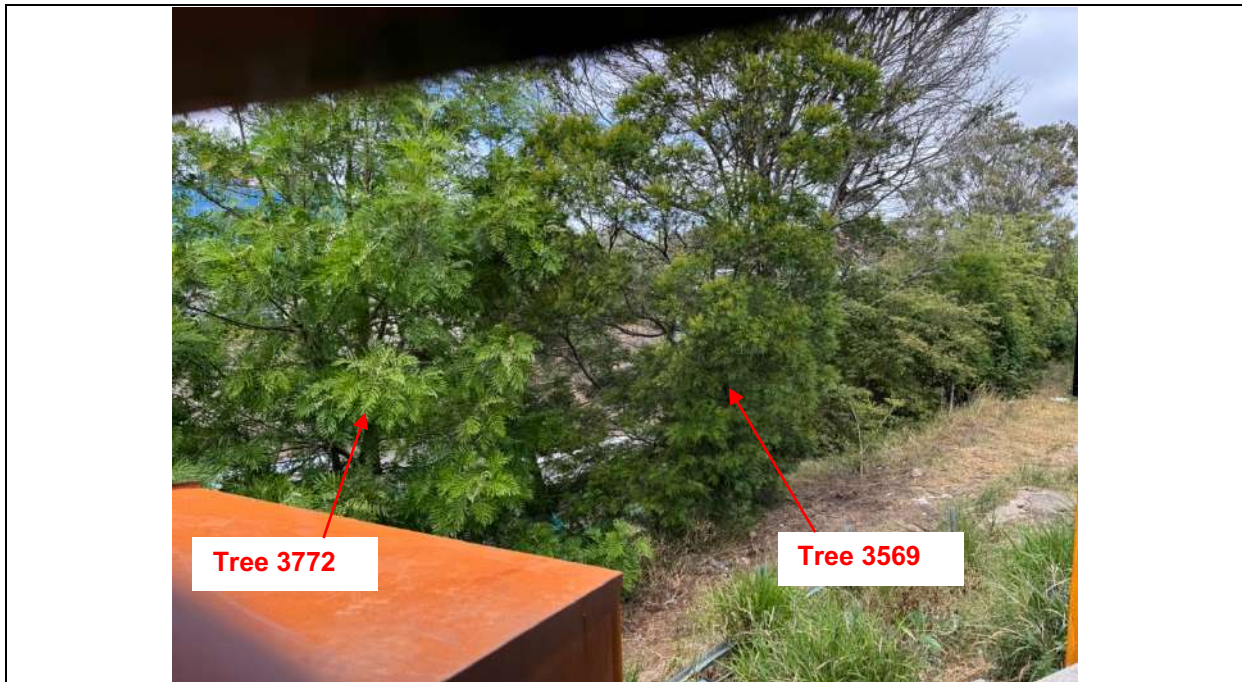
**Image 22:** Looking towards tree 3569 and 3772. The trees are recommended for removal.
