# CIDS & ODS Tree Impact Assessment Report

## SWM3- Tree and Vegetation Management Work Part 2 Instruction

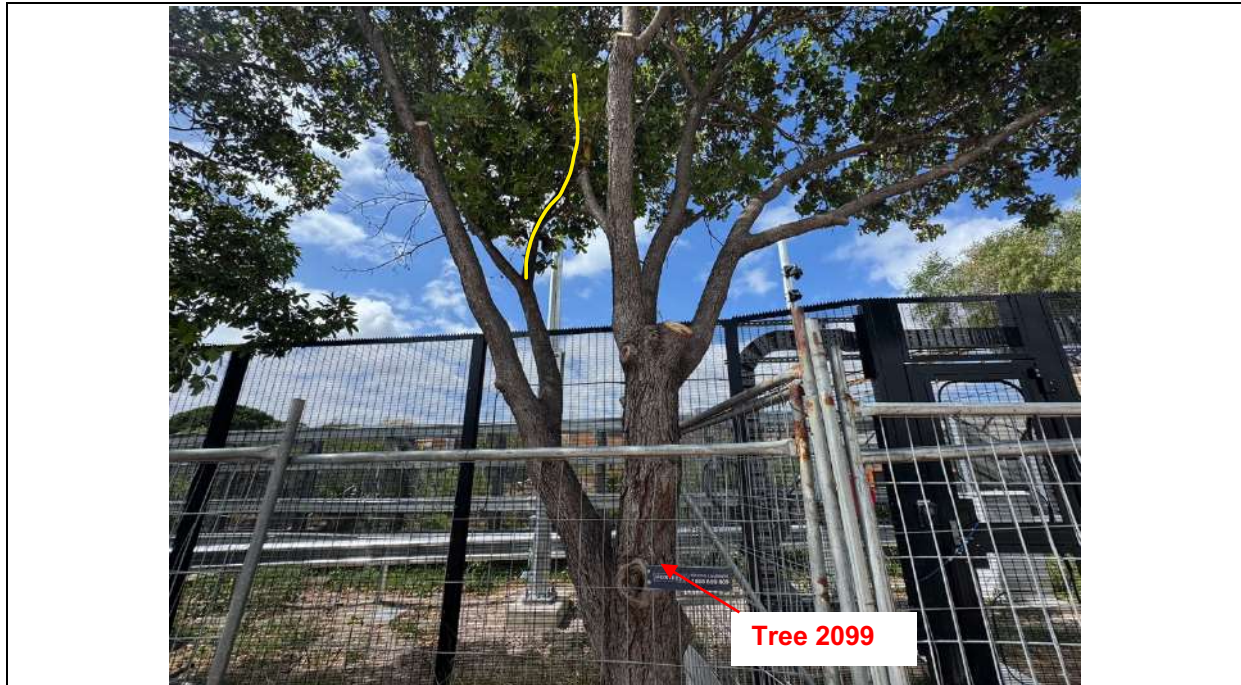
**Image 23:** Looking towards tree 2099. The 80mm diameter third order branch marked yellow requires pruning to provide fence clearance. The pruning will result in the removal of approximately 5% of the live foliage area of the tree.

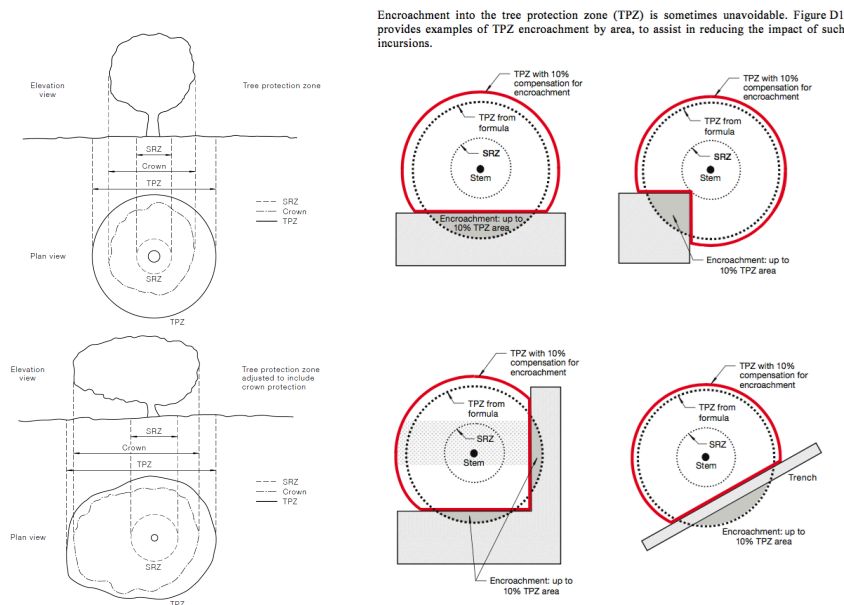
2. **Structural Root Zone:** This is the area around the base of a tree required for the trees stability in the ground. An area larger than the SRZ always need to be maintained to preserve a viable tree as it will only have a minor effect on the trees vigour and health. There are several factors that determine the SRZ which include height, crown area, soil type and soil moisture. It can also be influenced by other factors such as natural or built structures. Generally work within the SRZ should be avoided.
