Pre-Construction Minor Works Approval Form

Part 1: Application	
Contractor:	John Holland & Laing O'Rourke joint venture (JHLOR)
Project:	Sydenham Station and Junction
Application Title: (e.g. Smith St trenching works)	Design Investigation Works – Project Wide (inside and outside of rail corridor)
Application Number:	SSJ-PCMW-002
Application Date:	18/01/2018
Planning Approval:	<p>The Sydney Metro City and Southwest – Chatswood to Sydenham - Environmental Impact Statement</p> <p>The Sydney Metro City and Southwest - Environmental Impact Statement – Sydenham Station and Sydney Metro Trains Facility South Modification Report (MOD 4)</p> <p>The Sydney Metro City and Southwest - Environmental Impact Statement – Sydenham Station and Sydney Metro Trains Facility South Modification Submissions Report</p>
Minor Works Categories: <ul style="list-style-type: none"> Highlight as applicable. If Items 4, 8 or 11 are applicable, this form must be endorsed by an Environmental Representative. 	<ol style="list-style-type: none"> Survey, survey facilitation and investigations works (including road and building dilapidation survey works, drilling and excavation). Treatment of contaminated sites. Estab

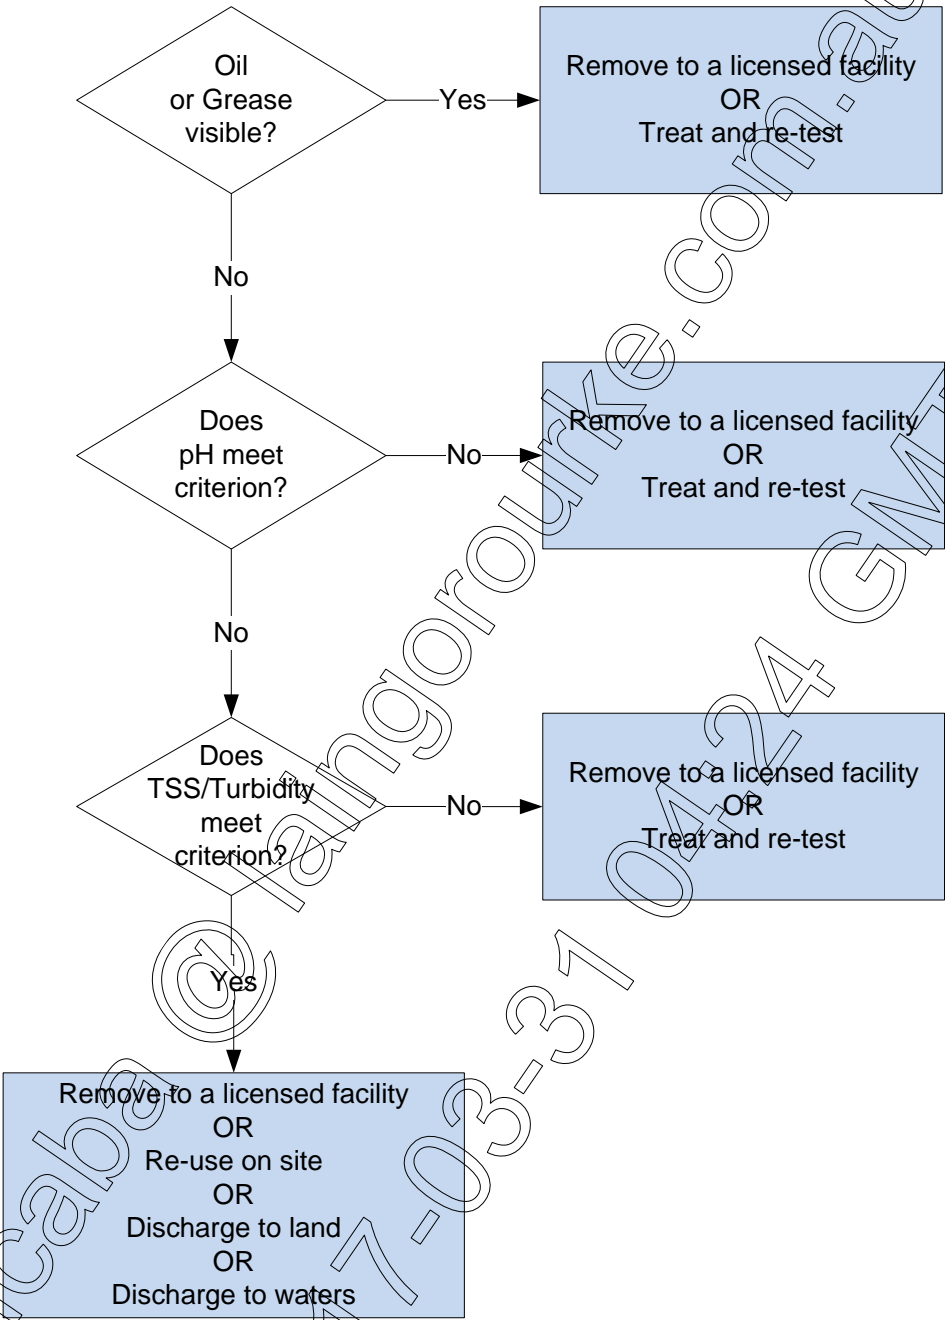
Figure 1: Process for testing water to determine options for removal, reuse, treatment or discharge

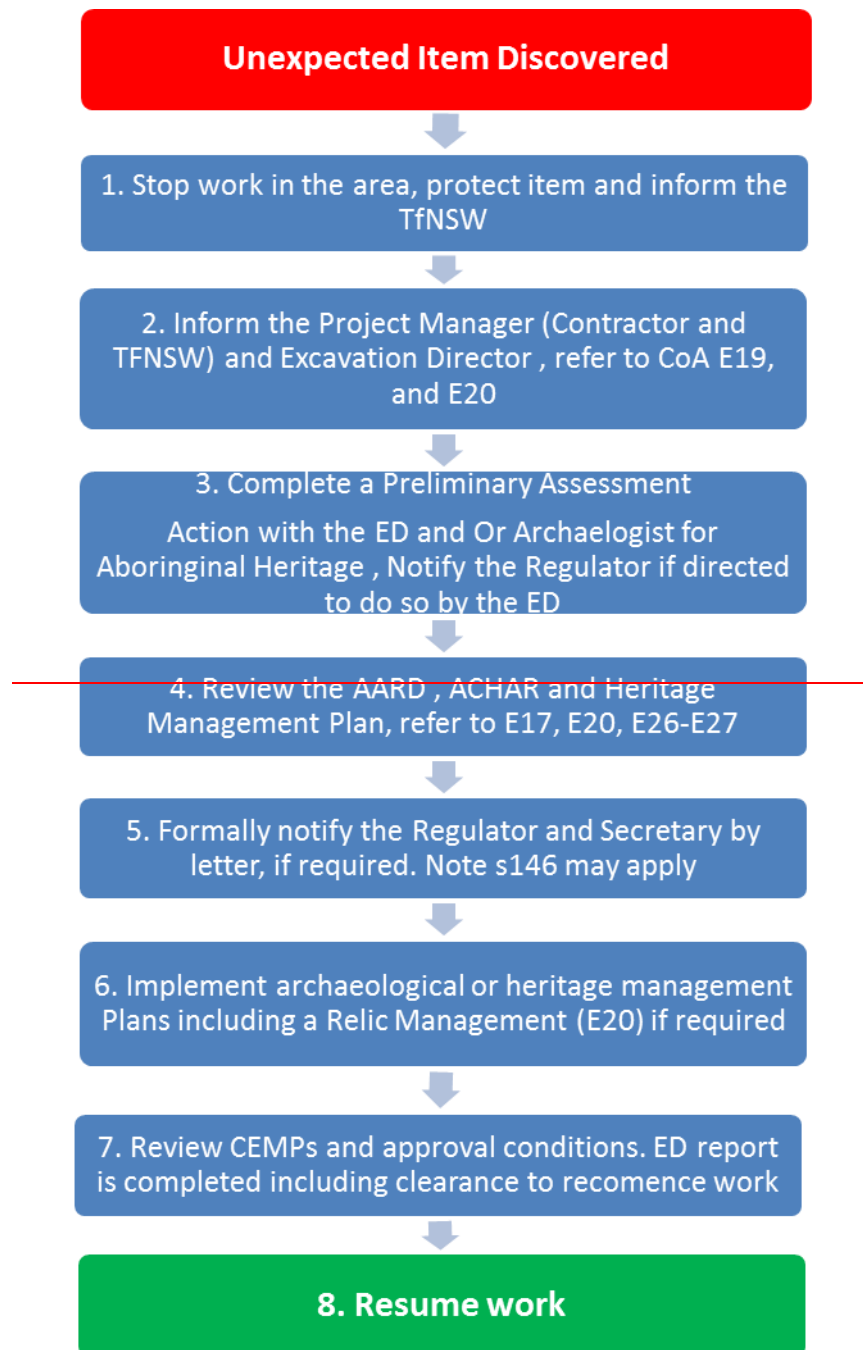
Figure 1 Overview of steps to be undertaken on the discovery of an unexpected heritage item

In the event that an unexpected heritage find (the find) is encountered on a Sydney Metro site, the flowchart in Figure 1 must be followed. There are eight steps in the procedure. These steps are summarised in Figure 1 and explained in detail in Table 2

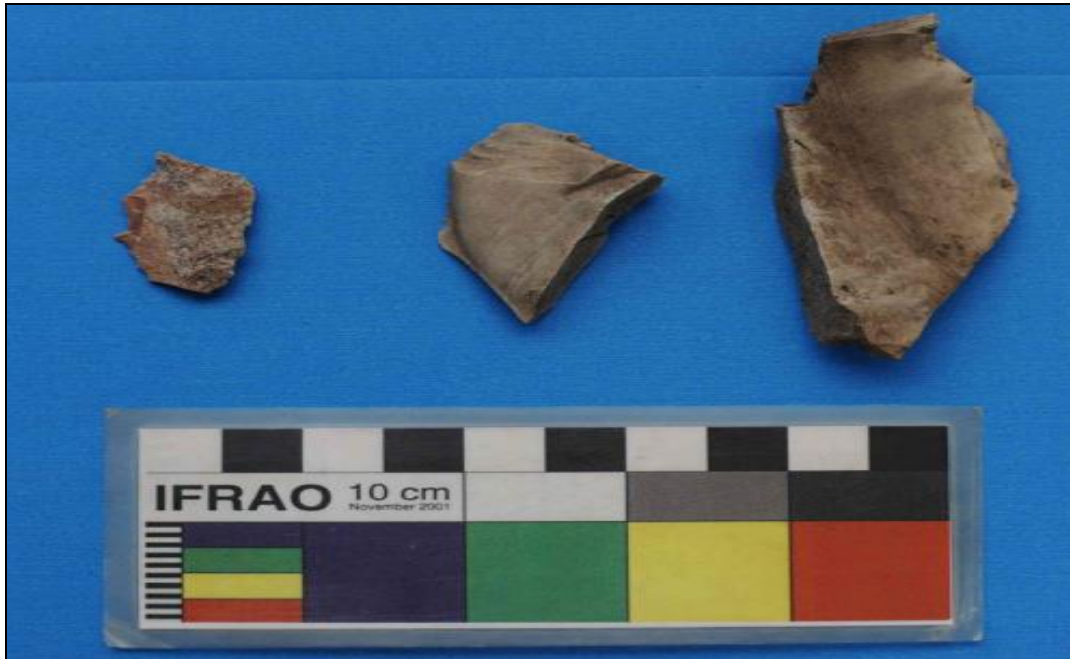
Photo 1 - Aboriginal artefacts found at the Wickham Transport Interchange, 2015

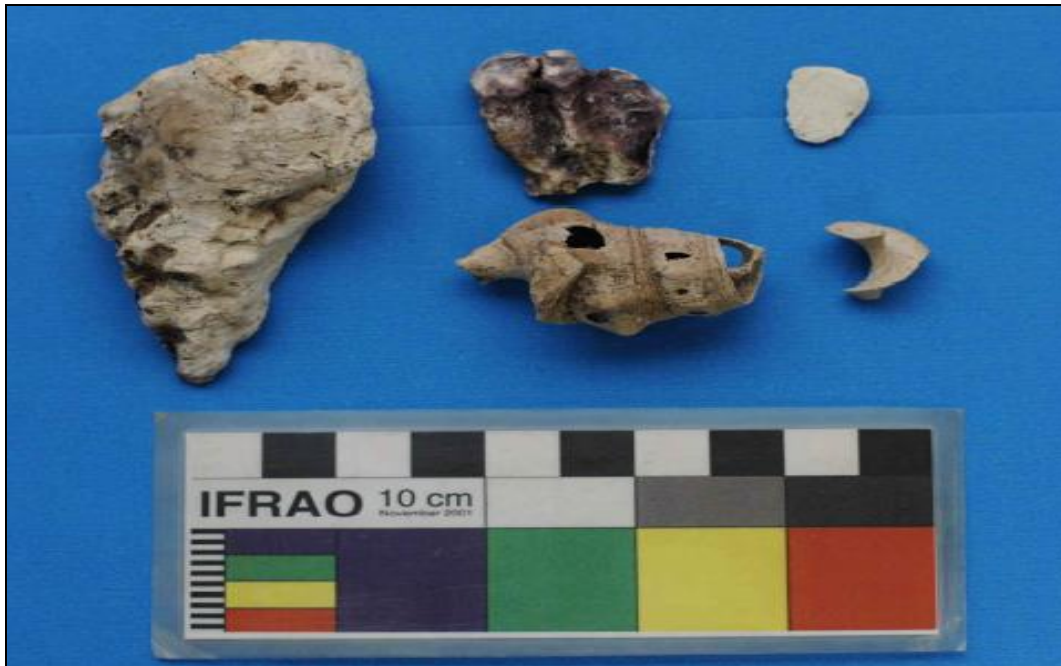
Photo 2 – Aboriginal artefacts (shell material) found at the Wickham Transport Interchange, 2015

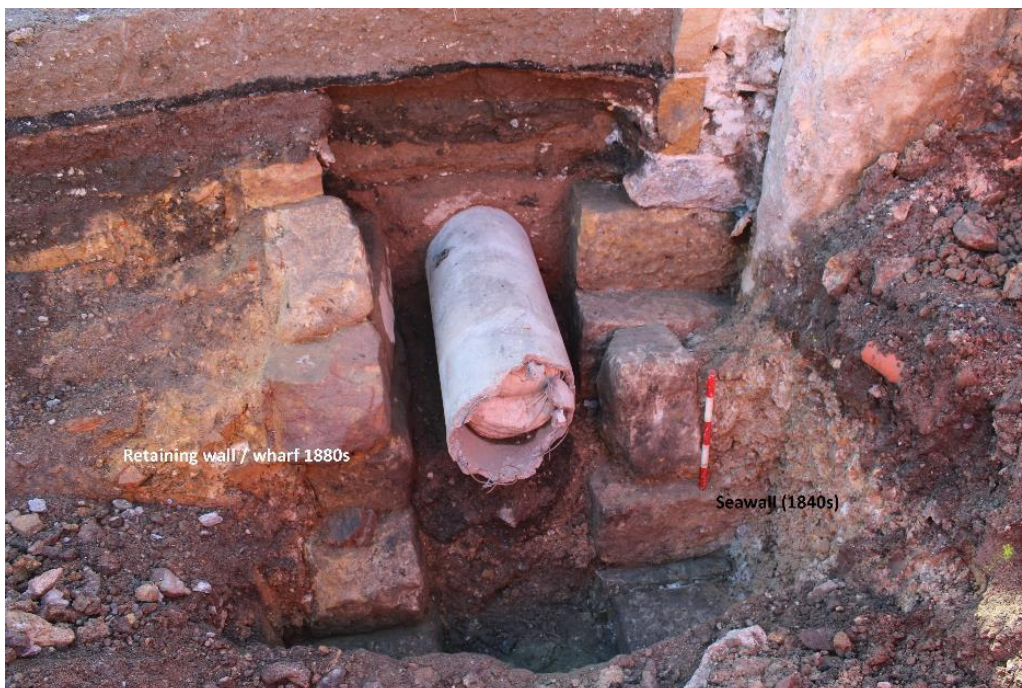
Photo 3 1840s seawall and 1880s retaining wall uncovered at Balmain East, 2016

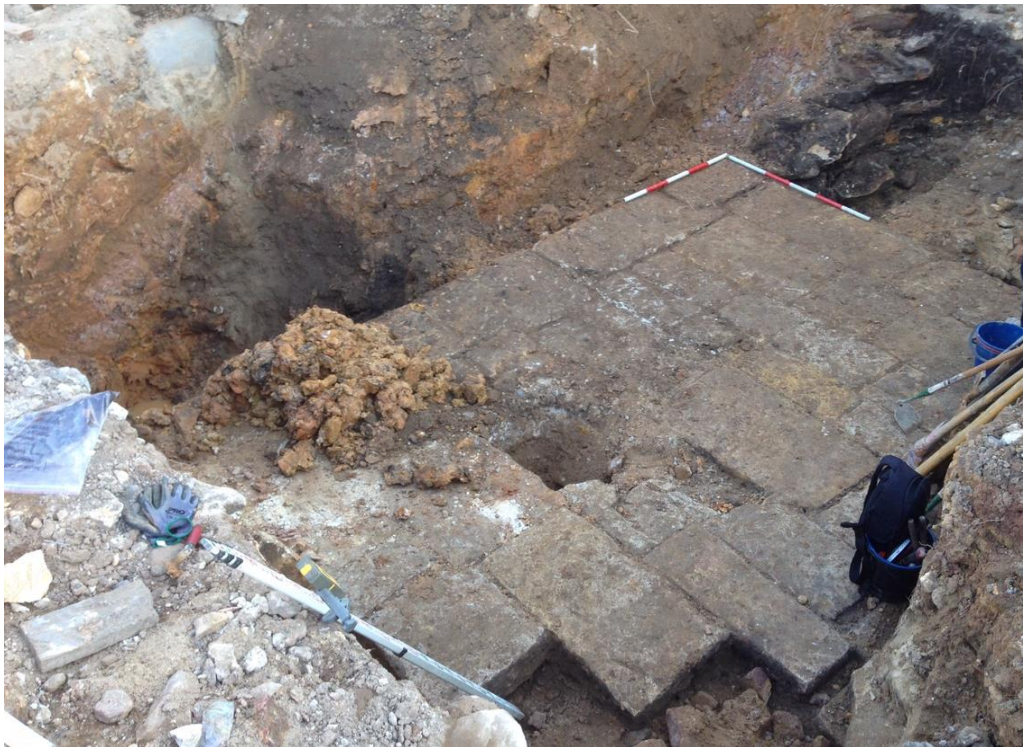
Photo 4 Sandstone pavers uncovered at Balmain East, 2016

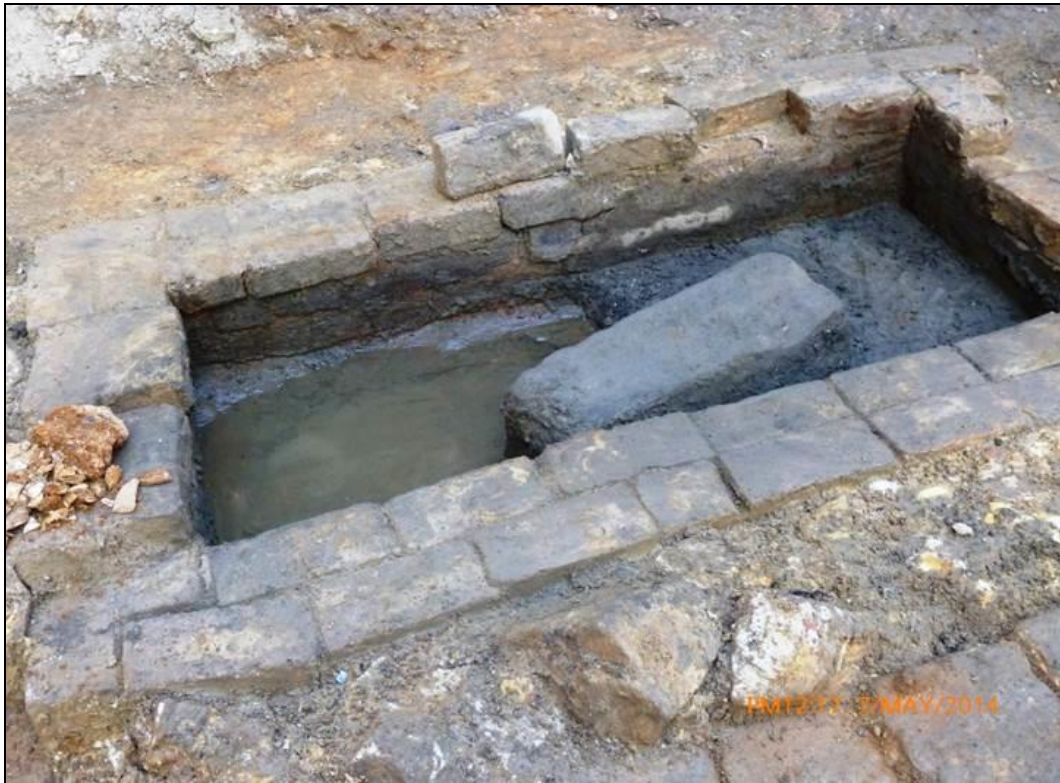
Photo 7 - Sandstone flagging and cesspit - Wynyard Walk project, 2014

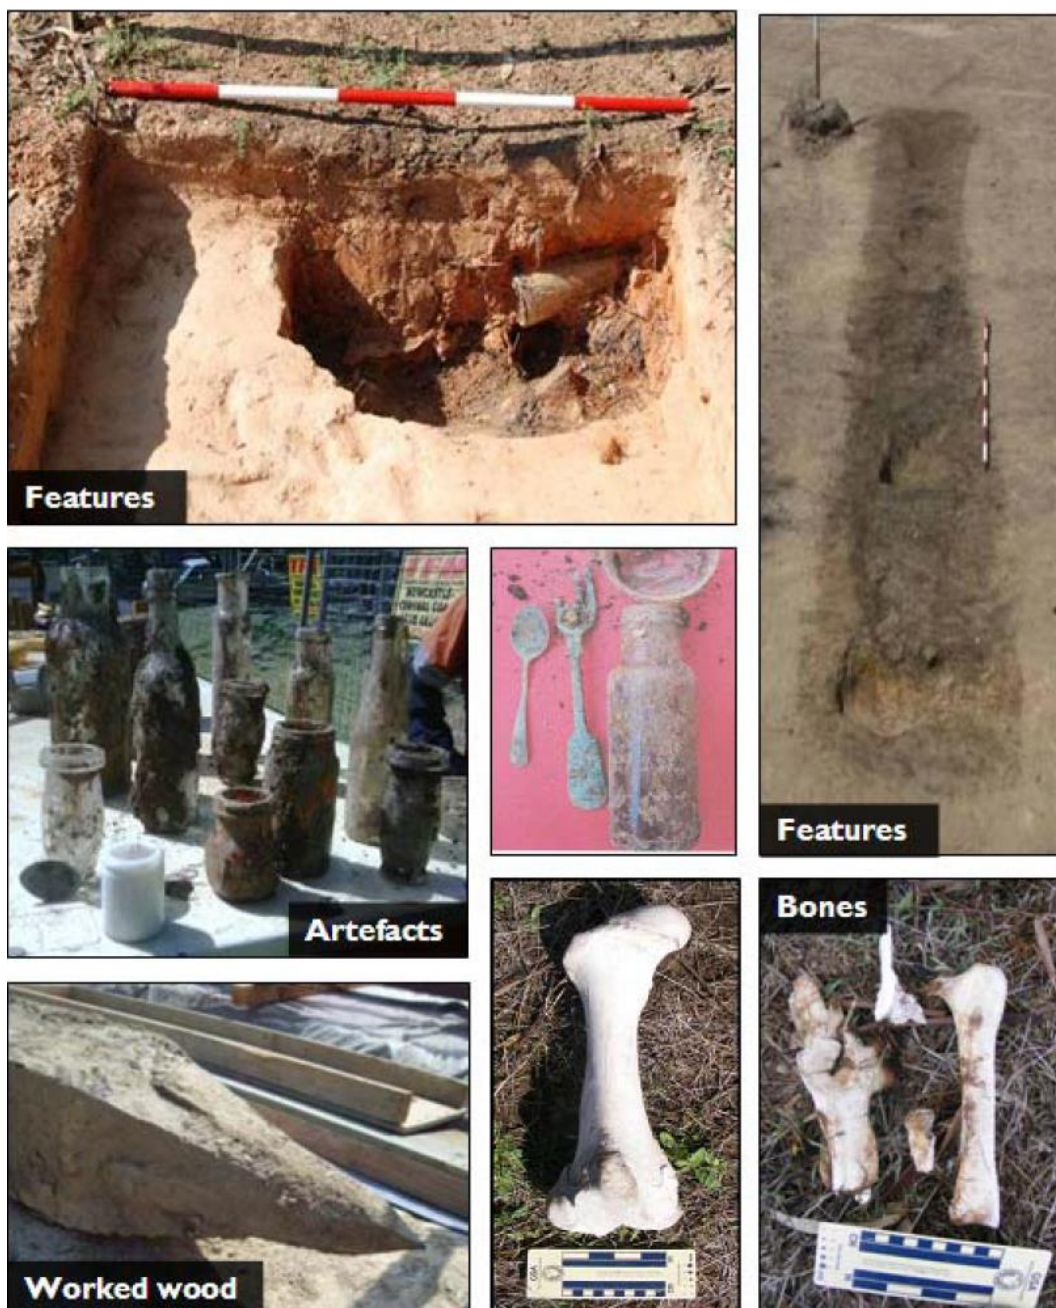
Photo 10 - Top left hand picture continuing clockwise: Stock camp remnants (Hume Highway Bypass at Tarcutta); Linear archaeological feature with post holes (Hume Highway Duplication), Animal bones (Hume Highway Bypass at

Woomargama); Cut wooden stake; Glass jars, bottles, spoon and fork recovered from refuse pit associated with a Newcastle Hotel (Pacific Highway, Adamstown Heights, Newcastle area) (RMS, 2015).

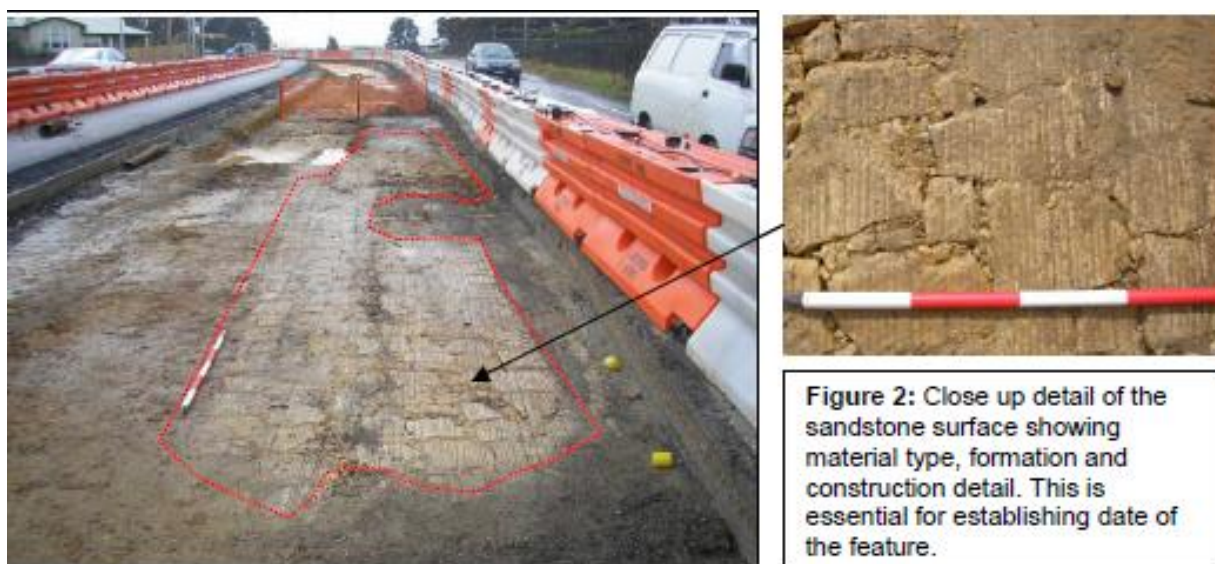
Figure 1: Telford road uncovered on the Great Western Highway (Leura) in 2008 (RMS, 2015).

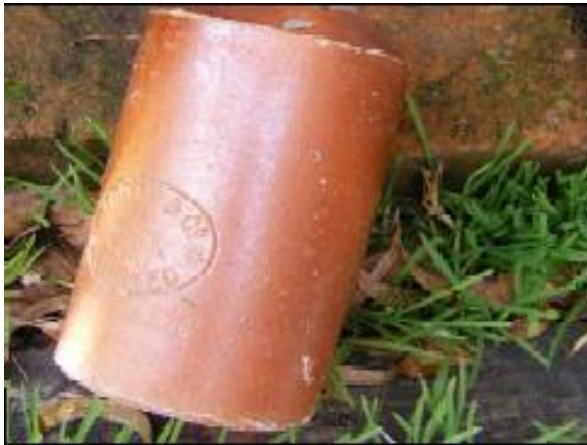
Figure 3: Ceramic bottle artefact with stamp.

Where unexpected items have a distinguishing feature, close up detailed photographs must be taken of these features, where practicable. In the case of a building or bridge, this may include diagnostic details architectural or technical features. See Figures 3 and 4 for examples.

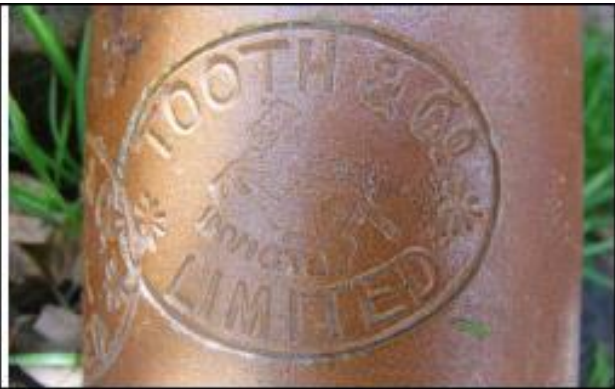
Figure 4: Detail of the stamp allows 'Tooth & Co Limited' to be made out. This is helpful to a specialist in gauging the artefact's origin, manufacturing date and likely significance.

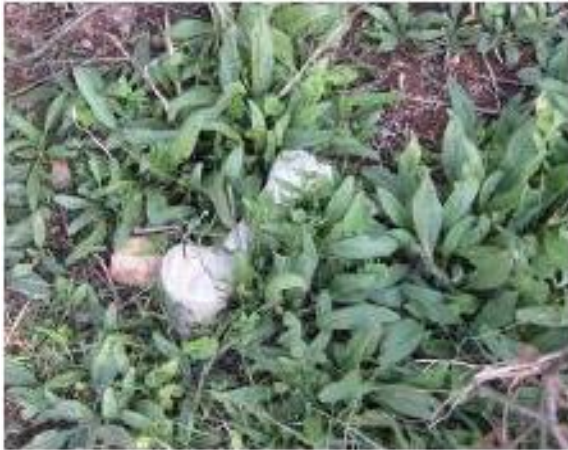
Figure 5: Bone concealed by foliage.

Ensure that photographs of bones are not concealed by foliage (Figure 5) as this makes it difficult to identify. Minor hand removal of foliage can be undertaken as long as disturbance of the bone does not occur. Excavation of the ground to remove bone(s) should not occur, nor should they be pulled out of the ground if partially exposed.

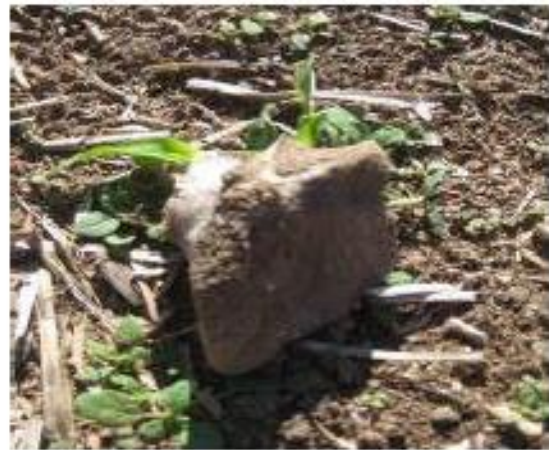
Figure 6: Bone covered in sediment

Where sediment (adhering to a bone found on the ground surface) conceals portions of a bone (Figure 6) ensure the photograph is taken of the bone (if any) that is not concealed by sediment.

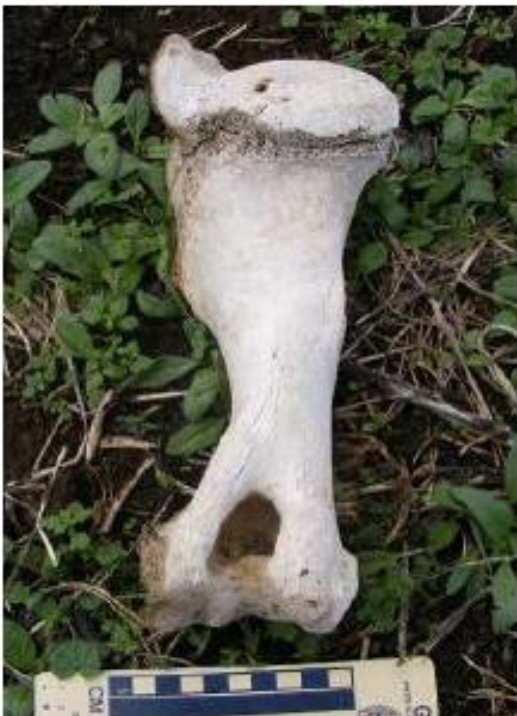
Figure 7: Photograph showing complete bone.

Ensure that all close up photographs include the whole bone and then specific details of the bone (especially the ends of long bones, the *epiphysis*, which is critical for species identification). Figures 7 and 8 are examples of good photographs of bones that can easily be identified from the photograph alone. They show sufficient detail of the complete bone and the epiphysis.

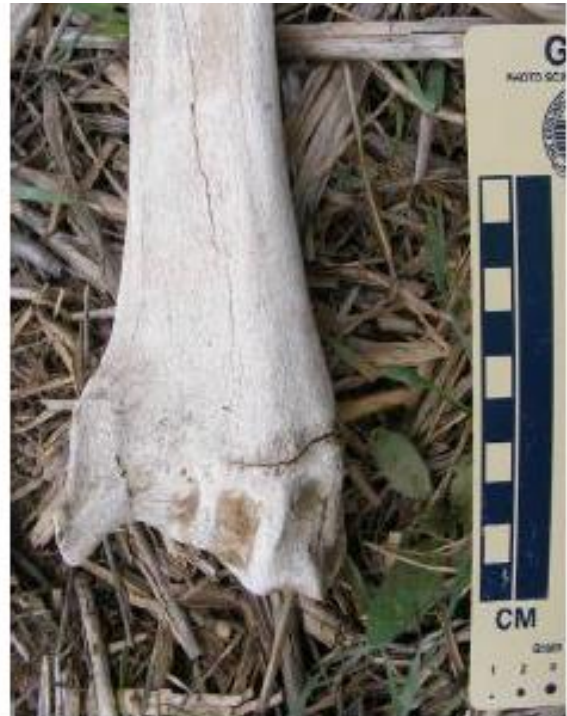
Figure 8: Close up of a long bone's epiphysis.

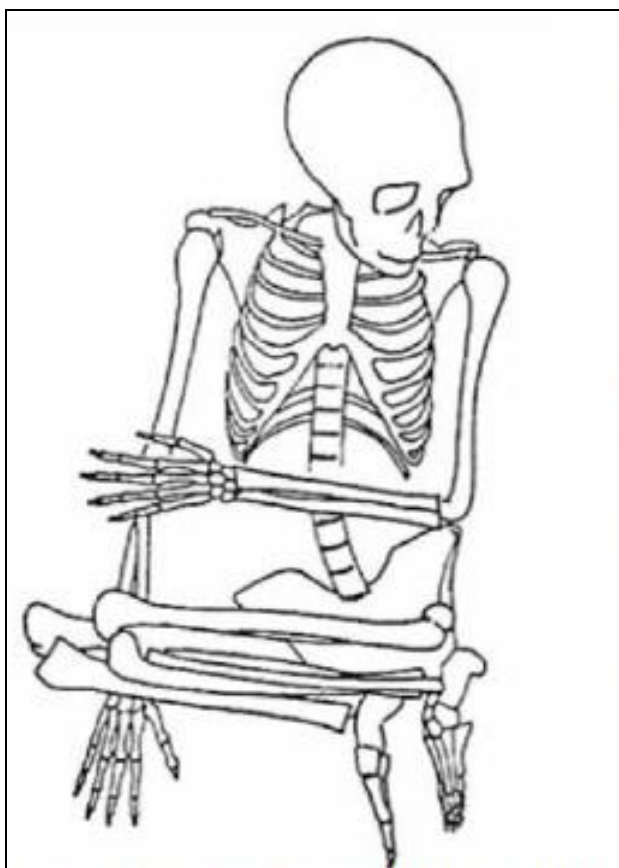
Figure 1: Schematic of a complete skeleton that is 'obviously' human¹².

On the very rare occasion where it is immediately obvious from the remains that they are human, the Project Manager (or a delegate) should **inform the police by telephone** prior to seeking specialist advice. It will be obvious that it is human skeletal remains where there is no doubt, as demonstrated by the example in Figure 1¹⁰. Often skeletal elements in isolation (such as a skull) can also clearly be identified as human. Note it may also be obvious that human remains have been uncovered when soft tissue and/or clothing are present.

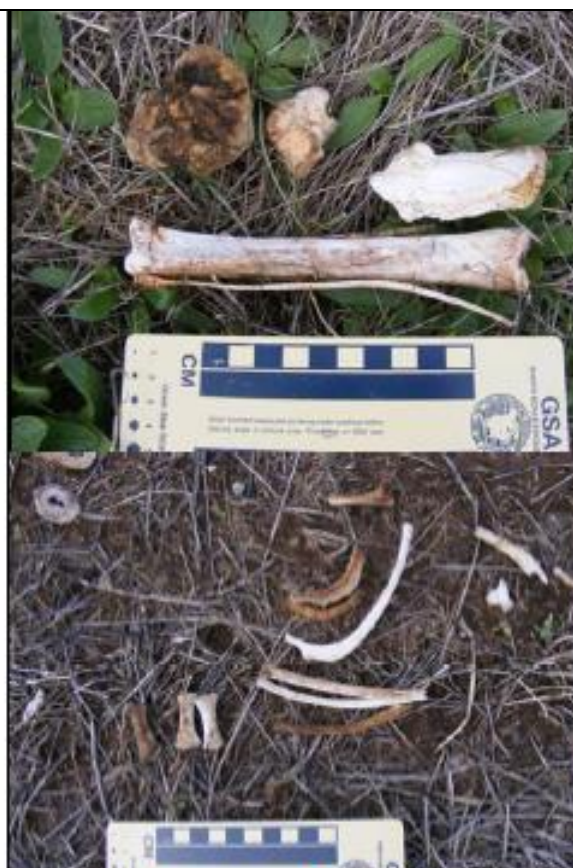
Figure 2: Disarticulated bones that require assessment to determine species.

Where it is not immediately obvious that the bones are human (in the majority of cases, illustrated by Figure 2), specialist assessment is required to establish the species of the bones. Photographs of the bones can assist this assessment if they are clear and taken in accordance with guidance provided in Appendix C. Good photographs often result in the bones being identified by a specialist without requiring a site visit; noting they are nearly always non-human. In these cases, non-human skeletal remains must be treated like any other unexpected archaeological find.

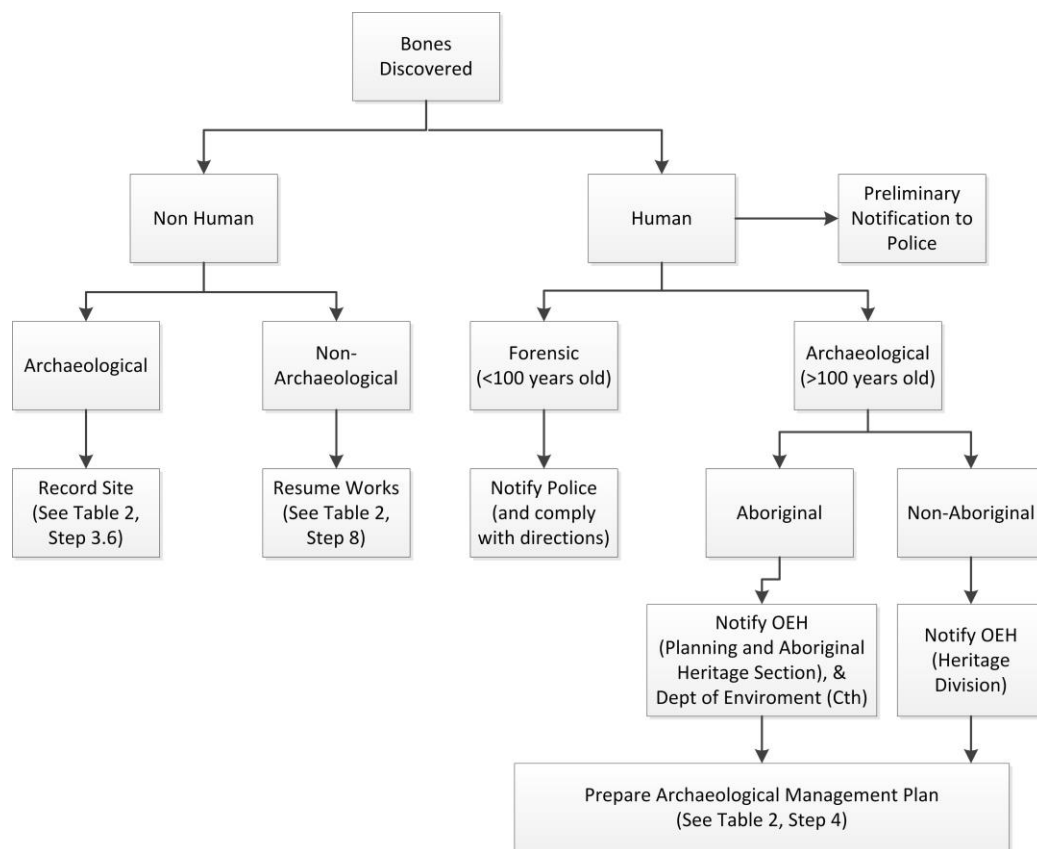
Figure 3 Overview of steps to be undertaken on the discovery of bones

Figure 3 summarises the notification pathways on finding bones.

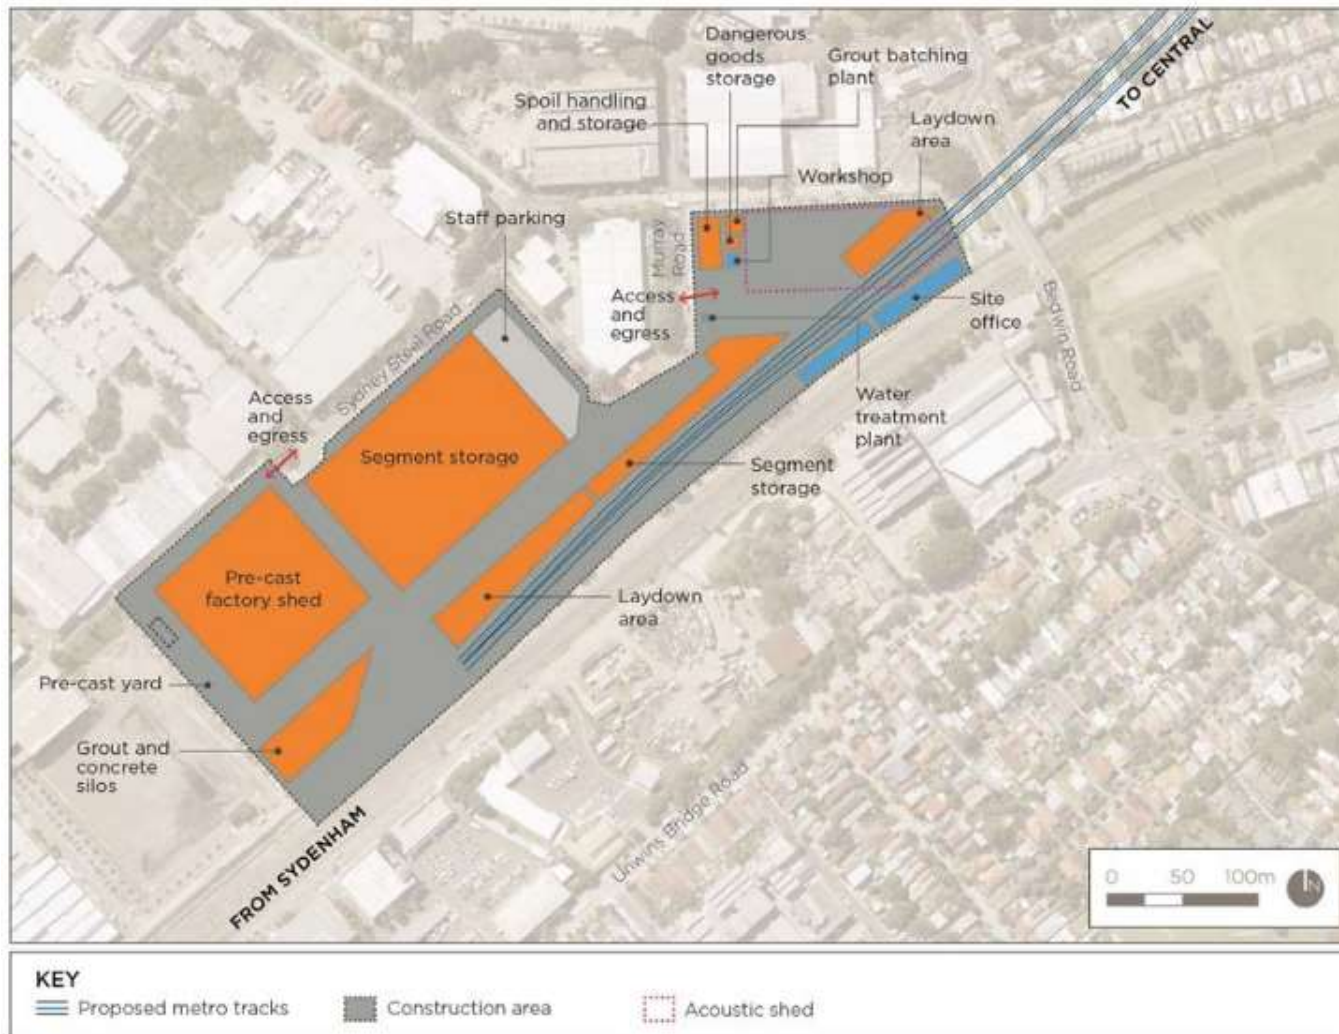
Figure 1-3: Key features of the Sydenham station and precinct works

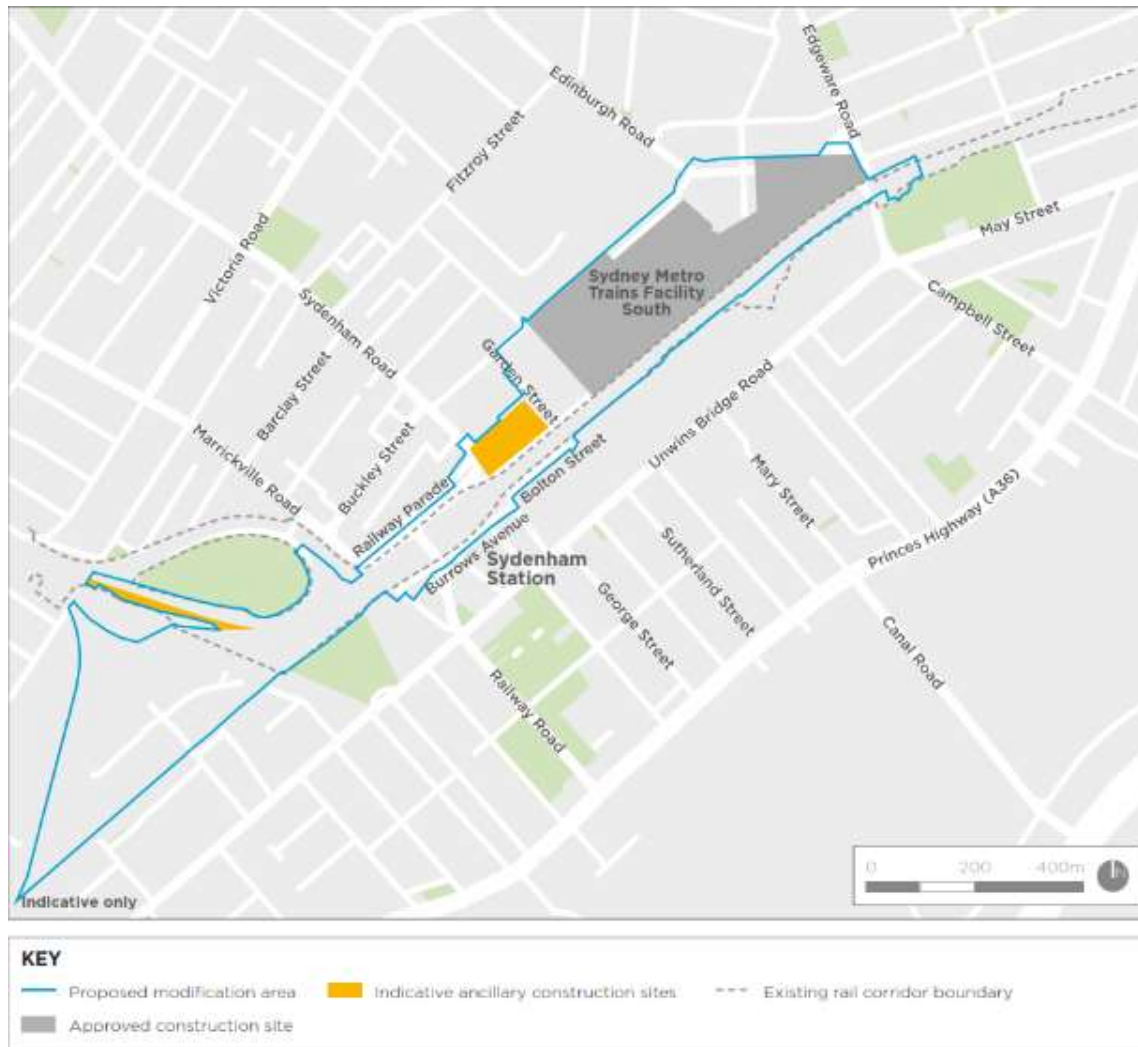
Figure 1-4: Construction sites

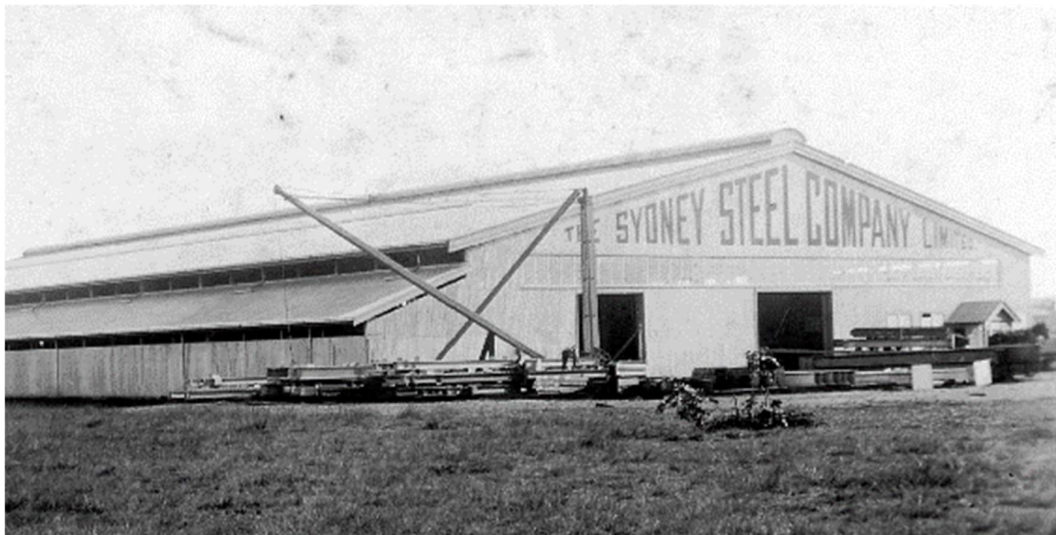
Figure 2-8: The main workshop at the Edinburgh Road Marrickville Sydney Steel Company factory, 1911. Source. Stuart 2012 *Sydney Steel: An Illustrated History of the Sydney Steel Company 1910-1979*.

In 1910, the Sydney Steel Company was established on a 22-acre site to the north of the rail line (within the Sydney Metro Trains Facility South Precinct boundary). This was a vast area of vacant land on the fringe of the city, adjacent to the main rail line and located between Sydenham and St Peters stations. Founded by Scottish migrant Alexander Stuart, the former Premier of NSW and Mayor of the former St Peters Council, the large factory was established on Edinburgh Road in Marrickville and supplied steel fabrication and distribution services to Sydney's expanding construction industry in the decades that followed (Figure 2-8).⁸

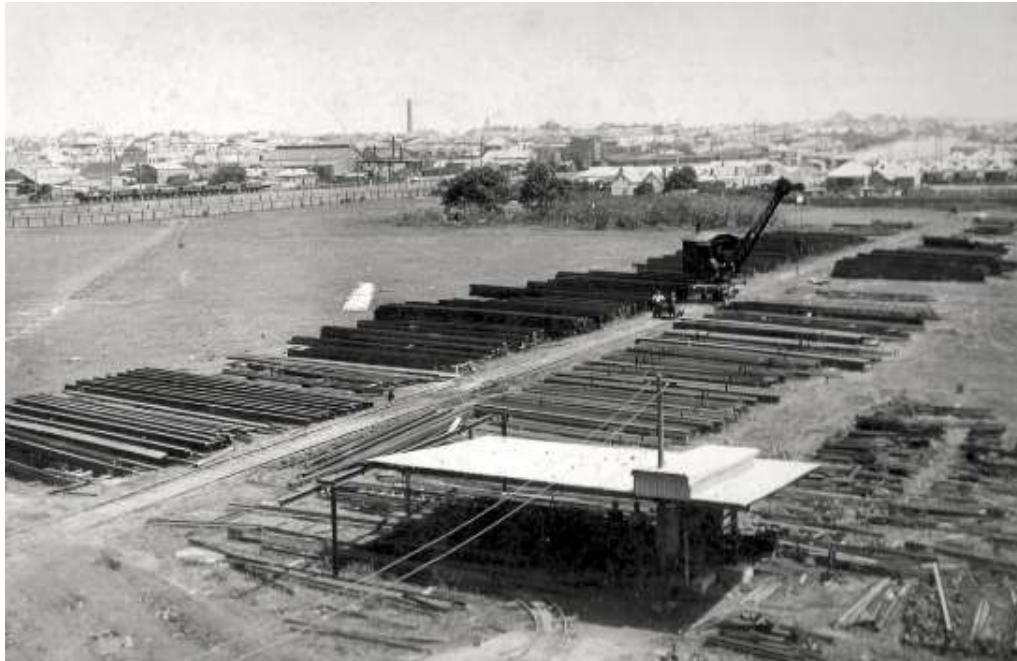
Figure 2-9: Photograph of the stockyard at the rear of the Sydney Steel Company workshop, taken from the roof of the workshop looking south towards Sydenham Station, c1913. Source. Stuart 2012 *Sydney Steel: An Illustrated History of the Sydney Steel Company 1910-1979*.

With merchandising of steel having been an important part of the company's business for several decades, the stockyard was originally laid out at the rear of the main Edinburgh Road workshop in 1913 (Figure 2-9 and Figure 2-10). A steam operated crane was installed in this location to move the stock.

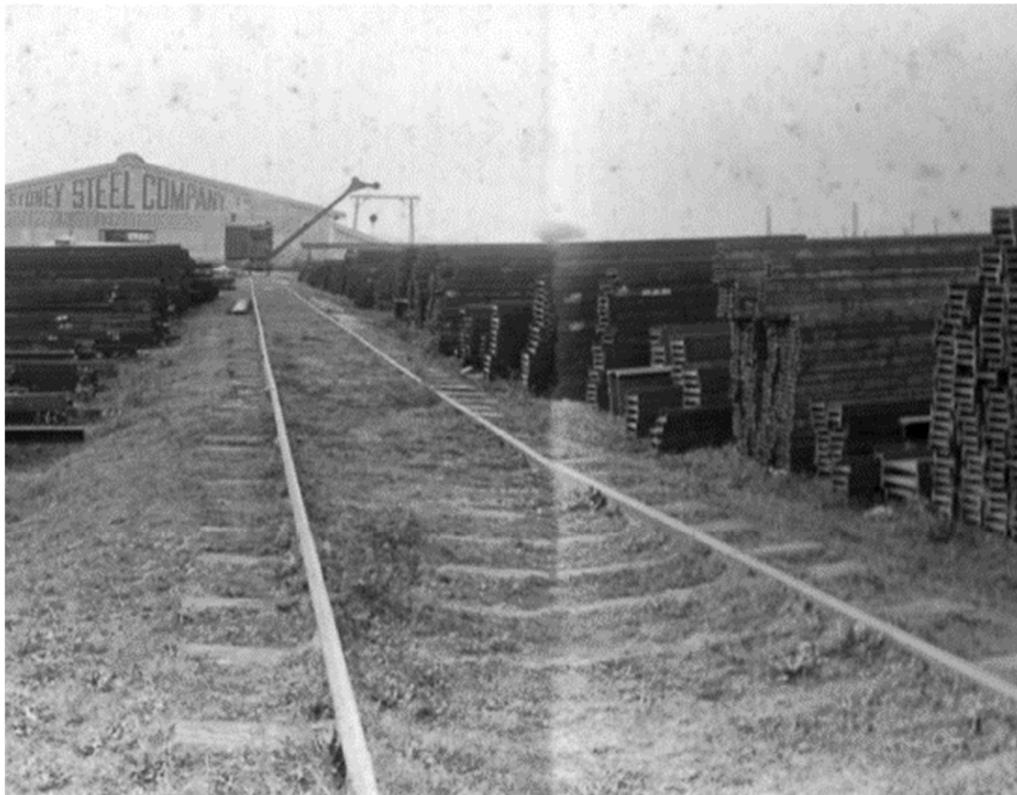
Figure 2-11: View of the Sydney Steel Company, Marrickville in 1919. A 44-tonne girder is seen being transported on a custom-made horse drawn limber to a rail siding near Sydenham Station. Source. Stuart 2012 *Sydney Steel: An Illustrated History of the Sydney Steel Company 1910-1979*.

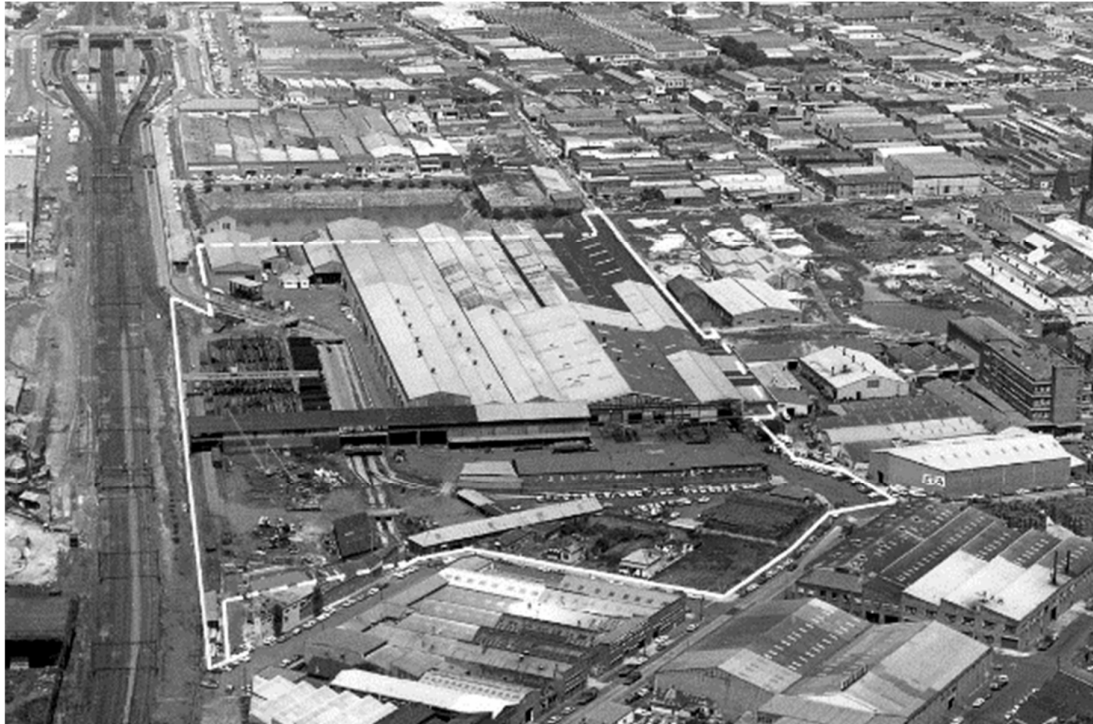
Figure 2-14: Photograph of the Sydney Steel Company in Marrickville in 1962, showing crane and buildings on land adjacent to railway line. Source. Stuart 2012 *Sydney Steel: An Illustrated History of the Sydney Steel Company 1910-1979*.

The post-World War II building boom resulted in significant expansion of the fabrication area at Edinburg Road during the 1950s. The stockyard was relocated adjacent to the rail line, where a giant crane was assembled, and additional buildings were constructed on the vacant land. By 1960, half of the 22-acre site had been developed as covered fabrication area. Sydney Steel Company had, by this time, become one of the largest employers in the suburb of Marrickville.

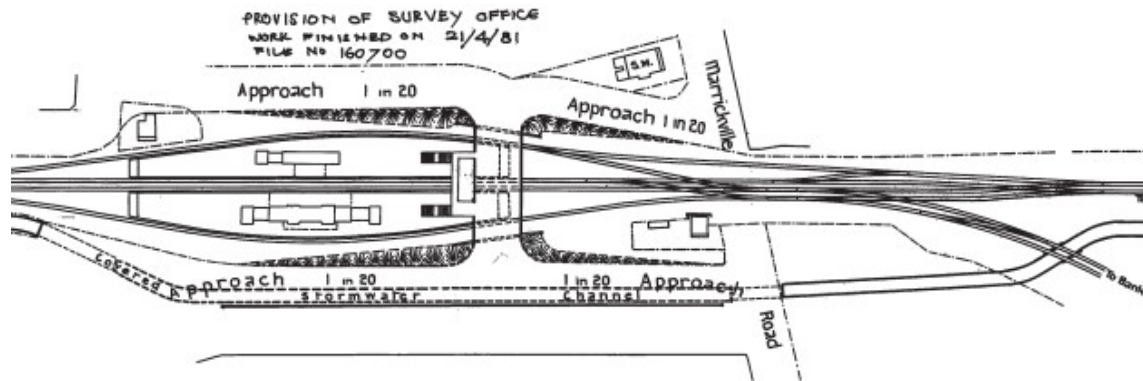
Figure 2-15: 1881 Plan of Marrickville (Sydenham) Station, showing the platform configuration prior to the construction of the Bankstown line. Source: State Records NSW, images 17420_a014_a014_a014000815.

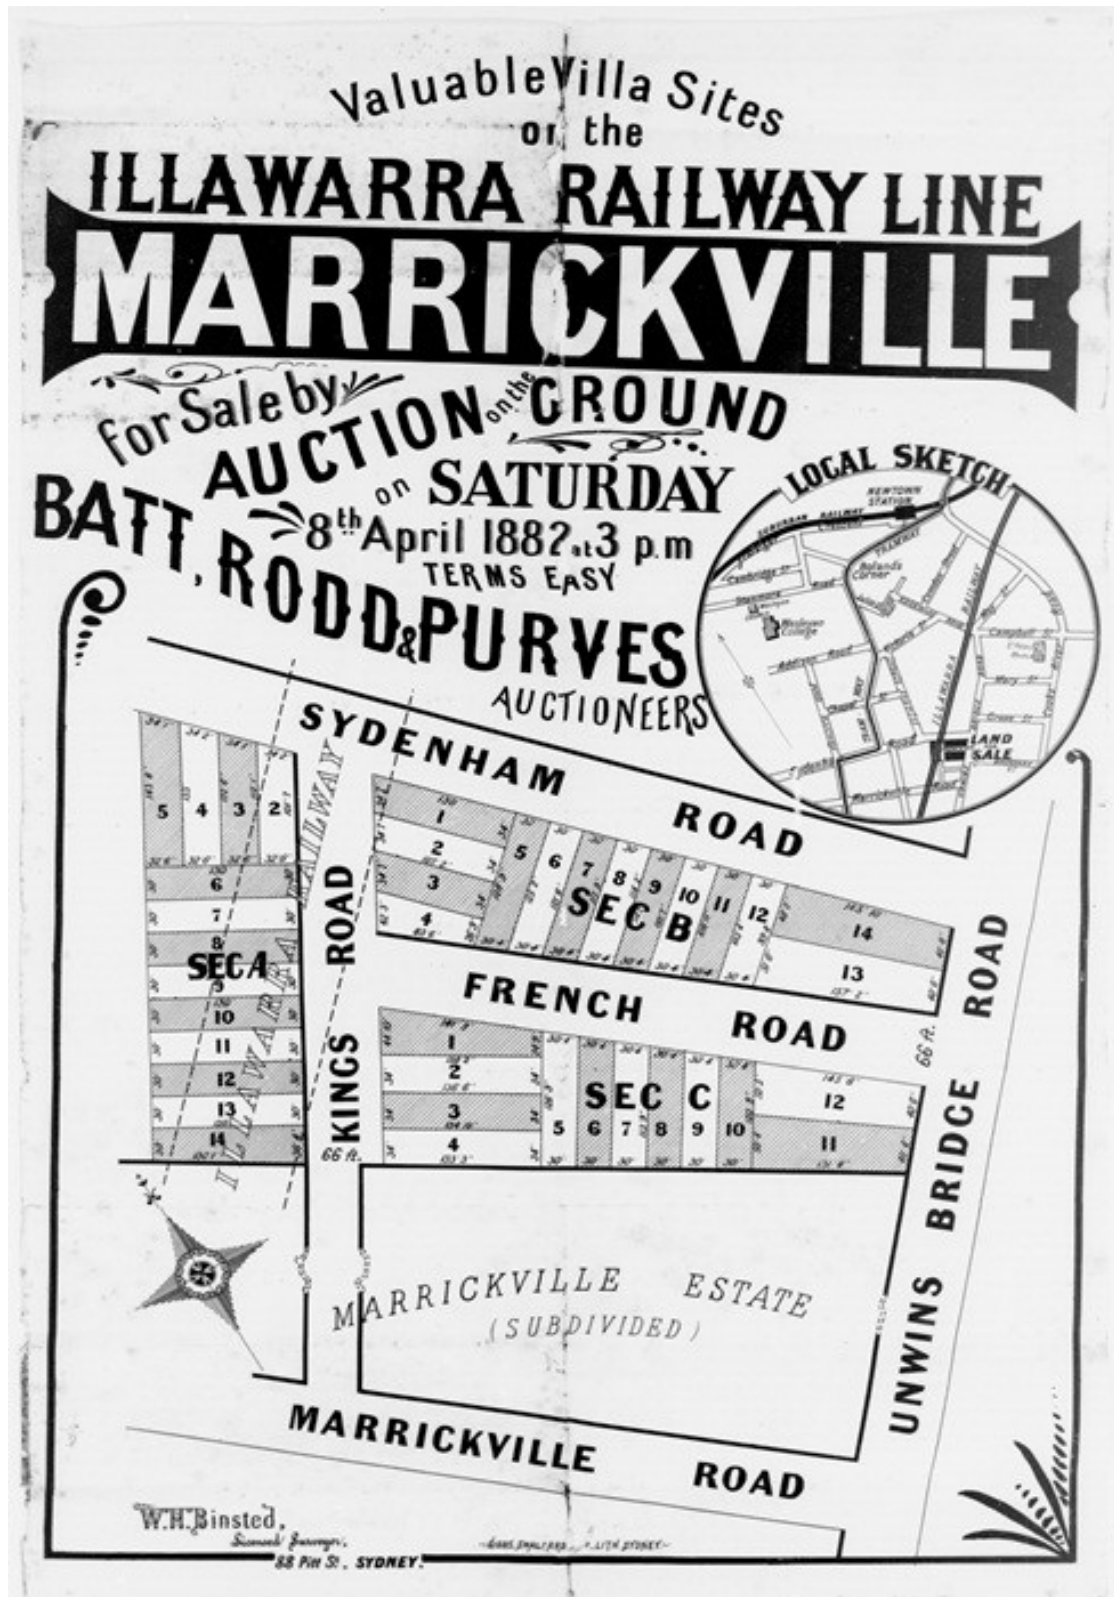
Figure 2-16: Subdivision plan from 1882 indicating the location of the proposed Illawarra Railway corridor. Source: Marrickville Library & History Services.

Sydenham Station, originally named 'Marrickville Station', was constructed on the first section of the Illawarra Railway line in 1884 (Figure 2-16).¹⁰ The station and associated buildings, including the station masters residence, were designed by the NSW Railways Department. The contract for the construction of the station was awarded to William Robinson in 1883.¹¹
