Pre-Construction Minor Works Approval Form

Part 1: Application							
Contractor:	John Holland & Laing O'Rourke joint venture (JHLOR)						
Project:	Sydenham Station and Junction						
Application Title:	Enabling Works						
(e.g. Smith St trenching works)	Site wide						
Application Number:	SSJ-PCMW-005 Document number: SMCSWSSJ-JHL-WSS-EM-REC-000001						
Application Date:	Rev01 - 20/04/2018 Rev02 - 11/05/2018						
Planning Approval:	ev02 – 11/05/2018 vdney Metro City and Southwest – Chatswood to Sydenham - Environmental Impact attement vdney Metro City and Southwest - Environmental Impact Statement – Sydenham attion and Sydney Metro Trains Facility South Modification Report (MOD 4) vdney Metro City and Southwest - Environmental Impact Statement – Sydenham attion and Sydney Metro Trains Facility South Modification Submissions Report vdney Metro City and Southwest Infrastructure Approval SSI 7400 (as modified) Survey, survey facilitation and investigations works (including road and building dilapidation survey works, drilling and excavation). Treatment of contaminated sites. Establishment of ancillary facilities (excluding demolition), including construction

Environmental Manag

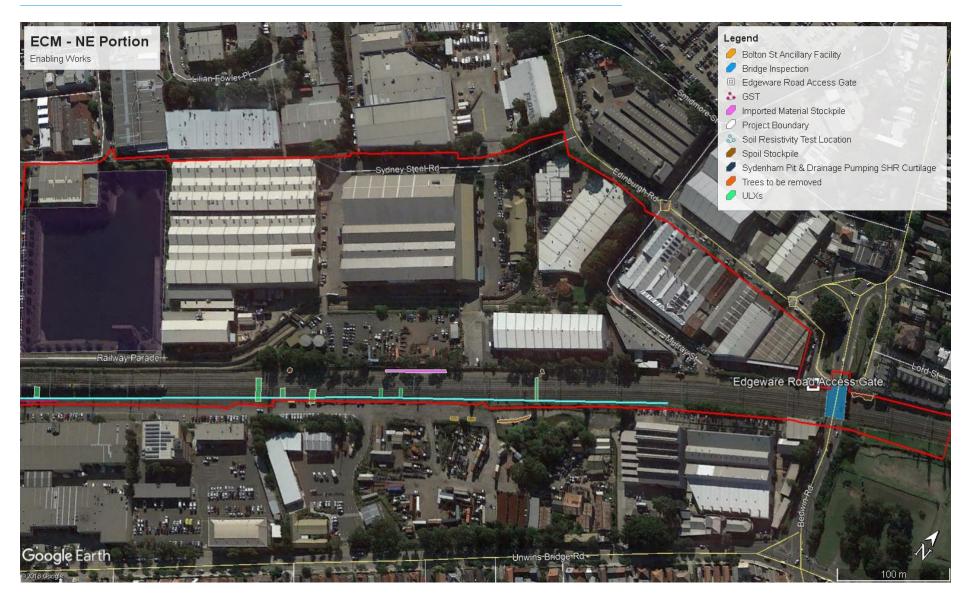
Work area, Environmental Risk Assessment and Environmental Control Map.

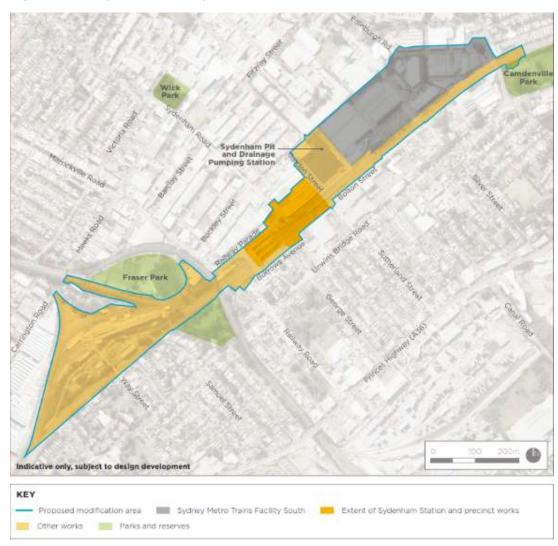
Figure 1-1: Study area of the project as modified

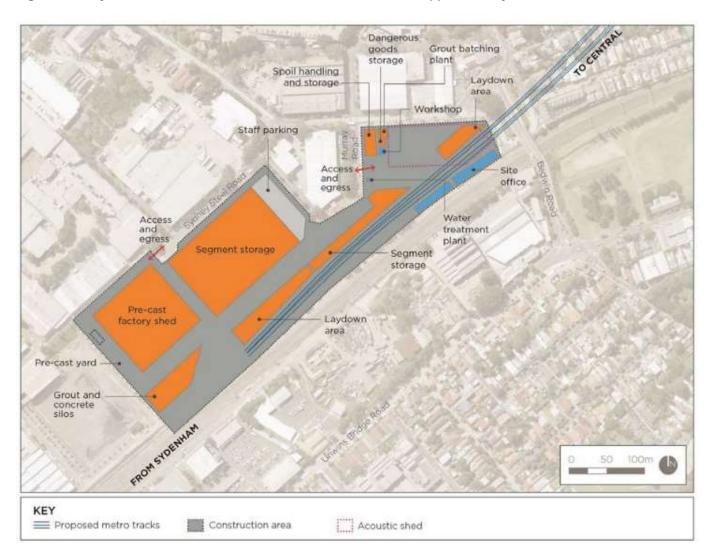
Figure 1-2: Key features of the Marrickville Dive Site and Southern Support Facility

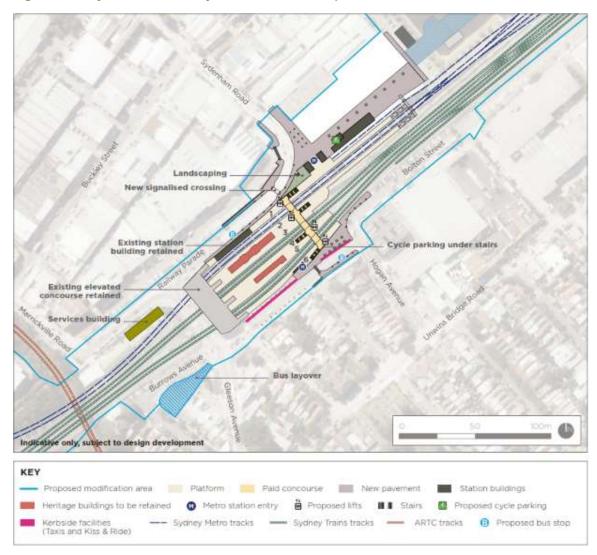
Figure 1-3: Key features of the Sydenham station and precinct works

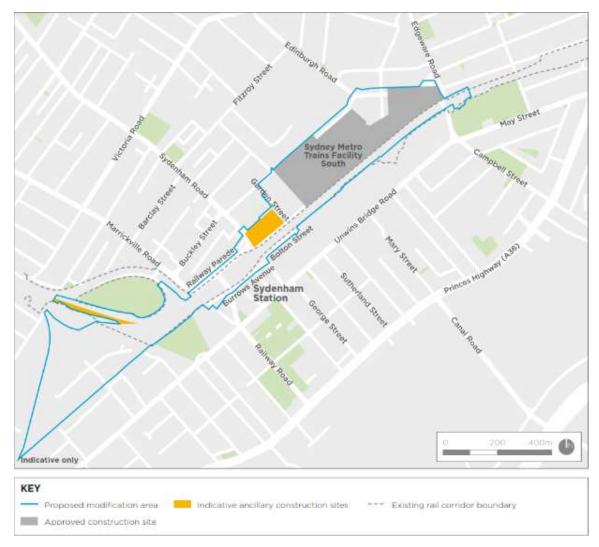
Figure 1-4: Construction sites

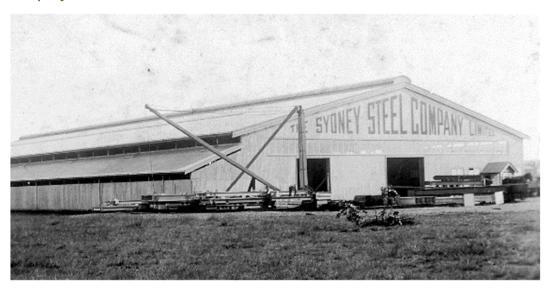
Figure 2-8: The main workshop at the Edinburgh Road Marrickville Sydney Steel Company factory, 1911. Source. Stuart 2012 Sydney Steel: An Illustrated History of the Sydney Steel Company 1910-1979.

In 1910, the Sydney Steel Company was established on a 22-acre site to the north of the rail line (within the Sydney Metro Trains Facility South Precinct boundary). This was a vast area of vacant land on the fringe of the city, adjacent to the main rail line and located between Sydenham and St Peters stations. Founded by Scottish migrant Alexander Stuart, the former Premier of NSW and Mayor of the former St Peters Council, the large factory was established on Edinburgh Road in Marrickville and supplied steel fabrication and distribution services to Sydney's expanding construction industry in the decades that followed (Figure 2-8).8

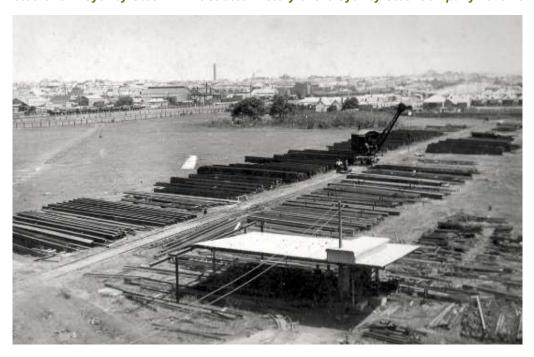
Figure 2-9: Photograph of the stockyard at the rear of the Sydney Steel Company workshop, taken from the roof of the workshop looking south towards Sydenham Station, c1913. Source. Stuart 2012 Sydney Steel: An Illustrated History of the Sydney Steel Company 1910-1979.

With merchandising of steel having been an important part of the company's business for several decades, the stockyard was originally laid out at the rear of the main Edinburgh Road workshop in 1913 (Figure 2-9 and Figure 2-10). A steam operated crane was installed in this location to move the stock.

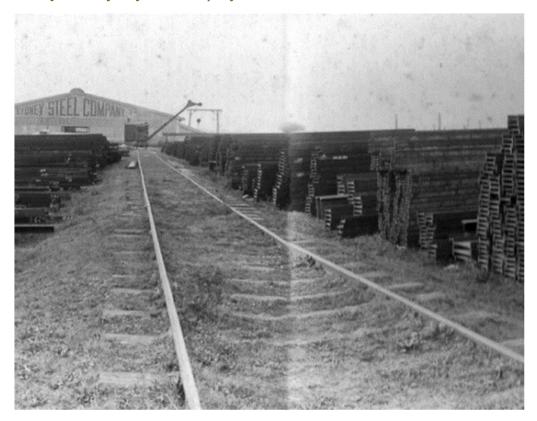
Figure 2-10: Photograph of the stockyard at the rear of the Sydney Steel Company workshop, showing steam operated crane, c1913. Source. Stuart 2012 Sydney Steel: An Illustrated History of the Sydney Steel Company 1910-1979.

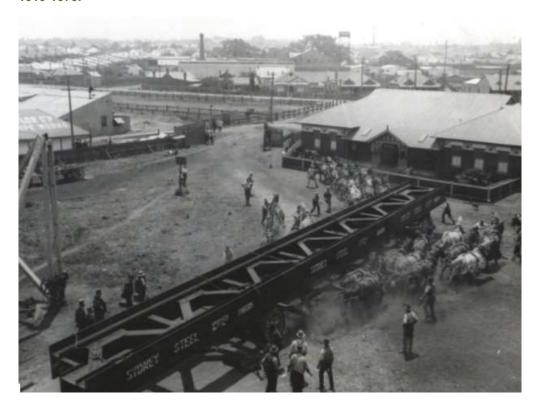
Figure 2-11: View of the Sydney Steel Company, Marrickville in 1919. A 44-tonne girder is seen being transported on a custom-made horse drawn limber to a rail siding near Sydenham Station. Source. Stuart 2012 Sydney Steel: An Illustrated History of the Sydney Steel Company 1910-1979.

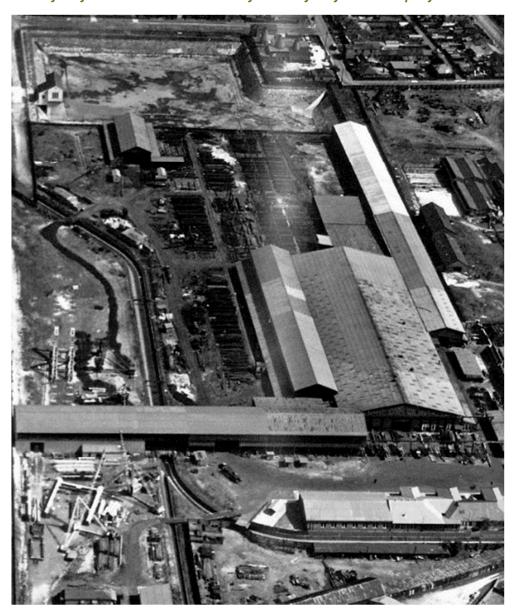
Figure 2-13: Photograph of the Sydney Steel Company in Marrickville in 1948. Source. Stuart 2012 Sydney Steel: An Illustrated History of the Sydney Steel Company 1910-1979.

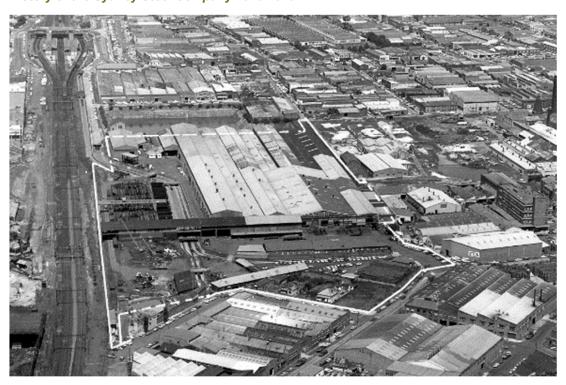
Figure 2-14: Photograph of the Sydney Steel Company in Marrickville in 1962, showing crane and buildings on land adjacent to railway line. Source. Stuart 2012 *Sydney Steel: An Illustrated History of the Sydney Steel Company 1910-1979.*

The post-World War II building boom resulted in significant expansion of the fabrication area at Edinburg Road during the 1950s. The stockyard was relocated adjacent to the rail line, where a giant crane was assembled, and additional buildings were constructed on the vacant land. By 1960, half of the 22-acre site had been developed as covered fabrication area. Sydney Steel Company had, by this time, become one of the largest employers in the suburb of Marrickville.

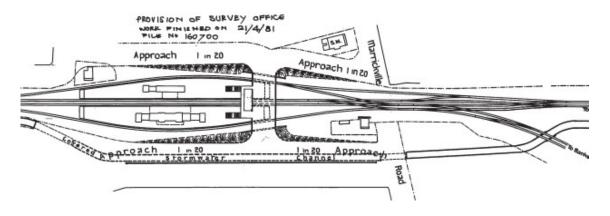
Figure 2-15: 1881 Plan of Marrickville (Sydenham) Station, showing the platform configuration prior to the construction of the Bankstown line. Source: State Records NSW, images 17420_a014_a014_a014000815.

In 1909 the railway line was extended to Bankstown, and the line from Edgeware Road to Sydenham was quadruplicated. This required the extension of the platforms at Sydenham Station. The railway cutting was widened and the original platforms were transformed into island platforms, requiring the construction of an extended footbridge to allow access. The footbridge was constructed by Dorman Long & Co Ltd., the same company that would engineer the Sydney Harbour Bridge. ¹³ The lines were electrified in 1926.

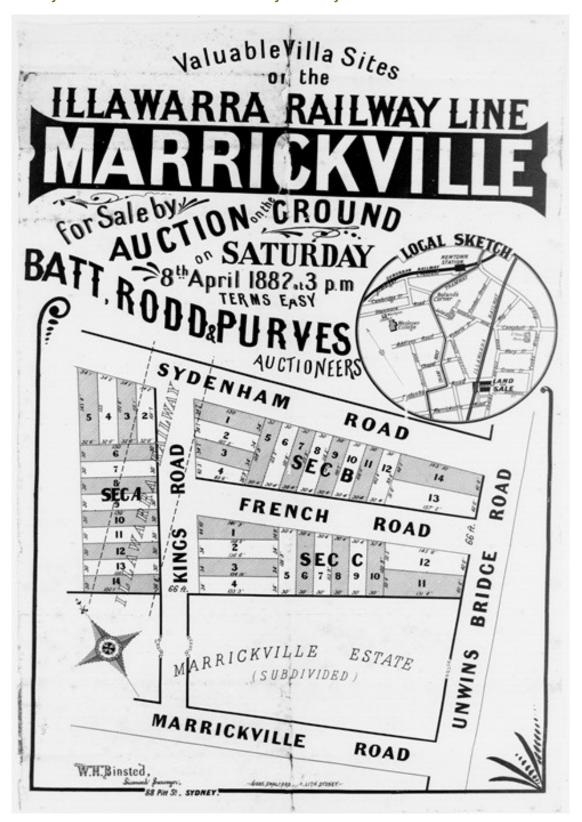
Figure 2-16: Subdivision plan from 1882 indicating the location of the proposed Illawarra Railway corridor. Source: Marrickville Library & History Services.

Sydenham Station, originally named 'Marrickville Station', was constructed on the first section of the Illawarra Railway line in 1884 (Figure 2-16).¹⁰ The station and associated buildings, including the station masters residence, were designed by the NSW Railways Department. The contract for the construction of the station was awarded to William Robinson in 1883.¹¹

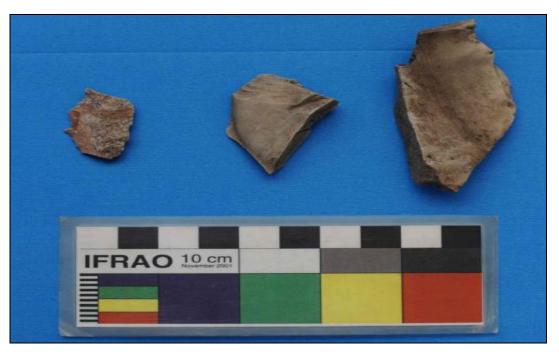
Photo 1 - Aboriginal artefacts found at the Wickham Transport Interchange, 2015

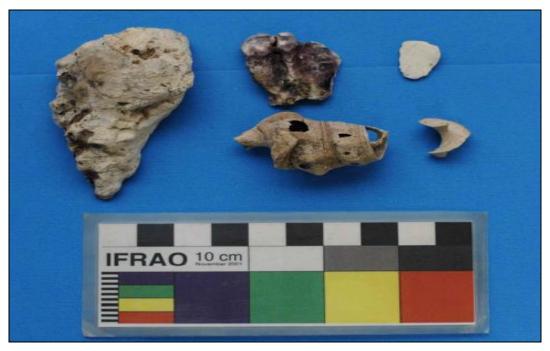
Photo 2 – Aboriginal artefacts (shell material) found at the Wickham Transport Interchange, 2015

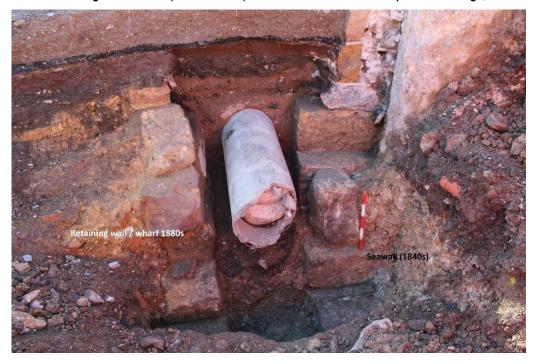
Photo 3 1840s seawall and 1880s retaining wall uncovered at Balmain East, 2016

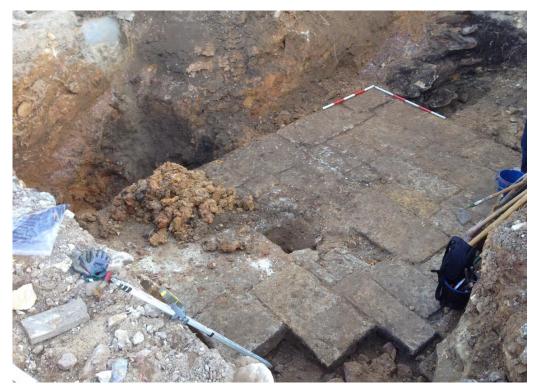
Photo 4 Sandstone pavers uncovered at Balmain East, 2016

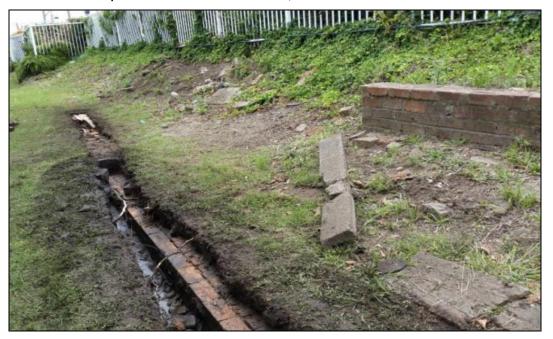
Photo 5 - Platform structure at Hamilton Railway Station classified as a 'work' by the project archaeologist - Wickham Transport Interchange project, 2015

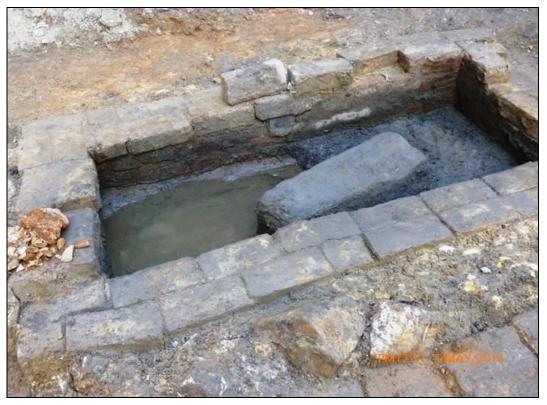
Photo 7 - Sandstone flagging and cesspit - Wynyard Walk project, 2014

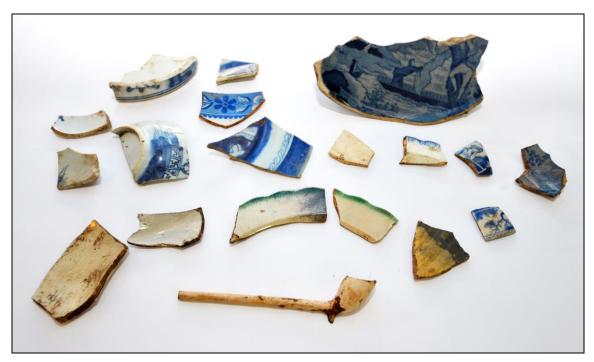
Photo 8 - Chinese Ming Dynasty pottery and English porcelain/pottery dating back to early 19th century -Wynyard Walk project, 2014

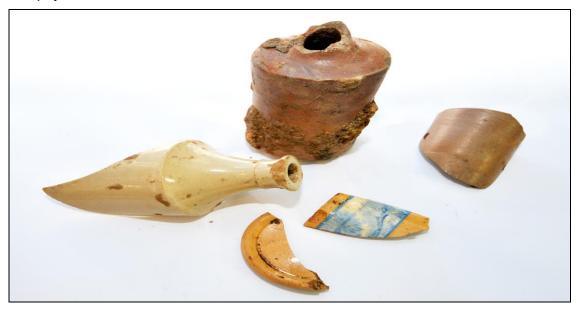
Photo 9 - Pottery made by convict potter Thomas Ball during the early settlement - Wynyard Walk project, 2014

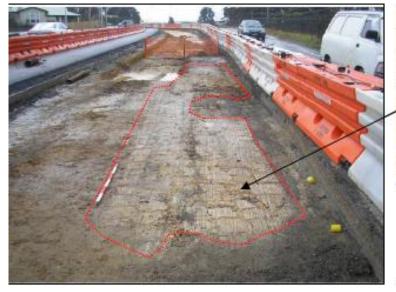
Figure 2: Close up detail of the sandstone surface showing material type, formation and construction detail. This is essential for establishing date of the feature.

It is important to take a general photograph (Figure 1) to convey the location and setting of the item. This will add value to the subsequent detailed photographs also required (Figure 2).

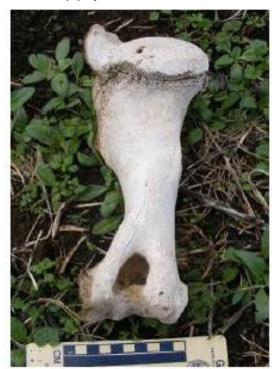
Figure 7: Photograph showing complete bone.

Ensure that all close up photographs include the whole bone and then specific details of the bone (especially the ends of long bones, the *epiphysis*, which is critical for species identification). Figures 7 and 8 are examples of good photographs of bones that can easily be identified from the photograph alone. They show sufficient detail of the complete bone and the epiphysis.

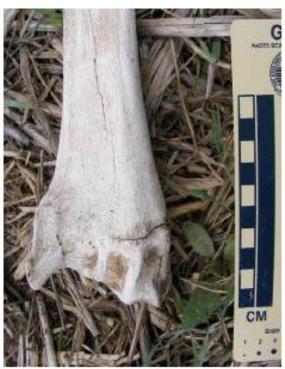
Figure 8: Close up of a long bone's epiphysis.

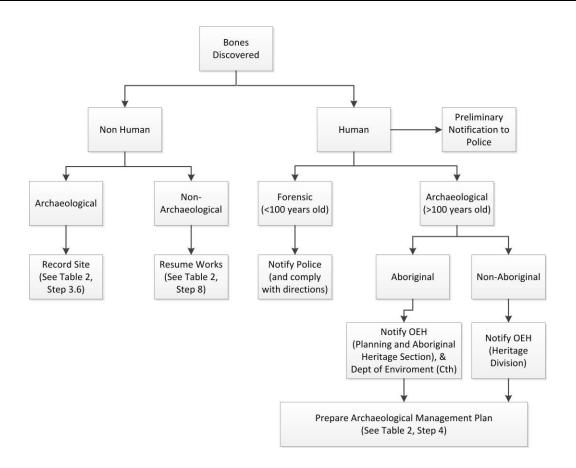
Figure 3 Overview of steps to be undertaken on the discovery of bones

After the appropriate verbal notifications (as described in 2B and 2C above), the Project Manager must proceed through the *Unexpected Heritage Items Exhumation Management Plan* (Step 4). It is noted that no *Exhumation Management Plan* is required for forensic cases (2A), as all future management is a police matter. Non-human skeletal remains must be treated like any other unexpected archaeological find and so must proceed to record the find as per Step 3.6.
