# Tree Impact Assessment Report – Southwest Metro Early Works

SMCSWSSJ-JHL-WEC-EM-REP-000001

This report has been produced to assess impacts to vegetation and detail the species and number of trees that will be removed as part of the Southwest Metro Early Works (SMEW).

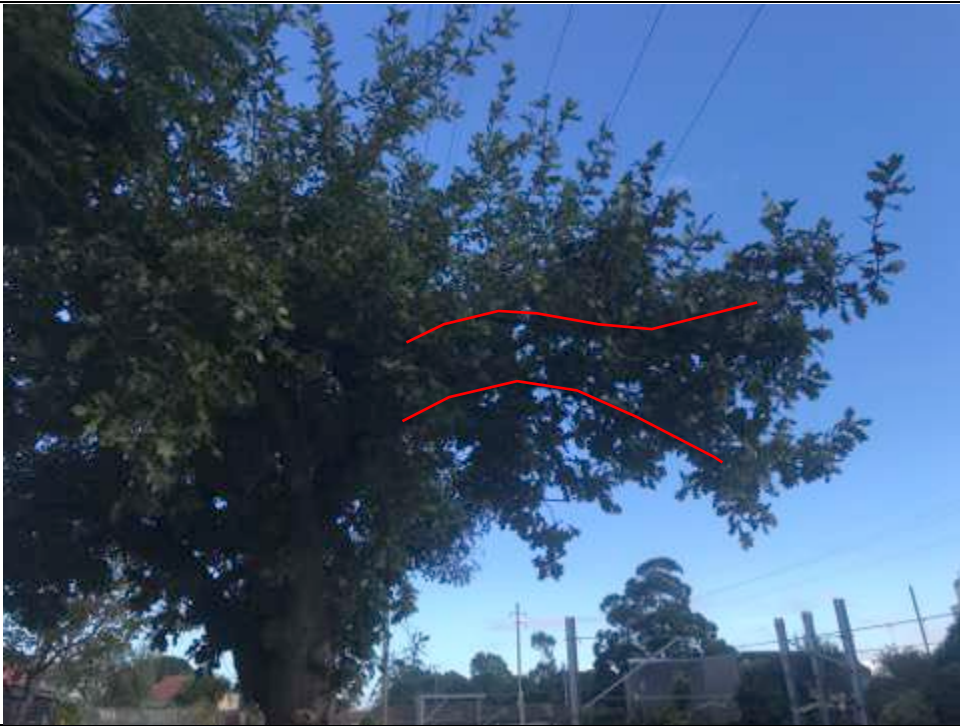
**Image 1:** Looking West to tree 74 showing required pruning for vehicle access. Both branches are 50mm diameter epicormic growth at 4-4.5m above ground to the North of the tree.

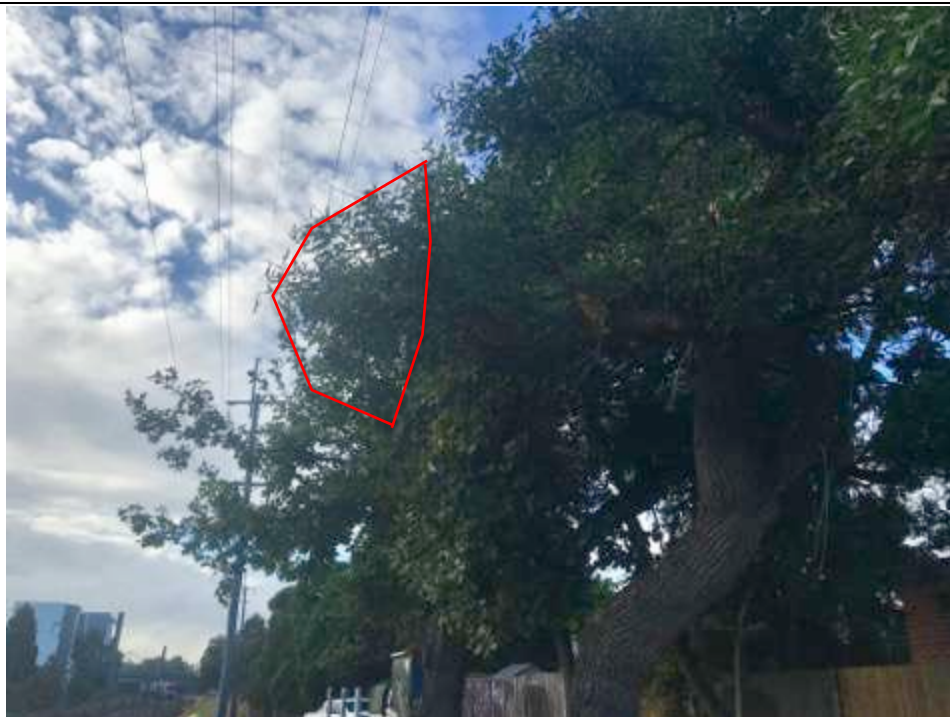
**Image 2:** Looking East to tree 75 showing required pruning for vehicle access. Minor tip pruning to the North of the tree is required to allow 4.5m clearance for vehicle access (circled red).

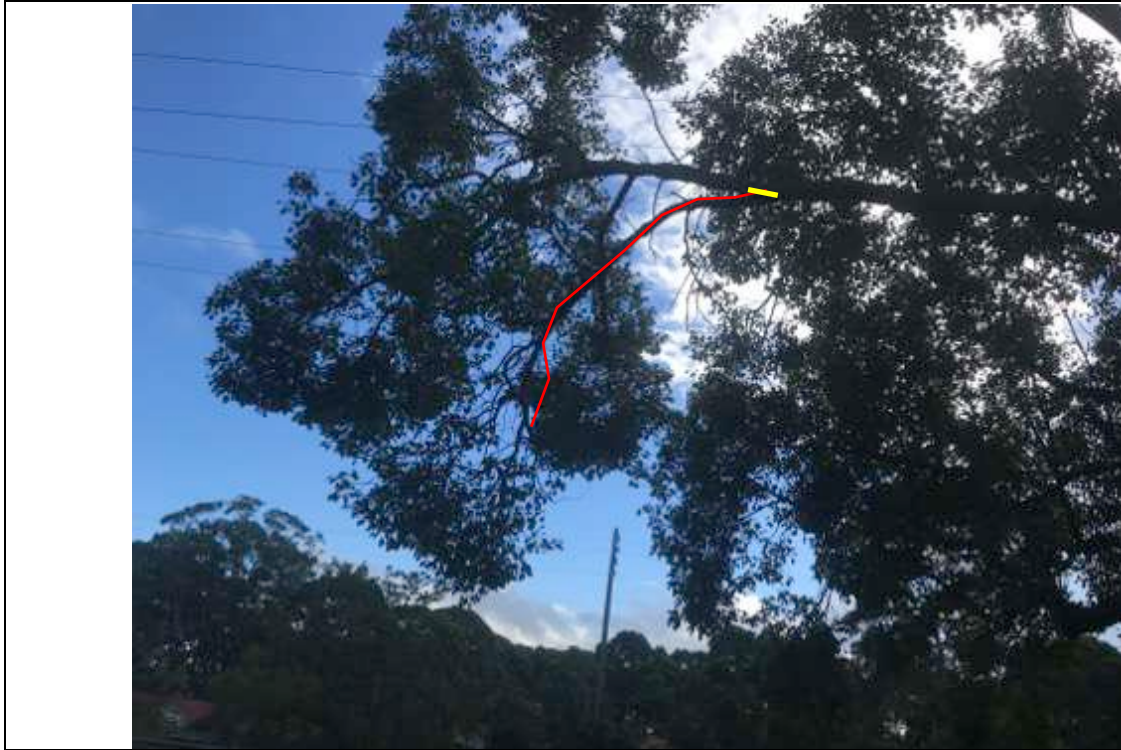
**Image 3:** Looking North to tree 80i showing required pruning for vehicle access. The 70mm diameter third order branch to the West at 5m above existing ground is to be removed. Pruning cut marked yellow.

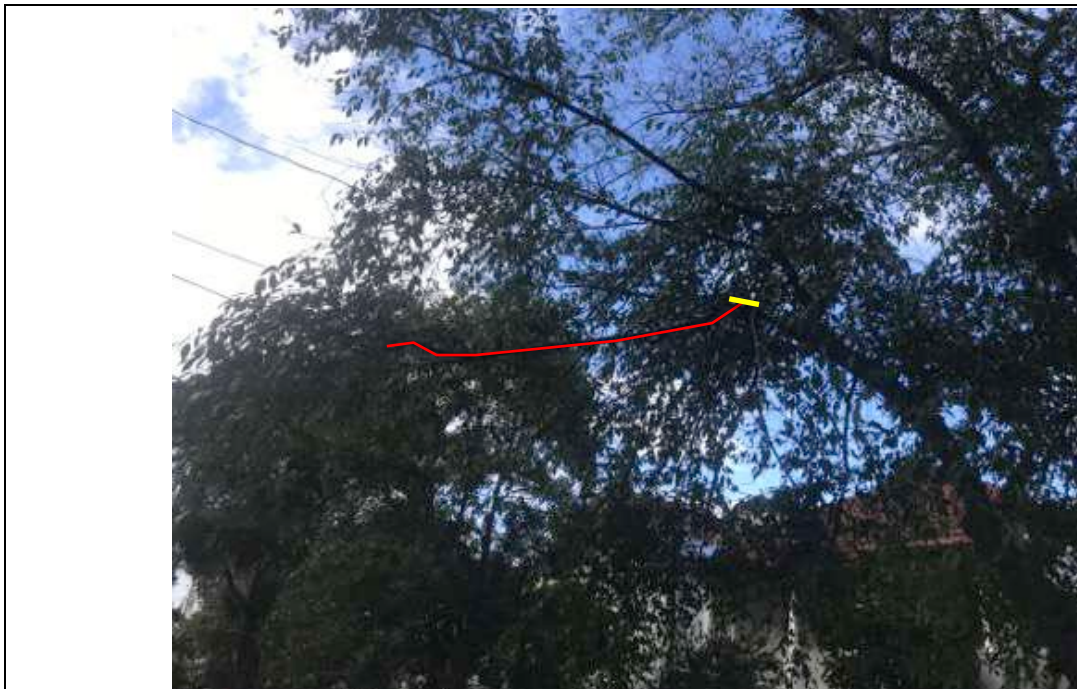
**Image 4:** Looking South West to tree 80k showing required pruning for vehicle access. The 50mm diameter third order branch to the North at 4m above existing ground is to be removed. Pruning cut marked yellow.

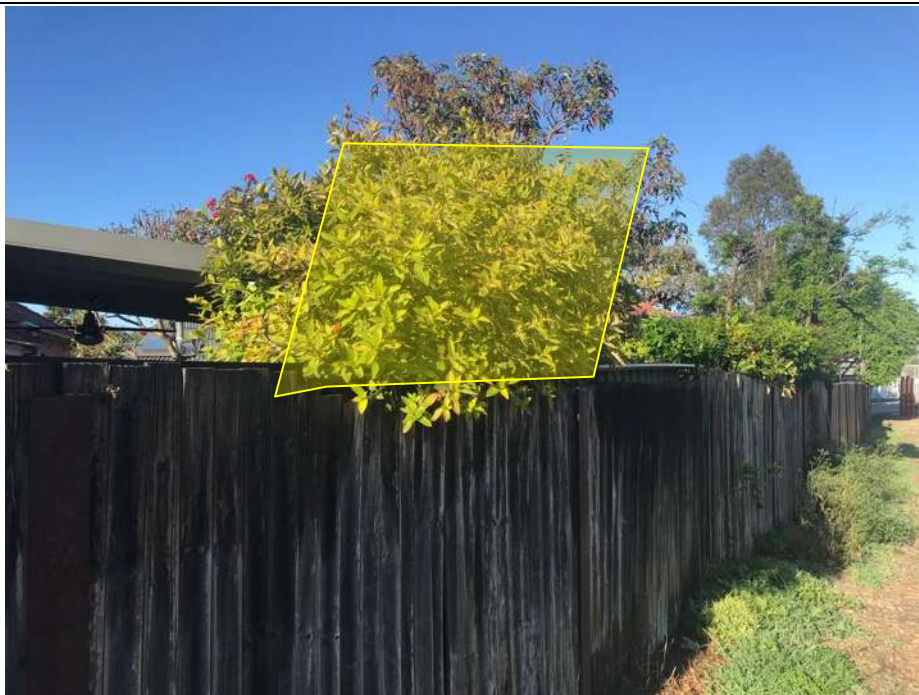
**Image 6:** Looking South West to tree 81a showing required pruning for the new security fence (shaded yellow). Minor tip pruning to the North of the tree is required to allow 3.5m clearance for the fence. The pruning will result in removing less than 5% of the overall live foliage area. The final cuts should not exceed 50mm in diameter.

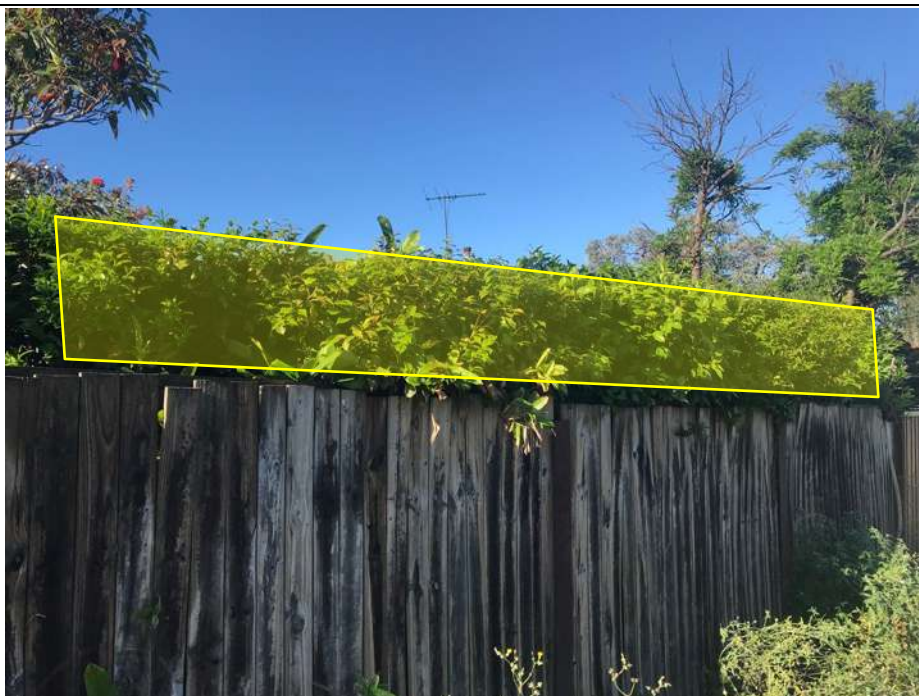
**Image 7:** Looking South West to tree 81b showing required pruning for the new security fence (shaded yellow). Minor tip pruning to the North of the tree is required to allow 3.5m clearance for the fence. The pruning will result in removing less than 5% of the overall live foliage area. The final cuts should not exceed 50mm in diameter.

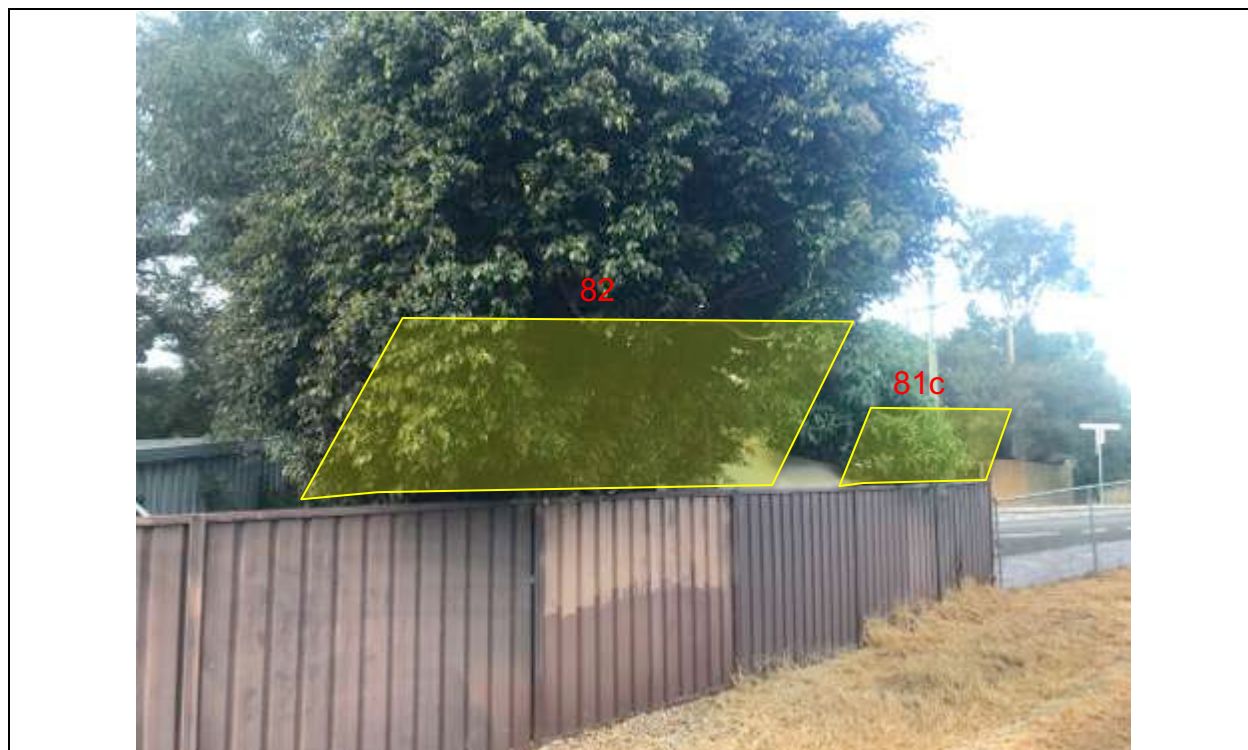
**Image 8:** Looking South West to tree 81c and 82 showing required pruning for the new security fence (shaded yellow). Minor tip pruning to the North of the trees is required to allow 3.5m clearance for the fence. The pruning will result in removing less than 5% of the overall live foliage area for tree 81c and removing approximately 10% of the overall live foliage area for tree 82. The final cuts should not exceed 50mm in diameter.

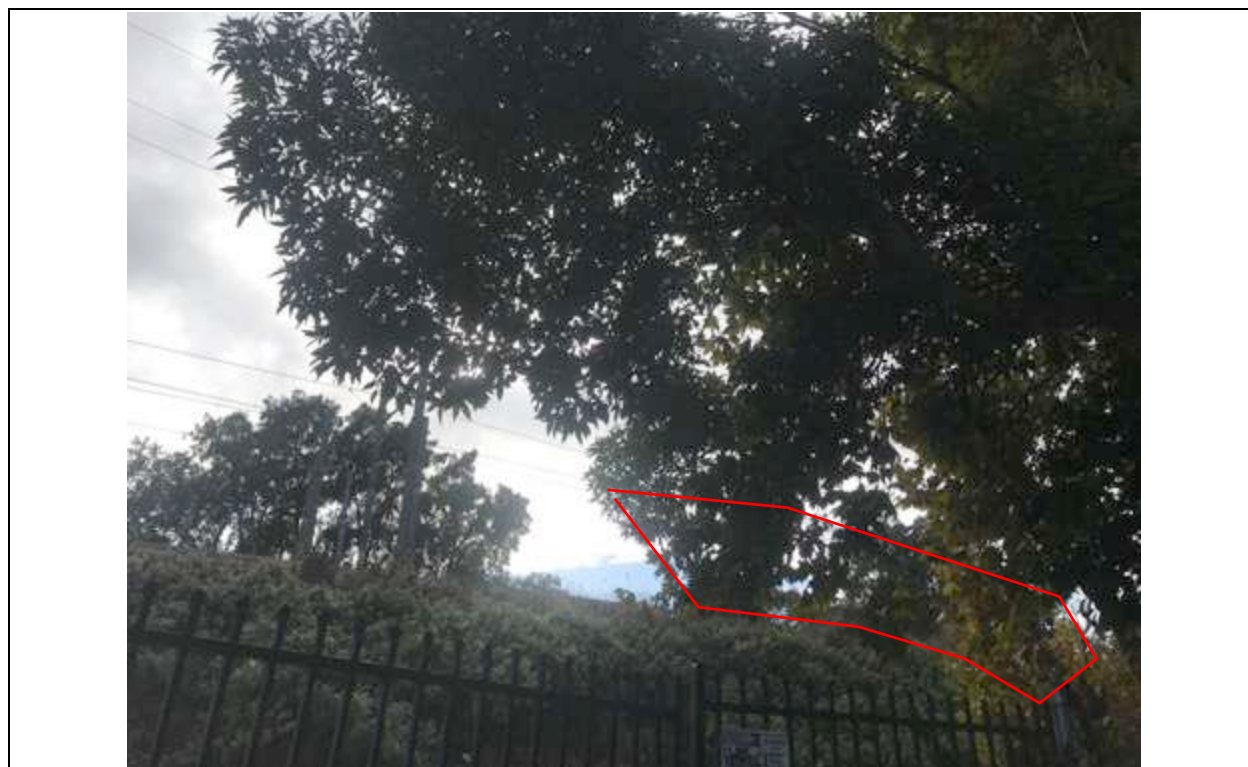
**Image 9:** Looking North East to the lower canopies of tree 100 and 100a showing required pruning for vehicle access. Minor tip pruning to the North and North West of the trees is required to allow 4.5m clearance for vehicle access (circled red).

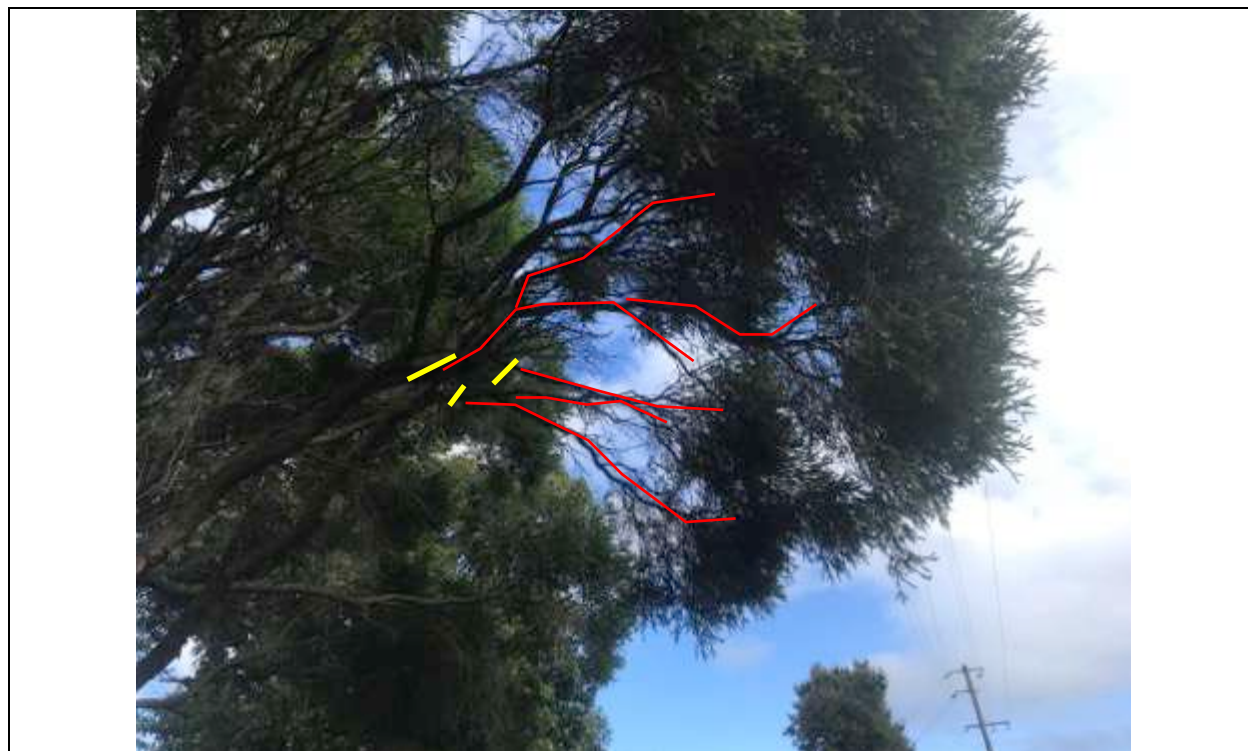
**Image 10:** Looking West to tree 124 showing required pruning for vehicle access. The three 30-50mm diameter third order branches to the North at 4m above existing ground are to be removed. Pruning cuts marked yellow.

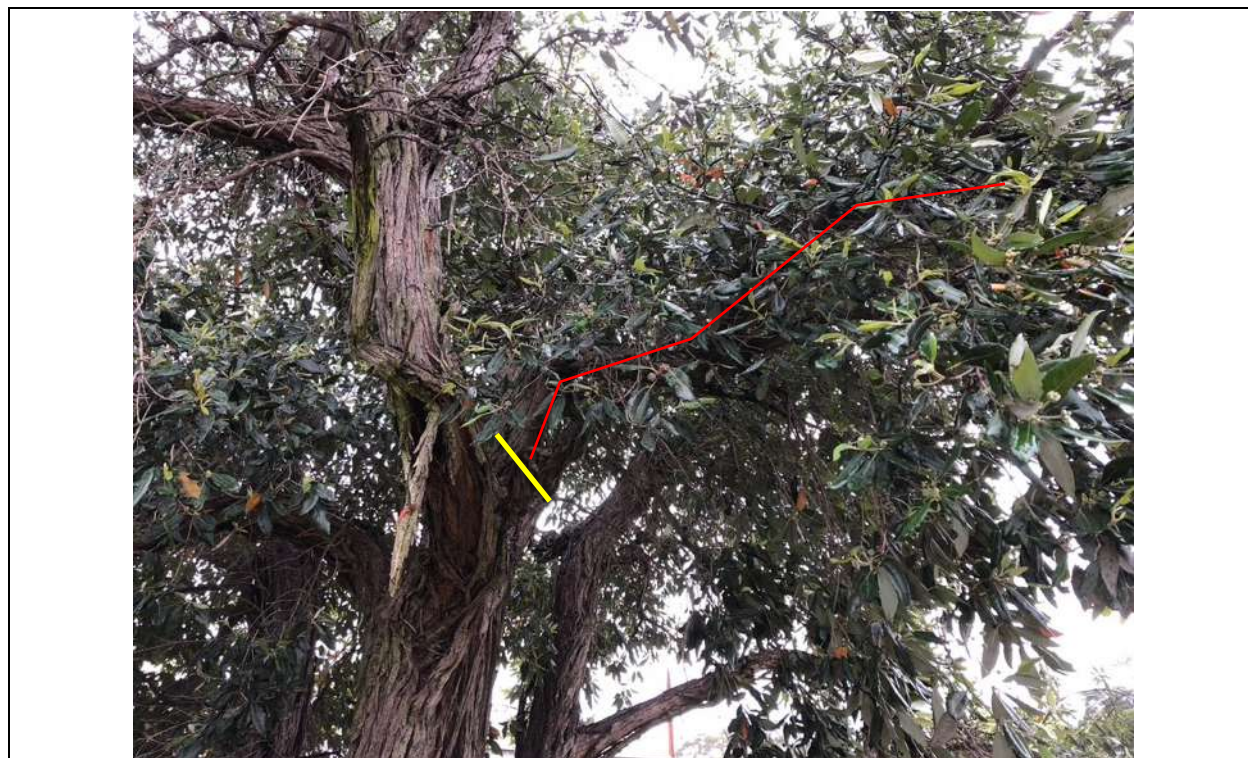
**Image 11:** Looking North to tree 134 showing required pruning for vehicle access. The 150mm diameter second order branch to the Southeast at 2m above existing ground is to be removed. Pruning cut marked yellow.

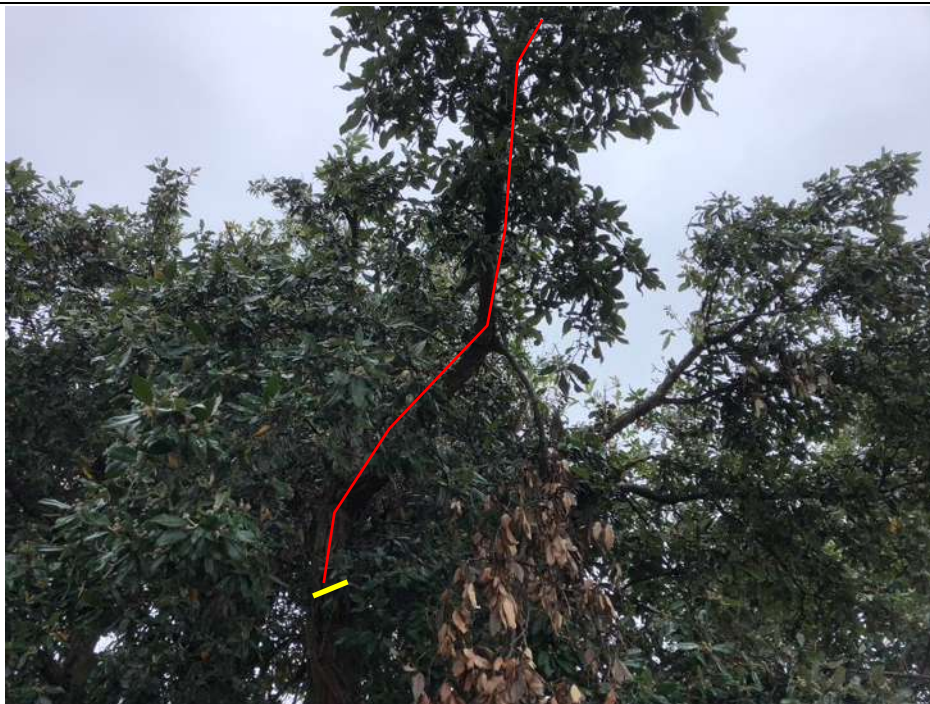
**Image 12:** Looking North to tree 139 showing required pruning for vehicle access. The 100mm diameter second third branch to the Southeast at 3m above existing ground is to be removed. Pruning cut marked yellow.

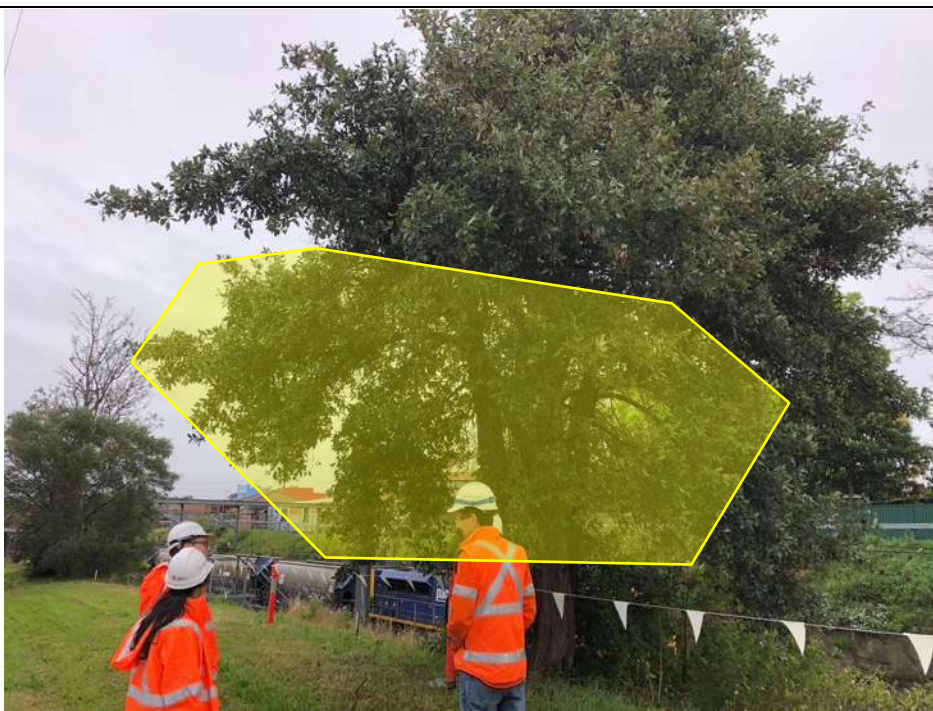
**Image 13:** Looking Northwest to tree 143 showing required pruning for vehicle access. Crown raising to a height of 3.5m above ground height will be required to the South of the tree (hatched yellow). The pruning will result in removing less than 5% of the overall live foliage area. Final pruning cuts should not exceed 100mm in diameter.

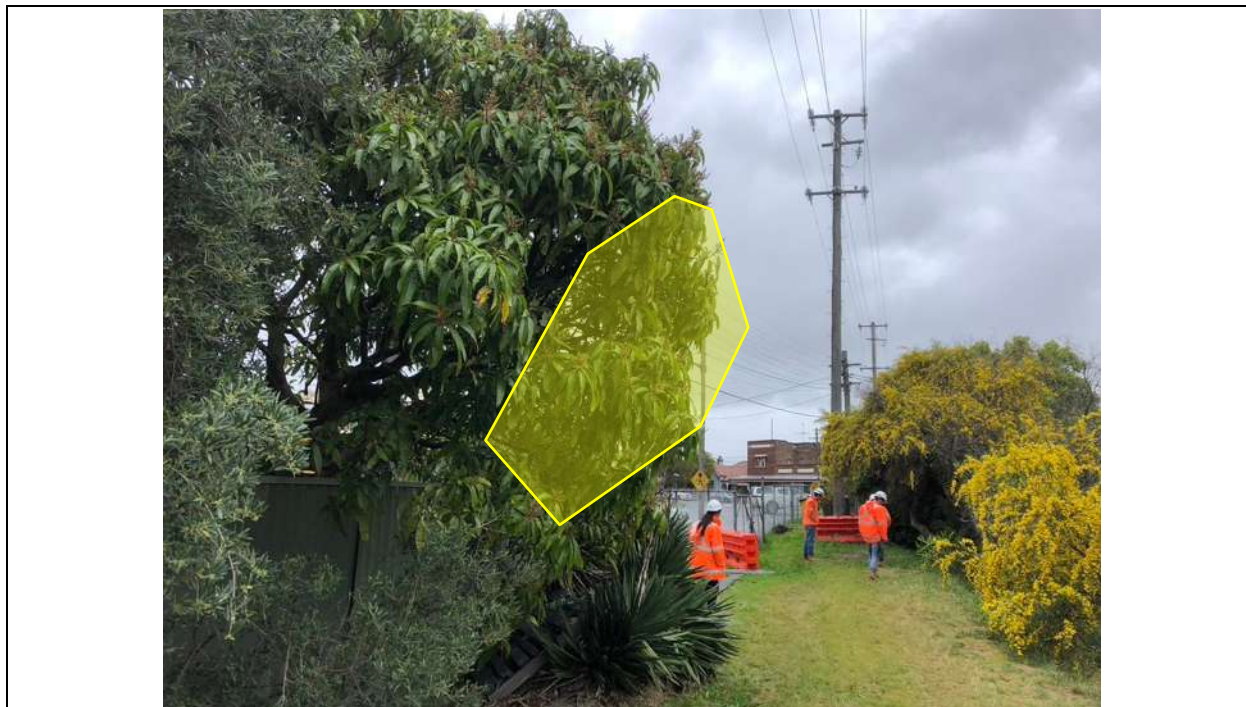
**Image 14:** Looking West to tree 157 showing required pruning for vehicle access. The crown is to be reduced by 0.5m to the South to a height 3.5m above ground height (hatched yellow). The pruning will result in removing less than 5% of the overall live foliage area. Final pruning cuts should not exceed 50mm in diameter.

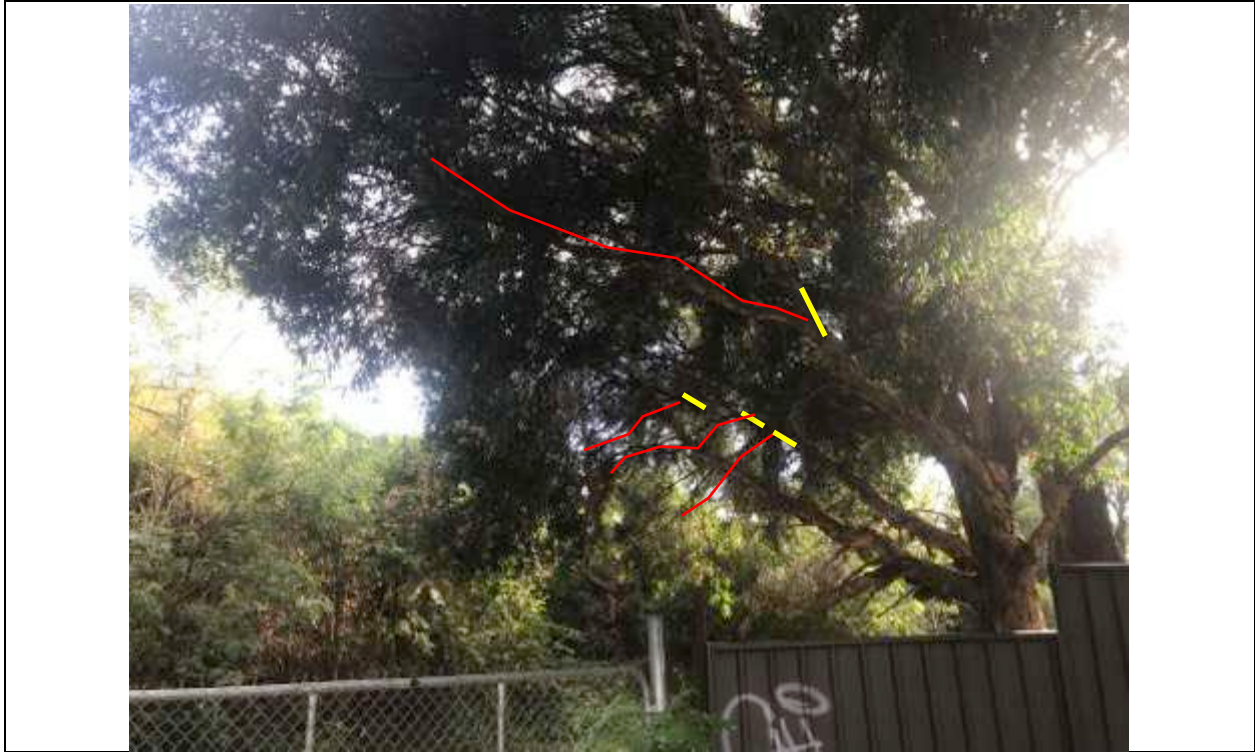
**Image 15:** Looking North East to tree 188 showing required pruning for vehicle access. The three 40mm diameter third order branches to the North at 4m above existing ground are to be removed. The 80mm second order branch to the West at 4m above ground is to be removed. Pruning cuts marked yellow.

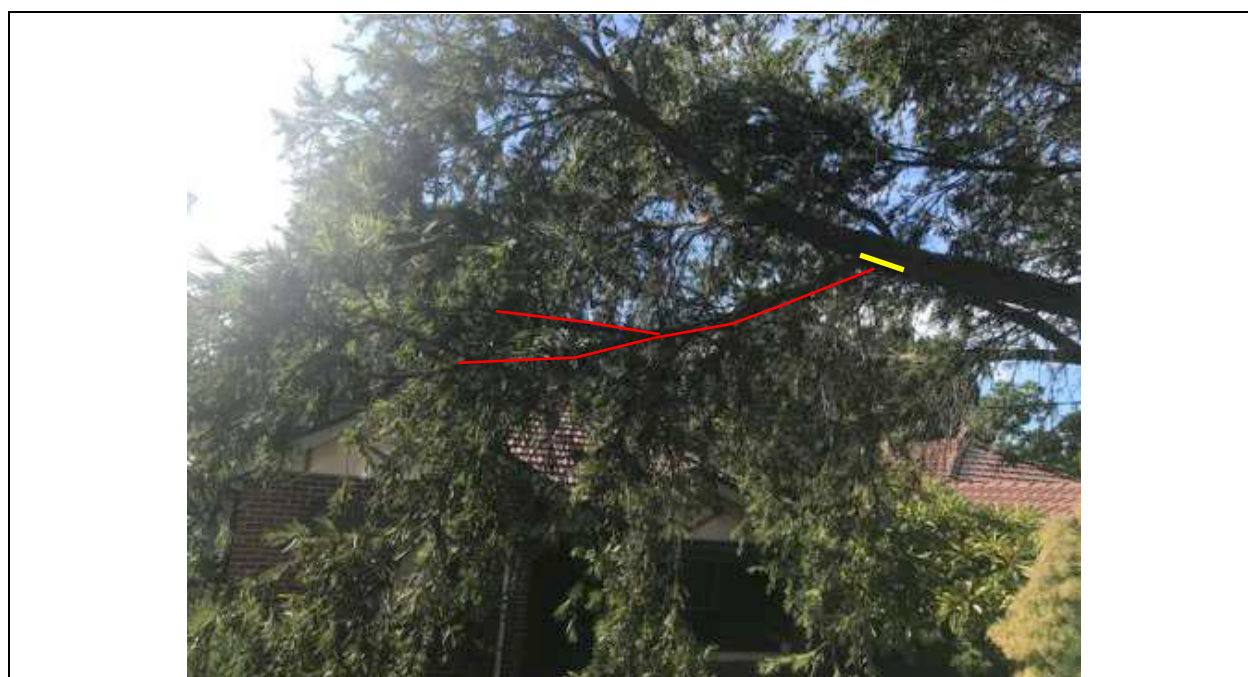
**Image 16:** Looking East to tree 214a showing required pruning for vehicle access. The 40mm diameter second order branch to the North at 2m above existing ground is to be removed. Pruning cuts marked yellow.

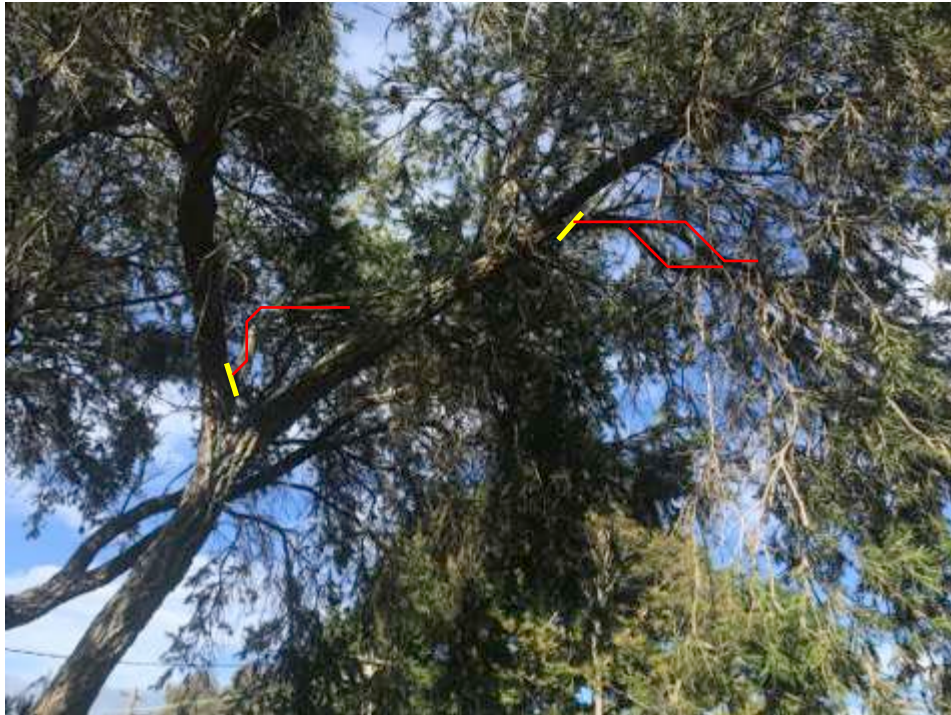
**Image 17:** Looking South to tree 214a showing required pruning for vehicle access. The two 40mm diameter third order branches to the North and North West at 3m above existing ground are to be removed. Pruning cuts marked yellow.

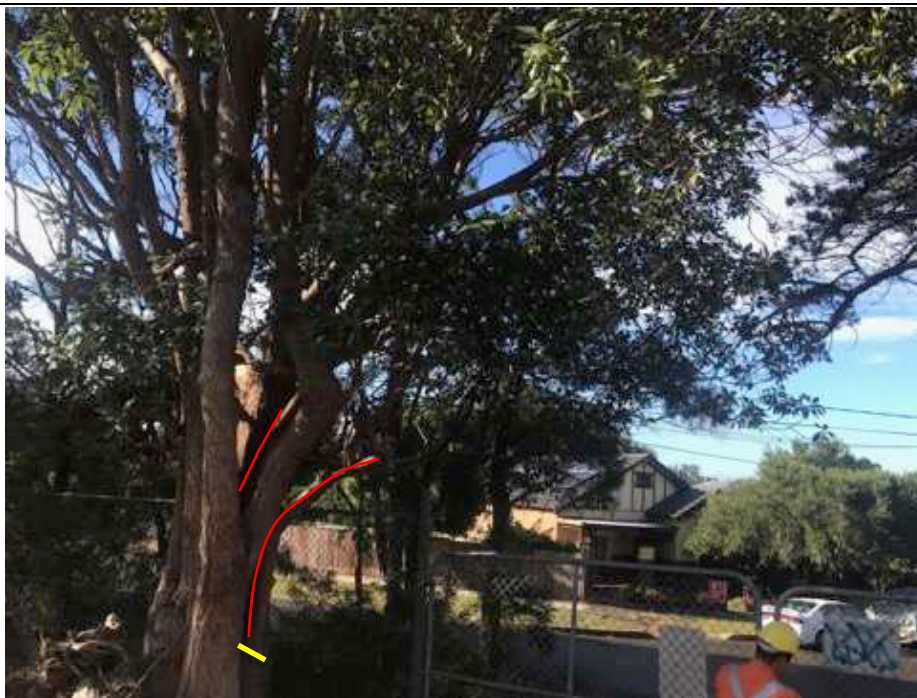
**Image 18:** Looking South East to tree 229 showing required pruning for vehicle access. The 120mm diameter epicormic growth at the base of the tree to the West is to be removed. Pruning cut marked yellow.

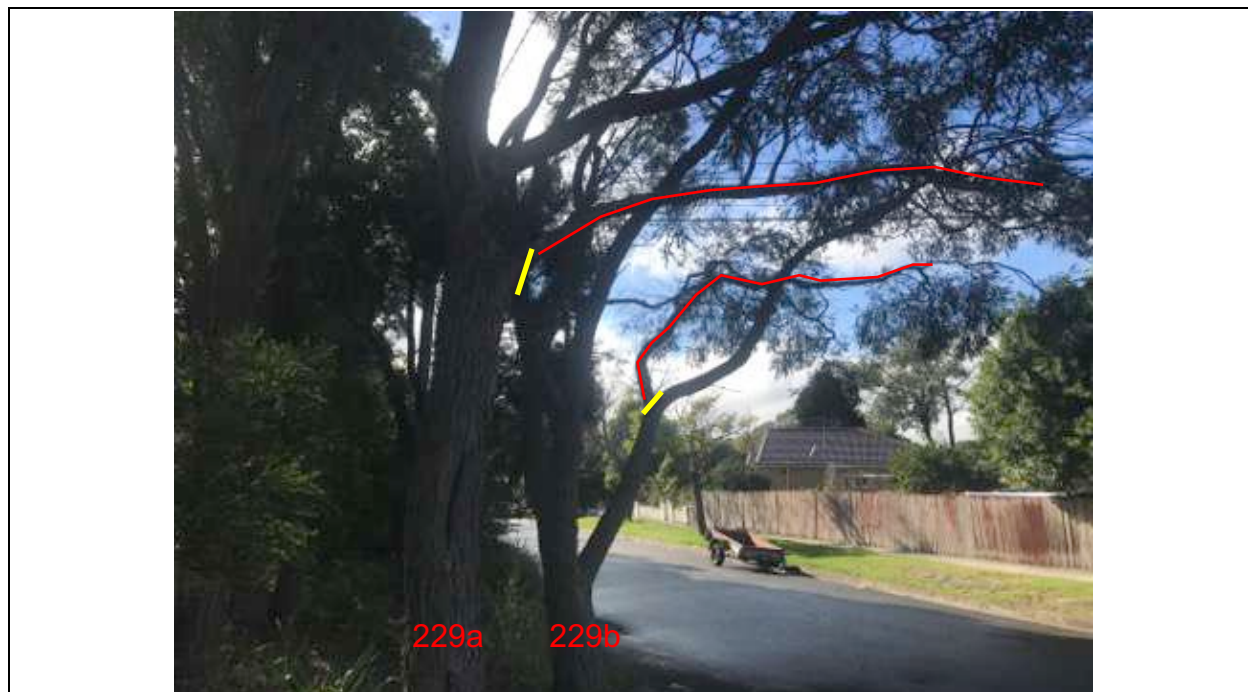
**Image 19:** Looking South East to tree 229a and 229b showing required pruning for vehicle access. For tree 229a the 90mm diameter lowest primary branch to the South at 2m is to be removed. For tree 229b the 90mm diameter second order branch to the South at 2m is to be removed. Pruning cuts yellow.

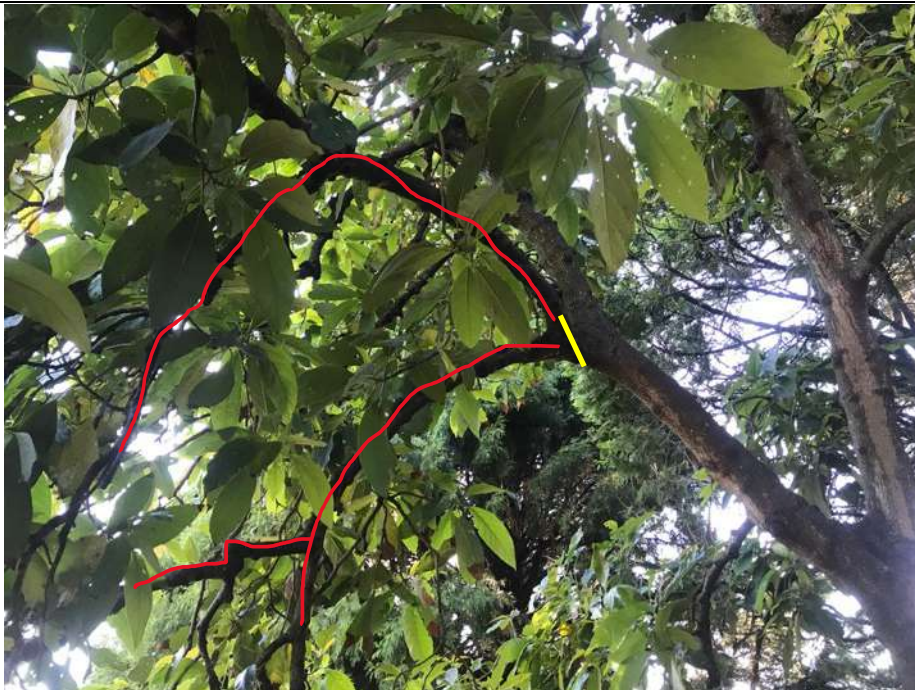
**Image 21:** Looking South East to tree 243a showing required pruning for the new security fence. The removal of the 100mm diameter second order branch at 3m to the West is required to allow 3.5m clearance for the fence. Pruning cut marked yellow.

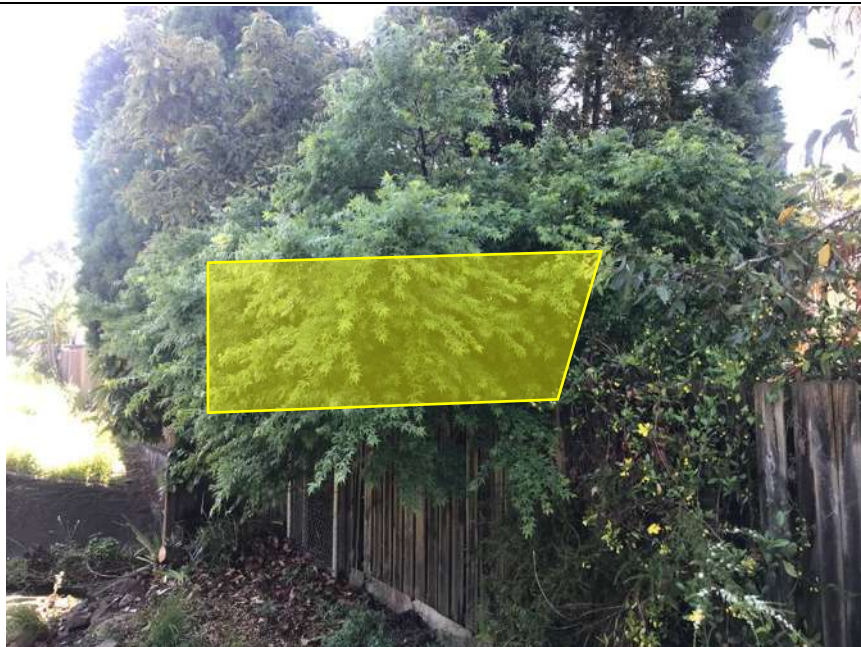
**Image 22:** Looking South East to tree 244 showing required pruning for the new security fence. Minor tip pruning to the North of the tree is required to allow 3.5m clearance for the fence. The pruning will result in removing approximately 20% of the overall live foliage area. The finished cut diameter should not exceed 50mm.

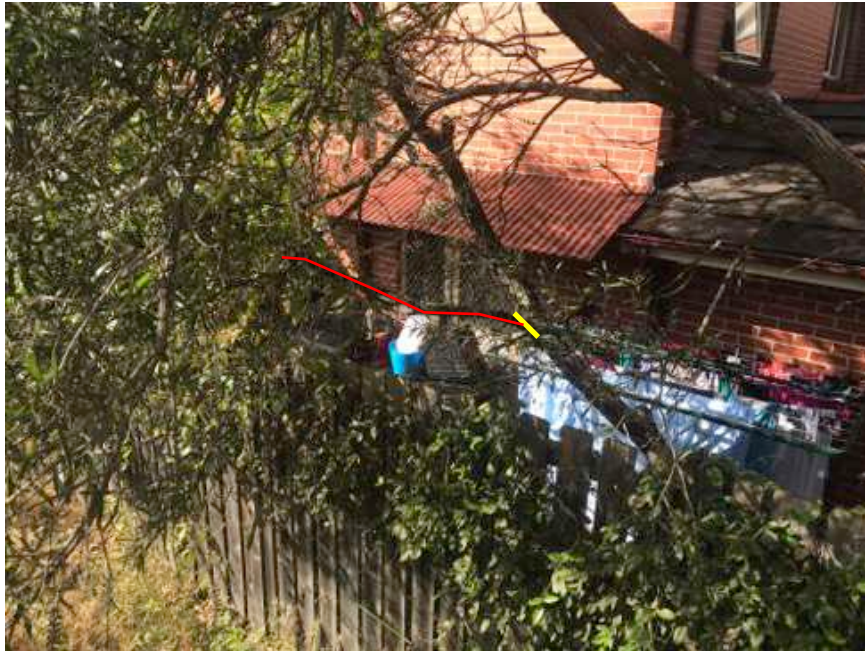
**Image 23:** Looking South East to tree 246 showing required pruning for the new security fence. The removal of the 50mm diameter lowest primary branch at 2m to the North is required to allow 3.5m clearance for the fence. Pruning cut marked yellow.

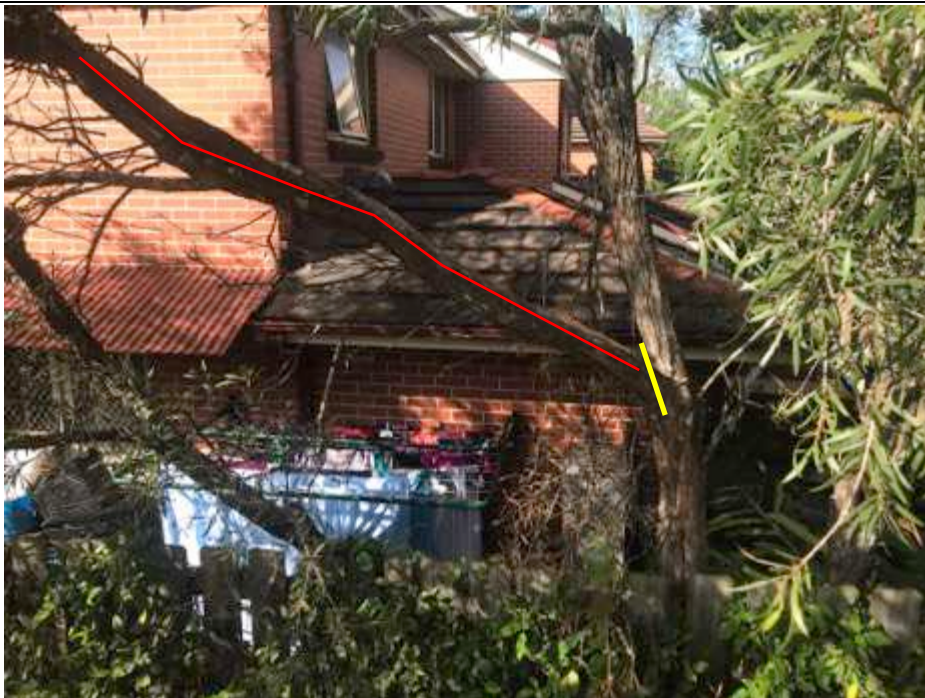
**Image 24:** Looking South East to tree 247 showing required pruning for the new security fence. The removal of the 100mm diameter lowest primary branch at 2.5m to the North East is required to allow 3.5m clearance for the fence. Pruning cut marked yellow.

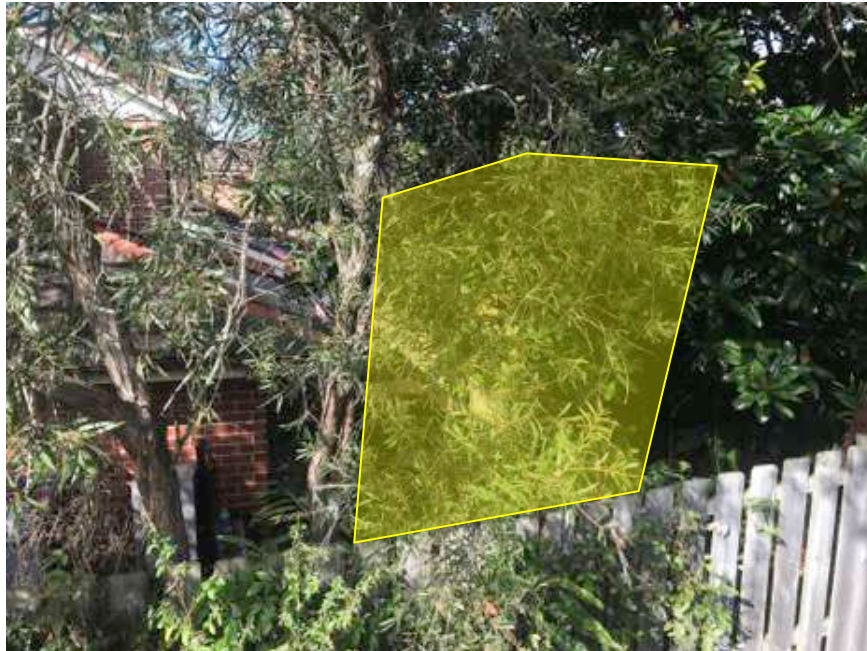
**Image 25:** Looking South East to tree 248 showing required pruning for the new security fence. Minor tip pruning to the North of the tree is required to allow 3.5m clearance for the fence. The pruning will result in removing approximately 5% of the overall live foliage area. The finished cut diameter should not exceed 50mm.

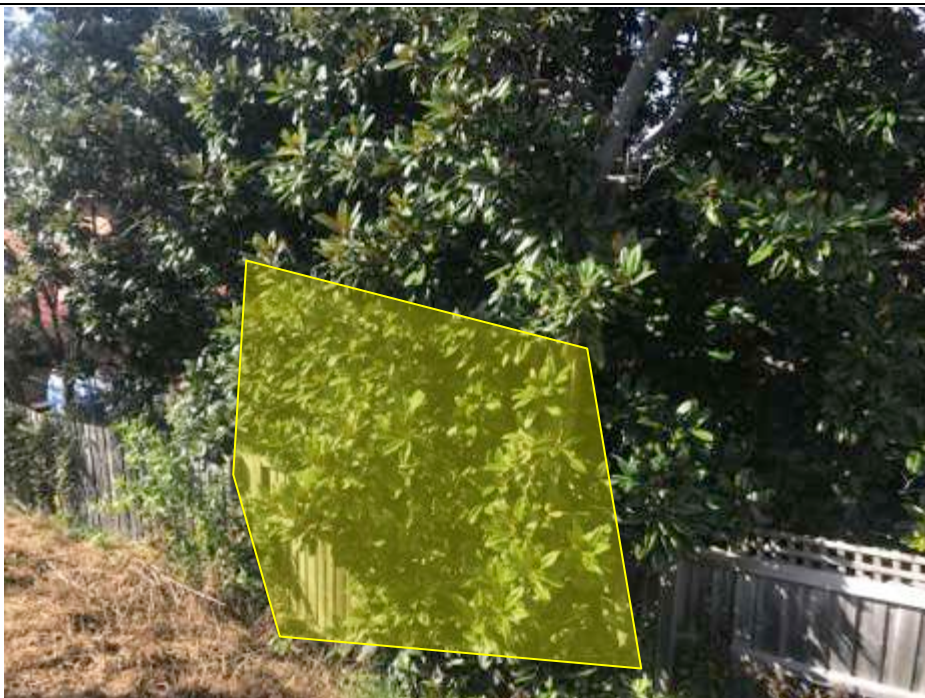
**Image 26:** Looking South East to tree 249 showing required pruning for the new security fence. Minor tip pruning to the North of the tree is required to allow 3.5m clearance for the fence. The pruning will result in removing approximately 5% of the overall live foliage area. The finished cut diameter should not exceed 50mm.

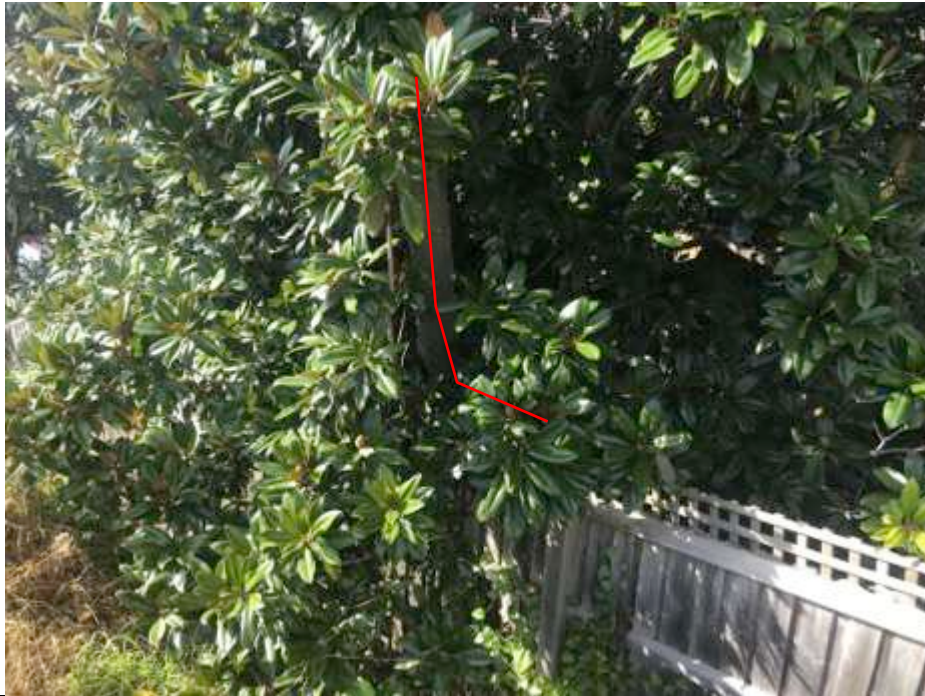
**Image 27:** Looking South East to tree 249 showing required pruning for the new security fence. The removal of the 250mm diameter first order branch at 1m to the North West is required.

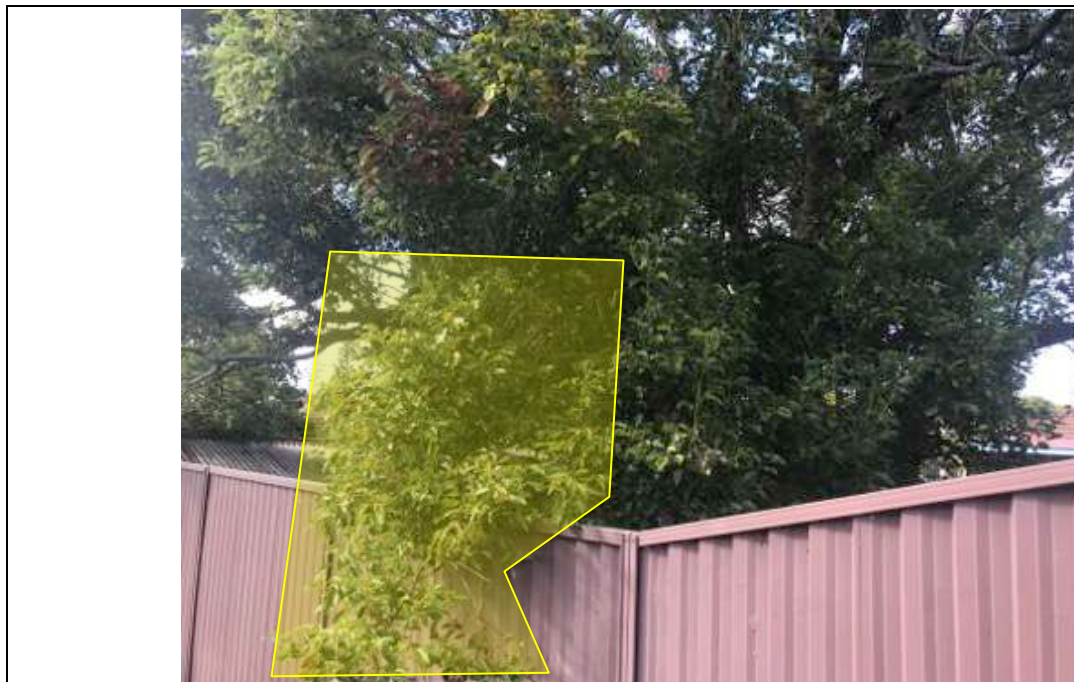
**Image 28:** Looking South East to tree 250 showing required pruning for the new security fence. Minor tip pruning to the North of the tree is required to allow 3.5m clearance for the fence. The pruning will result in removing approximately 5% of the overall live foliage area. The finished cut diameter should not exceed 50mm.

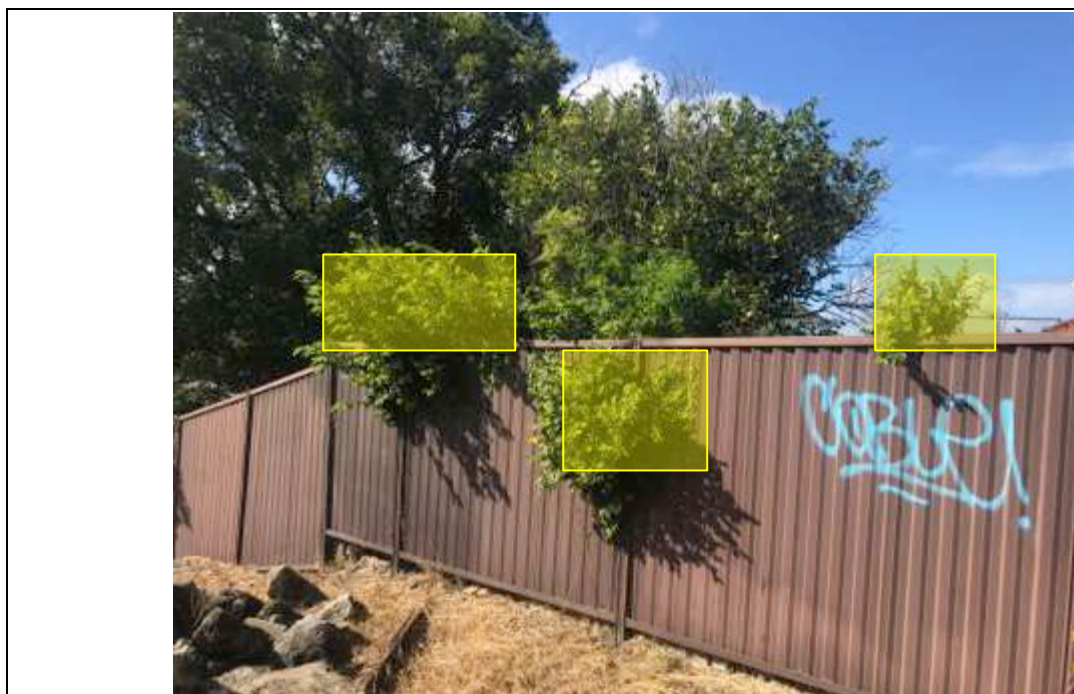
**Image 29:** Looking South East to tree 251 showing required pruning for the new security fence. Minor tip pruning to the North of the tree is required to allow 3.5m clearance for the fence. The pruning will result in removing approximately 10% of the overall live foliage area. The finished cut diameter should not exceed 50mm.

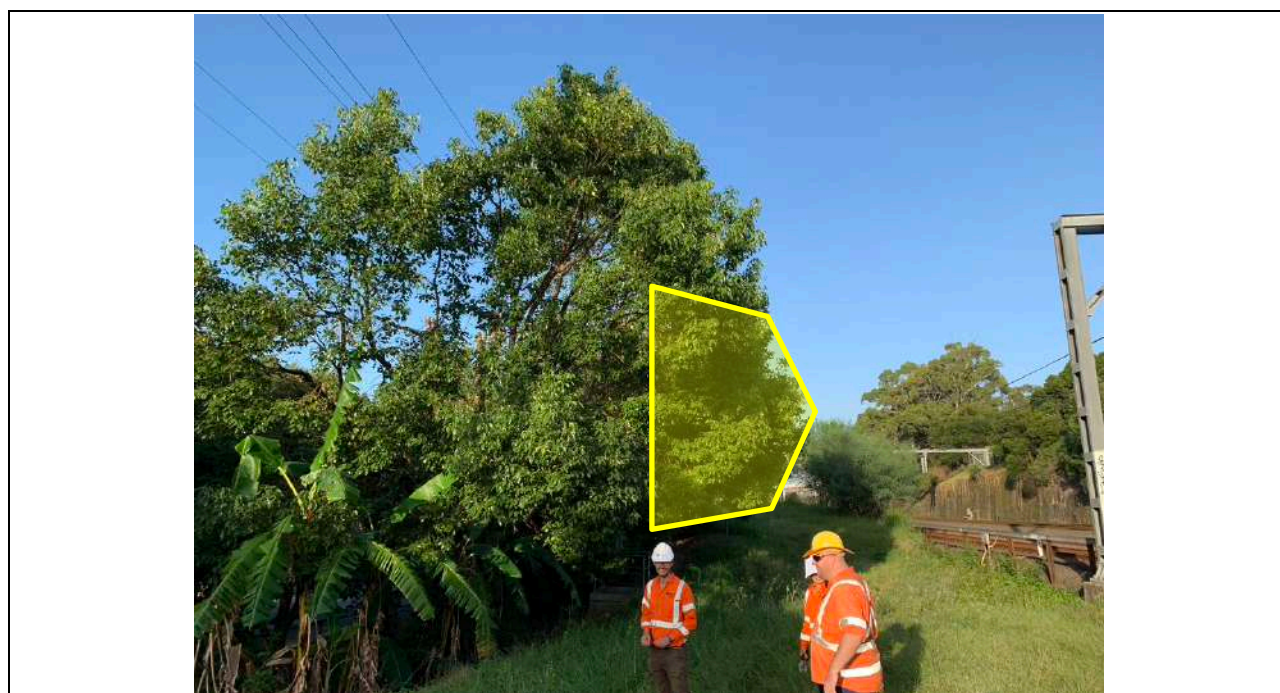
**Image 31:** Looking West towards tree 260, showing required pruning for the Qenos pipeline removal. The North side of the crown is to be raised by 5m (hatched yellow). The pruning will result in removing 10-15% of the overall live foliage area. Final pruning cuts should not exceed 100mm in diameter.
