# Tree Impact Assessment Report – Southwest Metro Early Works

SMCSWSSJ-JHL-WEC-EM-REP-000001

This report has been produced to assess impacts to vegetation and detail the species and number of trees that will be removed as part of the Southwest Metro Early Works (SMEW).

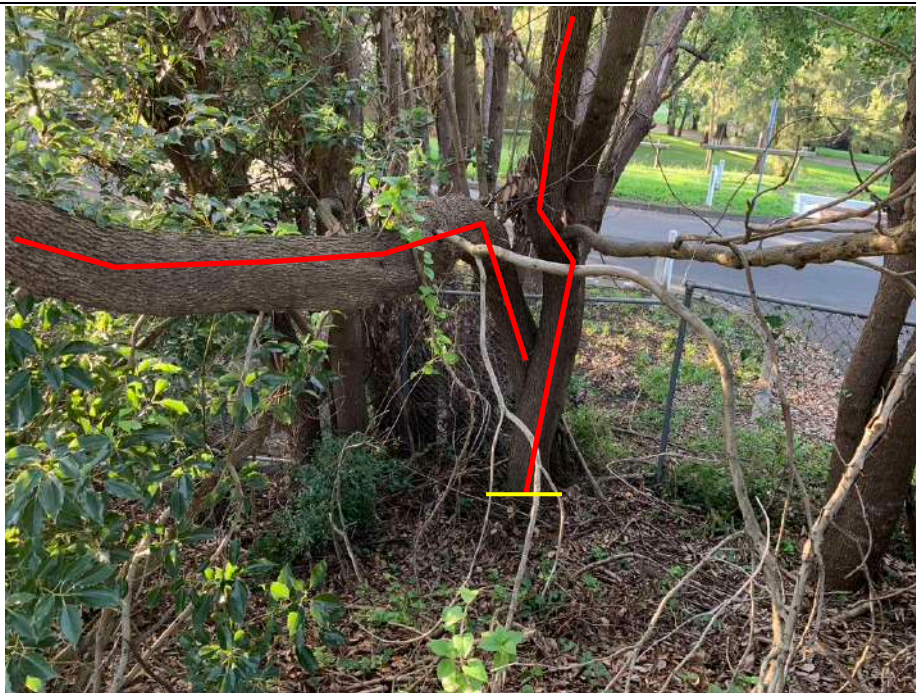
**Image 32:** Looking South towards tree 262, showing required pruning for the Qenos pipeline removal. The tree is multi stemmed and the tree has been continuously lopped for power line clearance. The two Western most stems are to be removed as close to the ground as practical. The pruning will result in removing 20-25% of the overall live foliage area of the tree. The remaining stems will be unaffected by the pruning.

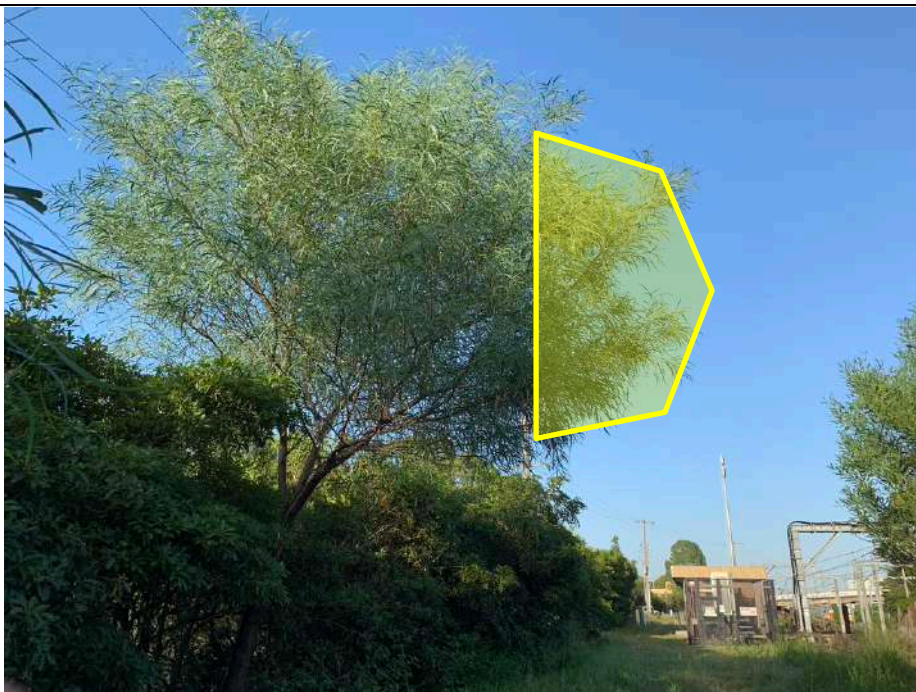
**Image 33:** Looking West towards tree 272, showing required pruning for the Qenos pipeline removal. The North side of the crown is to be reduced by 1.5m – 2.0m (hatched yellow). The pruning will result in removing 10-15% of the overall live foliage area. Final pruning cuts should not exceed 50mm in diameter.

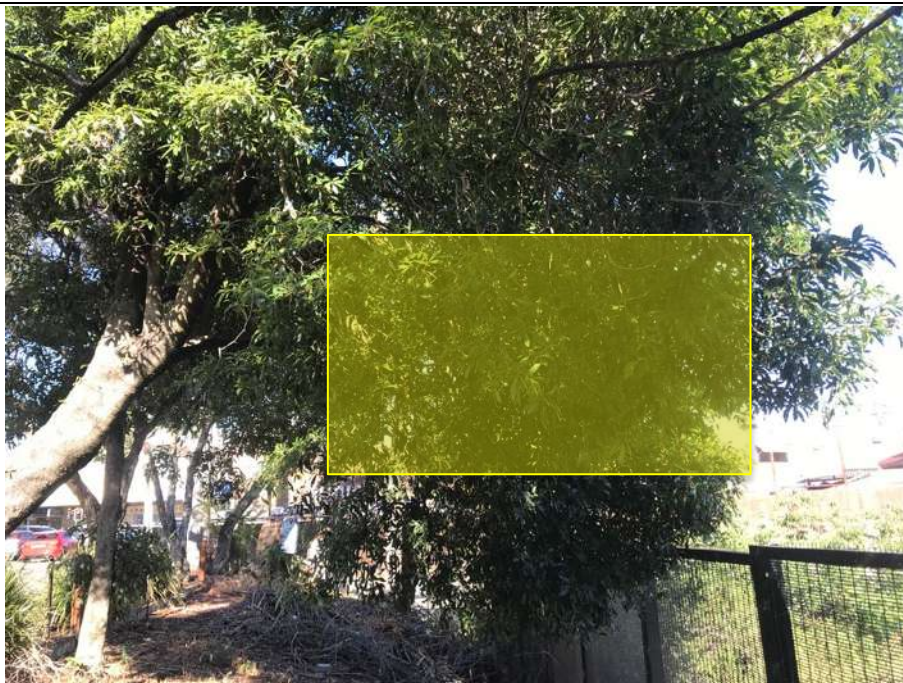
**Image 35:** Looking North West to tree 517 showing required pruning for the new security fence (Shaded yellow). Crown raising is required to allow 3.5m clearance for the fence. The pruning will result in removing approximately 10% of the overall live foliage area. The finished cut diameter should not exceed 50mm.

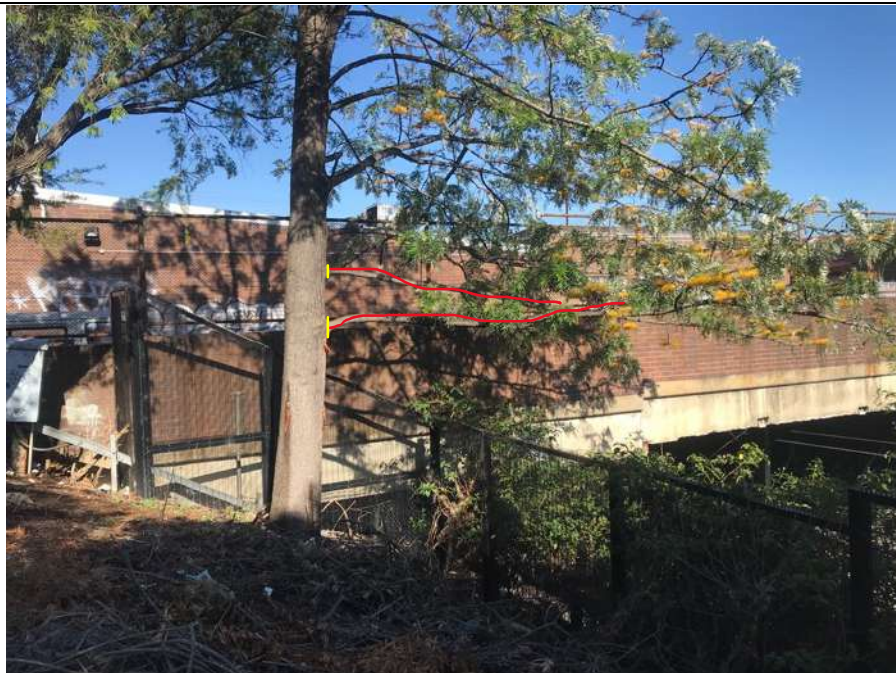
**Image 36:** Looking North West to tree 522 showing required pruning for the new security fence. The removal of the two lowest primary branches to the West at 3m and 3.5m above soil grade is required to allow 3.5m clearance for the fence. The branches are 100mm in diameter. Pruning cuts marked yellow.

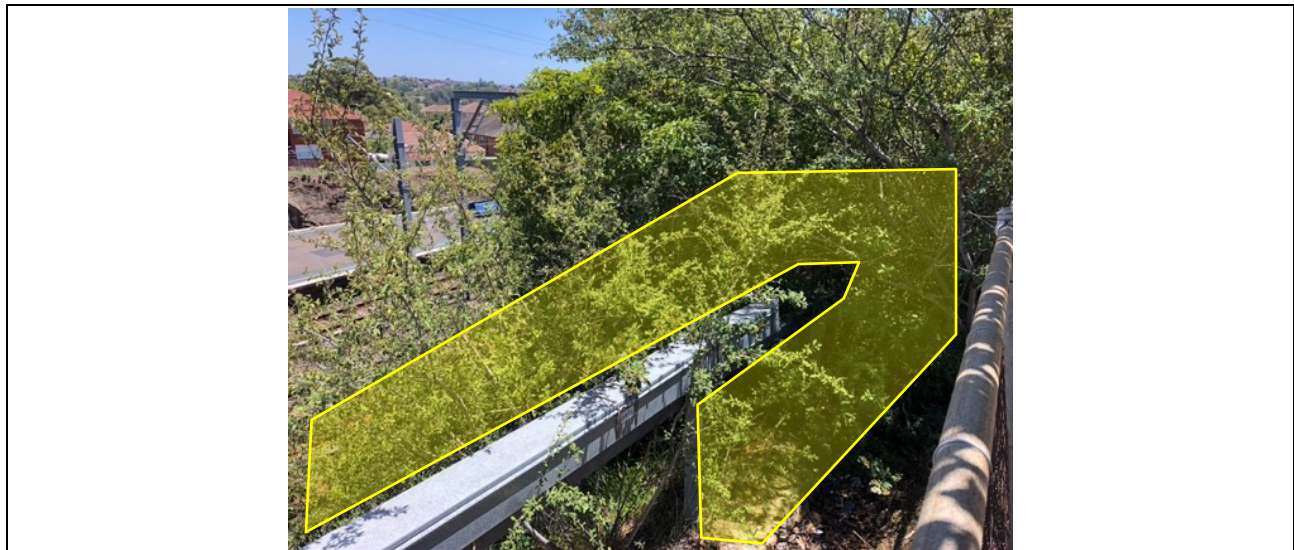
**Image 1:** Looking Southwest towards *vegetation* within G27 (Mixed species weeds). The *vegetation* within this area requires clearance pruning (hatched yellow) around the GST to allow for the proposed works area.

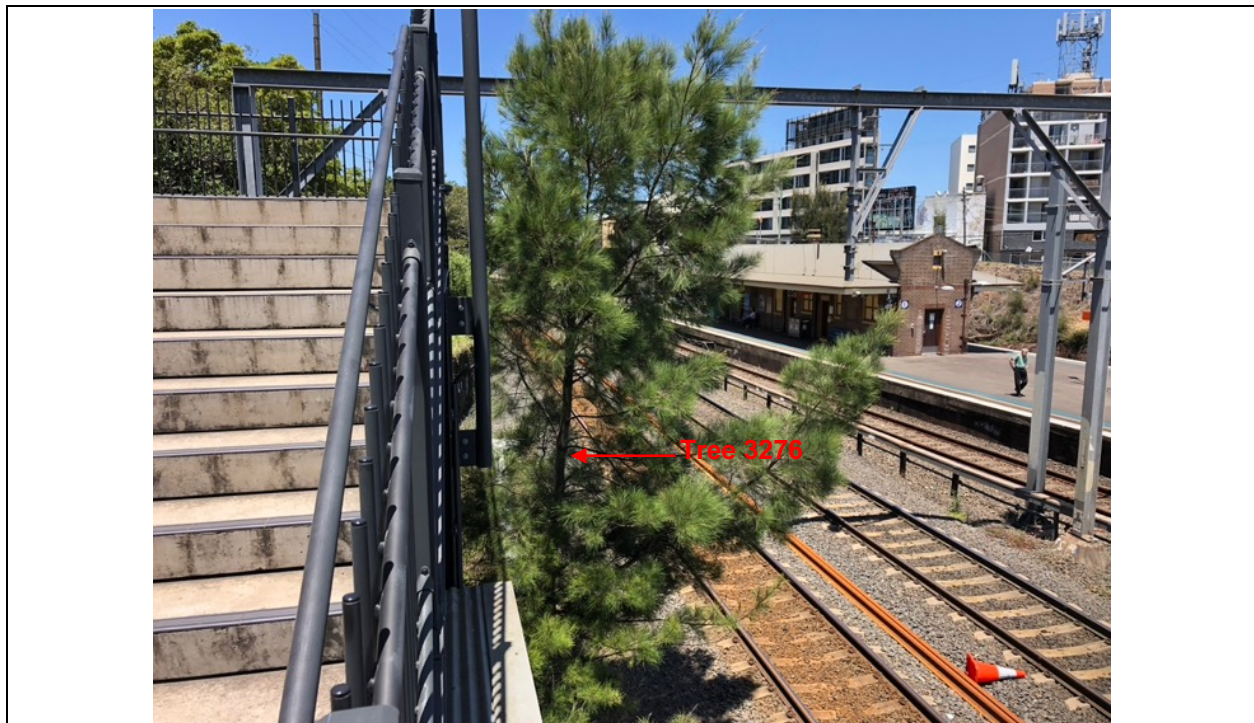
**Image 2:** Looking East towards tree 3276. Tree removal is recommended to accommodate the development.

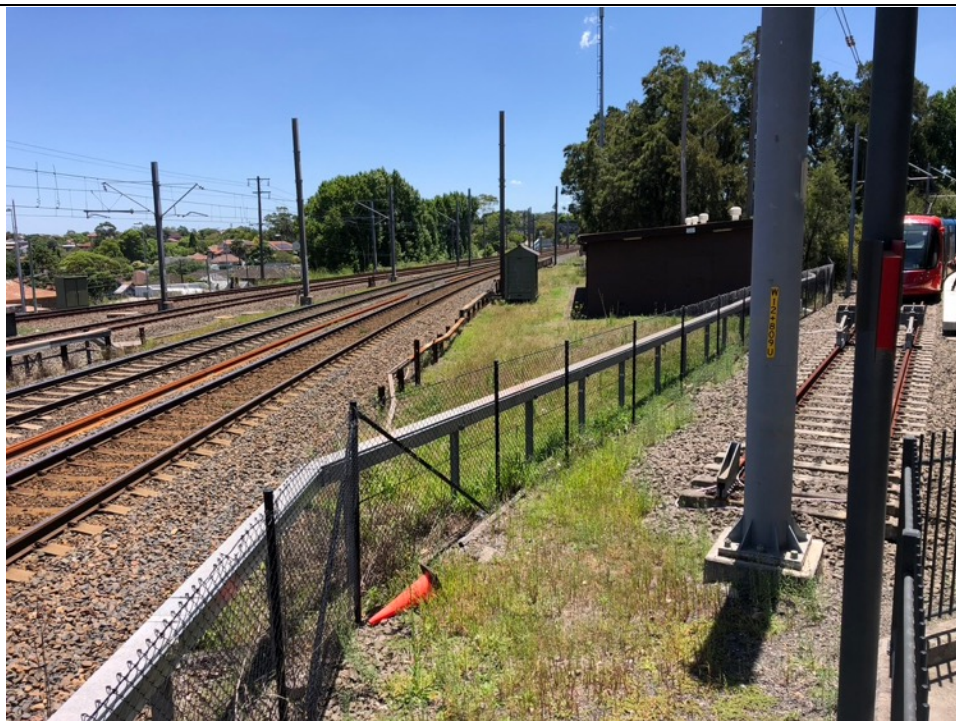
**Image 3:** Looking West towards Zone 3. No tree removal or pruning will be required within this area.

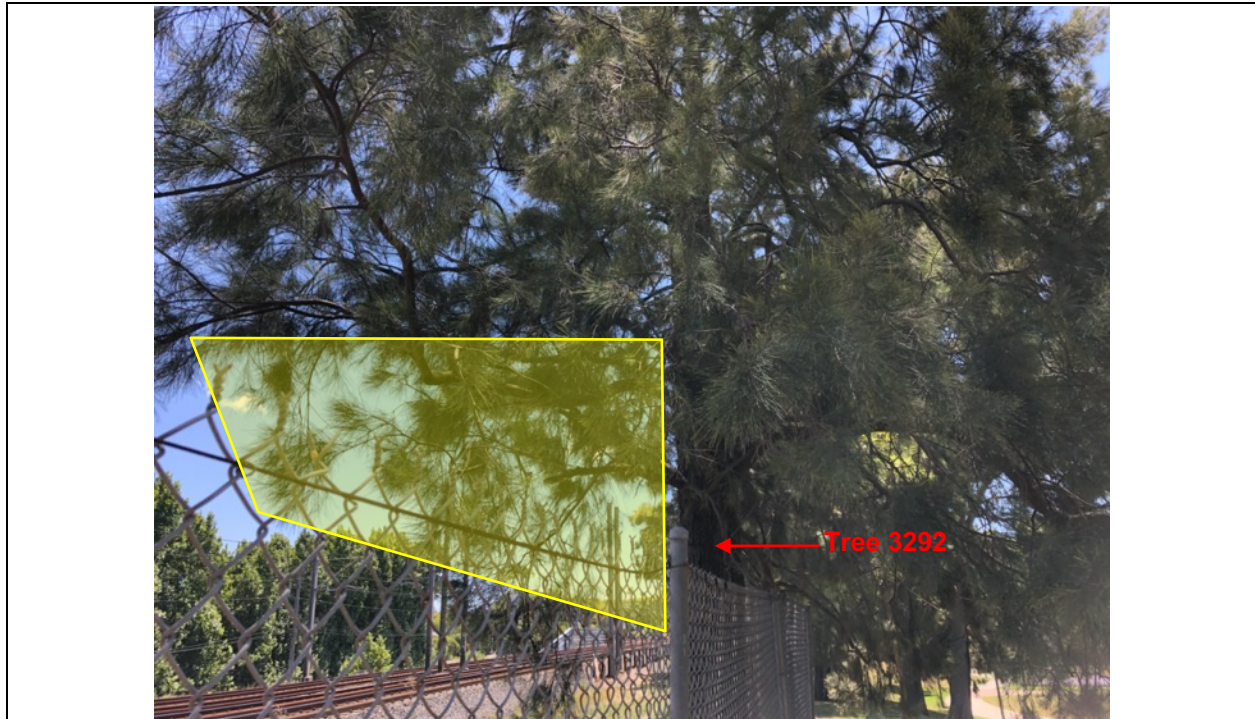
**Image 5:** Looking Southwest towards tree 3292 showing required pruning for vehicle access. The area hatched yellow is to be crown raised to a height of 4.5m above ground level. The pruning will result in the removal of approximately 10% of the overall live foliage area and will not significantly impact the tree.

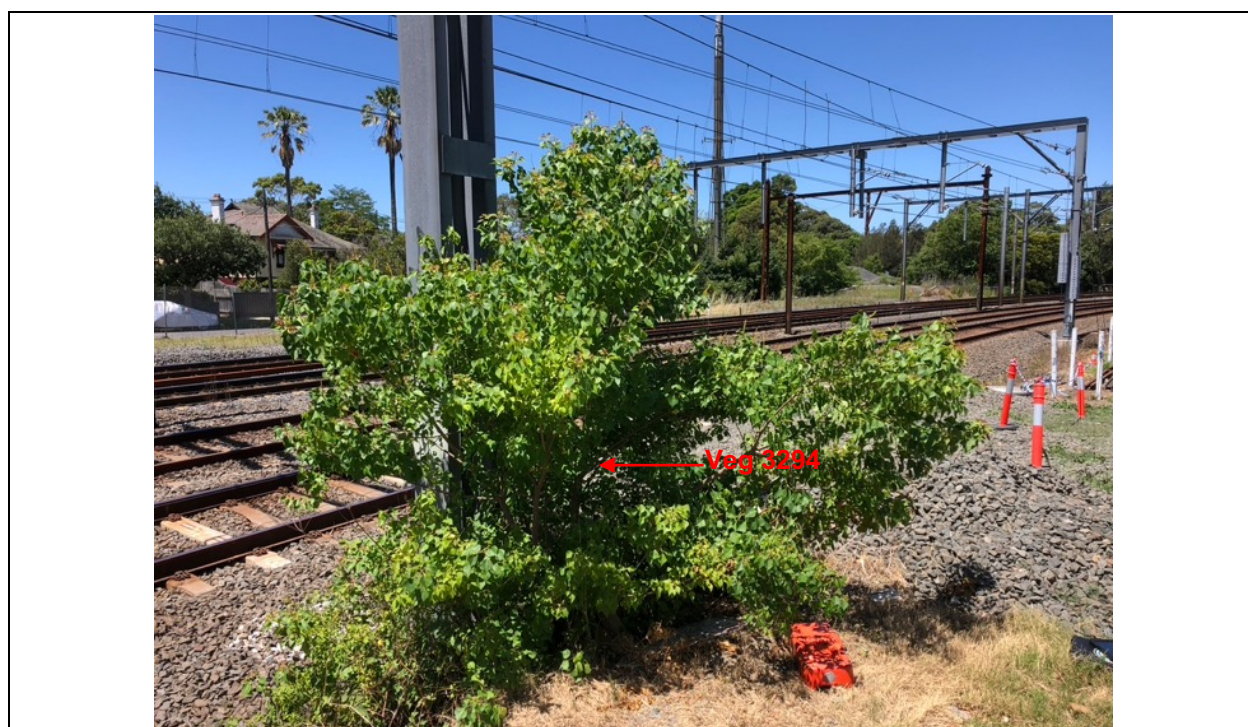
**Image 7:** Looking Northeast to *vegetation* 3294. *Vegetation* 3294 is to be removed to accommodate the proposed services trench.

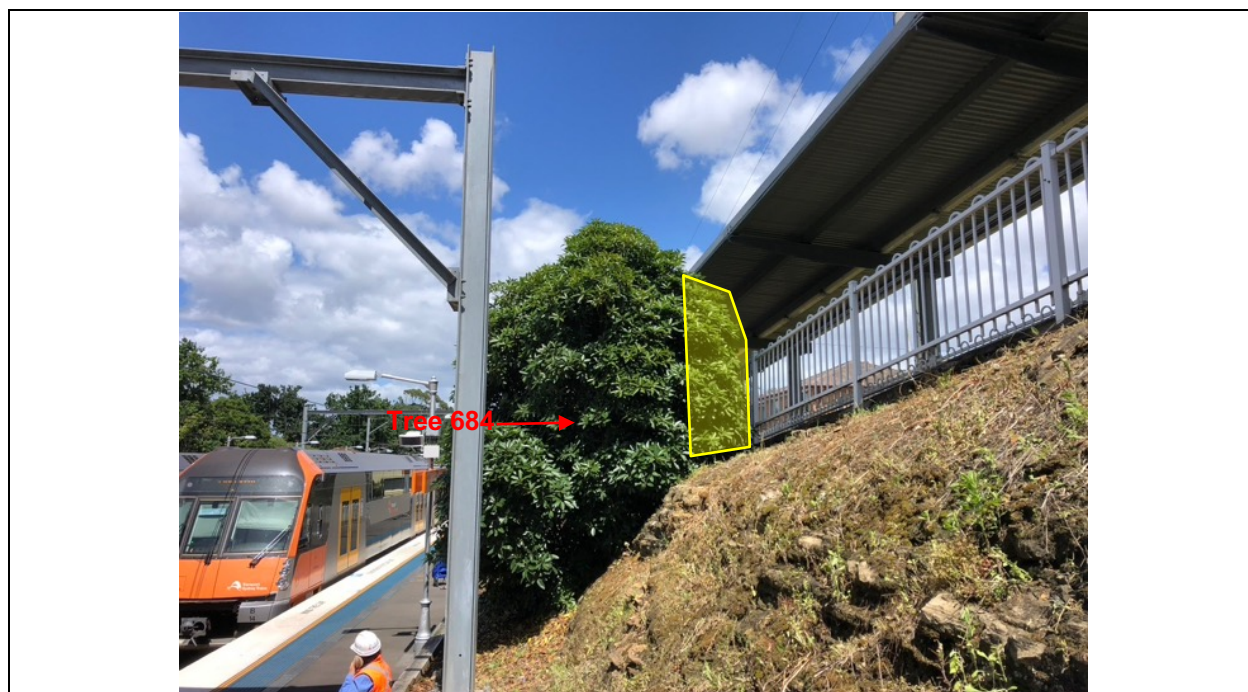
**Image 8:** Looking West towards tree 684 showing required pruning for work crew access. Clearance pruning is required to provide 1m of space from the existing white fence to the North of the tree (hatched yellow). The pruning will result in removing less than 5% of the overall live foliage area. Final pruning cuts should not exceed 50mm in diameter.

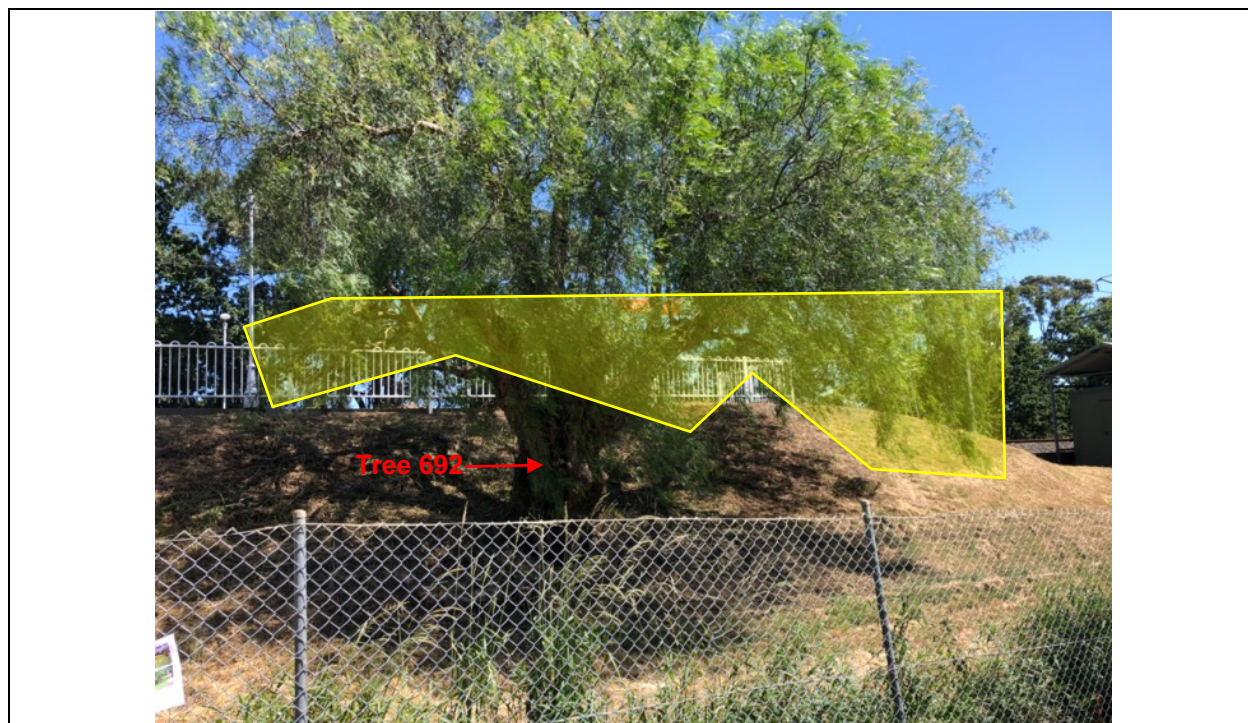
**Image 9:** Looking Southeast towards tree 692, showing required pruning for vehicle access (hatched yellow). Minor tip pruning to the North of the tree is required to allow 4.5m clearance for vehicle access. The pruning will result in removing less than 10% of the overall live foliage area. Final pruning cuts should not exceed 50mm in diameter.

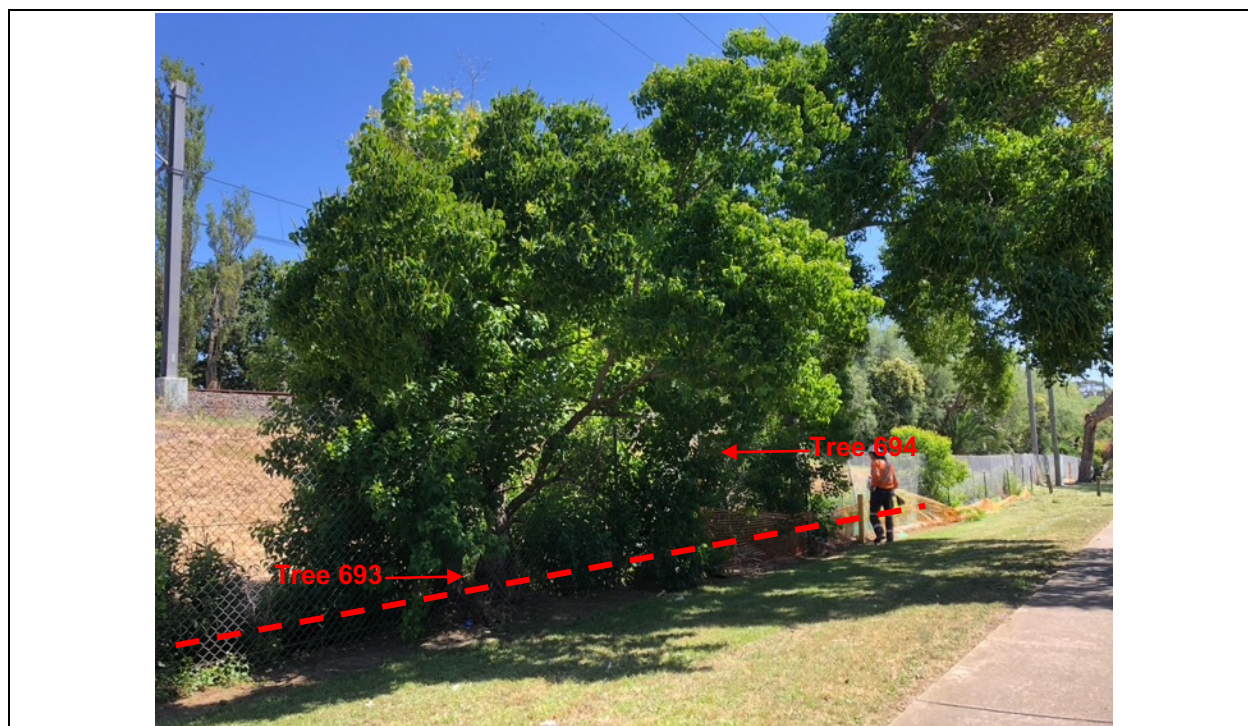
**Image 10:** Looking Southeast towards tree 693 and 694. Both trees are recommended for removal due to the proposed services trench (dashed red).

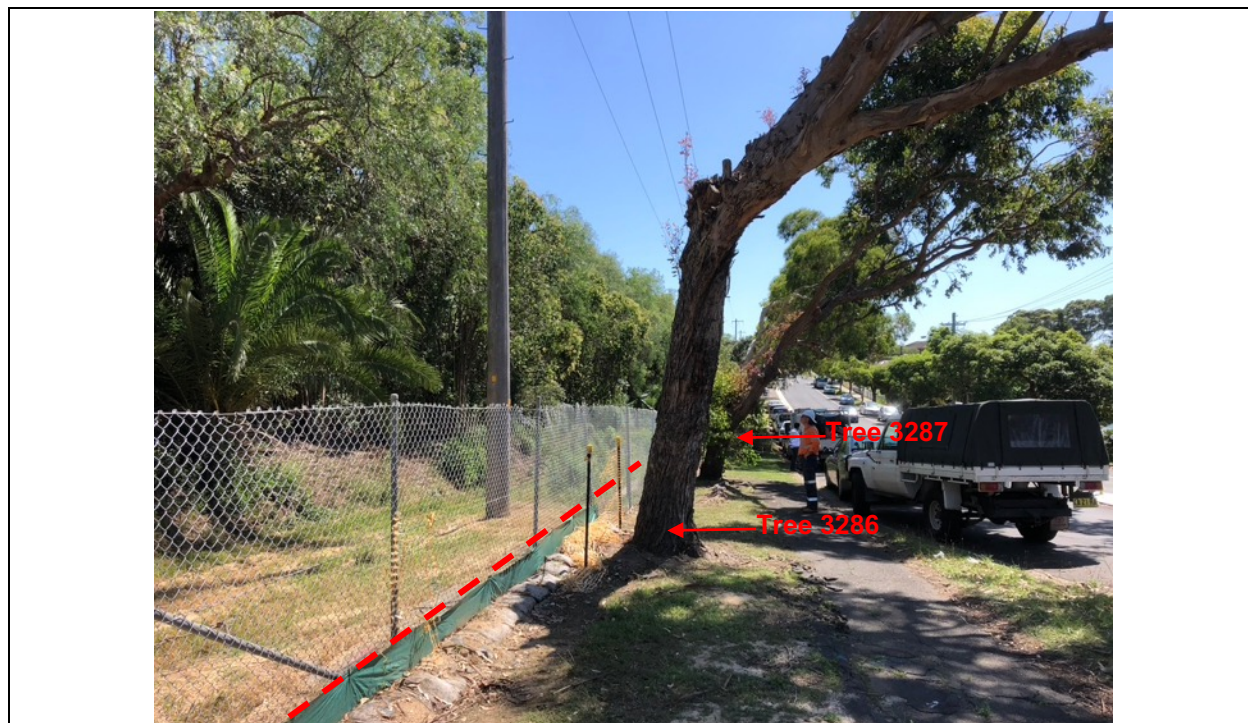
**Image 11:** Looking South towards tree 3286 and 3287. Both trees are recommended for removal due to the proposed services trench (dashed red).

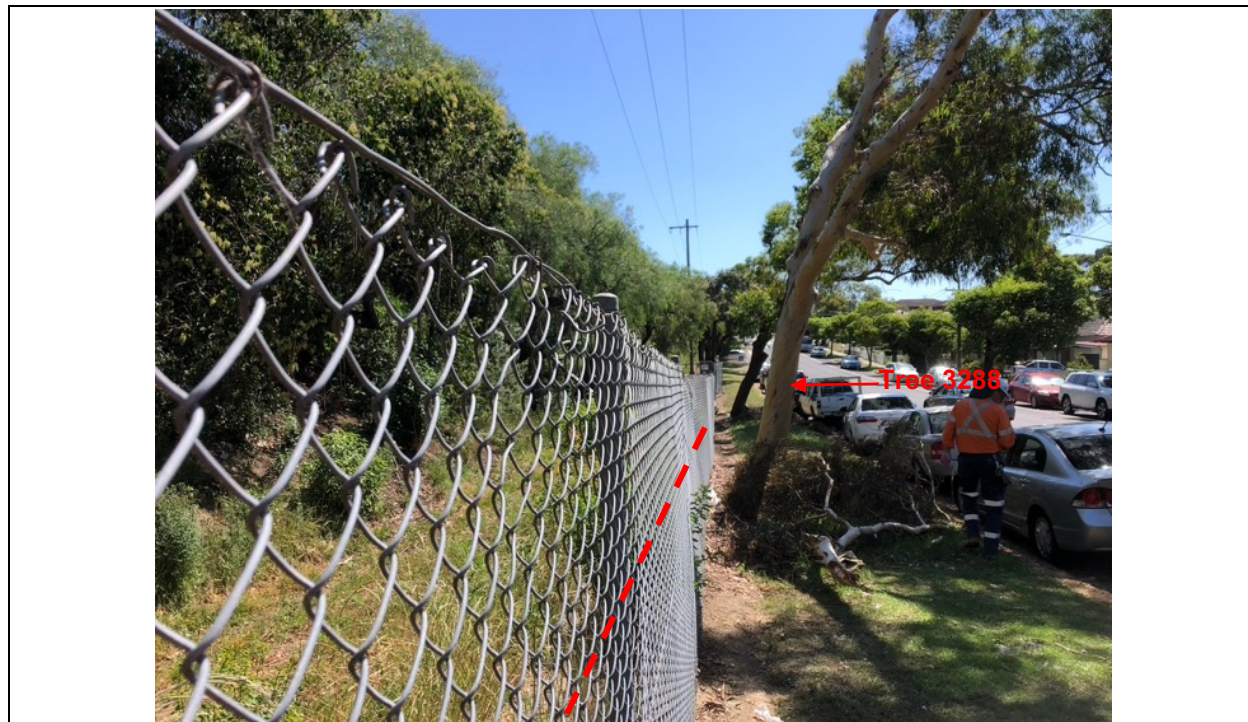
**Image 12:** Looking South towards tree 3288. The tree is recommended for removal due to the proposed services trench (dashed red).

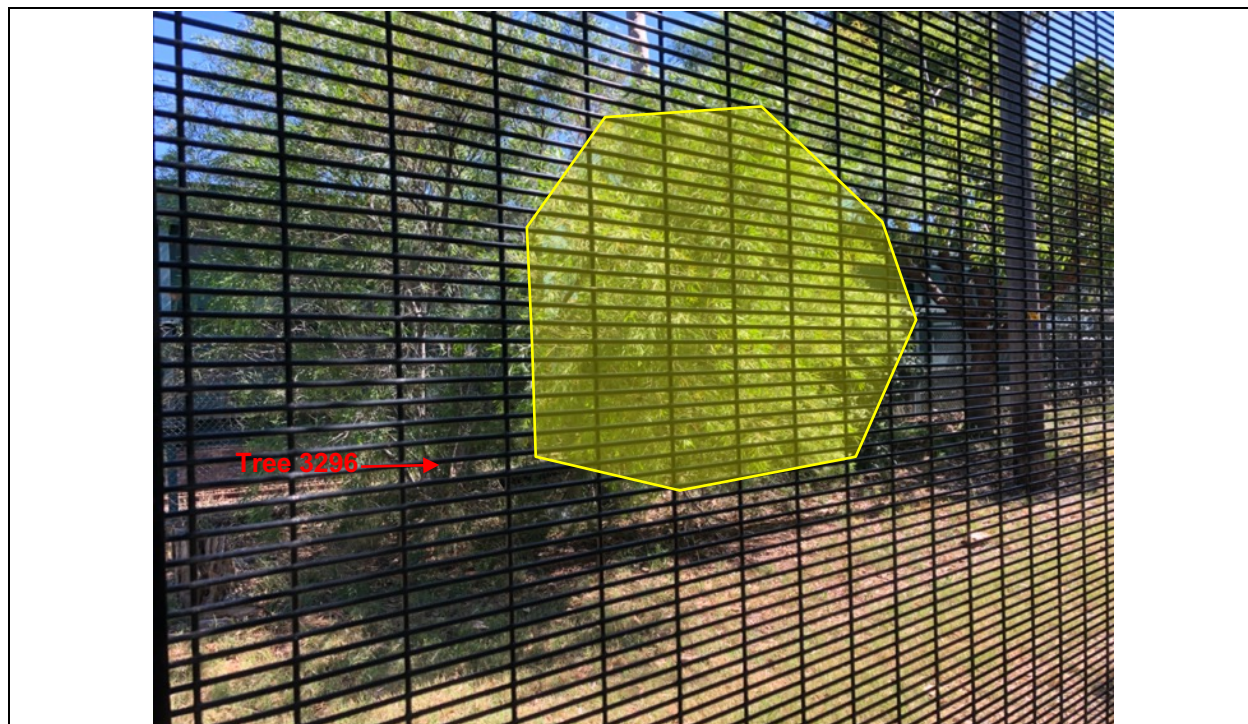
**Image 13:** Looking Southeast towards tree 3296, showing required pruning for vehicle access (hatched yellow). The pruning will result in removing less than 10% of the overall live foliage area. Final pruning cuts should not exceed 50mm in diameter.

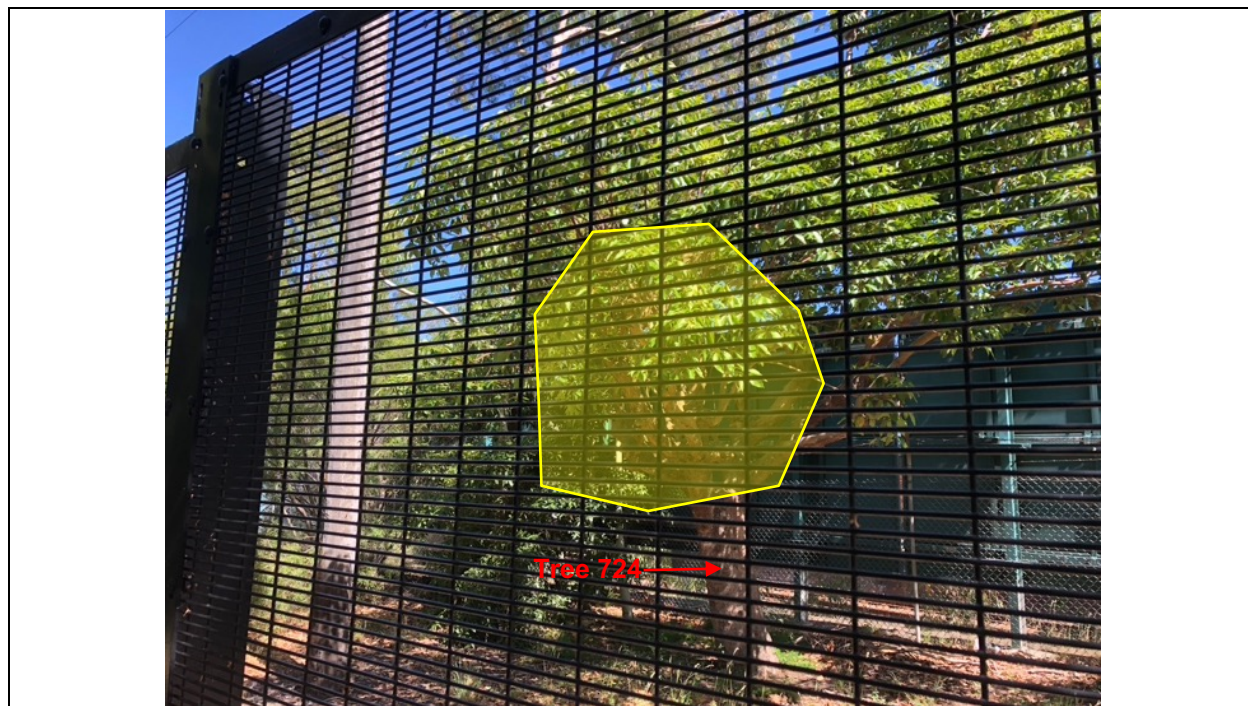
**Image 14:** Looking South towards tree 724, showing required pruning for vehicle access (hatched yellow). The pruning will result in removing less than 5% of the overall live foliage area. Final pruning cuts should not exceed 50mm in diameter.

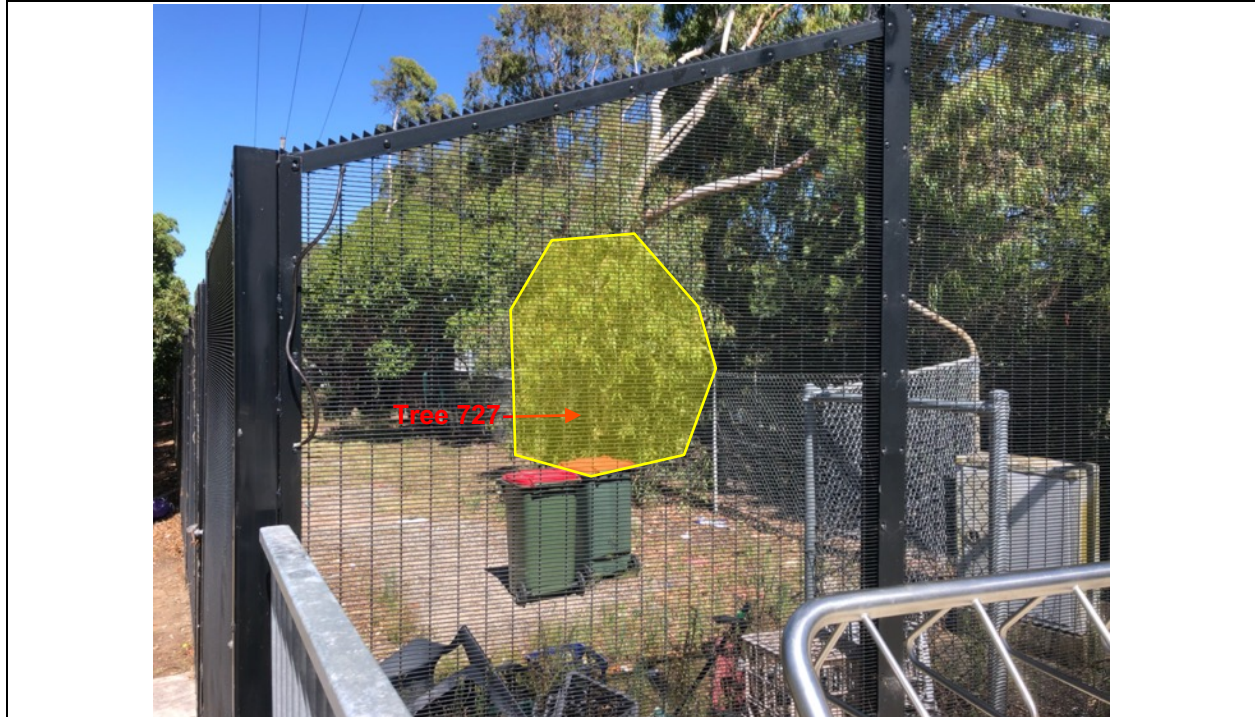
**Image 15:** Looking Southeast towards tree 727, showing required pruning for vehicle access (hatched yellow). The pruning will result in removing less than 5% of the overall live foliage area. Final pruning cuts should not exceed 50mm in diameter.

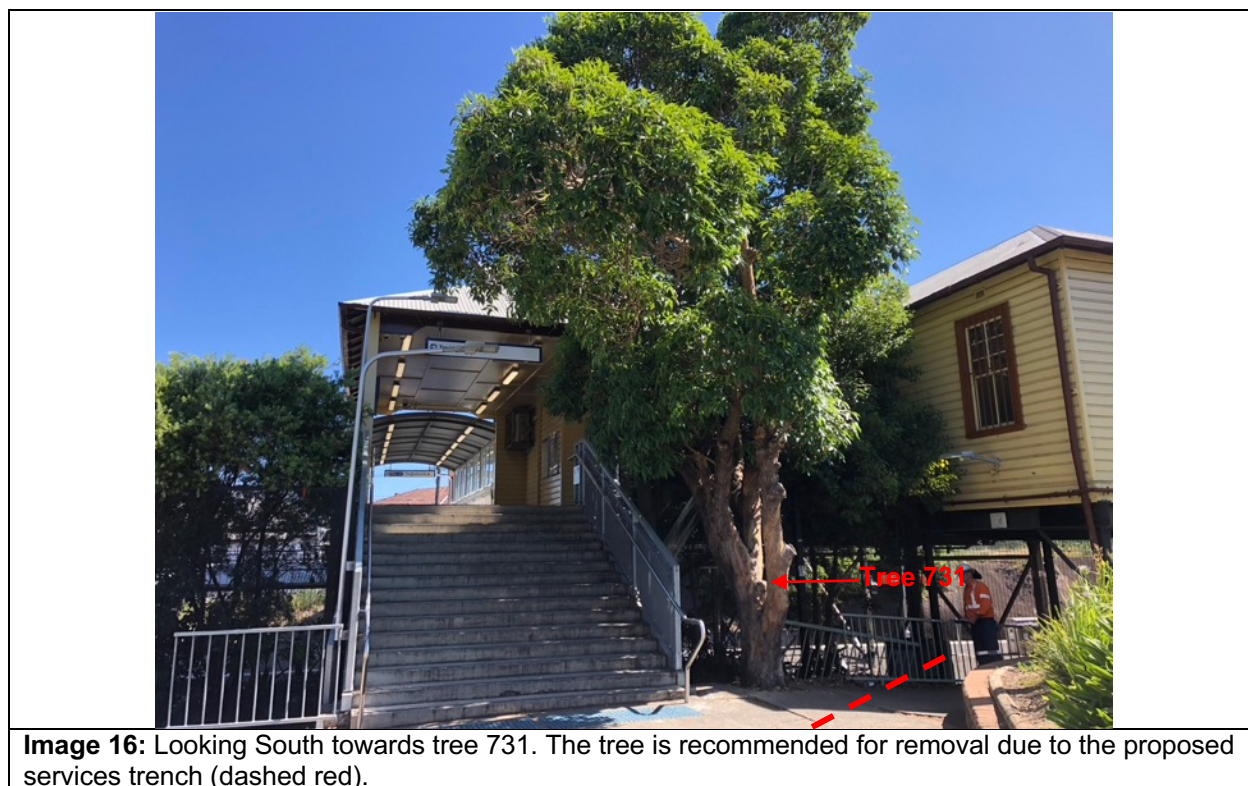
**Image 16:** Looking South towards tree 731. The tree is recommended for removal due to the proposed services trench (dashed red).

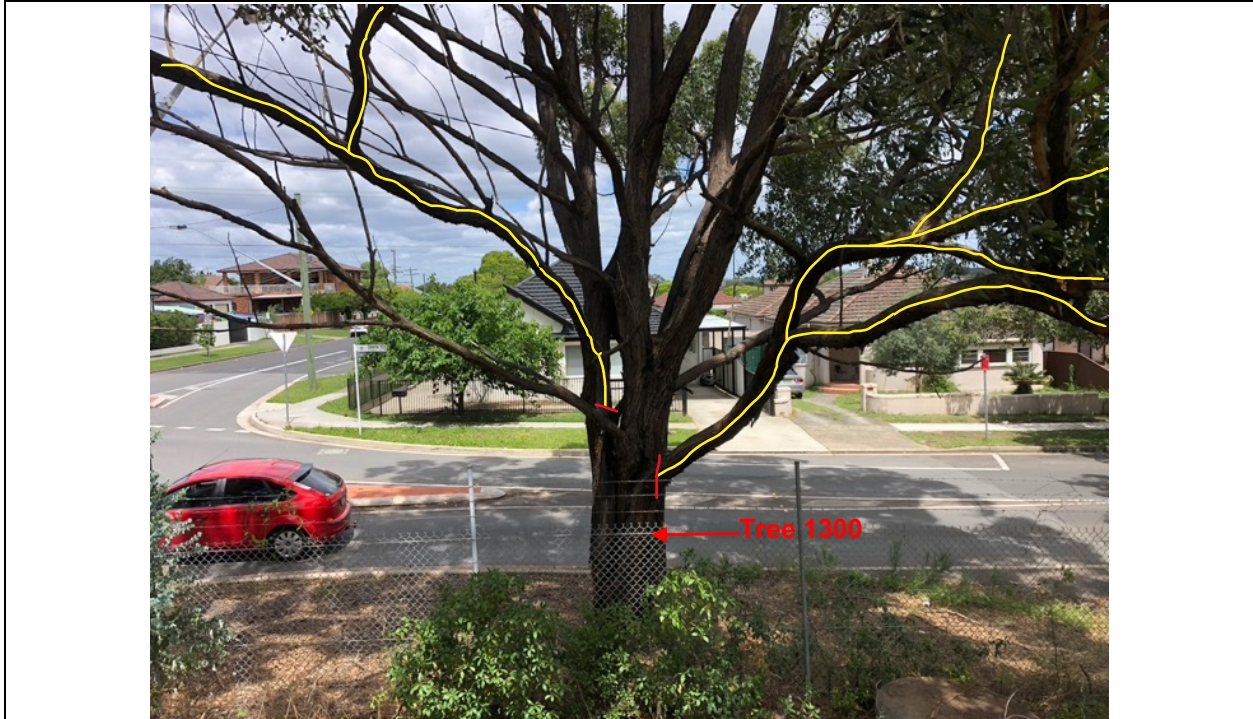
**Image 18:** Looking Southwest to tree 1300 showing required pruning for construction access. The 150mm diameter primary branch to the North at 2.5m above existing ground is to be removed. The 250mm diameter primary branch to the North at 2m above existing ground is to be removed. Branches marked yellow, pruning cuts marked red.

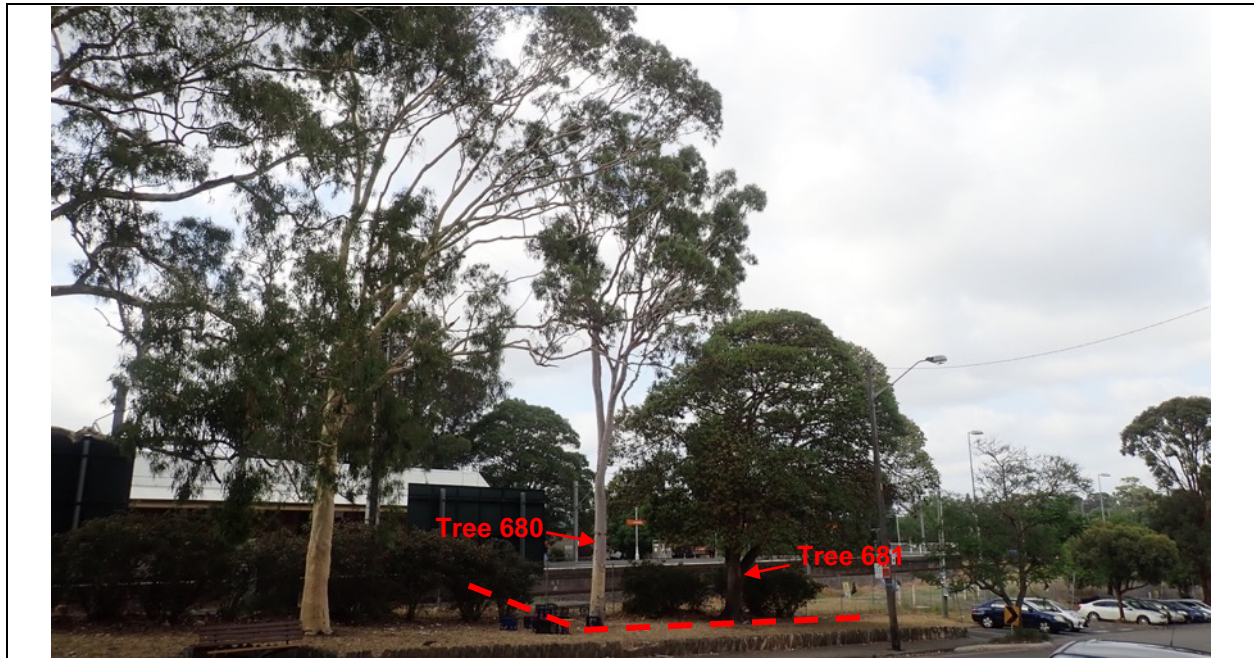
**Image 20:** Looking South towards tree 680 and 681. The trees are recommended for removal due to construction impacts from the proposed services trench (dashed red).

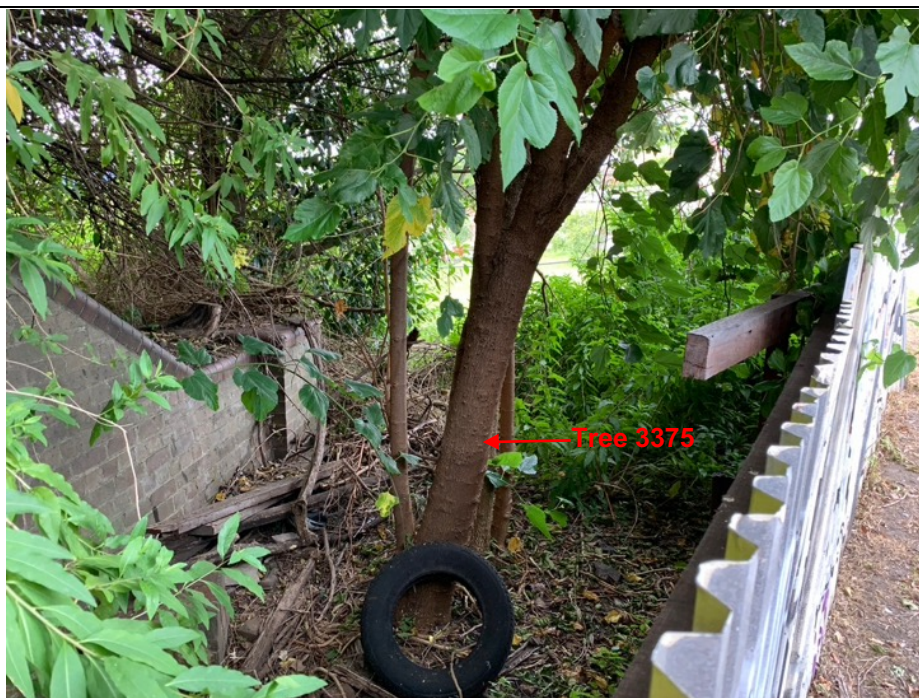
**Image 21:** Looking towards tree 3375. The tree is recommended for removal due to construction impacts.

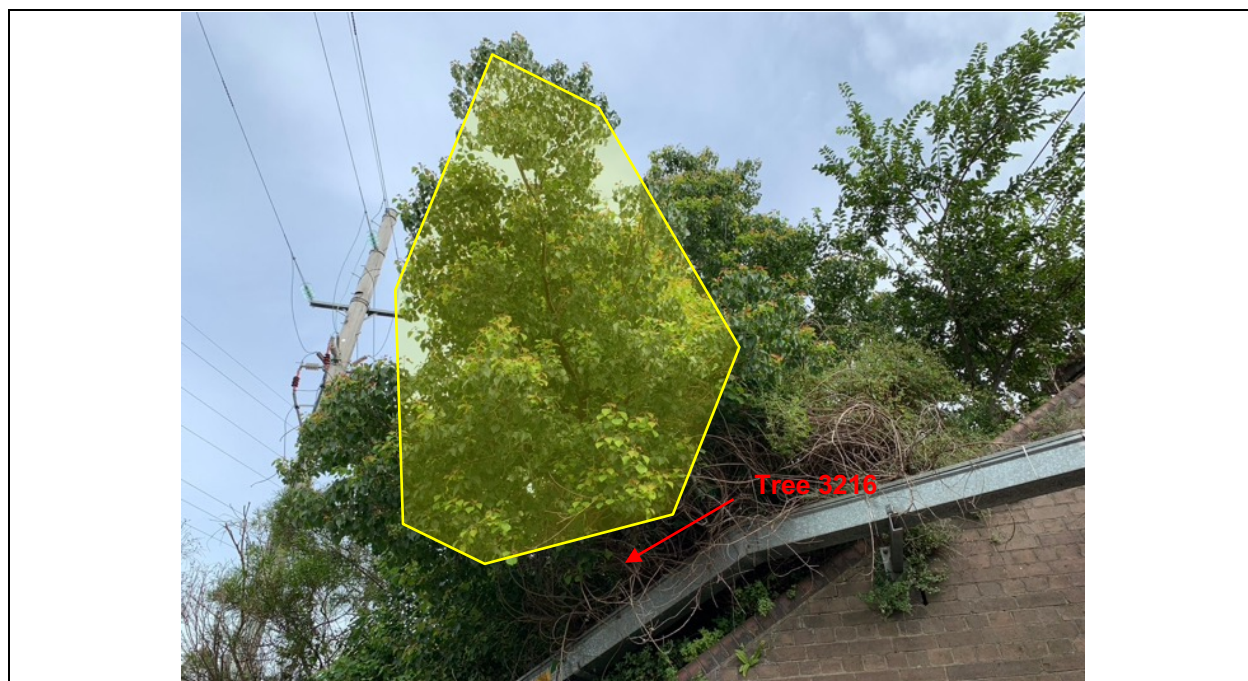
**Image 23:** Looking West towards tree 3216 showing required pruning for piling works (hatched yellow). The crown is to be reduced by 1m, in line with the brick wall. The pruning will result in removing 10% of the overall live foliage area of the tree. Final pruning cuts should not exceed 80mm in diameter.

9.21 **Zone 14B – Bridge Victoria Road:** The tree within this area is located adjacent to the proposed piling works. Canopy pruning will be required to allow for the piling works – see Image 23. The following tree has been identified in this area;

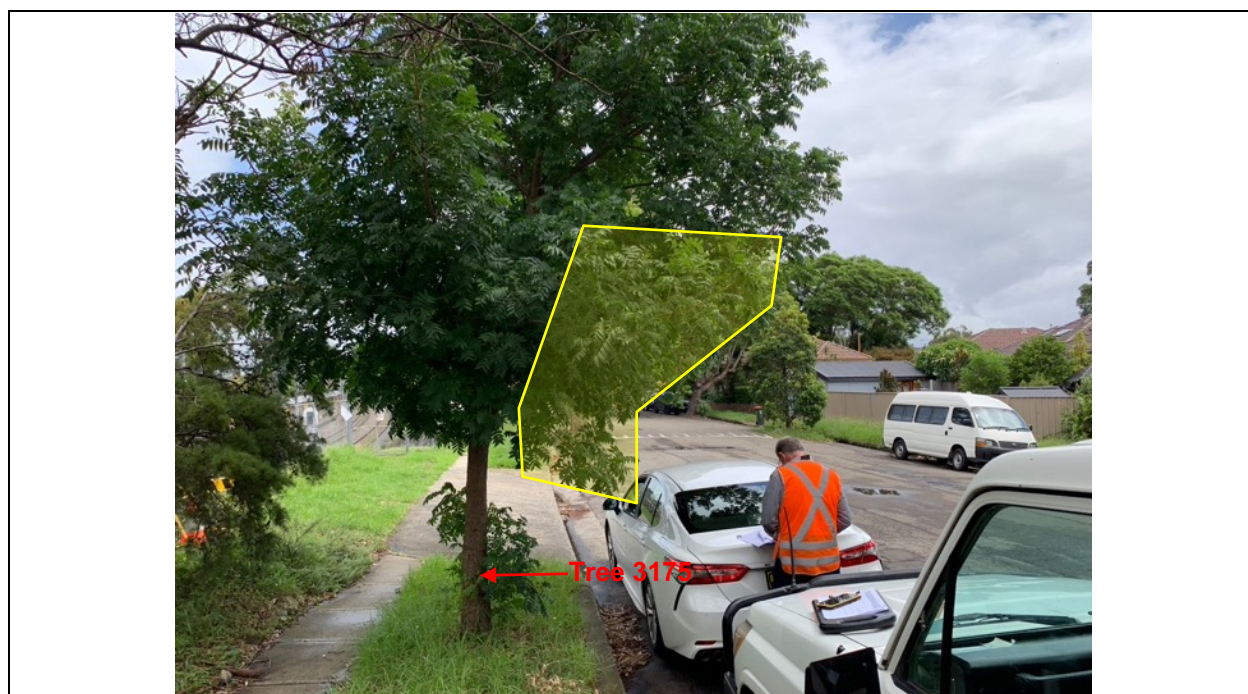
**Image 26:** Looking West towards tree 3175 showing required pruning for works area (hatched yellow). The North side of the canopy is to be raised by 3m. The pruning will result in removing less than 5% of the overall live foliage area. Final pruning cuts should not exceed 50mm in diameter.

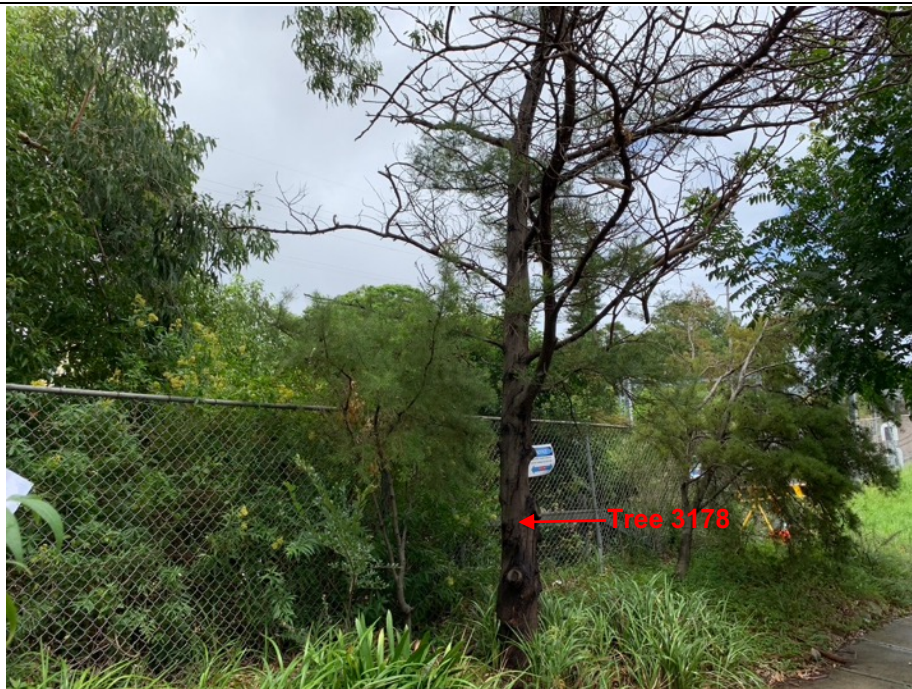
**Image 27:** Looking Southwest towards tree 3178. The tree is recommended for removal due to construction impacts.

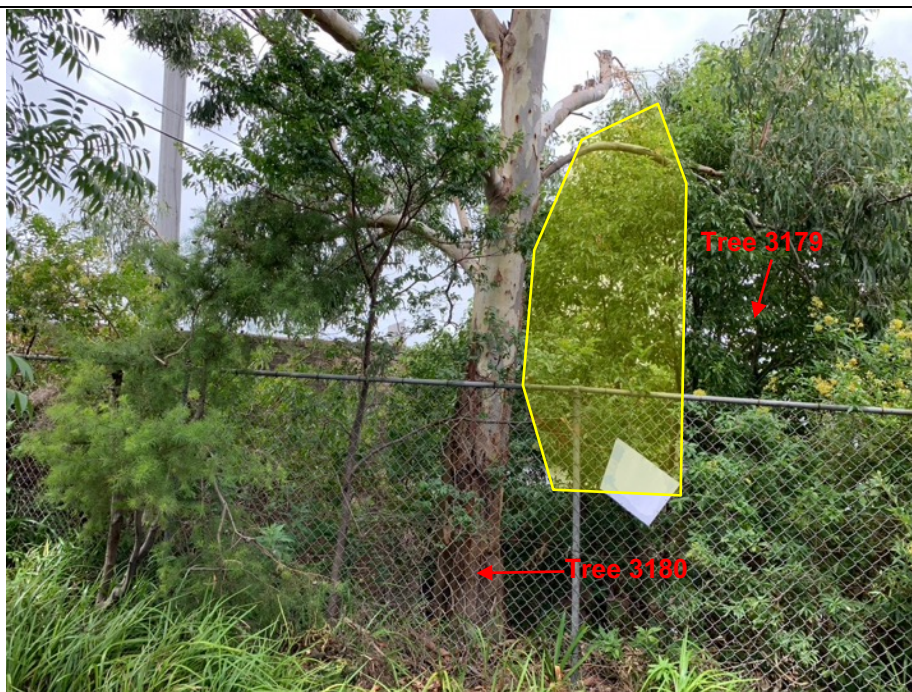
**Image 28:** Looking South towards tree 3179 and 3180. Showing required pruning for works area for tree 3179 (hatched yellow). The Northeast side of the crown is to be reduced by 1m. The pruning will result in removing less than 5% of the overall live foliage area. Final pruning cuts should not exceed 50mm in diameter. Tree 3180 is recommended for removal due to construction impacts.

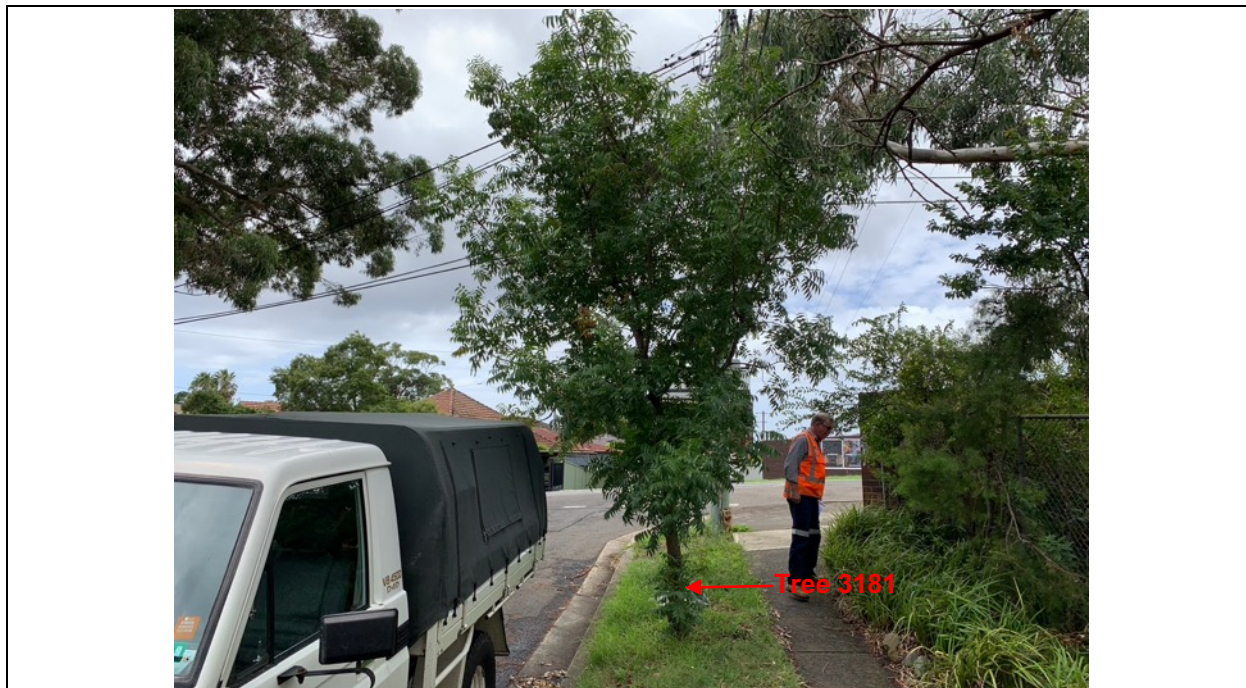
**Image 29:** Looking Southwest towards tree 3181. The tree is recommended for removal due to construction impacts.
