# Tree Impact Assessment Report – Southwest Metro Early Works

SMCSWSSJ-JHL-WEC-EM-REP-000001

This report has been produced to assess impacts to vegetation and detail the species and number of trees that will be removed as part of the Southwest Metro Early Works (SMEW).

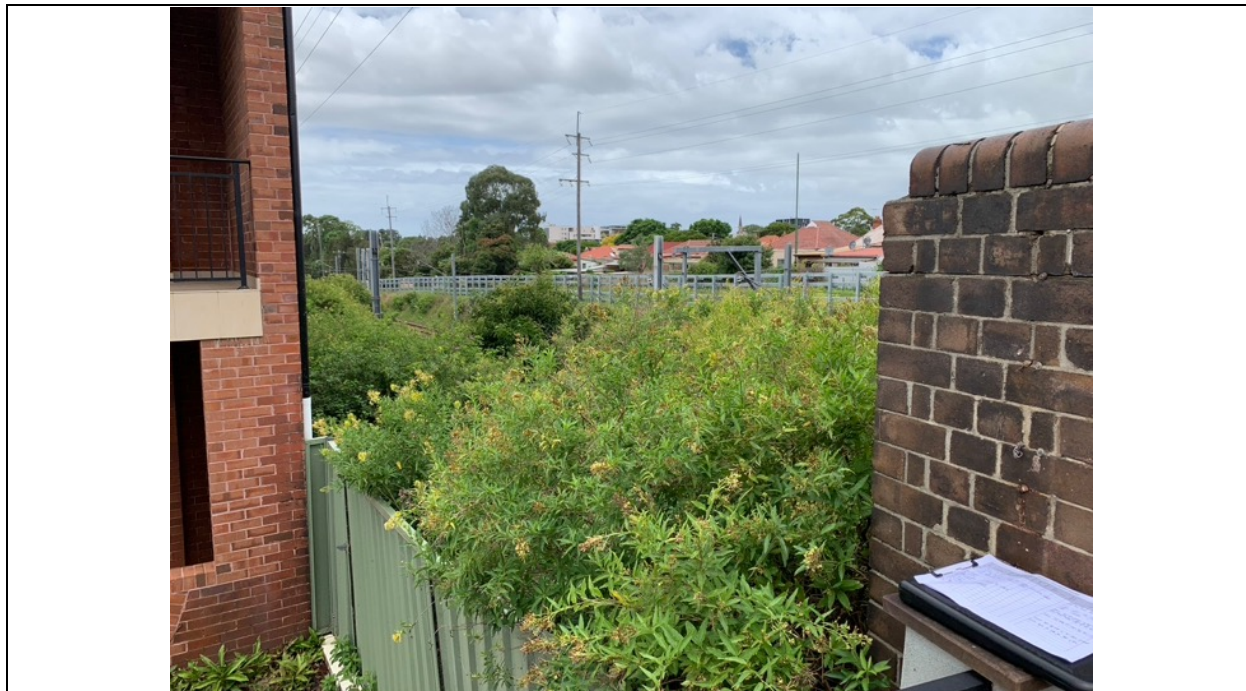
**Image 30:** Looking East towards small weed species on the upper embankment required to be removed to accommodate the development.

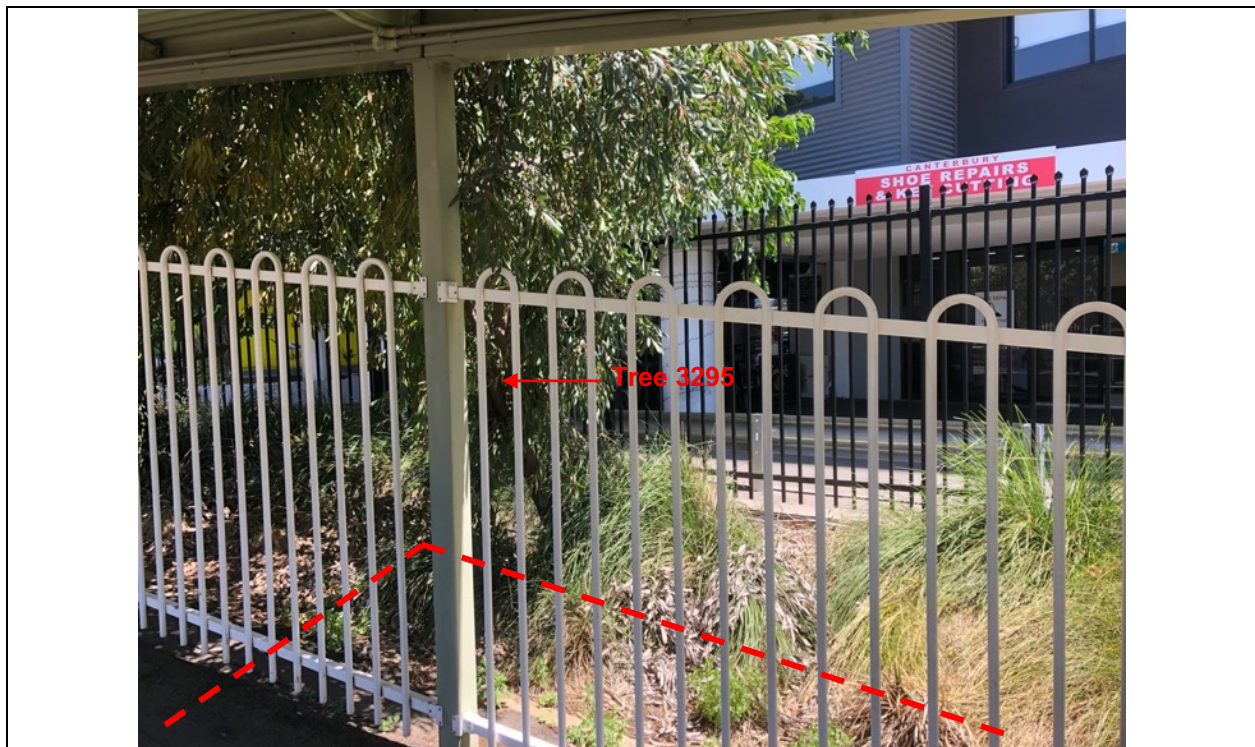
**Image 31:** Looking South towards tree 3295. The tree is recommended for removal due to construction impacts from the proposed GLT trench (dashed red).

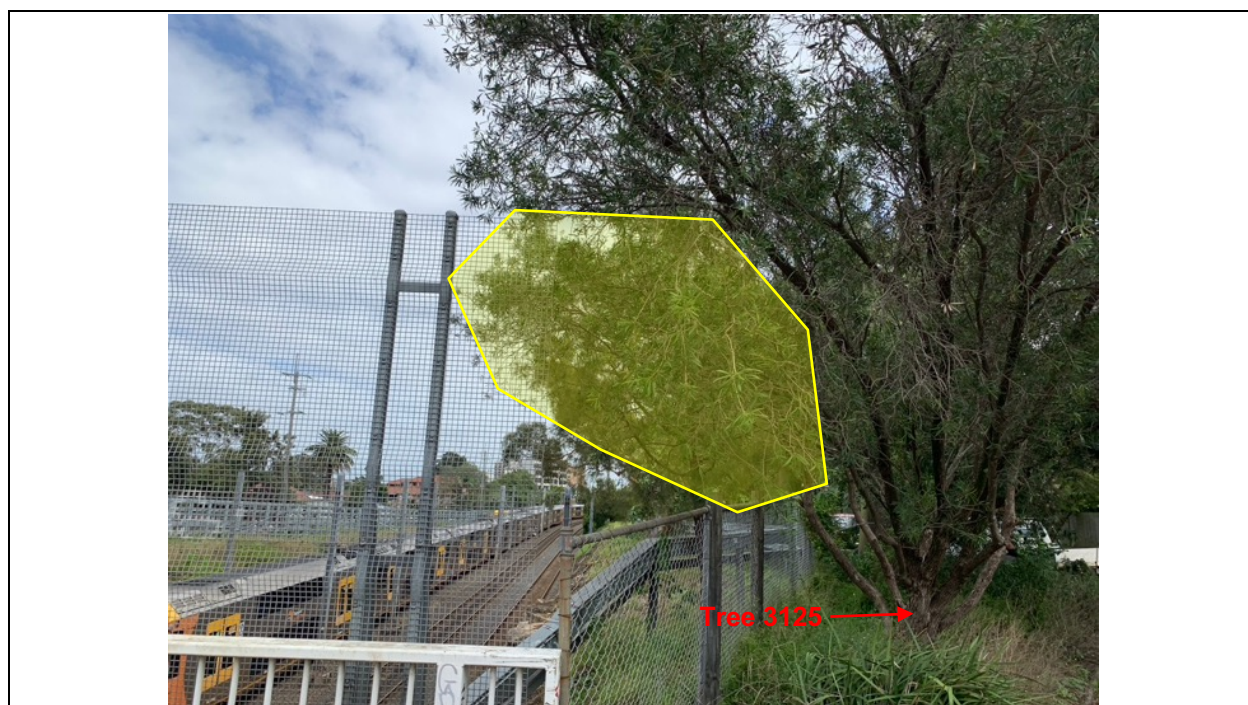
**Image 32:** Looking West towards tree 3125 showing required pruning for works area (hatched yellow). The South side of the canopy is to be reduced back to the fence line. The pruning will result in removing less than 10% of the overall live foliage area. Final pruning cuts should not exceed 80mm in diameter.

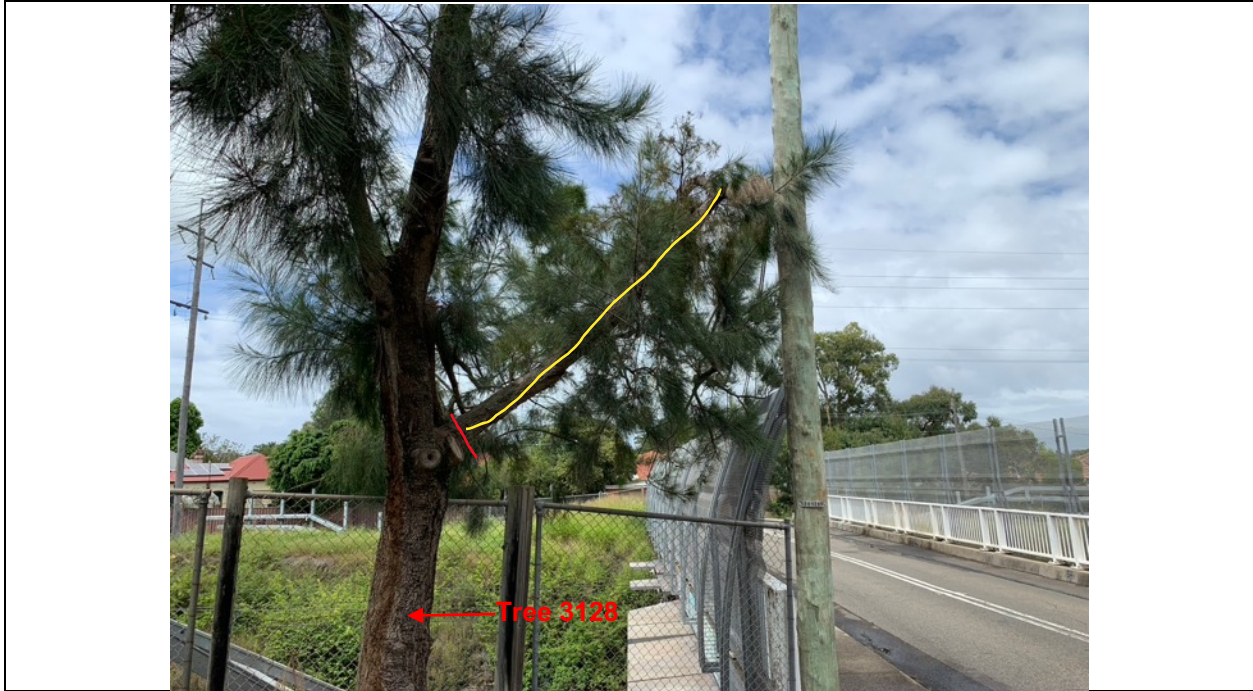
**Image 33:** Looking towards tree 3128 showing required pruning for works area. The first order branch to the Southwest at 2m is to be removed. The yellow line indicates the branch to be removed. The red line indicates the final pruning cut location. The pruning will result in removing approximately 20% of the overall live foliage area.

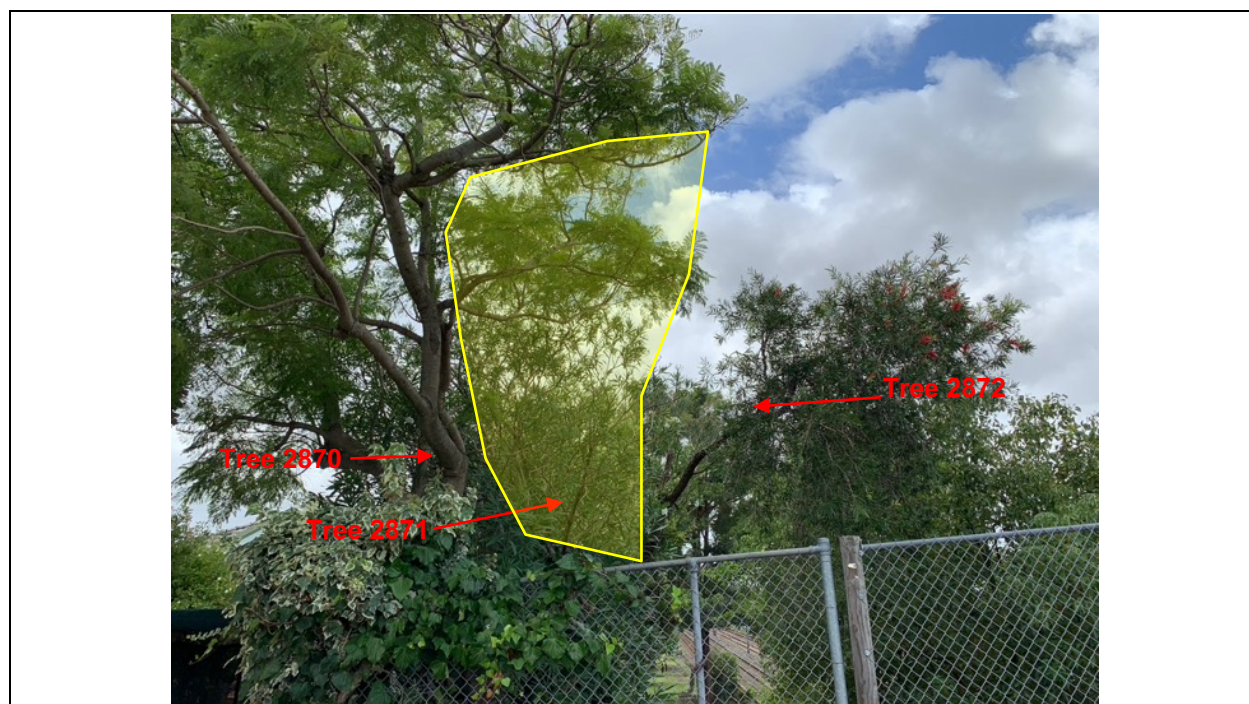
**Image 36:** Looking East towards tree 2870, 2871 and 2872. Showing the required pruning for tree 2870 and 2871 (hatched yellow). The South side of the crown of tree 2870 and 2871 is to be reduce by 1m. The pruning will result in removing approximately 10% of the overall live foliage area of each tree. Tree 2872 is recommended for removal due to construction impacts.

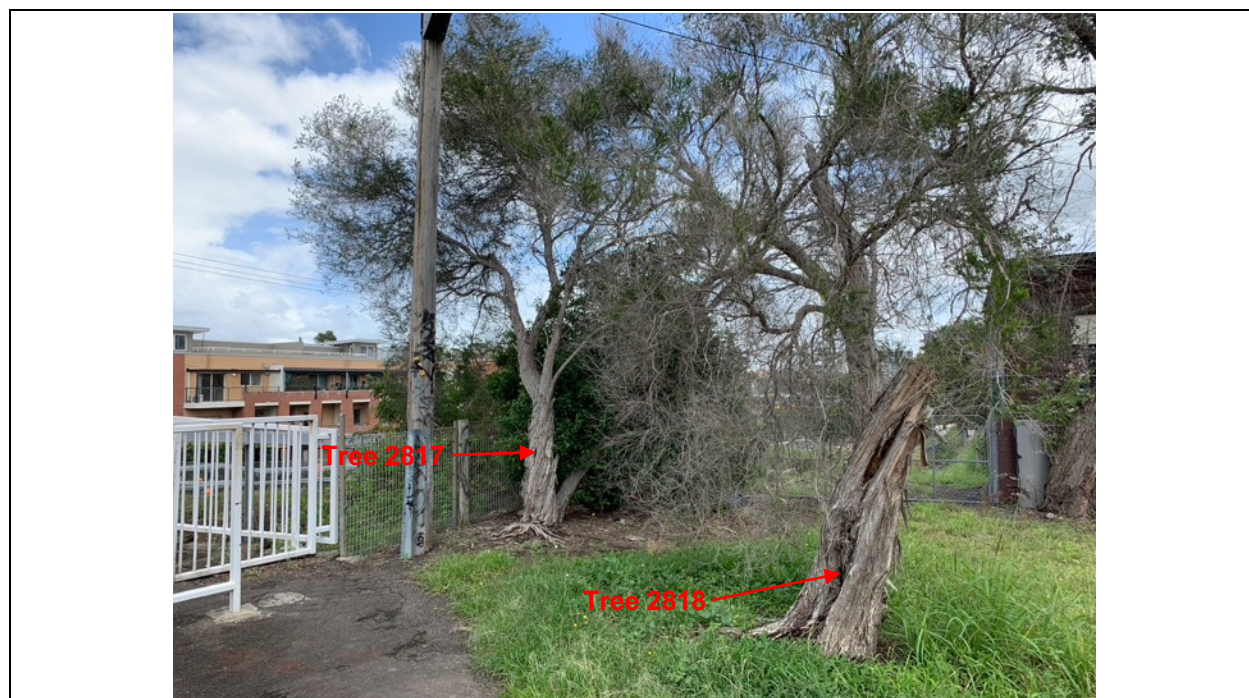
**Image 38:** Looking towards tree 2817 and 2818. Tree 2817 and 2818 are recommended for removal due to construction impacts.

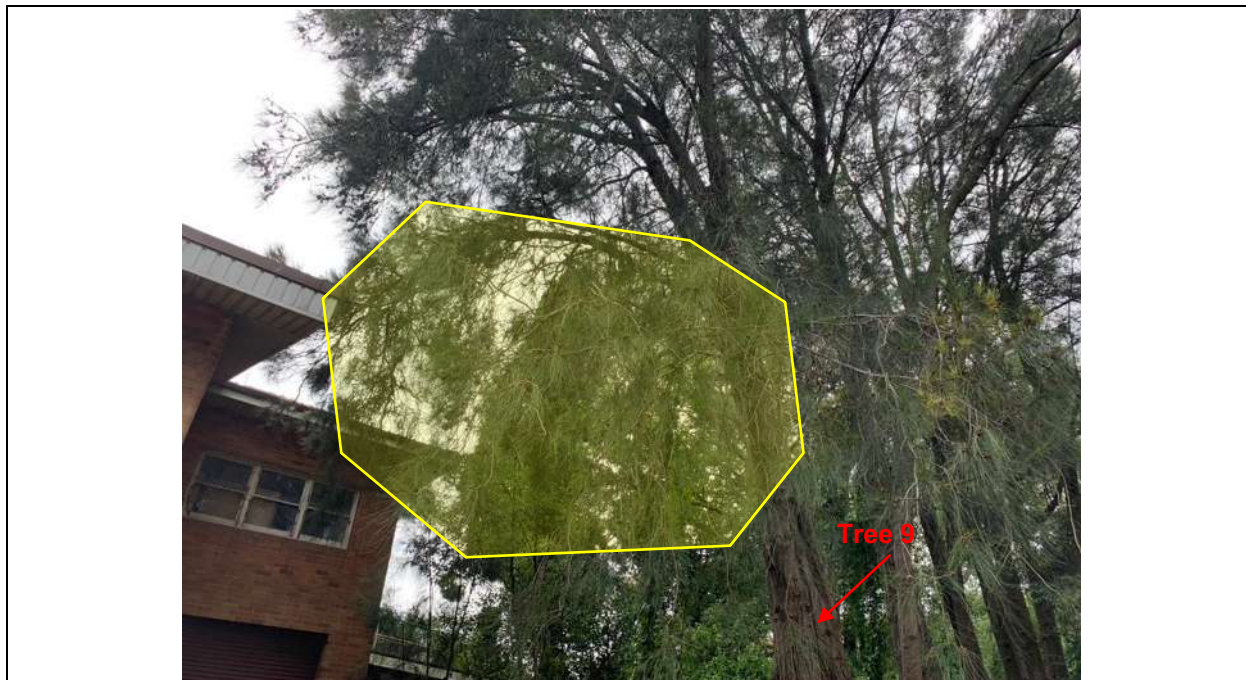
**Image 40:** Looking towards tree 9 showing the required canopy pruning (hatched yellow). The West side of the canopy of the Western most tree is to be crown raised to 10m. The pruning will result in the removal of less than 10% of the live foliage area of each tree. The finished cut diameter must not exceed 150mm.

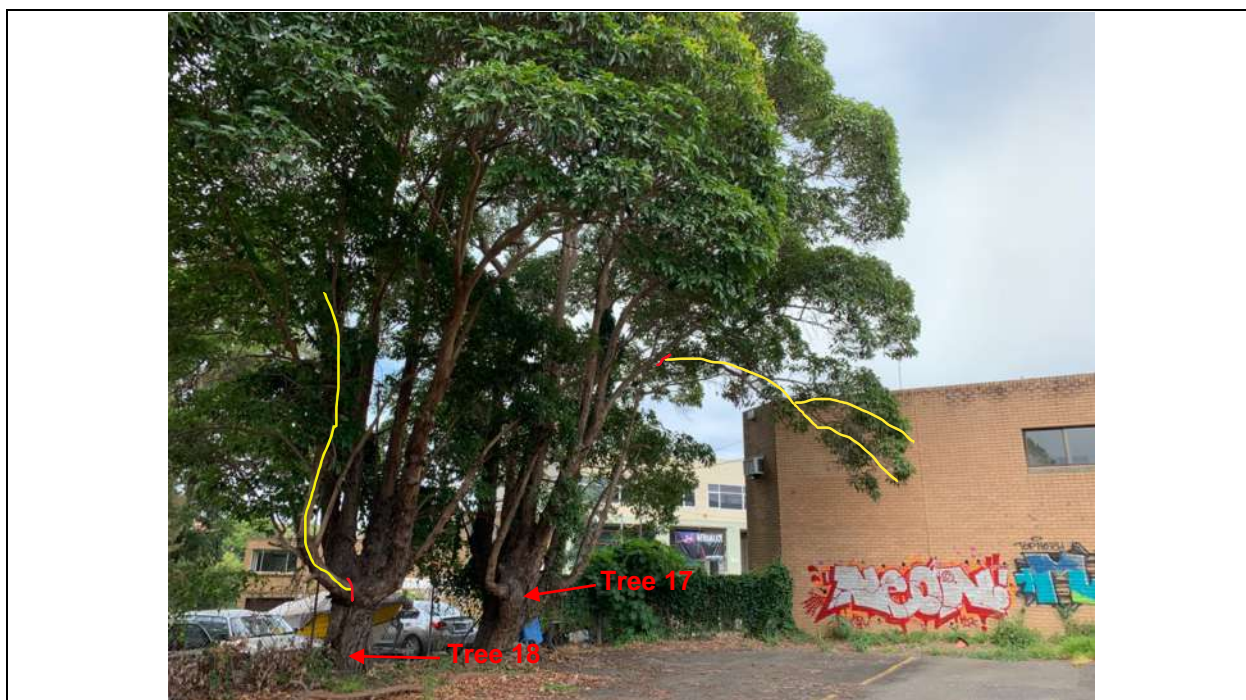
**Image 41:** Looking towards tree 17 and 18, showing the required pruning. The yellow lines indicate the branches to be removed. The red lines indicate the final pruning cut locations. The pruning will result in the removal of less than 10% of the live foliage area of each tree.

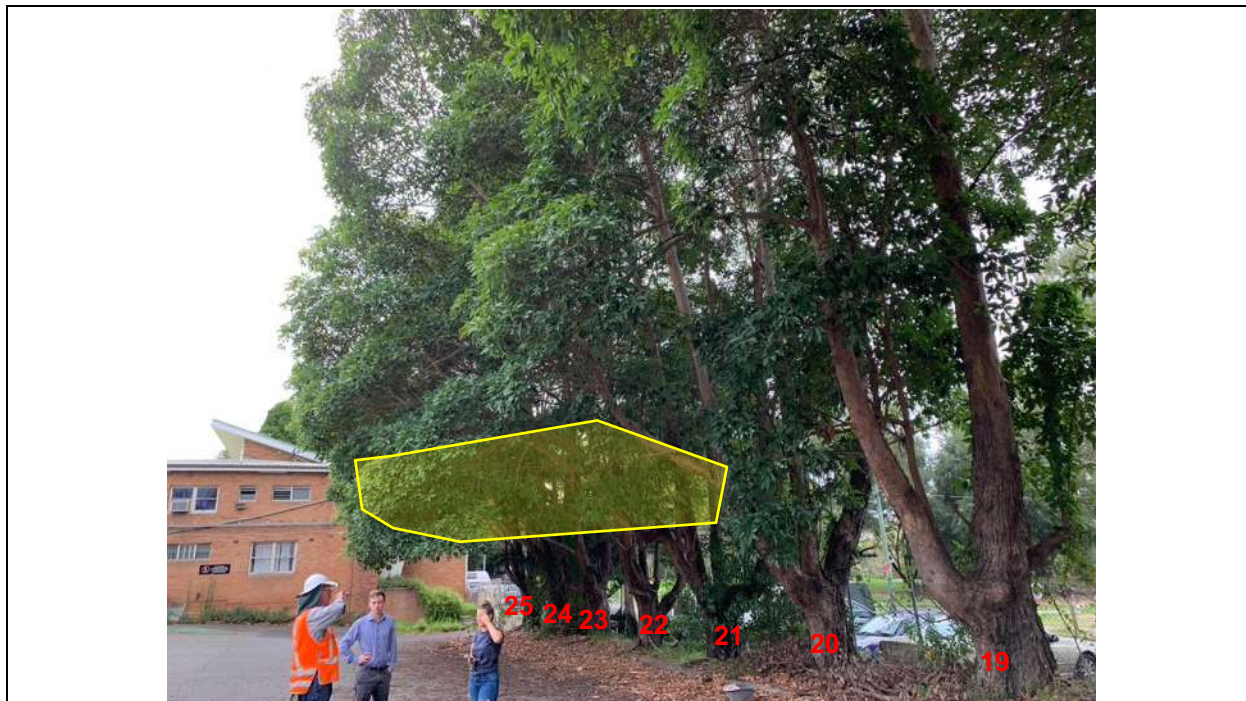
**Image 42:** Looking towards tree 19-25. Tree 19 and 20 are to be removed. Showing the required canopy pruning for tree 21, 22, 23, 24 and 25(hatched yellow). The North side of the canopy of each tree is to be crown raised to 8m. The pruning will result in the removal of less than 10% of the live foliage area of each tree. The finished cut diameter must not exceed 150mm.

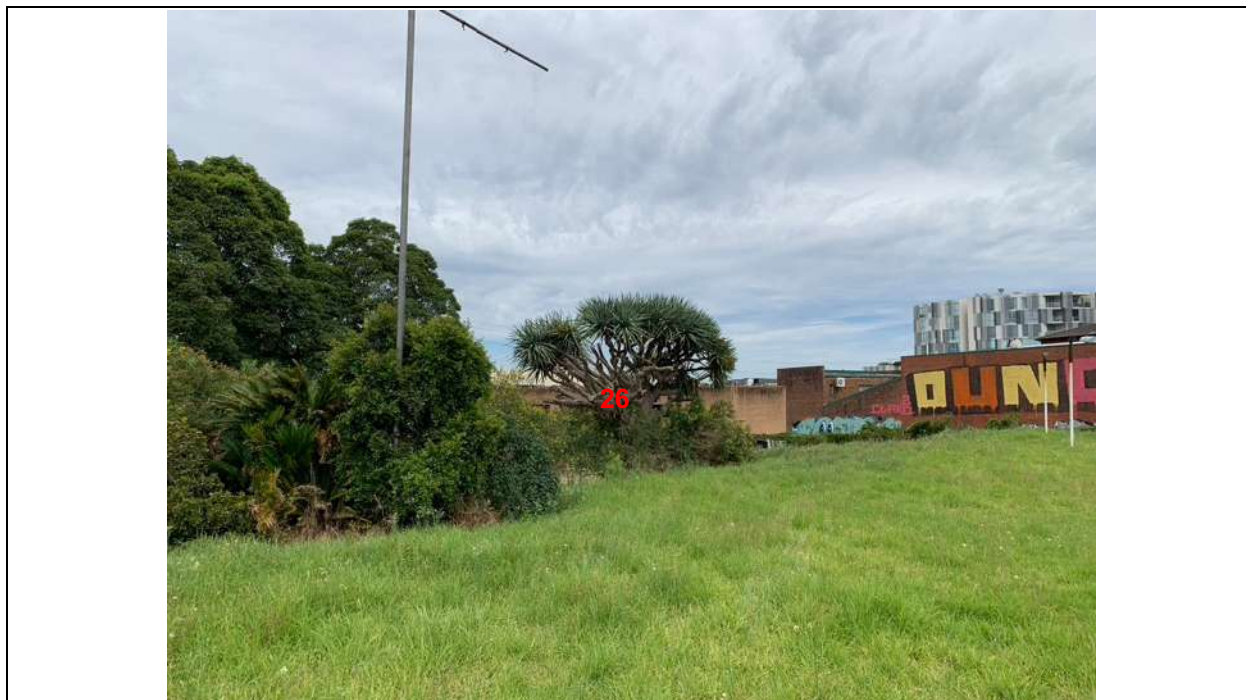
**Image 43:** Looking towards tree 26. No development impacts – to be retained and protected.

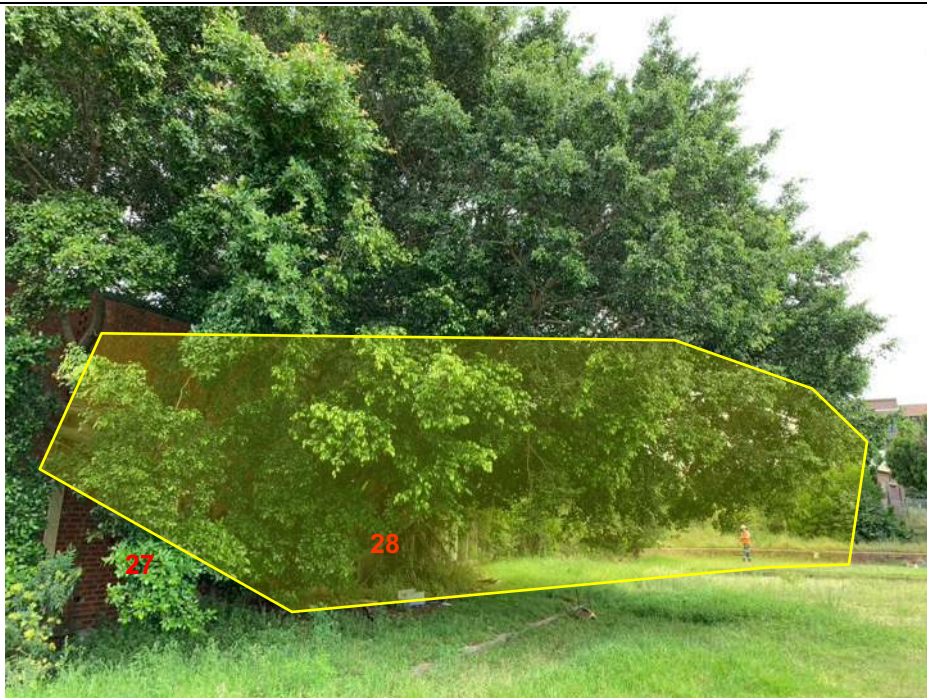
**Image 44:** Looking towards tree 27 and 28. Showing the required canopy pruning (hatched yellow). The East side of the canopy of each tree is to be crown raised to 5m. The pruning will result in the removal of less than 10% of the live foliage area of each tree. The finished cut diameter must not exceed 200mm.

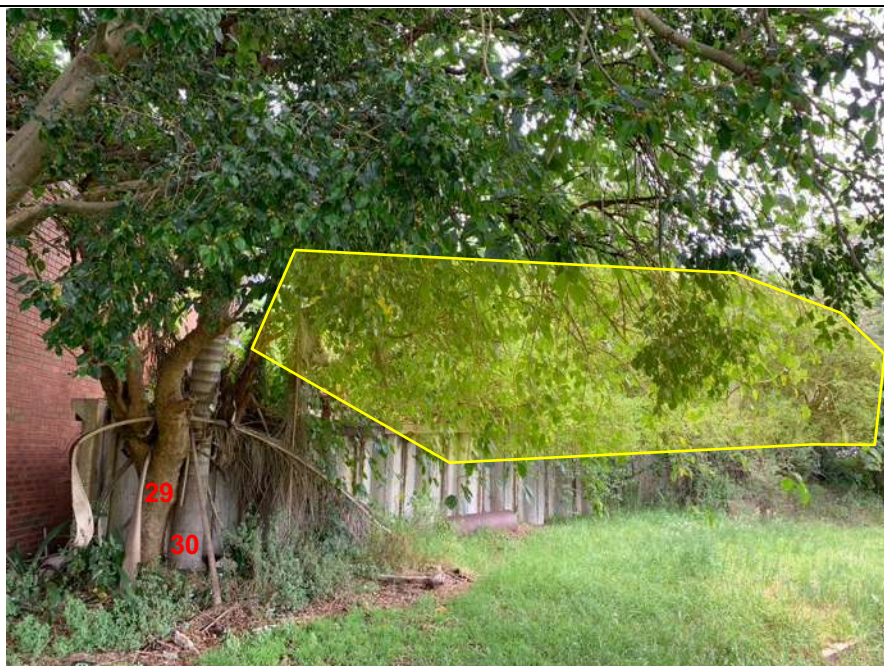
**Image 45:** Looking towards tree 29 and 30. Showing the required canopy pruning for tree 29 (hatched yellow). The East side of the canopy of the tree is to be crown raised to 5m. The pruning will result in the removal of less than 10% of the live foliage area of each tree. The finished cut diameter must not exceed 500mm. No canopy pruning is required for tree 30.

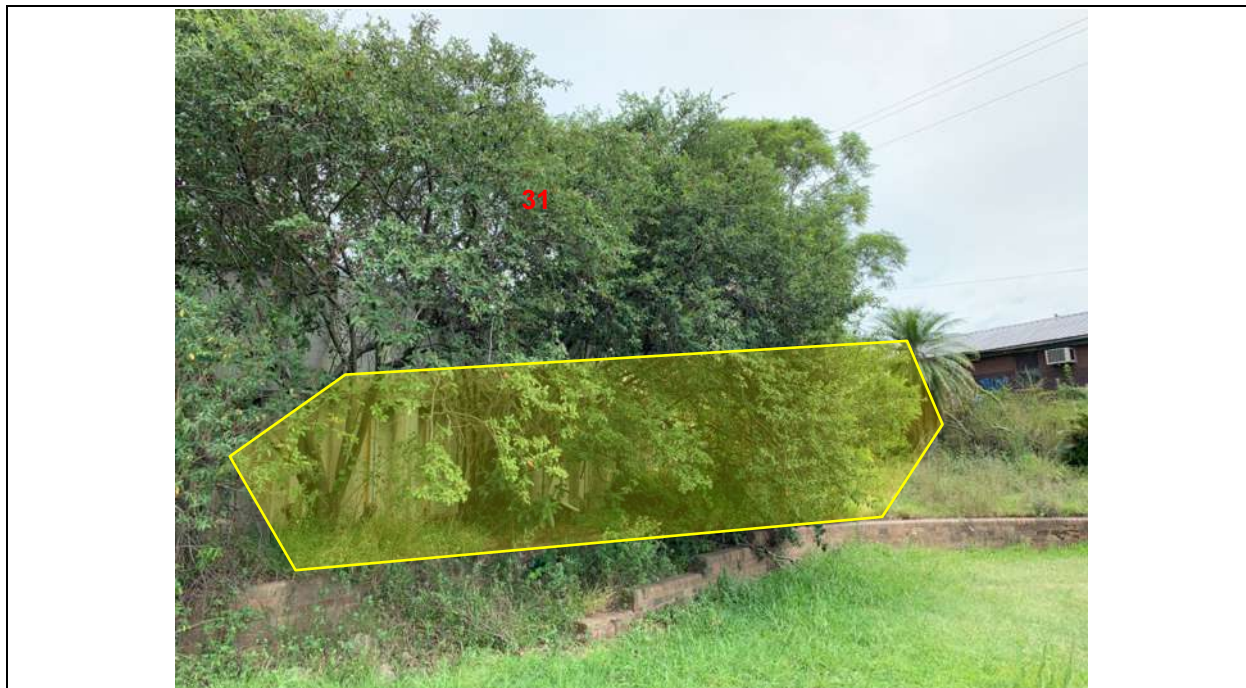
**Image 46:** Looking towards tree 31. Showing the required canopy pruning for the trees (hatched yellow). The East side of the canopy of the tree is to be crown raised to 3.5m. The pruning will result in the removal of less than 10% of the live foliage area of each tree. The finished cut diameter must not exceed 100mm.

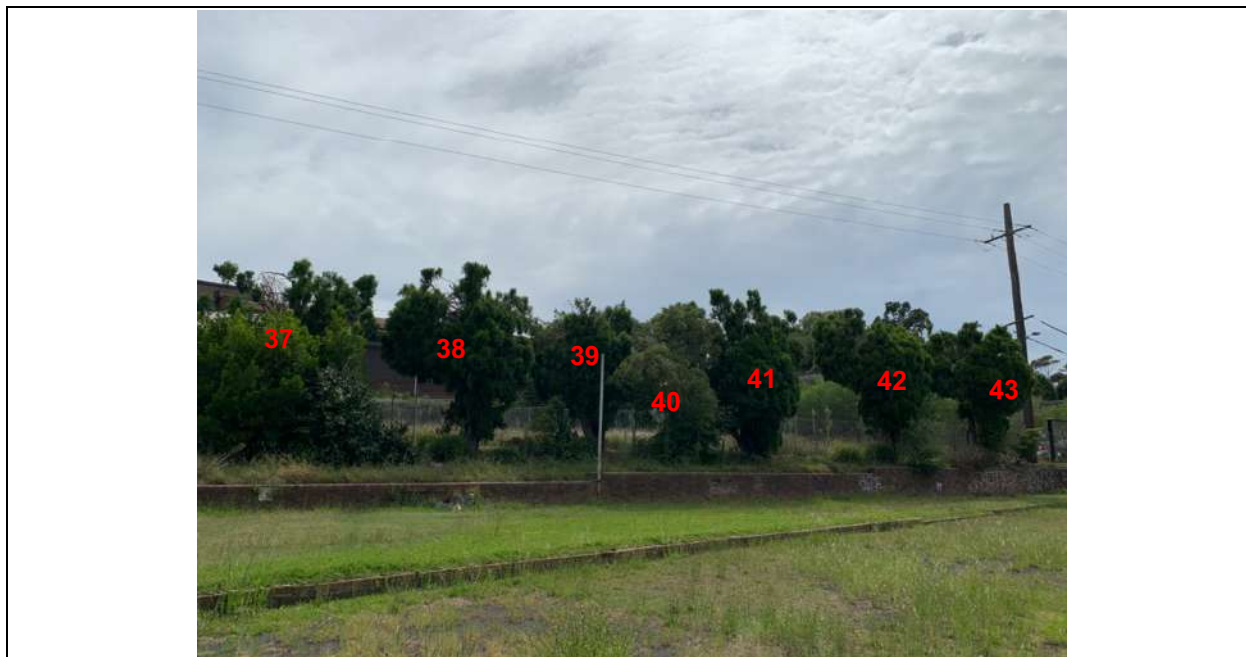
**Image 47:** Looking towards tree 37-43. Two pruning options have been proposed for these trees:  
 Option 1 - The North side of the canopy of each tree is to be crown raised to 3.5m.  
 Option 2 - The South side of the canopy of each tree is to be crown raised to 3m.  
 Both options will have similar impacts to the trees. Finished cut diameter must not exceed 150mm.

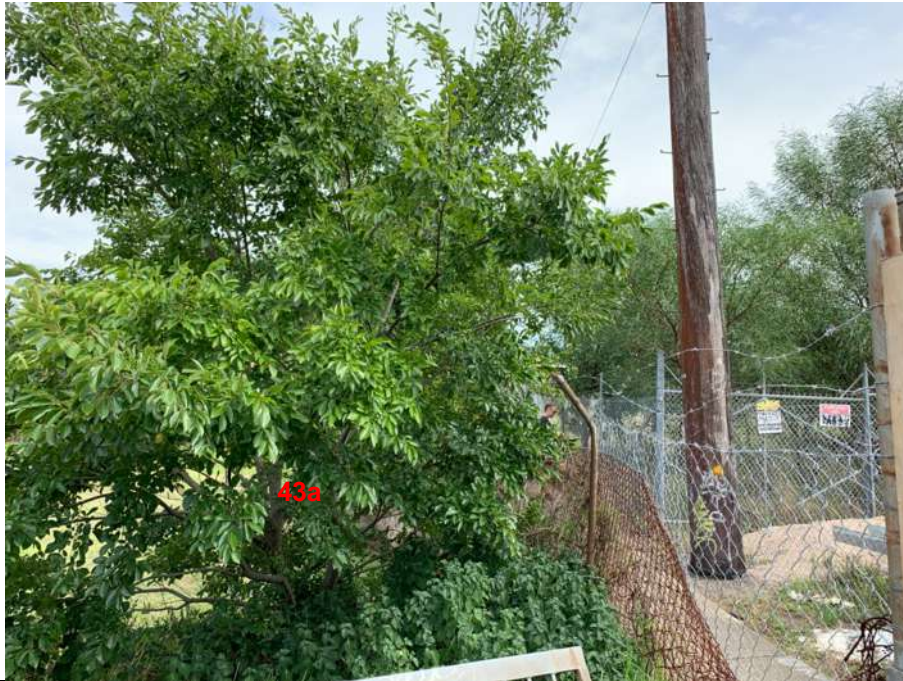
**Image 48:** Looking towards tree 43a. Tree 43a is recommended for removal due to development impacts from proposed fence.

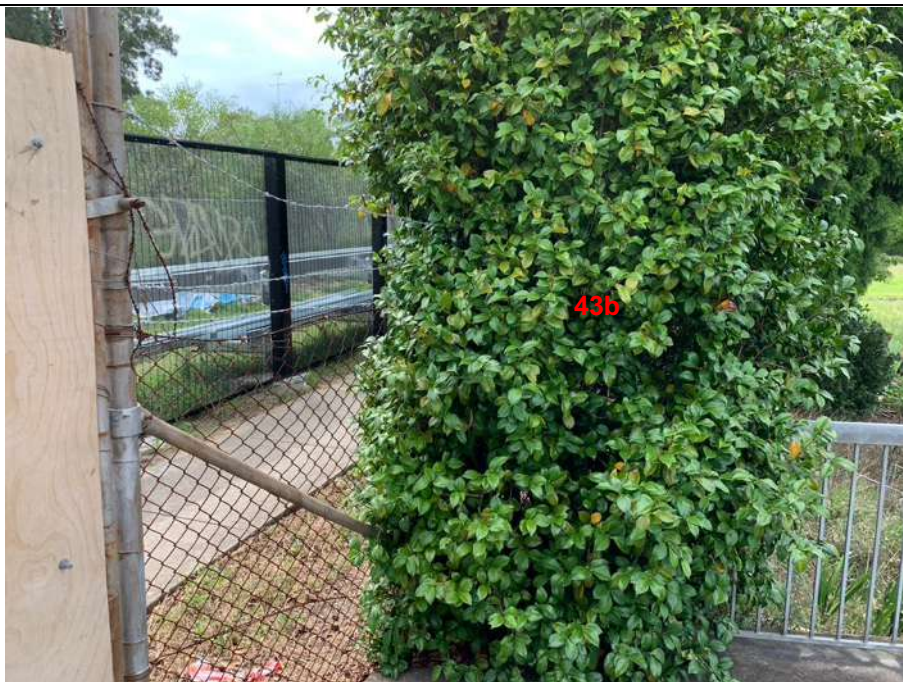
**Image 49:** Looking towards tree 43b. Tree 43b is recommended for removal due to development impacts from proposed fence.

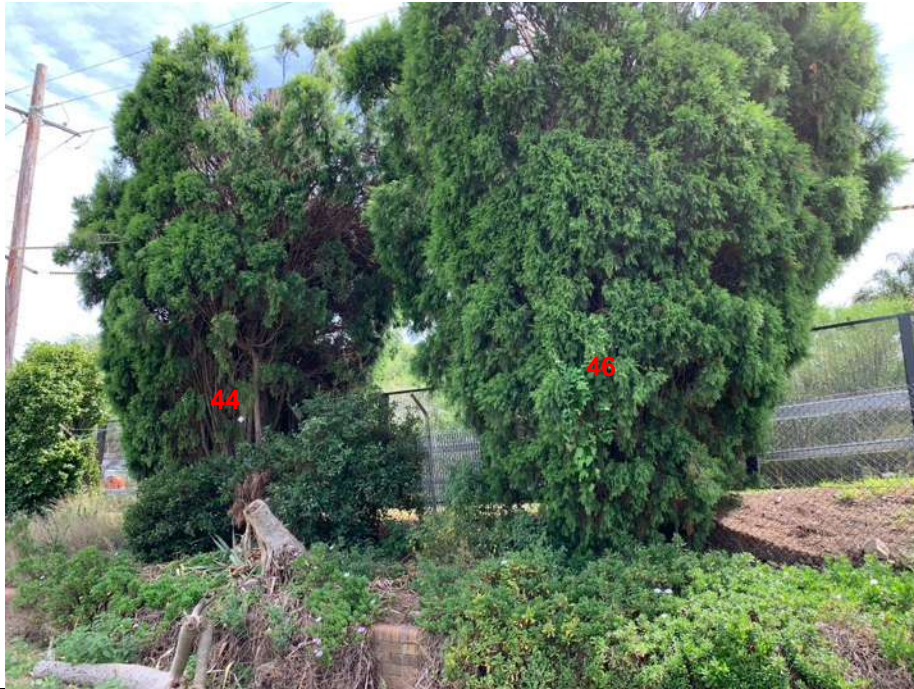
**Image 50:** Looking towards tree 44 and 46. Tree 44 and 46 are recommended for removal due to development impacts from proposed fence.

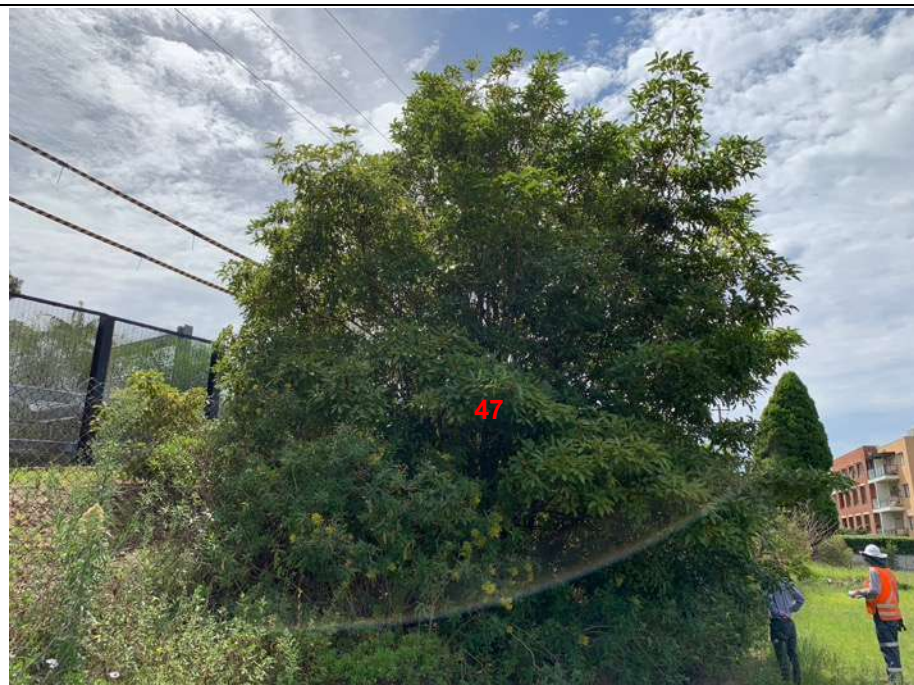
**Image 51:** Looking towards tree 47. Tree 47 is recommended for removal due to development impacts from proposed fence.

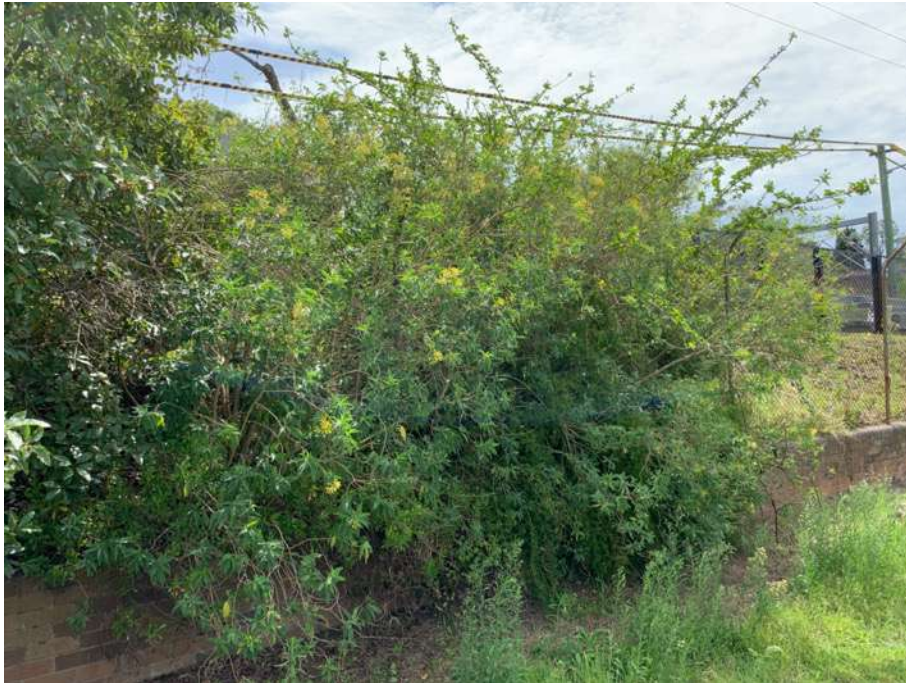
**Image 52:** Insignificant Small weed species to be removed adjacent to the fence.

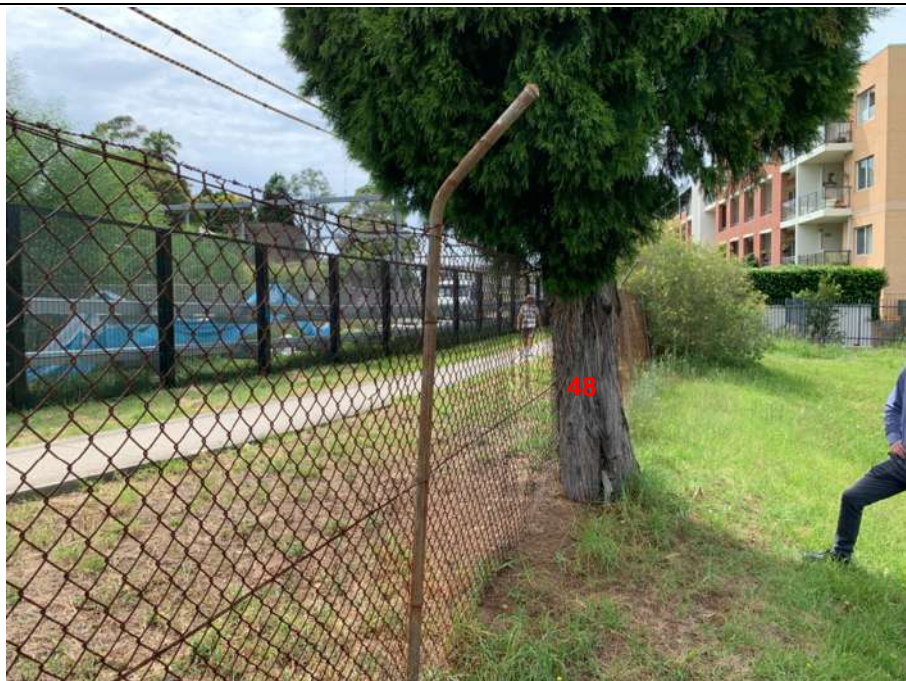
**Image 53:** Looking towards tree 48. Tree 48 is recommended for removal due to development impacts from proposed fence.

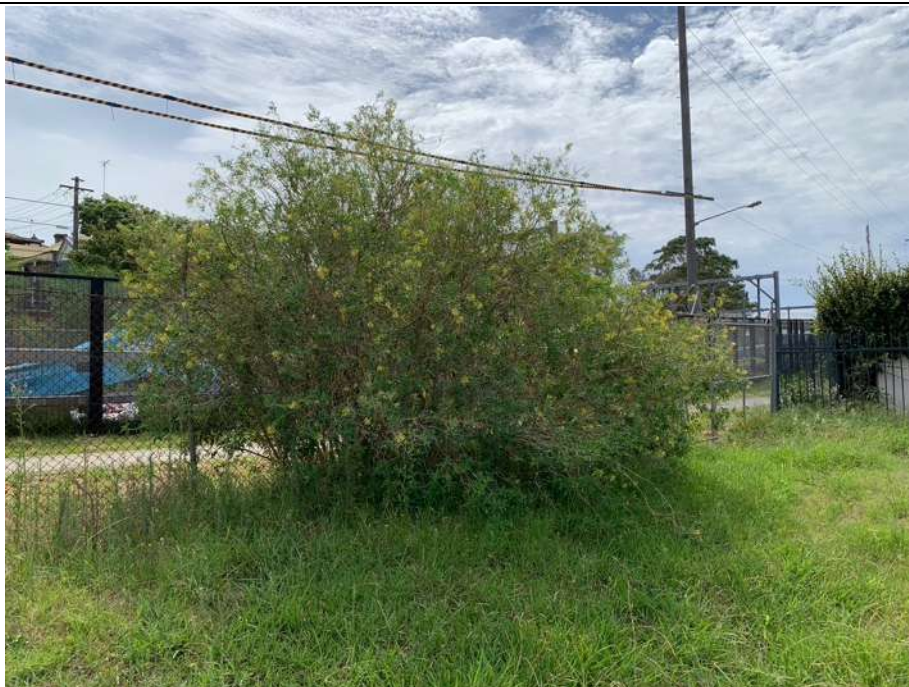
**Image 54:** Insignificant small weed species to be removed adjacent to the fence.

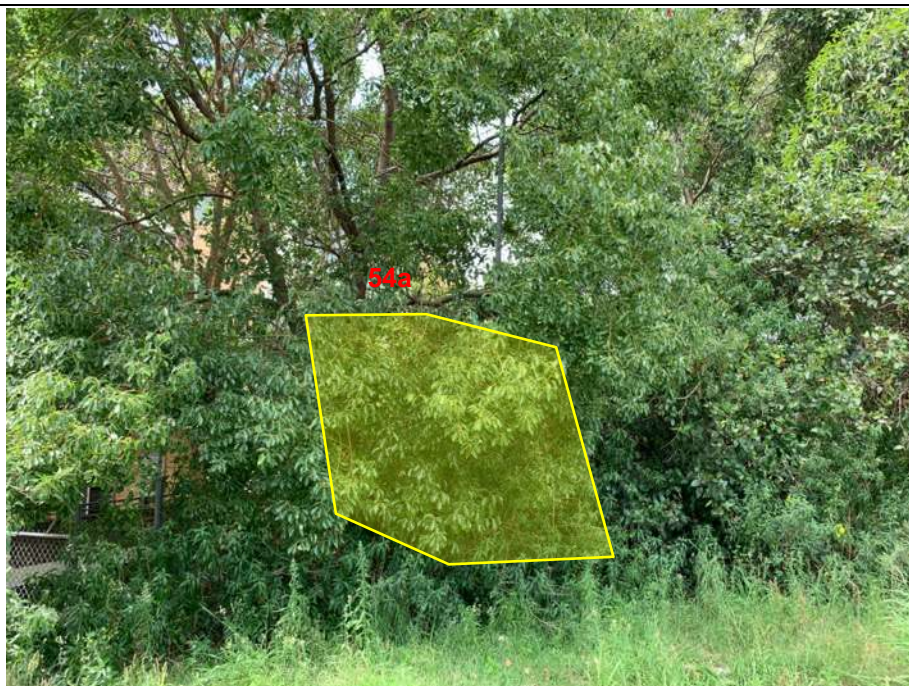
**Image 55:** Looking towards tree 54a. Showing the required canopy pruning for the tree (hatched yellow). The West side of the lower canopy of the tree is to be crown reduced by 1m. The pruning will result in the removal of less than 5% of the live foliage area of each tree. The finished cut diameter must not exceed 80mm.

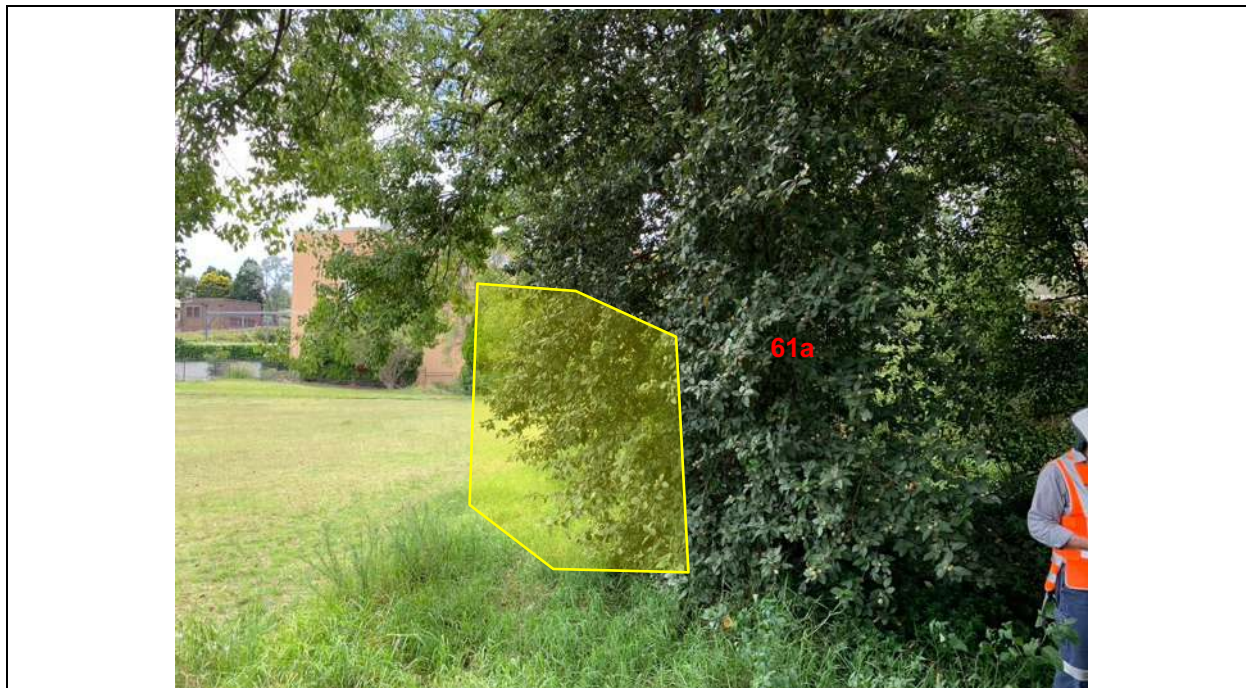
**Image 56:** Looking towards tree 61a. Showing the required canopy pruning for the tree (hatched yellow). The North side of the lower canopy of the tree is to be crown reduced by 1m. The pruning will result in the removal of less than 5% of the live foliage area of each tree. The finished cut diameter must not exceed 80mm.

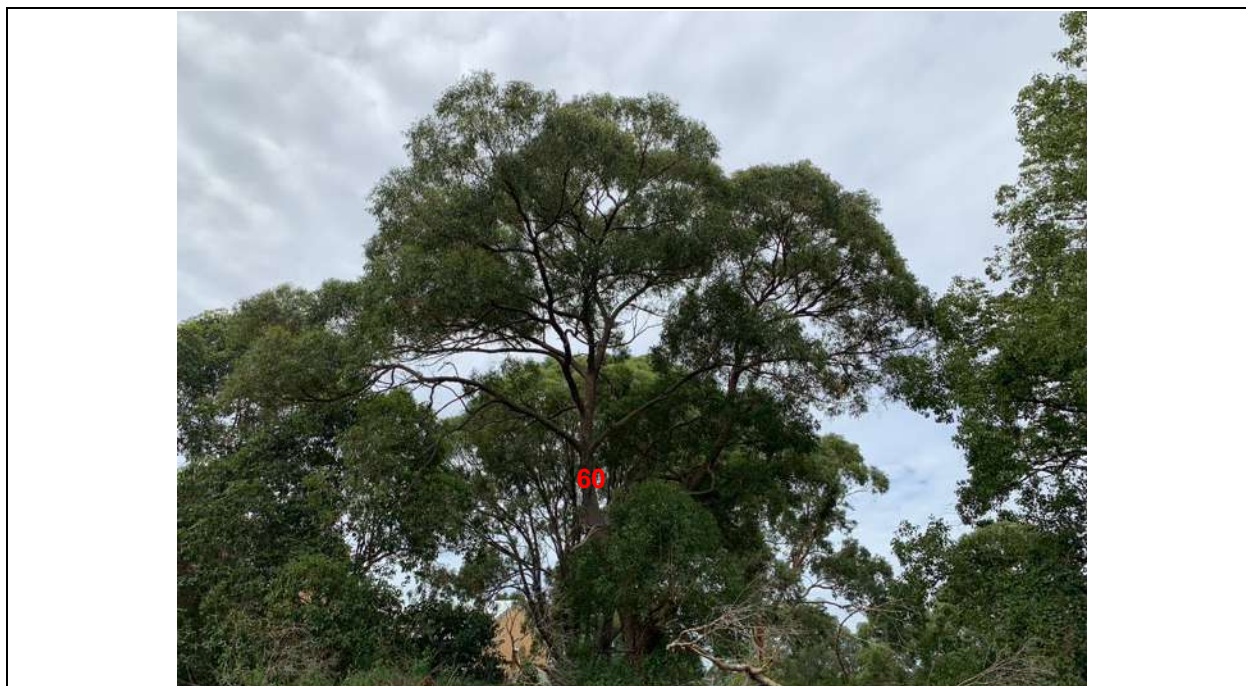
**Image 57:** Looking towards tree 60. No development impacts – to be retained and protected.

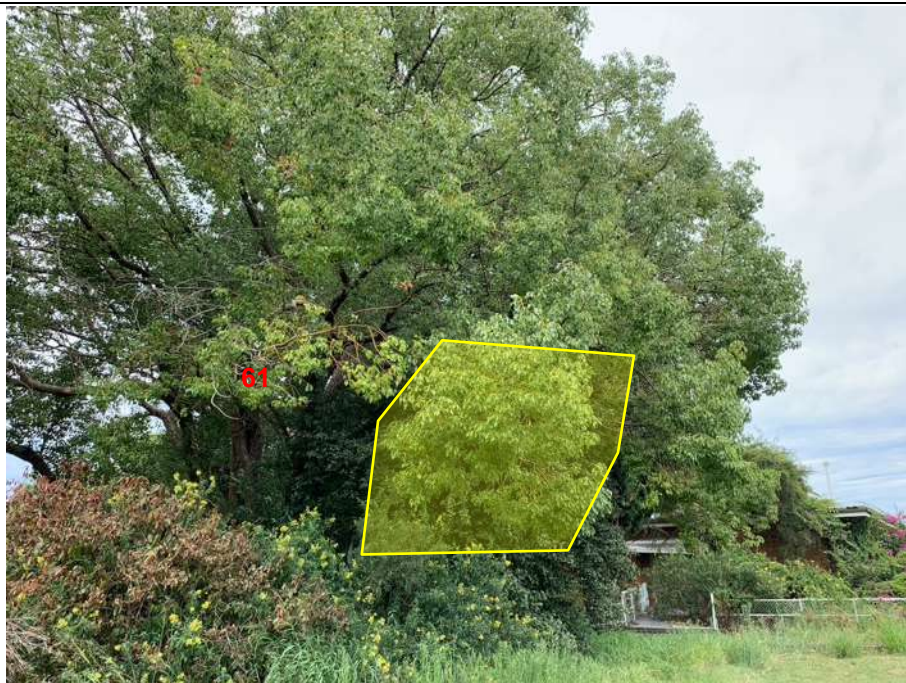
**Image 58:** Looking towards tree 61. Showing the required canopy pruning for the tree (hatched yellow). The North side of the canopy of the tree is to be crown raised by 5m. The pruning will result in the removal of less than 5% of the live foliage area of each tree. The finished cut diameter must not exceed 100mm.

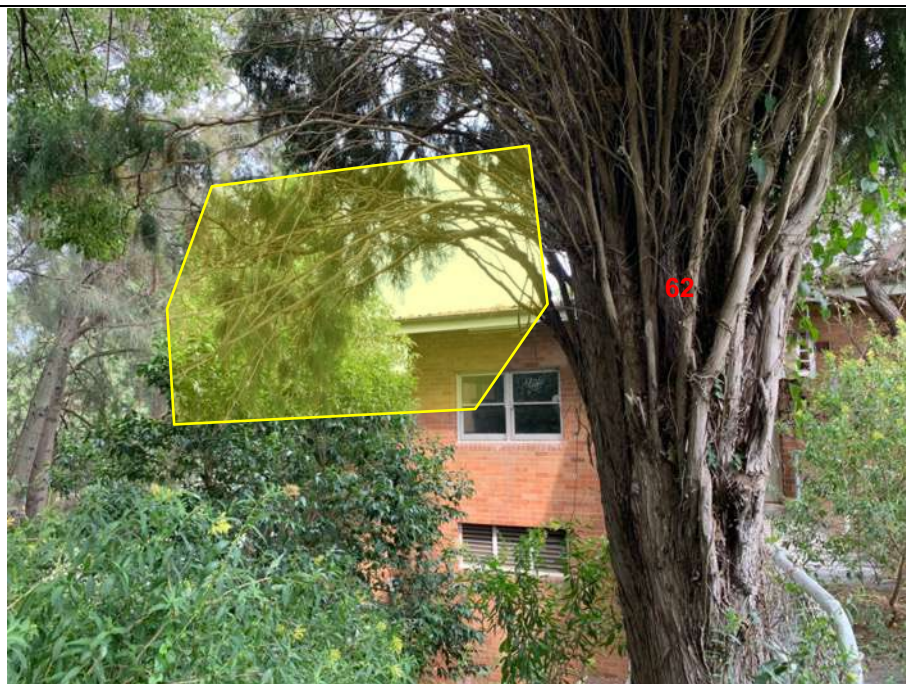
**Image 59:** Looking towards tree 62. Showing the required canopy pruning for the tree (hatched yellow). The North side of the canopy of the tree is to be crown raised by 5m. The pruning will result in the removal of less than 5% of the live foliage area of each tree. The finished cut diameter must not exceed 100mm.

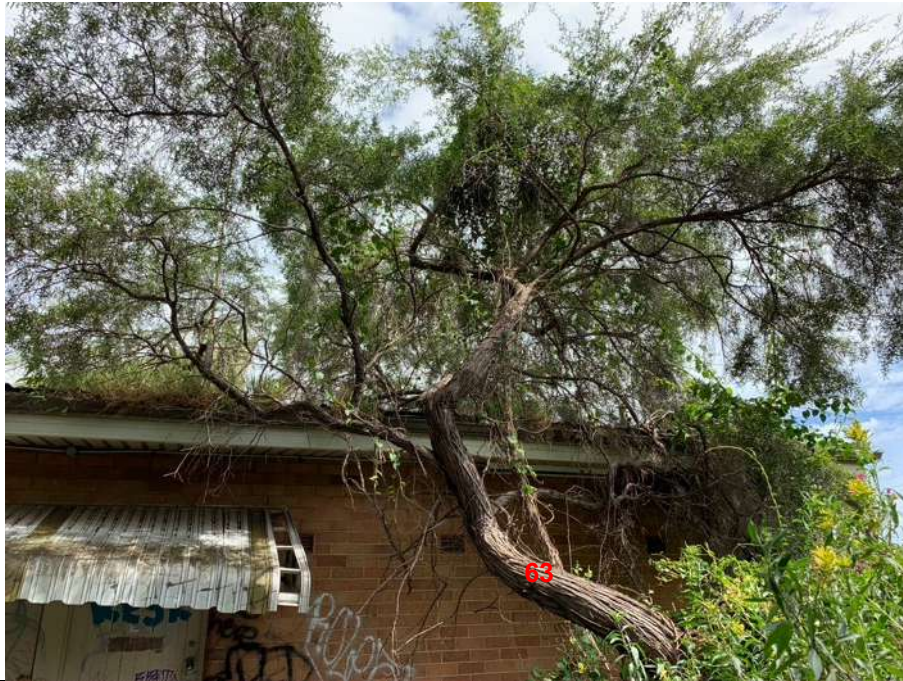
**Image 60:** Looking towards tree 63. Tree 63 is recommended for removal due to development impacts from the demolition works.

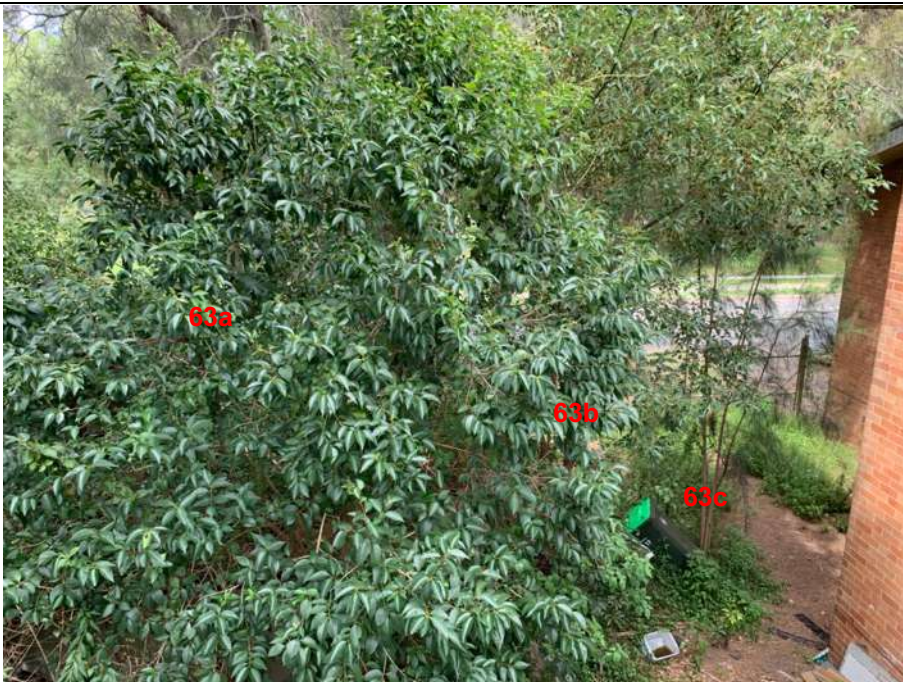
**Image 61:** Looking towards tree 63a, 63b and 63c. The trees are recommended for removal due to development impacts from the demolition works.
