# Tree Impact Assessment Report – Southwest Metro Early Works

SMCSWSSJ-JHL-WEC-EM-REP-000001

This report has been produced to assess impacts to vegetation and detail the species and number of trees that will be removed as part of the Southwest Metro Early Works (SMEW).

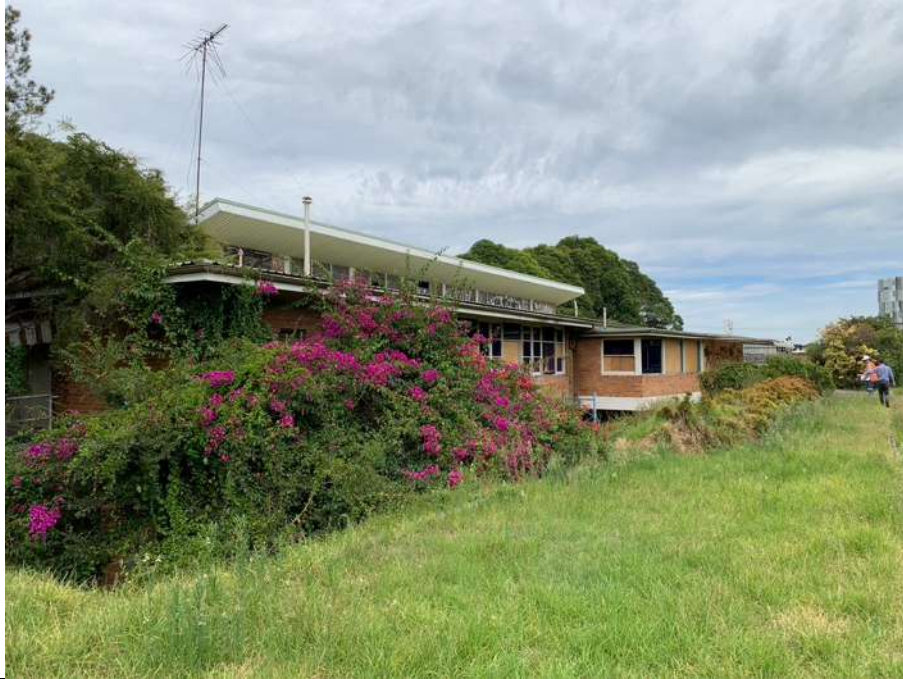
**Image 62:** Looking towards insignificant small weed species adjacent to the building – to be removed to accommodate the demolition works.

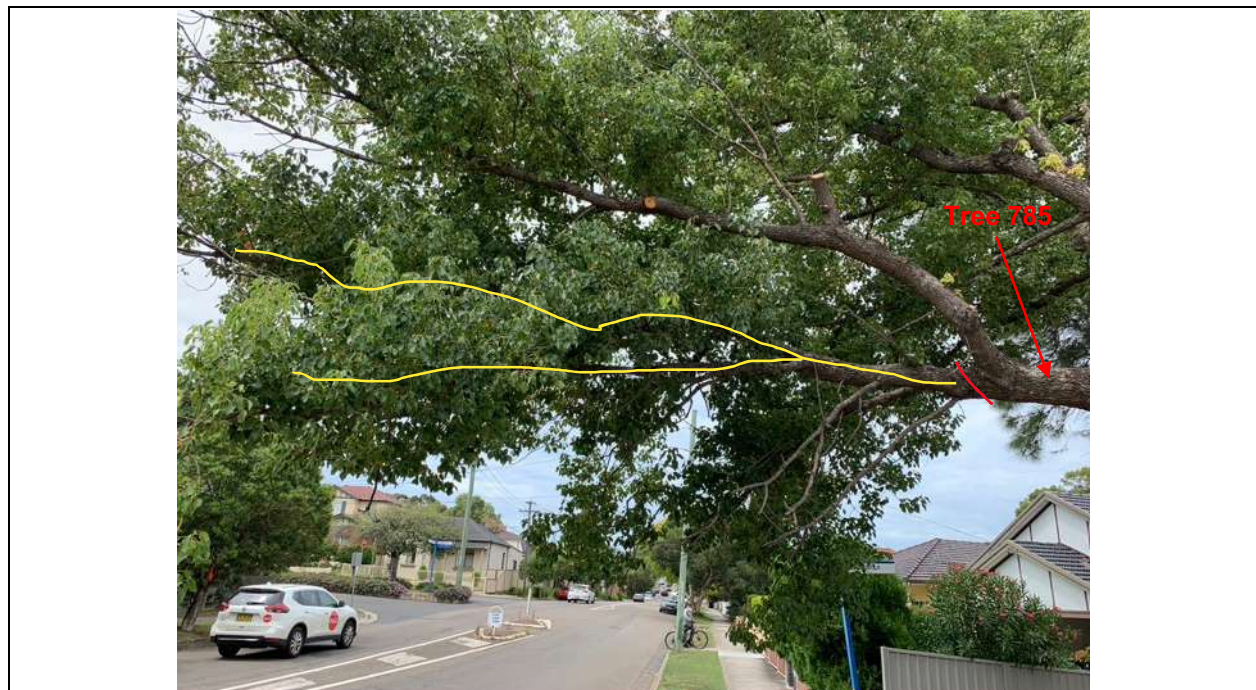
**Image 63:** Looking towards tree 785 showing the required canopy pruning. The 200mm diameter third order branch to the East @ 4m is to be removed. The yellow line indicates the branch to be removed, the red line indicates the final pruning cut location. (hatched yellow). The pruning will result in the removal of less than 5% of the live foliage area of each tree.

- 9.36 **Zone 20a – Bridge Loch Street SW Abutment:** The tree within this area is located adjacent to the proposed piling/works area and will require canopy pruning to allow for the works. The following tree has been identified in this area;

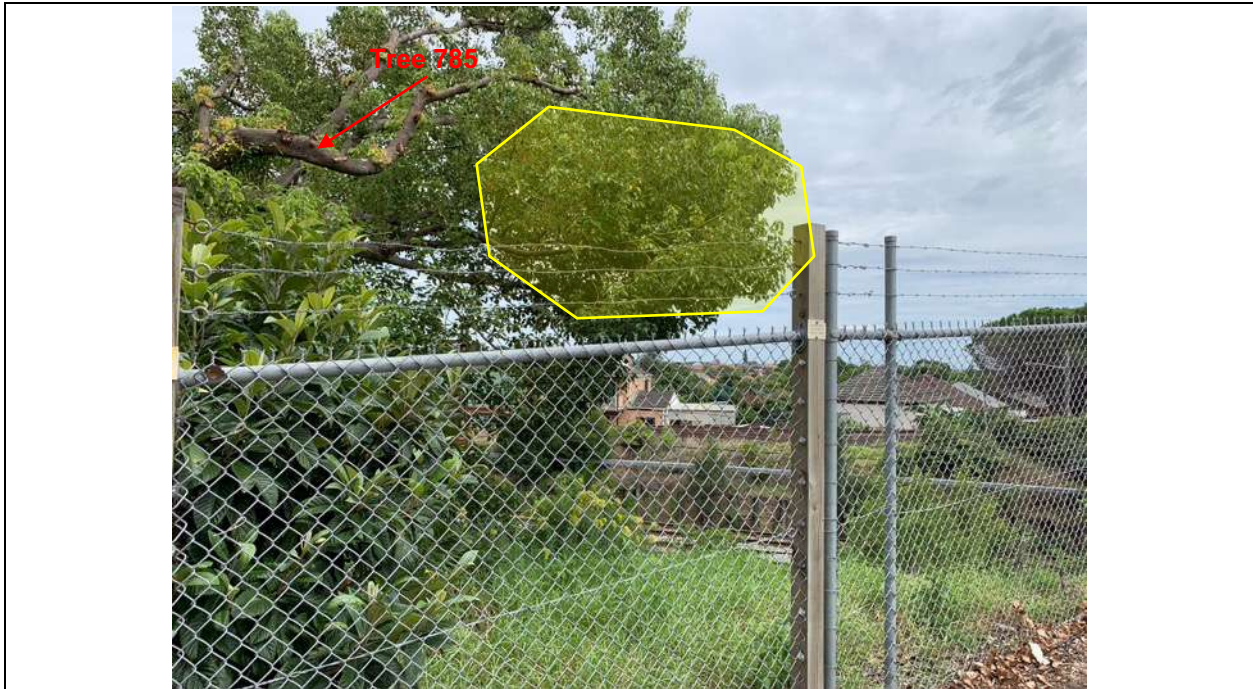
**Image 64:** Looking towards tree 785 showing the additional required canopy pruning (hatched yellow). The Northeast side of the canopy of is to be reduced by 2m. The pruning will result in the removal of less than 5% of the live foliage area of the tree. The finished cut diameter must not exceed 100mm.

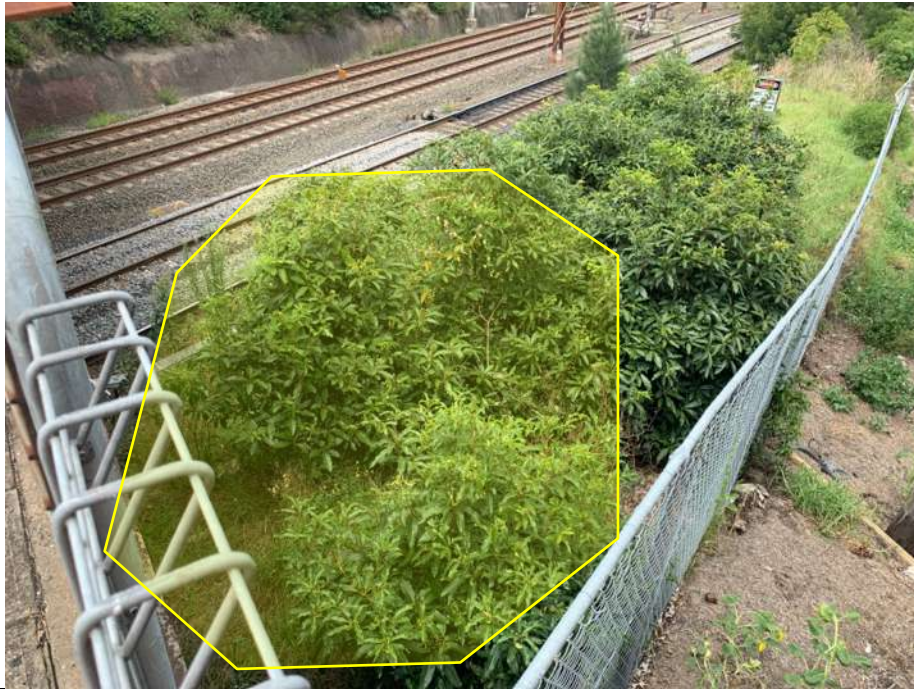
**Image 66:** Looking towards the small weed species to be removed to accommodate the piling works.

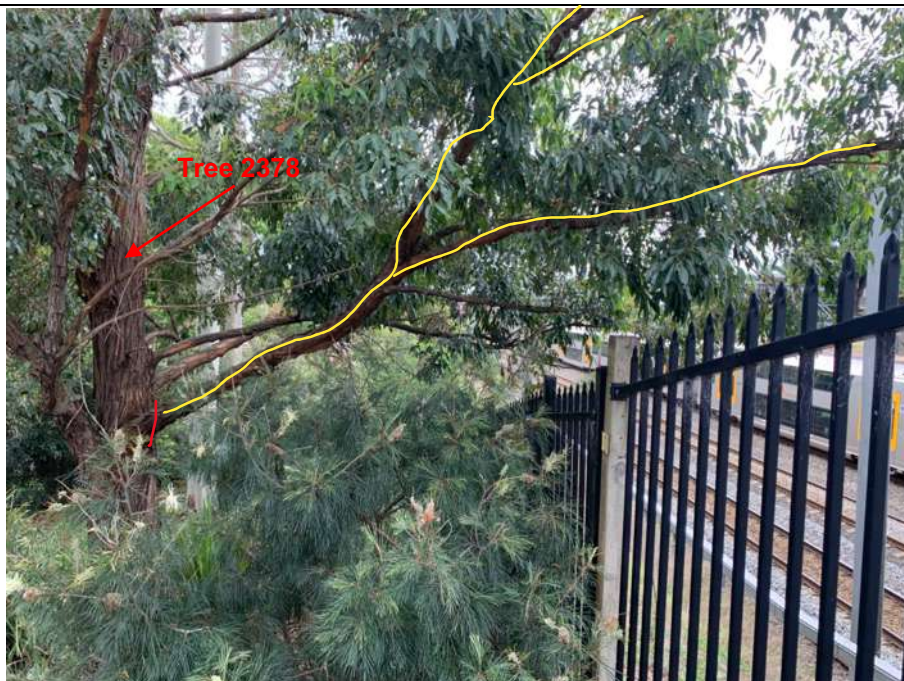
**Image 67:** Looking towards tree 2377 showing the required canopy pruning. The 130mm first order branch to eh Northeast at 1.5m is to be removed to allow for the piling works. The yellow line indicates the branch to be removed, the red line indicates the location of the final pruning cut. The pruning will result in the removal of less than 5% of the live foliage area.

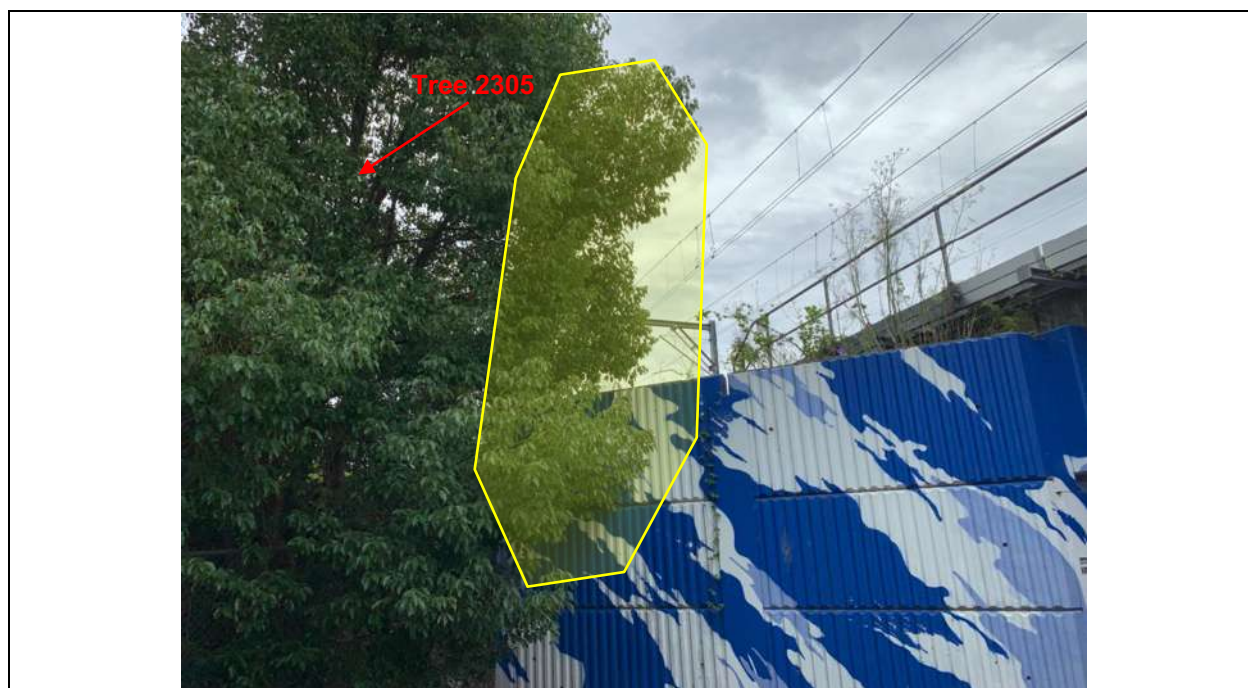
**Image 68:** Looking towards tree 2305 showing the required canopy pruning (hatched yellow). The West side of the canopy of is to be reduced by 2m. The pruning will result in the removal of less than 10% of the live foliage area of the tree. The finished cut diameter must not exceed 80mm.

- 9.39 **Zone 21 – Bridge Belmore Pedestrian underpass:** The tree within this area is located adjacent to the proposed piling/works area and will require canopy pruning to allow for the works. Additional insignificant small weed species are also to be removed adjacent to the piling area. The following tree has been identified in this area;

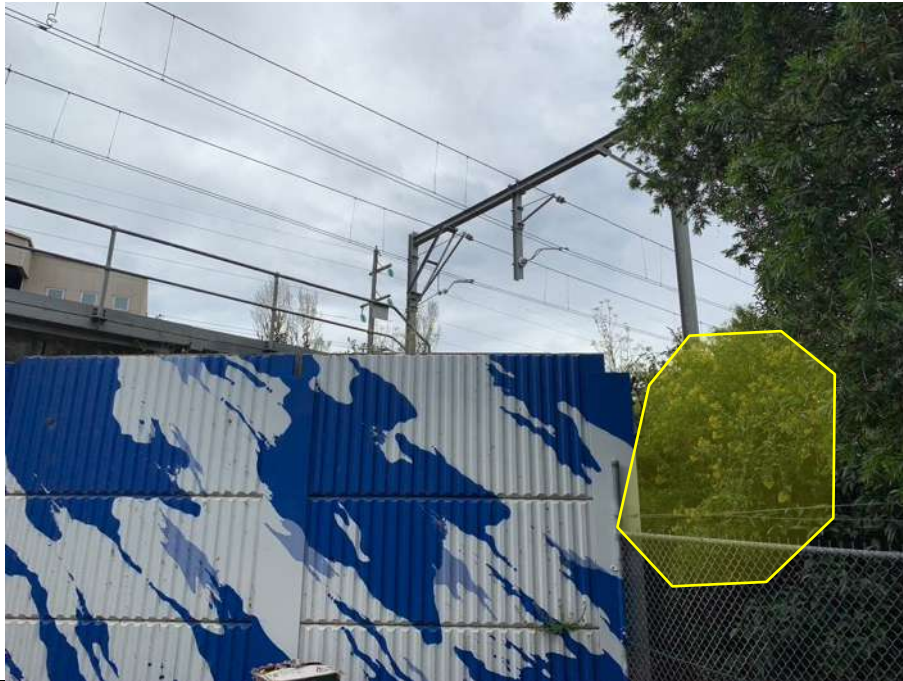
**Image 69:** Looking towards the small weed species to be removed to accommodate the piling works.

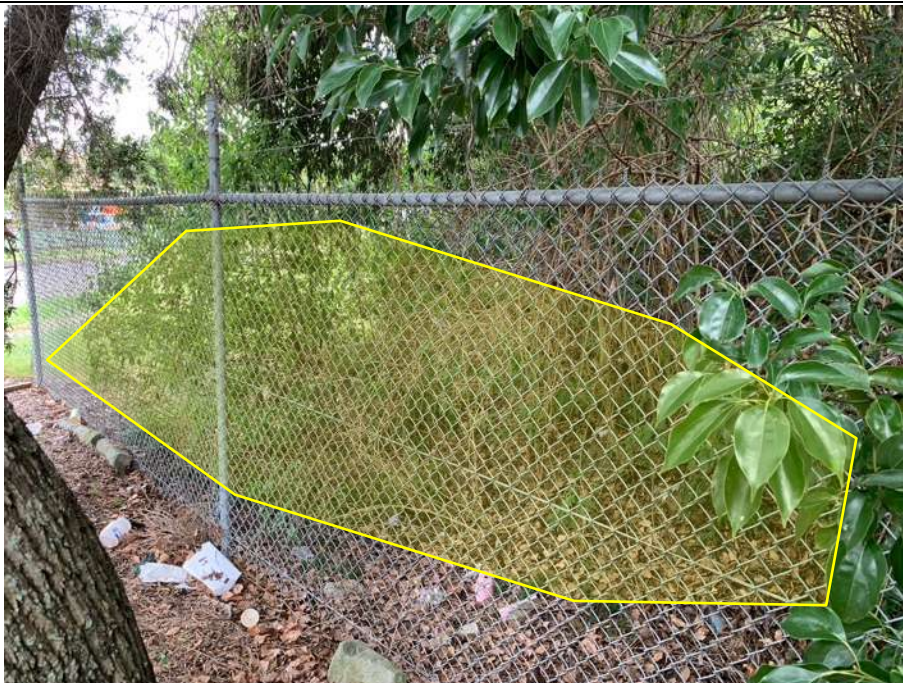
**Image 70:** Looking towards the small weed species to be removed to accommodate the piling works.

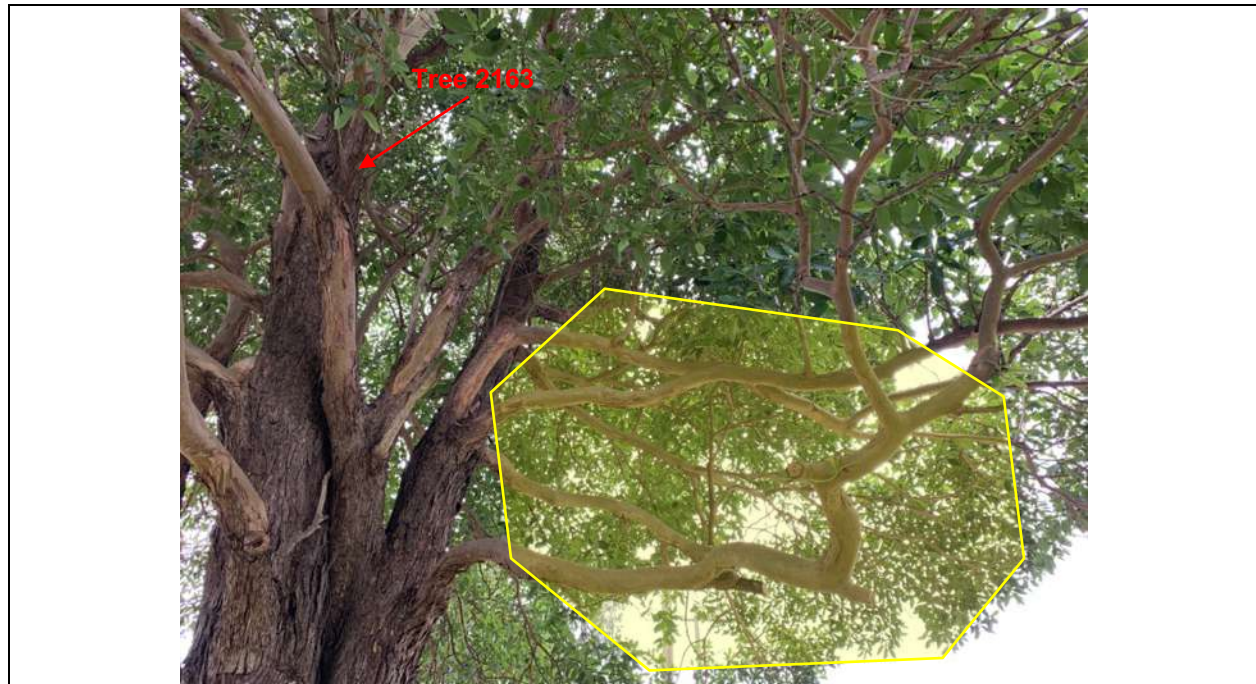
**Image 71:** Looking towards tree 2163 showing the required canopy pruning (hatched yellow). The North side of the canopy of is to be crown raised by 4.5m. The pruning will result in the removal of 15% of the live foliage area of the tree. The finished cut diameter must not exceed 120mm.

- 9.40 **Zone 22 – Bridge Moreton Street NW Abutment:** The tree within this area is located adjacent to the proposed piling/works area and will require canopy pruning to allow for the works. Additional small weed species/vegetation is also to be removed adjacent to the piling area. The following tree has been identified in this area;

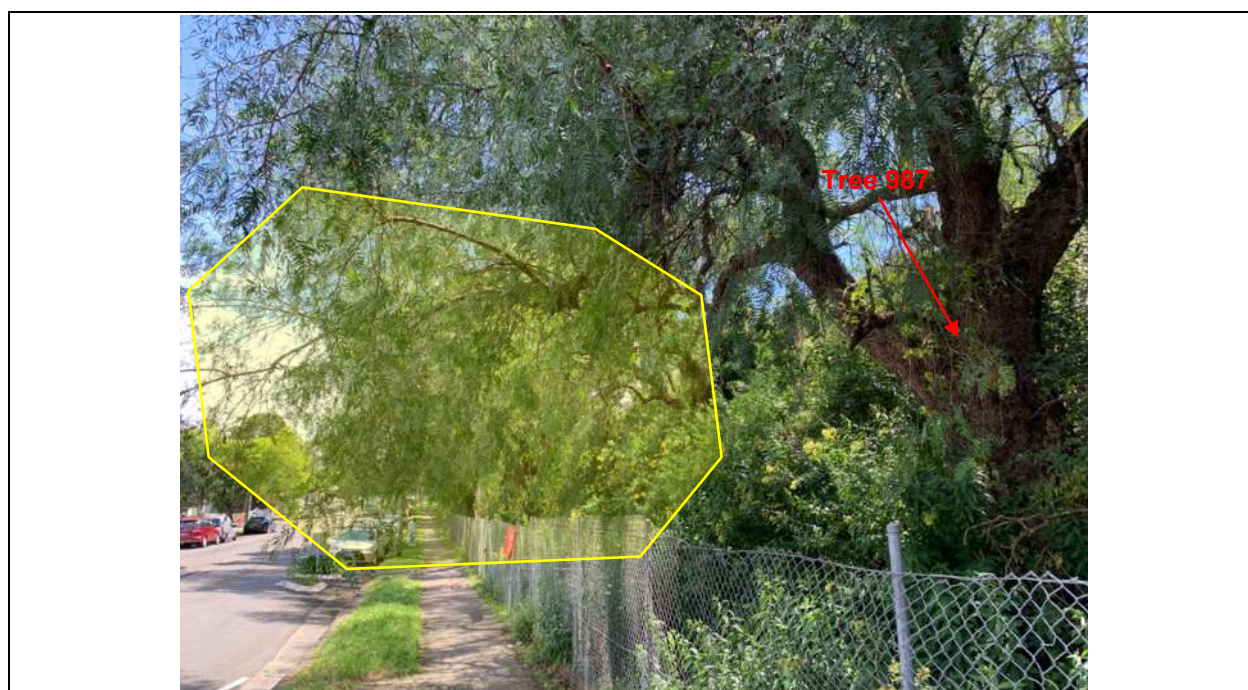
**Image 72:** Looking towards tree 987 showing the required canopy pruning (hatched yellow). The South side of the canopy of is to be crown raised by 4m. The pruning will result in the removal of less than 10% of the live foliage area of the tree. The finished cut diameter must not exceed 120mm.

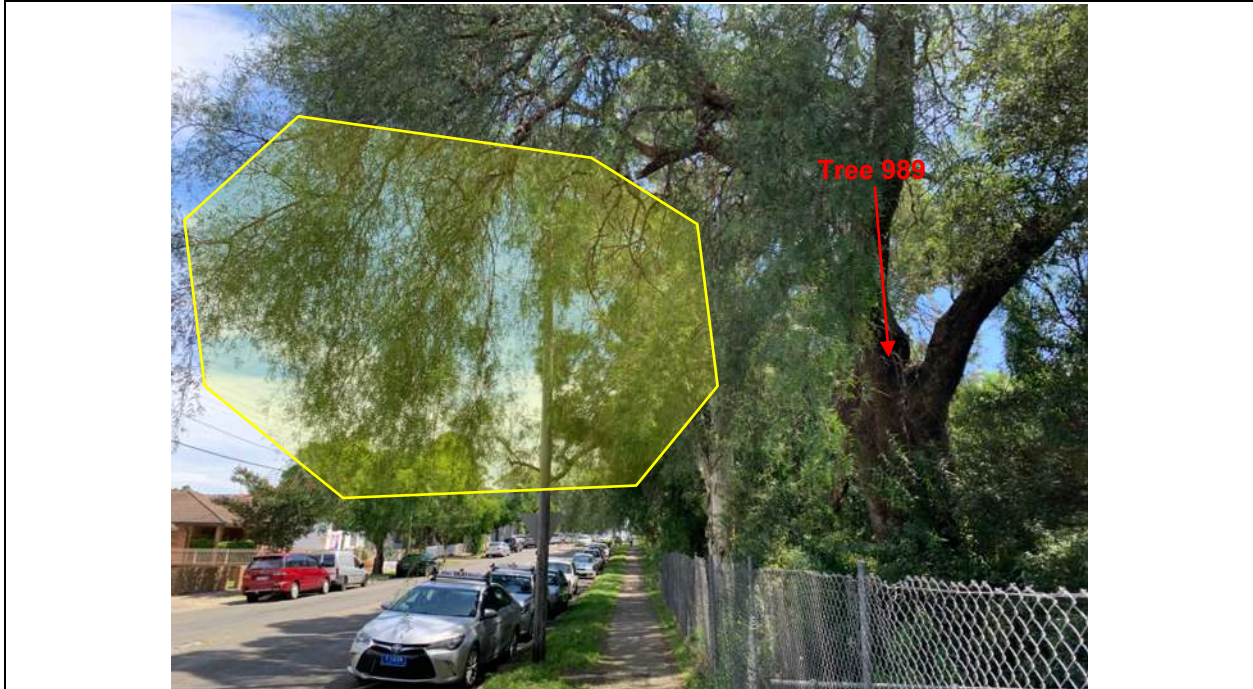
**Image 73:** Looking towards tree 989 showing the required canopy pruning (hatched yellow). The South side of the canopy of is to be crown raised by 4m. The pruning will result in the removal of less than 10% of the live foliage area of the tree. The finished cut diameter must not exceed 500mm.

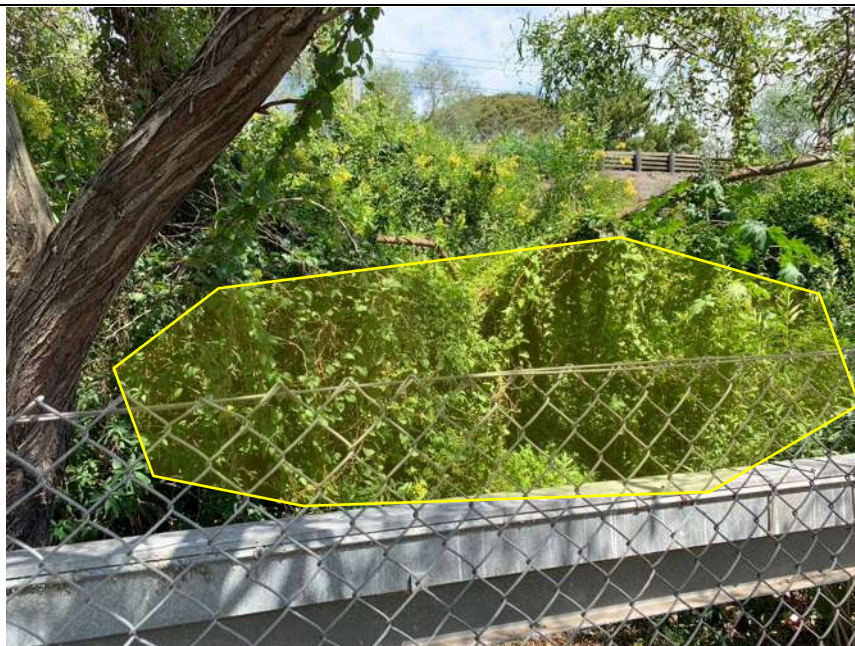
**Image 74:** Showing small weed species/vegetation to be removed for the proposed works area.

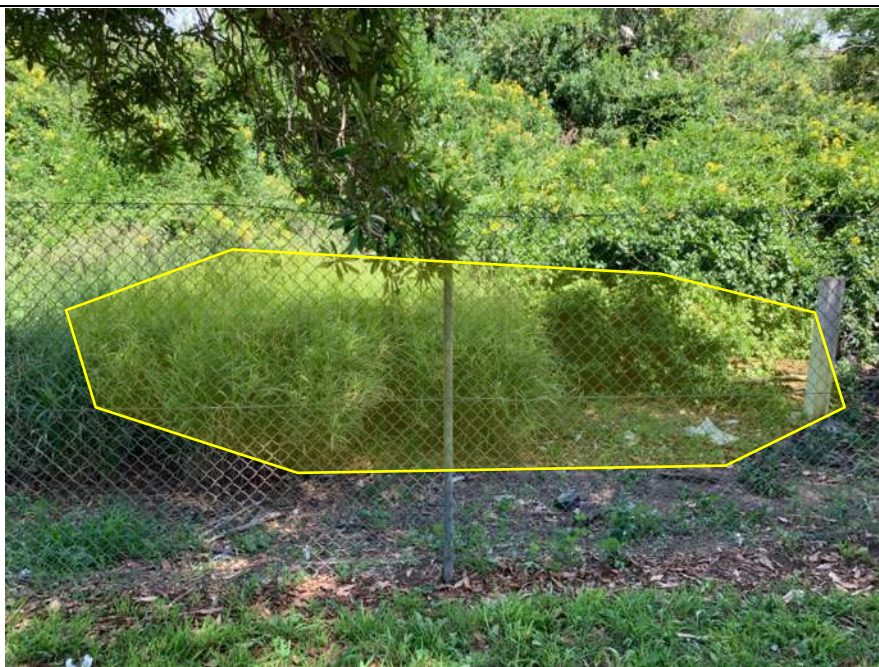
**Image 75:** Showing small weed species/vegetation to be removed for the proposed works area.

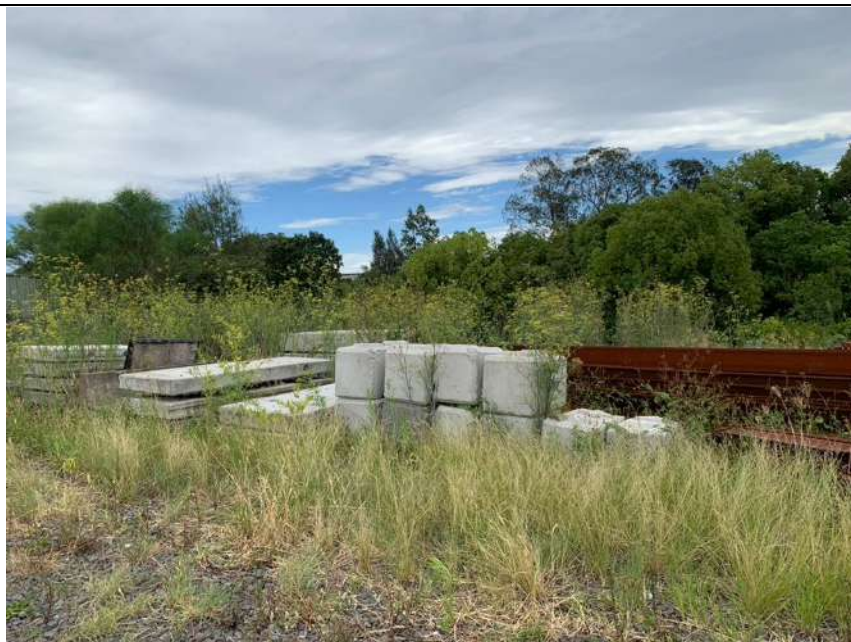
**Image 76:** Showing small weed species/vegetation to be removed for the proposed works area.

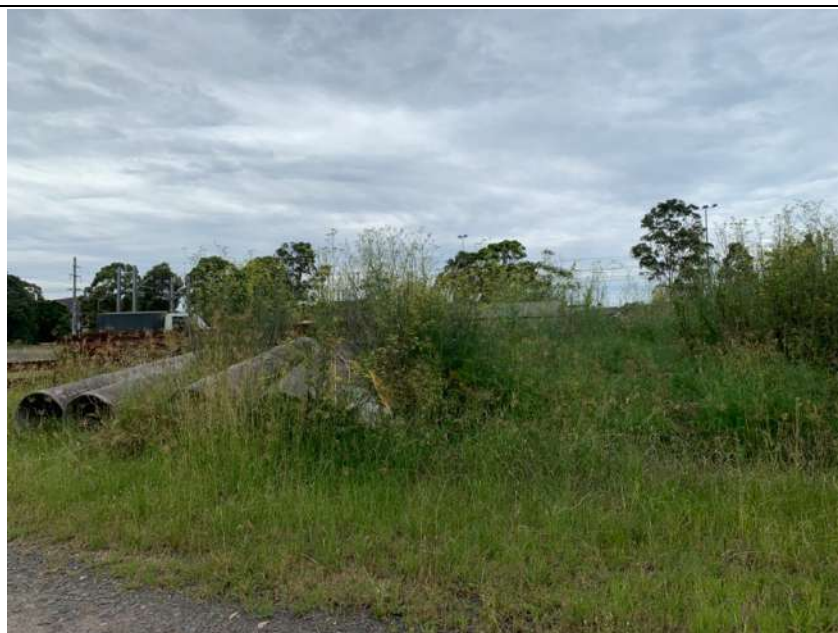
**Image 77:** Showing small weed species/vegetation to be removed for the proposed works area.

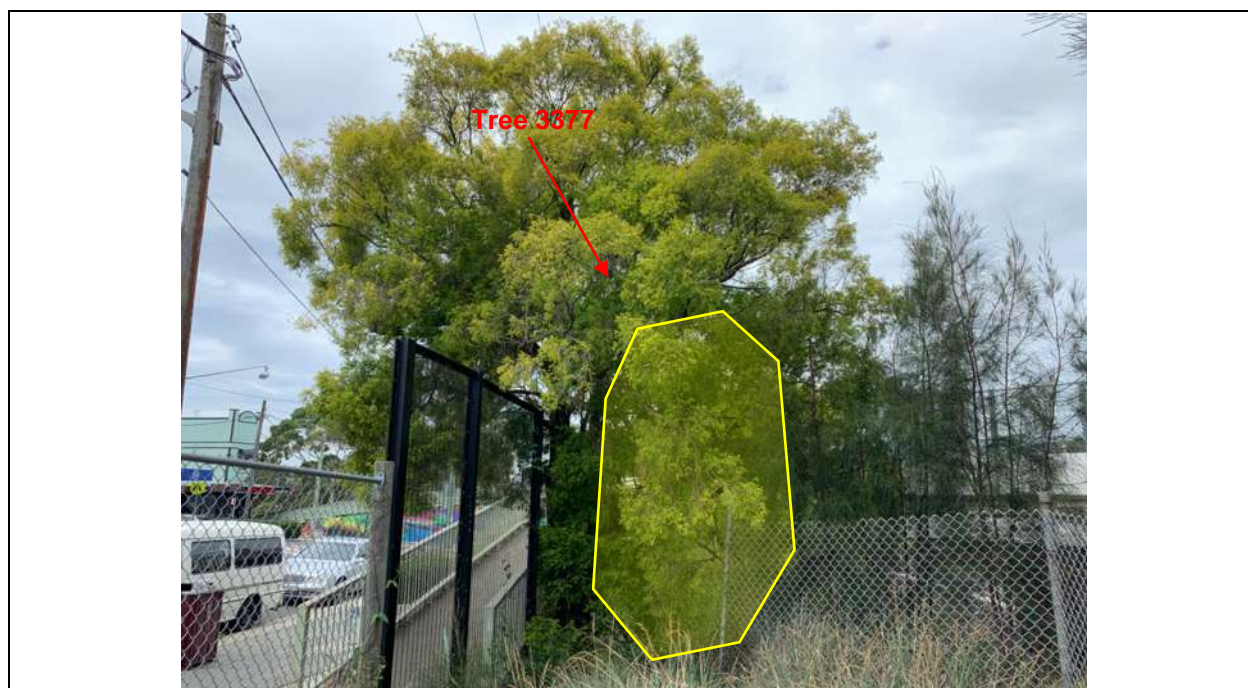
**Image 78:** Looking towards tree 3377 showing the required canopy pruning (hatched yellow). The West side of the canopy of is to be crown raised by 2m. The pruning will result in the removal of less than 10% of the live foliage area of the tree. The finished cut diameter must not exceed 100mm.

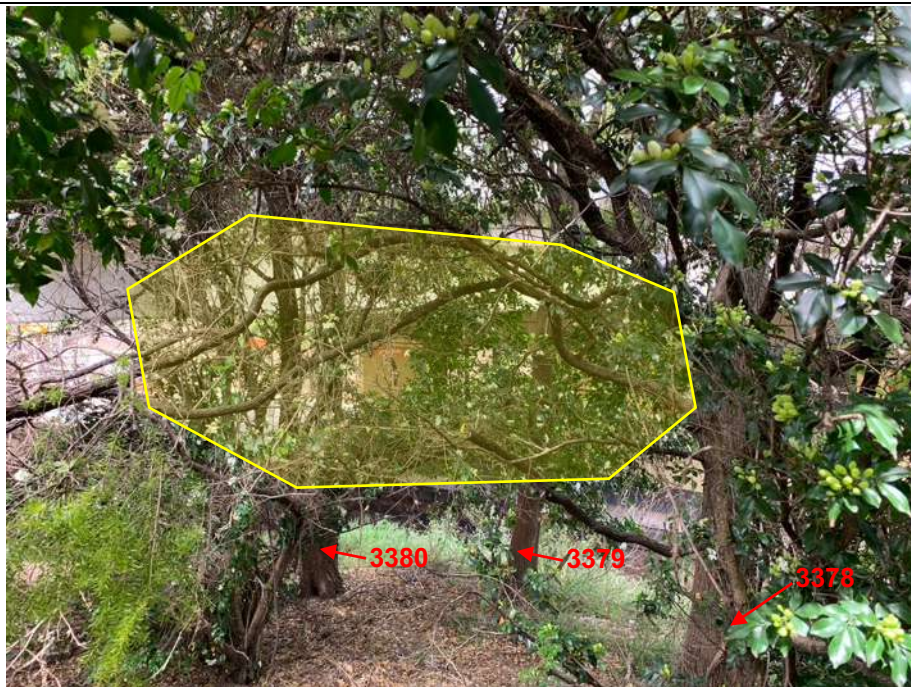
**Image 79:** Looking towards tree 3378 showing the required canopy pruning (hatched yellow). The Southwest side of the canopy of is to be crown raised by 2m. The pruning will result in the removal of less than 10% of the live foliage area of the tree. The finished cut diameter must not exceed 100mm. No canopy pruning is required for tree 3379 and 3380.

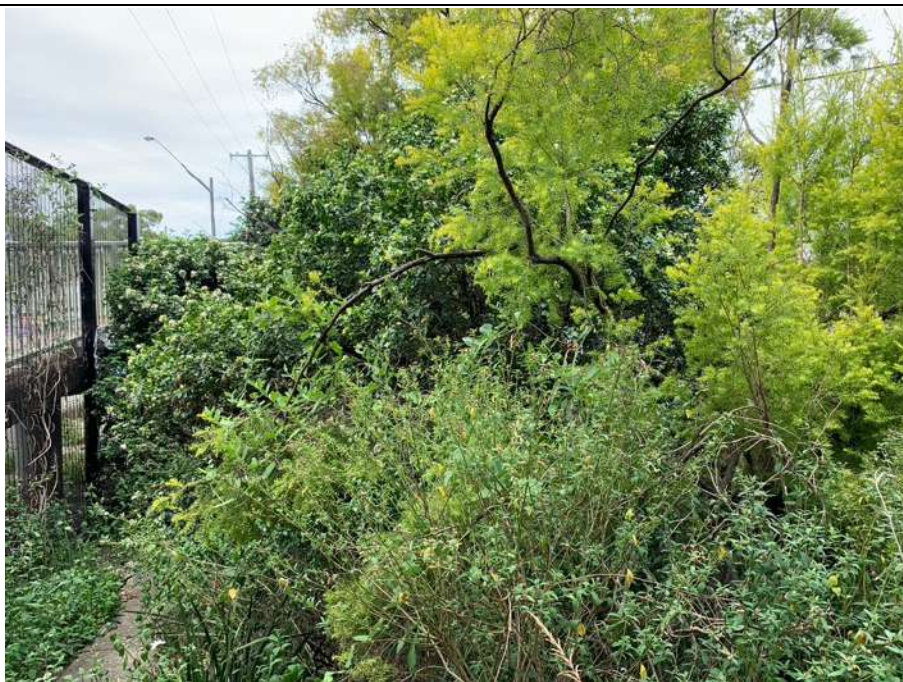
**Image 80:** Showing small weed species to be removed for the proposed works area.

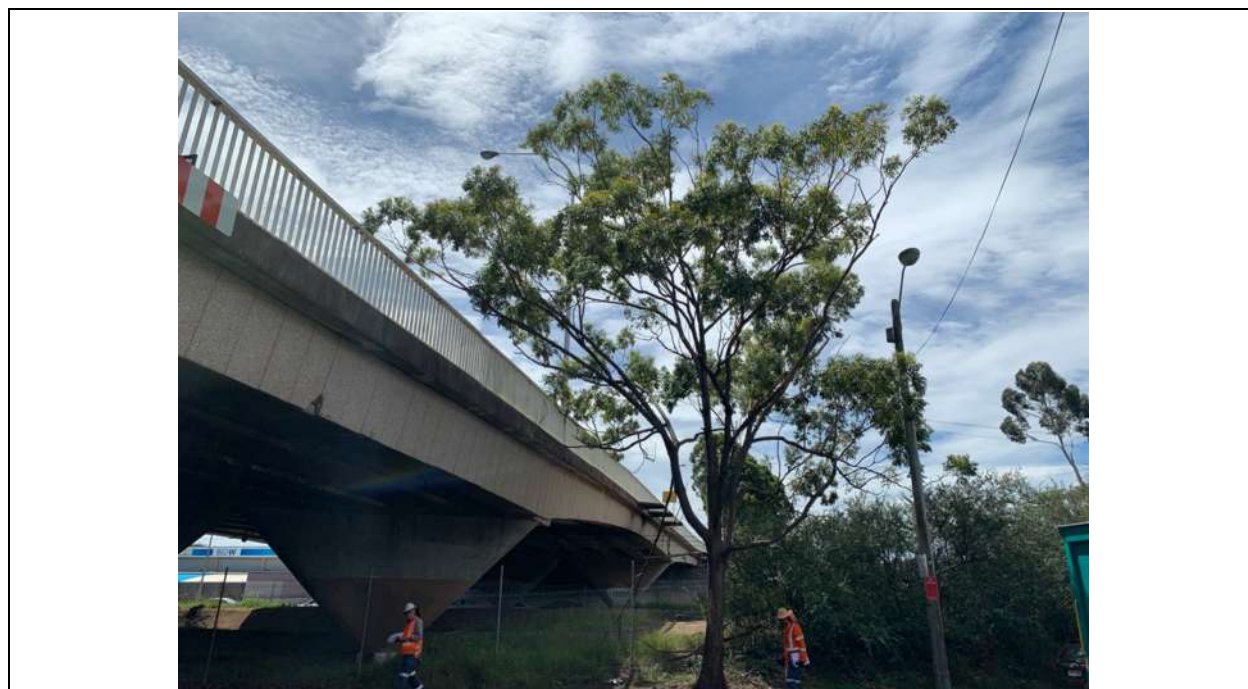
**Image 81:** Showing tree 1510, recommended for removal due to development impacts from the proposed works area.

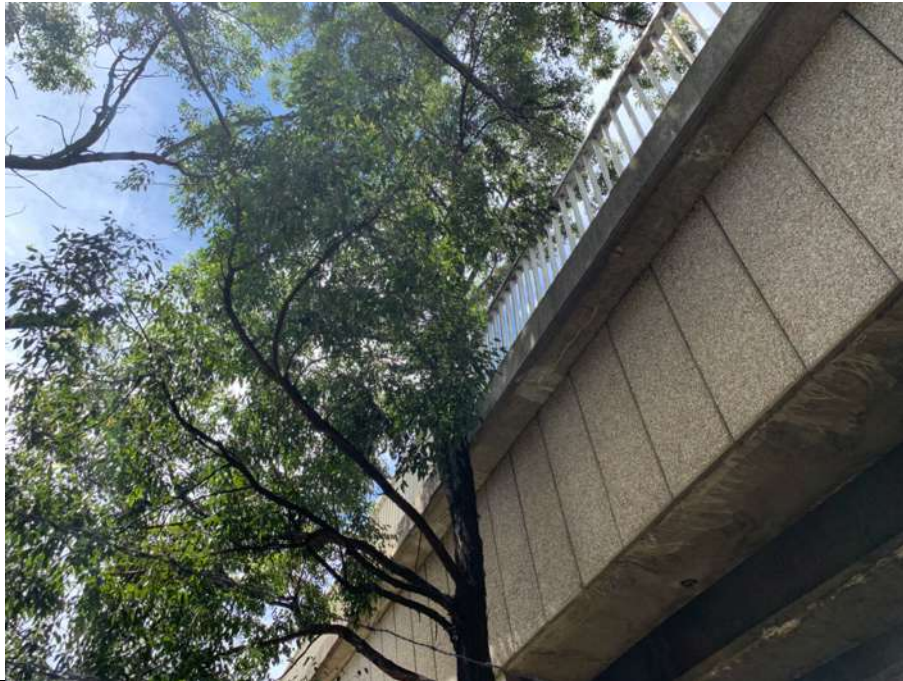
**Image 82:** Showing tree 1511, recommended for removal due to development impacts from the proposed works area.
