Planning Approval Consistency Assessment Form

Assessment name:	SMDS Corridor Design Clashes
Prepared by:	Jonny Steele – Metron T2M Dan Keegan - JHLOR
Prepared for:	Sydney Metro – Southwest Metro Corridor Works
Assessment number:	SWM013
Status:	Final
Version:	02
Planning approval:	SSI-8256
Date required:	25/06/21
iCentral number:	SM-21-00036038
© Sydney Metro 2020

Appendix A – Location of identified design clashes and consolidation of habitats following ecological inspection

Appendix B – Threatened Ecological Community Clash Detection Report

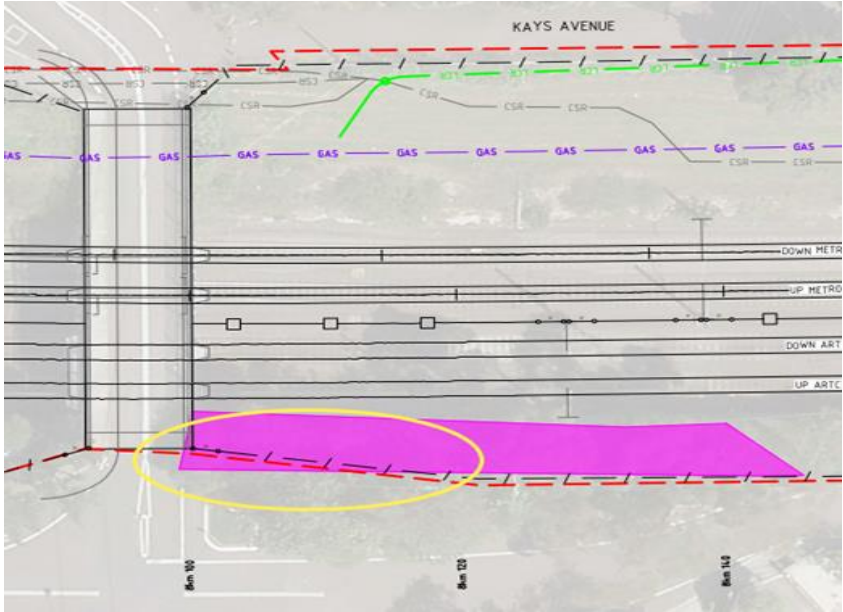
Location	Details of clash
Challis Avenue between Marrickville and Dulwich Hill stations – north side of rail line	<p>New fence encroaches into PCT (8km-100 to 8km-150).</p>

<p>[Key: PCT– purple, fence – black dash]</p>

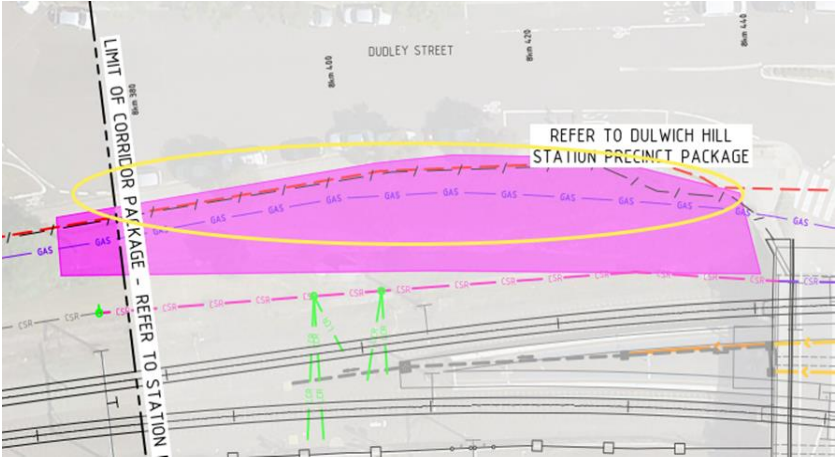
Location	Details of clash
<p>Dudley Street between Marrickville and Dulwich Hill stations – south side of rail line</p>	<p>New fence encroaches into PCT (8km-370 to 8km-440).</p>

<p>[Key: PCT – purple, fence – black dash]</p>

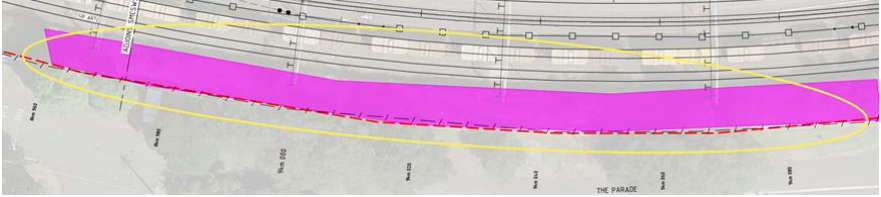
Location	Details of clash
Garnet Street between Dulwich Hill and Hurlstone Park stations – both sides of rail line	<p>To north of rail line - New fence encroaches into PCT, following existing fence line (8km-960 to 9km-100)</p>

<p>[Key: TEC – purple, fence – black dash]</p> <p>To south of rail line – local communications route (LCR) encroaches into PCT (9km-080 to 9km-100):</p>

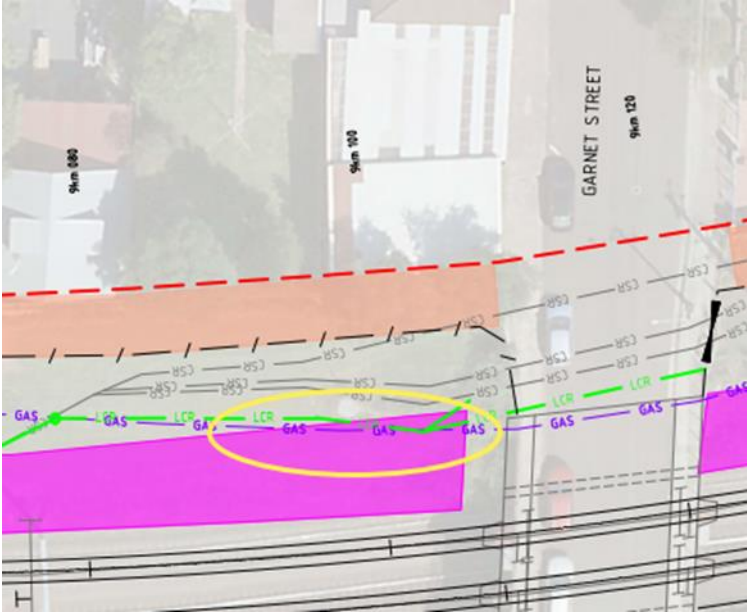
<p>[Key: TEC – purple]</p>

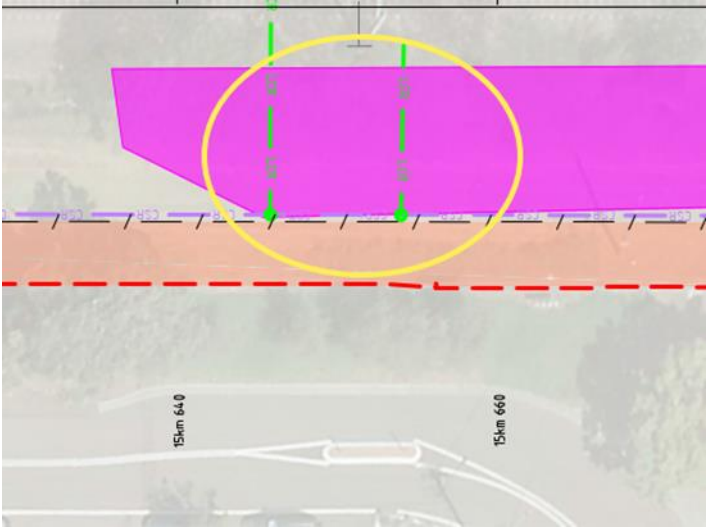
Location	Details of clash
Railway Parade between Lakemba and Wiley Park stations – north side of rail line	<p>LCR clashes with PCT (eastern section of patch) (15km-640 to 15km-660).</p>

<p>[Key: TEC – purple]</p>
Breust Pl, west of Punchbowl station – north side of rail line	<p>CSR and LCR clash with TEC (17km-180 to 17km-260).</p>

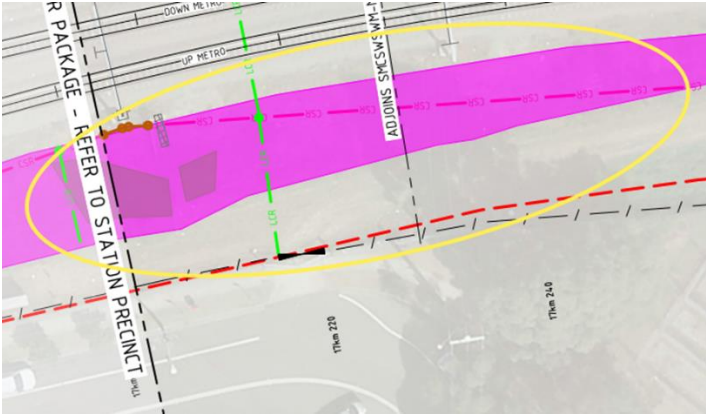
<p>[Key: TEC – purple]</p>

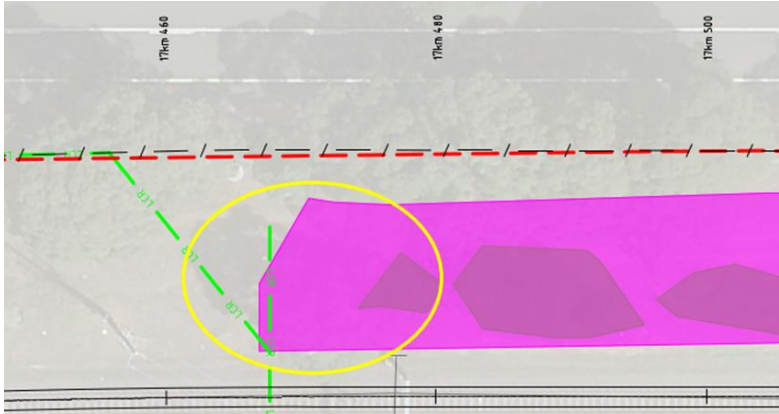
Location	Details of clash
South Terrace, west of Punchbowl station – south side of rail line	<p>LCR encroaches into TEC (17km-470 to 17km-475):</p>

<p>[Key: TEC – purple]</p>
South Terrace, east of Bankstown station – south side of rail line	<p>New fence encroaches into TEC, following existing fence line. Eastern clash (18km030 to 18km-340):</p>

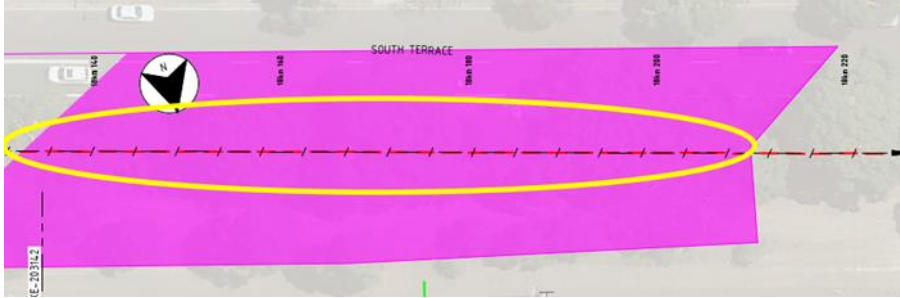
<p>[Key: TEC – purple, fence – black dash]</p> <p>Western clash (18km-270 to 18km-340):</p>

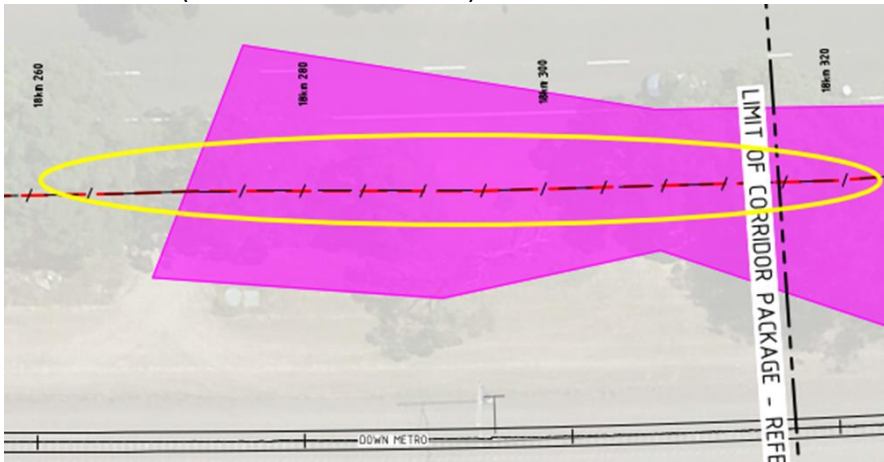
<p>[Key: TEC – purple, fence – black dash]</p>

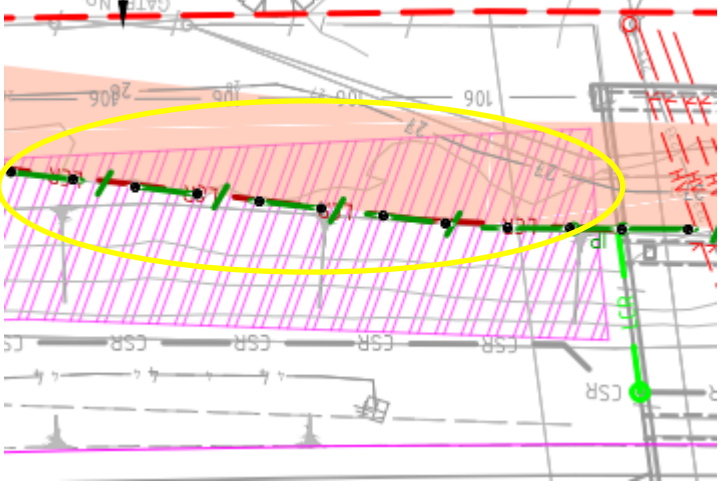
Location	Details of clash
Moreton Street, between Belmore and Lakemba stations – north side of rail line	<p>New fence and LCR clash with TEC (14km-530 to 14km-660).</p>

<p>[Key: TEC – purple hatch Fence – green dash LCR – red dash]</p>

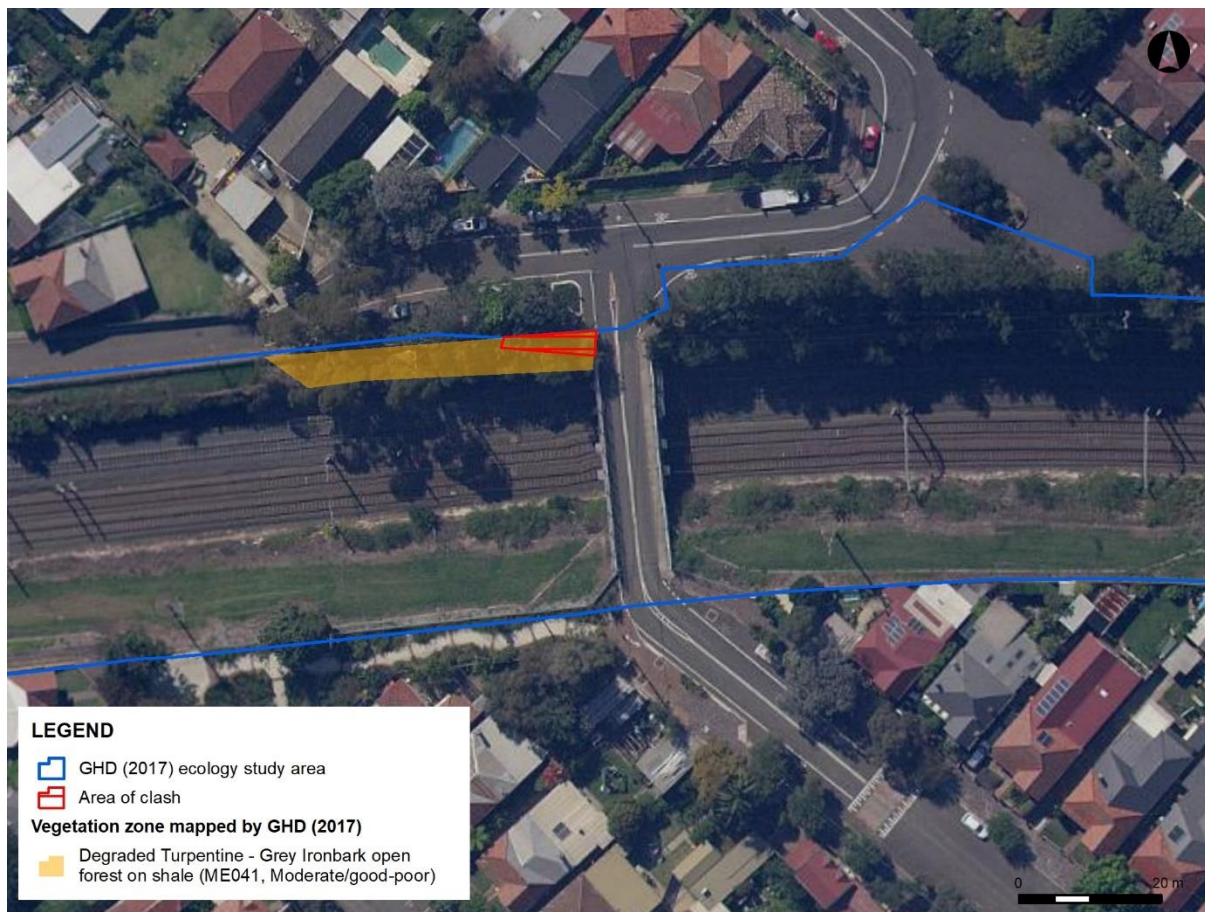
Figure 4-1: Challis Avenue - area of clash

Realignment – trackside – The width of the PCT at this location would preclude realigning the fence trackside.

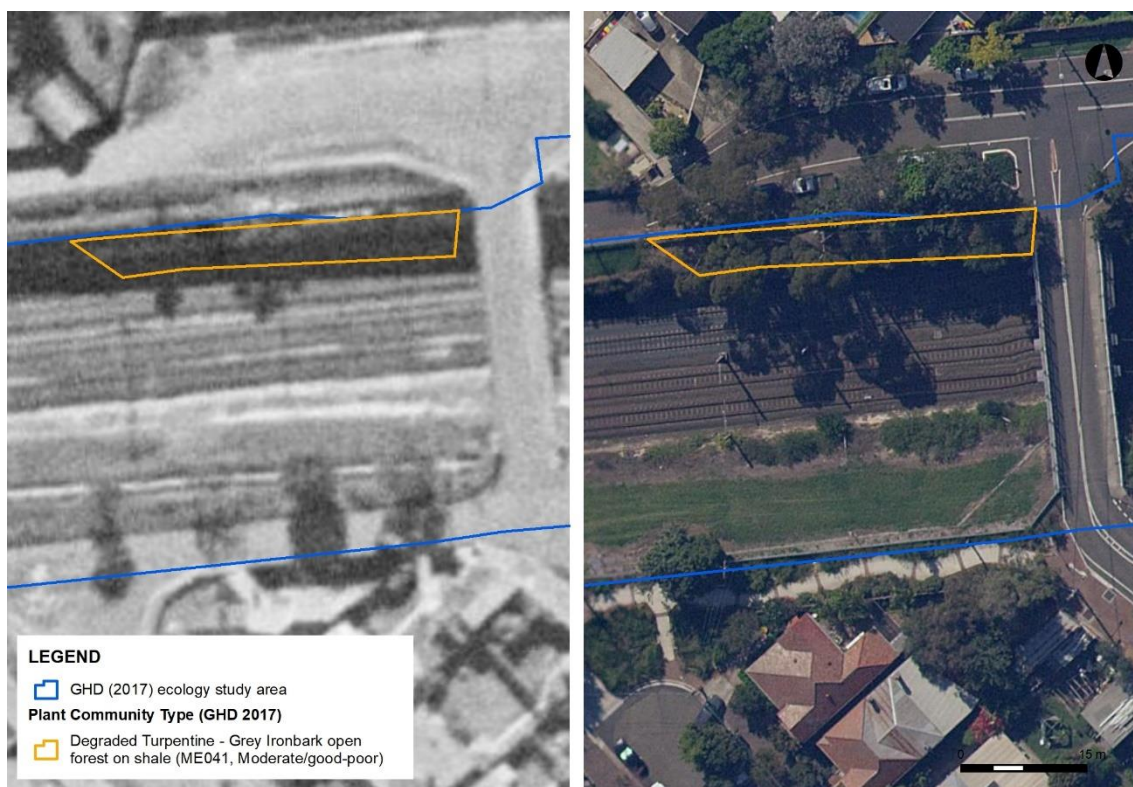
Figure 4-2: Challis Avenue - 1943 historical photo and current aerial photo

The 1943 aerial photograph shows this area appears to be largely cleared, with some small trees or shrubs growing on the rail batter slope, as inferred from shadows visible immediately to the south of the mapped patch. In comparison, the most recent aerial photograph shows dense vegetation across the site including larger tree crowns. Both aerial photographs are shown in Figure 4-2.

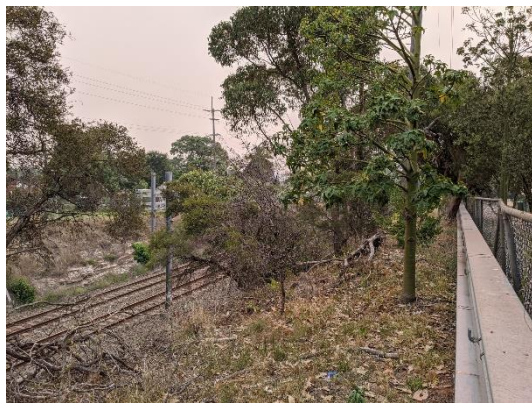
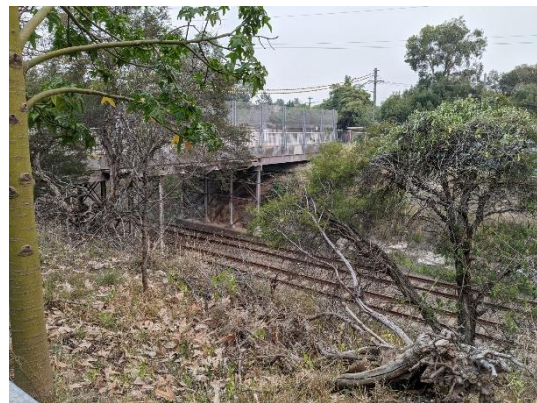
Figure 4-3: Challis Avenue site photos

Scattered shrubs over disturbed groundcover

The mapped patch comprises native shrubs and small trees, most of which are likely to have been planted, over a sparse exotic ground layer. Some shrubs may have regenerated naturally, however given the mixture of native shrub species observed and the absence of native groundcover species across most of the patch, this is unlikely.

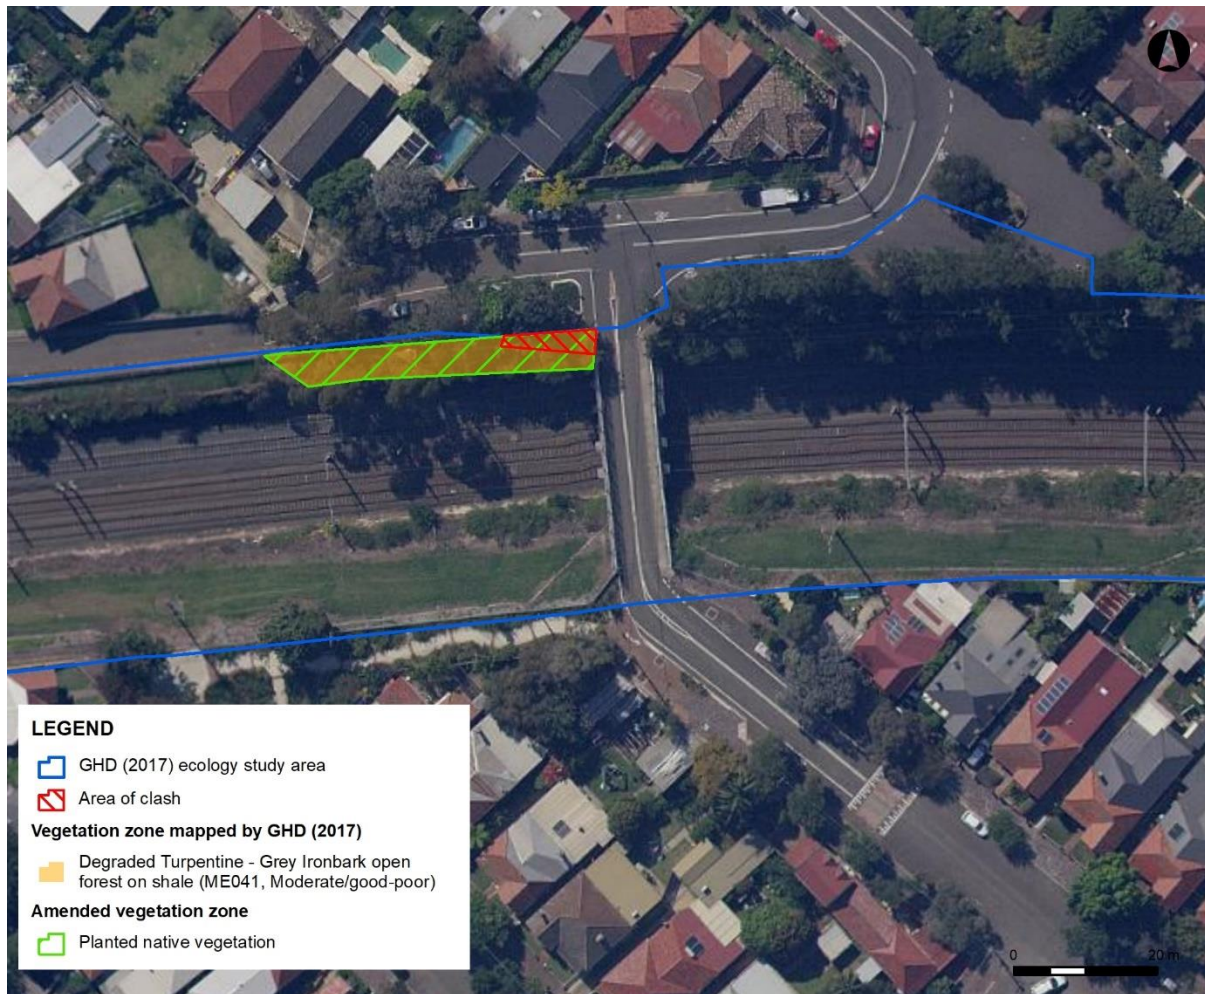
Figure 4-4: Challis Avenue – revised mapping

The remapping of the habitat has removed the clash, and the fence line design is compliant with REMM B1. Undertaking a clash MCA is not considered necessary.

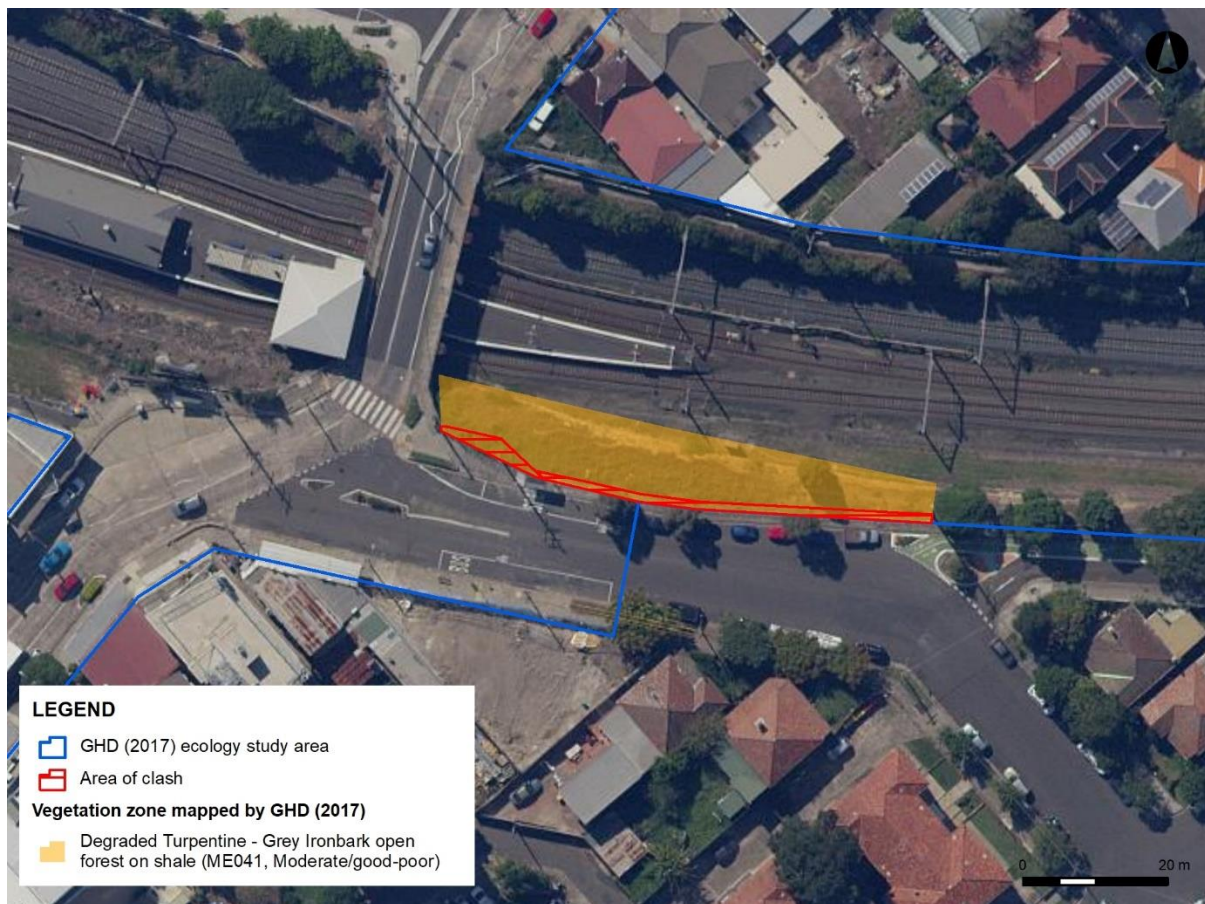
Figure 4-5: Dudley Street - area of clash

Realignment – trackside – The width of the PCT at this location would preclude realigning the fence trackside. Gas pipes and CSR would also constrain the potential for realignment.

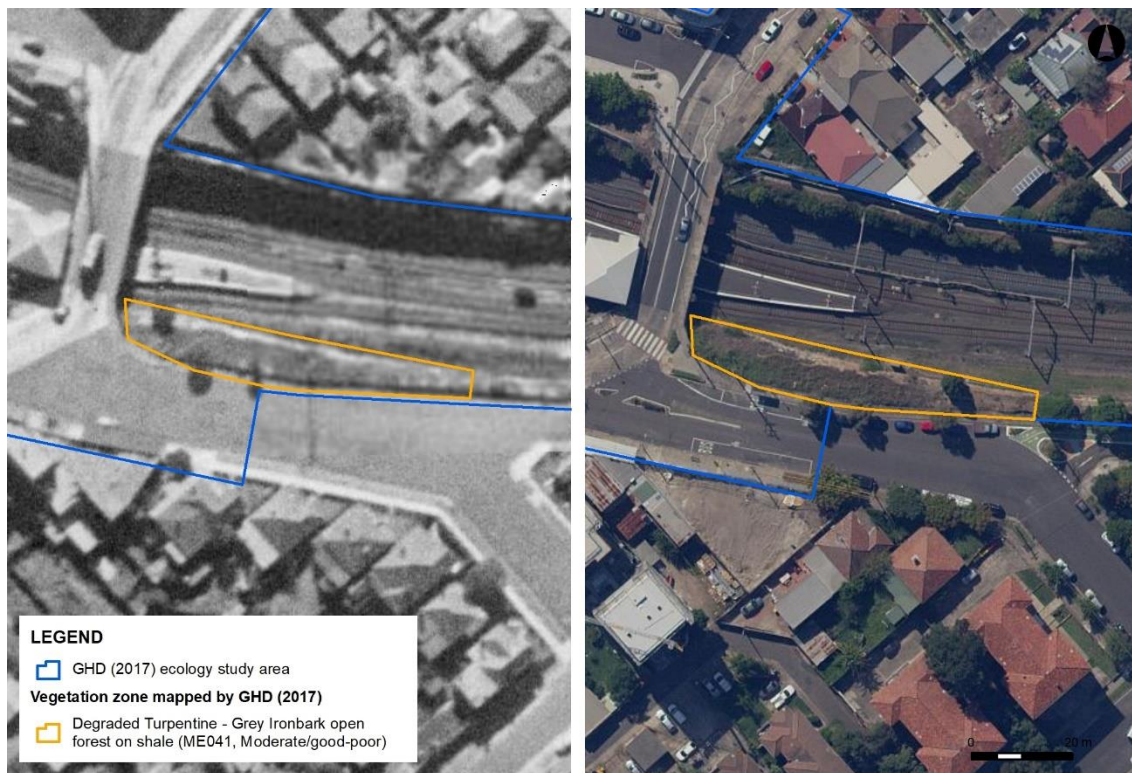
Figure 4-6: Dudley Street – 1943 historical photo and current aerial photo

The 1943 aerial photograph shows this area is largely cleared, with a few small trees or shrubs visible, as shown in Figure 4-6. The current aerial photograph shows the site remains cleared, with one small tree visible in the east.

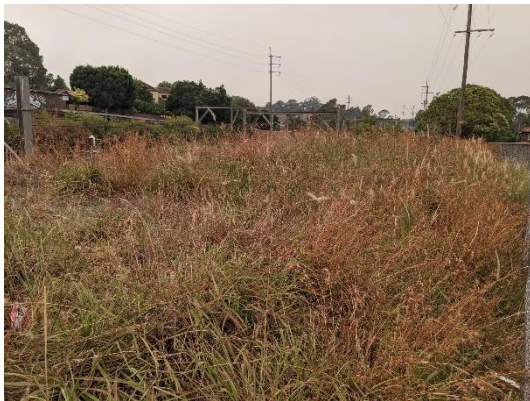
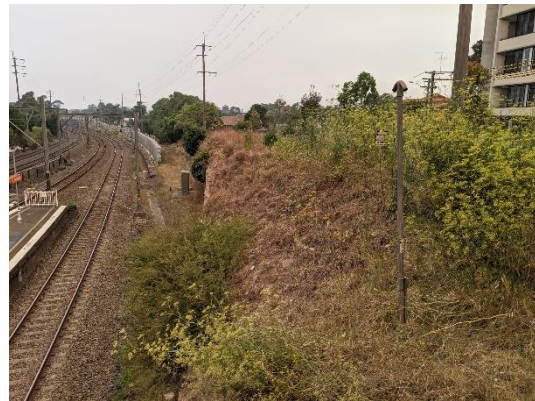
Figure 4-7: Dudley Street site photos

Native grass dominance in east of patch

Exotic dominance in west of patch

The mapped patch comprises patches of native grass interspersed with weedy exotic shrubs, grasses, and herbs. The western 20 metres of this patch does not appear to be native vegetation, with exotic species dominant. It is possible that the native grass in the central and eastern parts of the patch has been planted, but it may have regenerated from retained soils on the site. The native grassland is considered significant given that it is likely to be one of the only patches of native grass in the locality and is used by Council as a seed collection site. A 1-2 metre strip along the southern boundary of the patch is pavement outside the fenced area.

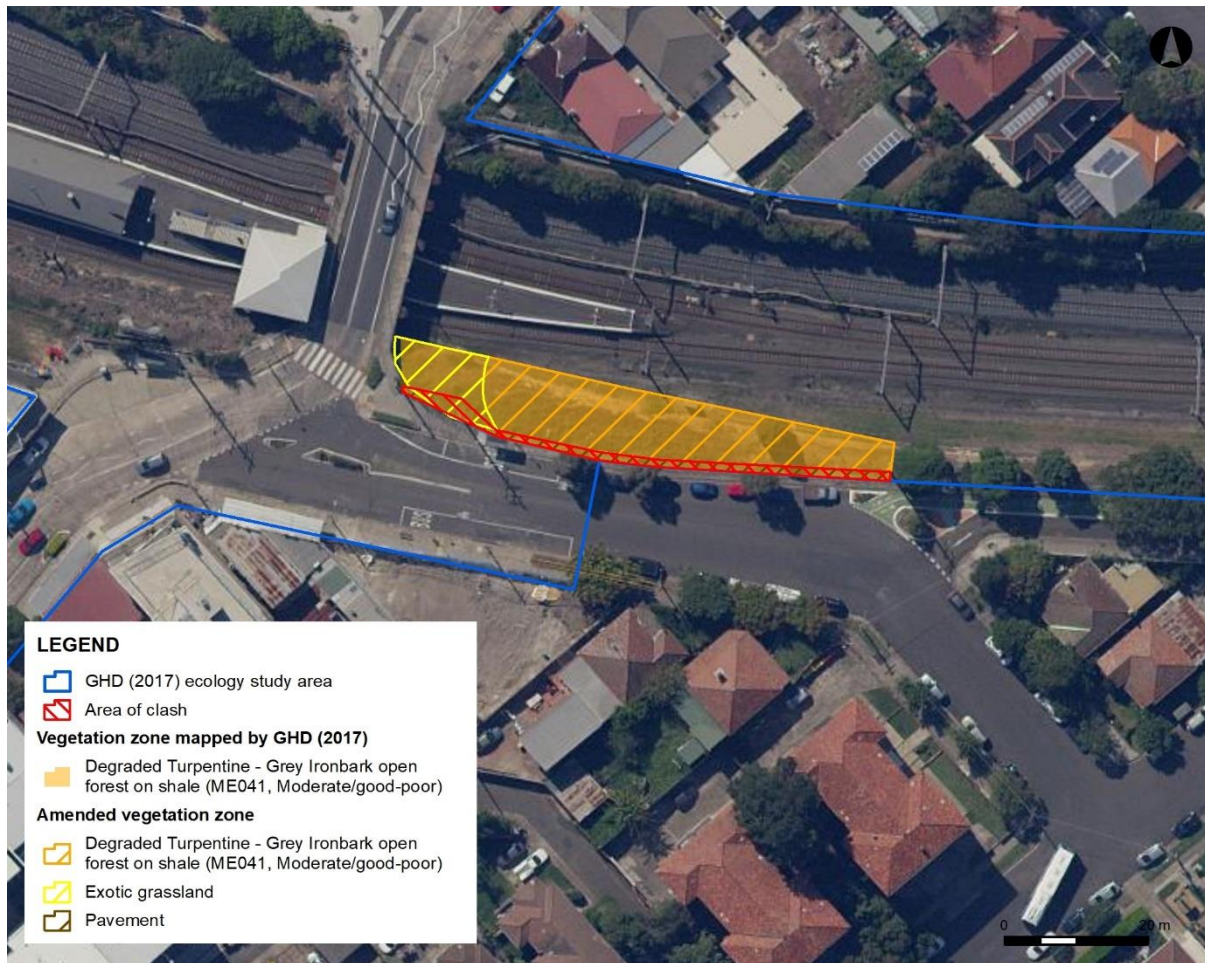
Figure 4-8: Dudley Street – revised mapping

The remapping of the habitat has removed the clash, and the fence line design is compliant with REMM B1. Undertaking a clash MCA is not considered necessary.

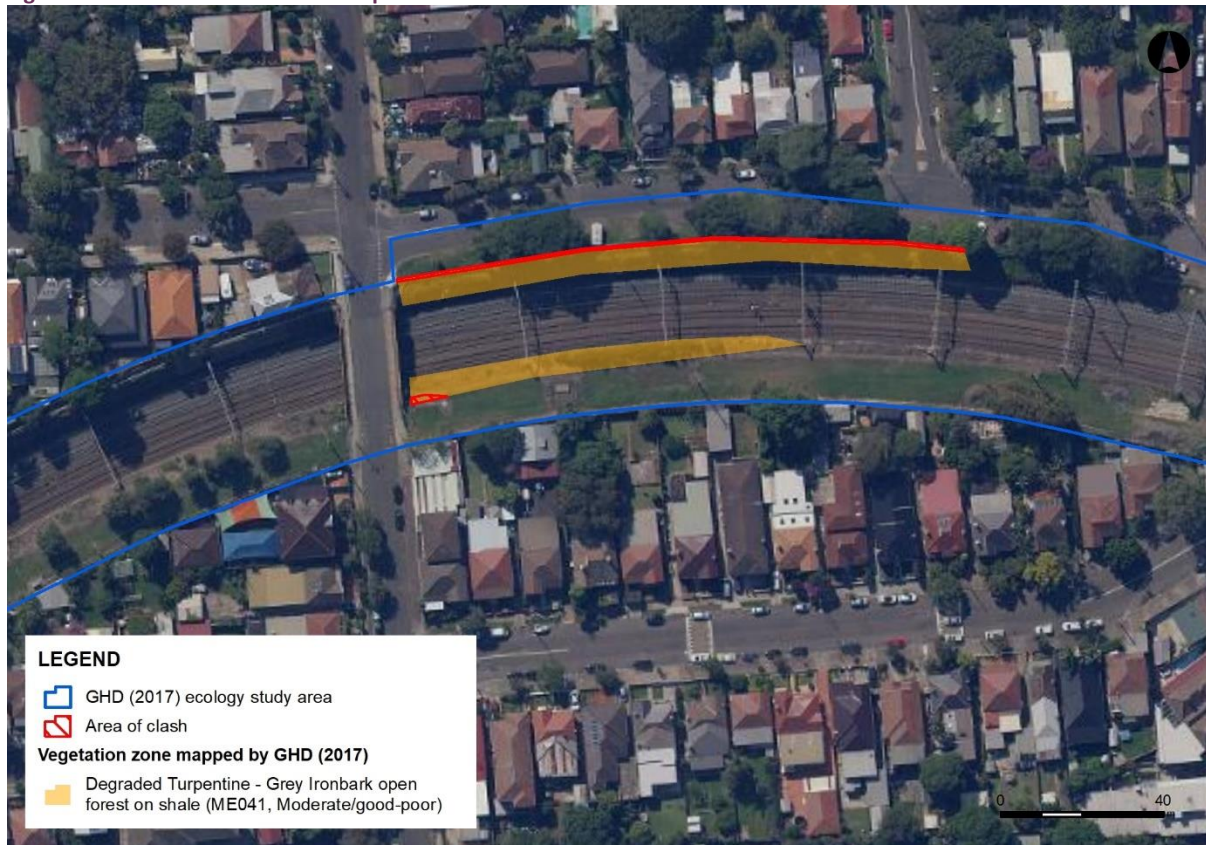
Figure 4-9: Garnet Street - area of impact

Fence realignment (north side) – trackside – The width of the PCT at this location would preclude realigning the fence trackside.

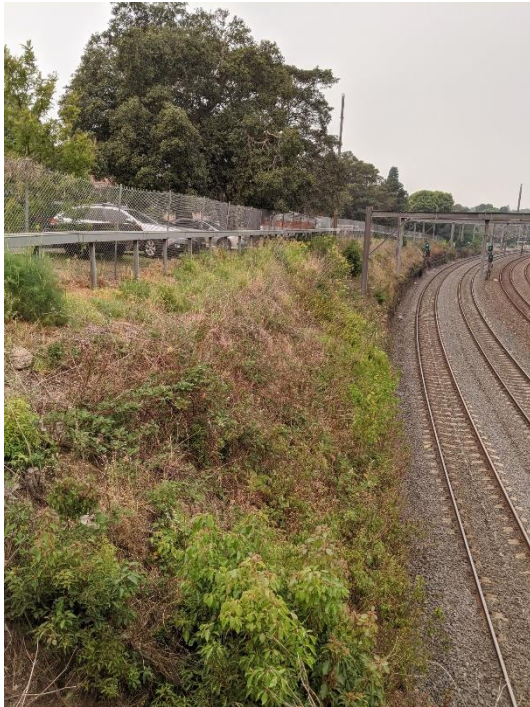
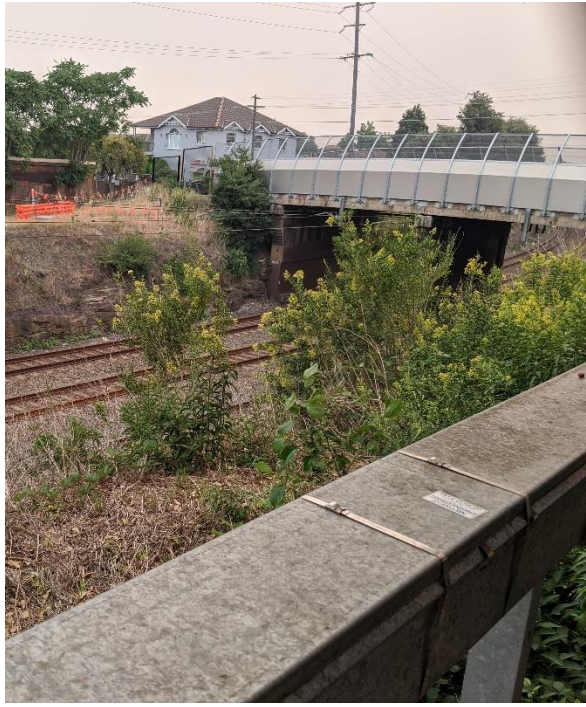
Figure 4-11: Garnet Street site photos

Exotic vegetation on north side of rail line

The mapped patch comprises exotic shrubs, grasses, and herbs. It is possible that a native ground layer component is present, however no native species were observed within the area inspected. This vegetation is not considered to be consistent with Degraded Turpentine – Grey Ironbark open forest on shale (ME041, Moderate/good – poor), as mapped by GHD (2017), or any other PCT. The classification of this entire 0.09 ha patch of vegetation has been revised to Exotic scrub or forest (Figure 4-12), which has removed the clash.

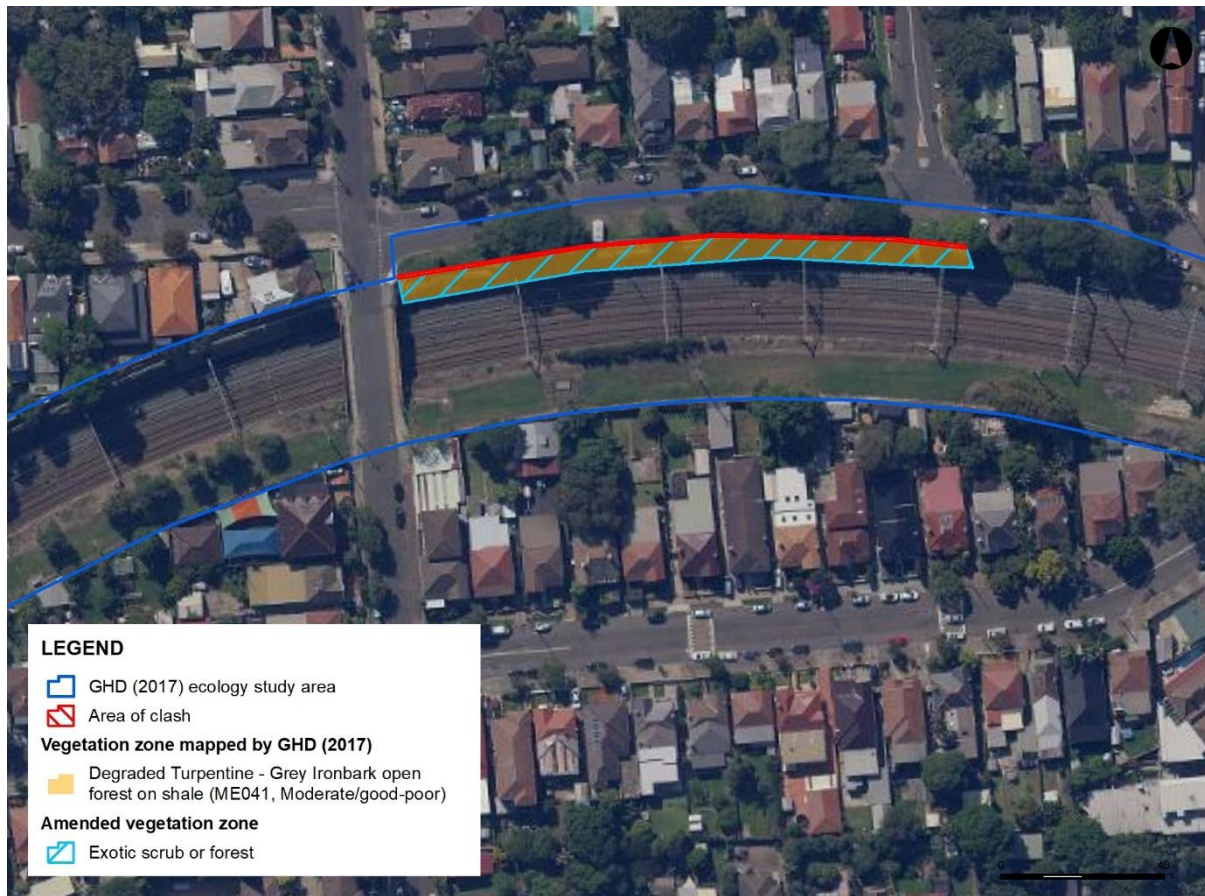
Figure 4-12: Garnet Street – revised mapping

The remapping of the vegetation has removed the fence clashes, and the design is compliant with REMM B1. Undertaking a clash MCA is not considered necessary.

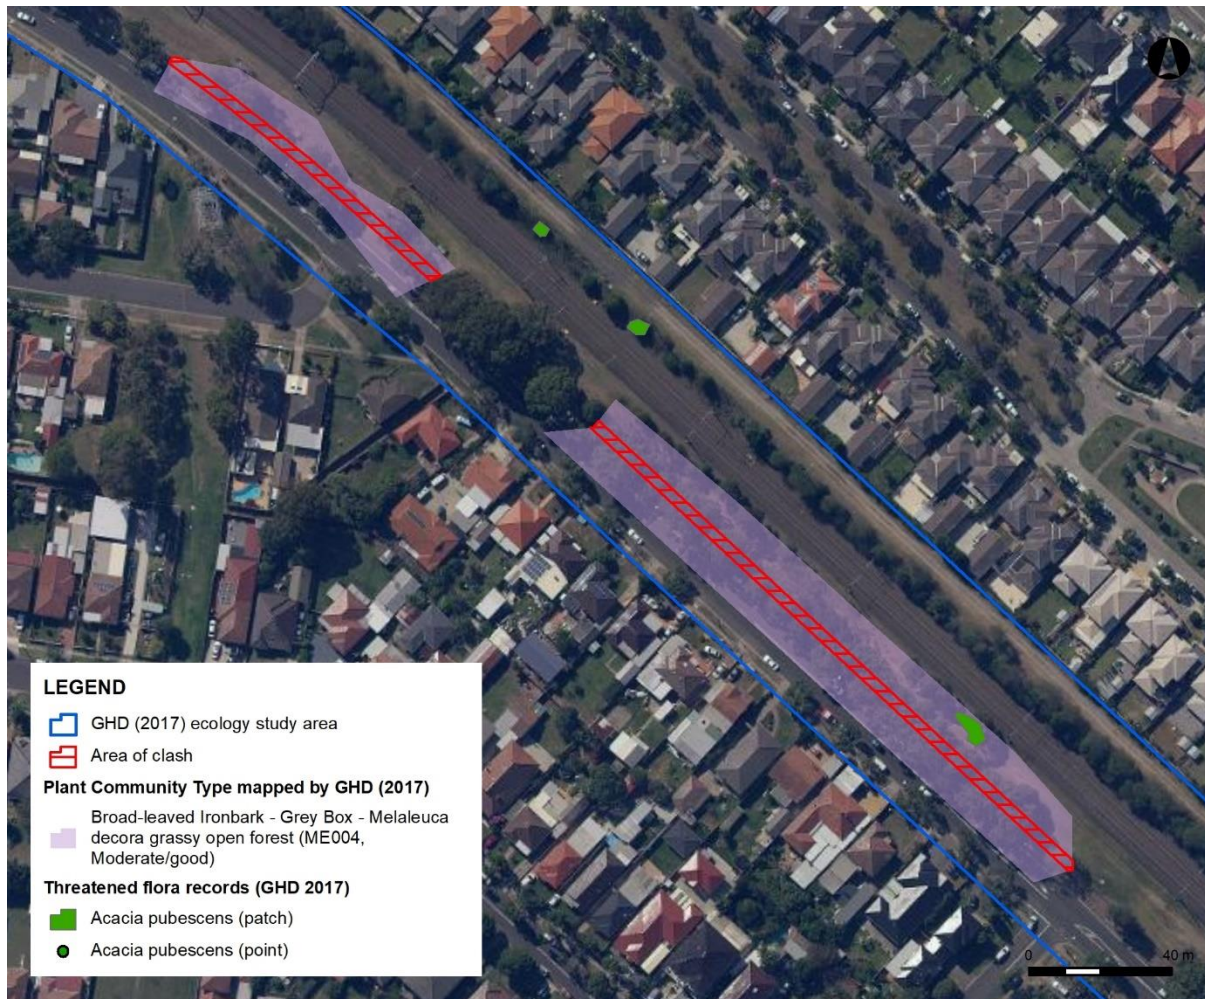
Figure 4-16: South Terrace (east of Bankstown Station) - area of clash

Realignment – trackside – The south-eastern patch of the TEC is wide, terminating close to the rail track. Its proximity could preclude the re-alignment of the fence trackside.

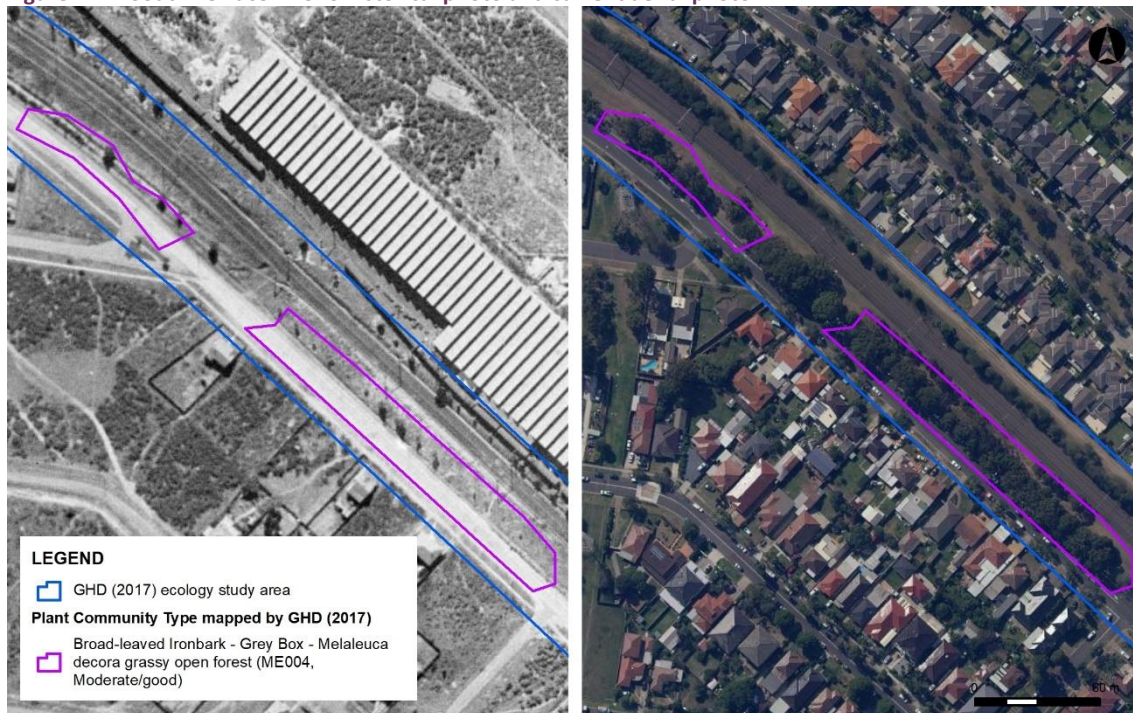
Figure 4-17: South Terrace – 1943 historical photo and current aerial photo

The 1943 aerial photograph (Figure 4-17) shows this area is partly cleared road reserve and partly cleared grassland, with a row of planted trees visible along the fence line. The current photo shows dense cover of tree crowns across most of the site.

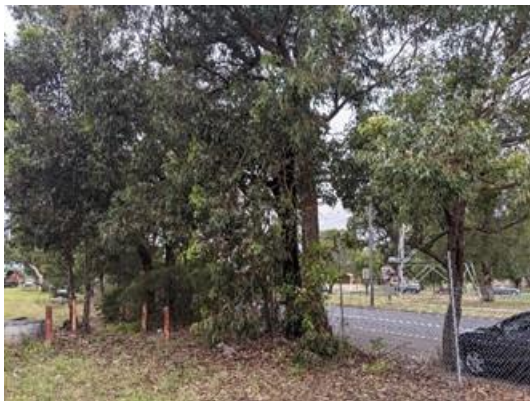
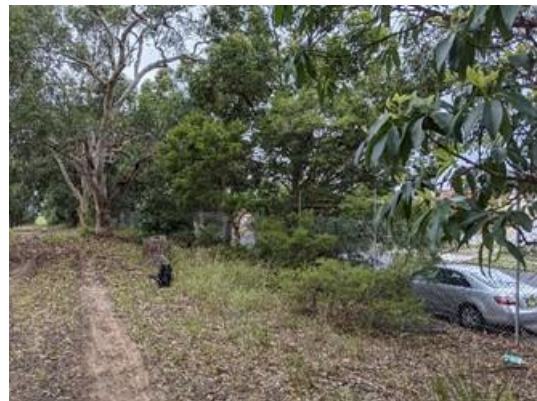
Figure 4-18: South Terrace site photos

Trees of *Eucalyptus fibrosa* in north-western patch

Northern extent of south-eastern patch; existing haul road visible on left

GHD (2017) calculated a site value score of 38.54 for areas of vegetation mapped as Broad-leaved Ironbark – Grey Box – *Melaleuca decora* grassy open forest (ME004, Moderate/good), using data collected from two locations, including South Terrace, in 2016. Assessment of data collected from the patch at South Terrace in 2020 calculated a site value score of 33.16, which is above the FBA offset threshold for threatened ecological communities.

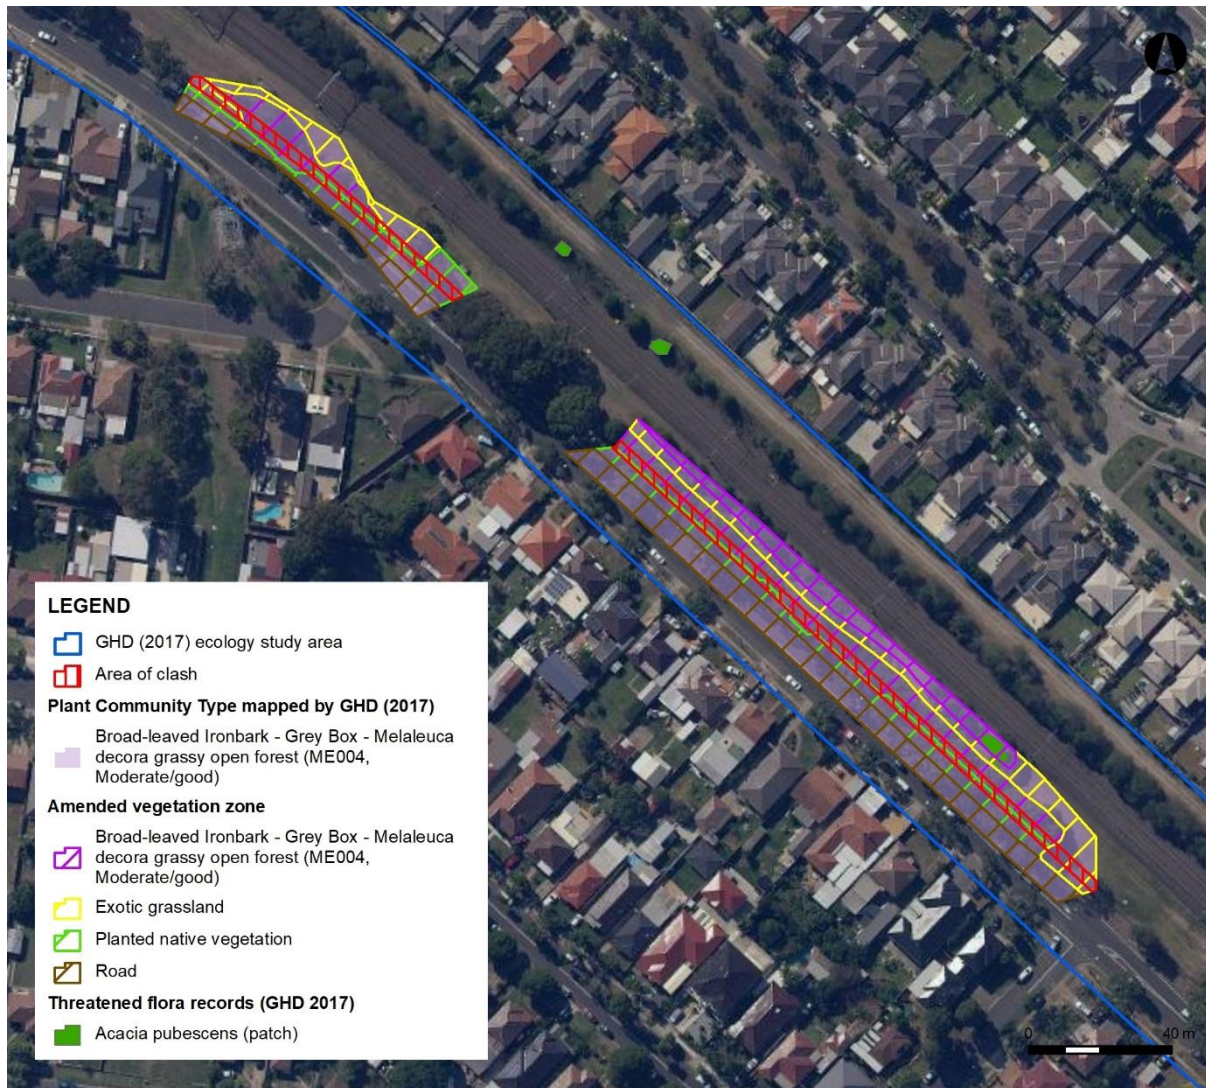
Figure 4-19: South Terrace – revised mapping

The installation of the new fence along the existing alignment would result in disturbance of some areas of TEC along South Terrace. This disturbance would form a direct impact to the TEC.

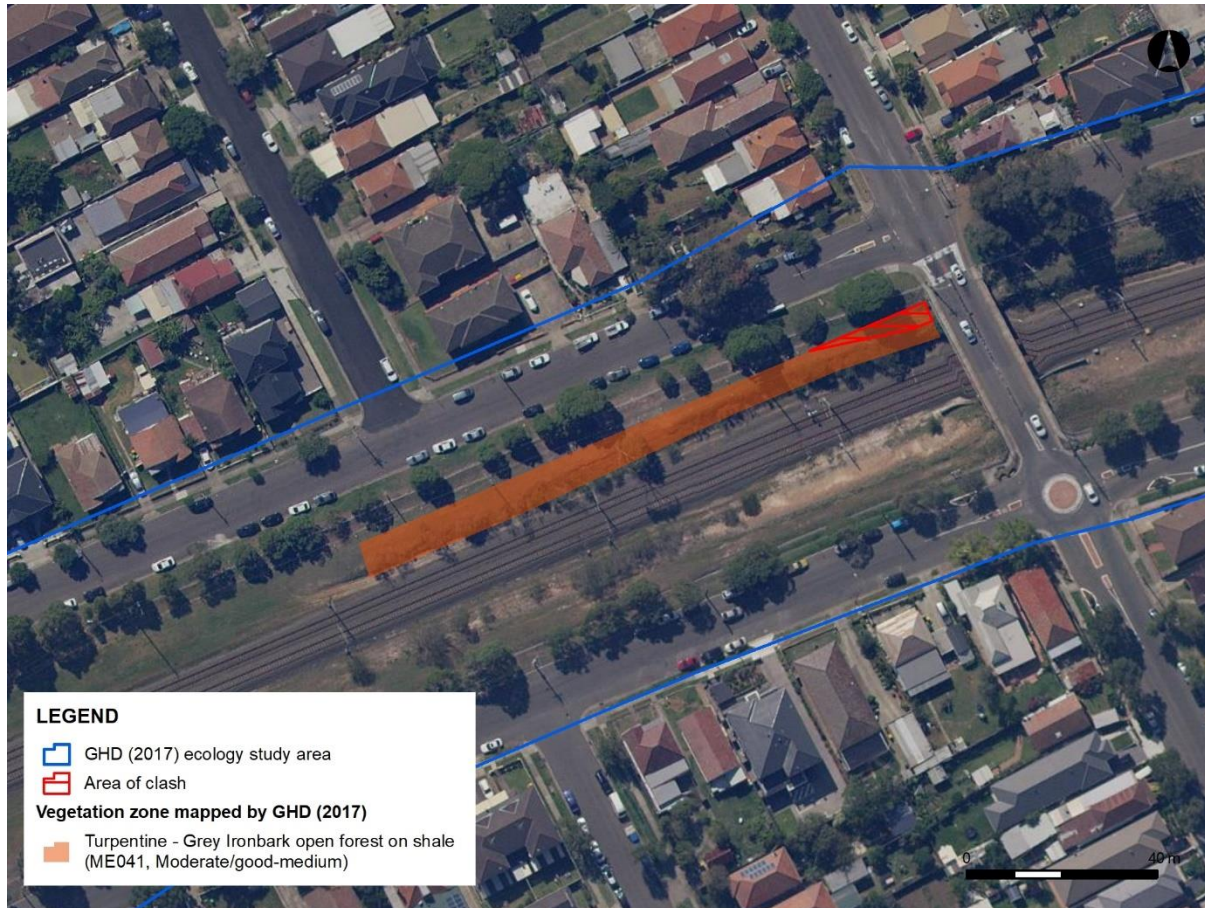
Figure 4-20: Moreton Street (between Belmore and Lakemba stations) - area of clash

Realignment – trackside – The width and length of the habitat at this location would preclude realigning the fence or LCR trackside.

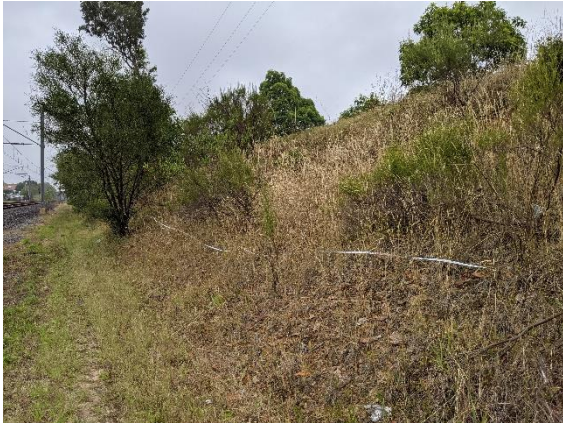
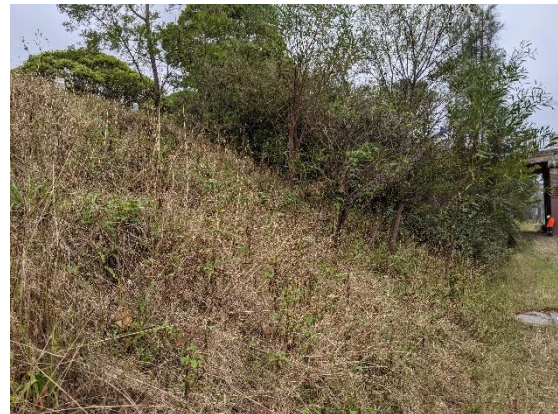
Figure 4-22: Moreton Street site photos

Native grass dominant in central section of patch

Exotic dominated vegetation in north-east of patch

GHD (2017) calculated a site value score of 39.58 for areas of vegetation mapped as Turpentine – Grey Ironbark open forest on shale (ME041, Moderate/good), using data collected from two locations, including Moreton Street, in 2016. Assessment of data collected from the patch at Moreton Street in 2020 calculated a site value score of 15.8, which is below the FBA offset threshold for threatened ecological communities.

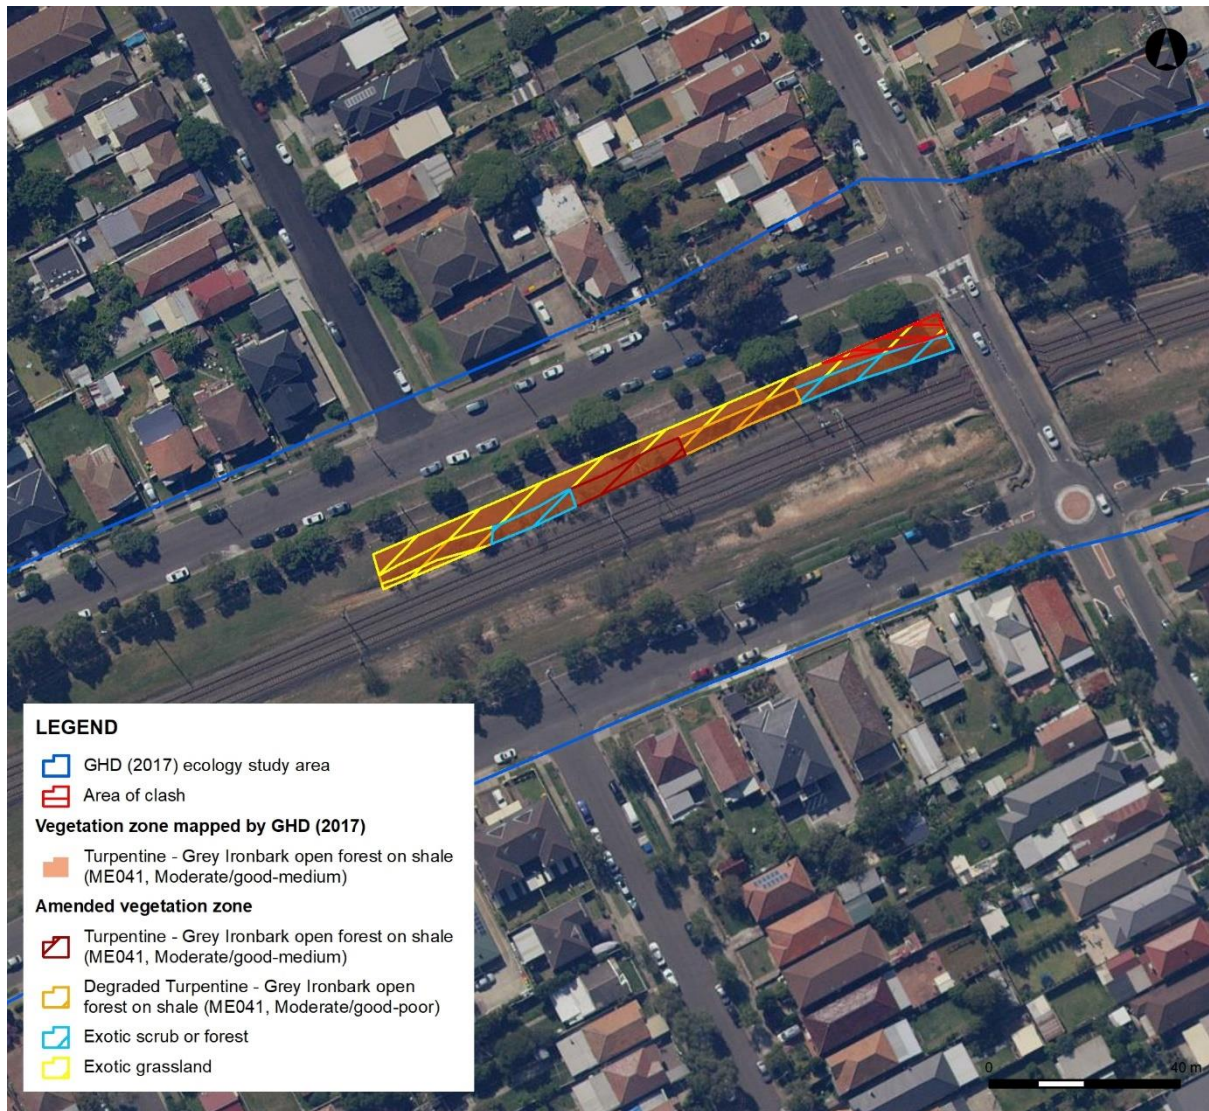
Figure 4-23 Moreton Street – revised mapping

The remapping of the vegetation has removed the fence clashes, and the design is compliant with REMM B1. Undertaking a clash MCA is not considered necessary.
