Planning Approval Consistency Assessment Form

Assessment name:	SMDS Corridor Design Clashes
Prepared by:	Jonny Steele – Metron T2M Dan Keegan - JHLOR
Prepared for:	Sydney Metro – Southwest Metro Corridor Works
Assessment number:	SWM013
Status:	Final
Version:	02
Planning approval:	SSI-8256
Date required:	25/06/21
iCentral number:	SM-21-00036038
© Sydney Metro 2020

Appendix A – Location of identified design clashes and consolidation of habitats following ecological inspection

Appendix B – Threatened Ecological Community Clash Detection Report

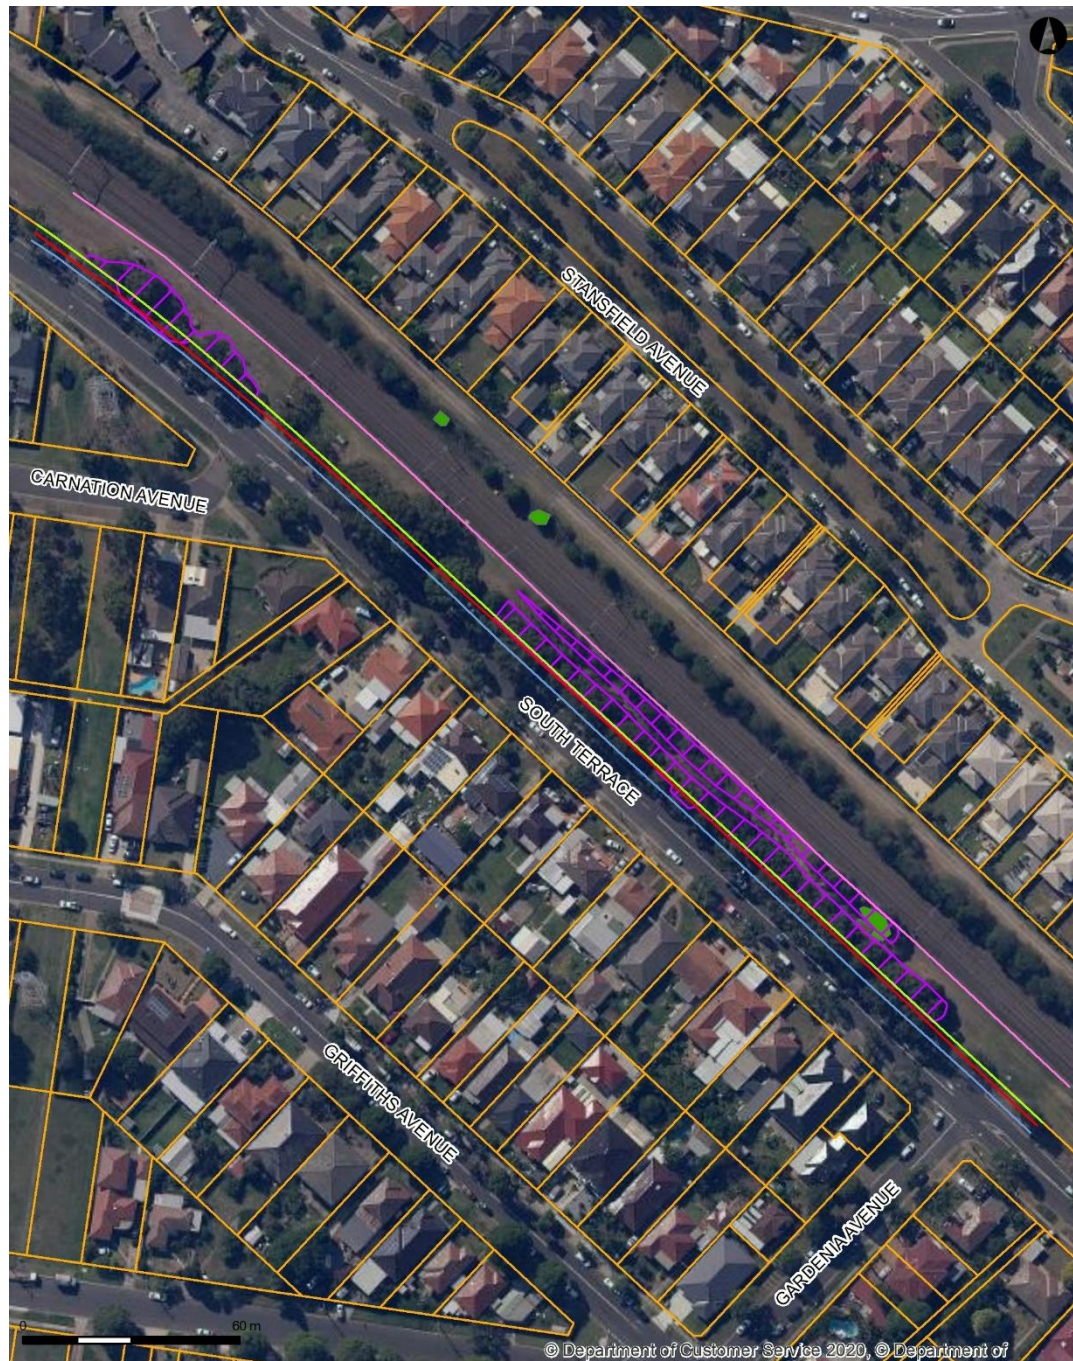
The indicative alignments of options 1 to 4 are shown in Figure 1.

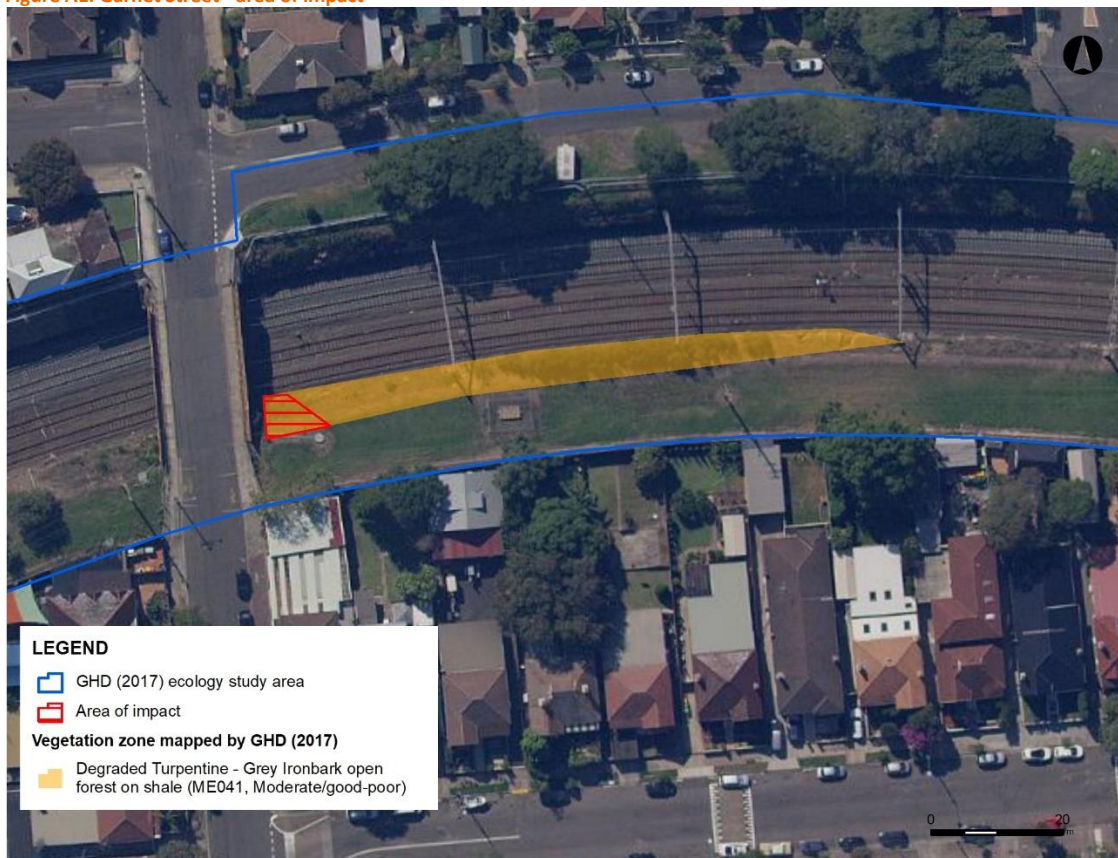
Figure A1: Garnet Street - area of impact

The site was inspected on 19 December 2020 by Jane Rodd, Senior Ecologist. The mapped patch of Degraded Turpentine – Grey Ironbark open forest on shale on the south side of the rail line consists of a steep slope with dense cover of exotic groundcover species, including *Ageratina adenophora* (Crofton Weed), *Plantago lanceolata* (Plantain), *Paspalum dilatatum* (Paspalum), *Avena sp.* (Oatgrass), *Eragrostis curvula* (African Lovegrass), *Gomphocarpus fruticosus* (Narrow-leaved Cotton Bush), *Briza maxima* (Quaking Grass) and the widely planted cosmopolitan native grass species *Cynodon dactylon* (Couch).

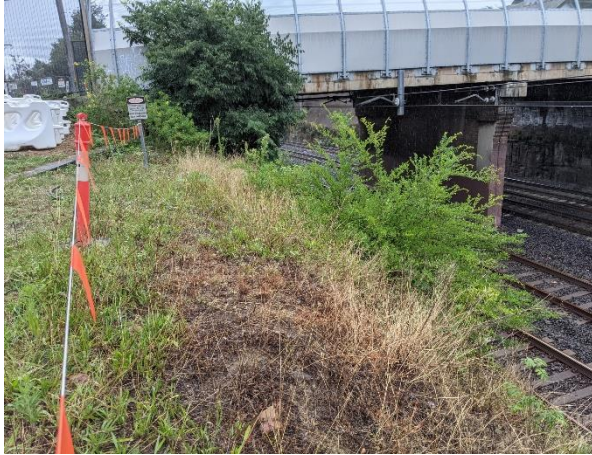
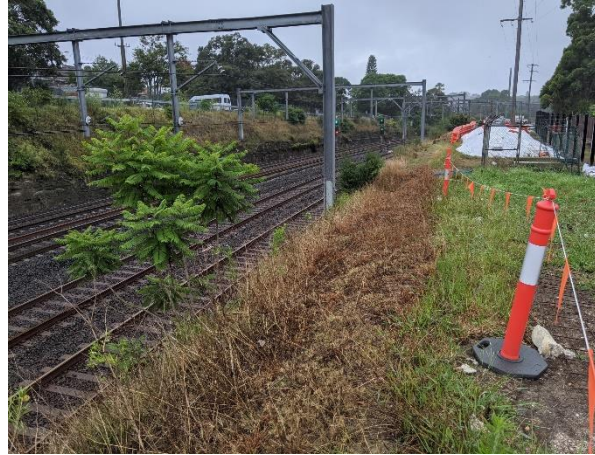
Figure A2: Garnet Street site photos

Exotic vegetation on south side of rail line (looking west towards Garnet Street overbridge)

Exotic vegetation on south side of rail line (looking east)

The mapped patch is dominated by exotic trees and shrubs, grasses, and herbs. It is possible that a native ground layer component is present, however few native species were observed within the area inspected. This vegetation is not considered to be consistent with Degraded Turpentine – Grey Ironbark open forest on shale (ME041, Moderate/good – poor), as mapped by GHD (2017), or any other PCT. The classification of this entire 0.05 ha patch of vegetation has been revised to Exotic scrub or forest (

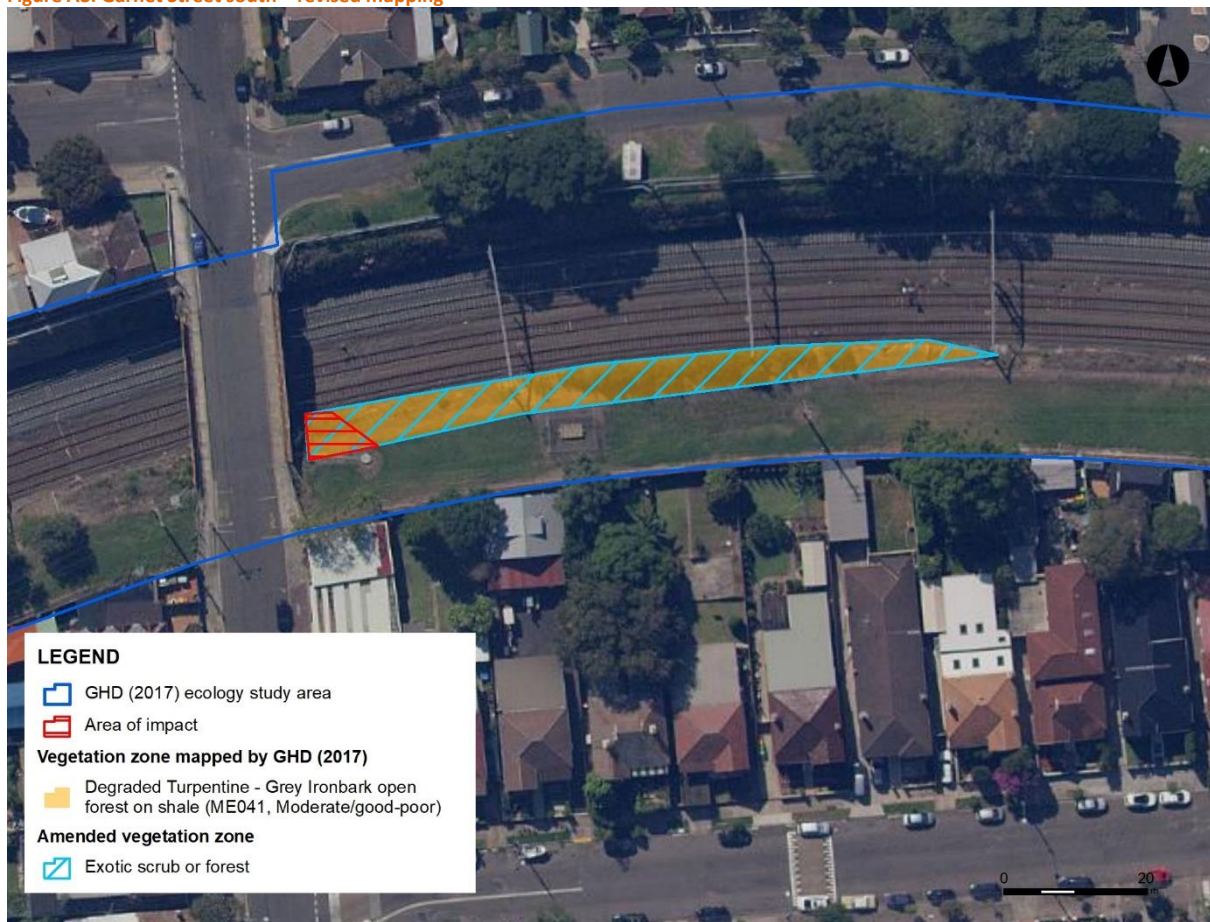
Figure A3: Garnet Street south – revised mapping

The remapping of the vegetation has removed the fence clashes, and the design is compliant with REMM B1. Undertaking a clash MCA is not considered necessary.

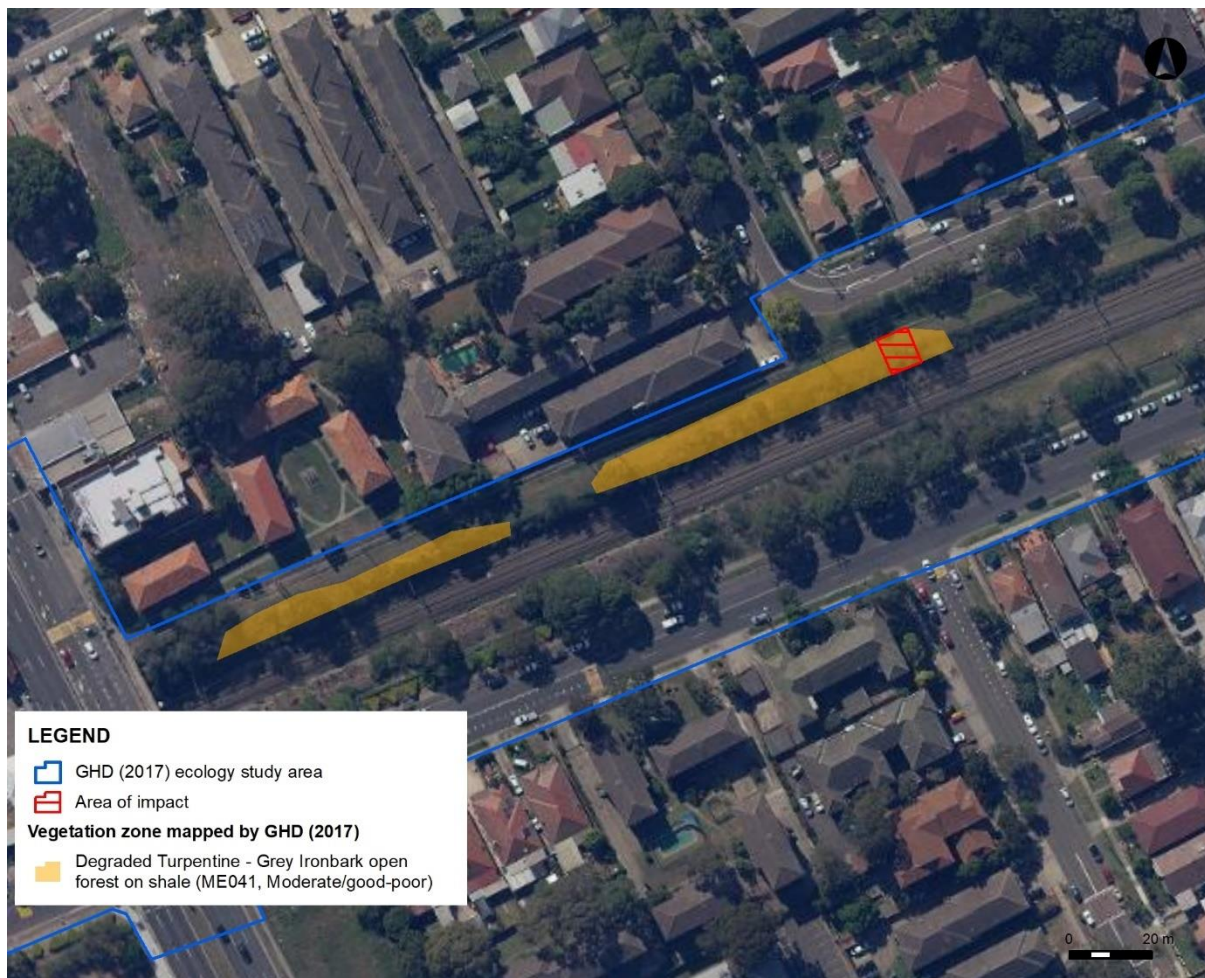
Figure A4: Railway Parade - area of clash

The site was inspected on 19 December 2020 by Jane Rodd, Senior Ecologist. Patch was inspected from the top of the slope, as the middle and lower sections of the slope could not be safely accessed. The areas in the south-west of the patch were not able to be inspected in detail due to the dense shrub cover at the top of the slope.

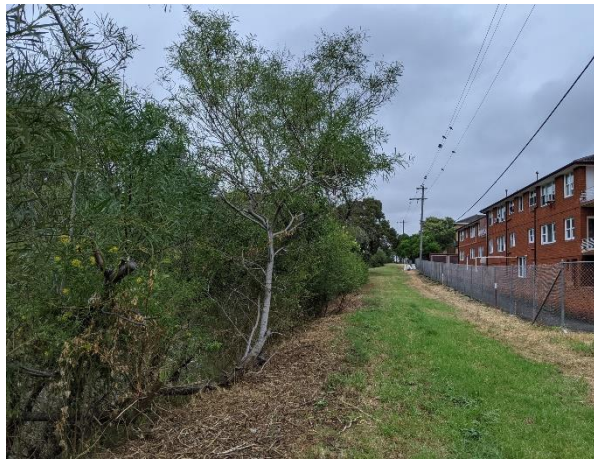
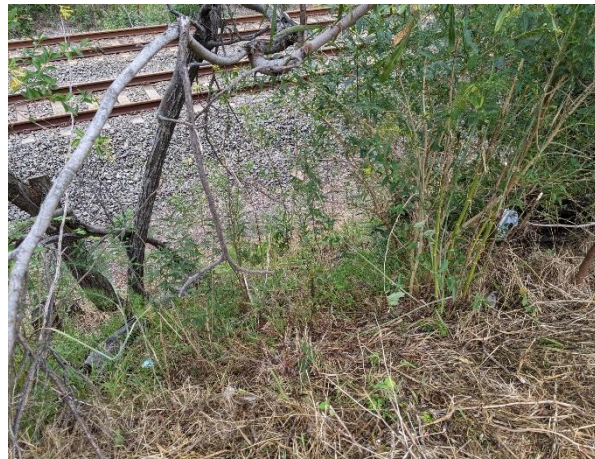
Figure A5: Railway Parade site photos

Vegetation dominated by *Acacia saligna* (looking south-west)

Ground layer of vegetation in the east of the patch
