# Southwest Metro Sydenham to Bankstown – Construction Heritage Management Plan

SMCSWSSJ-JHL-WEC-EM-PLN-000013

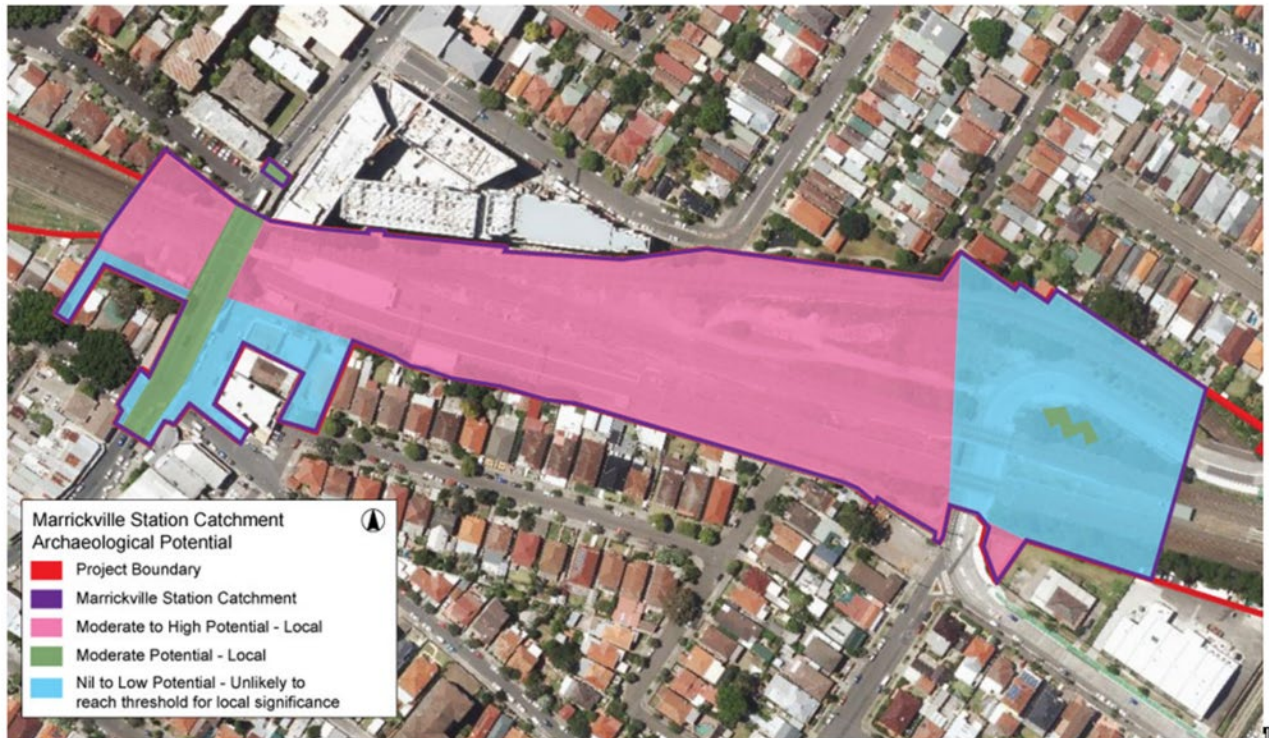
**Figure 4-16: Archaeological potential at Marrickville Station**

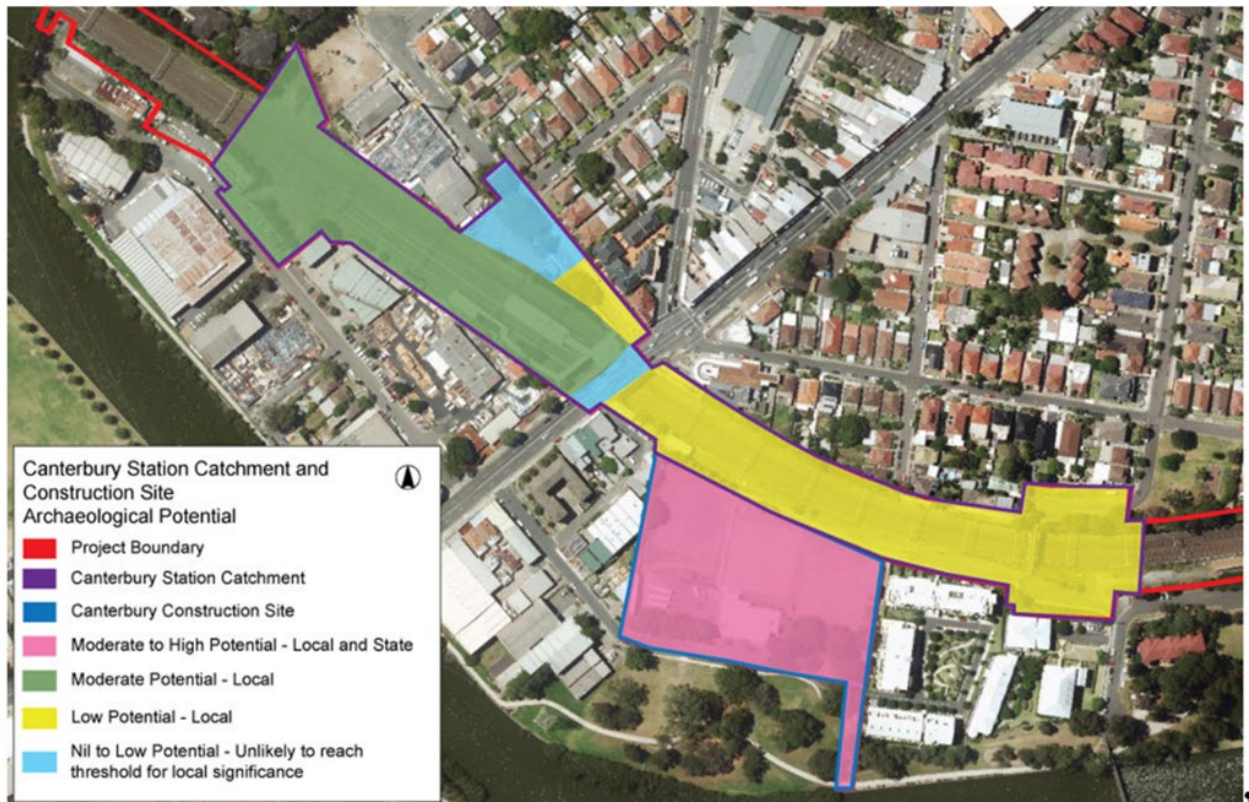
**Figure 4-17: Archaeological potential at Canterbury Station**

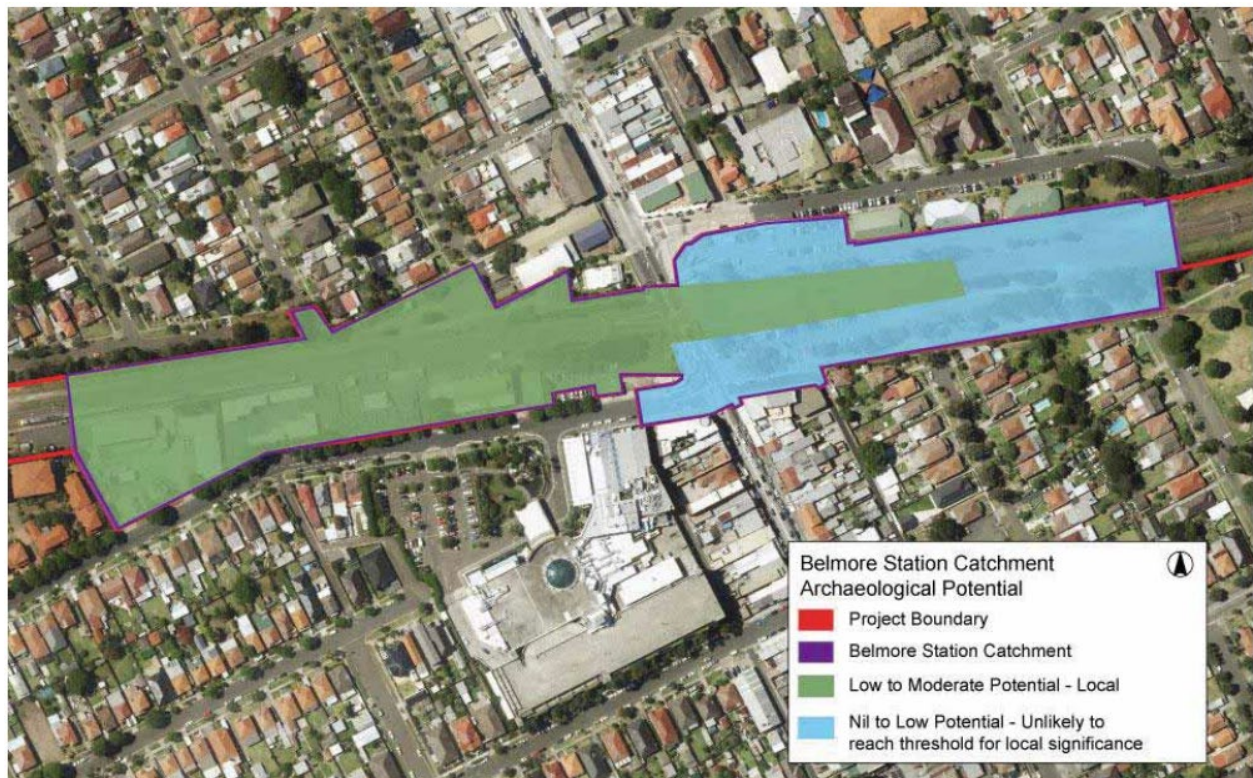
Figure 4-18: Archaeological potential at Belmore Station

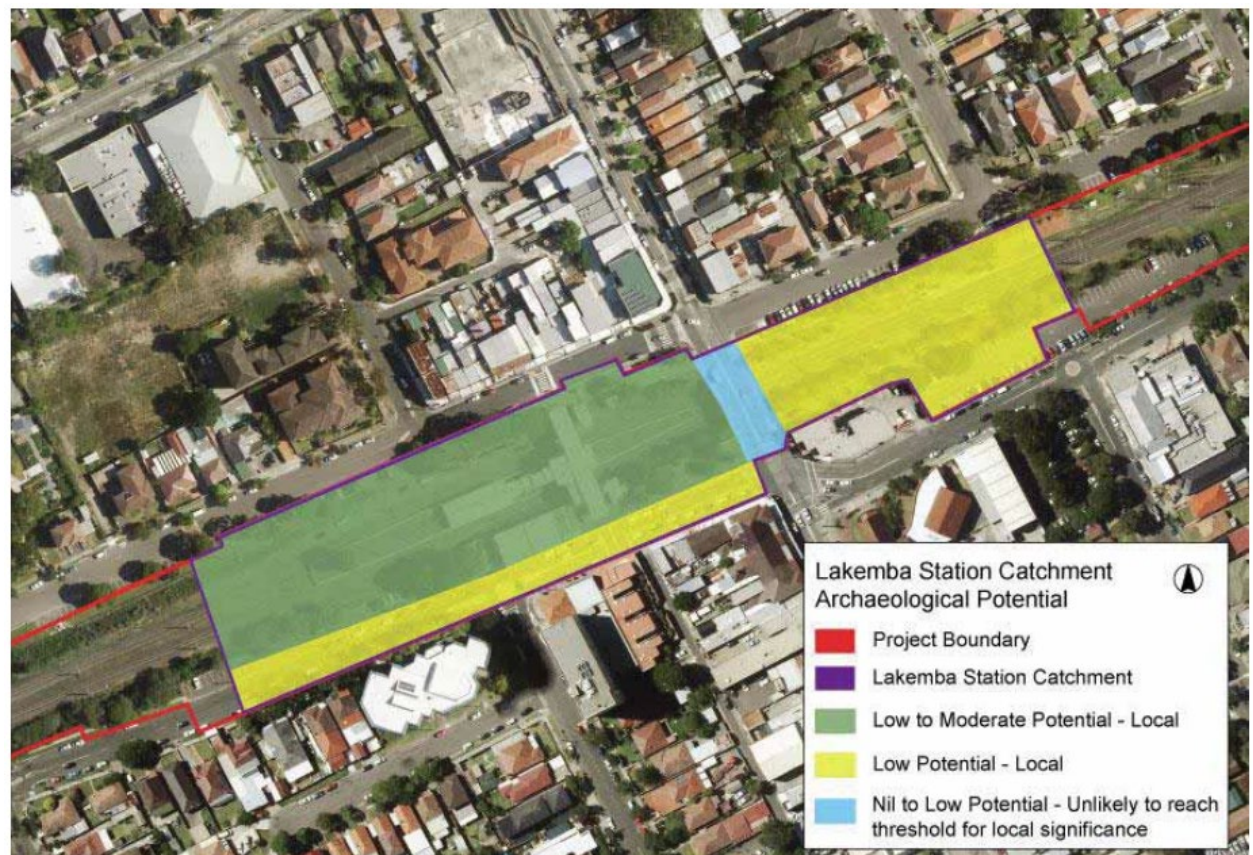
Figure 4-19: Archaeological potential at Lakemba Station

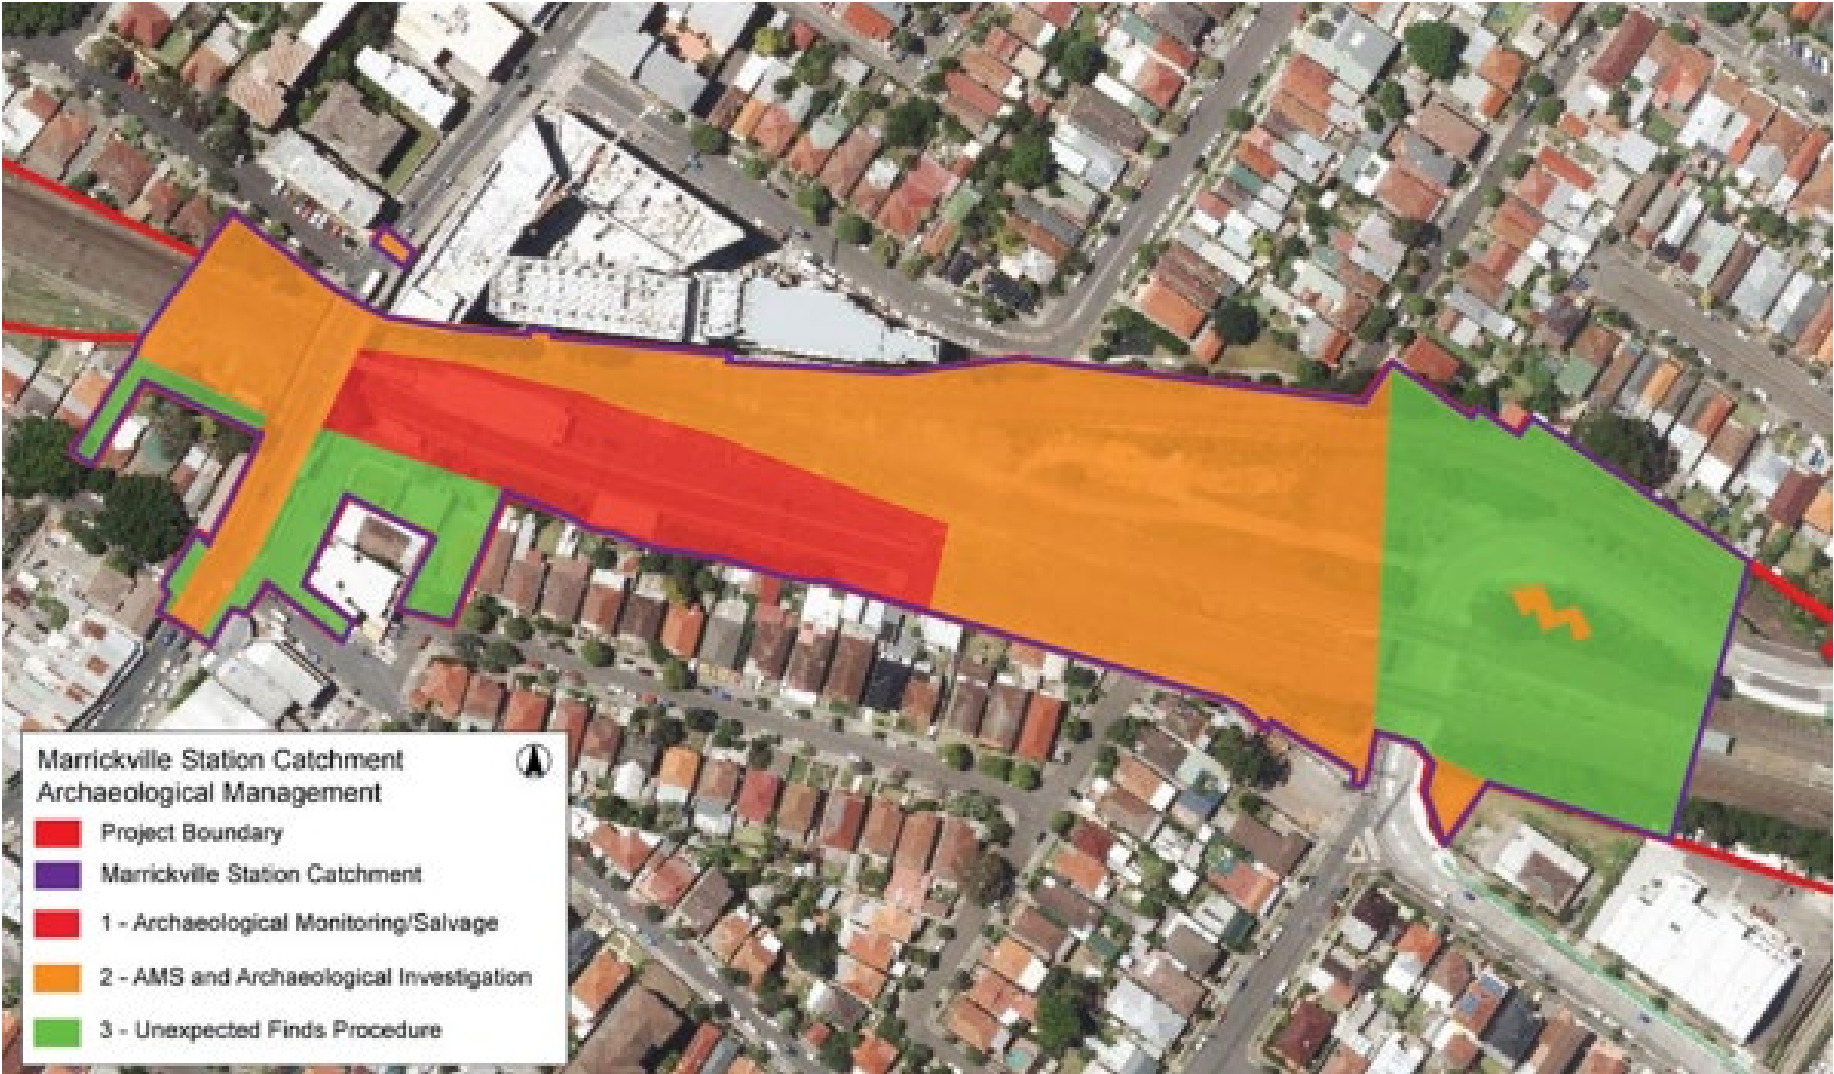
Figure 6-1 Archaeological Management zoning for Marrickville Station (Artefact Heritage 2017c)

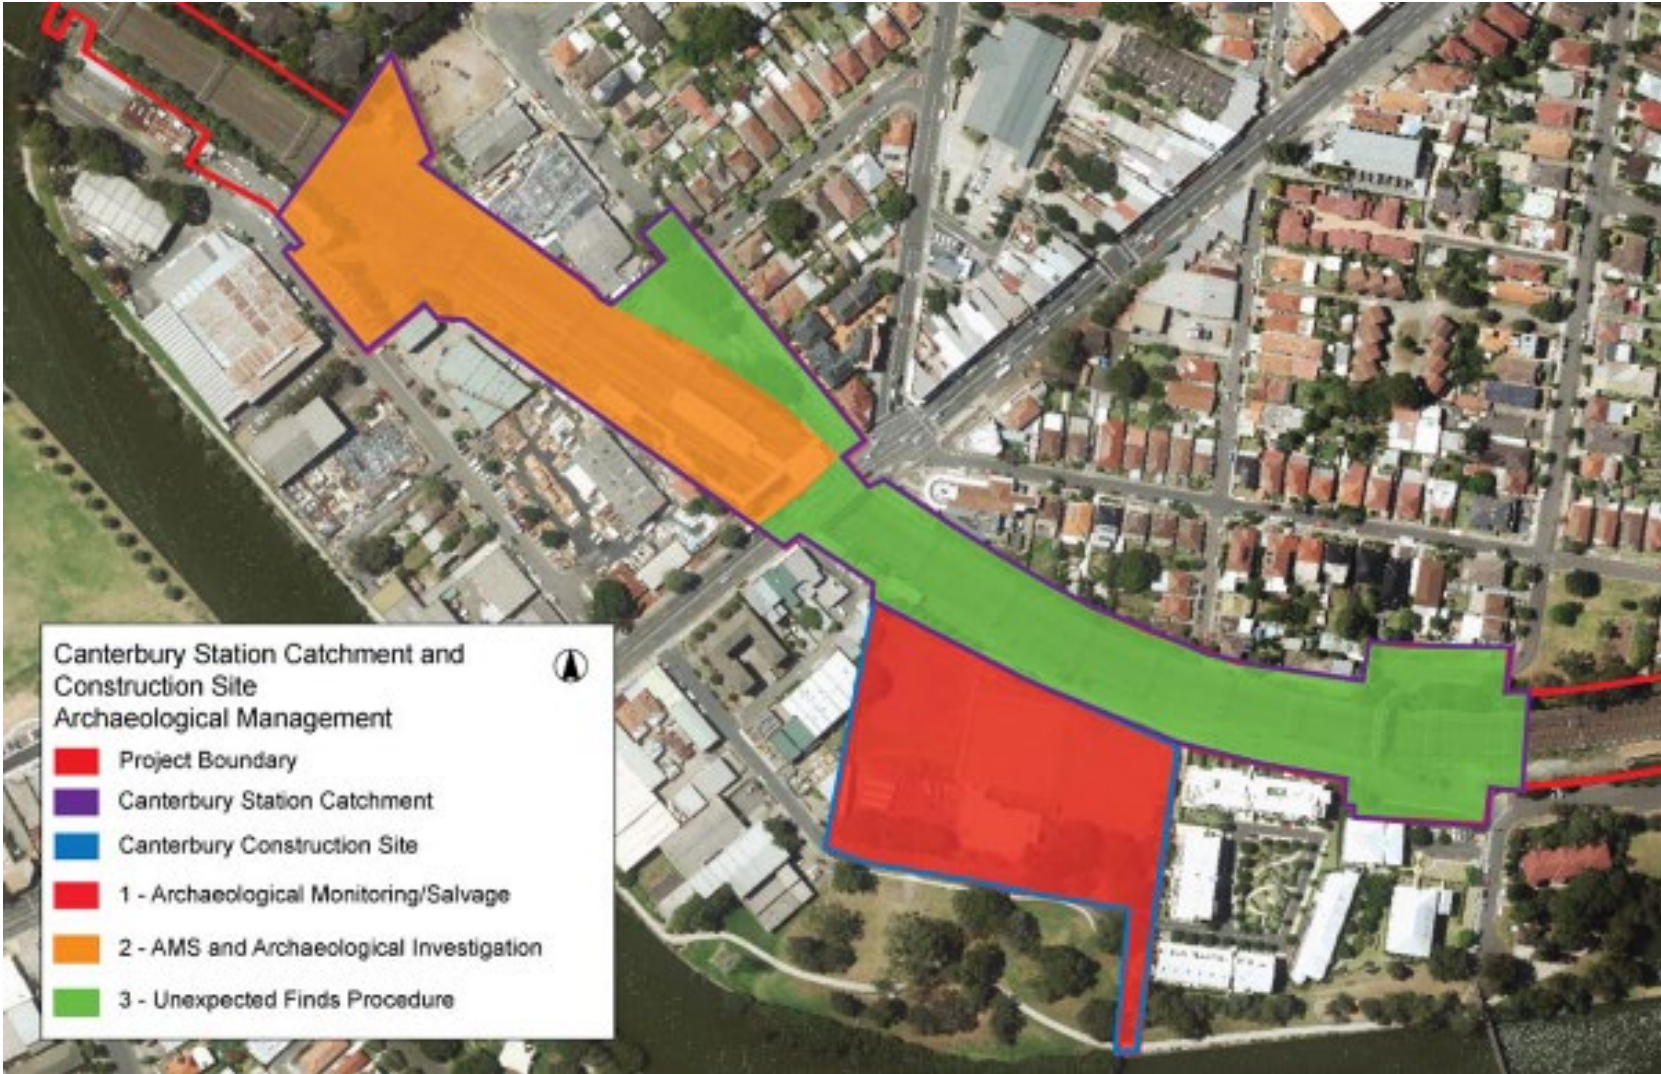
Figure 6-2 Archaeological Management zoning for Canterbury Station (Artefact Heritage 2017c)

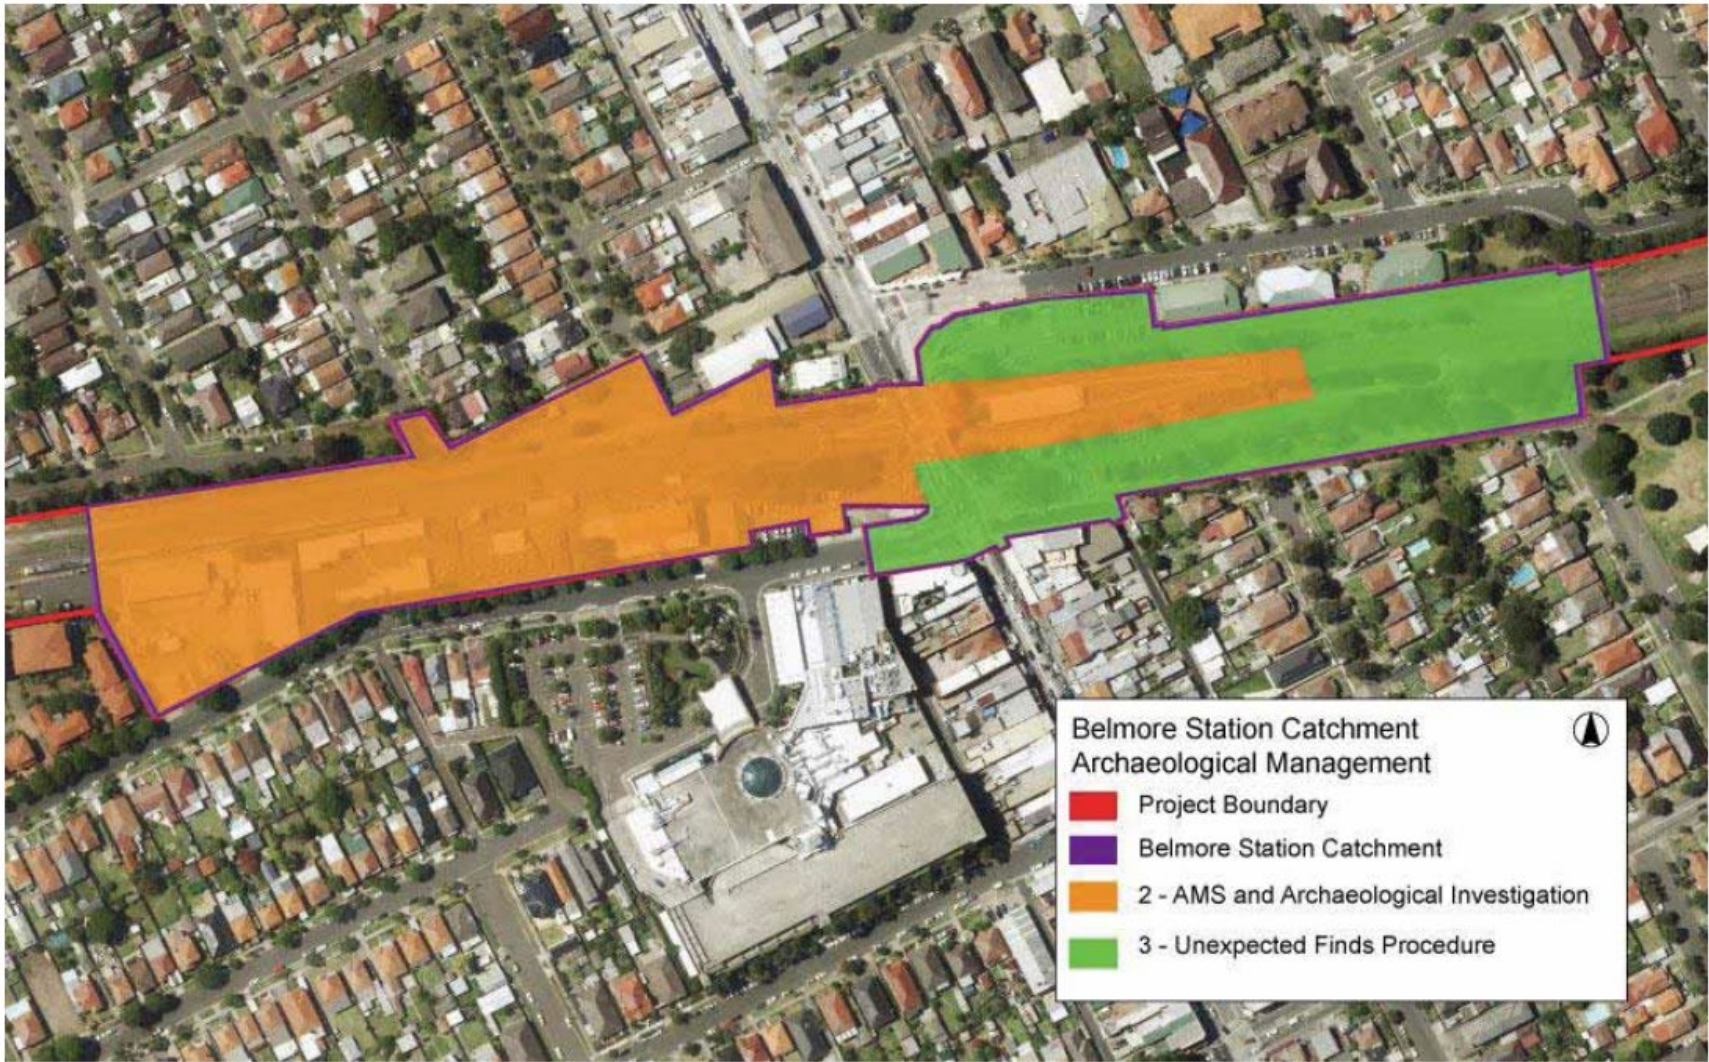
Figure 6-3 Archaeological Management zoning for Belmore Station (Artefact Heritage 2017c)

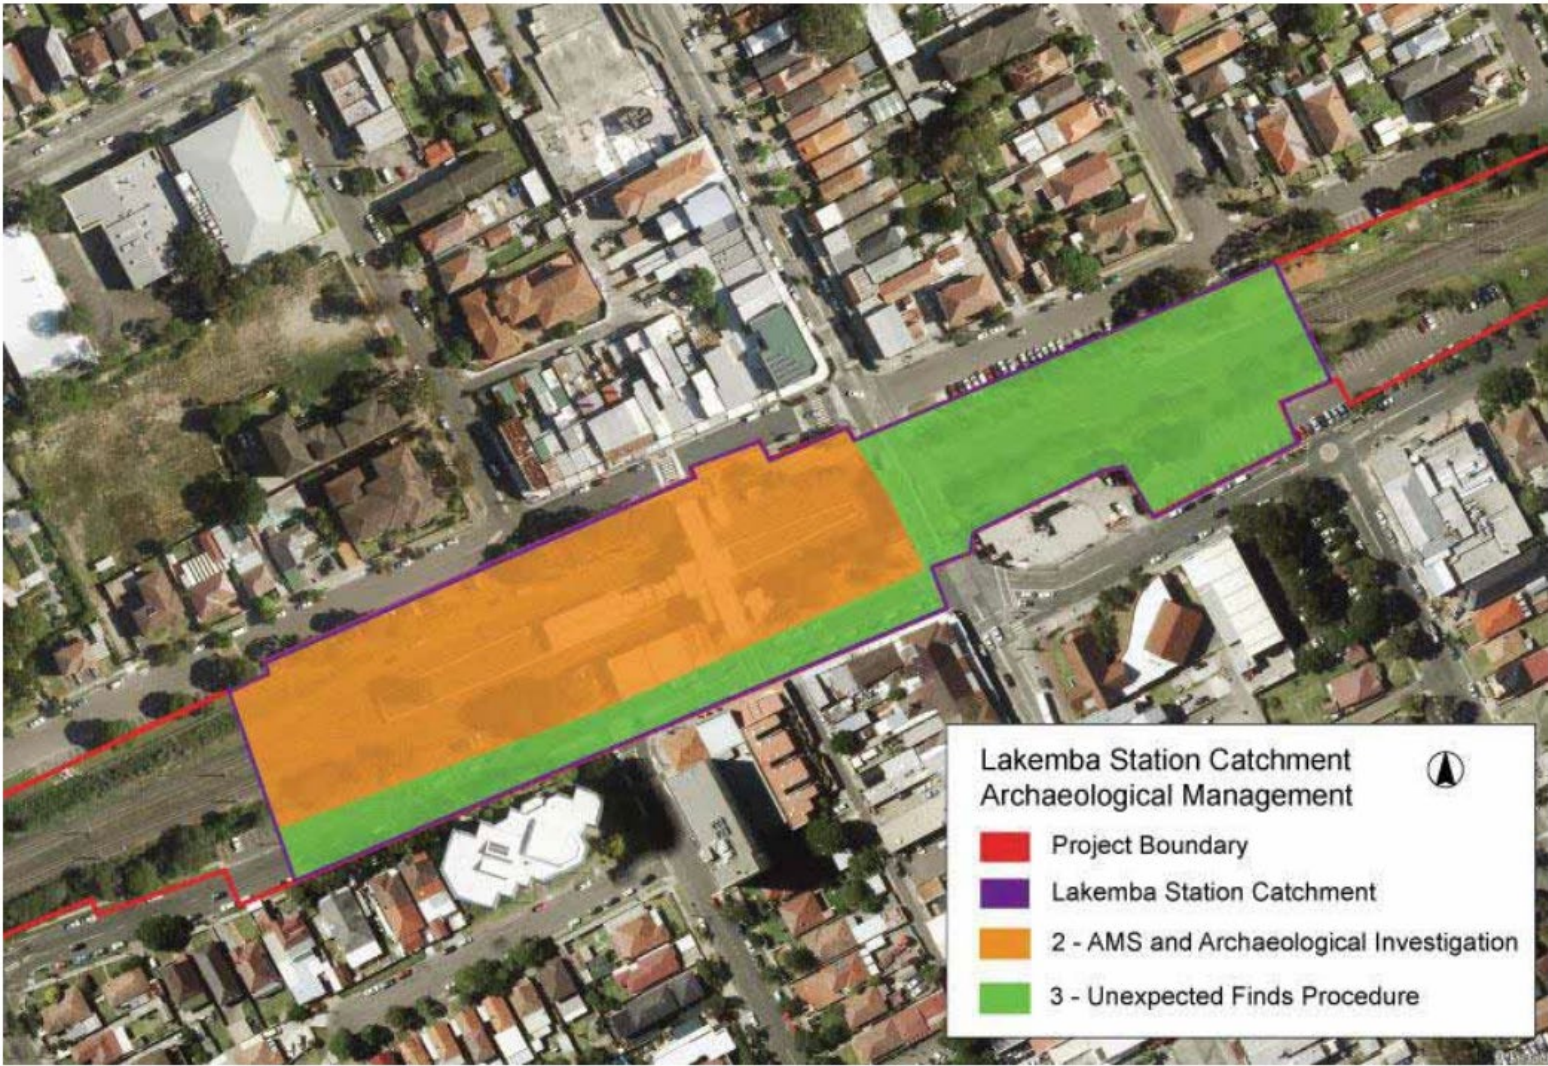
Figure 6-4 Archaeological Management zoning for Lakemba Station (Artefact Heritage 2017c)

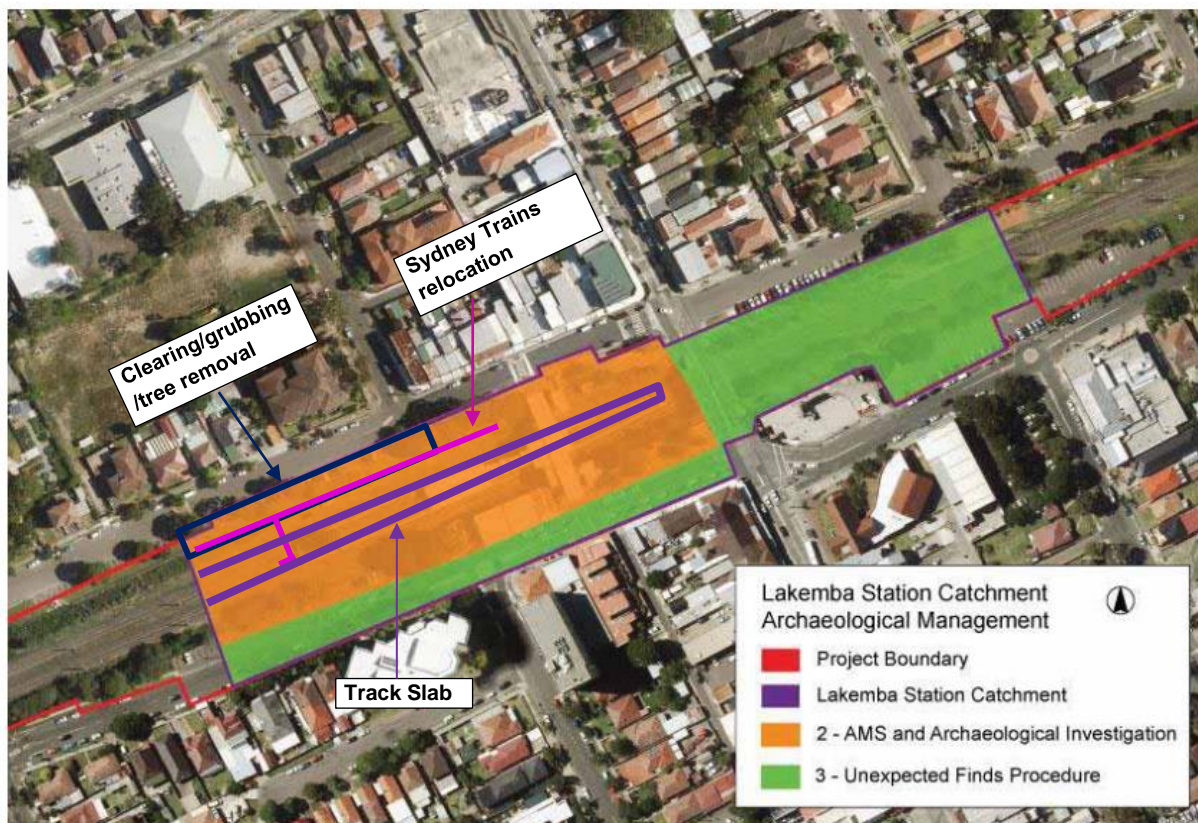
**Figure 29: Primary proposed excavation works within Lakemba Station**
