Southwest Metro Corridor and Bankstown Early Works Construction Monitoring Report 3 March 2022- August 2022

SMCSWSSJ-JHL-WEC-EM-REP-000027

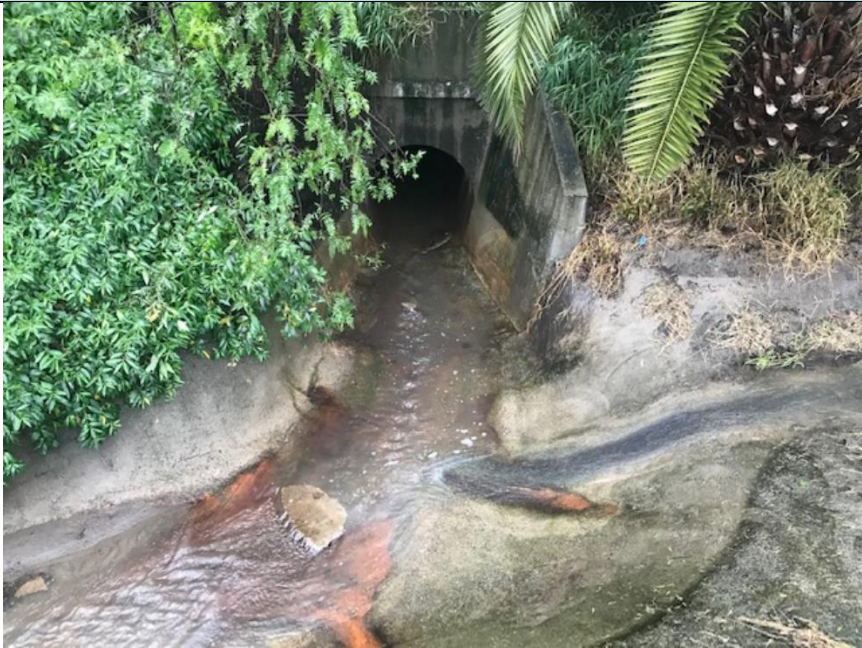
<p>Middle culvert</p>

Western most culverts	<p>No JHLOR work in area - WP3. Access checked - no dirty water flowing from stabilised access down to culverts.</p> <p>Wiley Park Station Contractor alongside culverts – no construction activities observed.</p>

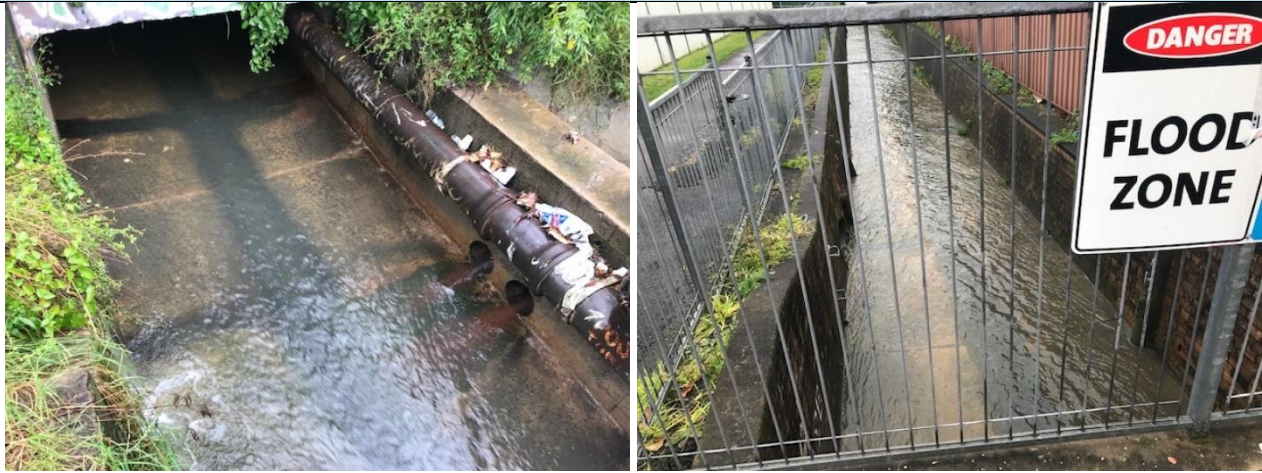
<p>Upstream (South side) – No photo's taken on this side.</p> <p>Western most culverts</p> <p>Middle culvert/pond</p> <p>Eastern most culvert. Both sides of road</p>			
Location 7 Bankstown	Nil		<p>No PO available – not inspected – no JHLOR works in catchment</p> <p>NOTE: This flow line is below ground and runs across the corridor from Nth to Sth and can be seen through pits only. They are all inside corridor</p>			
Location 7ALT City side of Bankstown DOWN track (near Stacey St)	Nil	<p><u>Sth Side (only)</u></p> <p>Water clarity and colour: High flow, turbid water.</p> <p>Odour: Nil</p> <p>Description of flow and quantity/ Visible runoff (into the water body): see above</p> <p>Oil and Grease: Nil</p> <p>Details of any foreign objects within the water: No debris in water</p> <p>Other comments/description Nil</p>
