# Southwest Metro Works Stage 3 Construction Monitoring Report 3 September 2025- February 2026

SMCSWSW8-JHL-WEC-EM-REP-000001

Document Details	
<b>Title</b>	Construction Monitoring Report
<b>Client</b>	Sydney Metro City & Southwest
<b>Client reference no.</b>	SMCSWSW8-JHL-WEC-EM-REP-000001
<b>JHLOR JV contract no.</b>	K44

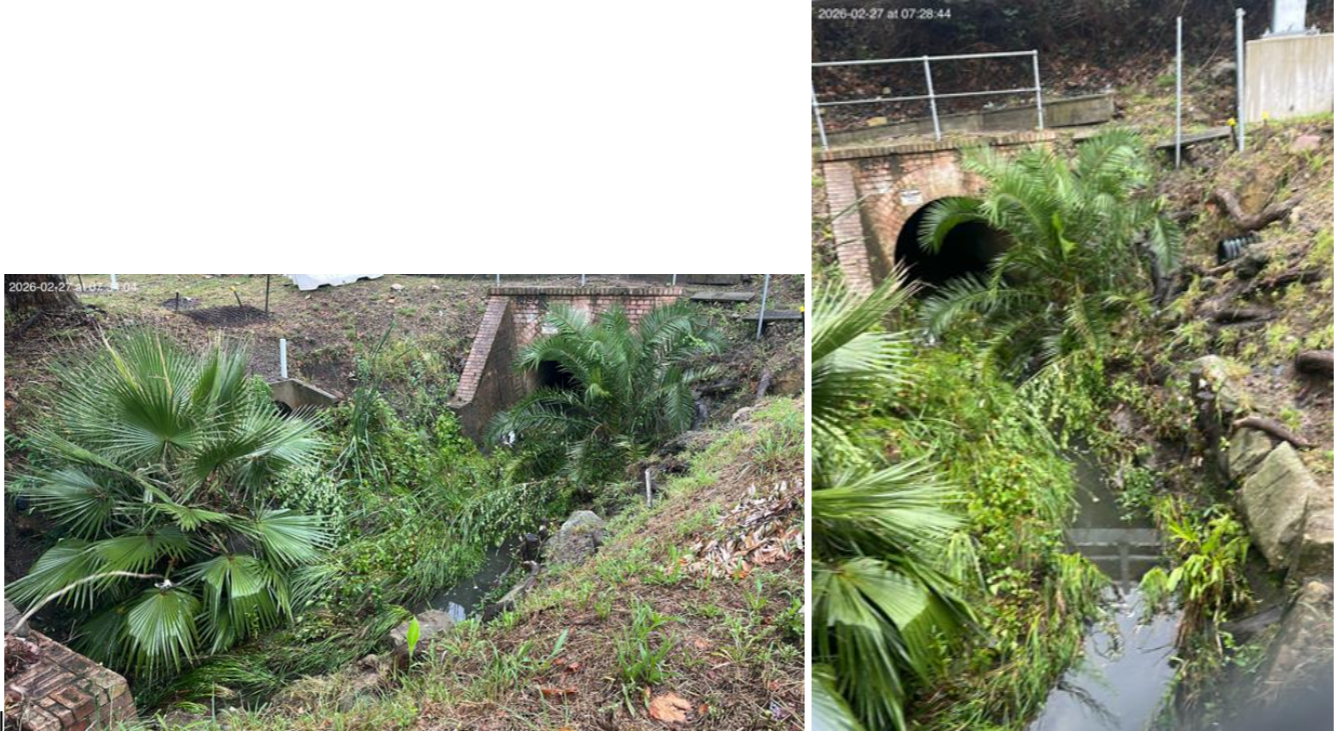
<p style="text-align: center;"><b>LHS Inlet (Concrete Headwall)</b> Unknown upstream source. No cloud plume in main culvert from inlet</p> <p style="text-align: center;"><b>RHS Inlet (Black pipe)</b> No cloud plume in main culvert from inlet on RHS.</p>	<p>JHLOR construction activities (for OHCB) at Ewart/Terrace Rd have been completed and surfaces have been stabilised since before the Xmas break.</p>

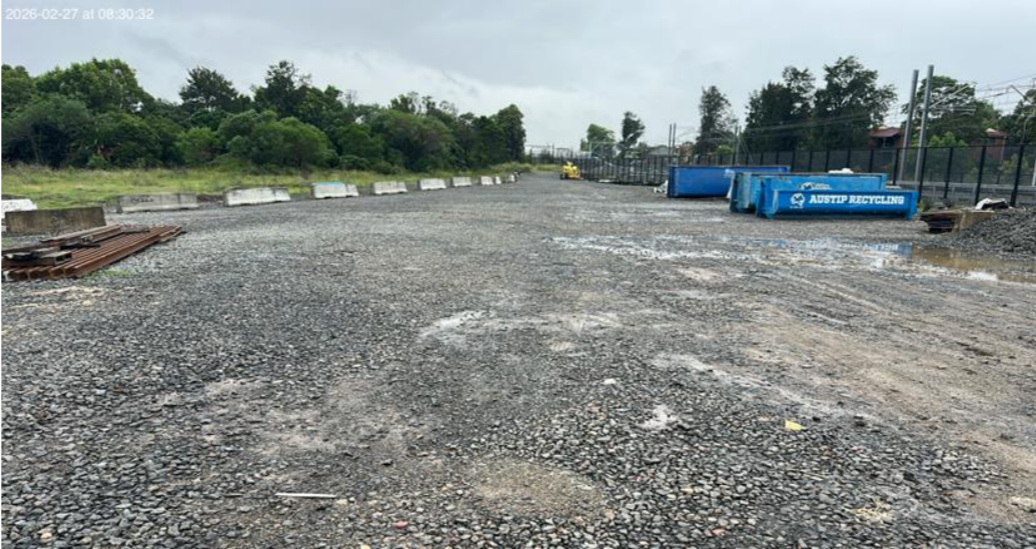
<p><b>Location 5</b> Lakemba, country side</p>	<p>Only commissioning work on the platform buildings up at Station. Landscaping on the nature strip/outside of corridor (UP side) is completed and hardstand stabilised. ERSED in place. Exposed surfaces are covered.</p> <p>No excavation type work on the inside of corridor (Upside)</p> <p>No construction activities on the DWN side of corridor both inside/outside of corridor.</p>	<p><b>Water clarity and colour:</b> <b>Odour:</b> N/A</p> <p><b>Description of flow and quantity/ Visible runoff (into the water body):</b> N/A</p> <p><b>Oil and Grease:</b> Nil</p> <p><b>Details of any foreign objects within the water:</b> N/A</p> <p><b>Other comments/description:</b> N/A</p>	<p style="text-align: center;"><b>Nth side of corridor (UP side)</b> No photos taken Drainage network below ground/road – water from road discharges into drop pit</p> <p style="text-align: center;"><b>Sth side of corridor – Two culverts (Down Side)</b> Vegetation obscures bottom of culverts. Looks clean.</p>

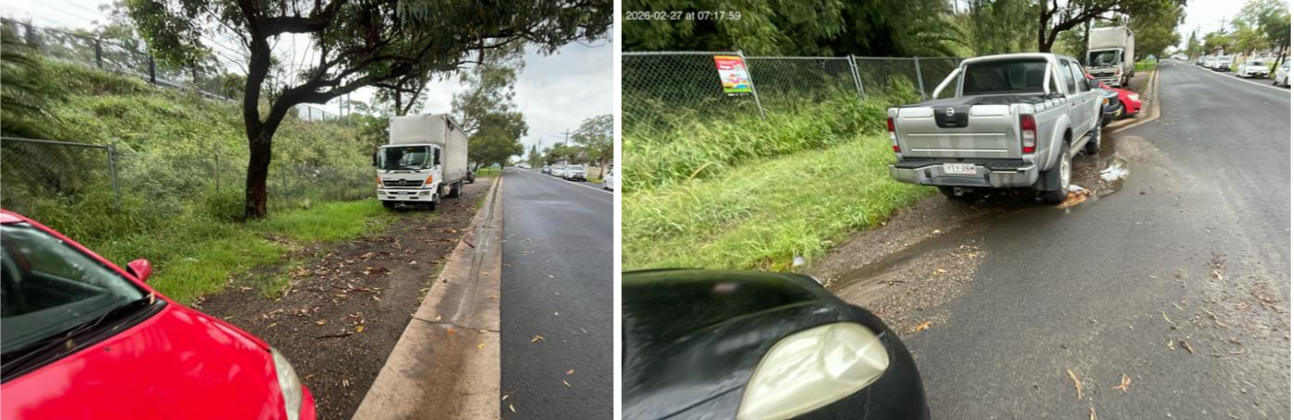
Inspection Type:	JHLOR Construction Activities in area	Comments from Inspection of waterways	Photos	Additional Observations Are there any impacts related to JHLOR construction works	Follow up action required	Outcome of follow up action
<p><b>Location 6</b> Wiley Park, countryside.</p>	<p>No JHLOR excavation works on the UP &amp; DWN side of the tracks</p> <p>Contractor (not JHGLOR) is using the WP3 access as laydown of plant, equipment &amp; Engineering fill (DGB).</p>	<p><b>Water clarity and colour:</b> See detail below photos</p> <ul style="list-style-type: none"> <li>• <b>Downstream (UP side):</b> See notes in photo section.</li> <li>• <b>Upstream (DWN side):</b> See notes in photo section.</li> </ul> <p><b>Odour:</b> Nil</p> <p><b>Description of flow and quantity/ Visible runoff (into the water body):</b> See notes in photo section.</p> <p><b>Oil and Grease:</b> Nil</p> <p><b>Details of any foreign objects within the water:</b> Nil.</p> <p><b>Other comments/description:</b> Nil</p>	<p style="text-align: center;"><b>CORRIDOR (UP SIDE) UPSTREAM AREA</b></p> <p><b>Inside</b> of corridor - Area upstream of open Culverts at Gate WP3 is well stabilised. <b>Outside</b> of corridor – very low flow of water in concrete channel down to western most culvert. Water looks clear.</p> <div style="display: flex; justify-content: space-around;">

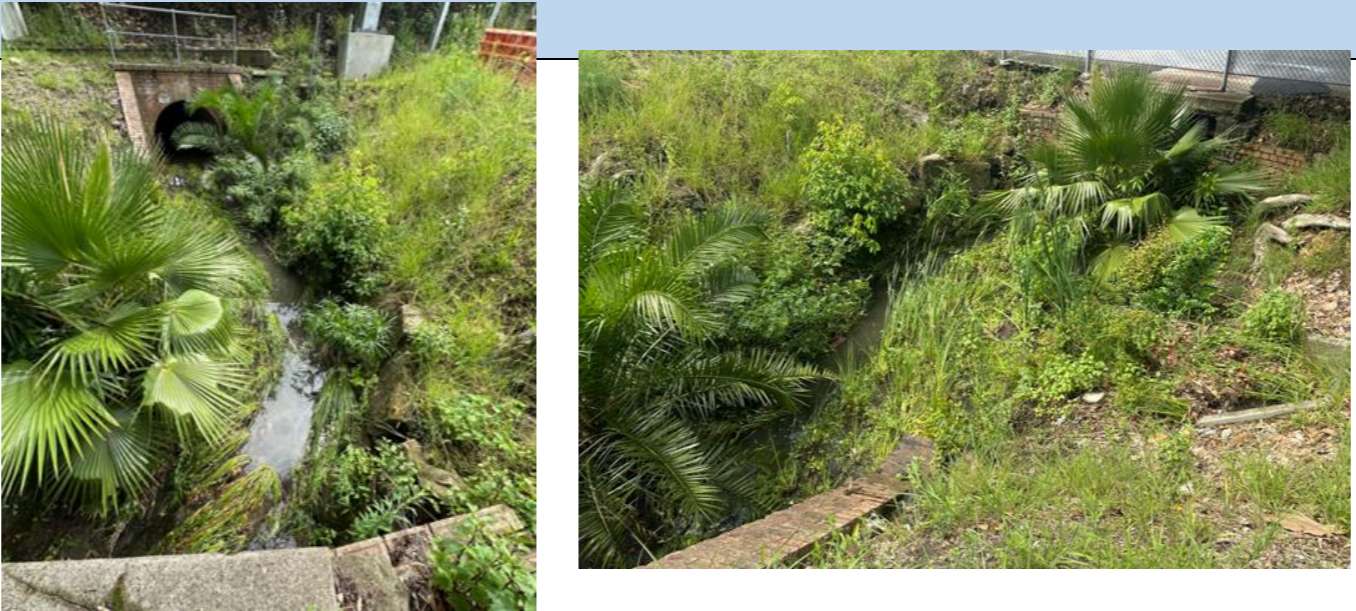
<p style="text-align: center;"><b>LHS Inlet (Concrete Headwall)</b> Unknown upstream source. No cloud plume in main culvert from inlet</p> <p style="text-align: center;"><b>RHS Inlet (Black pipe)</b> No cloud plume in main culvert from inlet on RHS.</p>	<p>JHLOR construction activities (for OHCB) at Ewart/Terrace Rd have been completed and surfaces have been stabilised since before the Xmas break.</p>

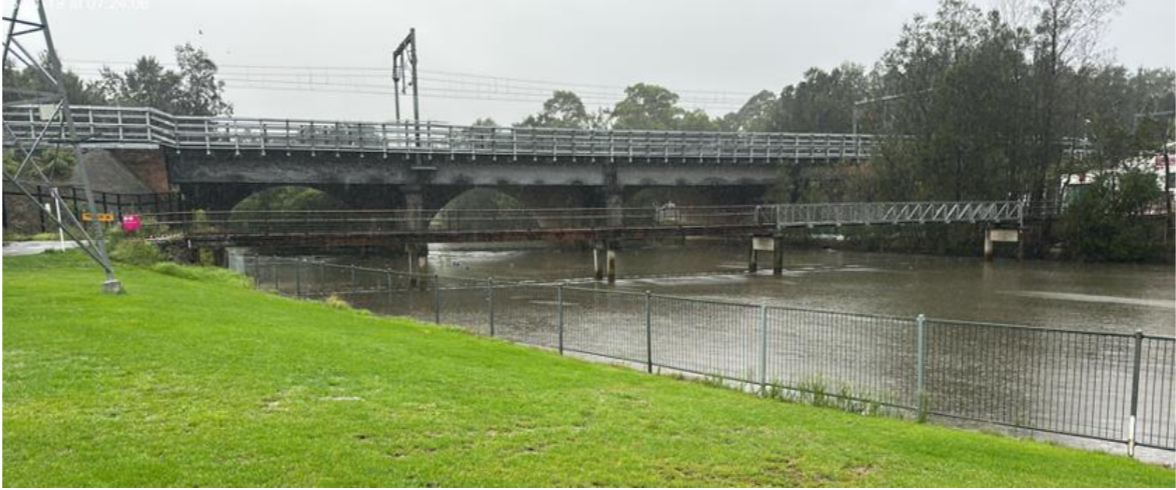
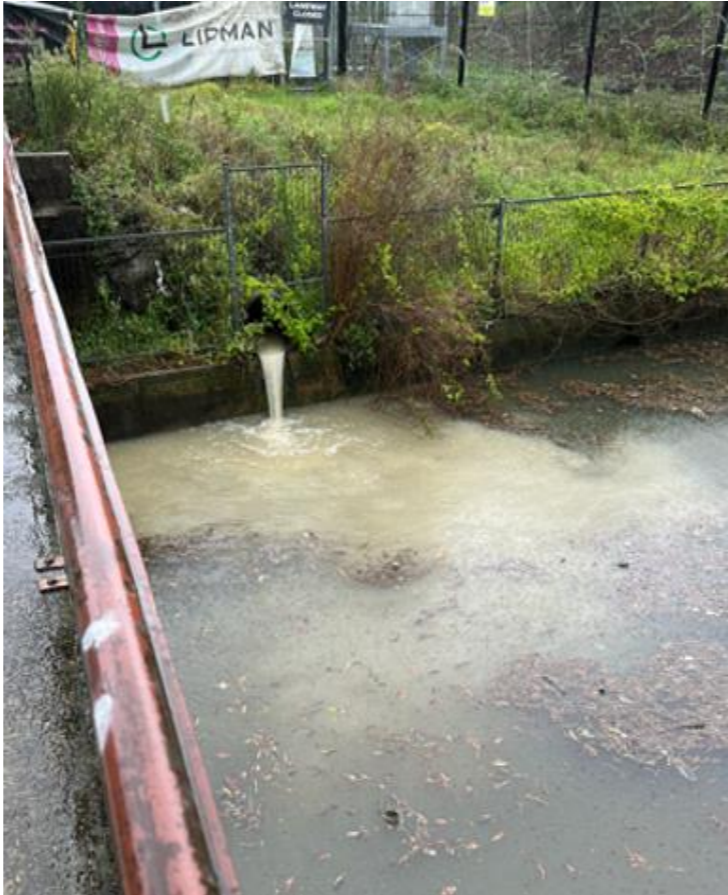
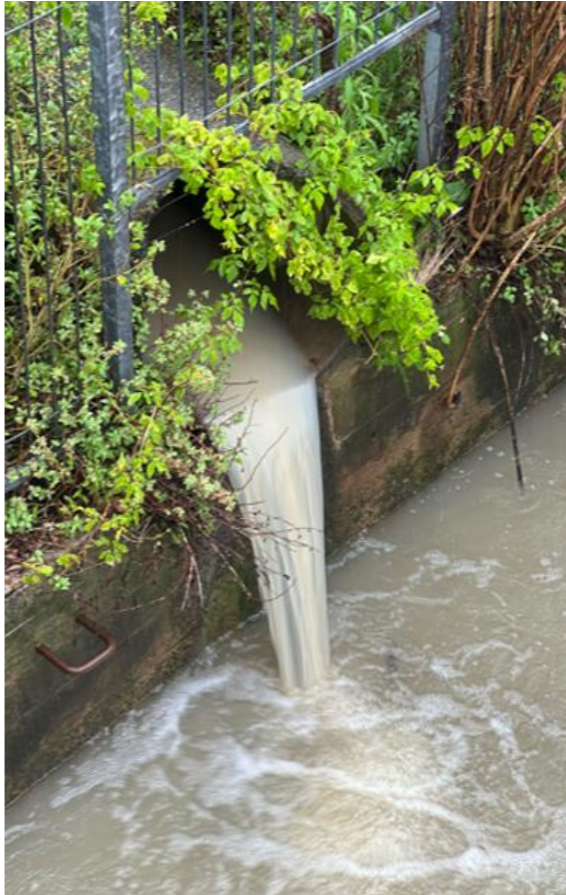
<p><b>Location 2</b></p> <p>Hurlstone Park, countryside</p>	<p>No JHLOR construction/excavation activities along the corridor near this location</p>	<p><b>Water clarity and colour:</b> <b>Odour:</b> N/A</p> <p><b>Description of flow and quantity/ Visible runoff (into the water body):</b> N/A</p> <p><b>Oil and Grease:</b> N/A</p> <p><b>Details of any foreign objects within the water:</b> N/A</p> <p><b>Other comments/description:</b> N/A</p>	<p><b>NO PO AVAILABLE, AREA LOCKED – AREA NOT INSPECTED</b></p>	<p>Area alongside tracks and open culvert are very heavily vegetated. No activities in this area for 12 months +</p>		
<p><b>Location 3</b></p> <p>West bank of Cook's River</p>	<p>No JHLOR construction/excavation activities along the corridor near this location or any work back to Campsie</p>	<p><b>Water clarity and colour:</b> Turbid water at outlet of SW pipe. Water in pond and river is dirty.</p>		<p>Cooks River – tide is in.</p>

<p>NOTE: Upstream photos taken along Wairoa, CB6 and locations near Gould St show turbid water flowing from corridor – unknown source but comes from under track culvert and is thought to be "legacy work" from Sydney Trains old work behind concrete barrier where they excavated into the open channel to release water from upstream</p> <p>Not from JHLOR works (no groundbreaking construction activities upstream).</p>

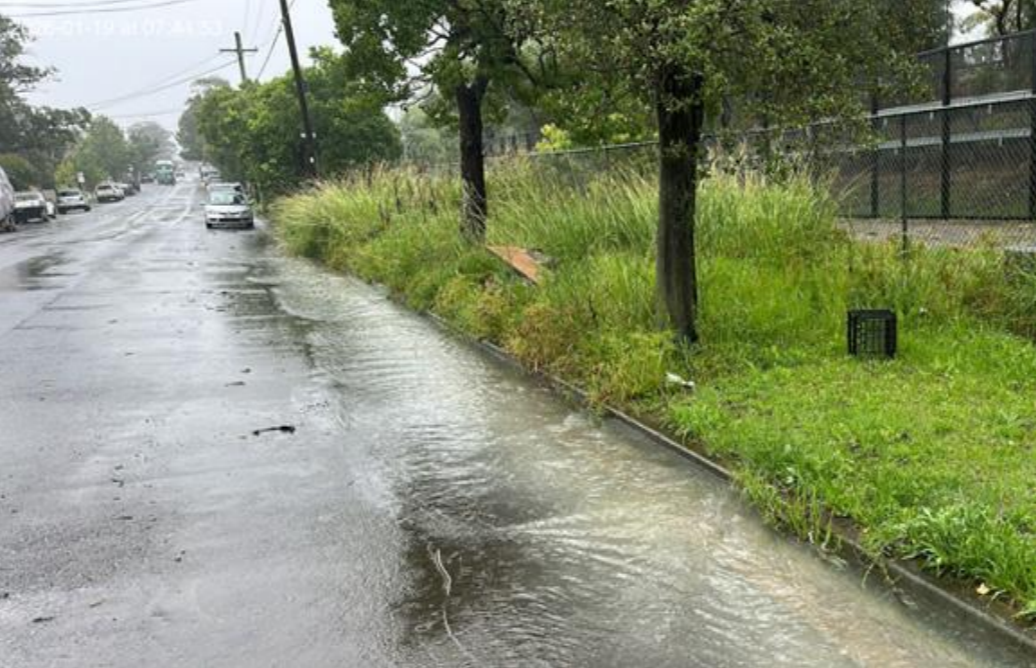
<p data-bbox="914 825 2163 888"><b>Area at Gould/Park St.</b> Turbid water drains from corridor (Legacy work from Sydney Trains old work behind concrete barrier where they excavated into the open channel to release water)</p>

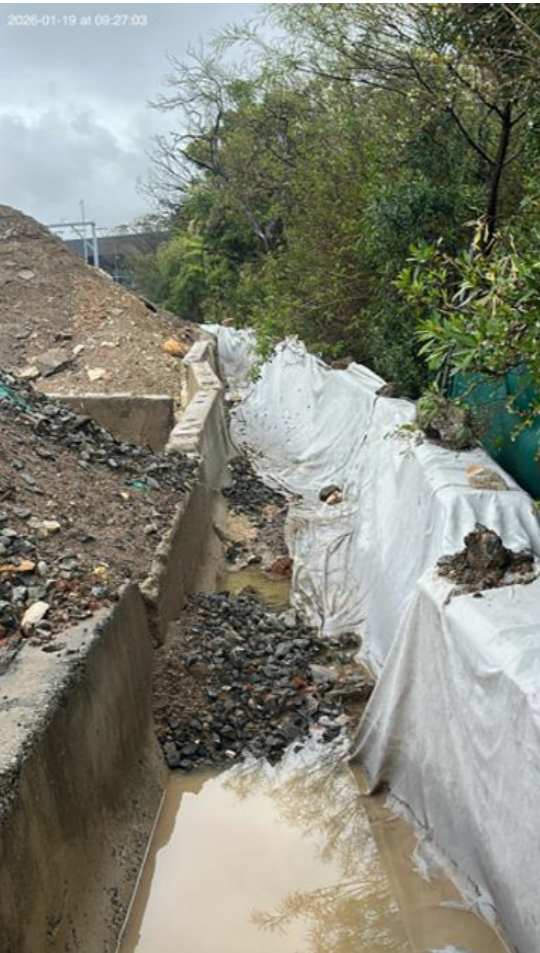
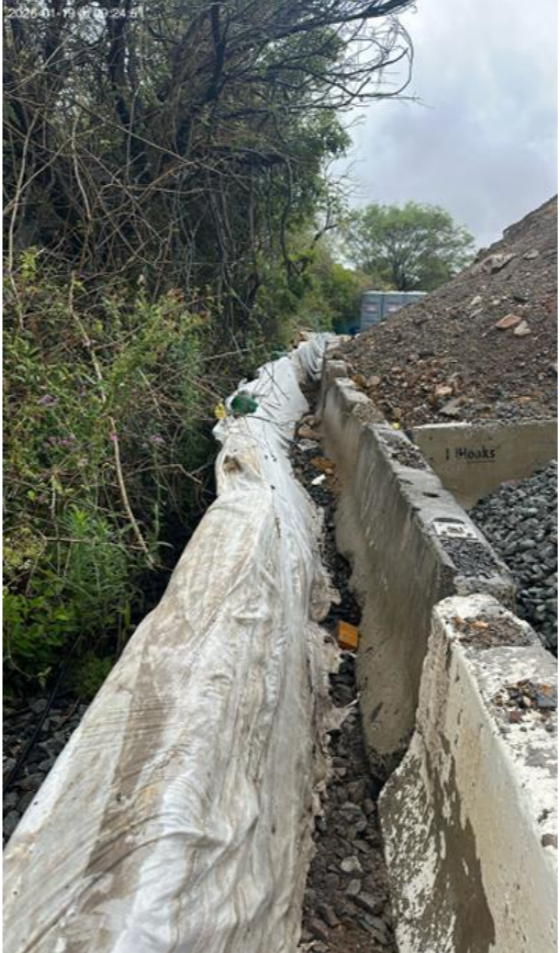
<p><b>BelmoreT Wedge Stockpile area.</b> Photos from top of batter above the ballast access road - Double concrete barrier &amp; geofab ERSED controls. Small volume of ponded water remains on top of platform (No dirty water seen along bottom of batter/ballast access track)</p>

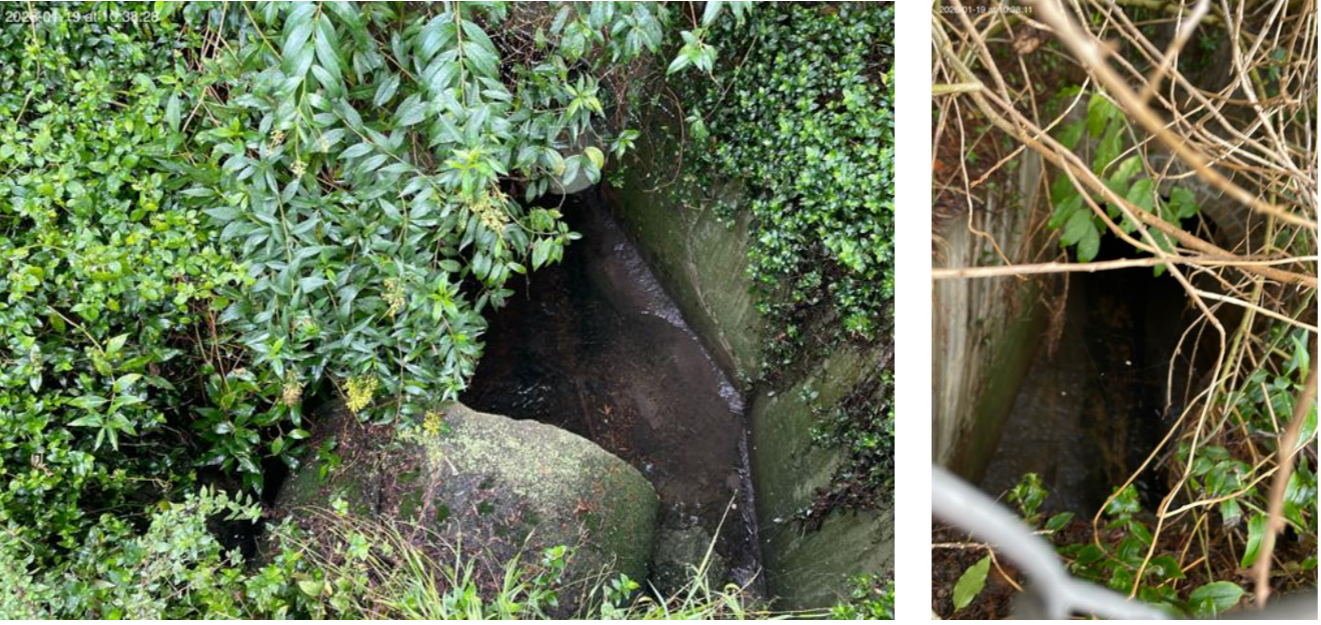
Inspection Type:	JHLOR Construction Activities in area	Comments from Inspection of waterways	Photos	Additional Observations Are there any impacts related to JHLOR construction works	Follow up action required	Outcome of follow up action
	<p>corridor (UP side) is completed and hardstand stabilised. ERSED in place. Exposed surfaces are covered.</p> <p>No excavation type work on the inside of corridor (Upside)</p> <p>No construction activities on the DWN side of corridor both inside/outside of corridor.</p>	<p>N/A</p> <p><b>Oil and Grease:</b> Nil</p> <p><b>Details of any foreign objects within the water:</b> N/A</p> <p><b>Other comments/description:</b> N/A</p>	<p>Vegetation obscures bottom of culverts but looks like water is clear.</p>

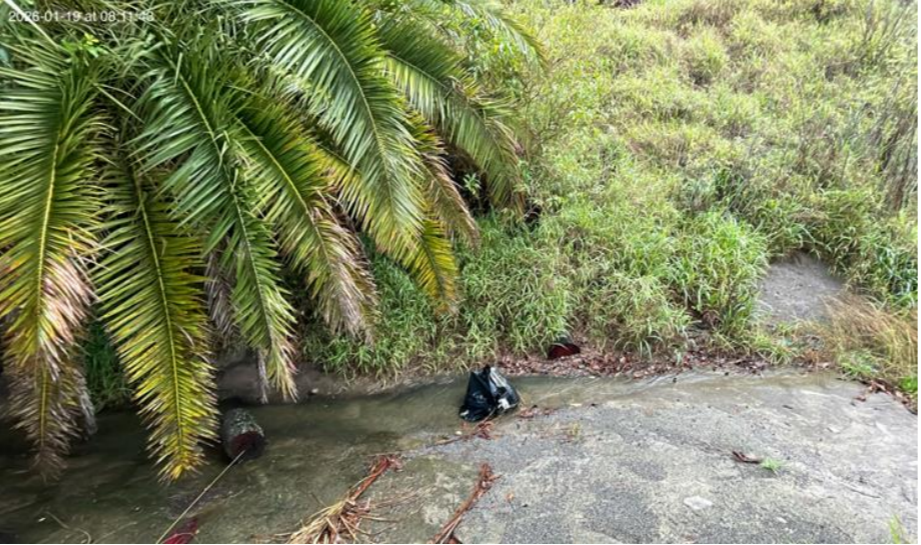
<p style="text-align: center;"><b>Western most culvert</b></p> <p>Water at high level, looks like standing water without flow. Clean water through main culvert with clean water flow from inlet on RHS.</p>

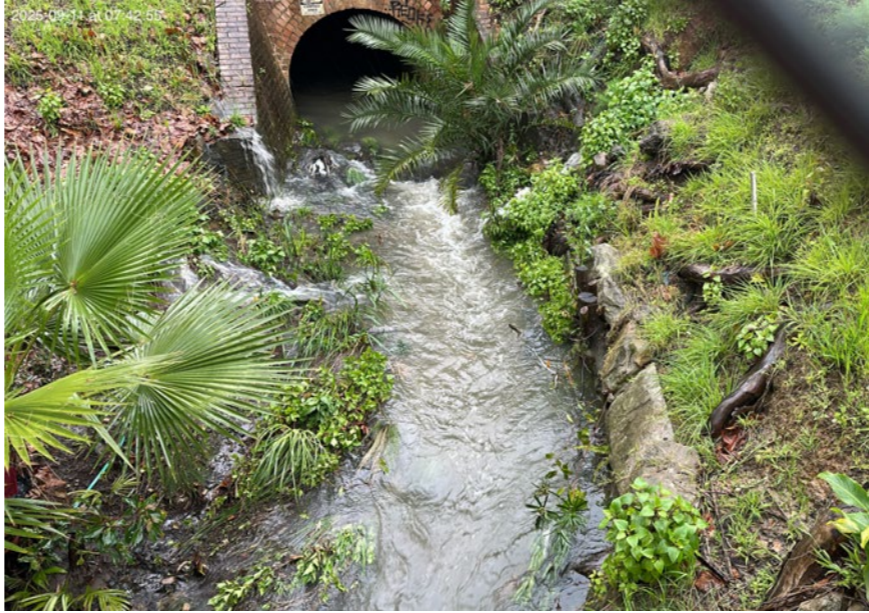
Inspection Type:	JHLOR Construction Activities in area	Comments from Inspection of waterways	Photos	Additional Observations Are there any impacts related to JHLOR construction works	Follow up action required	Outcome of follow up action
<p><b>Location 1</b></p> <p>Dulwich Hill MSB (Ewart Culvert), country side of commuter car park</p>	<p>No work in this area in +- last 3 weeks</p> <p>Surfaces alongside this culvert on the:</p> <ul style="list-style-type: none"> <li>west side around the culvert is stabilised – vegetation and heavy leaf litter.</li> <li>East side (alongside MSB) stabilised with vegetation and geofab cover</li> </ul>	<p><b>Water clarity and colour:</b></p> <p>High flow water in main culvert looks slightly turbid.</p> <p><i>Side inlet on LHS:</i> Unknown upstream source. Unable to determine if turbid as too much white water. No cloud plume in main culvert from inlet</p> <p><i>Side inlet on RHS:</i> Unable to determine if turbid as too much white water. No cloud plume in main culvert from inlet on RHS.</p> <p><b>Odour:</b> Nil</p>

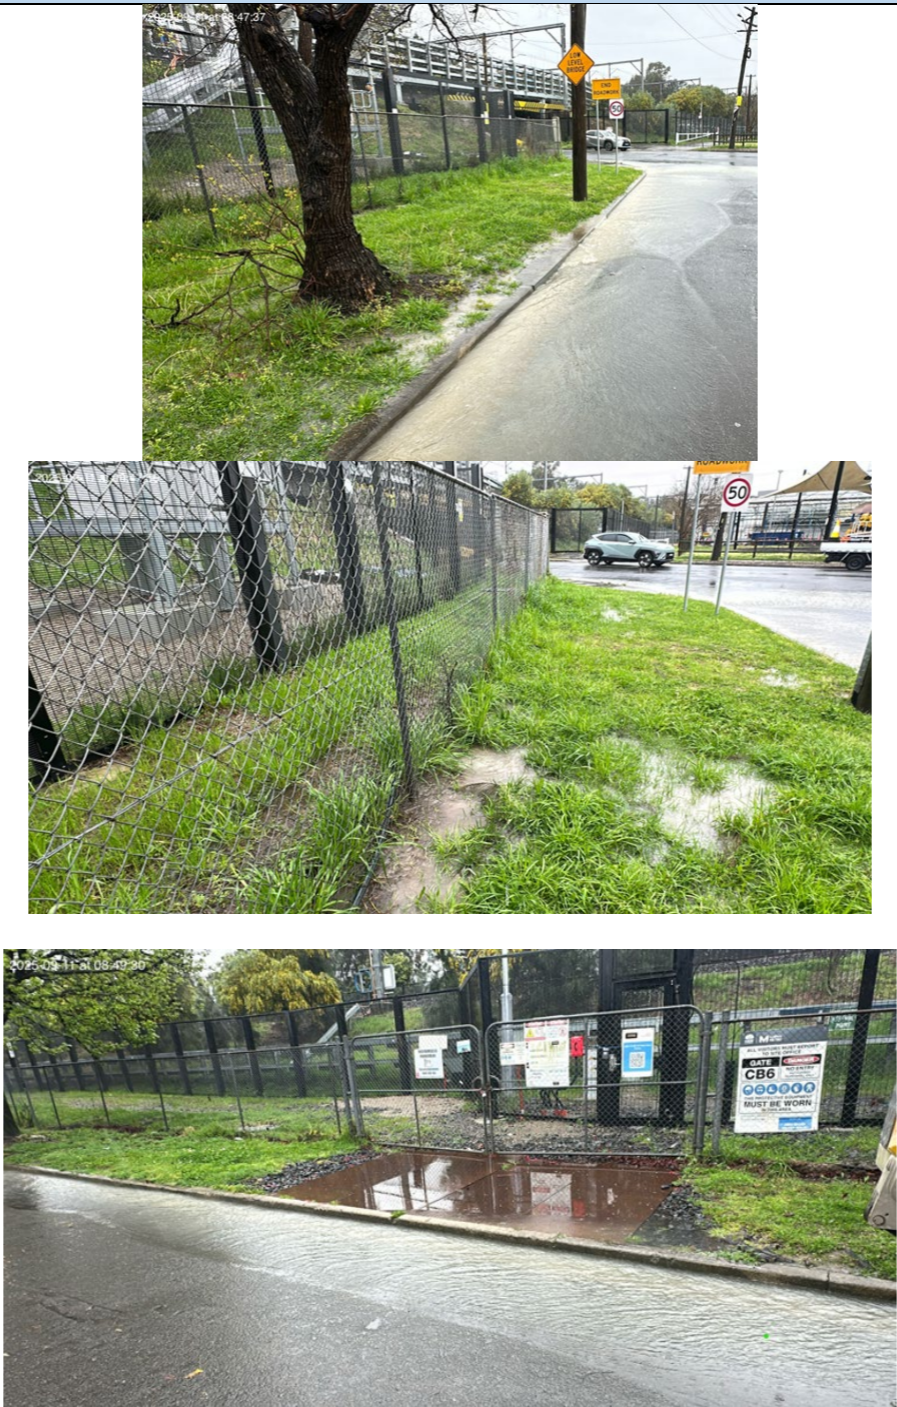
<p>The photos show a paved path next to a grassy area with a tree. The second photo shows a fenced area with a road and a 50 speed limit sign. The third photo shows a gate with a sign that reads 'GATE CB6 MUST BE WORK' and a small pond of water.</p> <p>Upstream at Wairoa. No flow from access gate CB6.</p>

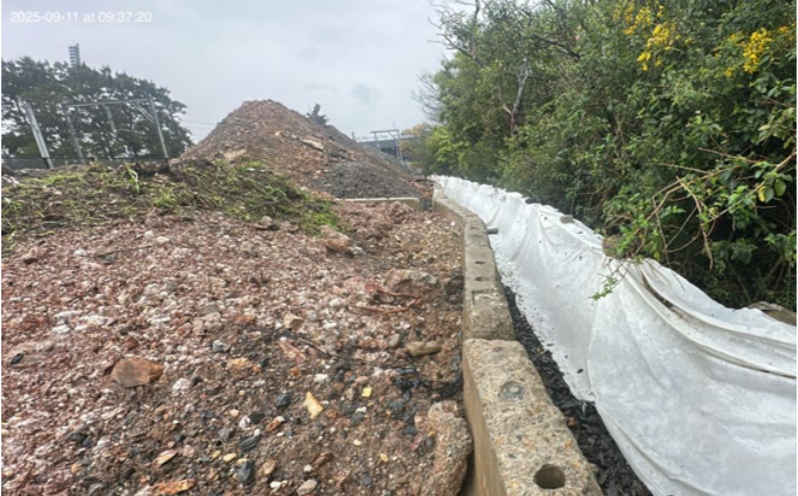
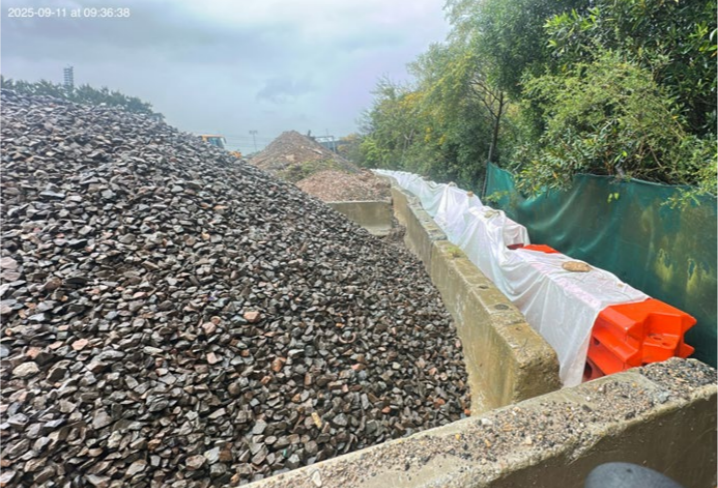
<p data-bbox="914 905 2145 1031"><b>Toe of batter on side of ballast Access road</b> – Water ponds in this location (the signs of turbidity is from truck wheels). NOTE: Dirty water does not drain to open culvert. Vegetated swale was checked alongside access – no signs of dirty water</p>

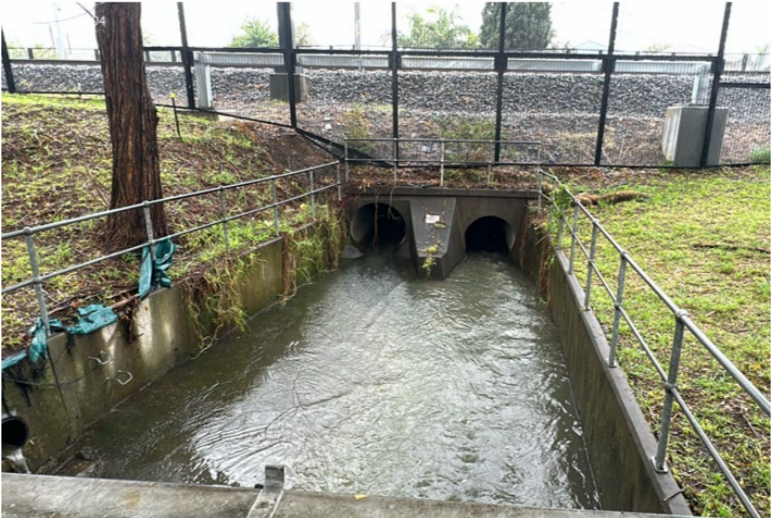
<p><b>Eastern most Culvert</b> – high flow, slightly turbid water through main culvert.</p>			
<p><b>Location 7</b> Bankstown</p>	<p>Nil activities in the area</p>		<p><b>No PO available – not inspected – no JHLOR works in catchment.</b> NOTE: This flow line is below ground and runs across the corridor from Nth to Sth and can be seen through pits only. They are all inside corridor.</p>			
<p><b>Location 7ALT</b>  City side of Bankstown DOWN track (near Stacey St)</p>	<p>No JHLOR excavation activities have been carried out alongside the corridor near this location in the last couple of months.  Area stable with heavy vegetation growth in corridor CESS and alongside culvert</p>	<p><b>Sth Side</b> <b>Water clarity and colour:</b> high flow, clear water  <b>Odour:</b> Nil  <b>Description of flow and quantity/ Visible runoff (into the water body):</b> see above.  <b>Oil and Grease:</b> Nil  <b>Details of any foreign objects within the water:</b> No debris in water  <b>Other comments/description</b> Nil</p>

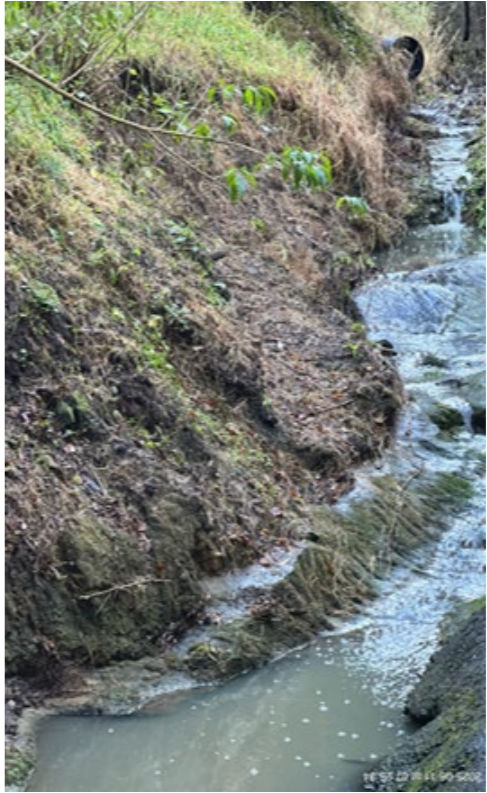
<p data-bbox="1041 1896 2041 1959"><u>Downstream from JHLOR discharge point:</u> Downstream water observed to be very slightly turbid - potentially from scour on batter.</p>

<p data-bbox="2190 1843 2635 1938">This photo shows previous status of downstream batter during event dated 11/8/25. Batter showed signs of slip.</p>		
Location 9 Bankstown	Culvert backfilled.	<b>Water clarity and colour:</b>	<b>JHLOR site.</b> Brick culvert filled in. No reporting & no photos required
