# Southwest Metro Works Stage 3 Construction Monitoring Report 3 September 2025- February 2026

SMCSWSW8-JHL-WEC-EM-REP-000001

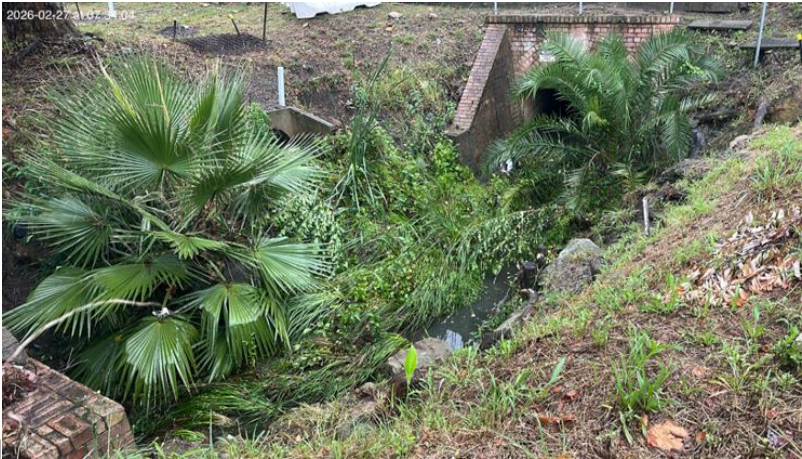
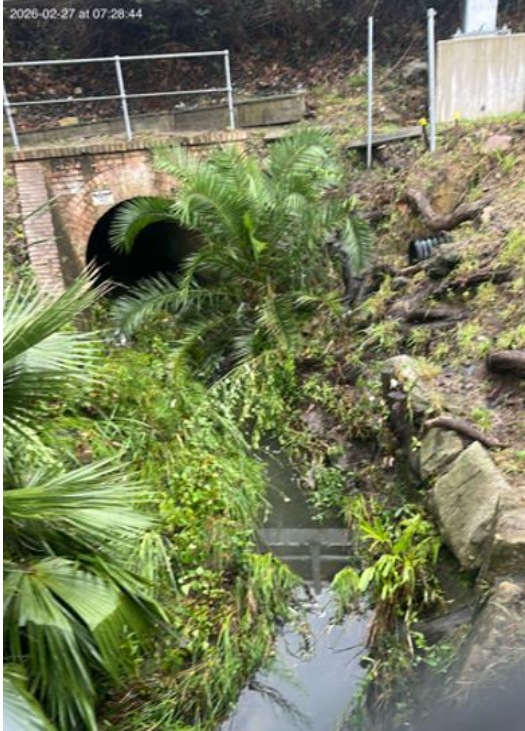
| Inspection Type: | JHLOR Construction Activities in area | Comments from Inspection of waterways | Photos | Additional Observations<br>Are there any impacts related to JHLOR construction works | Follow up action required | Outcome of follow up action |
|---|---|---|---|---|---|---|
| <b>Location 1</b><br><br>Dulwich Hill MSB (Ewart Culvert), country side of commuter car park | No work in this area in<br><br>Surfaces alongside this culvert on the: <ul style="list-style-type: none"><li>LHS (west side) around the culvert is stabilised – vegetation and heavy leaf litter.</li><li>RHS (East side, alongside MSB) stabilised with vegetation and geofab cover</li></ul> . | <b>Water clarity and colour:</b><br>Low flow water in main culvert looks slightly turbid.<br><br><i>Side inlet on LHS:</i><br>Unknown upstream source. No cloud plume in main culvert from inlet<br><br><i>Side inlet on RHS:</i> No cloud plume in main culvert from inlet on RHS.<br><br><b>Odour:</b> Nil<br><br><b>Description of flow and quantity/ Visible runoff (into the water body):</b><br>Currently low flow of water with signs of "high" flow & damage to vegetation.<br><br><b>Oil and Grease:</b> Nil<br><br><b>Details of any foreign objects within the water:</b> Nil<br><br><b>Other comments/description:</b><br>N/A | <div></div> <div></div> <div><b>LHS Inlet (Concrete Headwall)</b><br/>Unknown upstream source. No cloud plume in main culvert from inlet<br/><br/><b>RHS Inlet (Black pipe)</b><br/>No cloud plume in main culvert from inlet on RHS.</div> | JHLOR construction activities (for OHCB) at Ewart/Terrace Rd have been completed and surfaces have been stabilised since before the Xmas break. | | |

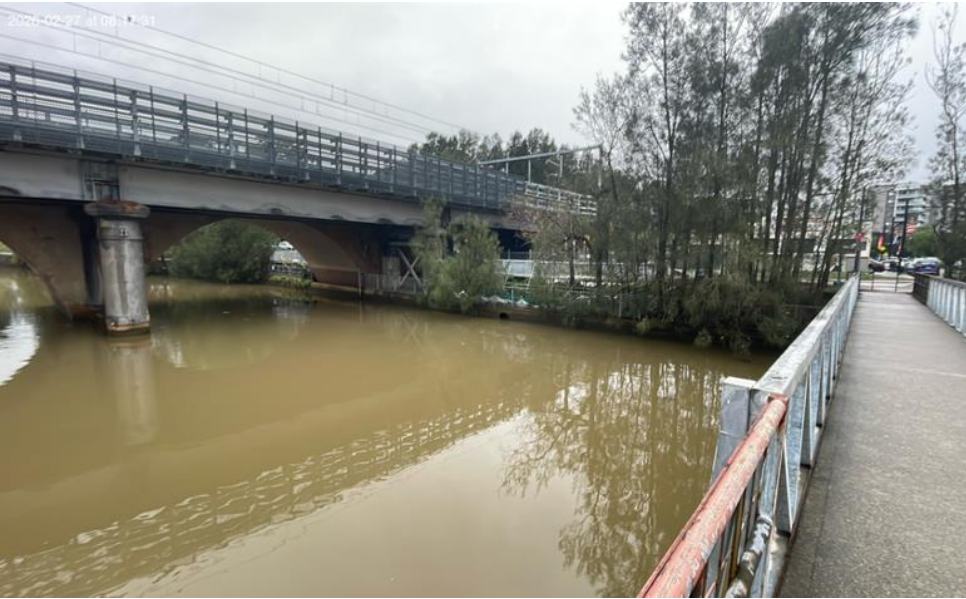
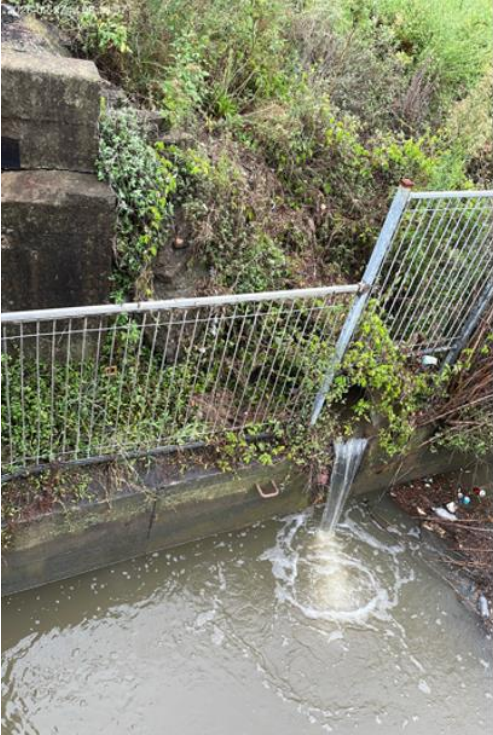
| Inspection Type: | JHLOR Construction Activities in area | Comments from Inspection of waterways | Photos | Additional Observations<br>Are there any impacts related to JHLOR construction works | Follow up action required | Outcome of follow up action |
|---|---|---|---|---|---|---|
| | <p>station. Corridor area is vegetated/stabilized all the way up to Campsie other than alongside the concrete crash barrier (Martinus).</p> <p>NOTE: No photos taken along Wairoa, CB6 and locations near Gould St</p> | <p><b>Odour:</b> Nil</p> <p><b>Description of flow and quantity/ Visible runoff (into the water body):</b><br/>Med flow</p> <p><b>Oil and Grease:</b> Nil</p> <p><b>Details of any foreign objects within the water:</b> N/A</p> <p><b>Other comments/description:</b><br/>N/A</p> | <p><b>Storm Water outlet at River</b></p> <p><b>Upstream Photos from Cooks River along Wairoa to the access gate CB6.</b><br/>No photos taken in this area</p> <p><b>Area at Gould/Park St.</b><br/>No photos taken in this area</p> | | | |

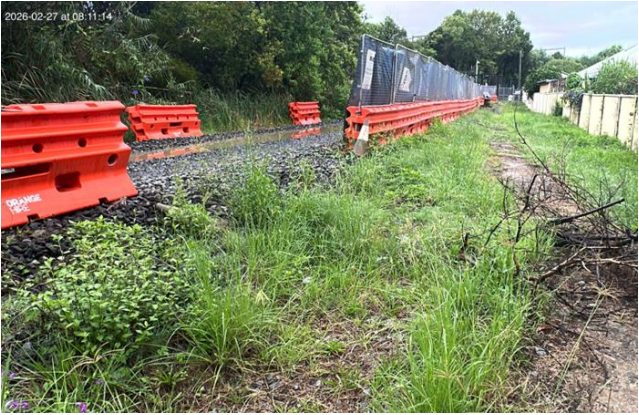
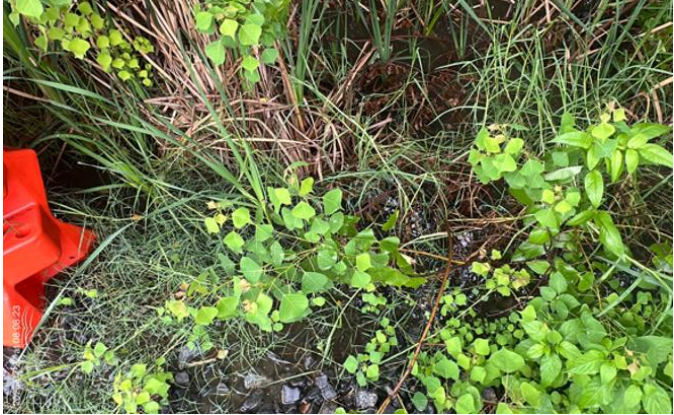
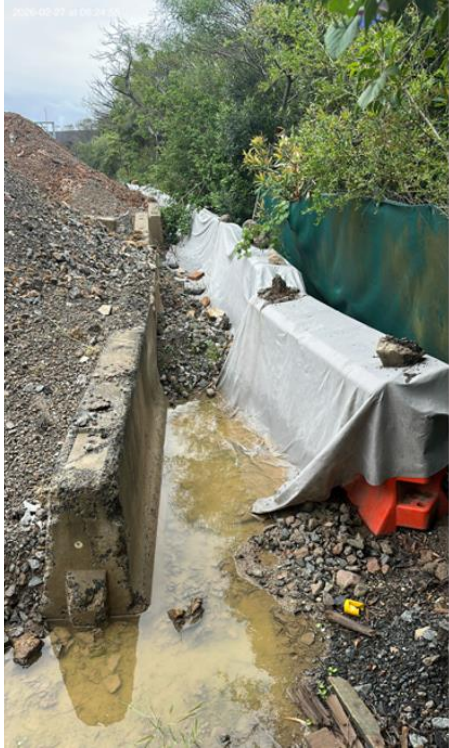
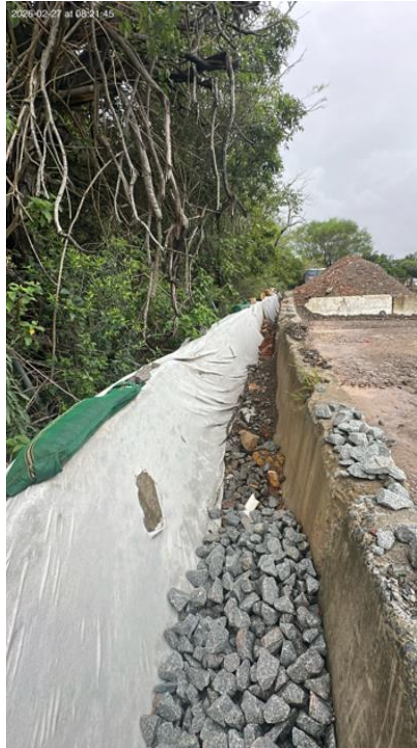
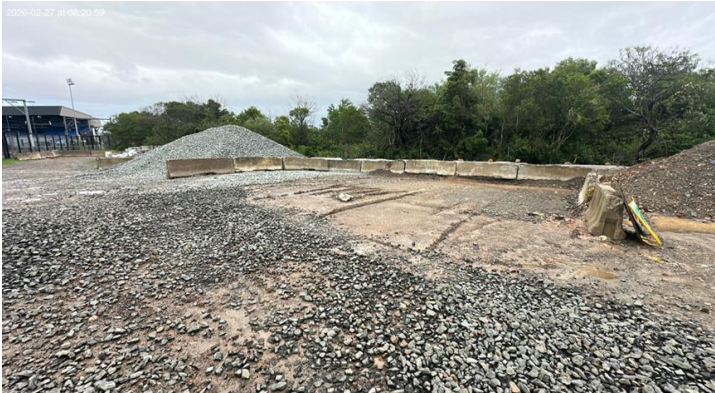
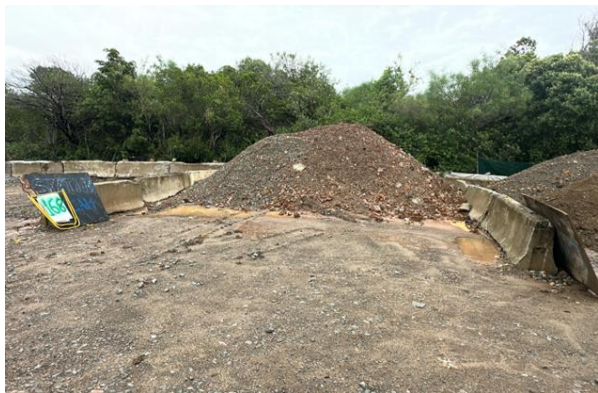
| Inspection Type: | JHLOR Construction Activities in area | Comments from Inspection of waterways | Photos | Additional Observations<br>Are there any impacts related to JHLOR construction works | Follow up action required | Outcome of follow up action |
|---|---|---|---|---|---|---|
| | | | <div></div> <p><b>BelmoreT Wedge Stockpile area.</b> Photos from top of batter above the ballast accesss road - Double concrete barrier &amp; geofab ERSED controls. Volume of ponded water remains on top of platform retained in the stockpile bays. (No dirty water seen along bottom of batter/ballast access track)</p> <div></div> <div></div> | | | |

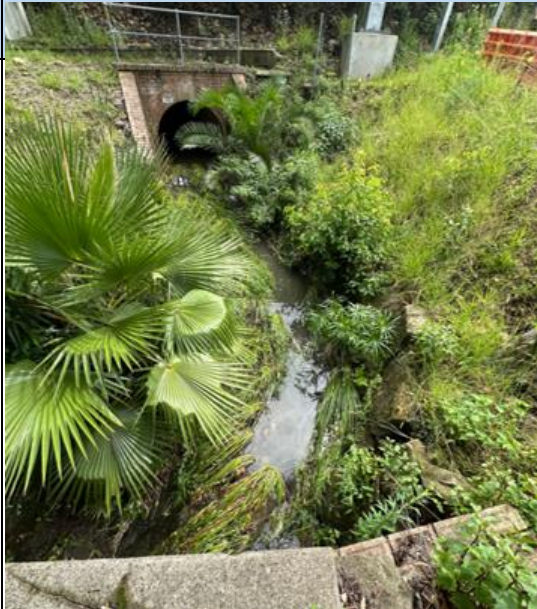
| Inspection Type: | JHLOR Construction Activities in area | Comments from waterways | Photos | | Additional Observations<br>Are there any impacts related to JHLOR construction works | Follow up action required | Outcome of follow up action |
|---|---|---|---|---|---|---|---|
| <b>Location 1</b><br><br>Dulwich Hill MSB (Ewart Culvert), country side of commuter car park | No work in this area in +- last 4 weeks<br><br>Surfaces alongside this culvert on the: <ul style="list-style-type: none"><li>west side around the culvert is stabilised – vegetation and heavy leaf litter.</li><li>East side (alongside MSB) stabilised with vegetation and geofab cover</li></ul> . | <b>Water clarity and colour:</b><br>Low flow water in main culvert looks slightly turbid.<br><br><i>Side inlet on LHS:</i> Unknown upstream source. No cloud plume in main culvert from inlet<br><br><i>Side inlet on RHS:</i> No cloud plume in main culvert from inlet on RHS.<br><br><b>Odour:</b> Nil<br><br><b>Description of flow and quantity/ Visible runoff (into the water body):</b> Currently low flow of water with signs of damage to vegetation.<br><br><b>Oil and Grease:</b> Nil<br><br><b>Details of any foreign objects within the water:</b> Nil<br><br><b>Other comments/description:</b> N/A | <br><br><b>LHS Inlet (Concrete Headwall)</b><br>Unknown upstream source. No cloud plume in main culvert from inlet<br><br><b>RHS Inlet (Black pipe)</b><br>No cloud plume in main culvert from inlet on RHS. | | JHLOR construction activites (for OHCB) at Ewart/Terrace Rd have been completed and surfaces have been stabilised since before the Xmas break. | | |

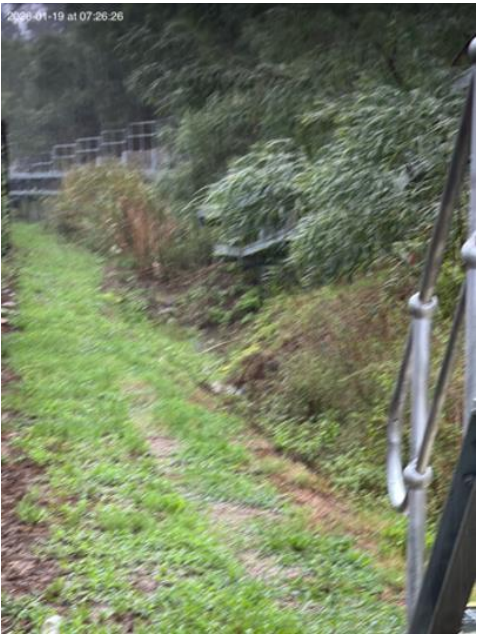
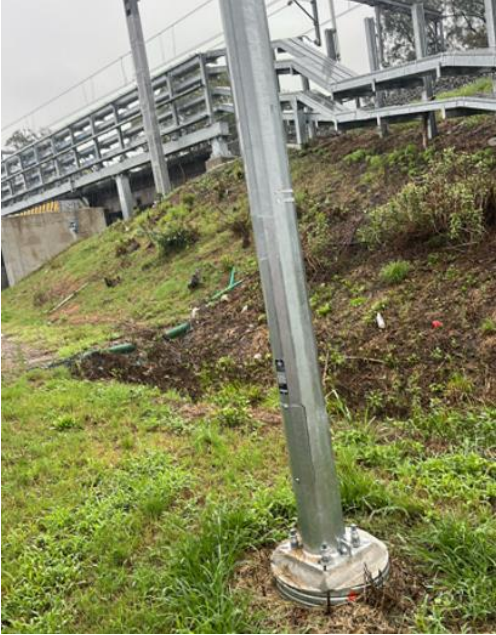
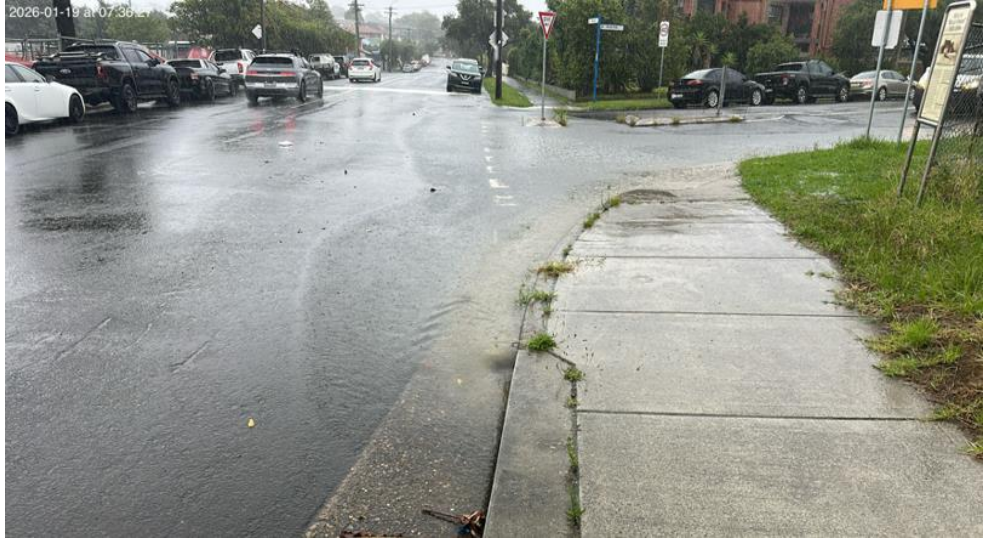
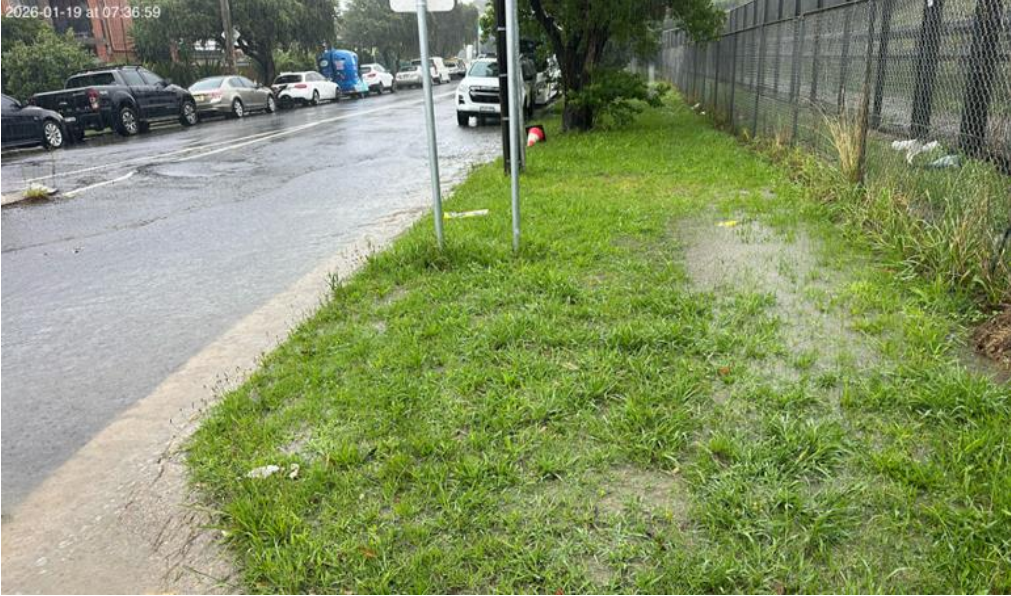
| Inspection Type: | JHLOR Construction Activities in area | Comments from Inspection of waterways | Photos | Additional Observations<br>Are there any impacts related to JHLOR construction works | Follow up action required | Outcome of follow up action |
|---|---|---|---|---|---|---|
| | <p>station. Corridor area is vegetated/stabilized all the way up to Campsie other than alongside the concrete crash barrier (Martinus).</p> <p>NOTE: Upstream photos taken along Wairoa, CB6 and locations near Gould St show turbid water flowing from corridor – unknown source but comes from under track culvert and is thought to be “legacy work” from Sydney Trains old work behind concrete barrier where they excavated into the open channel to release water from upstream</p> <p>Not from JHLOR works (no groundbreaking construction activities upstream).</p> | <p><b>Odour:</b> Nil</p> <p><b>Description of flow and quantity/ Visible runoff (into the water body):</b> High flow</p> <p><b>Oil and Grease:</b> Nil</p> <p><b>Details of any foreign objects within the water:</b> N/A</p> <p><b>Other comments/description:</b> N/A</p> | <p>Storm Water outlet at River</p> | <p>NOTE: Upstream photos taken along Wairoa, CB6 and locations near Gould St show turbid water flowing from corridor – unknown source but comes from under track culvert and is thought to be “legacy work” from Sydney Trains old work behind concrete barrier where they excavated into the open channel to release water from upstream</p> <p>Not from JHLOR works (no groundbreaking construction activities upstream).</p> | | |

| Inspection Type: | JHLOR Construction Activities in area | Comments from Inspection of waterways | Photos | Additional Observations<br>Are there any impacts related to JHLOR construction works | Follow up action required | Outcome of follow up action |
|---|---|---|---|---|---|---|
| | | | <p>Upstream Photos from Cooks River along Wairoa to the access gate CB6.</p> <div></div> | | | |

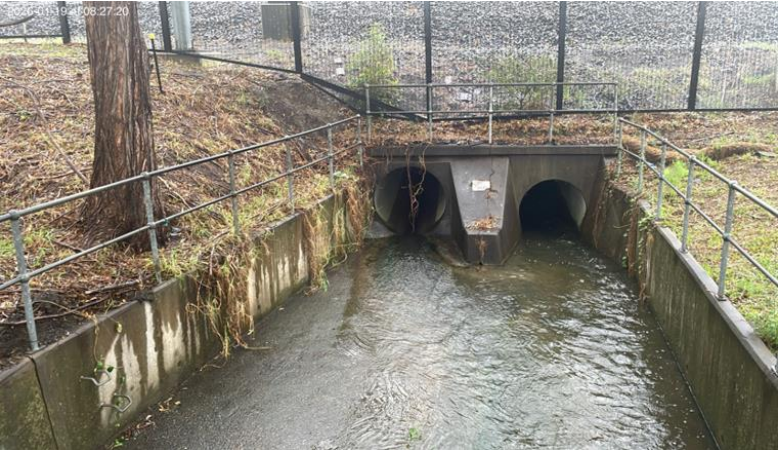
| Inspection Type: | JHLOR Construction Activities in area | Comments from Inspection of waterways | Photos | Additional Observations<br>Are there any impacts related to JHLOR construction works | Follow up action required | Outcome of follow up action |
|---|---|---|---|---|---|---|
| <b>Location 7ALT</b><br><br>City side of Bankstown DOWN track (near Stacey St) | <p>No JHLOR excavation activities have been carried out alongside the corridor near this location in the last 6-8 months.</p> <p>Area stable with heavy vegetation growth in corridor CESS and alongside culvert</p> | <p><b><u>Sth Side</u></b></p> <p><b>Water clarity and colour:</b> high flow, clear water</p> <p><b>Odour:</b> Nil</p> <p><b>Description of flow and quantity/ Visible runoff (into the water body):</b> see above.</p> <p><b>Oil and Grease:</b> Nil</p> | | | | |

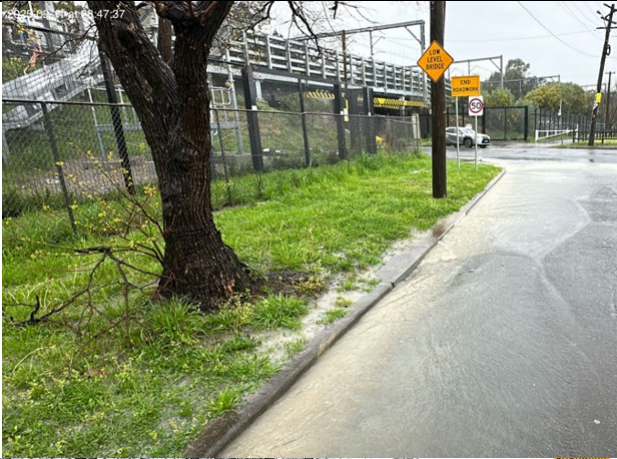
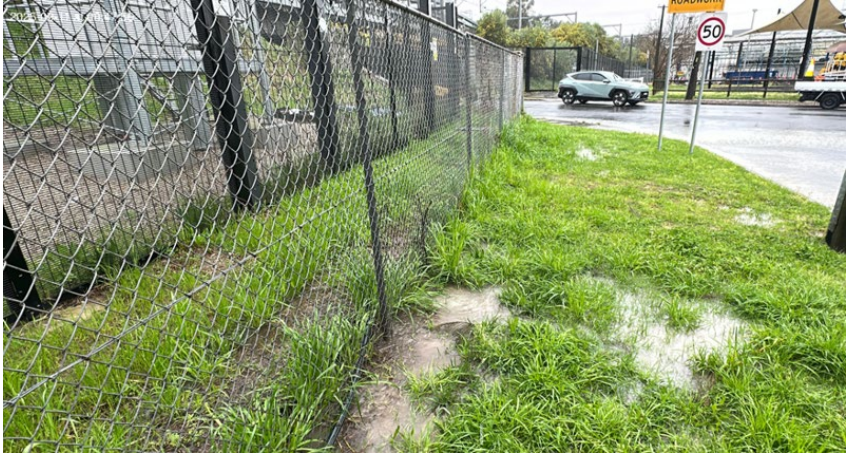
| Inspection Type: | JHLOR Construction Activities in area | Comments from Inspection of waterways | Photos | Additional Observations<br>Are there any impacts related to JHLOR construction works | Follow up action required | Outcome of follow up action |
|---|---|---|---|---|---|---|
| | | Other comments/description:<br>N/A | <div></div> <div></div> <div></div> <div>Upstream at Wairoa. No flow from acess gate CB6.</div> | | | |

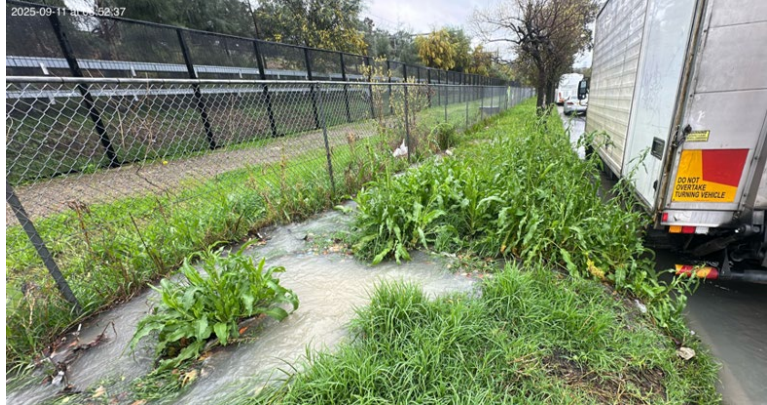
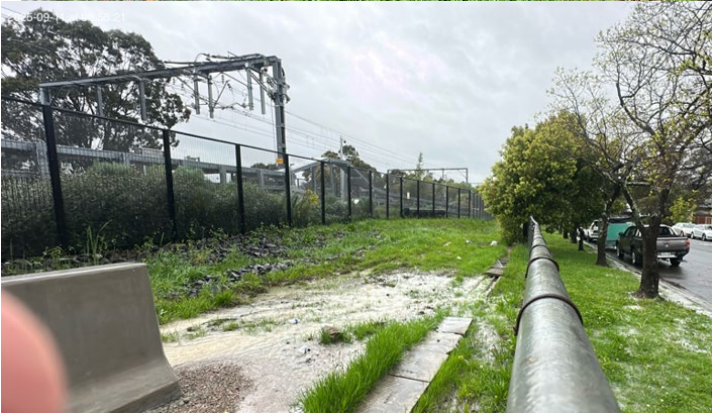
| Inspection Type: | JHLOR Construction Activities in area | Comments from Inspection of waterways | Photos | Additional Observations<br>Are there any impacts related to JHLOR construction works | Follow up action required | Outcome of follow up action |
|---|---|---|---|---|---|---|
| | | | <div></div> <p>Area at Gould/Park St. Slightly turbid water drains from corridor (ST old work behind concrete barrier where they excavated into the open channel to release water)</p> | | | |

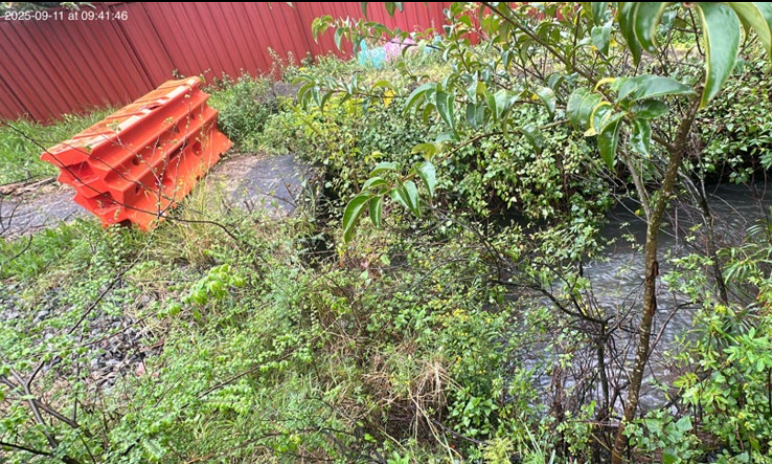
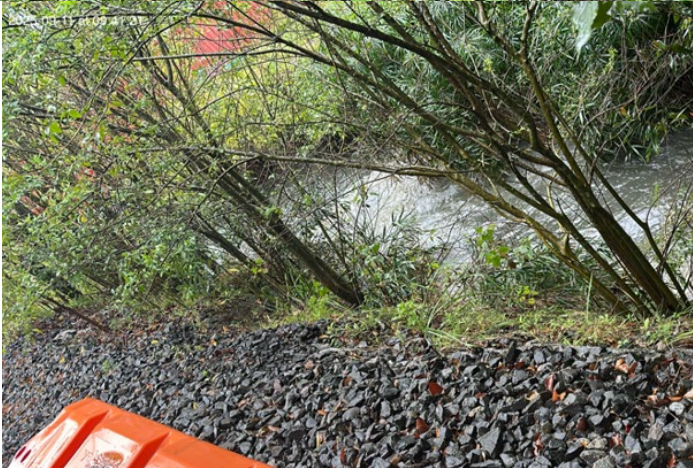
| Inspection Type: | JHLOR Construction Activities in area | Comments from Inspection of waterways | Photos | Additional Observations<br>Are there any impacts related to JHLOR construction works | Follow up action required | Outcome of follow up action |
|---|---|---|---|---|---|---|
| Location 4<br>Belmore Triangle Access Road | <p>BelmoreT – There is a ballast access road alongside this open channel</p> <p>Access track opens into BelmoreT transit space and also into Stockpile area at BelmoreT Wedge</p> | <p><b>Water clarity and colour:</b> Very Slightly turbid water through SW culvert.</p> <p><b>Odour:</b> Nil</p> <p><b>Description of flow and quantity/ Visible runoff (into the water body):</b> medium. No visible signs of sediment flow from ballast access road. Dirty water on track side of road is from truck wash along ballast road. None of this is draining into open culvert - It stays on this side and settles in vegetated pond.</p> <p><b>Oil and Grease:</b> Nil</p> <p><b>Details of any foreign objects within the water:</b> N/A</p> | <div></div> <p>SW outlet alongside access/ballast road. Very Slightly turbid water flows from inside culvert pipe.</p> | <p>This water outlet location is alongside a stabilized ballast track that allows access into BelmoreT Area</p> <p><b>Belmore Triangle Area:</b></p> <ol style="list-style-type: none"><li>1.Transit area.</li><li>2.Surface in the BelmoreT area is mostly covered by ballast.</li><li>3.There is a mid batter berm (mulch) in place to divide catchment (concrete barrier divider placed).</li><li>4.Thick vegetated area around lower sed fence at bottom of area. Mulch berm added.</li><li>5.No stockpiling of spoil in this area as it is only a transit point for plant and vehicles to hi-rail pad and BelmoreT wedge.</li></ol> <p><b>Belmore Triangle Wedge Area:</b></p> <p>Stockpiles (spoil and Engineered fill) are located on top of batter above the access road. No sign of spoil movement down slope onto ballast access road – see ponded water on side of ballast access track</p> <p>Stockpile area is flat.</p> | | |

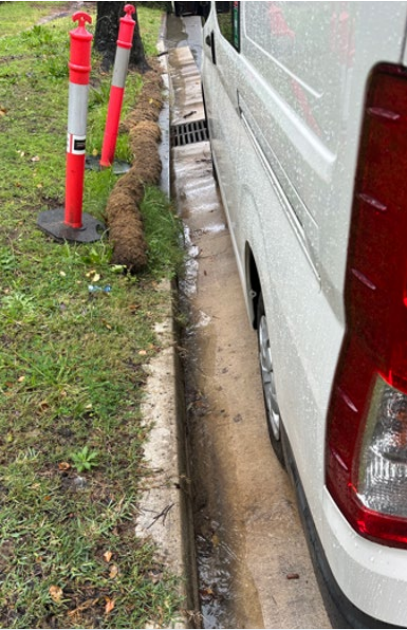
| Inspection Type: | JHLOR Construction Activities in area | Comments from Inspection of waterways | Photos | Additional Observations<br>Are there any impacts related to JHLOR construction works | Follow up action required | Outcome of follow up action |
|---|---|---|---|---|---|---|
| | | <b>Other comments/description:</b><br>N/A | <div></div> <div></div> <p><b>Redman Pde – Upstream Status &amp; Controls.</b> Lifted ERSED controls at drainage pit on Redman Pde. No access along Redman Pde for JHLOR trucks .... blocked by Council Work Site. Clear water flowing in kerb</p> | Top of batter at the spoil stockpiles is surrounded by double barrier and geofab curtain over barriers. | | |

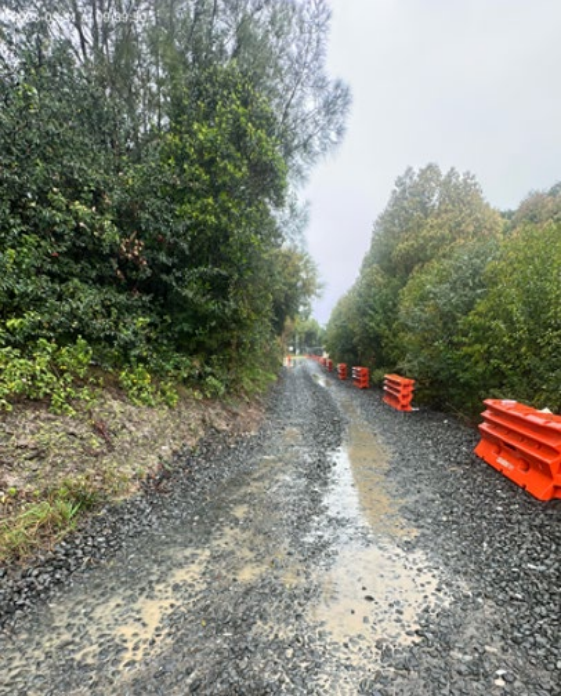
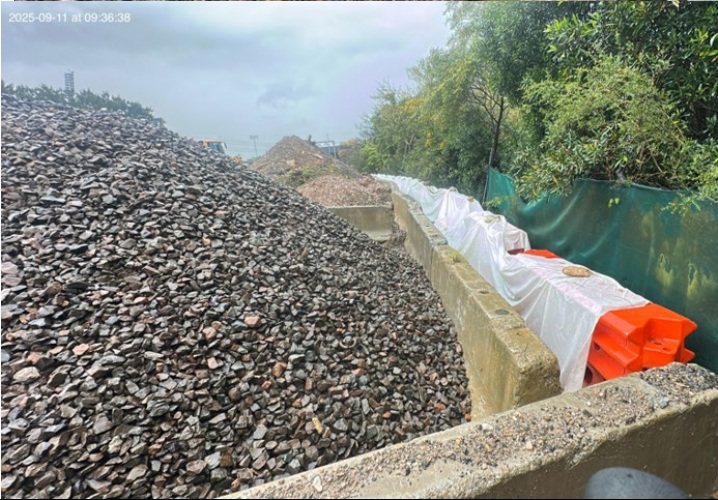
| Inspection Type: | JHLOR Construction Activities in area | Comments from Inspection of waterways | Photos | Additional Observations<br>Are there any impacts related to JHLOR construction works | Follow up action required | Outcome of follow up action |
|---|---|---|---|---|---|---|
| | | | <div><p><b>Toe of batter on side of ballast Access road</b> – Water ponds in this location (the signs of turbidity is from truck wheels).</p><p>NOTE: Dirty water does not drain to open culvert. Vegetated swale was checked alongside access – no signs of dirty water</p><div></div></div> | | | |

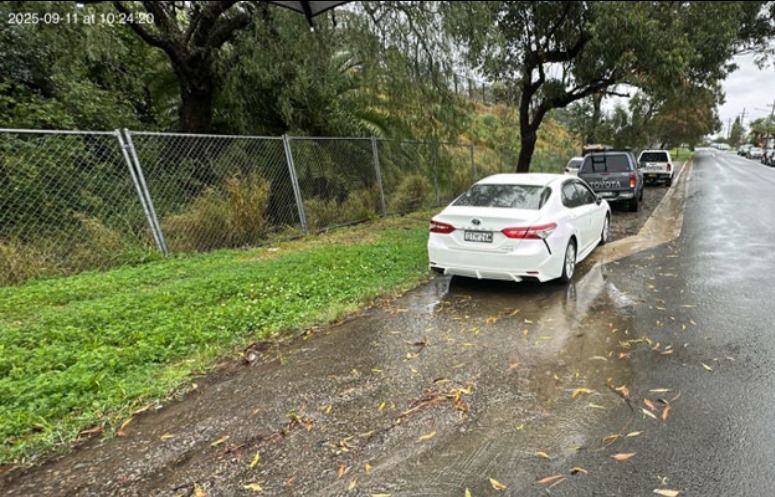
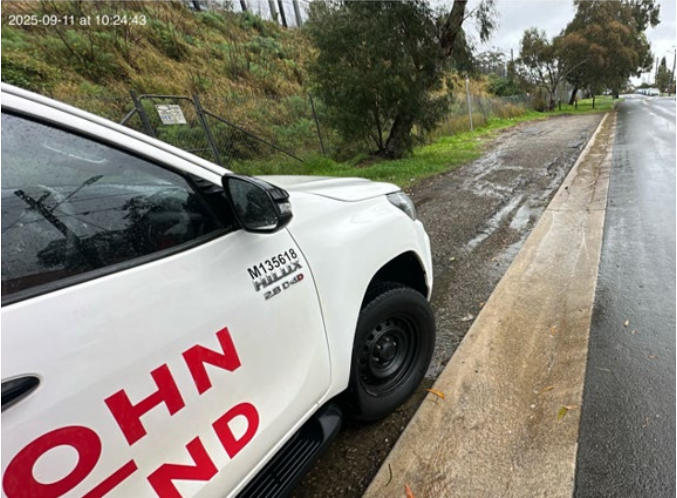
| Inspection Type: | JHLOR Construction Activities in area | Comments from Inspection of waterways | Photos | Additional Observations<br>Are there any impacts related to JHLOR construction works | Follow up action required | Outcome of follow up action |
|---|---|---|---|---|---|---|
| | | | <div><div></div><div></div></div> <p>Area upstream of Culvert on outside corridor – clear water flowing in channel</p> | | | |

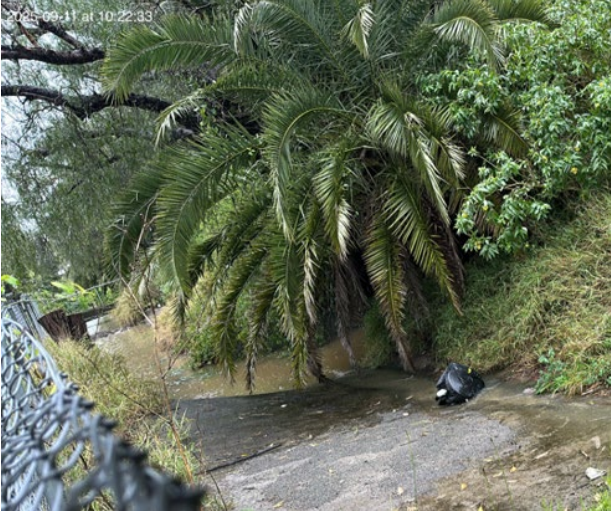
| Inspection Type: | JHLOR Construction Activities in area | Comments from Inspection of waterways | Photos | Additional Observations<br>Are there any impacts related to JHLOR construction works | Follow up action required | Outcome of follow up action |
|---|---|---|---|---|---|---|
| | | | <div><p><b>Western most culvert</b></p><p>High level, looks like standing water without flow. Turbid water through main culvert with very slightly turbid water flow from inlet on RHS.</p><p><b>Middle culvert:</b></p><p>High level, looks like standing water without flow. Turbid water through middle culvert</p></div> | | | |

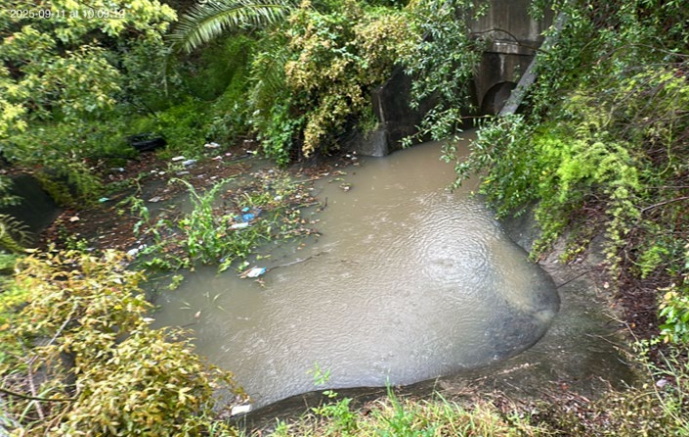
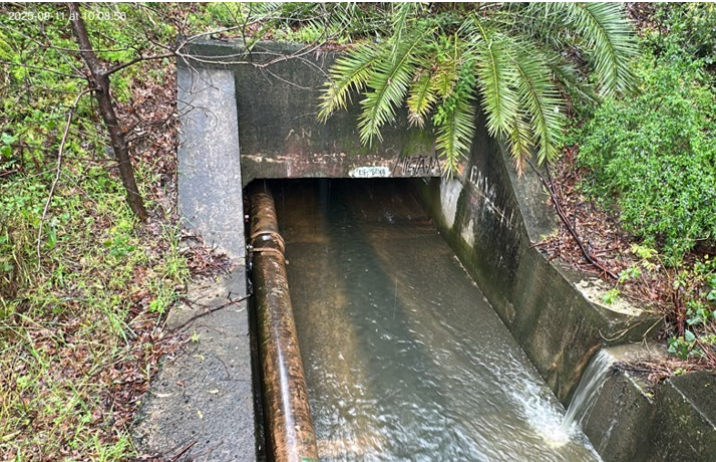
| Inspection Type: | JHLOR Construction Activities in area | Comments from Inspection of waterways | Photos | Additional Observations<br>Are there any impacts related to JHLOR construction works | Follow up action required | Outcome of follow up action |
|---|---|---|---|---|---|---|
| | | | <div><p><b>Middle culvert</b> – Turbid water draining off batters. Leaf litter on surface.</p><p><b>Eastern most Culvert</b> – high flow, slightly turbid water through main culvert.</p></div> | | | |
