## Pre-Construction Minor Works Approval Form

Part 1: Application	
<b>Contractor:</b>	John Holland & Laing O'Rourke joint venture (JHLOR)
<b>Project:</b>	Sydenham Station and Junction
<b>Application Title:</b> (e.g. Smith St trenching works)	Enabling Works Site wide
<b>Application Number:</b>	SSJ-PCMW-005 Document number: SMCSWSSJ-JHL-WSS-EM-REC-000001
<b>Application Date:</b>	Rev01 - 20/04/2018 Rev02 – 11/05/2018
<b>Planning Approval:</b>	Sydney Metro City and Southwest – Chatswood to Sydenham - Environmental Impact Statement Sydney Metro City and Southwest - Environmental Impact Statement – Sydenham Station and Sydney Metro Trains Facility South Modification Report (MOD 4) Sydney Metro City and Southwest - Environmental Impact Statement – Sydenham Station and Sydney Metro Trains Facility South Modification Submissions Report Sydney Metro City and Southwest Infrastructure Approval SSI 7400 (as modified)
<b>Minor Works Categories:</b> <ul style="list-style-type: none"> <li>Highlight as applicable.</li> <li>If Items 4, 8 or 11 are applicable, this form must be endorsed by an Environmental Representative.</li> </ul>	<ol style="list-style-type: none"> <li>Survey, survey facilitation

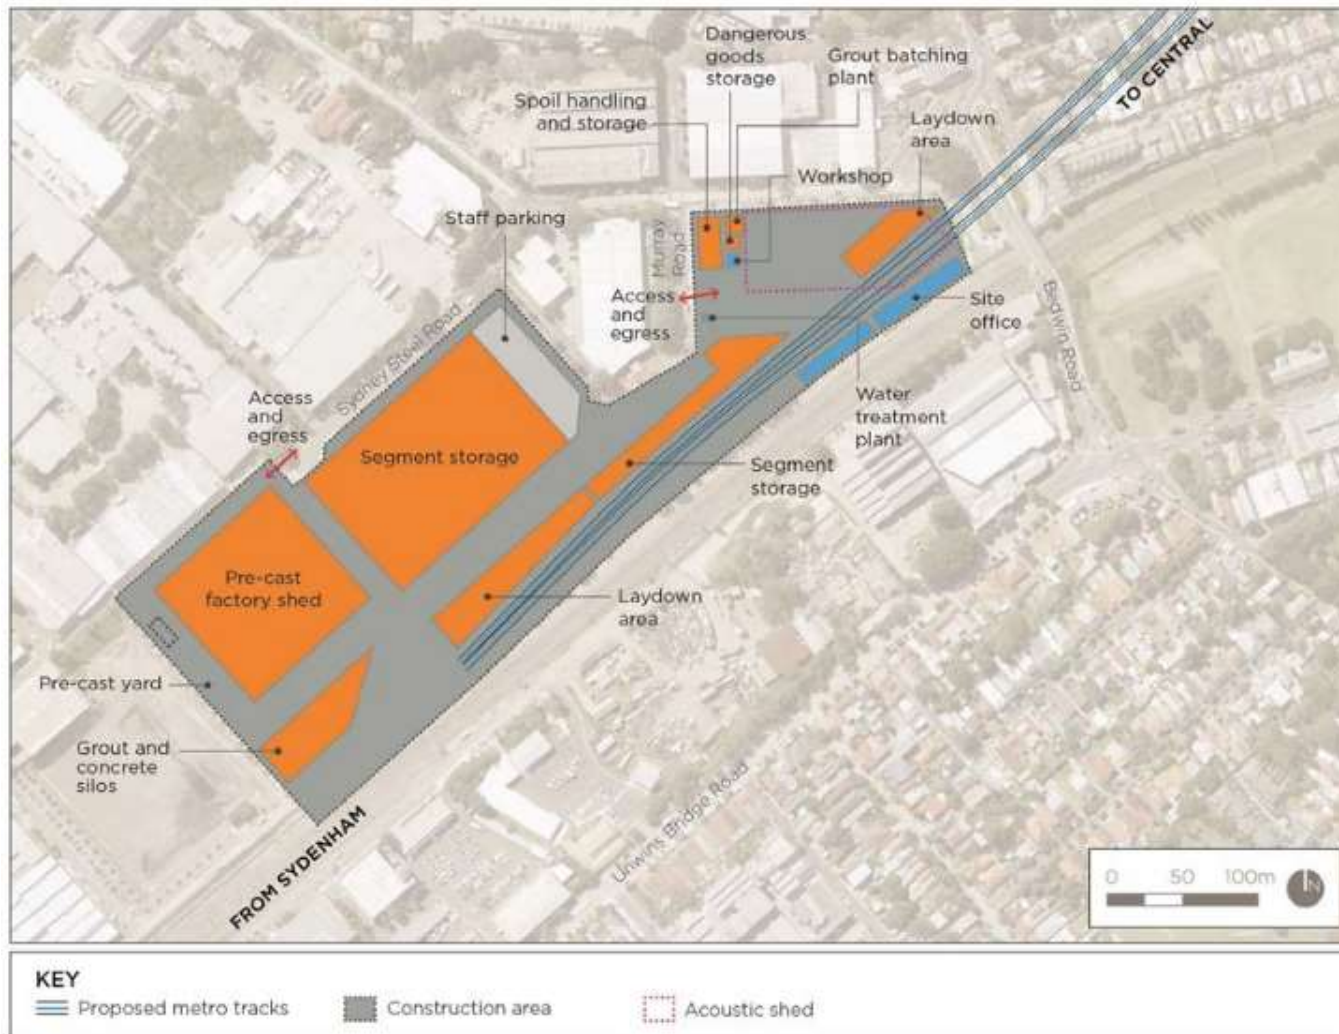
Figure 1-2: Key features of the Marrickville Dive Site and Southern Support Facility

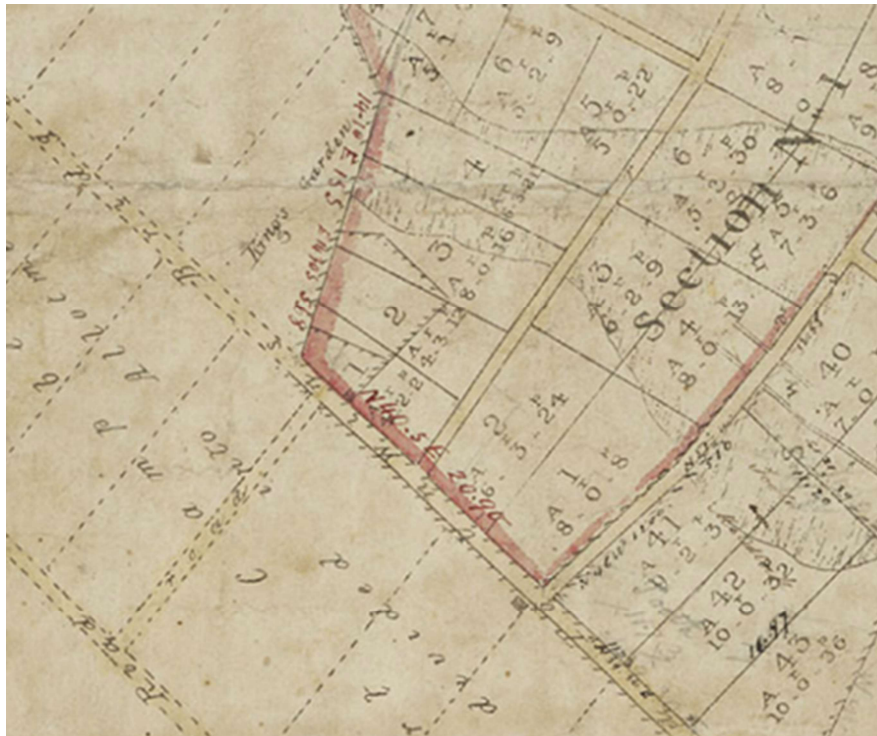
**Figure 2-3: Detail from J. Allans plan of Sydenham Farms. Swamp Road and Unwin's Bridge Road. The approximate location of Sydenham Station is arrowed. Plan no. 1 / J. Dating between 1840 and 1850. SLNSW M2 811.1826/1840/1.**

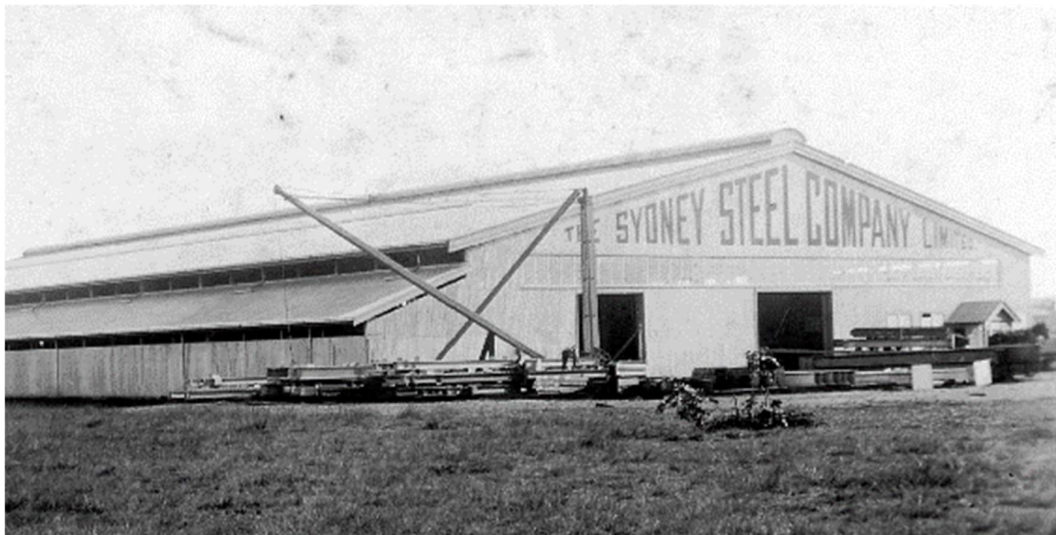
**Figure 2-8: The main workshop at the Edinburgh Road Marrickville Sydney Steel Company factory, 1911. Source. Stuart 2012 *Sydney Steel: An Illustrated History of the Sydney Steel Company 1910-1979*.**

In 1910, the Sydney Steel Company was established on a 22-acre site to the north of the rail line (within the Sydney Metro Trains Facility South Precinct boundary). This was a vast area of vacant land on the fringe of the city, adjacent to the main rail line and located between Sydenham and St Peters stations. Founded by Scottish migrant Alexander Stuart, the former Premier of NSW and Mayor of the former St Peters Council, the large factory was established on Edinburgh Road in Marrickville and supplied steel fabrication and distribution services to Sydney's expanding construction industry in the decades that followed (Figure 2-8).<sup>8</sup>

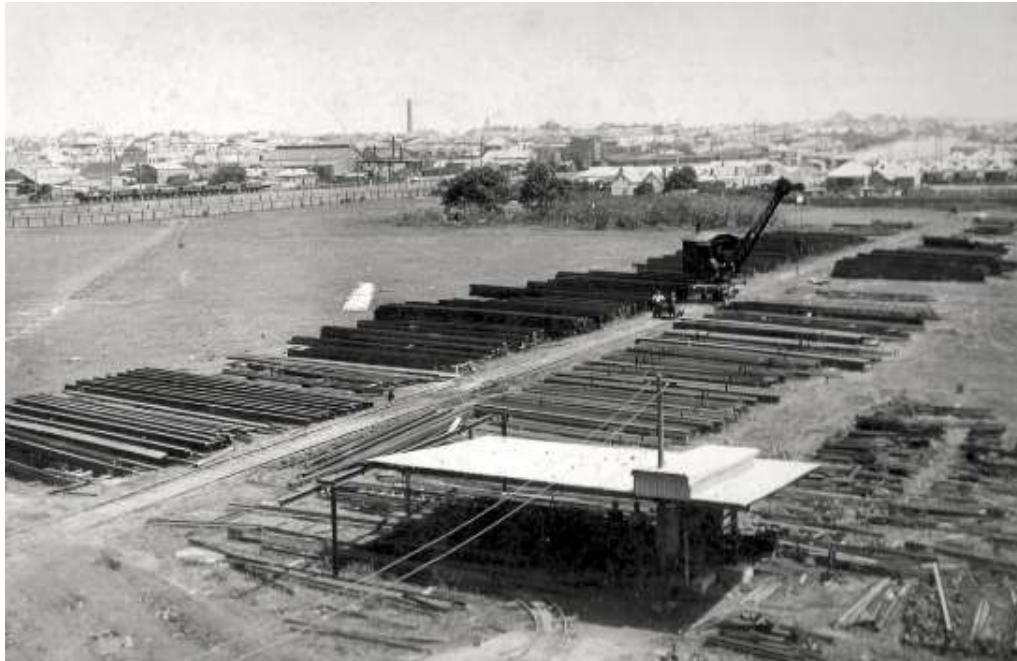
**Figure 2-9: Photograph of the stockyard at the rear of the Sydney Steel Company workshop, taken from the roof of the workshop looking south towards Sydenham Station, c1913. Source. Stuart 2012 *Sydney Steel: An Illustrated History of the Sydney Steel Company 1910-1979*.**

With merchandising of steel having been an important part of the company's business for several decades, the stockyard was originally laid out at the rear of the main Edinburgh Road workshop in 1913 (Figure 2-9 and Figure 2-10). A steam operated crane was installed in this location to move the stock.

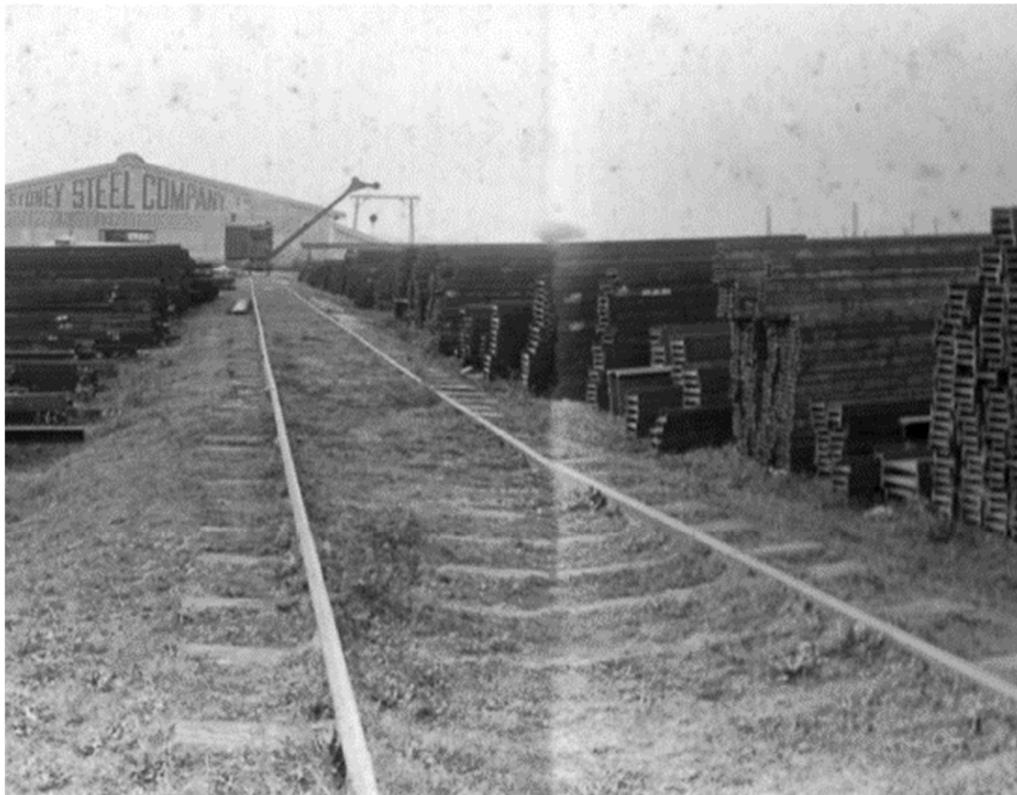
**Figure 2-10: Photograph of the stockyard at the rear of the Sydney Steel Company workshop, showing steam operated crane, c1913. Source. Stuart 2012 *Sydney Steel: An Illustrated History of the Sydney Steel Company 1910-1979*.**

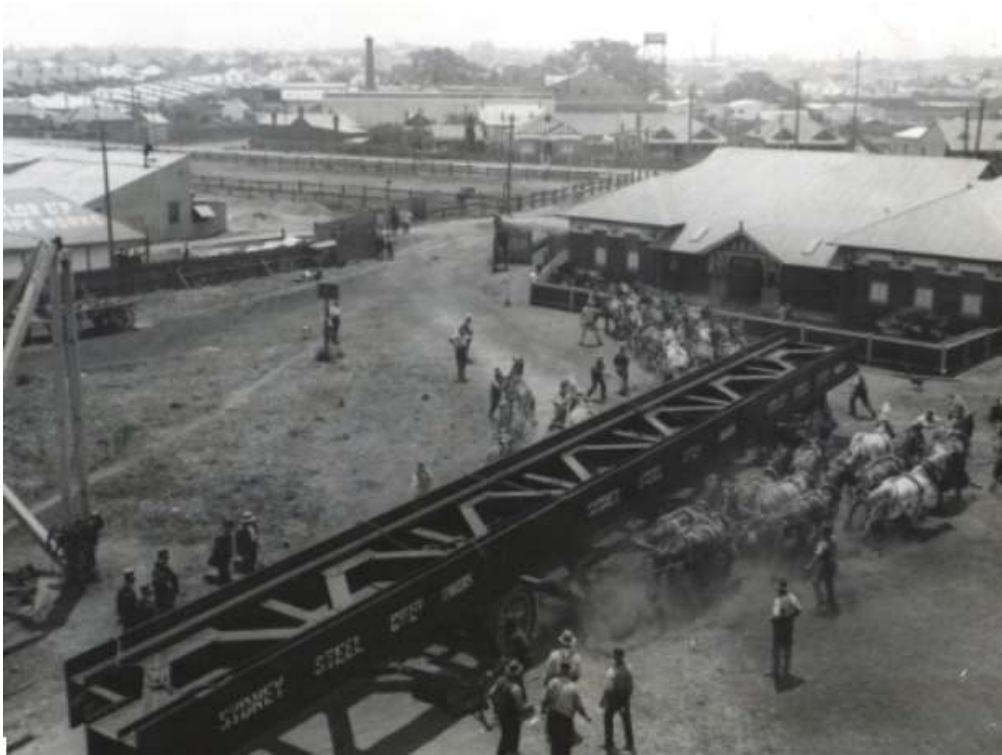
**Figure 2-11: View of the Sydney Steel Company, Marrickville in 1919. A 44-tonne girder is seen being transported on a custom-made horse drawn limber to a rail siding near Sydenham Station. Source. Stuart 2012 *Sydney Steel: An Illustrated History of the Sydney Steel Company 1910-1979*.**

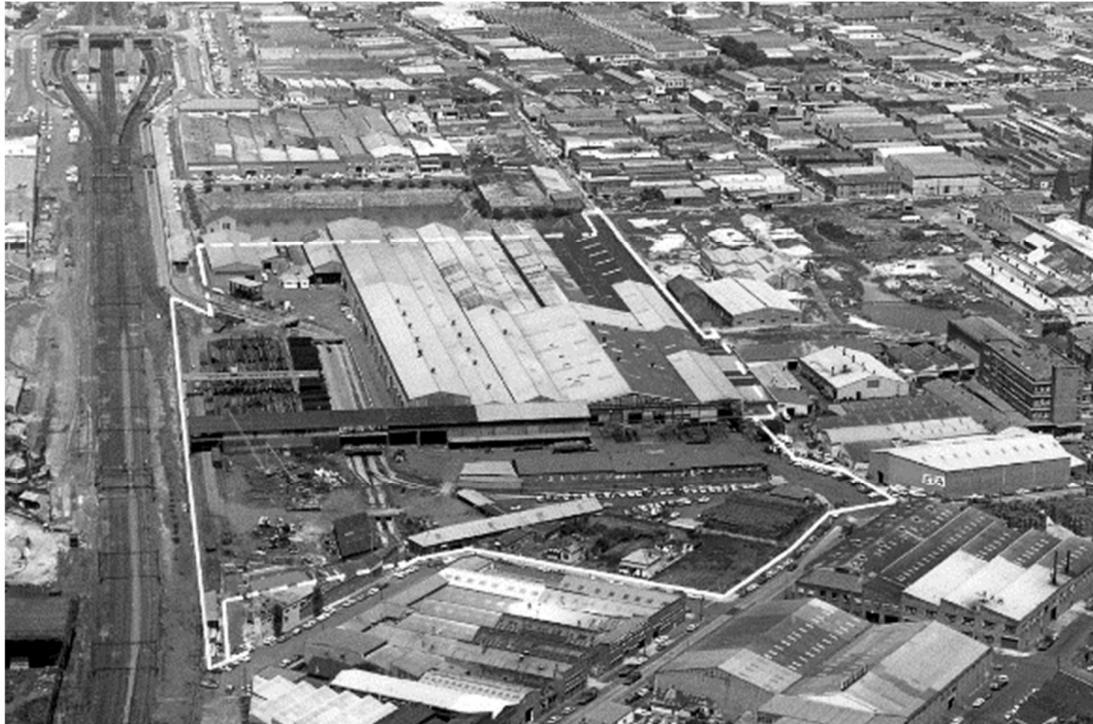
**Figure 2-14: Photograph of the Sydney Steel Company in Marrickville in 1962, showing crane and buildings on land adjacent to railway line. Source. Stuart 2012 *Sydney Steel: An Illustrated History of the Sydney Steel Company 1910-1979*.**

The post-World War II building boom resulted in significant expansion of the fabrication area at Edinburg Road during the 1950s. The stockyard was relocated adjacent to the rail line, where a giant crane was assembled, and additional buildings were constructed on the vacant land. By 1960, half of the 22-acre site had been developed as covered fabrication area. Sydney Steel Company had, by this time, become one of the largest employers in the suburb of Marrickville.

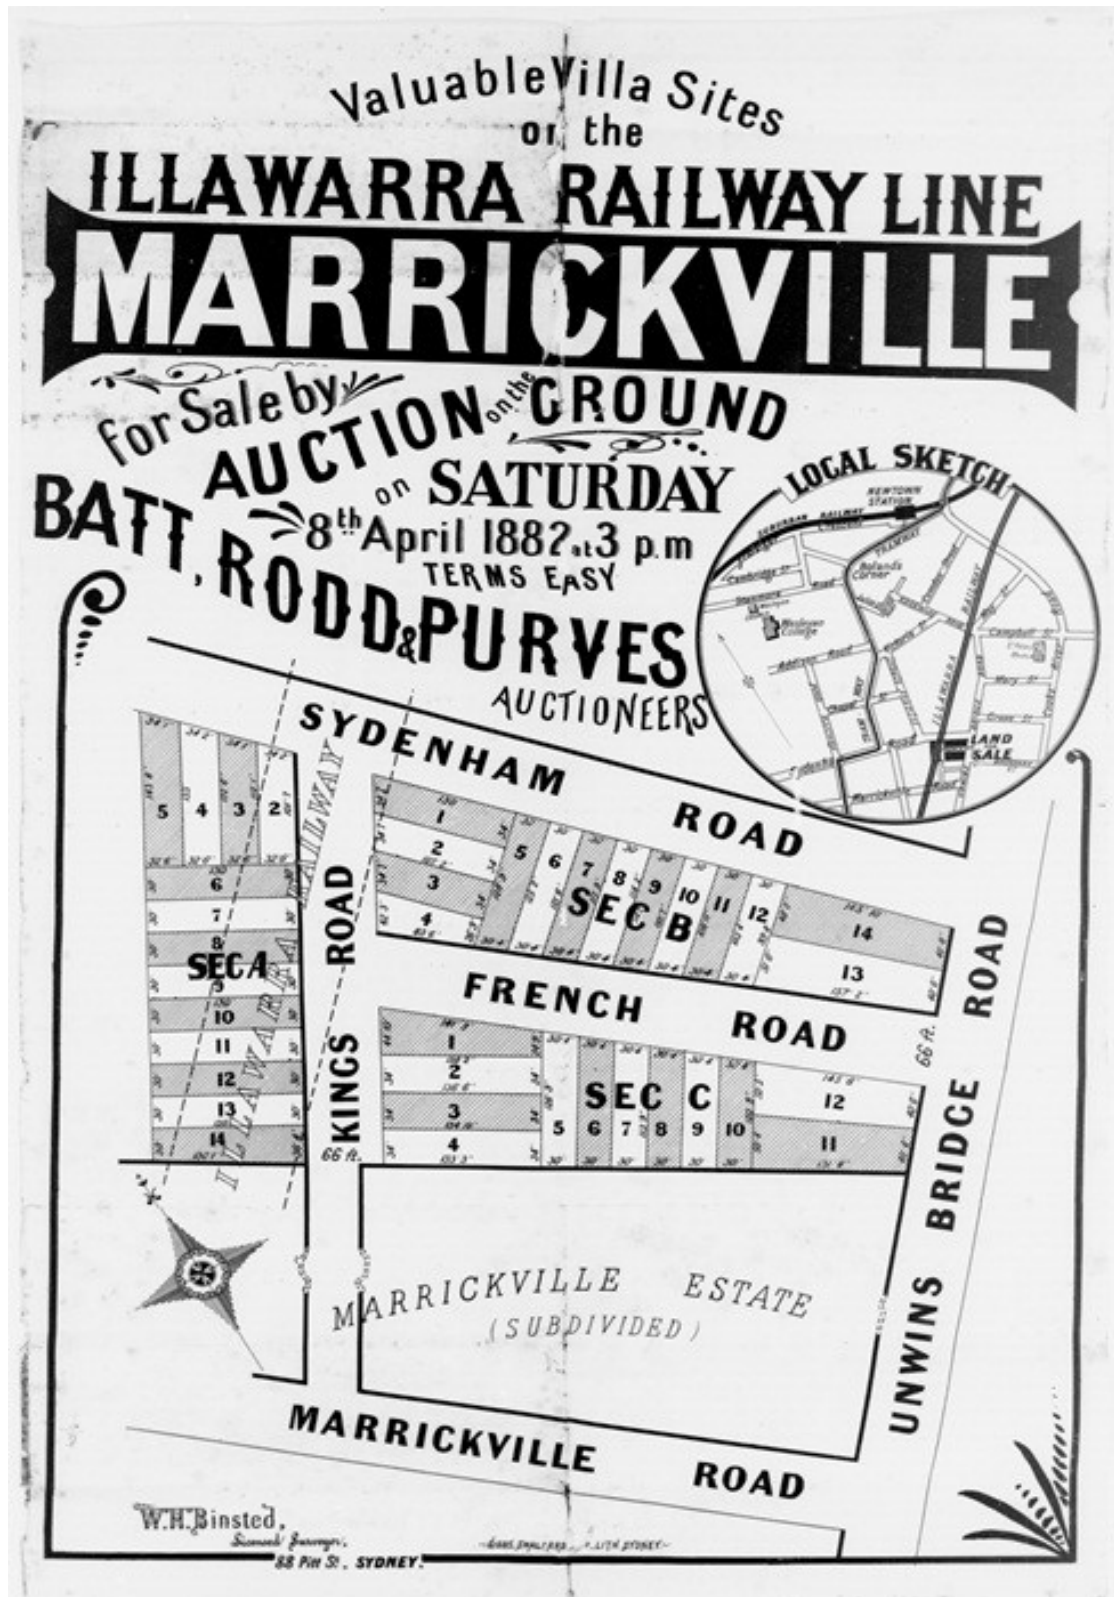
Figure 2-16: Subdivision plan from 1882 indicating the location of the proposed Illawarra Railway corridor. Source: Marrickville Library & History Services.

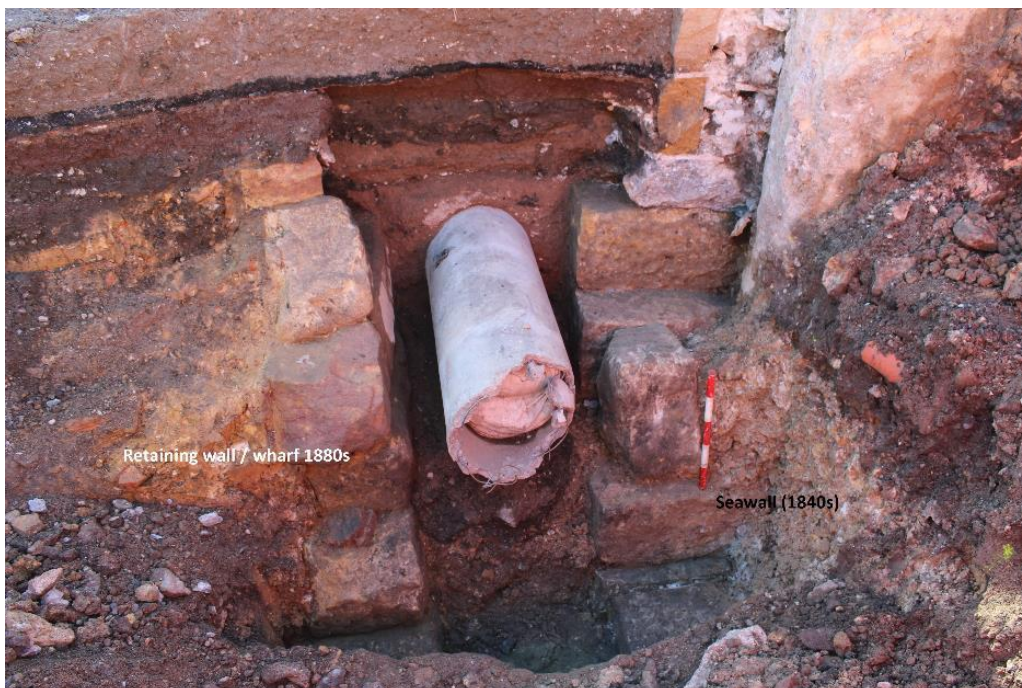
**Photo 3 1840s seawall and 1880s retaining wall uncovered at Balmain East, 2016**

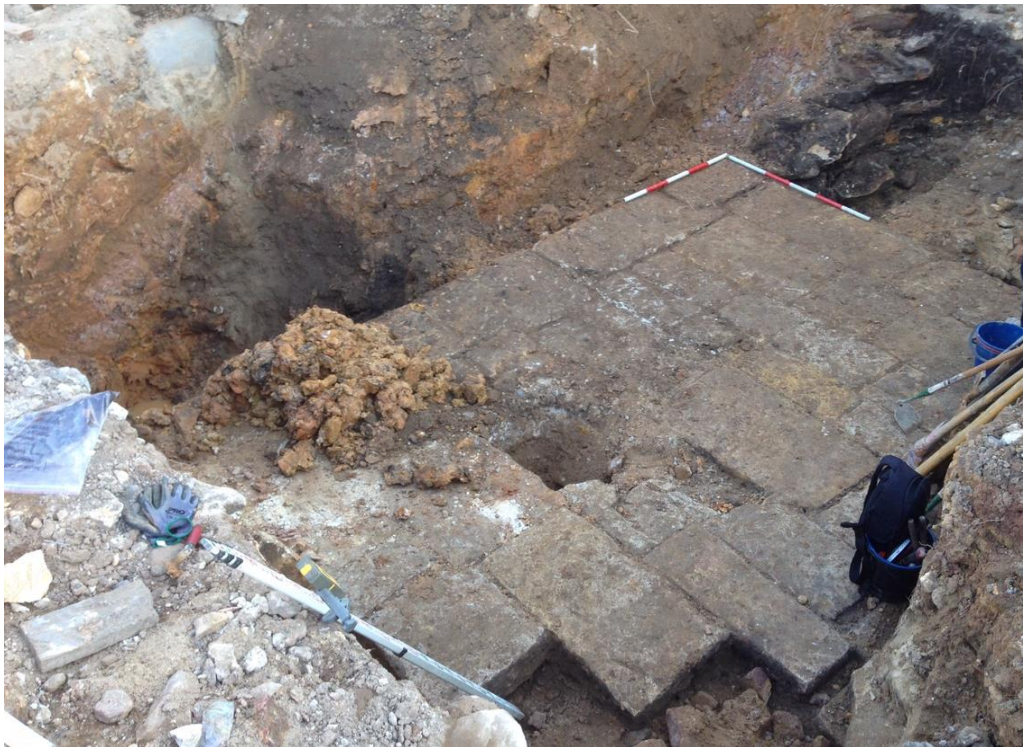
**Photo 4 Sandstone pavers uncovered at Balmain East, 2016**

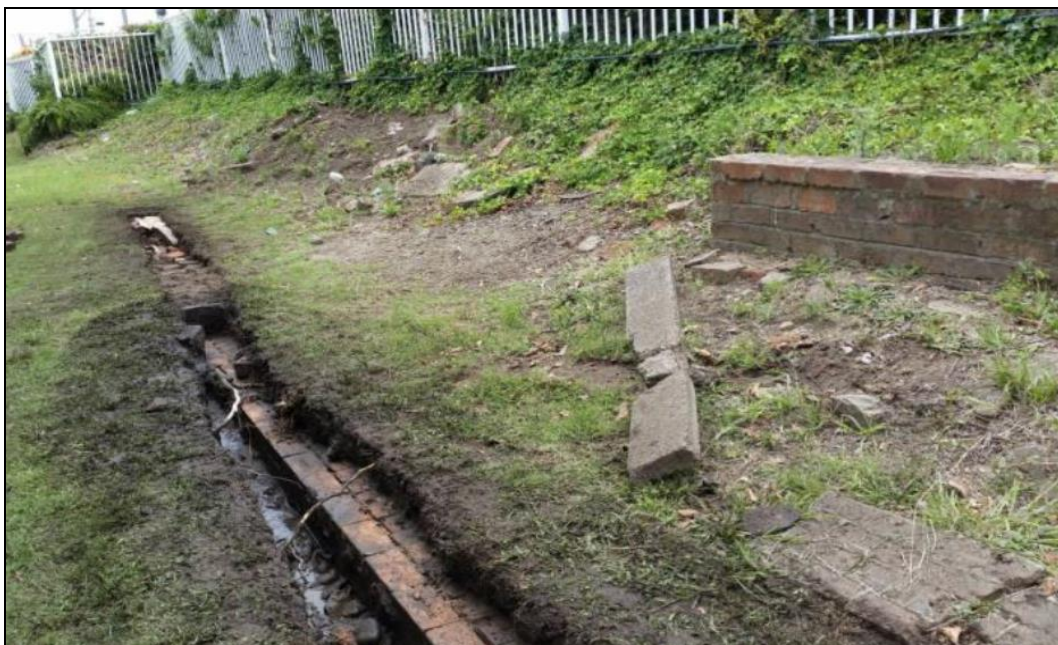
**Photo 5 - Platform structure at Hamilton Railway Station classified as a 'work' by the project archaeologist - Wickham Transport Interchange project, 2015**

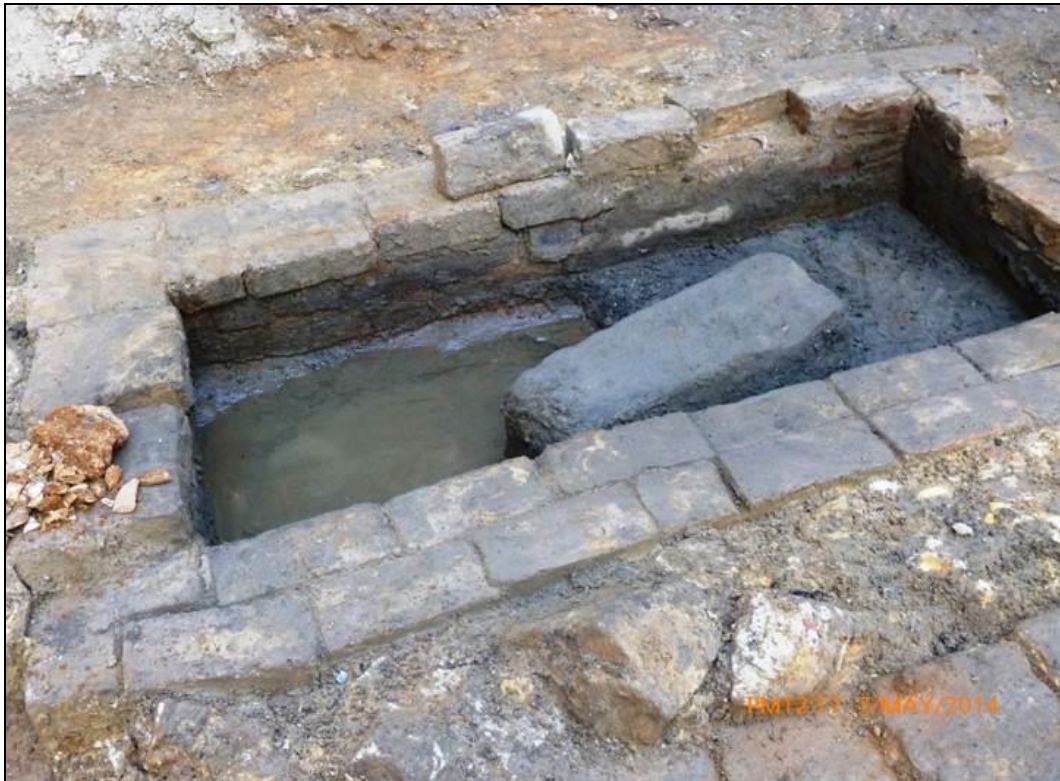
**Photo 7 - Sandstone flagging and cesspit - Wynyard Walk project, 2014**

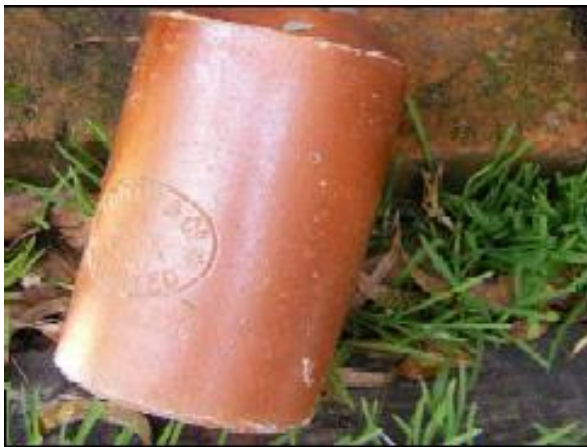
**Figure 3:** Ceramic bottle artefact with stamp.

Where unexpected items have a distinguishing feature, close up detailed photographs must be taken of these features, where practicable. In the case of a building or bridge, this may include diagnostic details architectural or technical features. See Figures 3 and 4 for examples.

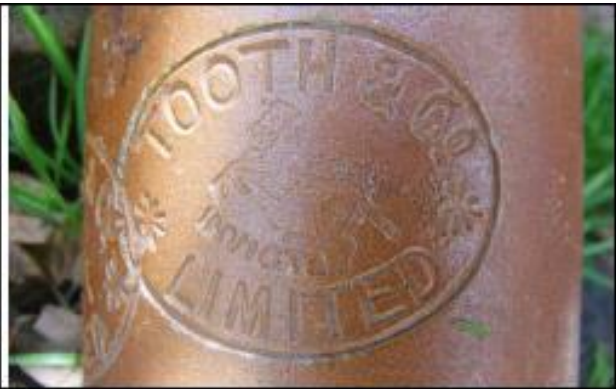
**Figure 4:** Detail of the stamp allows 'Tooth & Co Limited' to be made out. This is helpful to a specialist in gauging the artefact's origin, manufacturing date and likely significance.
