Pre-Construction Minor Works Approval Form

| Project: | Sydenham Station and Junction |
| Application Title: (e.g. Smith St trenching works) | Site Investigation and Utility Works within Sydenham Station and Sydenham Pit Heritage Curtilage |

SYDENHAM STATION AND JUNCTION
MINOR WORKS 004
HERITAGE IMPACT ASSESSMENT
4 MAY 2018

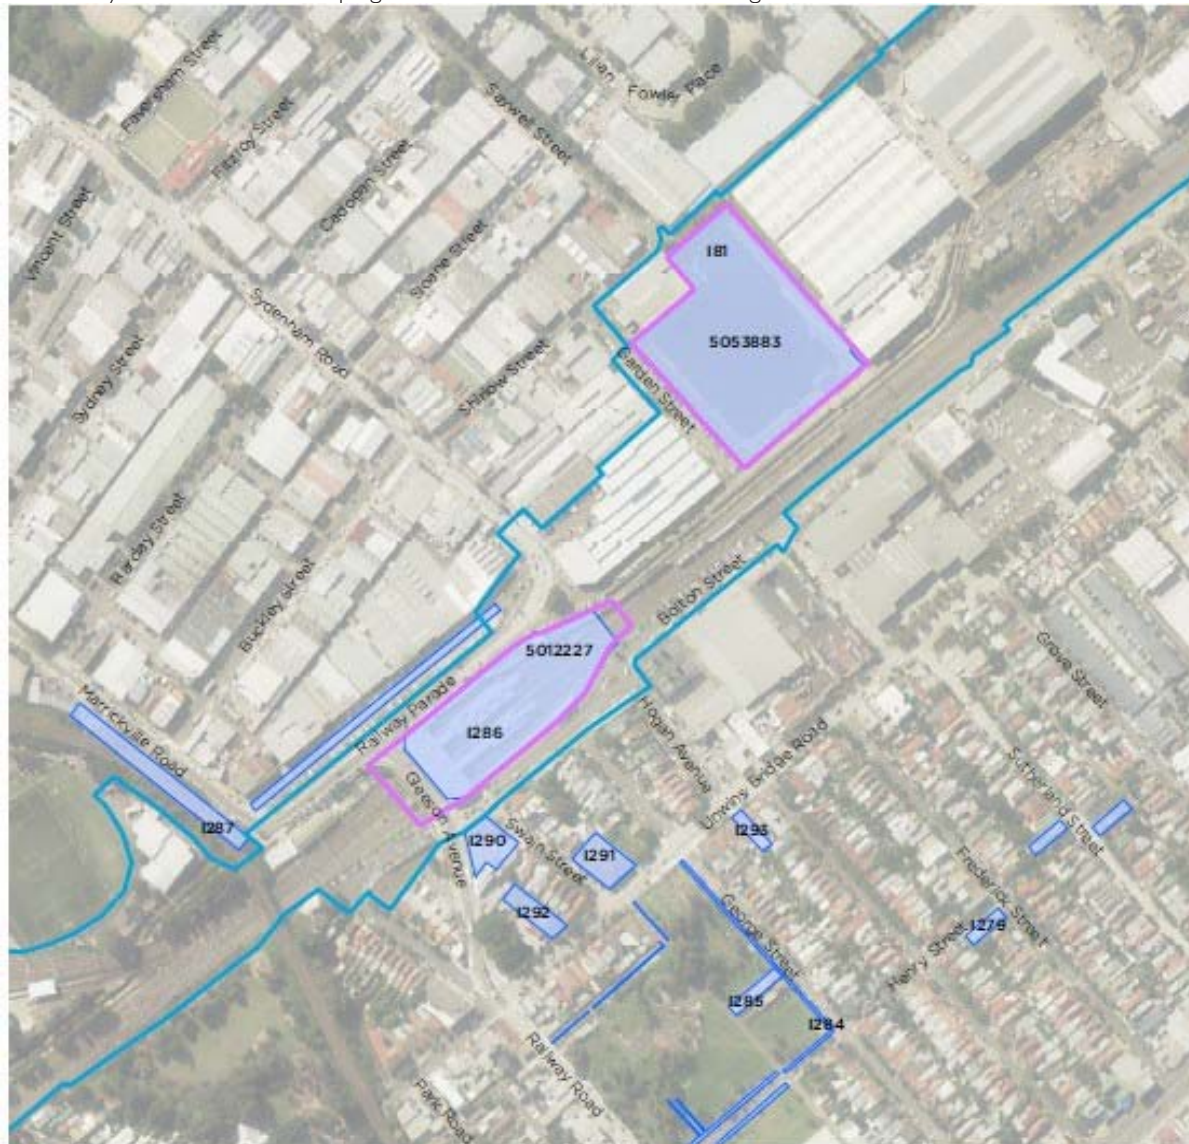
Figure 1 – Identification of heritage items within the vicinity of the Sydenham Station Precinct. (Source: Sydney Metro)

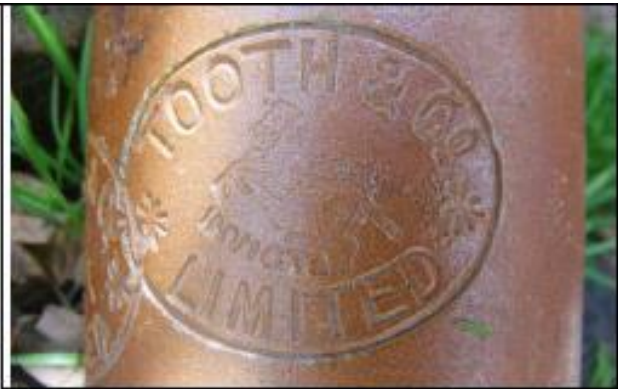
Figure 4: Detail of the stamp allows 'Tooth & Co Limited' to be made out. This is helpful to a specialist in gauging the artefact's origin, manufacturing date and likely significance.

Where unexpected items have a distinguishing feature, close up detailed photographs must be taken of these features, where practicable. In the case of a building or bridge, this may include diagnostic details architectural or technical features. See Figures 3 and 4 for examples.
